ALVEY TREE CONSULTING LLC

# Arborist Report

10 Star Island Drive  
Miami Beach

4/5/2019

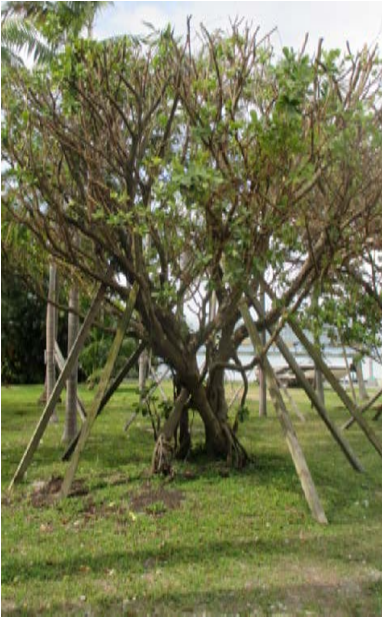
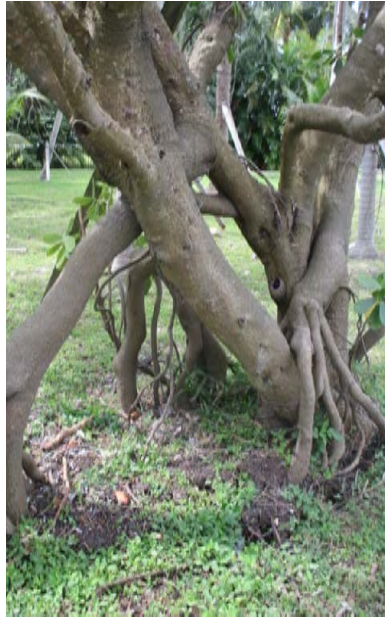
## Tree #97

Tree #97 is a Pitch-Apple located towards the rear of the property. It is in fair condition. It is multi-trunked and many prop roots are present. The DBH reflects the size of the two main leaders. Braces are currently around the tree. The canopy is on the thinner side, and numerous branches on the top of the crown have had heading cuts.

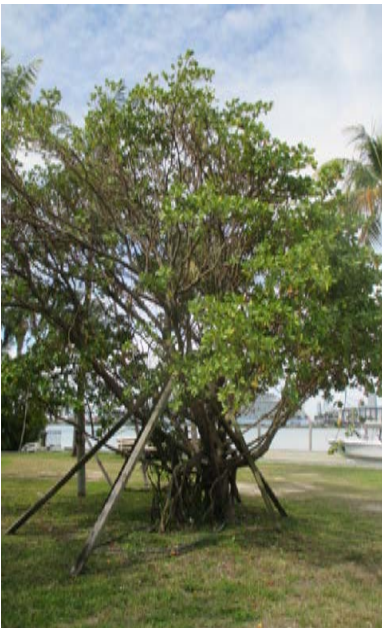
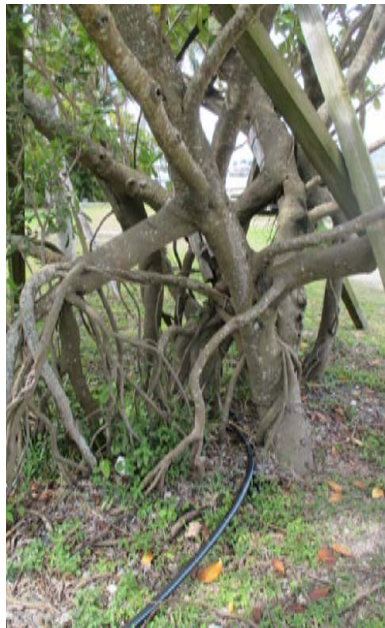
## Tree #98

Tree #98 is a Pitch-Apple located towards the rear of the property. It is in good condition. It is multi-trunked and many prop roots are present. The DBH reflects the size of the main leader. Braces are currently around the tree. There is a small amount of deadwood present and some interior foliage is yellow.

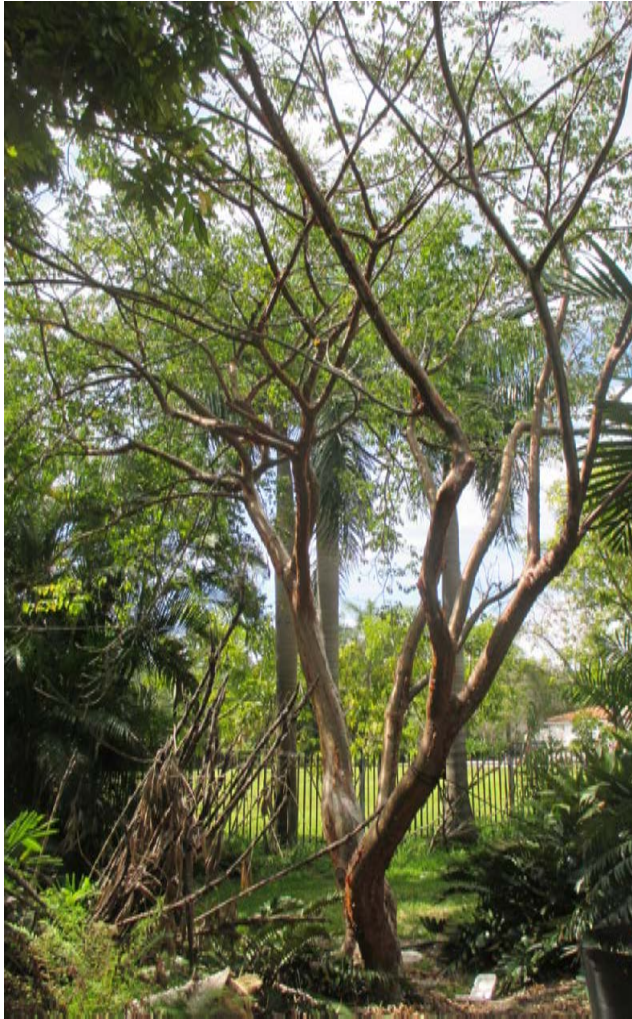
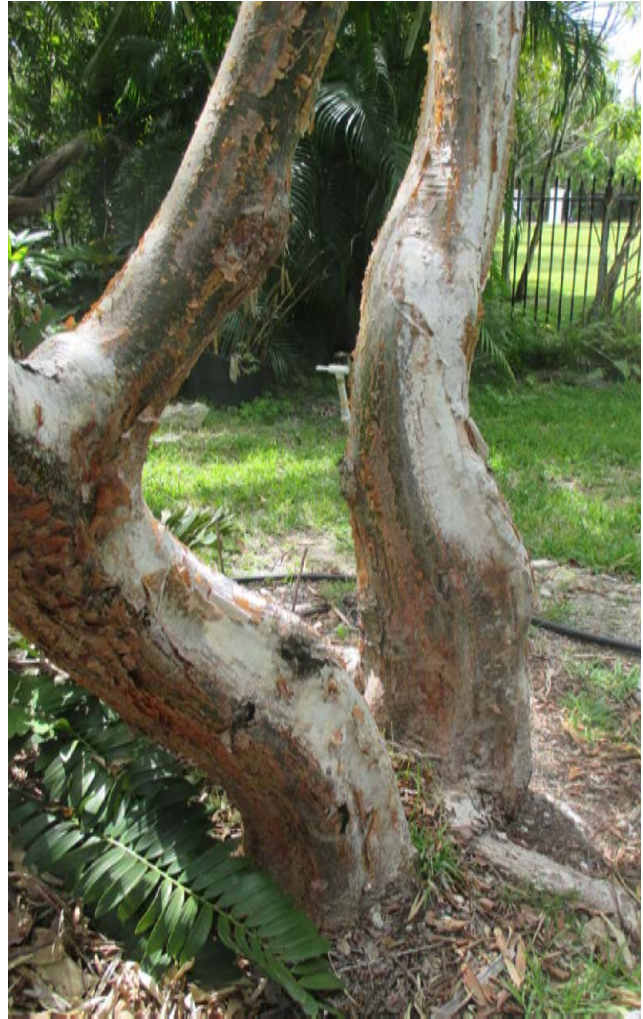
## Tree #111

Tree #111 is a double-trunked Gumbo Limbo located towards the front of the property. It is in good condition. The canopy is on the thin side, which may be because of the time of year, and there is a small amount of deadwood which can be pruned out.

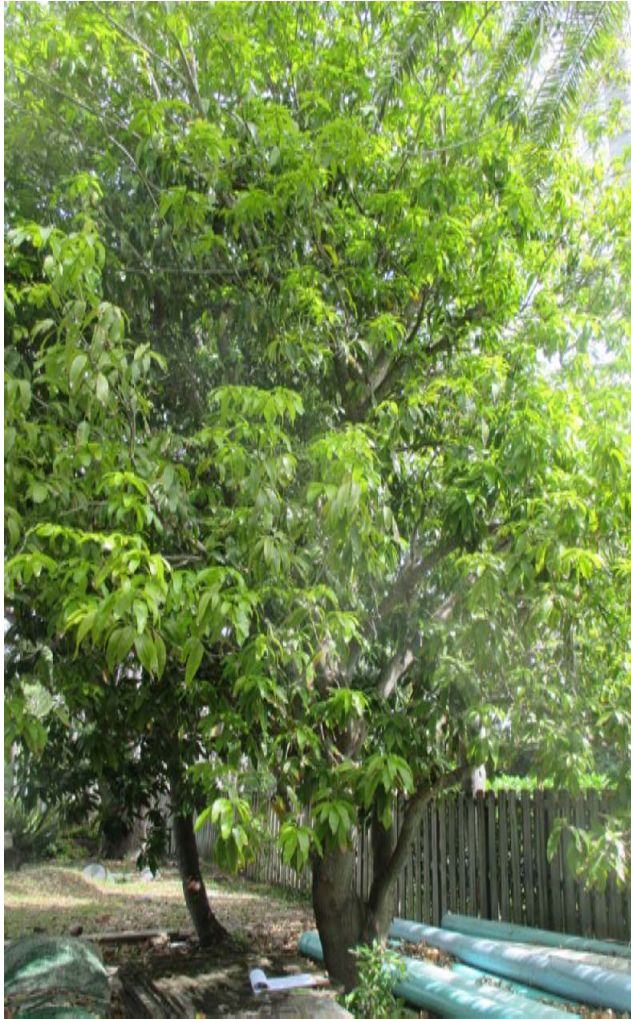
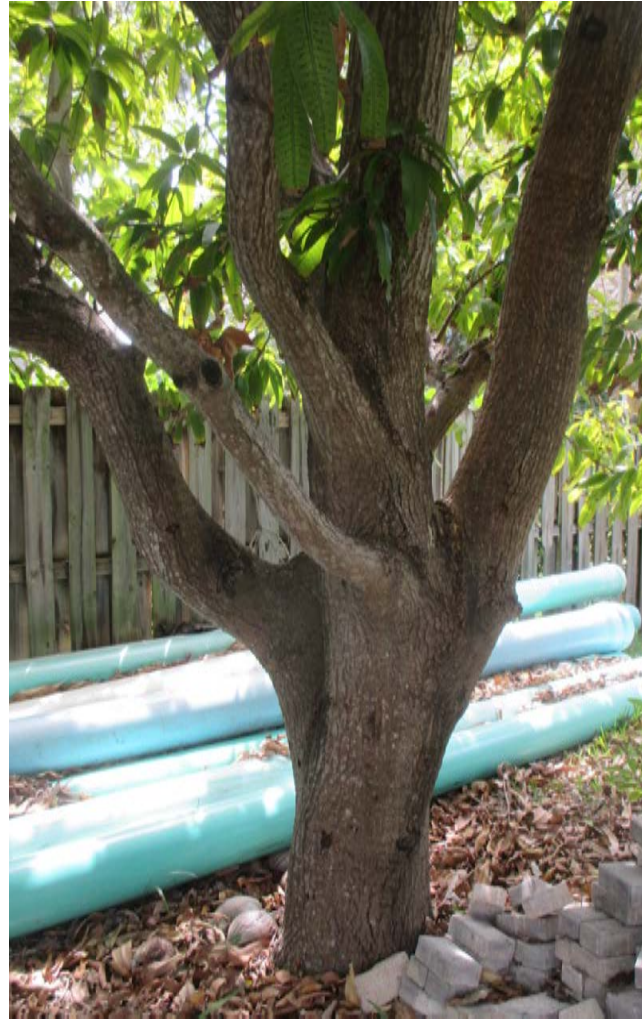
## Tree #113

Tree #113 is a Mango located the front of the property. It is in fair condition. It is multi-trunked and has a dense canopy. The foliage is somewhat chlorotic and there is necrosis on some of the leaf tips.

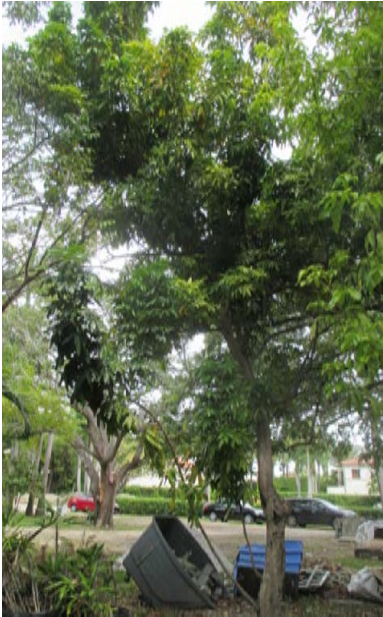
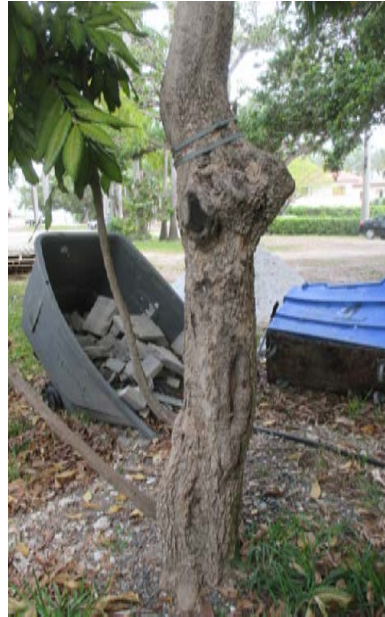
## Tree #114

Tree #114 is a Longan located towards the front of the property. It is in fair condition - there are multiple old trunk wounds that have nearly closed over, creating burls on the trunk. The foliage is somewhat chlorotic.

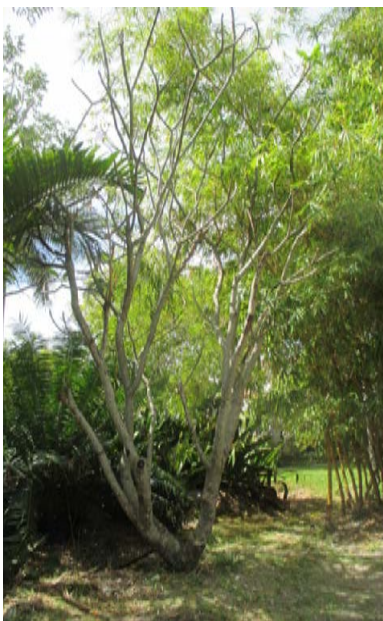
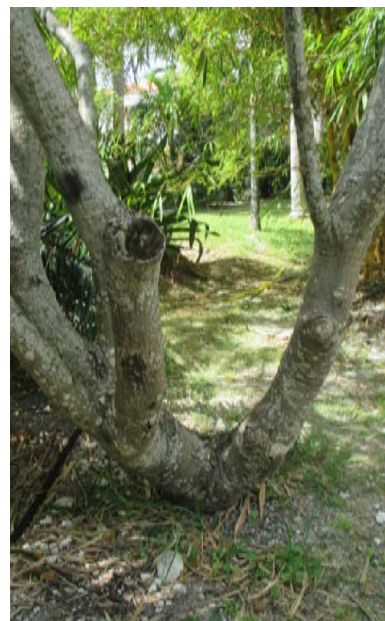
## Tree #115

Tree #115 is a Frangipani located towards the front of the property. It is in fair condition. There are no leaves at this time of year. The tree is multi-trunked and there is an old pruning cut with decay. The branch stubs should be pruned out.

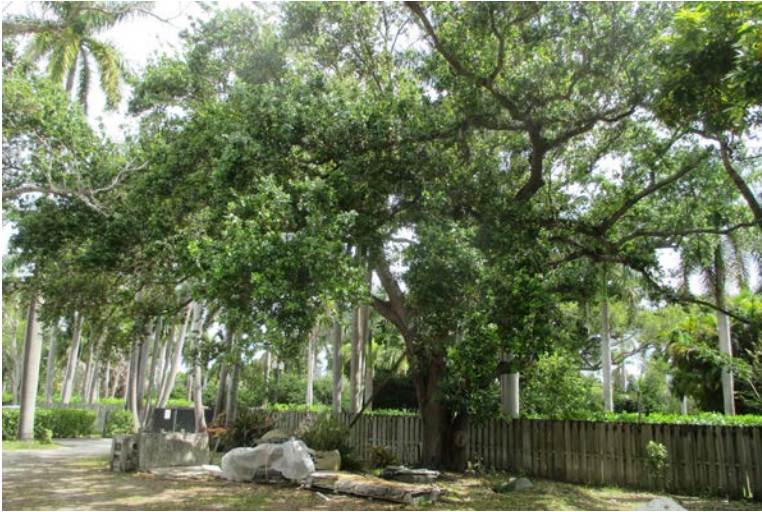
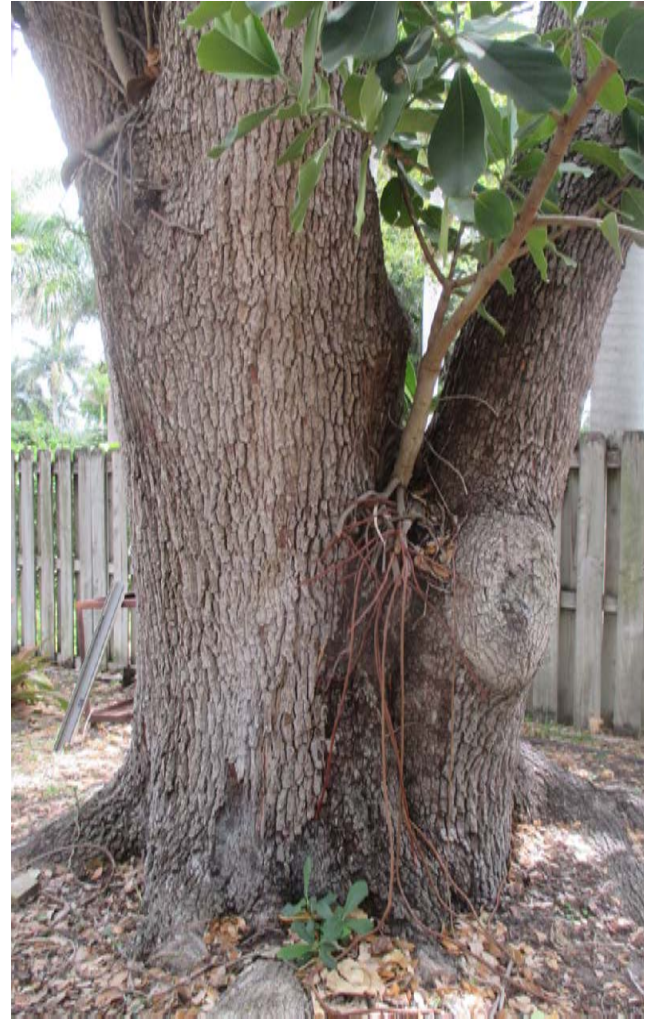
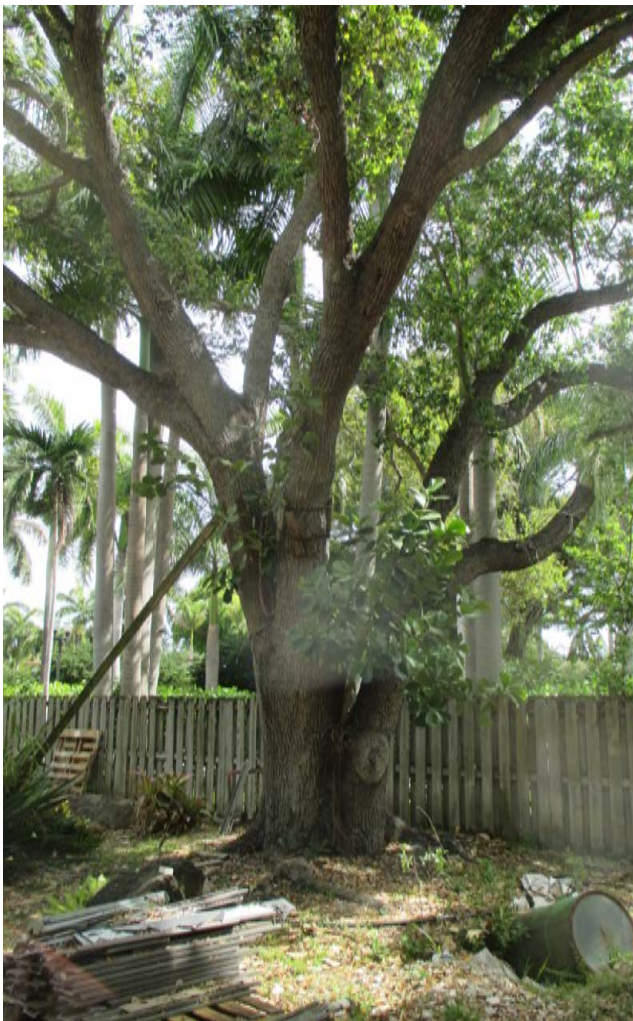
## Tree #117

Tree #117 is a large Live Oak located at the front of the property. It is in good condition, especially for a large, old tree. It is double-trunked with one smaller leader with an old wound present that has now closed over. The vegetation growing between the trunks should be removed. Included bark is present. The canopy is dense and wide-spreading. One limb that extended toward the street has been cut back. The trunk flare is clearly visible. The tree should be crown-cleaned for deadwood. This tree should be monitored on a periodic basis for health and structural integrity.

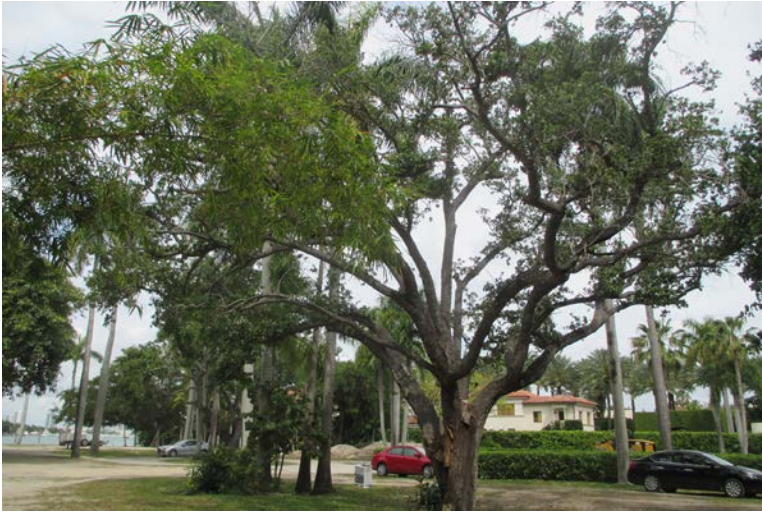
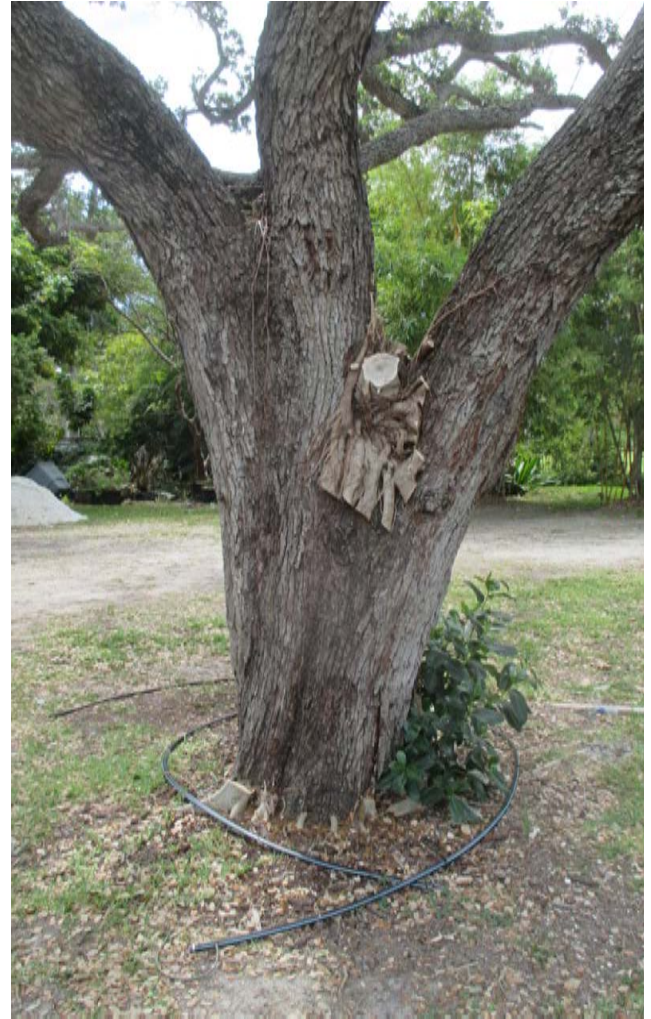
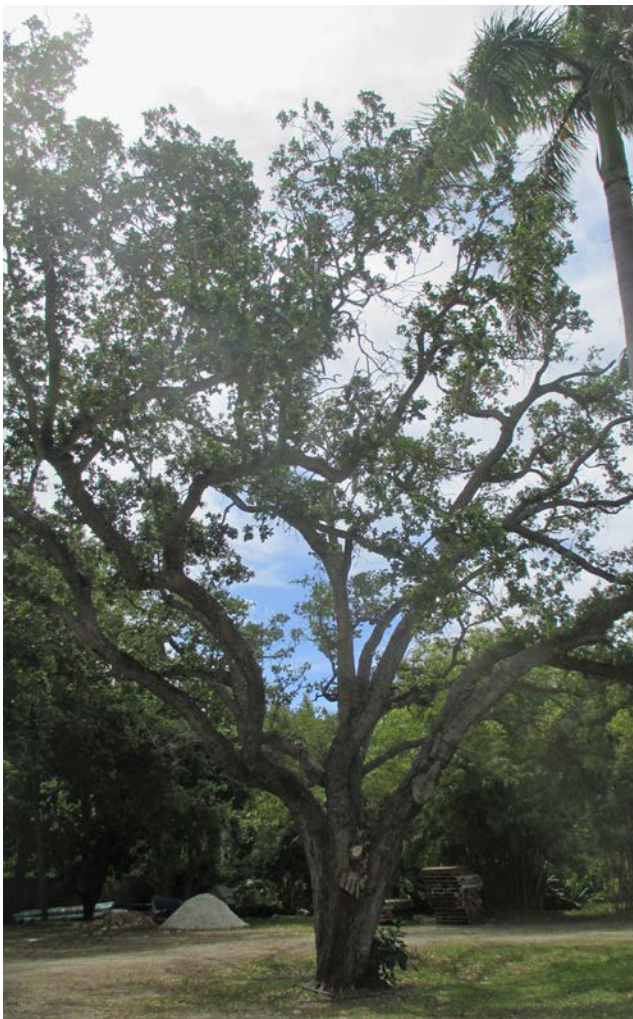
## Tree #118

Tree #118 is a Live Oak located towards the front of the property. It is in fair condition - the canopy is on the thinner side, and there is large diameter deadwood present. Epicormic shoots are growing along the limbs. Vegetation growing between the main leaders has recently been removed. Chainsaw injuries are present, but most are shallow and appear to have only penetrated the outer bark. There are multiple old pruning wounds throughout the tree that have closed over. The tree should be crown-cleaned for deadwood. This tree should be monitored on a periodic basis for health and structural integrity.

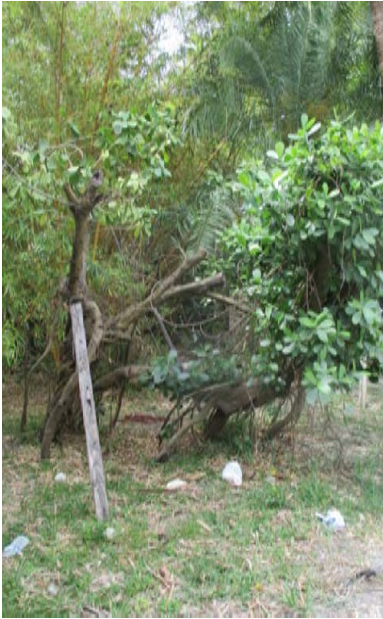
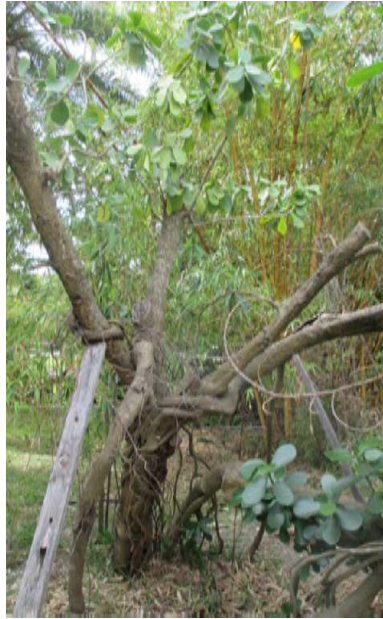
## Tree #123

Tree #123 is a Pitch-Apple located towards the center of the property. It is in poor condition. It is multi-trunked and many prop roots are present. The DBH reflects the size of the two main leaders. Braces are currently around the tree. The canopy has been hatracked and heavily cut back. Half the tree has very little regrowth, and may need to be removed.

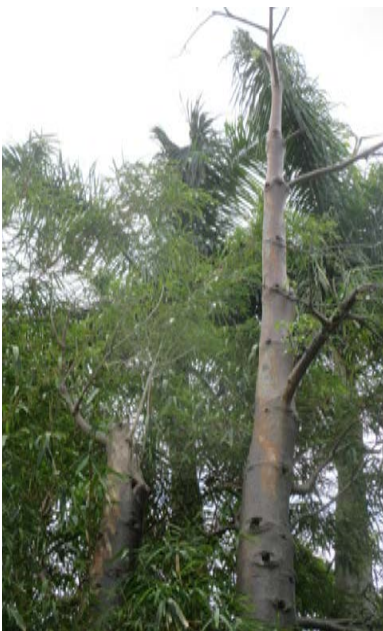
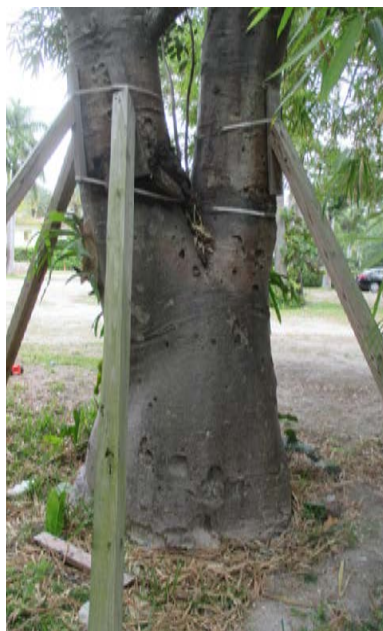
## Tree #124

Tree #124 is a large diameter Kapok located towards the center of the property. The tree divides into two main leaders, one of which is dead and has broken off. The other leader appears nearly dead. Braces are present around the tree. This tree will need to be removed.

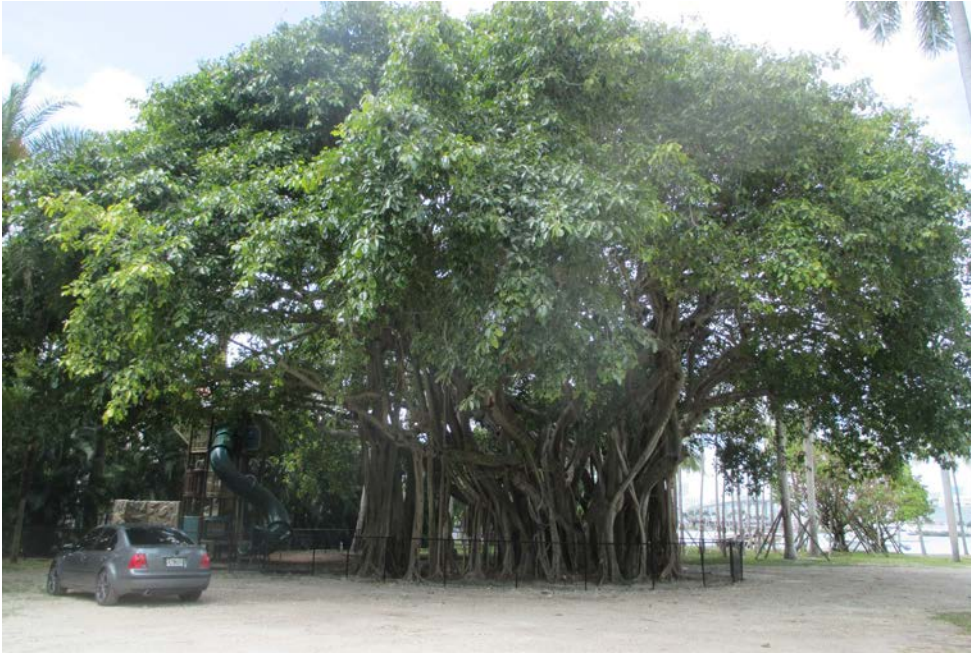
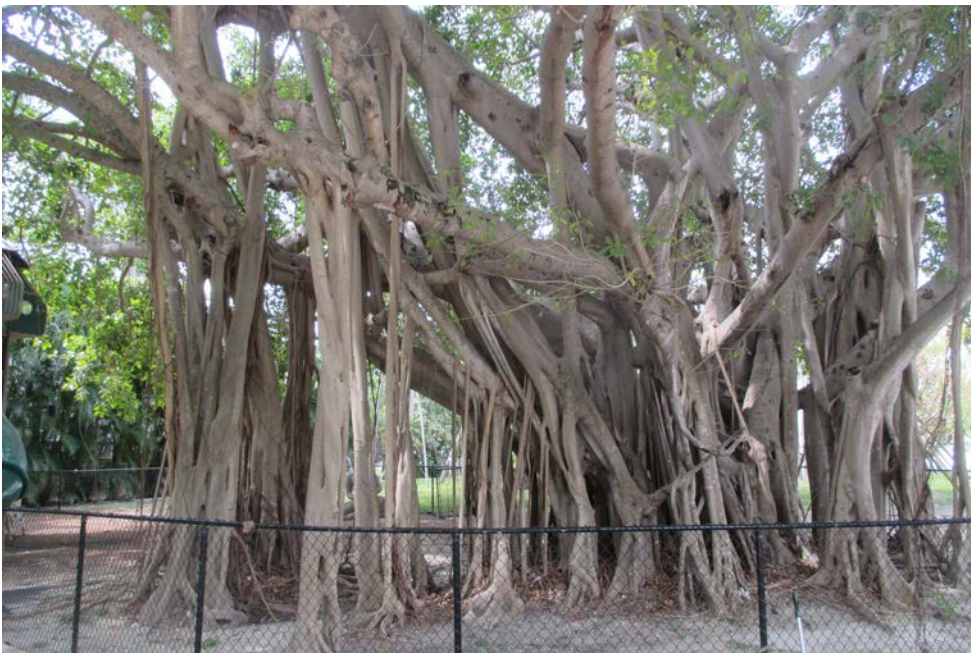
## Tree #131

Tree #131 is a large Banyan tree located towards the center of the property. It is in good condition, with a wide-spreading canopy. Much shade is provided to the playground located beneath it. The DBH includes the numerous prop roots that have formed to anchor the tree. The tree appears to have been routinely pruned, and little deadwood is present and few suckers are present. The canopy is dense and healthy, although some foliage was observed to have endured chewing insect damage. It is recommended that this specimen tree be preserved as is.

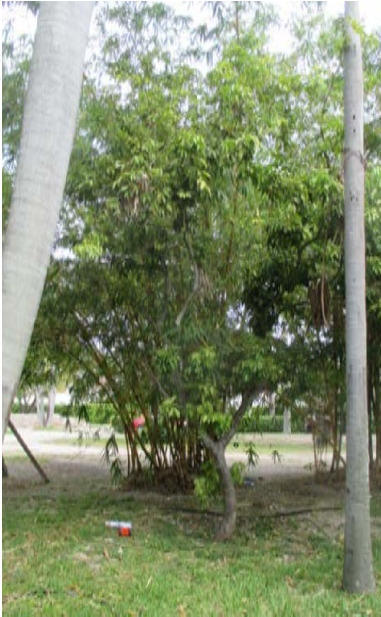
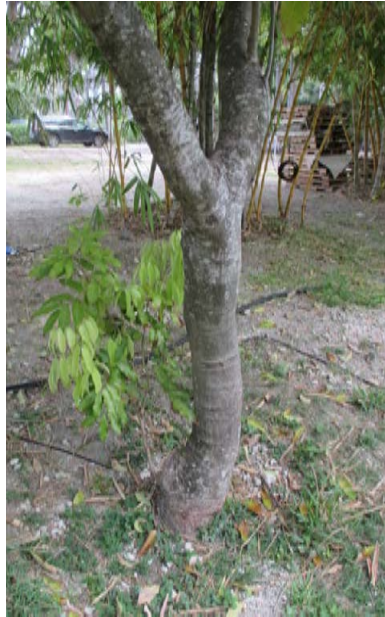
## Tree #153

Tree #153 is a Lychee that is located towards the center of the property. It is in fair condition with chlorosis and deadwood, and a cut wound located at the base. This tree's location is approximated in the diagram on the following page.
