RE: Certified Arborist Assessment
320 Hibiscus Drive, Lot 2, Miami Beach, Florida

Tree Table 320 Hibiscus Drive

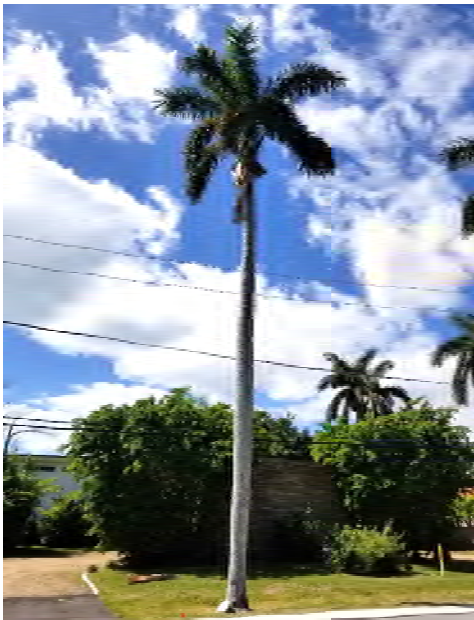
<p>Tree 15 royal palm (<i>Roystonea regia</i>) 13 inch DBH, Fair condition 35 foot height, 20 foot spread</p>

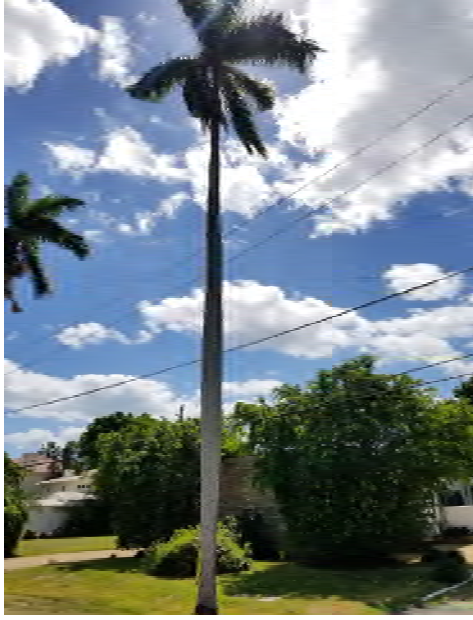
<p>Tree 16 royal palm (<i>Roystonea regia</i>) 11 inch DBH Fair condition 35 foot height, 15 foot spread</p>

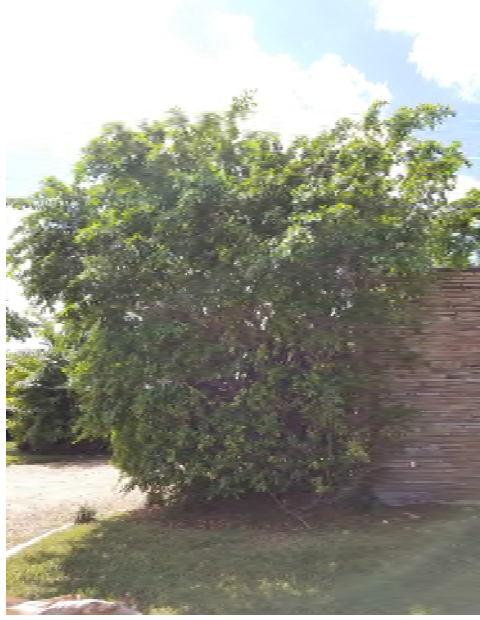
<p>Tree 17 laurel fig (<i>Ficus microcarpa</i>) cluster inch DBH Prohibited Species condition 20 foot height, 10 foot spread</p>

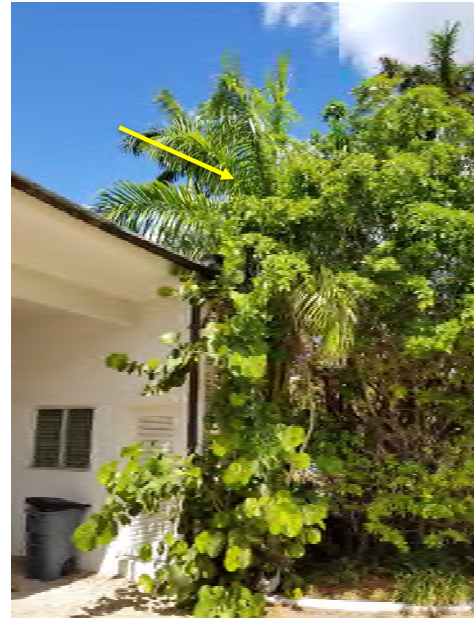
Prohibited species
<p>Tree 18 royal palm (<i>Roystonea regia</i>) 8 inch DBH, Good condition 20 foot height, 5 foot spread</p>

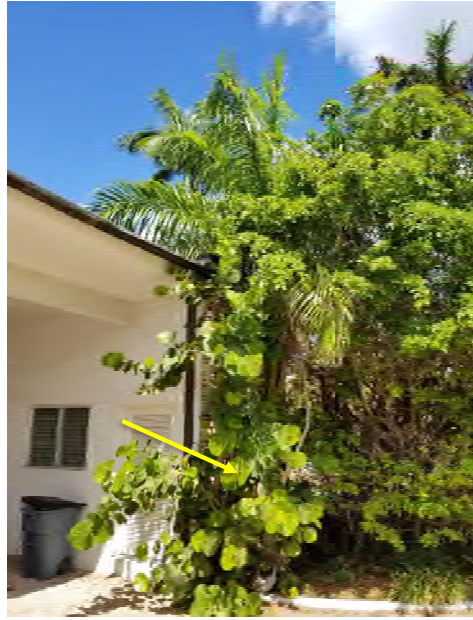
<p>Tree 19 seagrape (<i>Coccoloba uvifera</i>) 2 inch DBH Good condition 12 foot height, 5 foot spread</p>

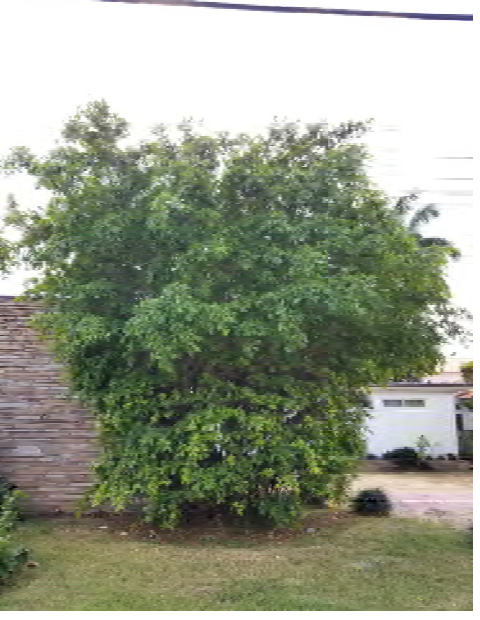
<p>Tree 20 laurel fig (<i>Ficus microcarpa</i>) cluster inch DBH Prohibited Species condition 20 foot height, 15 foot spread</p>

Prohibited species

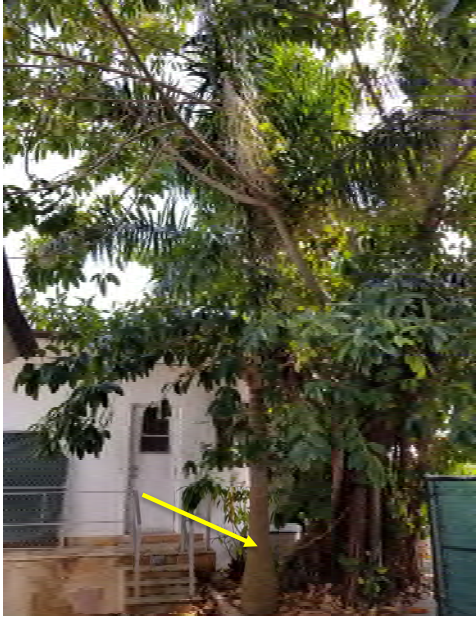
<p>Tree 21 royal palm (<i>Roystonea regia</i>) 10 inch DBH, Good condition 25 foot height, 15 foot spread</p>

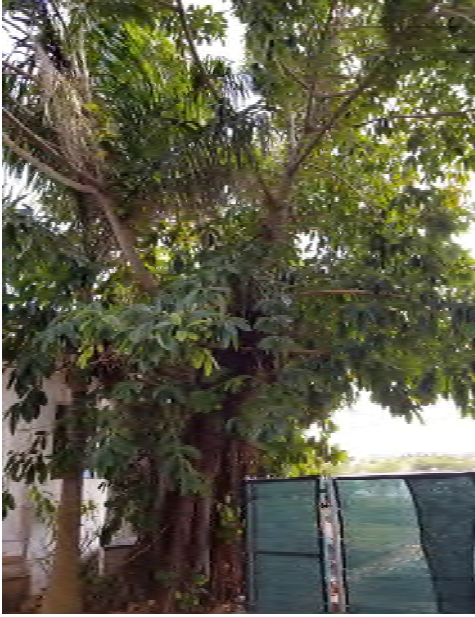
<p>Tree 22 rubber tree (<i>Ficus elastica</i>) 33 inch DBH Good condition 35 foot height, 20 foot spread</p>

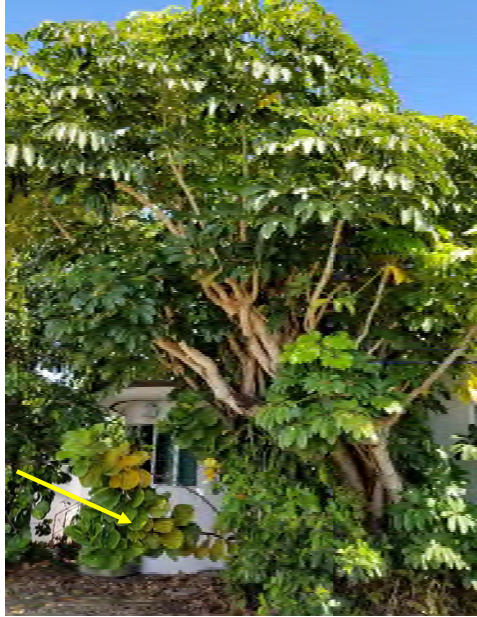
<p>Tree 23 fiddle leaf fig (<i>Ficus lyrata</i>) 3 inch DBH Fair condition 8 foot height, 5 foot spread</p>

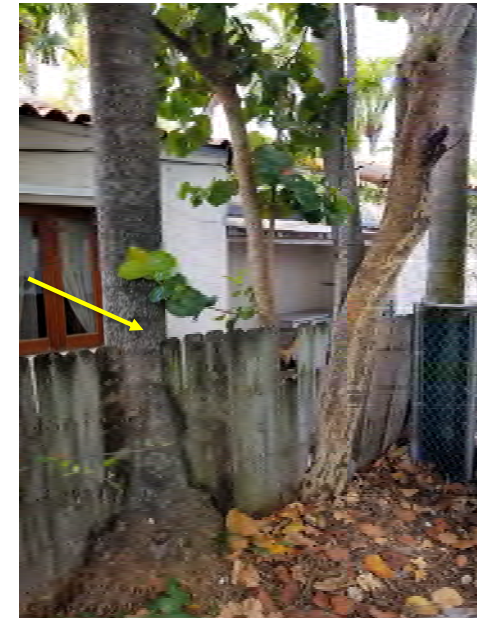
<p>Tree 24 umbrella tree (<i>Schefflera actinophylla</i>) 42 inch DBH, Prohibited Species condition 25 foot height, 30 foot spread</p>  	<p>Tree 25 seagrape (<i>Coccoloba uvifera</i>) 13 inch DBH Fair condition 20 foot height, 10 foot spread</p>   <p>Trunk shared with neighboring property</p>	<p>Tree 26 royal palm (<i>Roystonea regia</i>) 14 inch DBH Good condition 25 foot height, 15 foot spread</p>

<p>Trunk shared with neighboring property</p>
