JAMES LEGETTE

June 7, 2019

RE: 6626 Roxbury Lane, Miami Beach
Evaluation of Ficus Tree

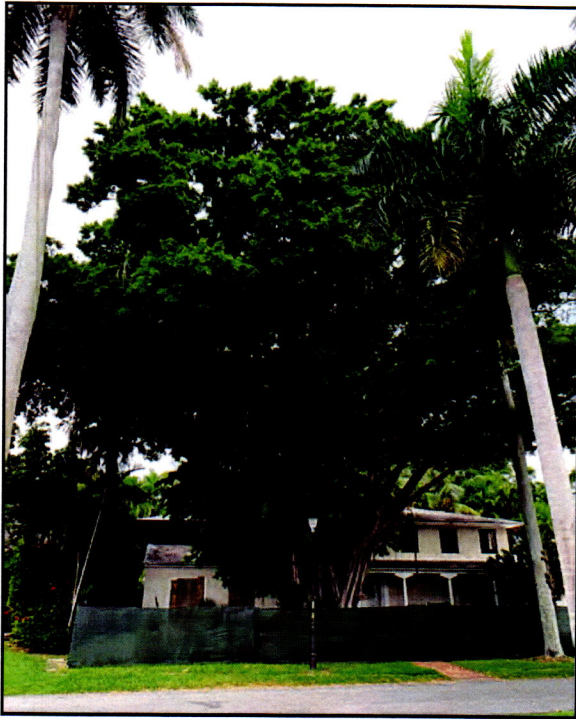
Photo 1 View looking west in front of house.

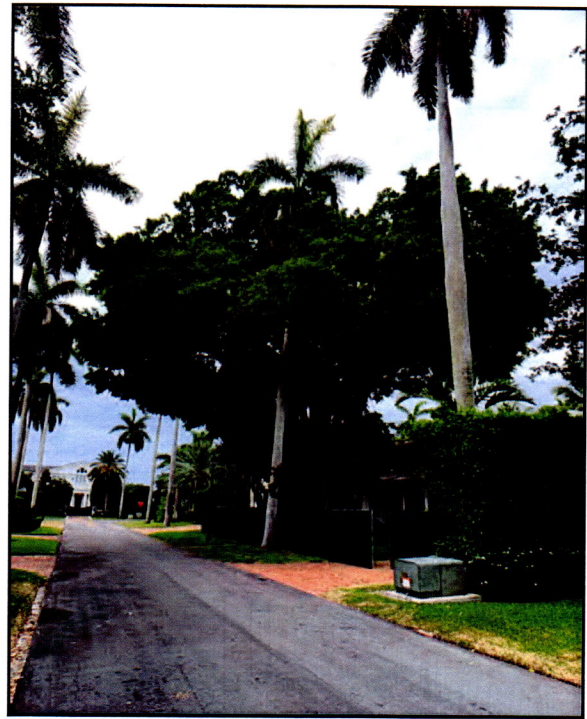
This tree is a *Ficus nitida* which is listed as a prohibited species by Miami-Dade County. While it is "exempt" from needing a permit from the City of Miami Beach for its removal, mitigation for the canopy loss will likely be required. The tree has a trunk diameter of $\pm 12'$ at breast height (DBH). The canopy is overgrown due to lack of maintenance and begins approximately 18' above ground and is approximately 50' in overall height. The total canopy area is approximately 7,800 square feet and extends approximately 25' over the roof of the house, 30' over the right-of-way and street, and 19' over the neighbor's property to the south (see attached photos). A large royal palm is growing through the canopy along the street (see Photo 2).

Photo 2 View looking south along Roxbury Lane. Note royal palm growing through canopy and canopy overhanging street.

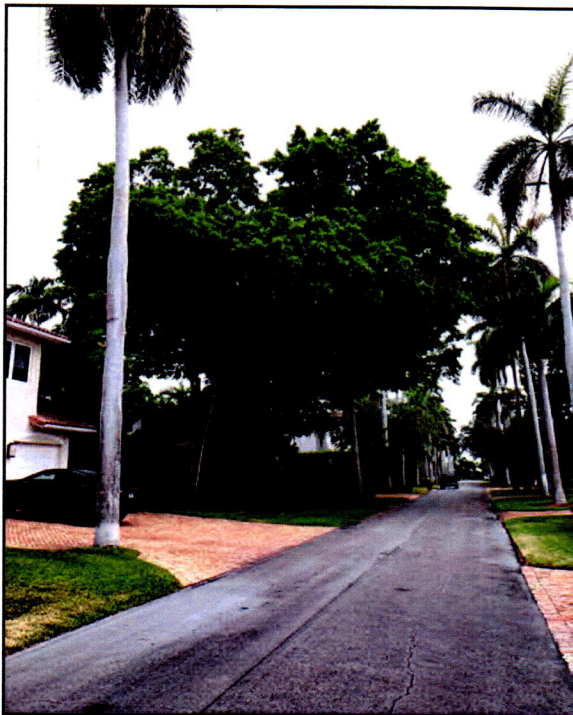
Photo 3 View looking north along Roxbury Lane showing canopy overhanging into yard to the south.

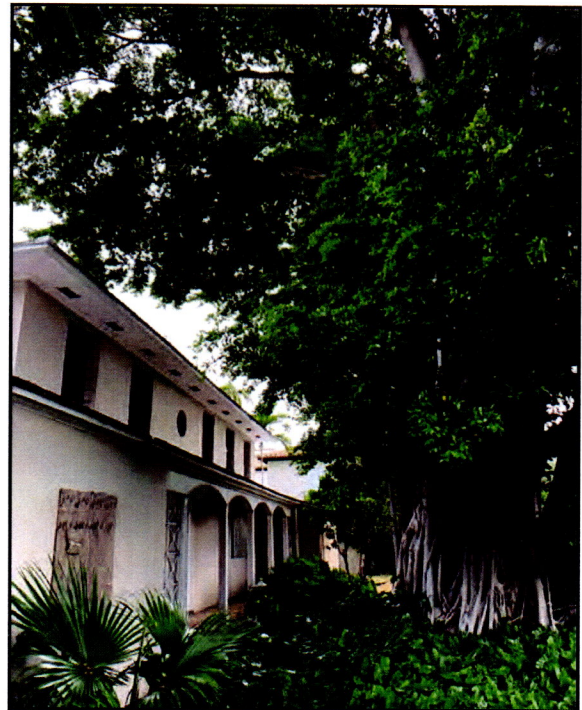
Photo 4 Canopy overhanging roof.

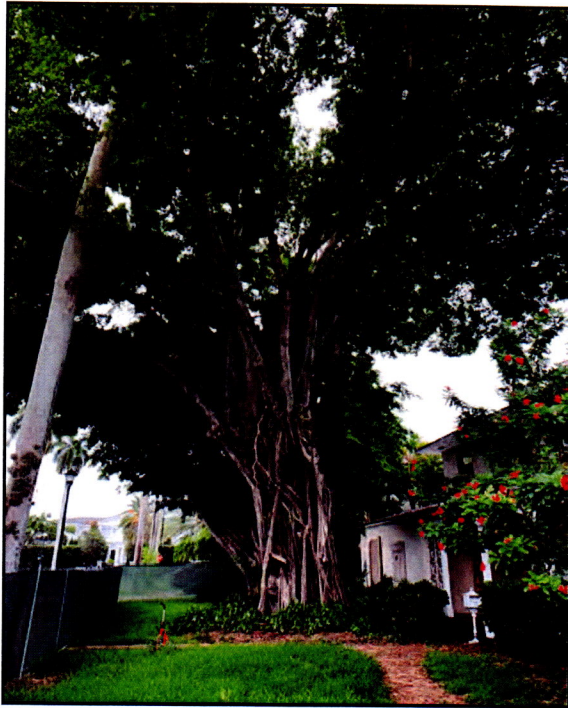
Photo 5 Close up of the trunk basal area looking south.

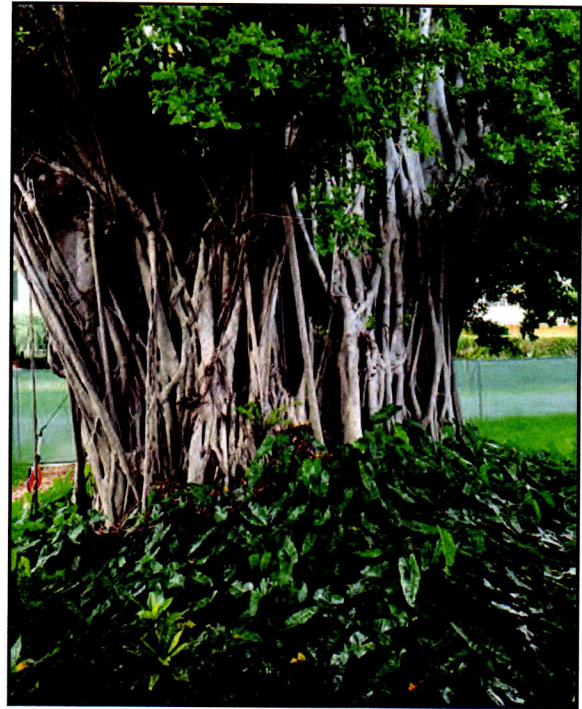
The root system is expansive and likely runs beneath the foundation of the house and beneath the asphalt in the street. A large amount of leaf matter has accumulated between the tree trunk and house slab which can create nuisance conditions (see Photo 6).

Photo 6 Large buildup of leaf debris between the trunk and house slab.

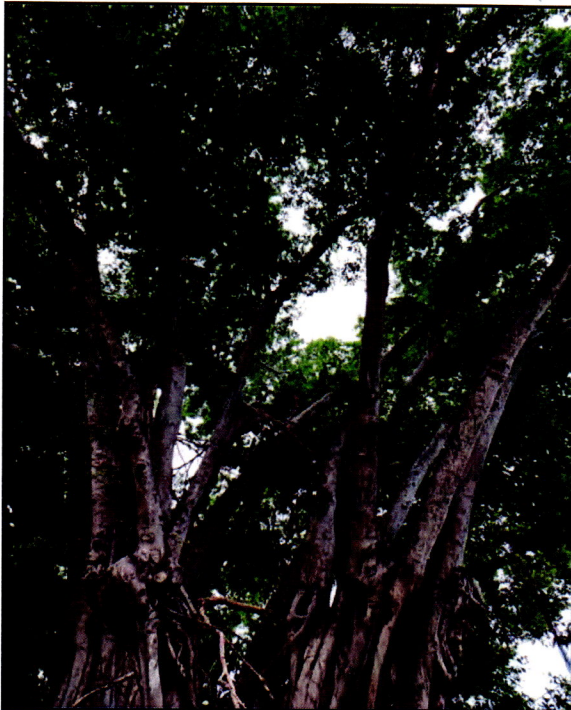
The tree does not appear to have any significant structural defects, trunk decay, or insect damage. It appears that the tree was cut back to a height of about 20' above ground after a storm event as evidenced by the branching pattern. In addition, there are some branches in the center of the canopy that were probably broken off during Hurricane Irma in 2017 and are now hanging down toward the ground. These broken branches have caused a hole in the center of the canopy and are hazardous (see Photos 7 & 8). Because of the overgrown canopy, the tree is subject to failure during a storm event.

Photo 7 Broken limbs ("hangers") in center of canopy.

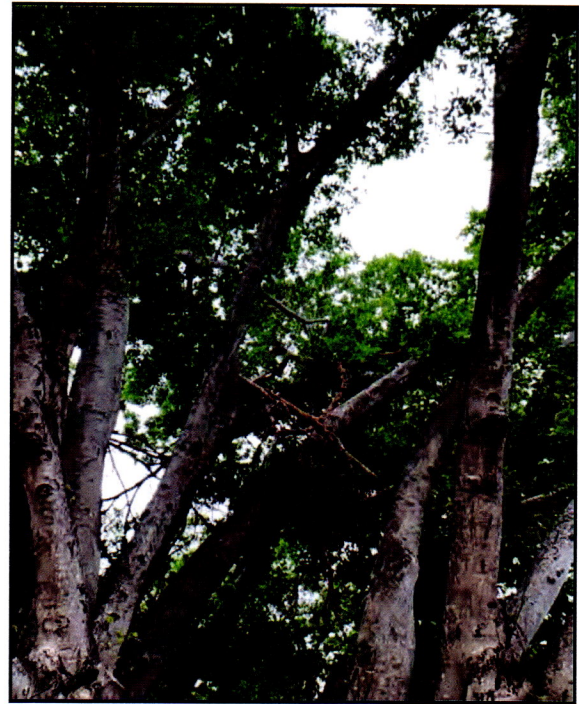
Photo 8 Close up of broken limbs and hole in upper canopy.
