# ***Tree Resource Evaluation for 220 West De Lido Drive, Miami Beach***

***July 30, 2019***

**I performed a tree resource evaluation at 220 West De Lido Drive, Miami Beach on July 30, 2019. The approximate locations of these trees and palms can be found on the schematic in Appendix B.**

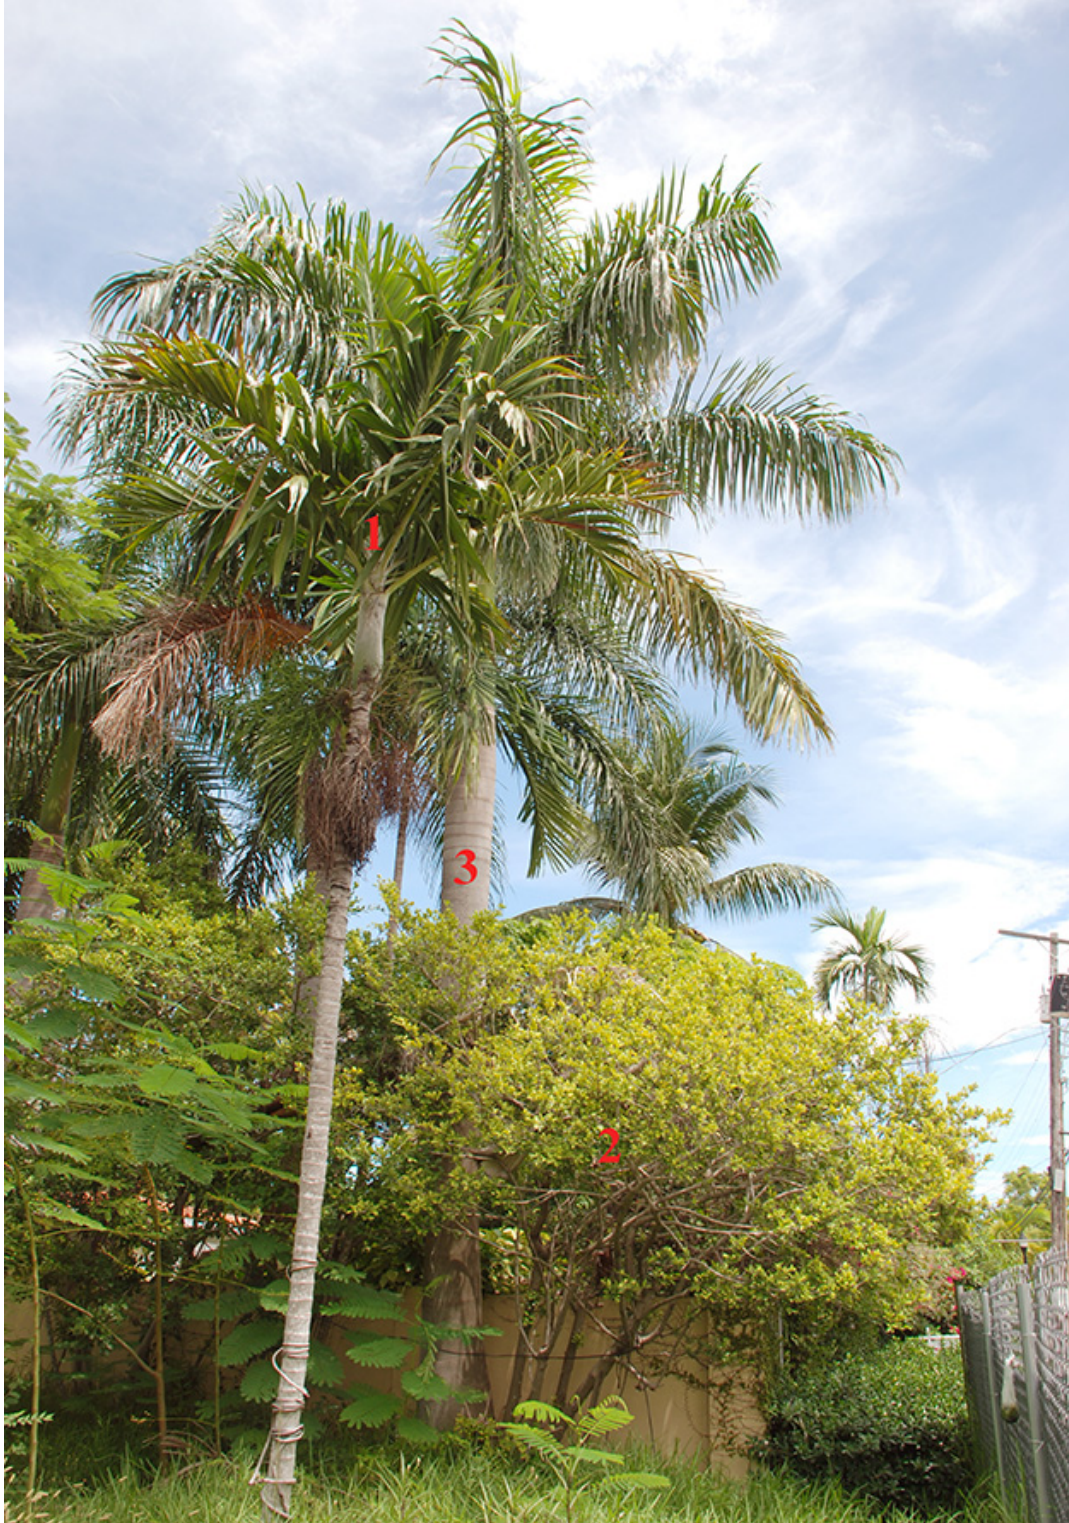
**Photo 1 above is palms 1 & 3, and tree 2 an invasive species near the northeast corner of the property.**

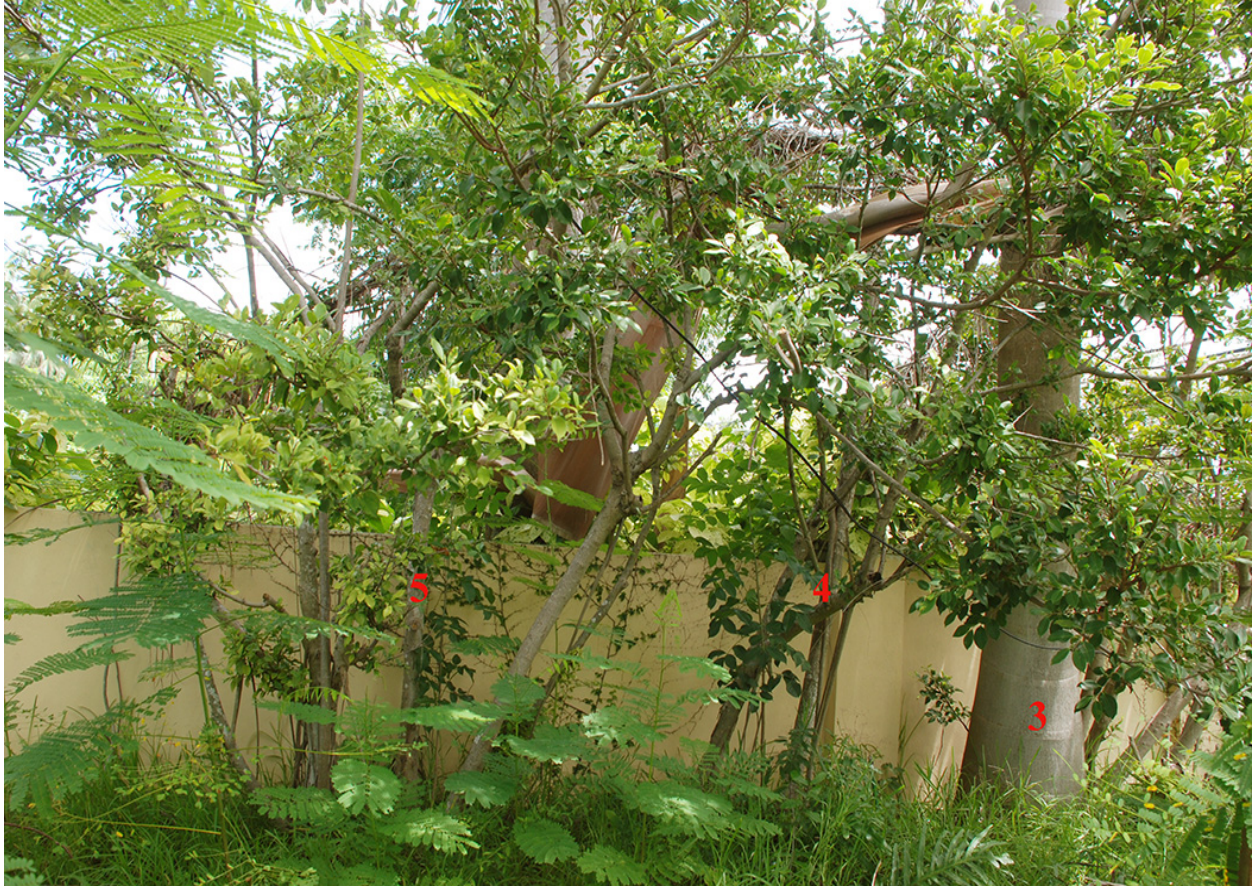
**Photo 2 above is trees 4 & 5 along the northern edge of the property. Both trees are invasive species.**

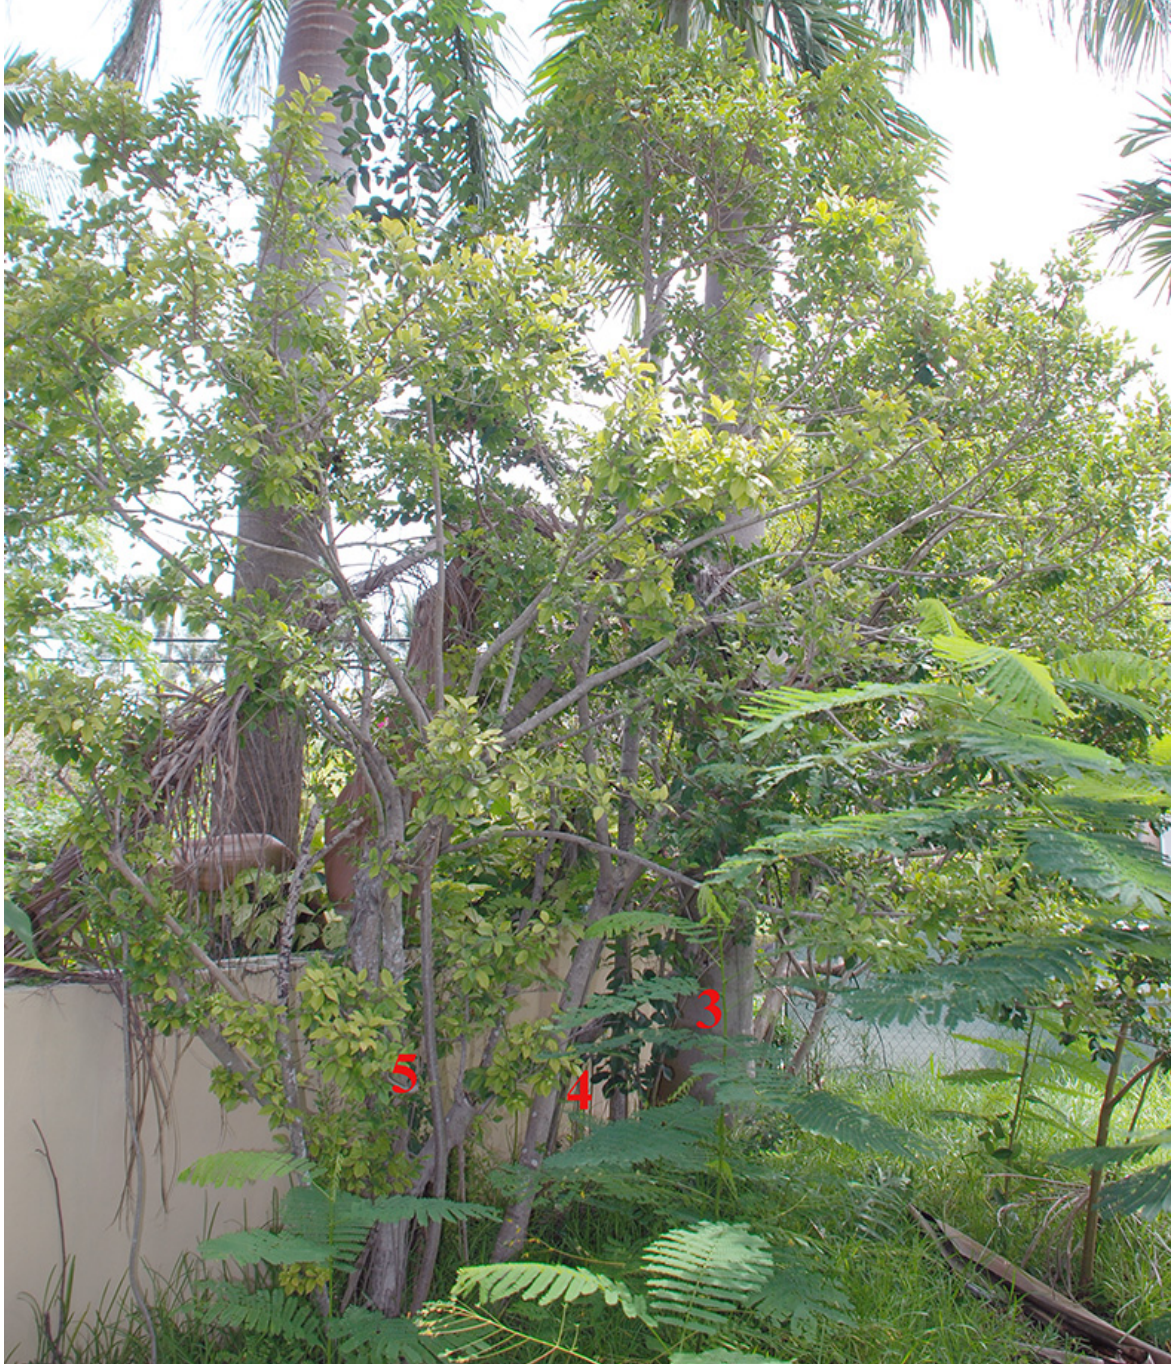
**Photo 3 above is trees 4 & 5 viewed from the west.**

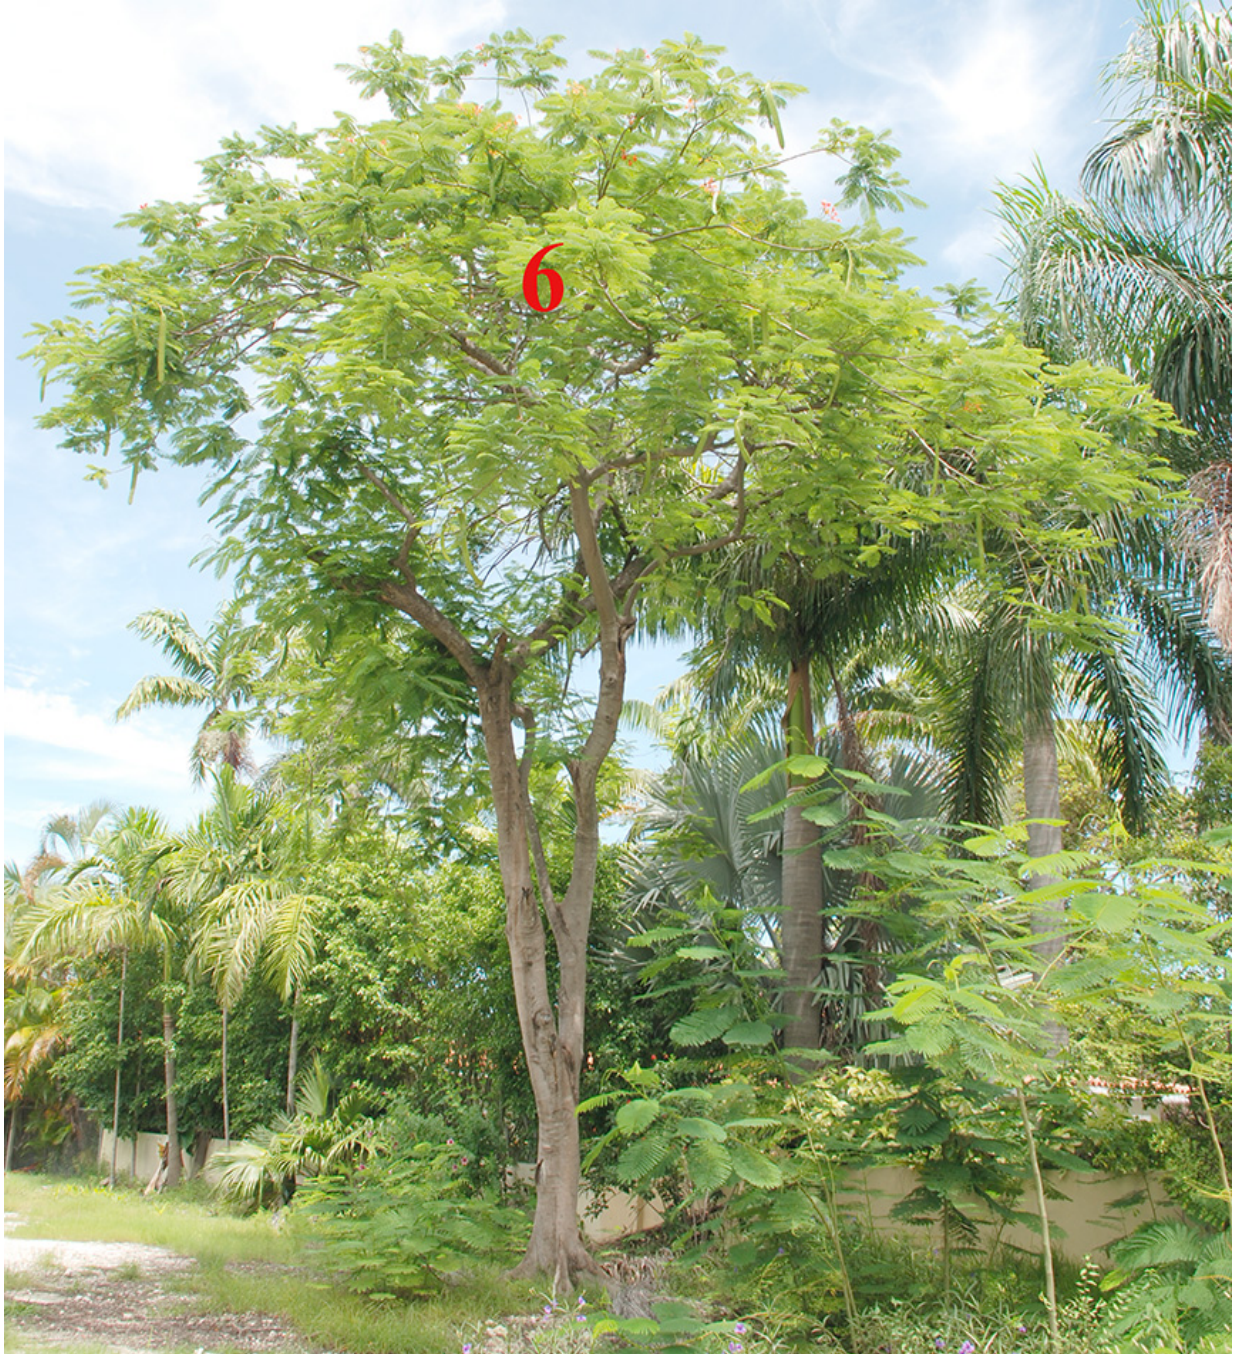
**Photo 4 above is tree 6 viewed from the east. See following photos.**

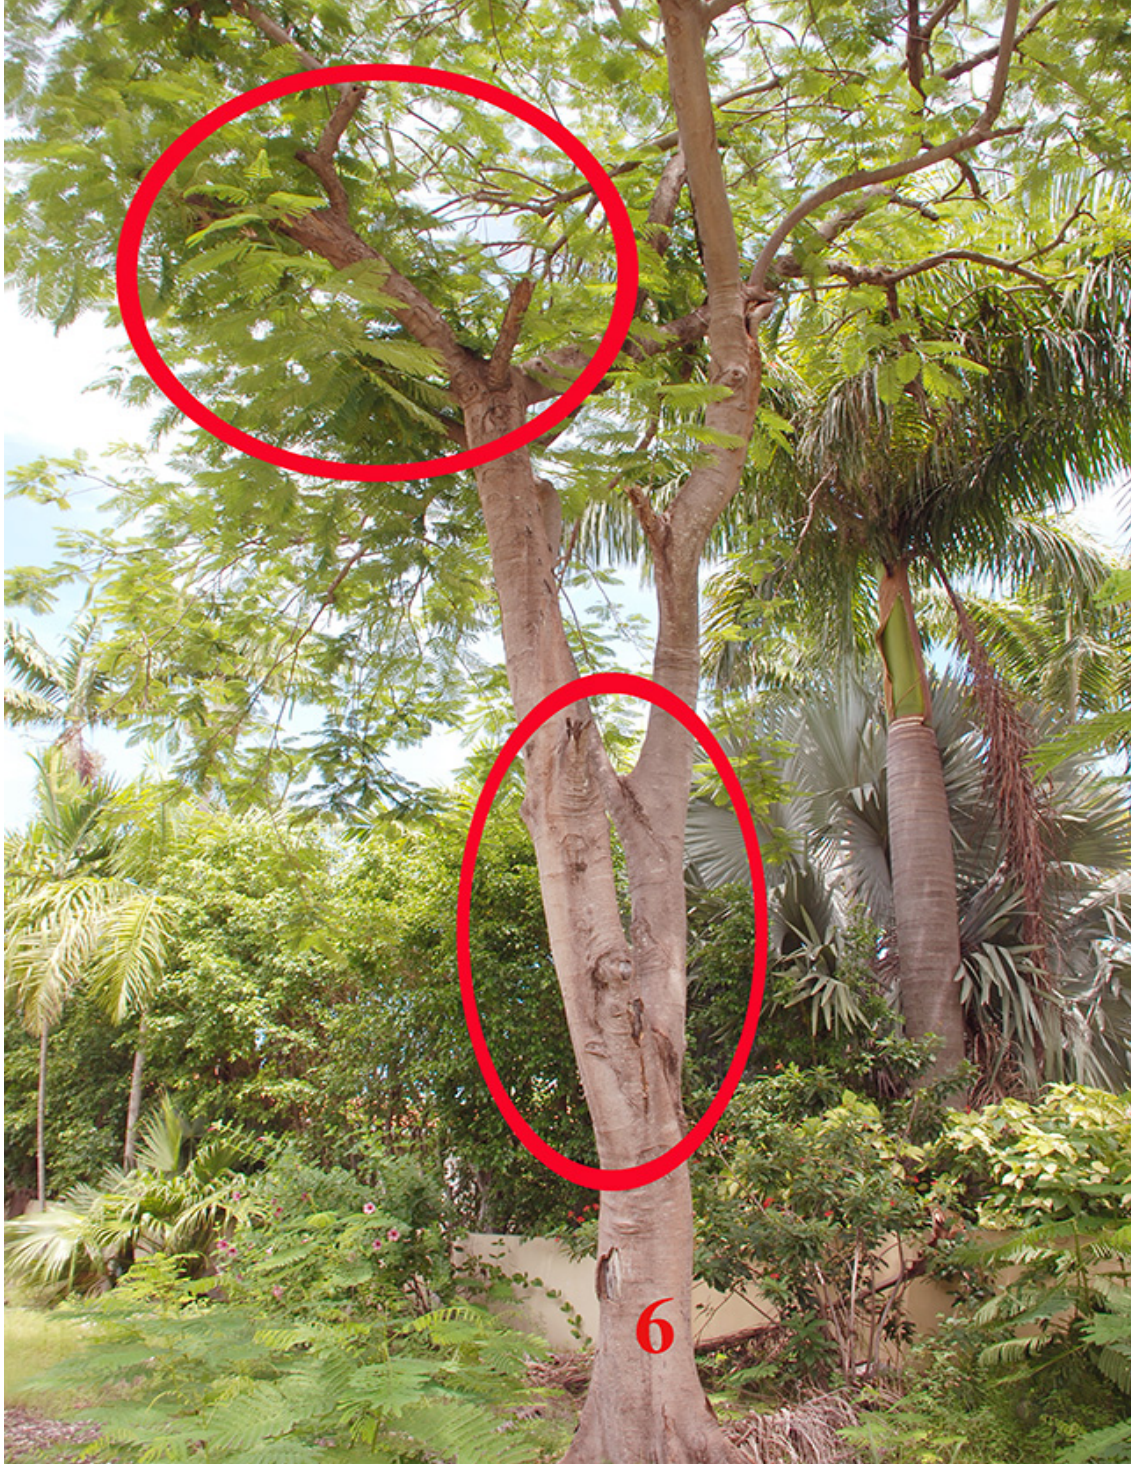
**Photo 5 above is the trunk of tree 6 viewed from the east. The upper circle indicates significant dead branches and the lower circle indicates trunk die-back. See following photo.**

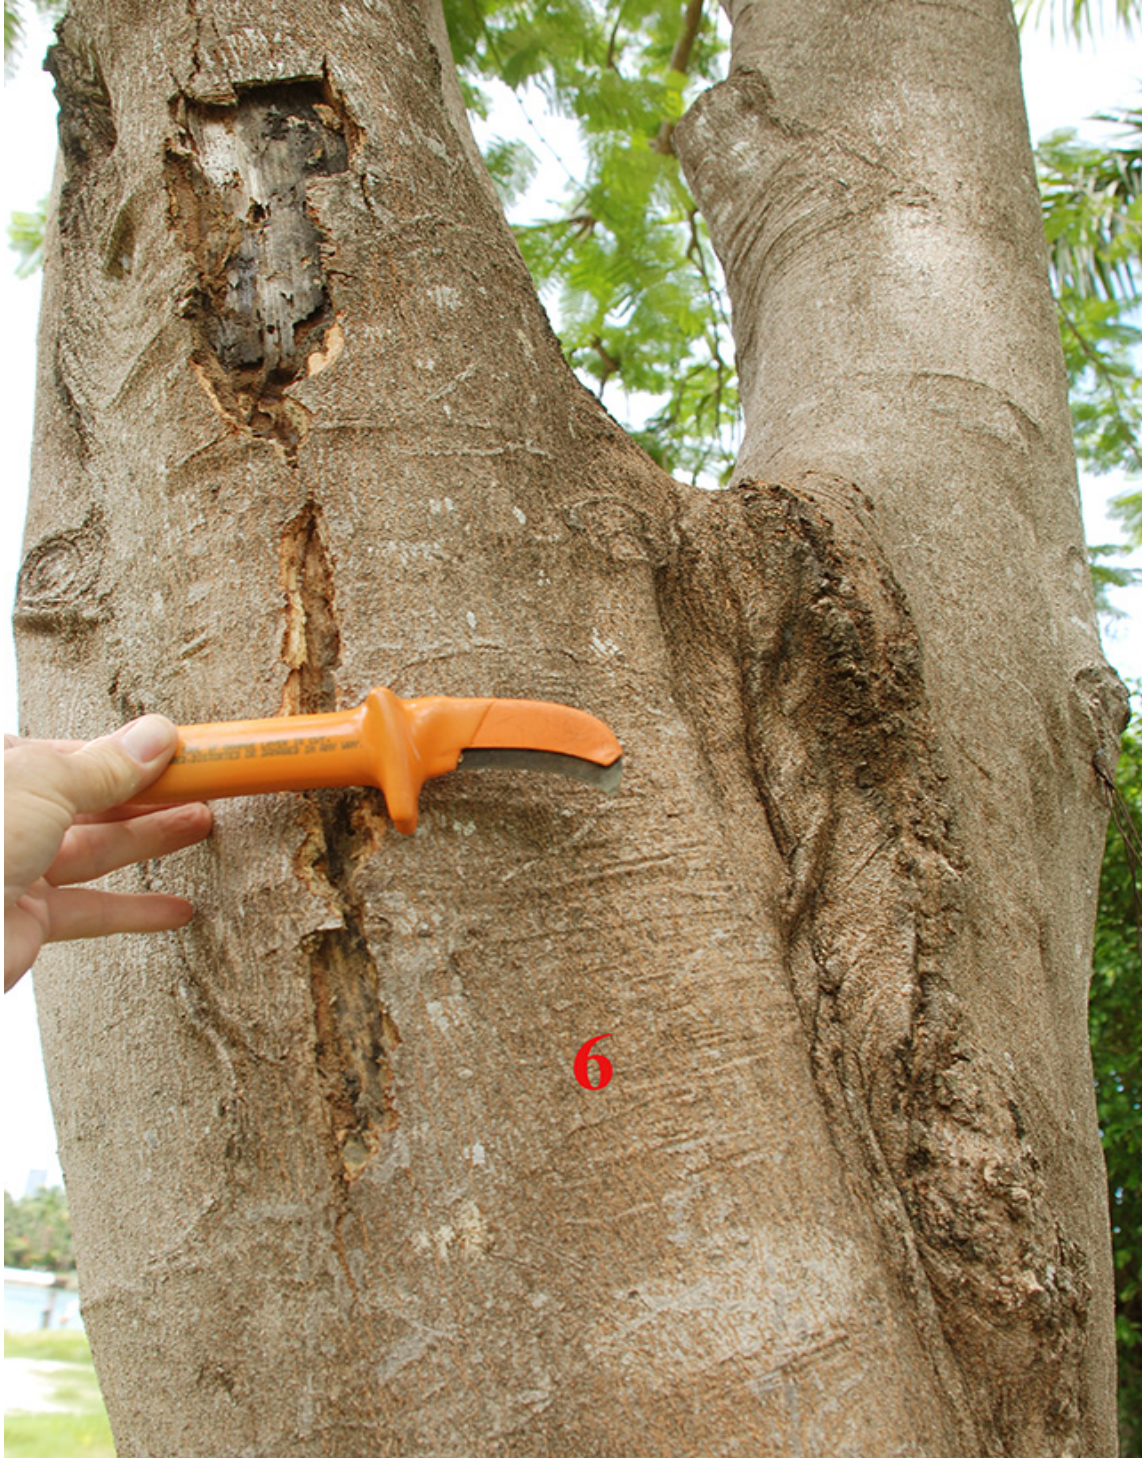
**Photo 6 above is a closer view of the weak codominant branch/trunk connection that is immediately next to significant decay on the southern branch. The orange knife is 7 inches in length. This tree should be removed.**

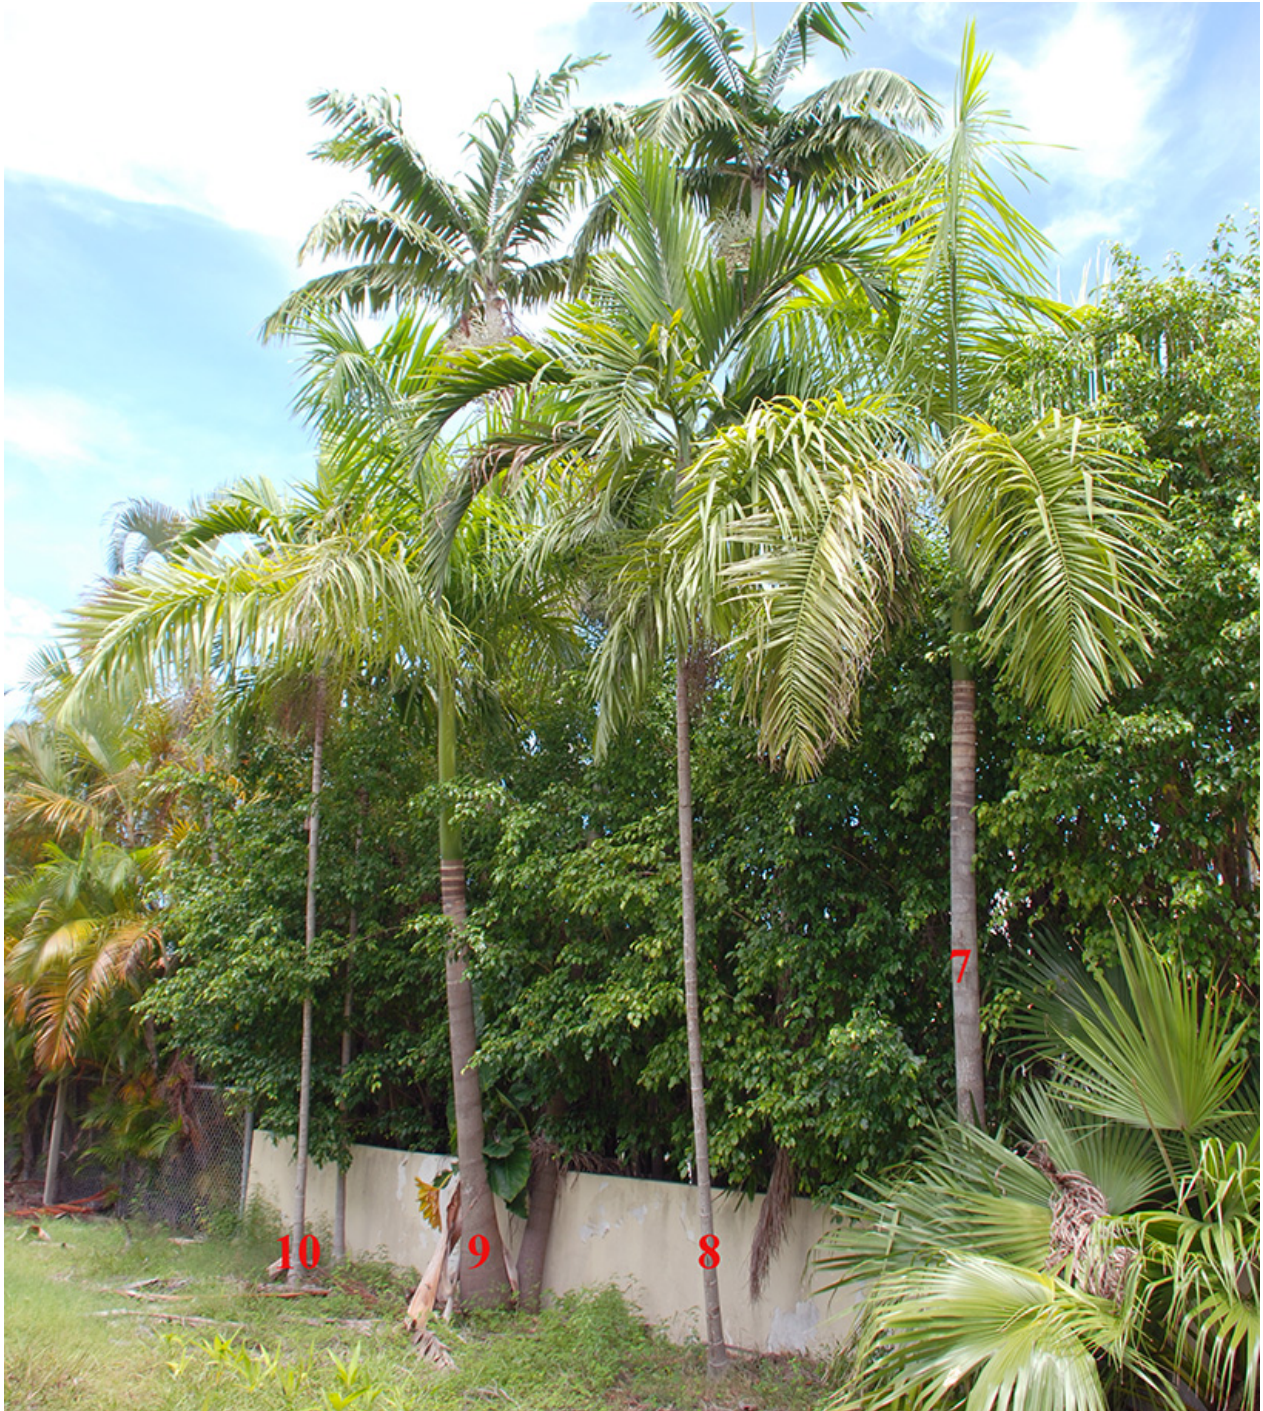
**Photo 7 above is palms 7, 8, 9 & 10 viewed from the east. Palms 7 & 9 are beginning to develop severe nutrient deficiencies.**

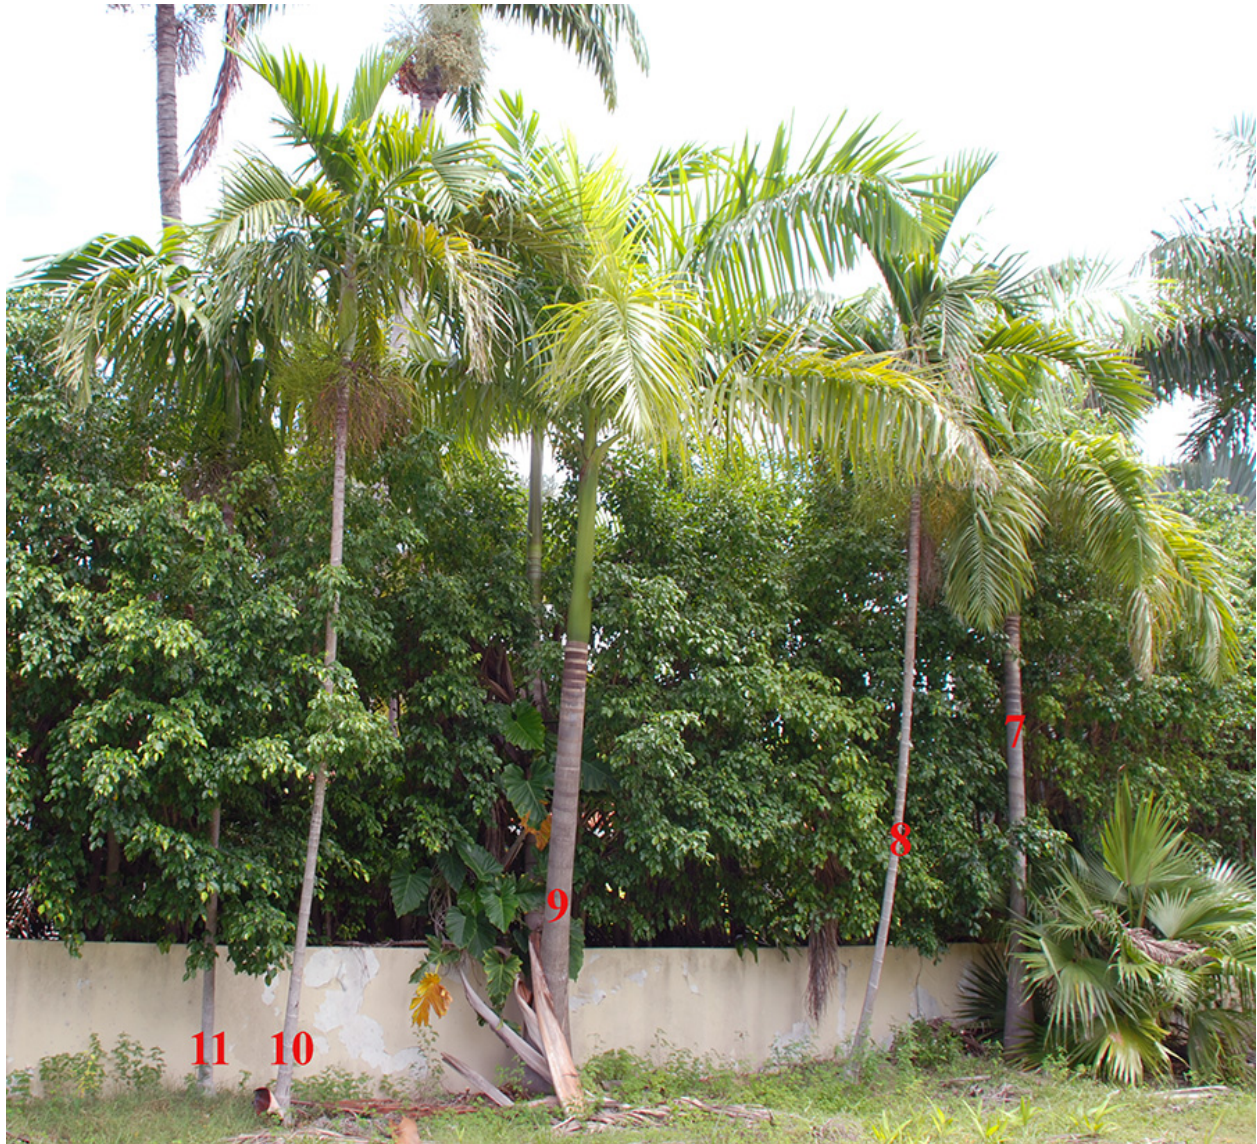
**Photo 8 above is palms 7, 8, 9, 10 & 11 viewed from the southwest. Palms 7 & 9 are beginning to develop severe nutrient deficiencies.**

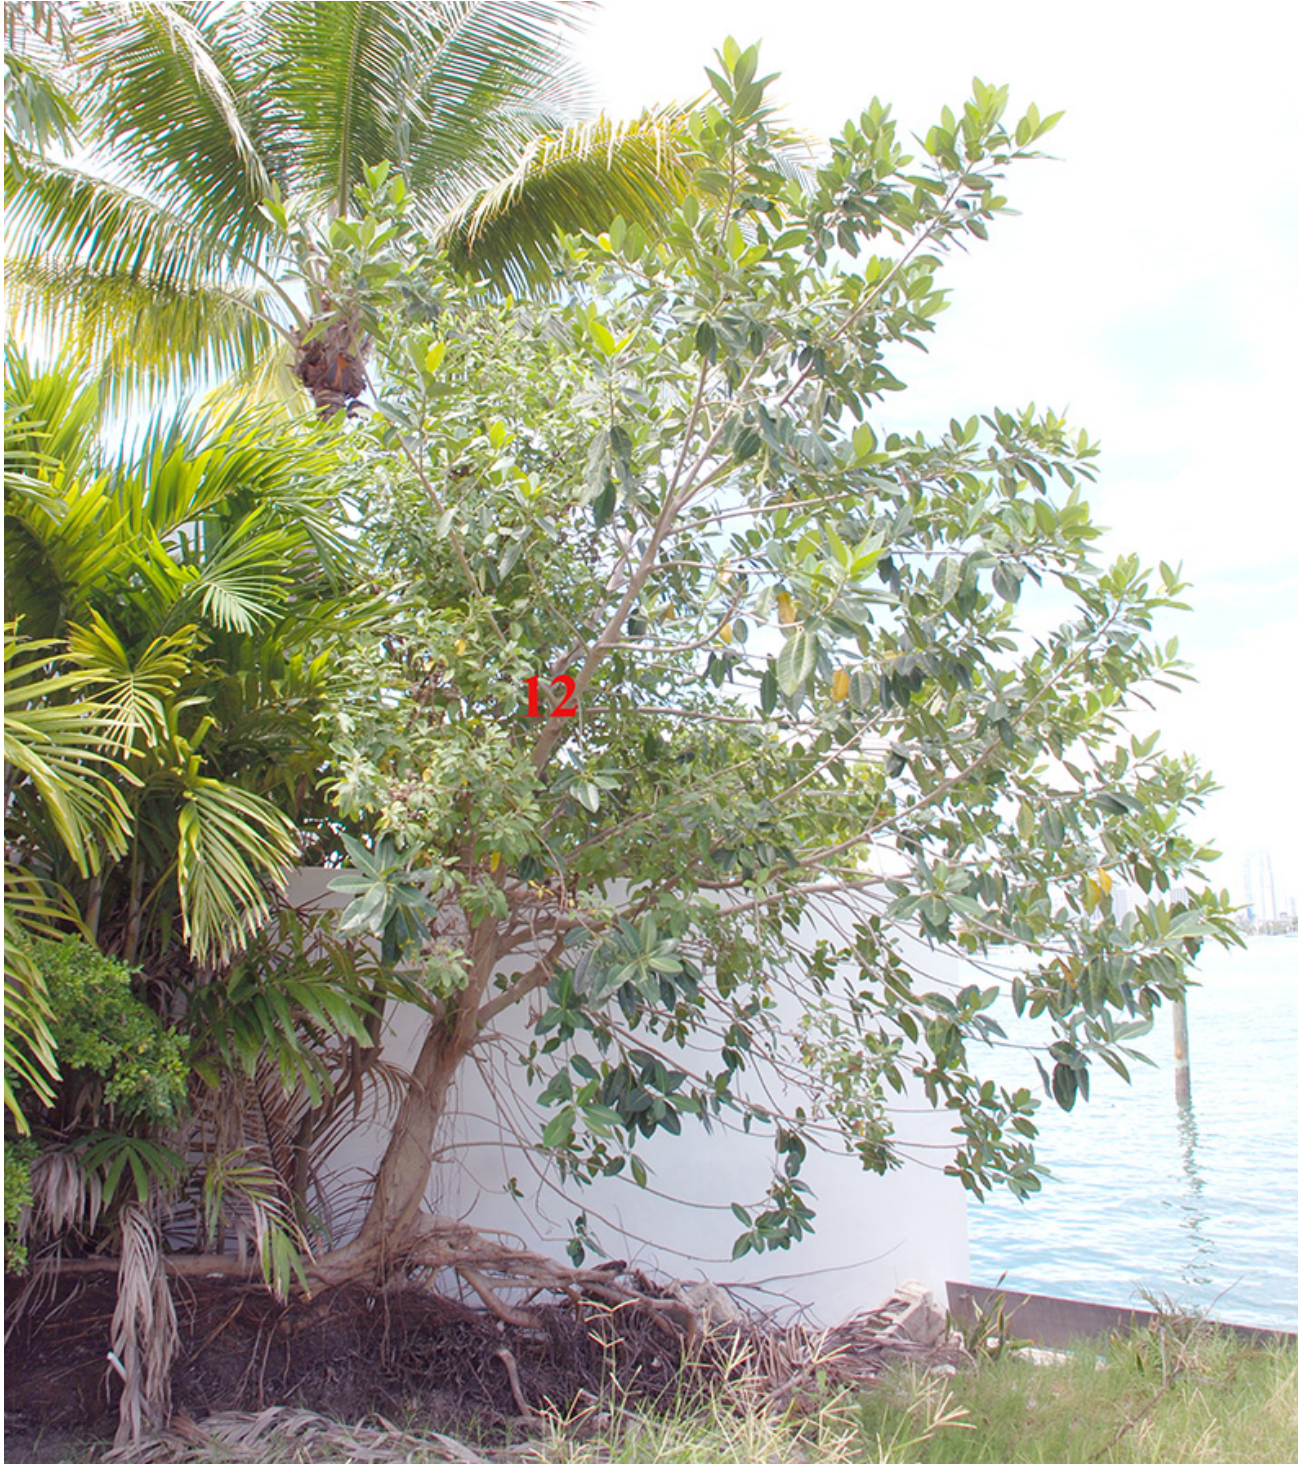
**Photo 9 above is tree 12 near the southwest corner of the property. The root plate is very restricted and exposed. This tree is not a good candidate for relocation. I recommend its removal.**

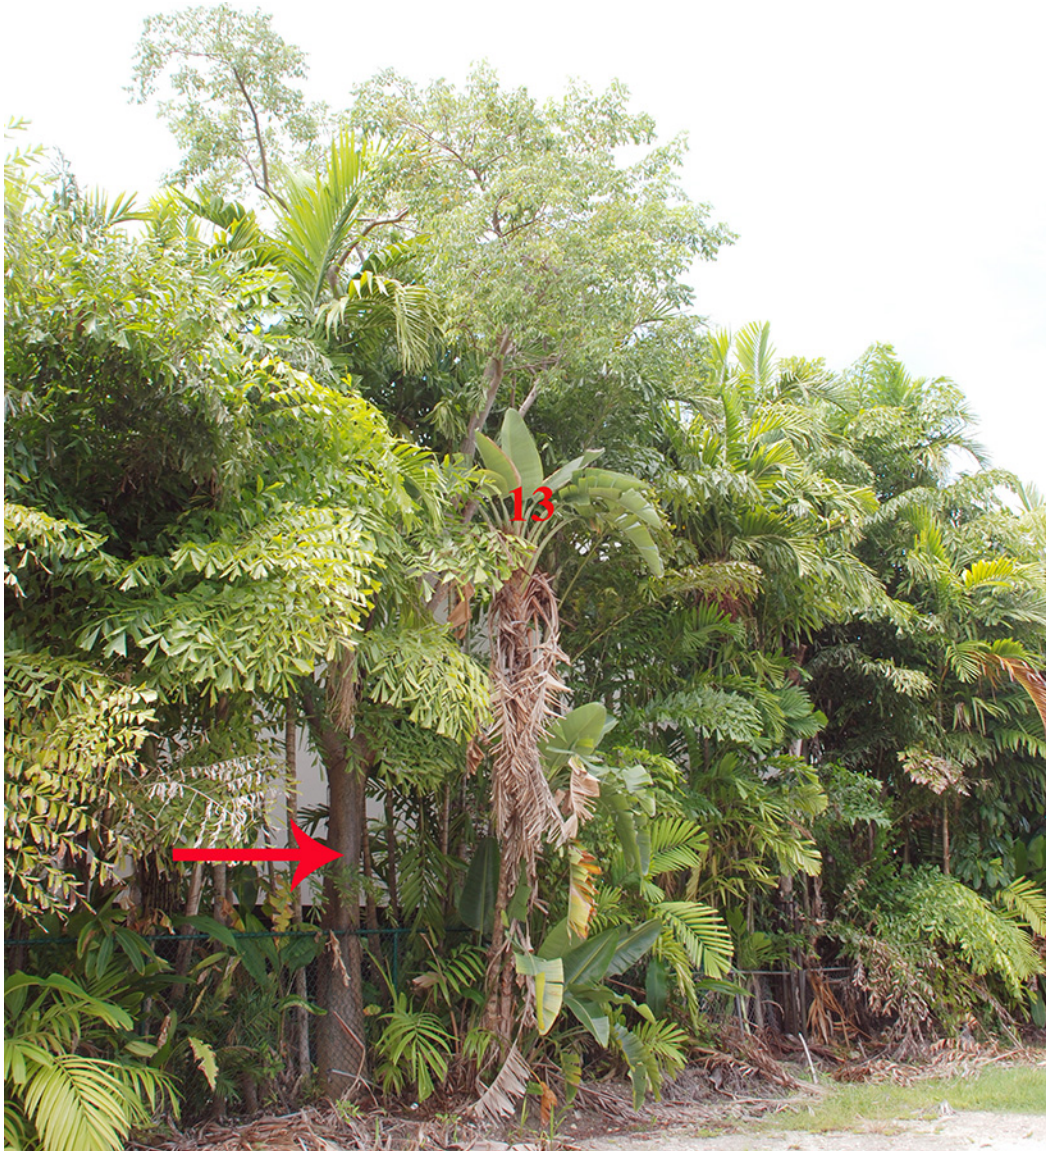
Photo 10 above is white bird of paradise 13 along the southern edge of the property. This species is not a true tree or palm.

The arrow indicates a *Bursera simaruba*, gumbo limbo that appears to be growing on the adjacent property. The DBH of this tree is approximately 18 inches, approximately 30 feet in height, and has a canopy diameter of approximately 25 feet. This tree appears to be in good condition.

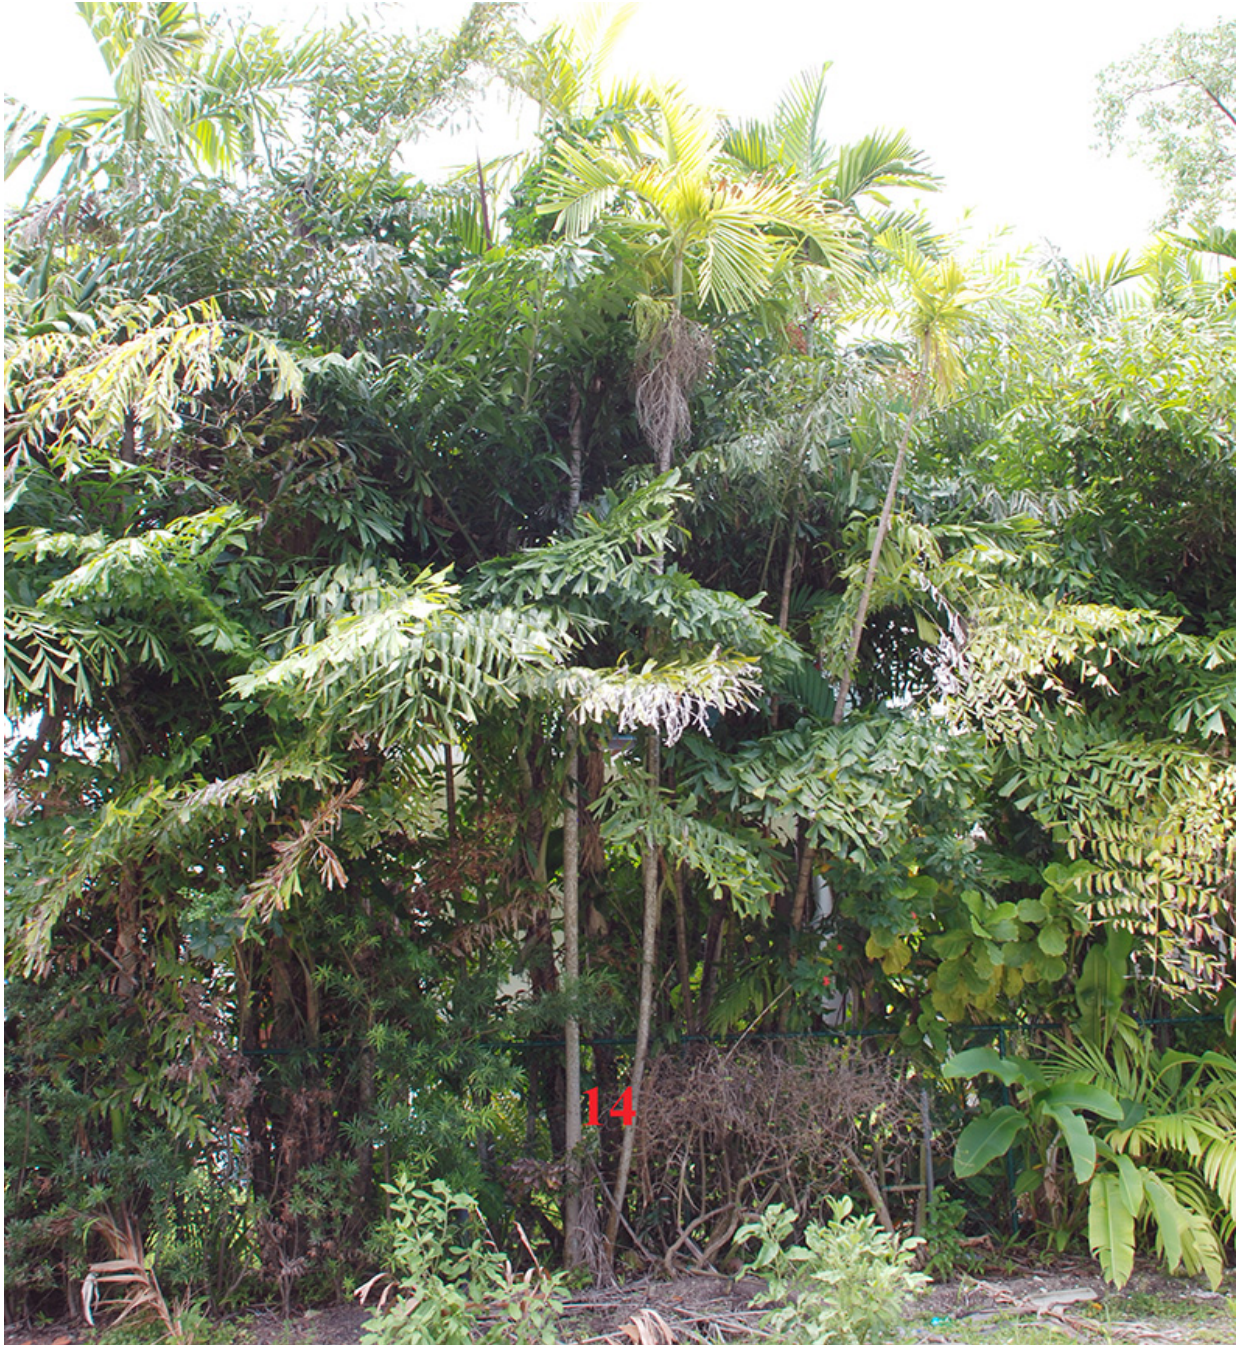
**Photo 11 above is double-trunked palm 14 along the southern edge of the property.**

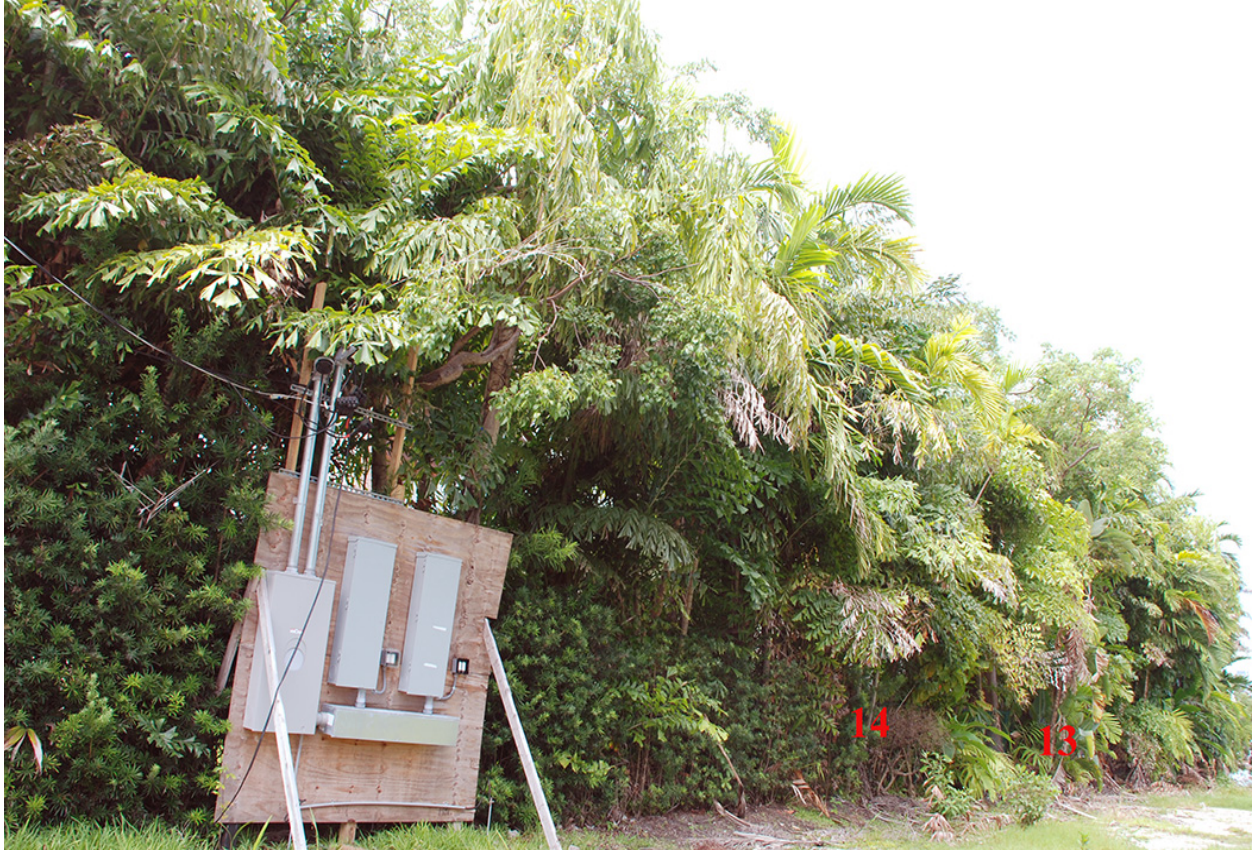
**Photo 12 above is a view east to west of the southern edge of the property. Only palm 14 and white bird of paradise 13 appear to be growing north of the property line.**
