# Biscayne Environmental, Inc.

RE: Tree Inventory and Evaluation  
816 84<sup>th</sup> Street, Miami Beach

Sheet Name: Site Photographs

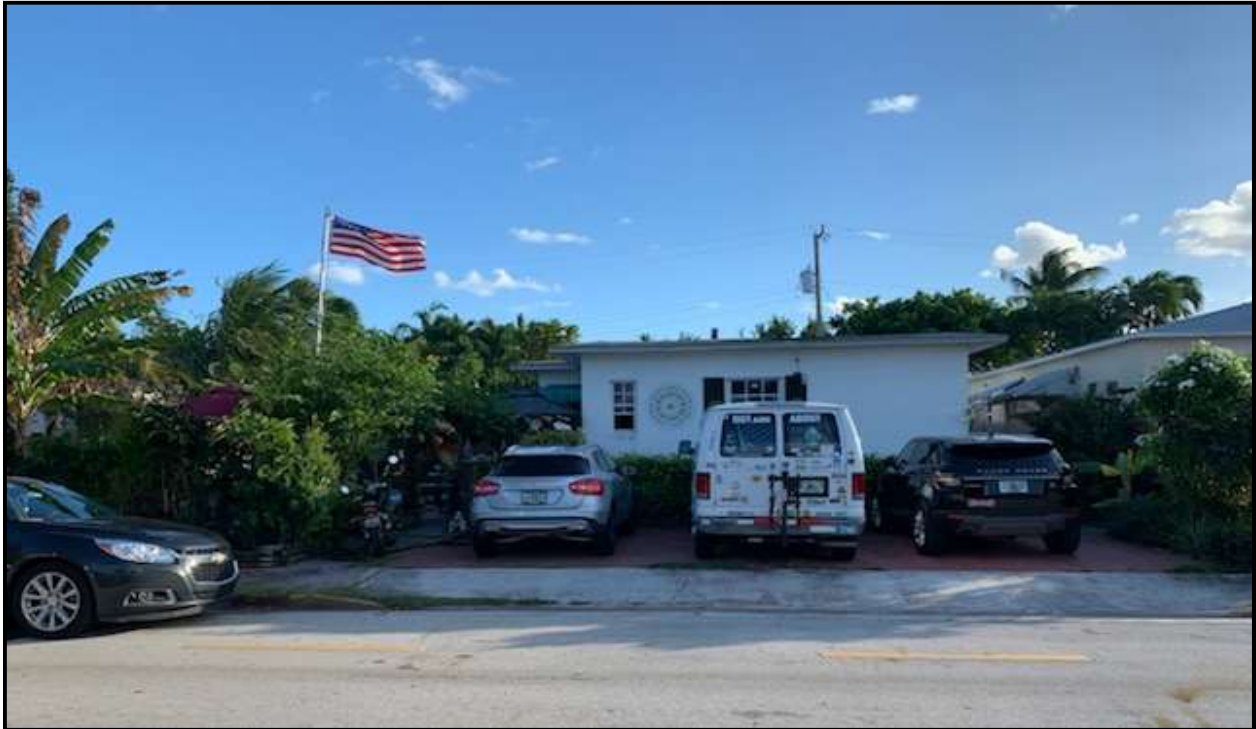
**Photo 1** View south looking at front of building showing ornamental landscape material on either side of the parked vehicles.

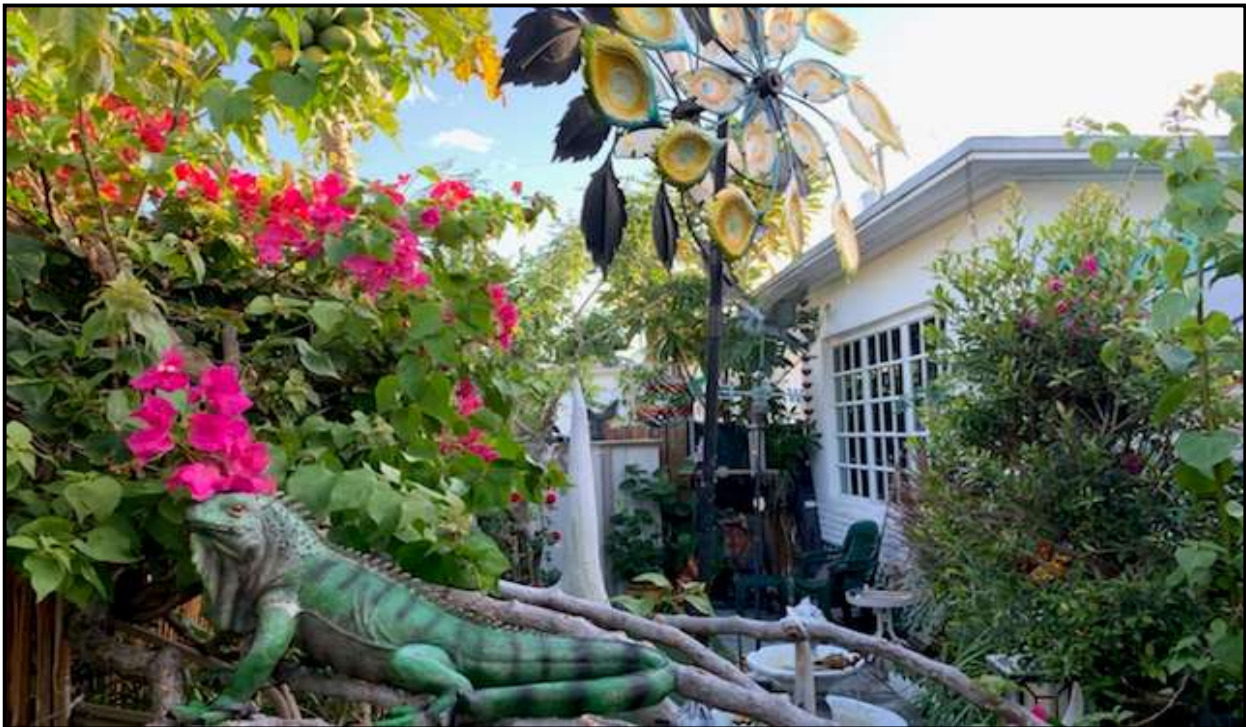
**Photo 2** View of bougainvillea, other ornamental landscape material and mamey tree (Item G) in rear right of photo. Note: iguana is plastic!!

Removal of the sabal palms, solitaire palm, and mamey may not require a permit from the City of Miami Beach for their removal due to their size and condition. If a permit is required, the tree replacement requirements should be minimal due to the limited canopy that will be affected. It should also be noted that none of the trees warrant preservation or relocation because of their size, type, or condition.

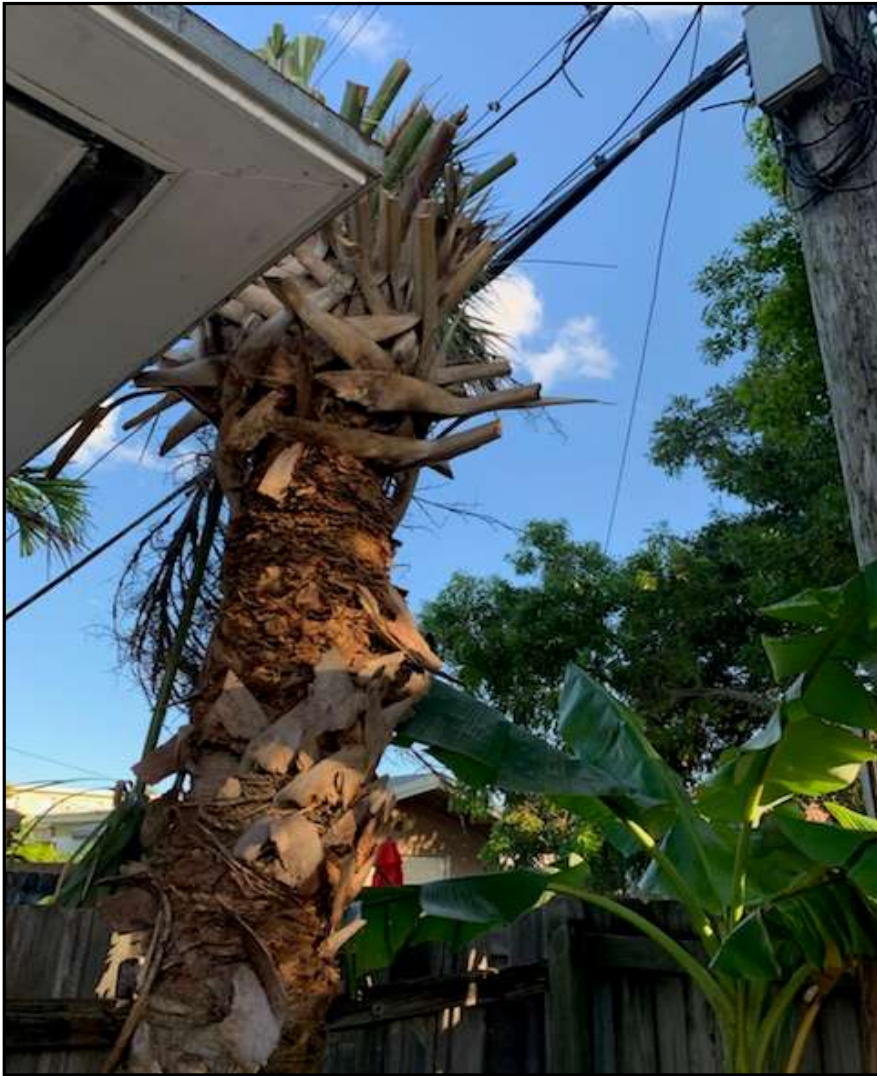
**Photo 3** View of cut sabal palm (Item P) growing into utility lines in southwest corner of property.

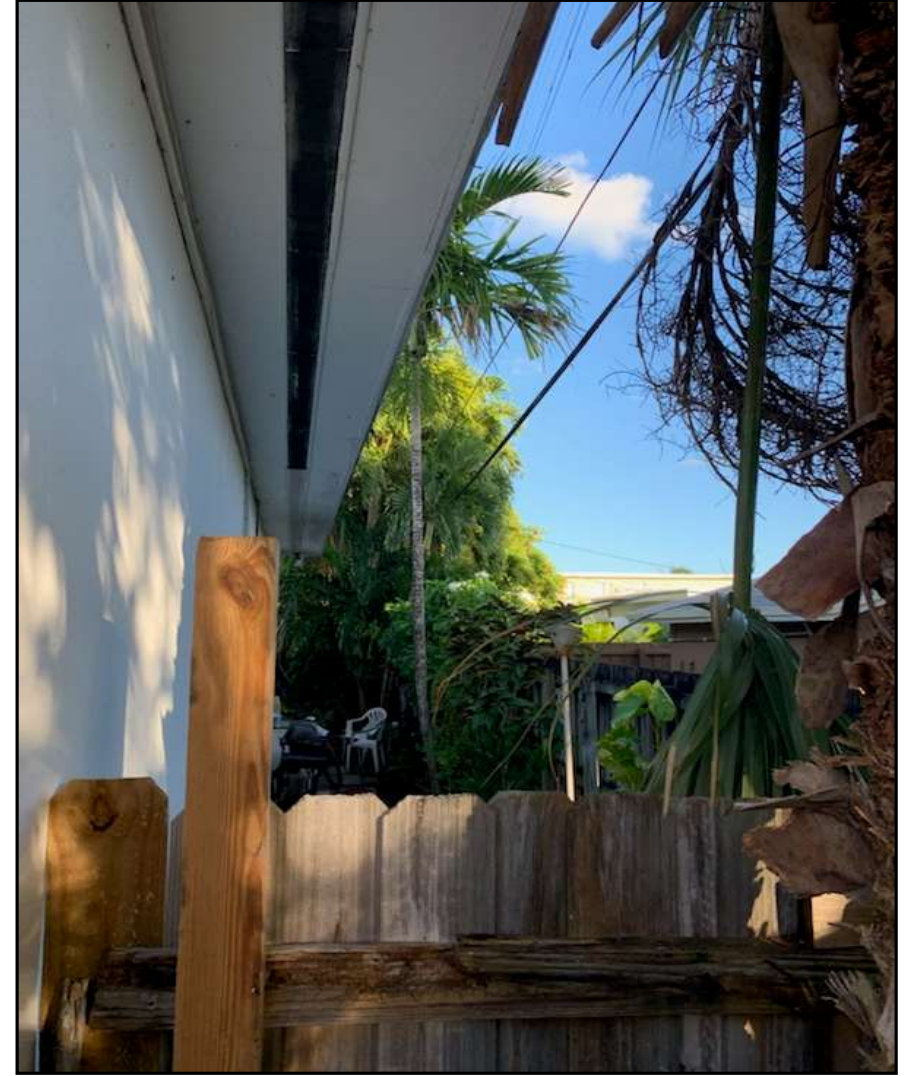
**Photo 4** View east along rear of structure showing solitaire palm
