RE: Certified Arborist Tree Risk and Viability Assessment
425-435 E Rivo Alto Drive, Miami Beach
NLE Project No. 15519001

PHOTO LOG

RE: Proposal for Certified Arborist Assessment and Tree Permitting Services
425-435 E Rivo Alto Drive, Miami Beach
NLE Project No. 15519001

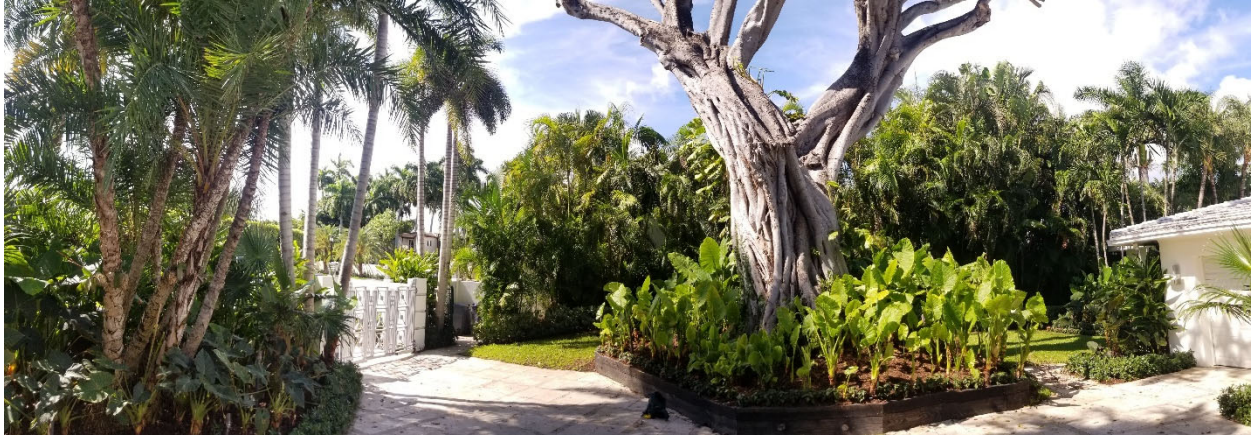
- The tree is located in the front yard of the residence, with driveway pavers bordering the southeast side and open/landscape area bordering the northwest side.

Photo 1. Overview of area surrounding Tree 31 (in center of photo). Driveway pavers and landscape area shown on opposing sides.

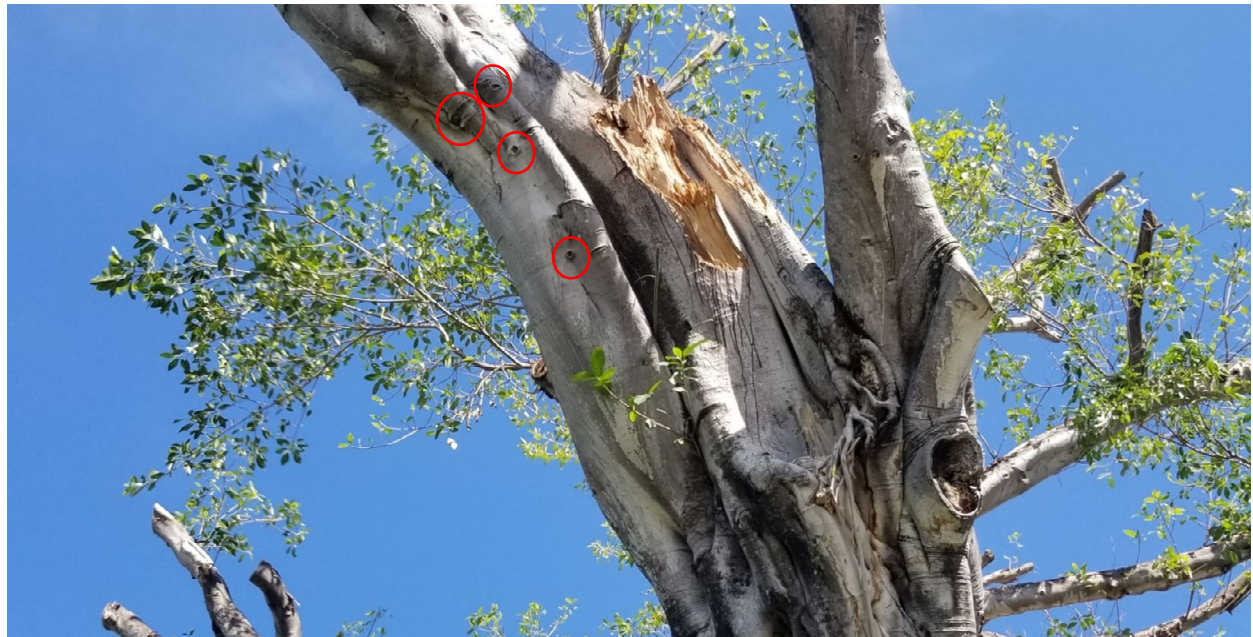
- This tree appears to have a fungal pathogen – a type of Botryosphaeria, producing a disease commonly referred to as sooty canker. This is evidenced by holes/cankers in the trunk/main stems, often with dark stained bark/wood. There is no established cure for Botryosphaeria, the tree's primary defense is to maintain high levels of health overall and outgrow the fungus.

- Based on information from the owner and observations of the canopy, a number of large branches have fallen over the past years.
- The owner has recently pruned back the canopy, owing to a recent major branch loss during a wind event.

Photo 2. Location of recent branch break (at approx. 20' in height). Fungal cankers/pitting shown in red circles.

- If the proposed development can avoid direct impacts to the soil mound surrounding the tree, it can remain in place.
- If the tree remains in place, a maintenance plan should be implemented including pruning and monitoring for health. Due to the pattern of branch failure and the presence of the fungus, structures and parking should not be located beneath the canopy.

- No additional canopy pruning should be conducted for the next 12 months. After that period, pruning should be conducted when needed under the direction of a Certified Arborist.

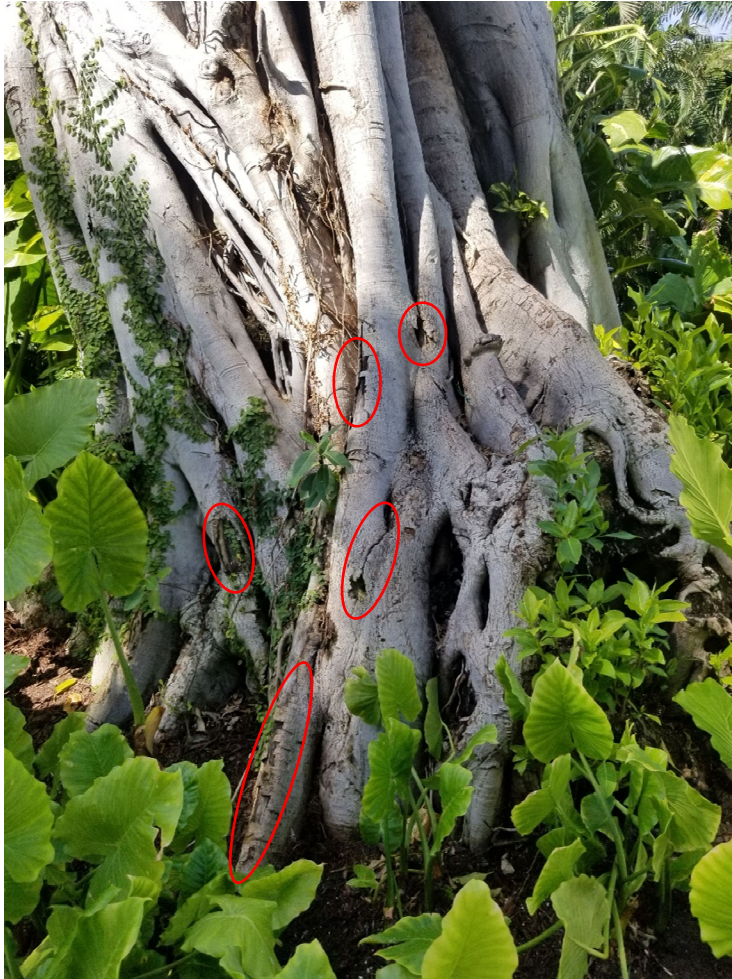
- Based on an excavation of a number of the primary/first order roots emerging from the root flair, the significant roots of this tree are largely confined to the soil mound surrounding the tree. The roots were observed to sharply plunge at a distance of approximately 3 feet from the edge of the trunk. NLE conducted excavations around the perimeter of the soil mound to a depth of 12 inches and did not identify any roots greater than one inch in diameter, or dense clusters of smaller diameter roots.

Photo 3. Base of the tree – angle of primary roots show their plunging form, fungal cankers circled in red.

- If the proposed development impacts the tree (including the soil mound), relocation of this tree can be considered. With the roots confined to the narrow diameter soil mound, the majority of roots can readily be captured within a root ball that can be relocated. Prior to relocation, this tree should be monitored for health/progression of the fungus, and the tree (fungus) treated with copper sulfate. Root pruning should be limited, with the goal of capturing the entire area within the soil mound. If the fungus spreads/health of the tree declines, removal of the tree should be considered.
