# ***Tree Resource Evaluation for 1710 West 23<sup>rd</sup> Street, Miami Beach***

***October 16, 2019***

## **Summary**

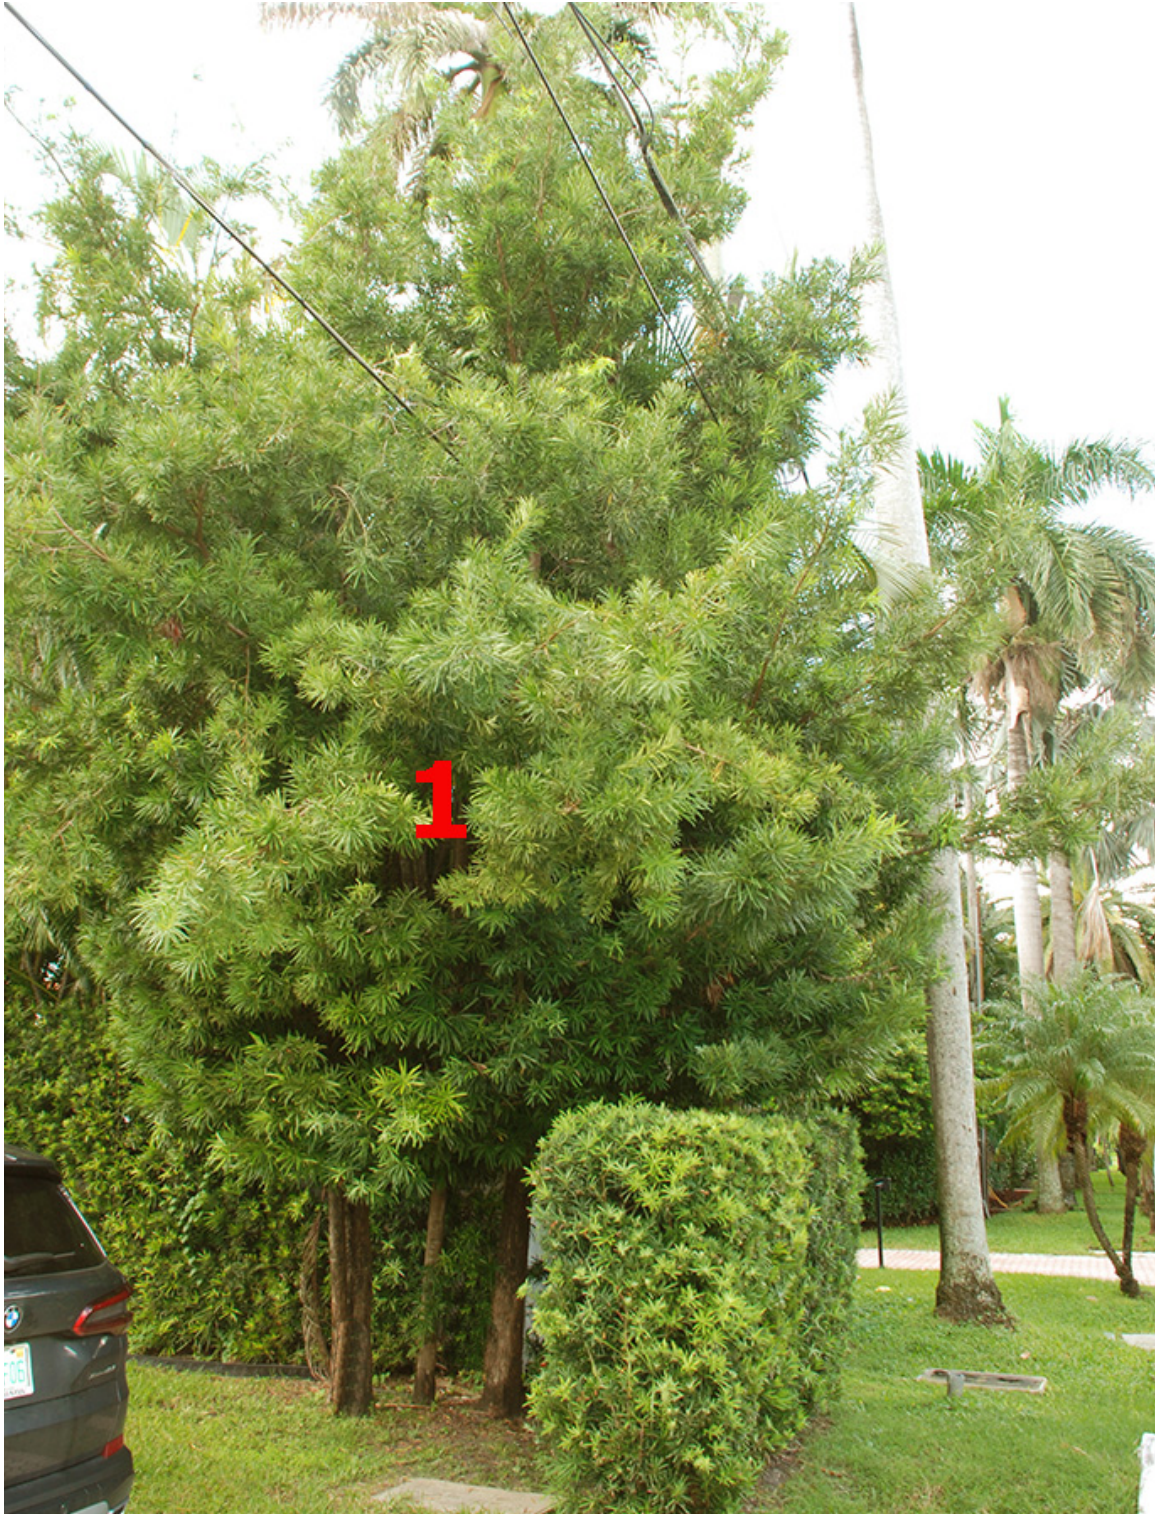
**Photo 1 above is tree 1 near the northwest corner of the property. Note the power lines above.**

| | <b>Scientific name</b> | <b>Common name</b> | <b>DBH</b> | <b>H/Ct</b> | <b>Canopy</b> | <b>Condition</b> | <b>TPZ</b> |
|---|---|---|---|---|---|---|---|
| 1 | Podocarpus macrophyllus | Podocarpus | 21" | 25' | 25' | Good | 5' |

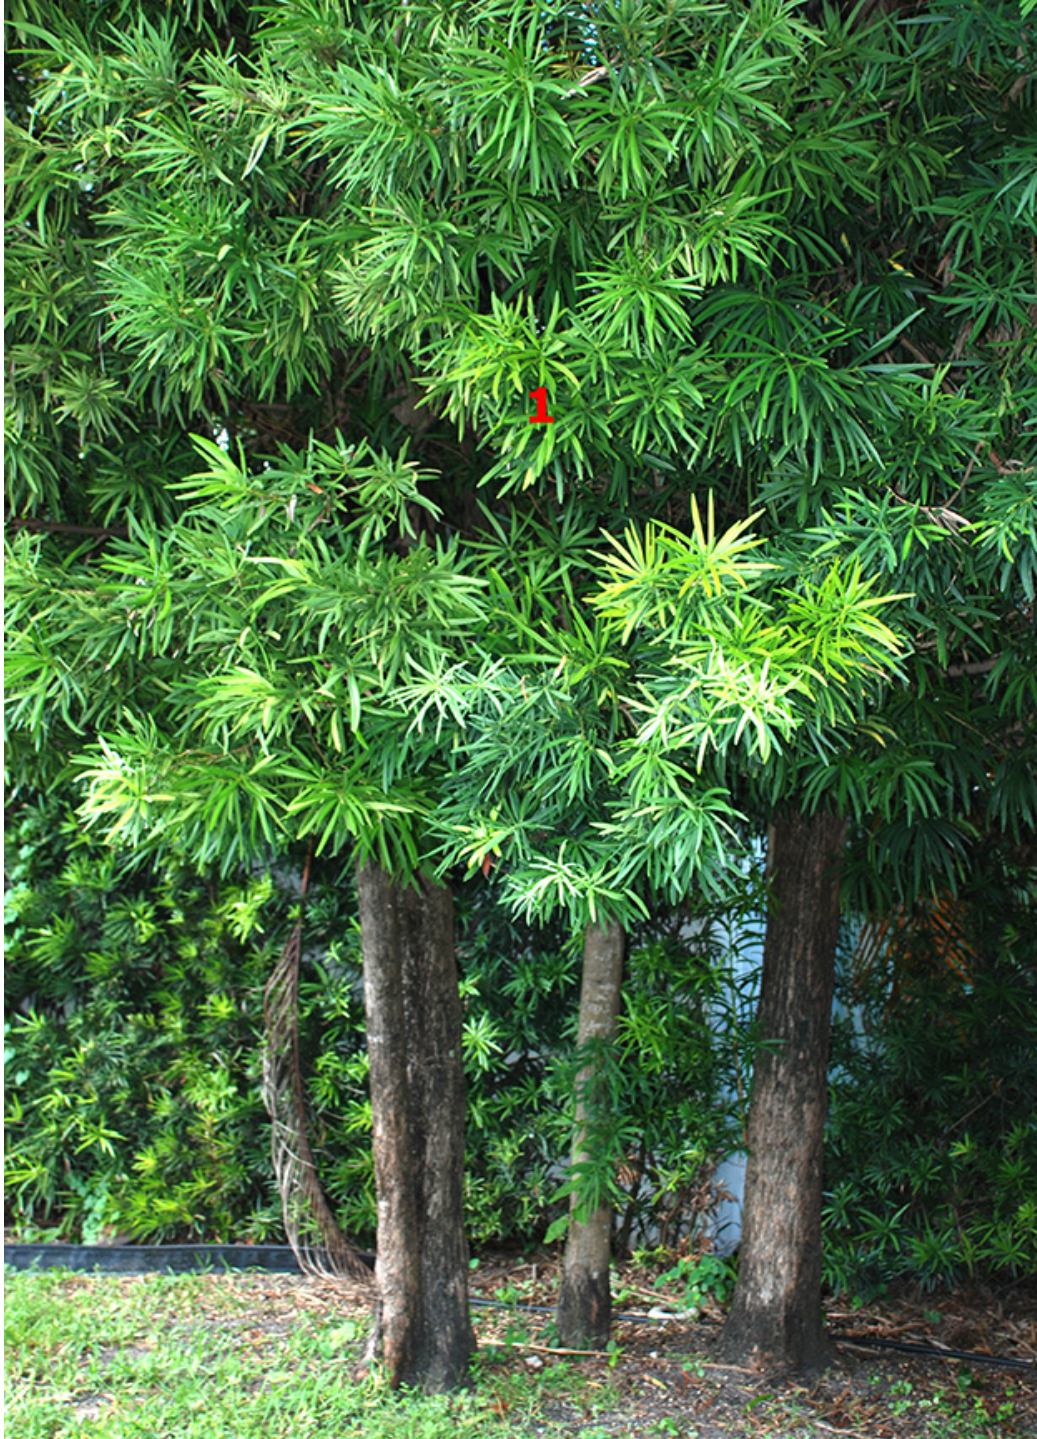
**Photo 2 above is the four trunks of tree 1. Since this group of trunks can only be successfully relocated as a single tree or clump and cannot be separated, I have noted this as a single tree.**

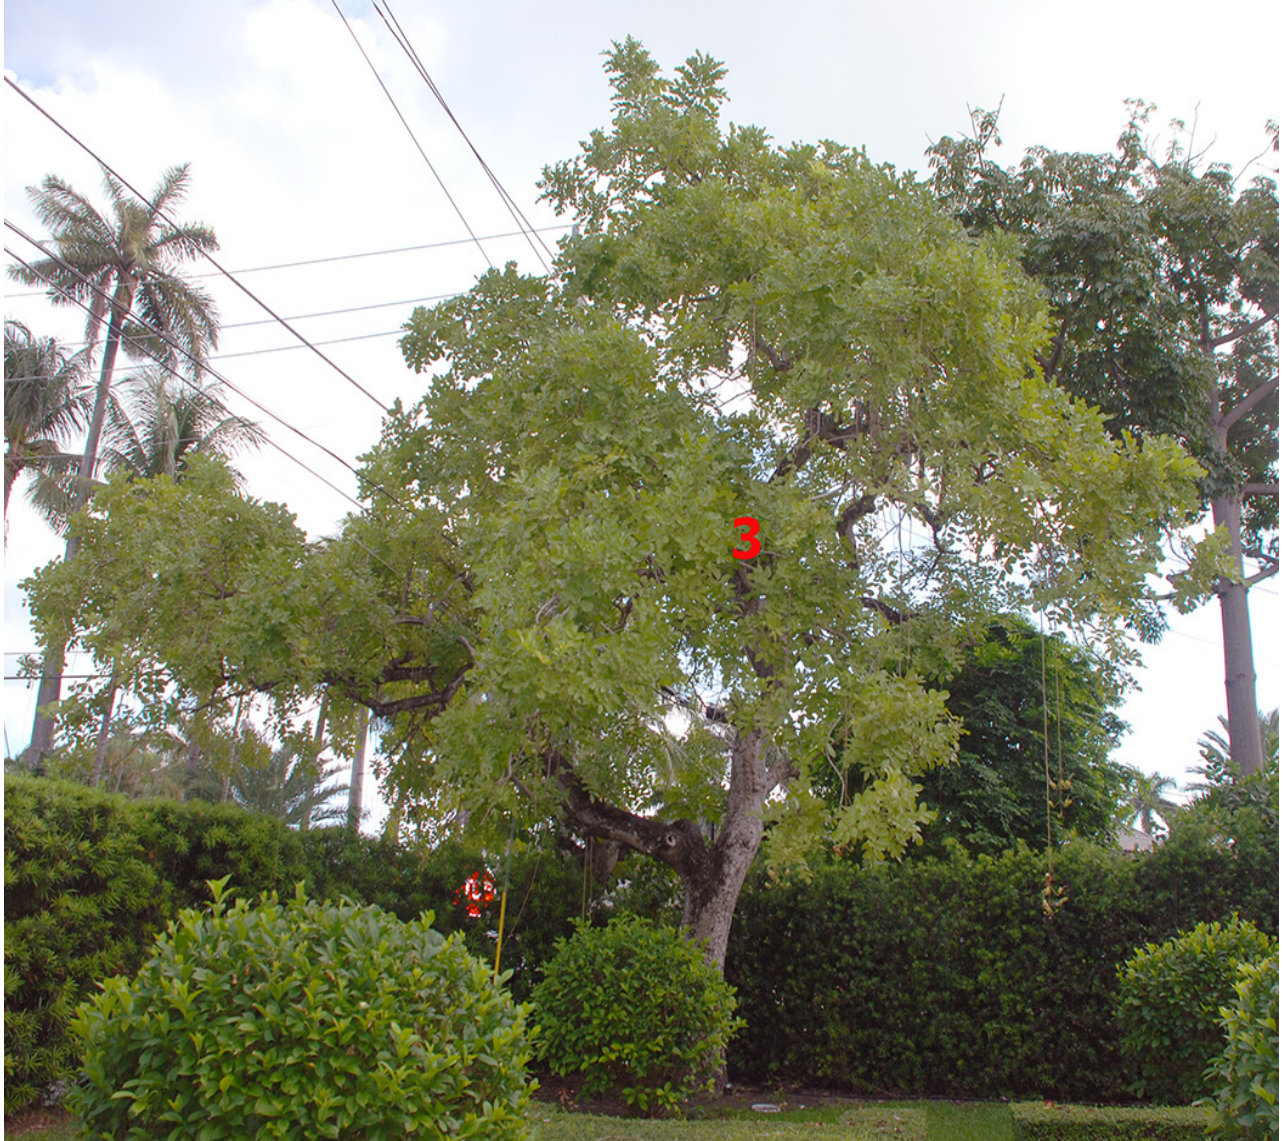
**Photo 3 above is tree 3 near the northeast corner of the property. Note the power lines.**

| | <b>Scientific name</b> | <b>Common name</b> | <b>DBH</b> | <b>H/Ct</b> | <b>Canopy</b> | <b>Condition</b> | <b>TPZ</b> |
|---|---|---|---|---|---|---|---|
| 3 | Kigelia pinnata | Sausage tree | 22" | 35' | 55' | Good | 18' |

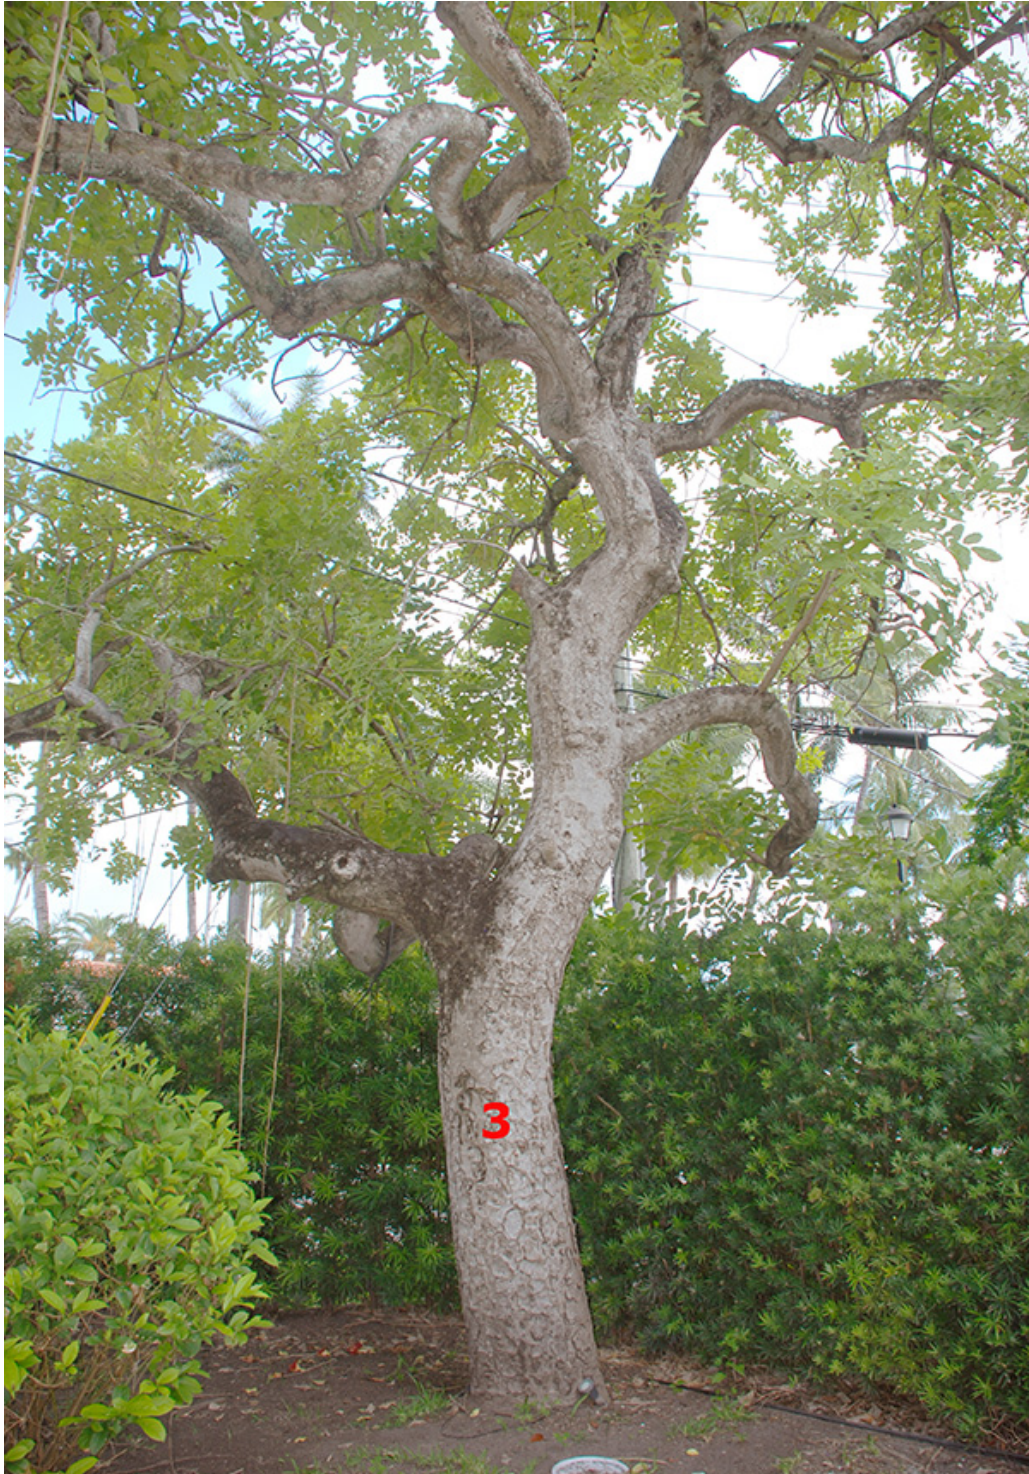
**Photo 3 above is the trunk of tree 3 showing no signs of decay or cavities on the root collar or trunk. This tree is a good candidate for relocation.**

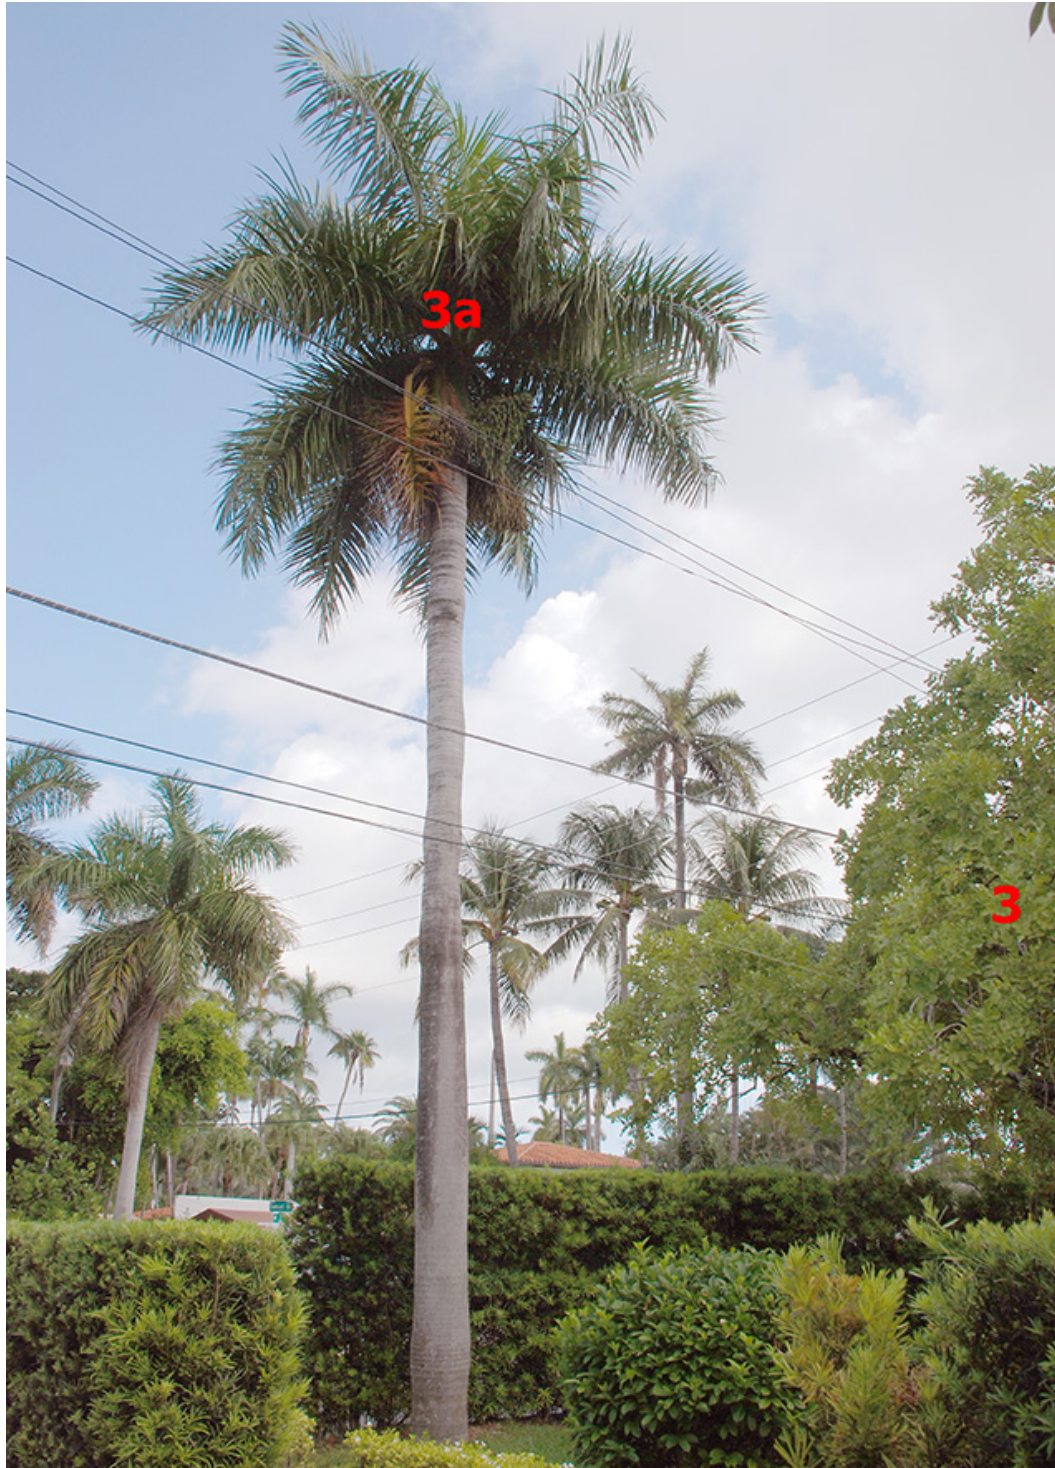
**Photo 4 above is palm 3a viewed from the south. Note the power lines.**

| | <b>Scientific name</b> | <b>Common name</b> | <b>DBH</b> | <b>H/Ct</b> | <b>Canopy</b> | <b>Condition</b> | <b>TPZ</b> |
|---|---|---|---|---|---|---|---|
| 3a | Roystonea regia | Royal palm | 19" | 30' | 28' | Good | 5' |

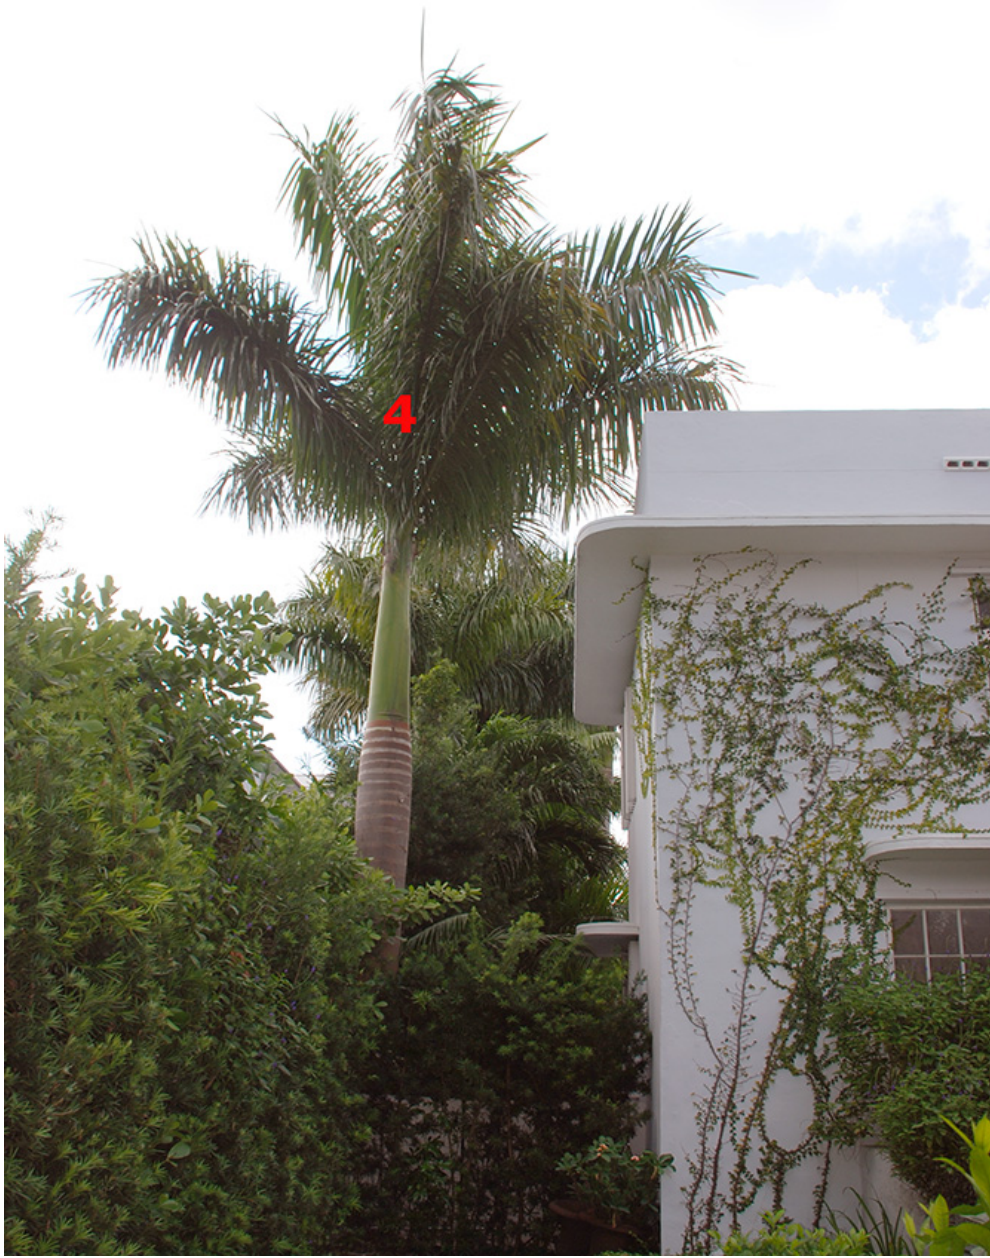
**Photo 5 above is palm 4 viewed from the north.**

| | <b>Scientific name</b> | <b>Common name</b> | <b>DBH</b> | <b>H/Ct</b> | <b>Canopy</b> | <b>Condition</b> | <b>TPZ</b> |
|---|---|---|---|---|---|---|---|
| 4 | Roystonea regia | Royal palm | 18" | 16' | 28' | Good | 5' |

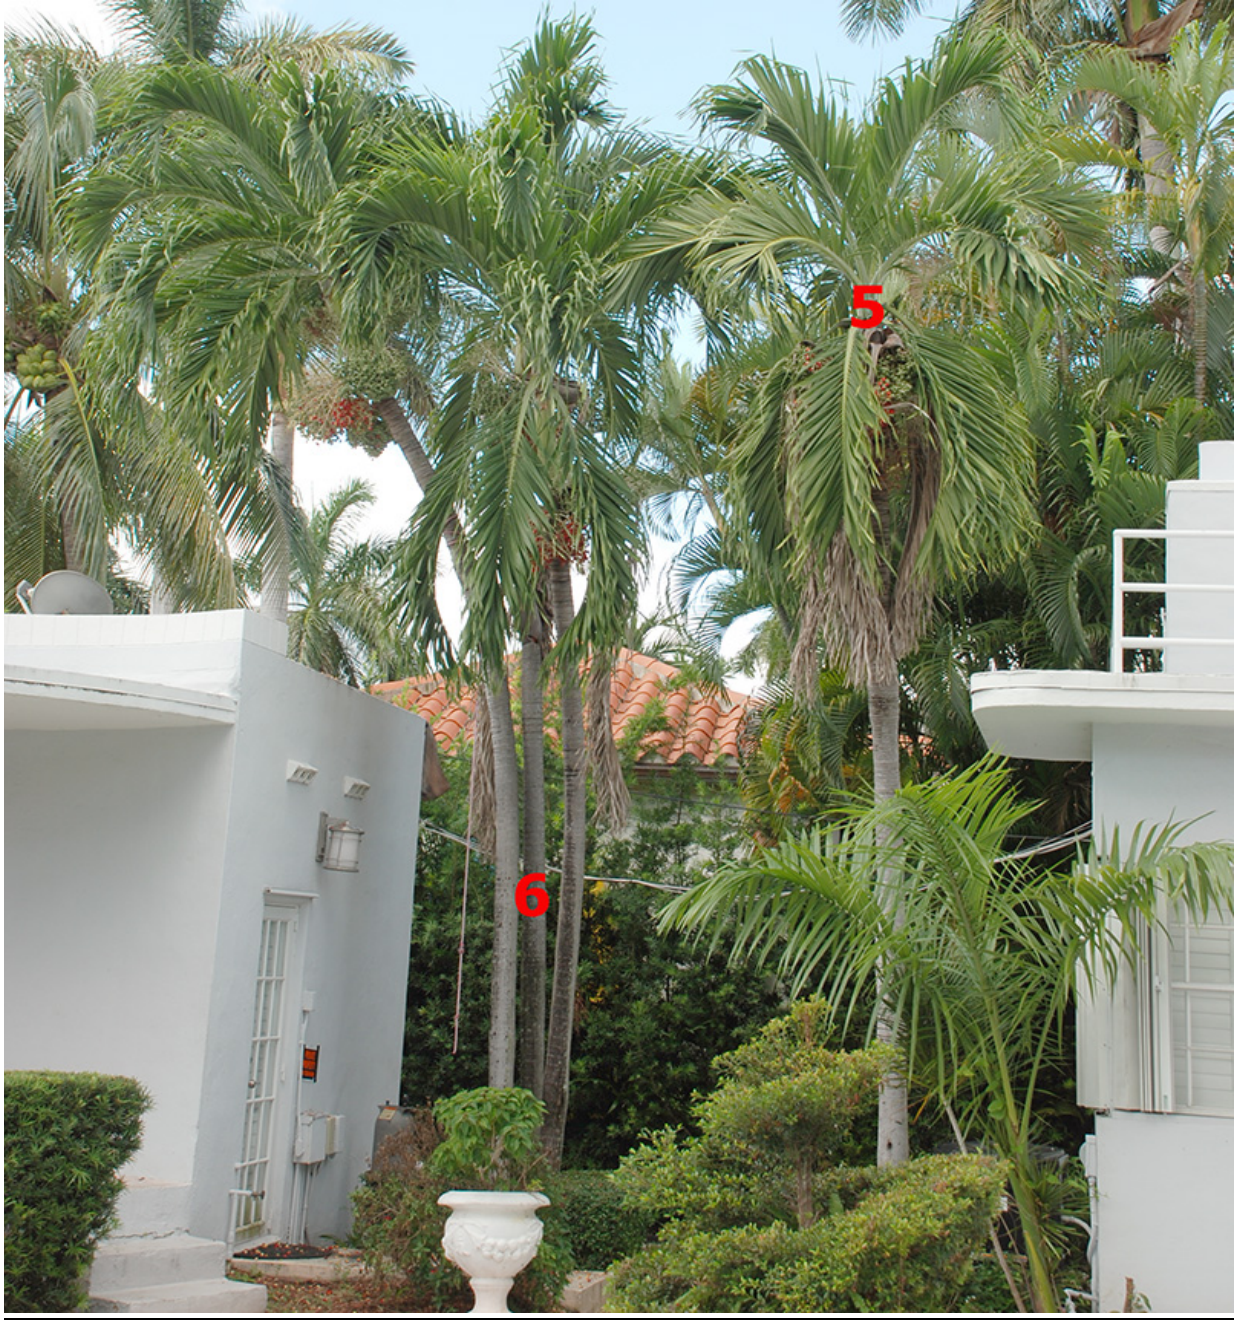
**Photo 6 above is single-trunked palm 5 and multi-trunked palm 6.**

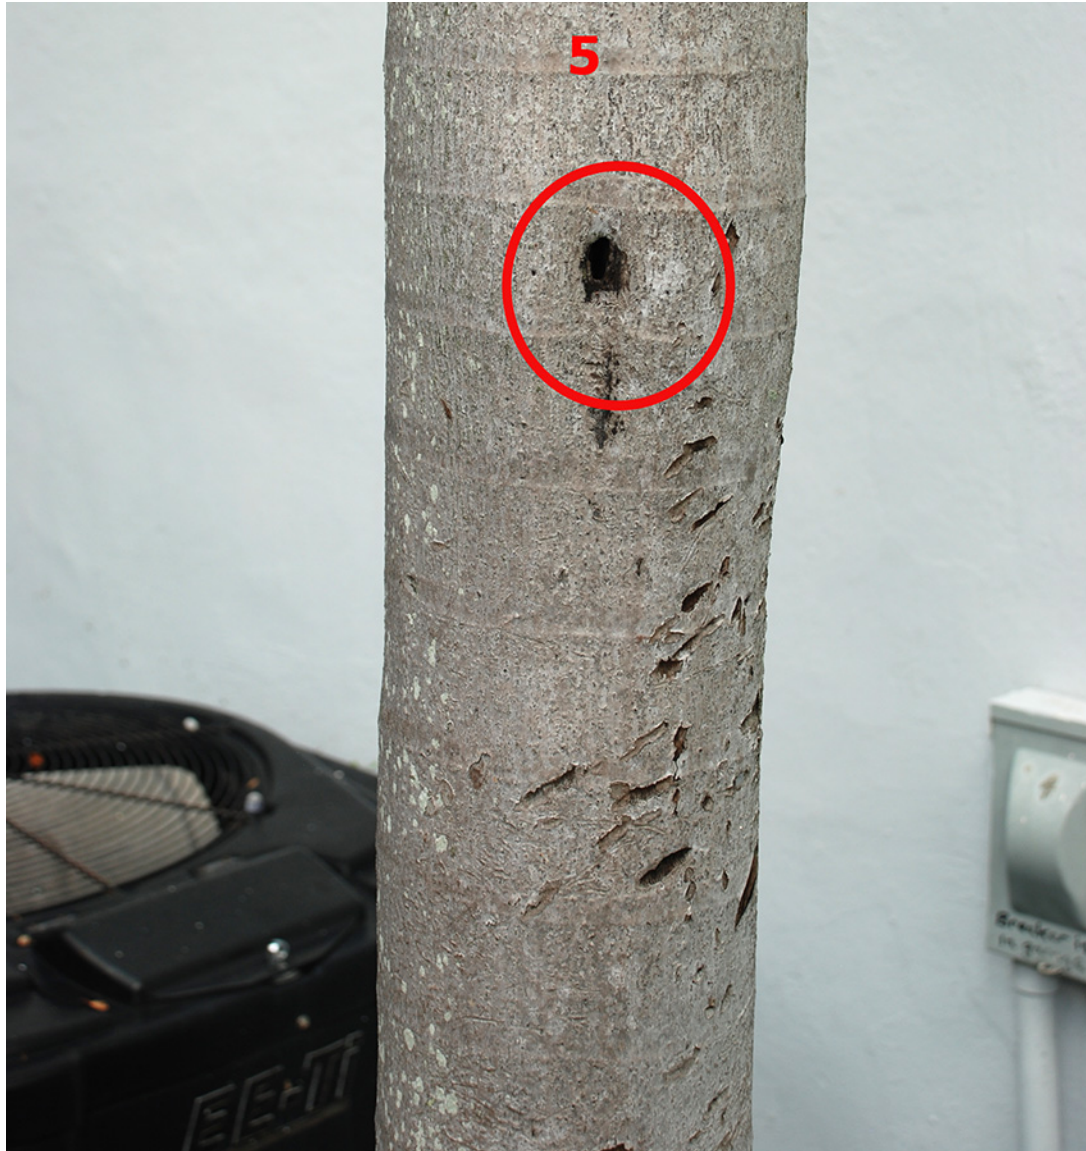
**Photo 7 above is the trunk of palm 5 with damage indicated. Some of the palms on this site have been climbed with spikes. This is against ANSI A300 Standards and ISA Best Management practices. I have rated all of the spiked palms, and palms that I found with oozing injection holes, as moderate and do not recommend their relocation.**

| | <b>Scientific name</b> | <b>Common name</b> | <b>DBH</b> | <b>H/Ct</b> | <b>Canopy</b> | <b>Condition</b> | <b>TPZ</b> |
|---|---|---|---|---|---|---|---|
| 5 | Adonidia merrillii | Christmas palm | 6" | 16' | 10' | Moderate | 3' |

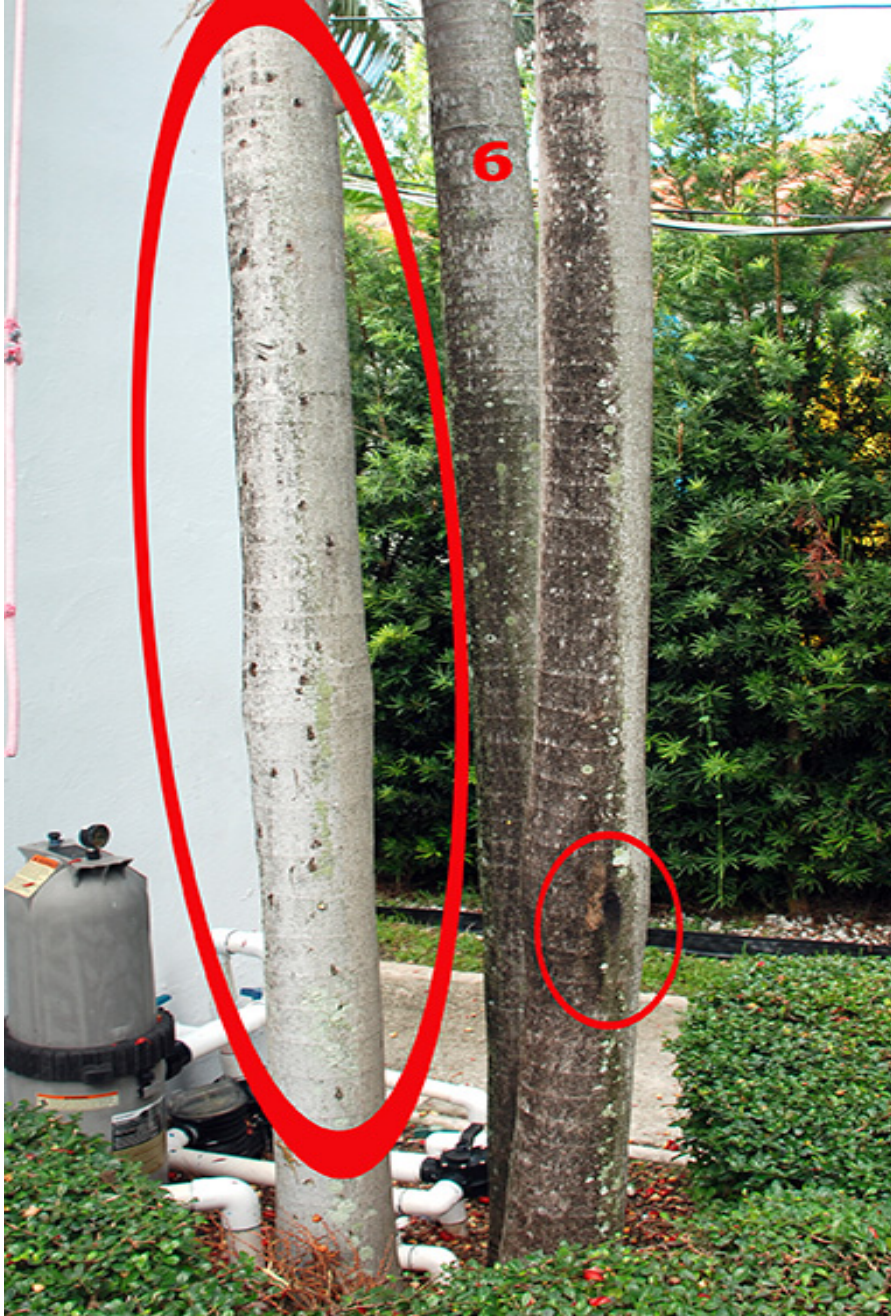
**Photo 8 above is multi-trunked palm 6 with signs of damage on the trunks. Some of the palms on this site have been climbed with spikes. This is against ANSI A300 Standards and ISA Best Management practices. I have rated all of the spiked palms, and palms that I found with oozing injection holes, as moderate and do not recommend their relocation.**

| | <b>Scientific name</b> | <b>Common name</b> | <b>DBH</b> | <b>H/Ct</b> | <b>Canopy</b> | <b>Condition</b> | <b>TPZ</b> |
|---|---|---|---|---|---|---|---|
| 6 | Adonidia merrillii | Christmas palm | 18" | 20' | 20' | Moderate | 3' |

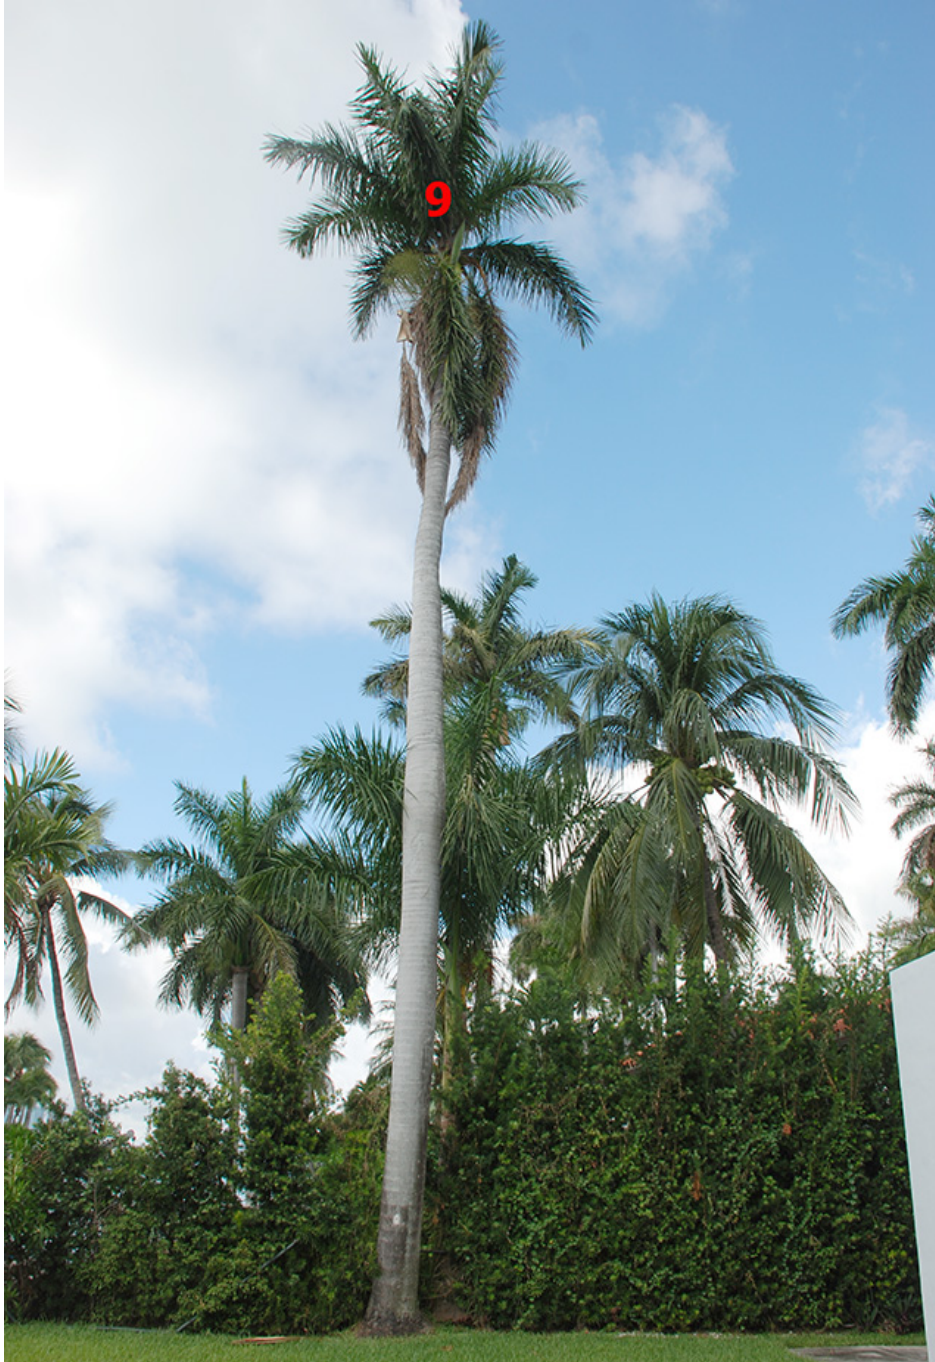
**Photo 9 above is palm 9 viewed from the east. See following photo.**

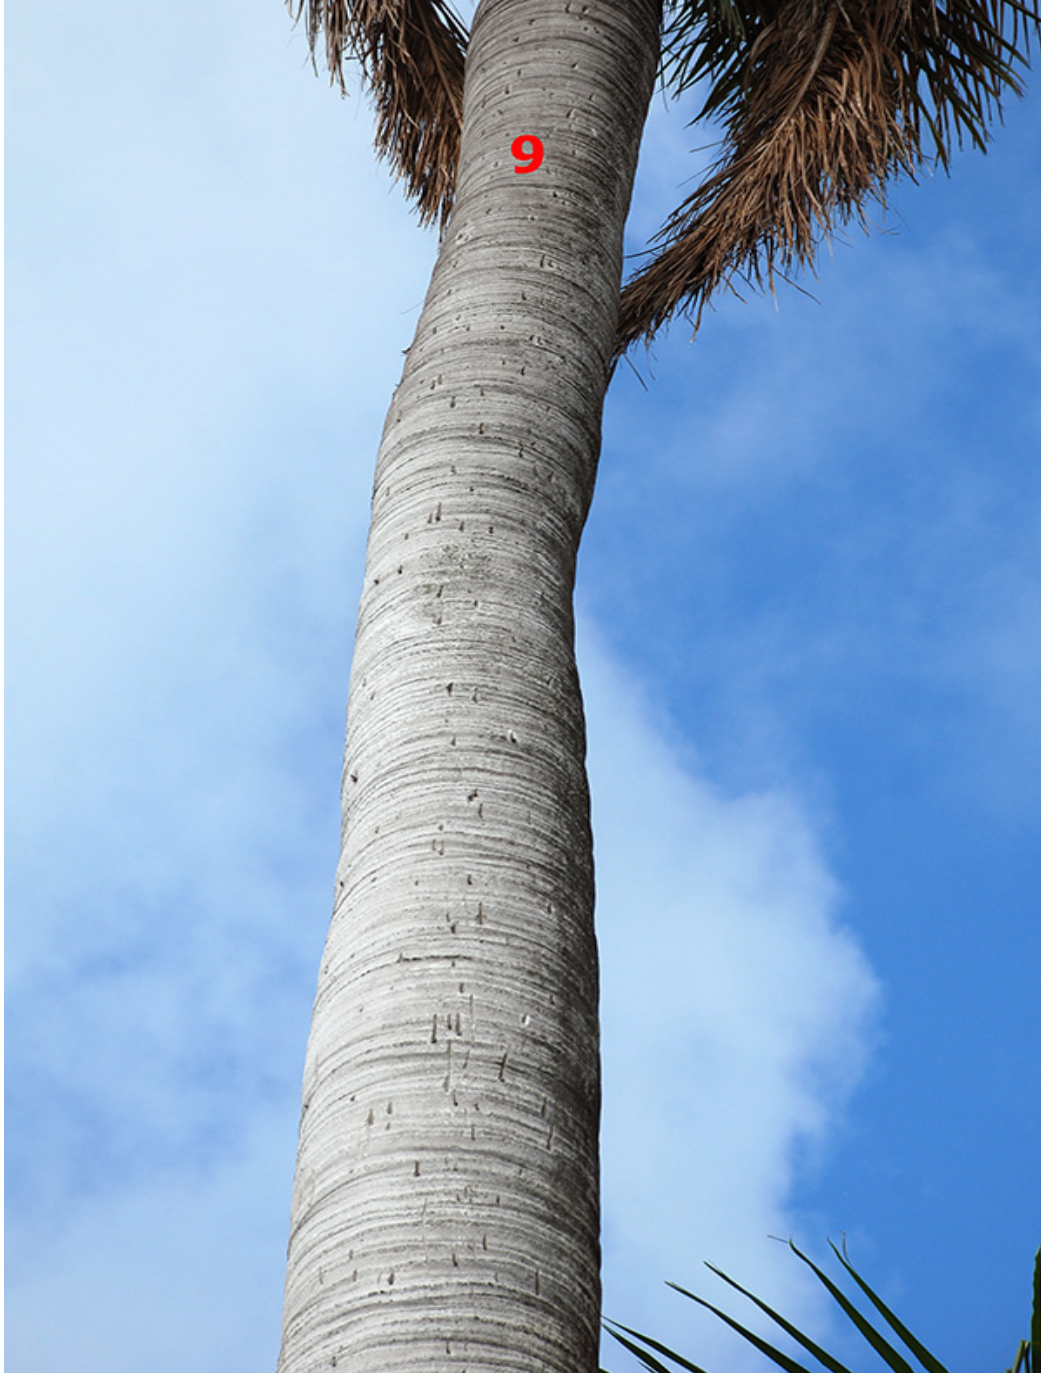
**Photo 10 above is a closer view of the trunk of palm 9. Some of the palms on this site have been climbed with spikes. This is against ANSI A300 Standards and ISA Best Management practices. I have rated all of the spiked palms, and palms that I found with oozing injection holes, as moderate and do not recommend their relocation.**

| | <b>Scientific name</b> | <b>Common name</b> | <b>DBH</b> | <b>H/Ct</b> | <b>Canopy</b> | <b>Condition</b> | <b>TPZ</b> |
|---|---|---|---|---|---|---|---|
| 9 | Roystonea regia | Royal palm | 21" | 55' | 26' | Moderate | 6' |

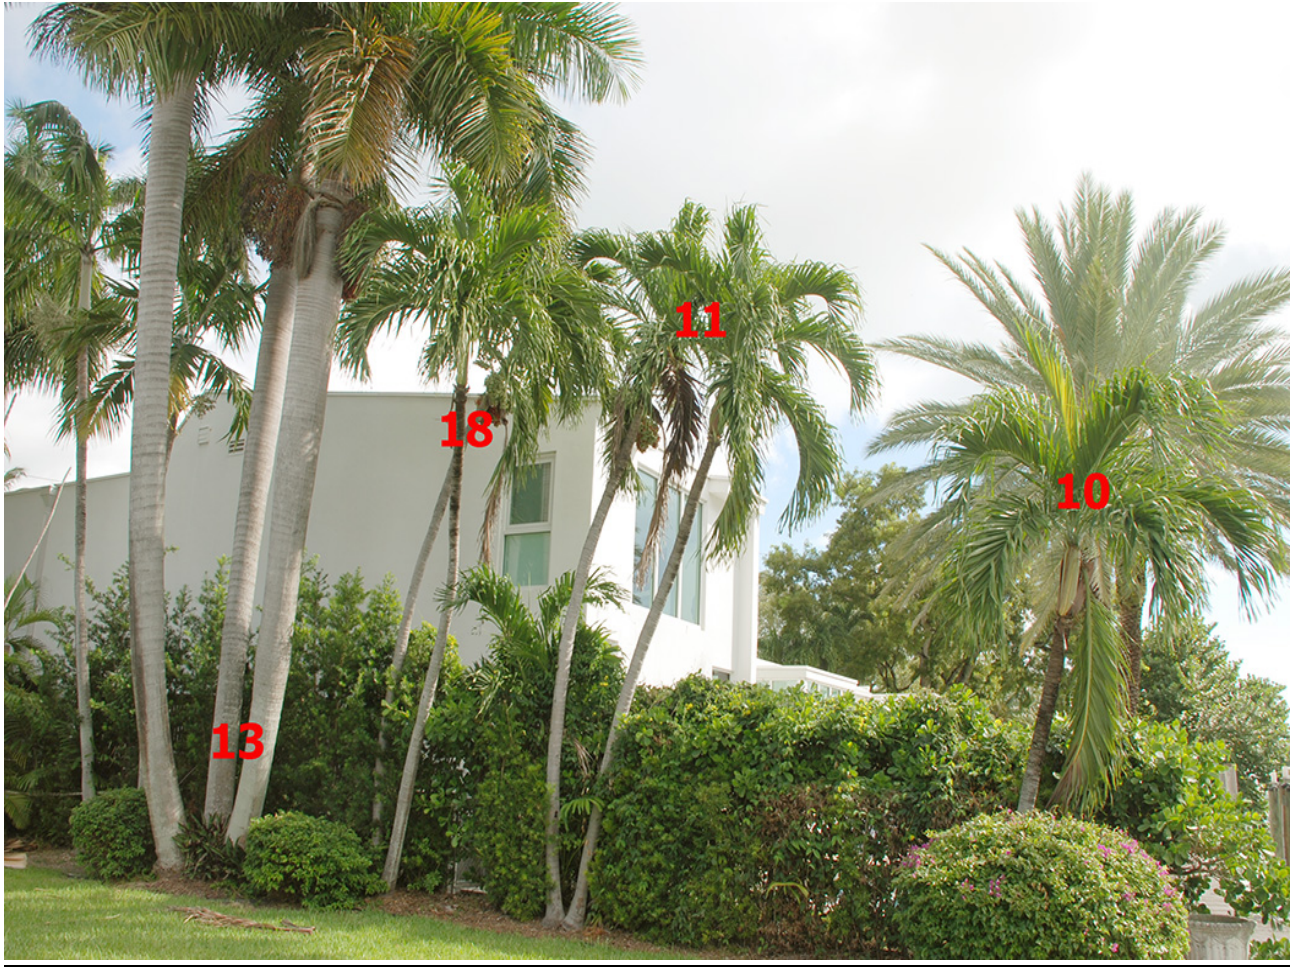
**Photo 11 above is palm 10 and multi-trunked palms 11, 18 & 13 viewed from the west.**

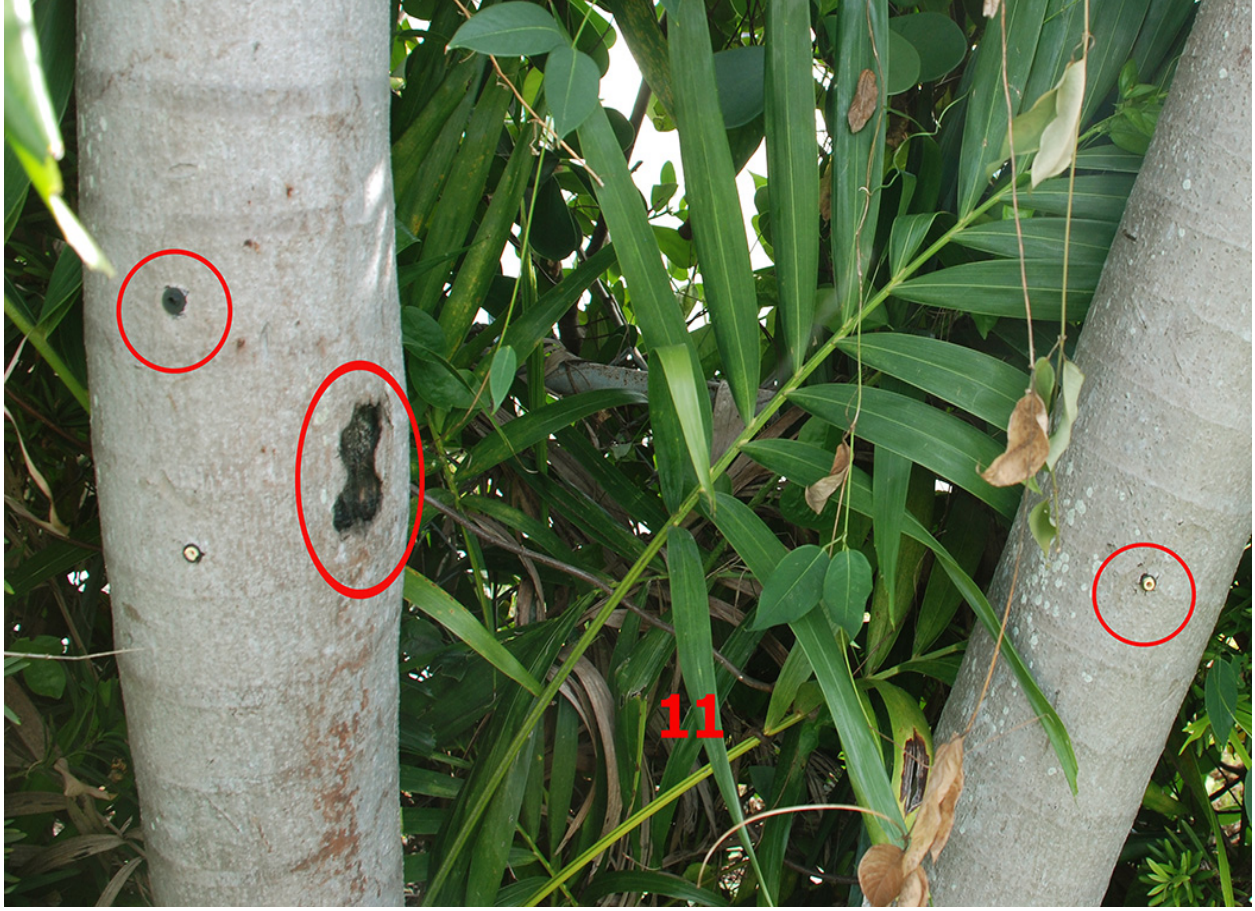
**Photo 12 above is a closer view of the trunks of palm 11. Some of the palms on this site have been climbed with spikes. This is against ANSI A300 Standards and ISA Best Management practices. I have rated all of the spiked palms, and palms that I found with oozing injection holes, as moderate and do not recommend their relocation.**

| | <b>Scientific name</b> | <b>Common name</b> | <b>DBH</b> | <b>H/Ct</b> | <b>Canopy</b> | <b>Condition</b> | <b>TPZ</b> |
|---|---|---|---|---|---|---|---|
| 11 | Adonidia merrillii | Christmas palm | 13" | 17' | 15' | Moderate | 4' |

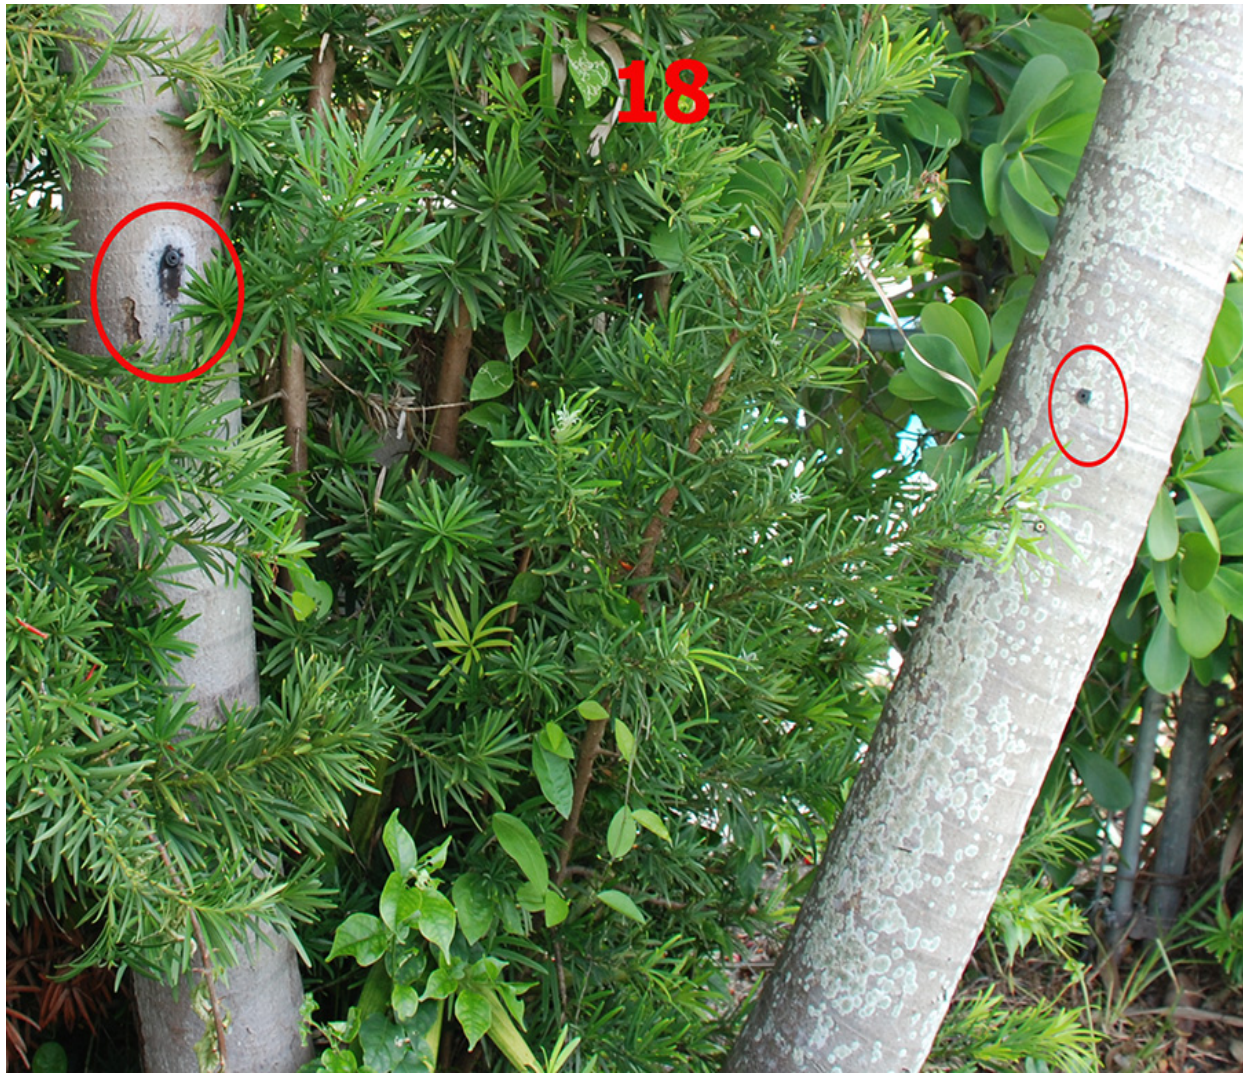
**Photo 13 above is a closer view of the trunks of palm 18. Some of the palms on this site have been climbed with spikes. This is against ANSI A300 Standards and ISA Best Management practices. I have rated all of the spiked palms, and palms that I found with oozing injection holes, as moderate and do not recommend their relocation.**

| | <b>Scientific name</b> | <b>Common name</b> | <b>DBH</b> | <b>H/Ct</b> | <b>Canopy</b> | <b>Condition</b> | <b>TPZ</b> |
|---|---|---|---|---|---|---|---|
| 18 | Adonidia merrillii | Christmas palm | 13" | 22' | 18' | Moderate | 4' |

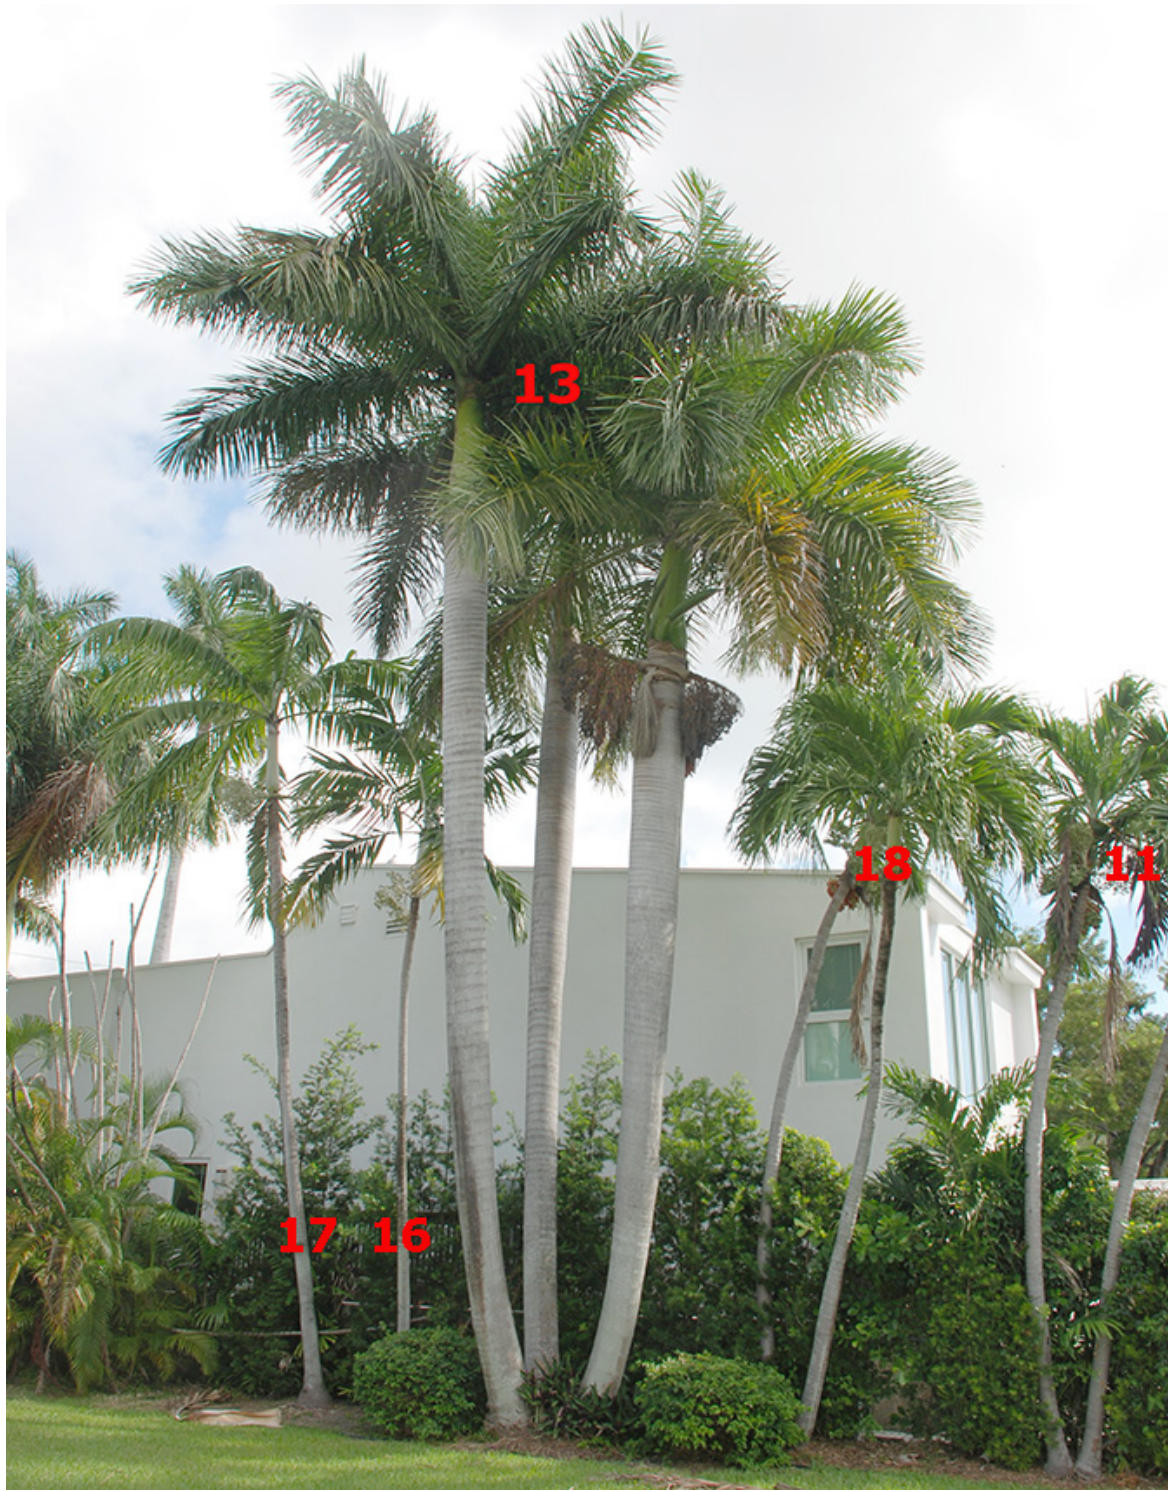
**Photo 14 above is multi-trunked palm 13 and single-trunked palms 16 & 17.**
