# ***Tree Resource Evaluation for 1710 West 23<sup>rd</sup> Street, Miami Beach***

***October 16, 2019***

## **Summary**

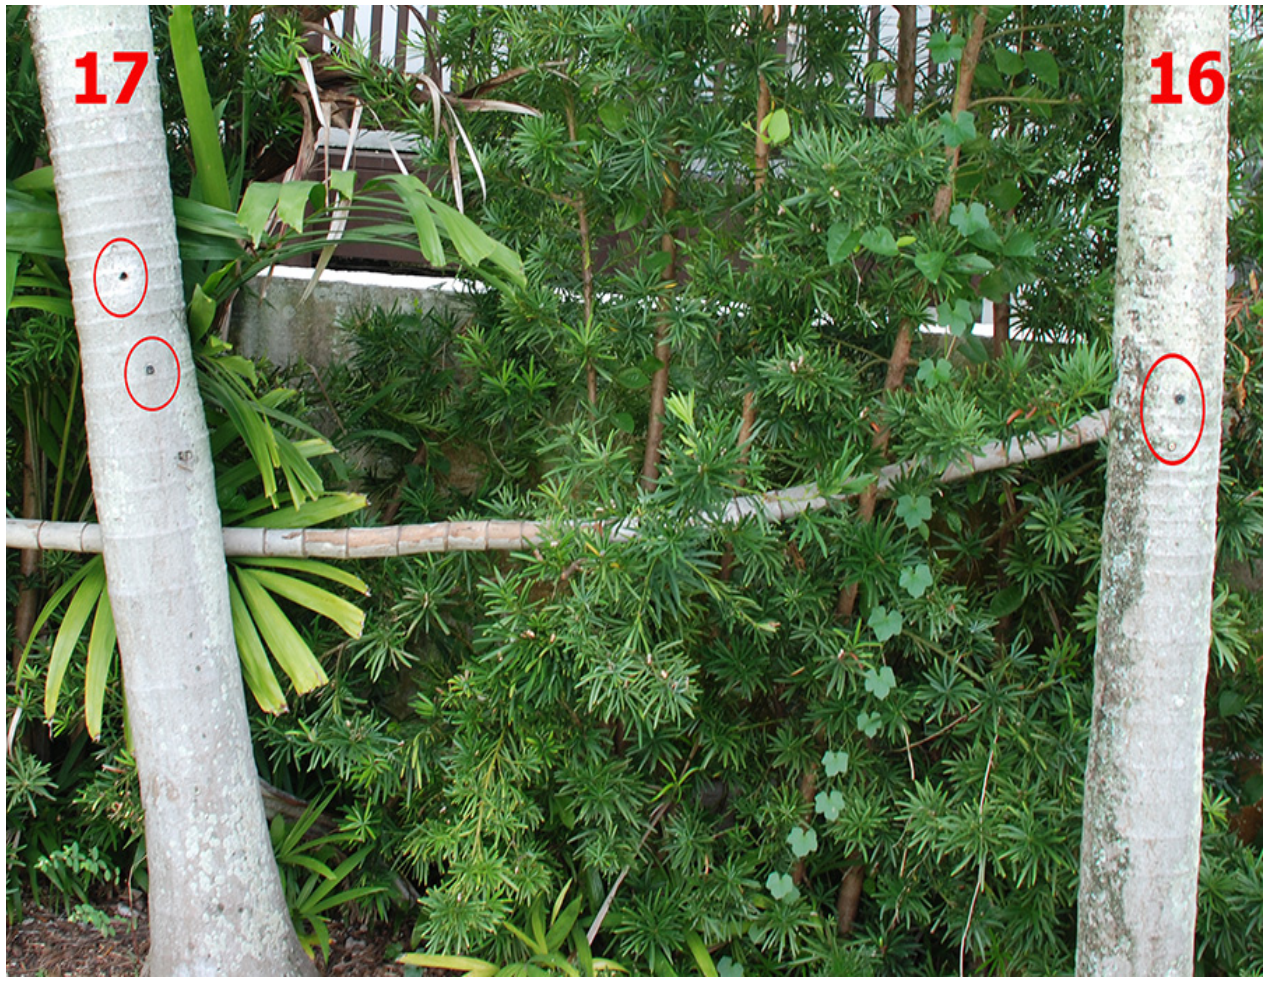
**Photo 15 above is a closer view of the trunks of palms 16 & 17 with signs of damage. Some of the palms on this site have been climbed with spikes. This is against ANSI A300 Standards and ISA Best Management practices. I have rated all of the spiked palms, and palms that I found with oozing injection holes, as moderate and do not recommend their relocation.**

| | <b>Scientific name</b> | <b>Common name</b> | <b>DBH</b> | <b>H/Ct</b> | <b>Canopy</b> | <b>Condition</b> | <b>TPZ</b> |
|---|---|---|---|---|---|---|---|
| 16 | Veitchia montgomeryana | Montgomery palm | 6" | 20' | 14' | Moderate | 4' |
| 17 | Veitchia montgomeryana | Montgomery palm | 7" | 25' | 18' | Moderate | 4' |

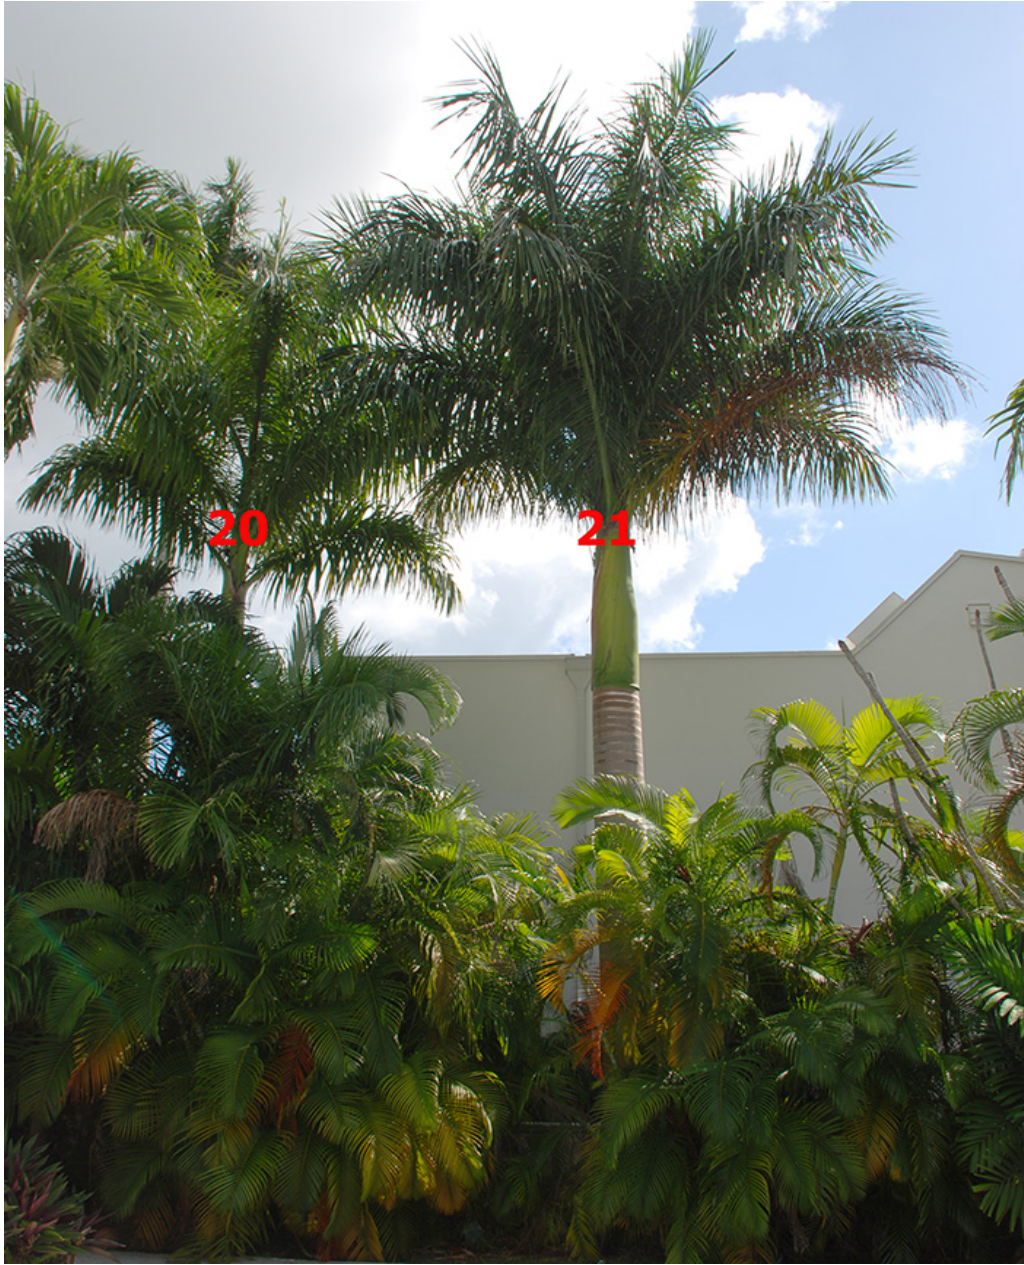
**Photo 16 above is palms 20 & 21.**

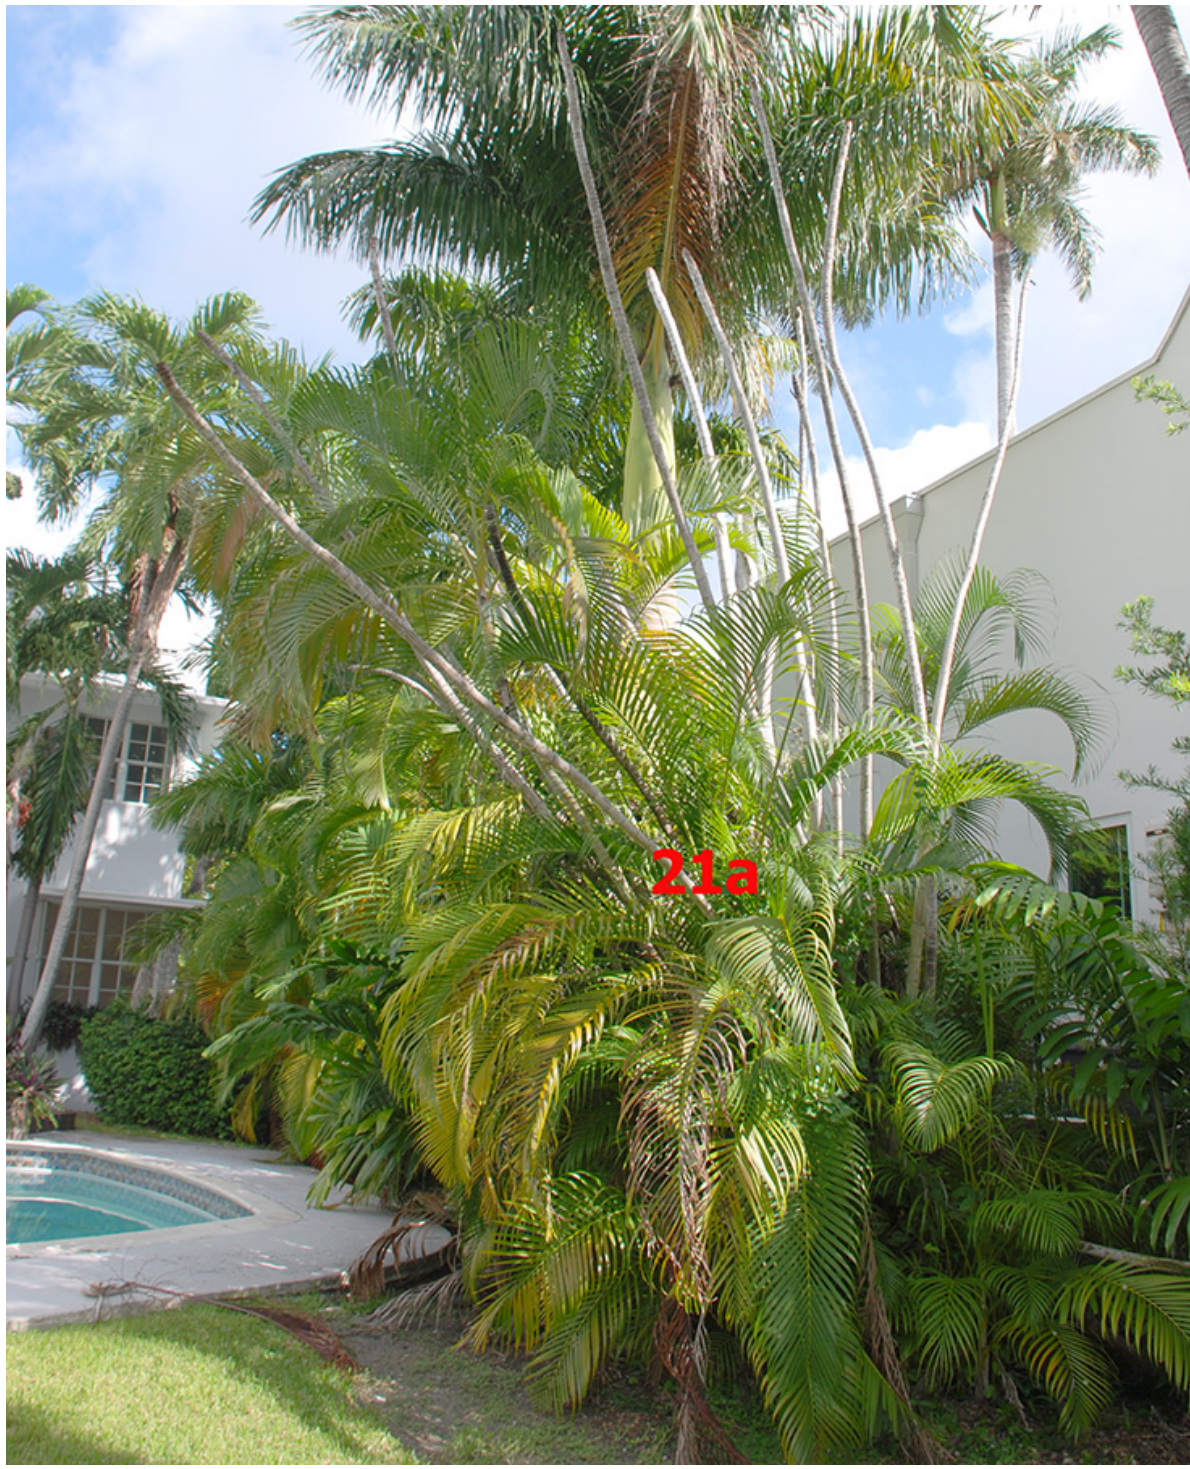
**Photo 17 above is palm 21a. This palm is dying, note the multiple dead trunks. I recommend its removal.**

| | <b>Scientific name</b> | <b>Common name</b> | <b>DBH</b> | <b>H/Ct</b> | <b>Canopy</b> | <b>Condition</b> | <b>TPZ</b> |
|---|---|---|---|---|---|---|---|
| 21a | Dypsis lutescens | Areca palm | 50" | 26' | 30' | Poor | |

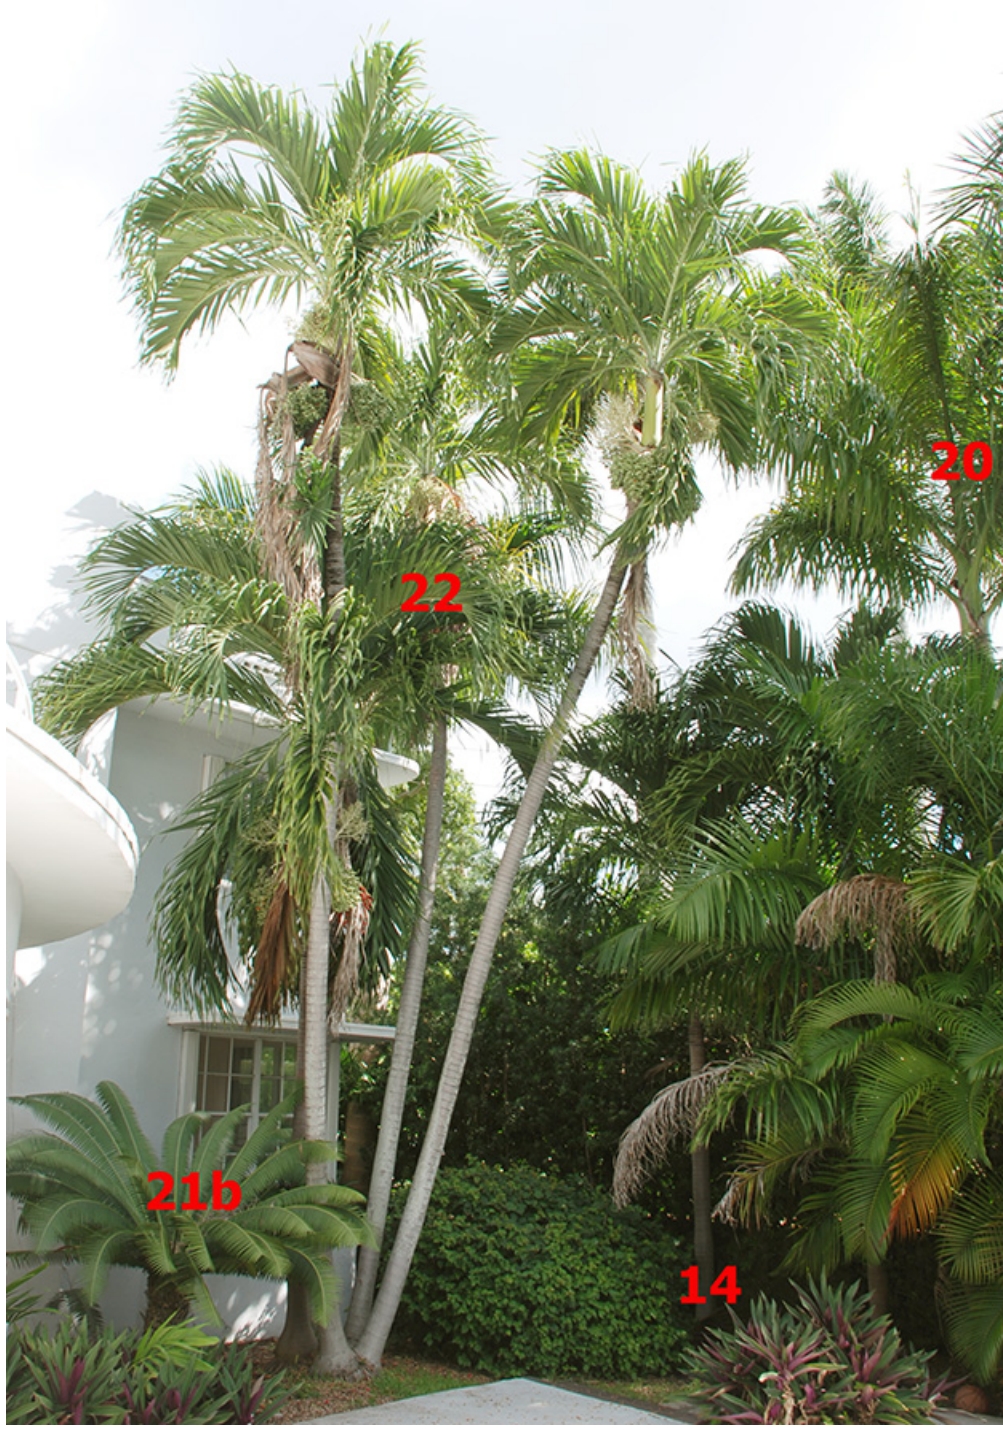
**Photo 18 above is cycad 21b, not a palm, and multi-trunked palm 22.**

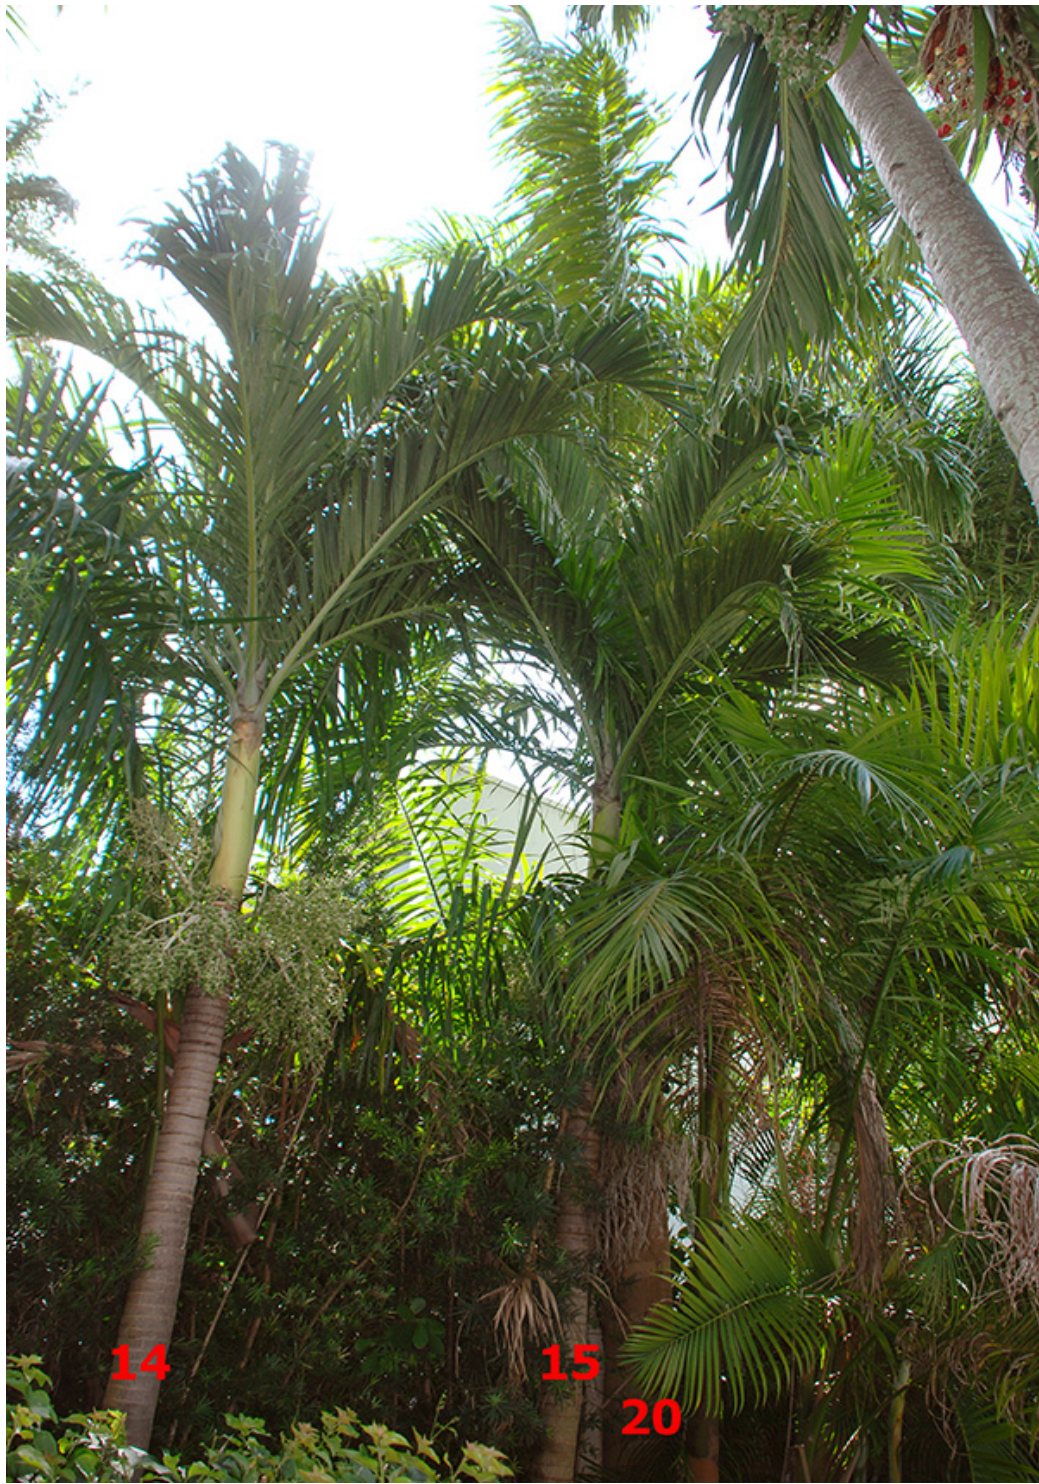
**Photo 19 above is palms 14, 15 & 20.**

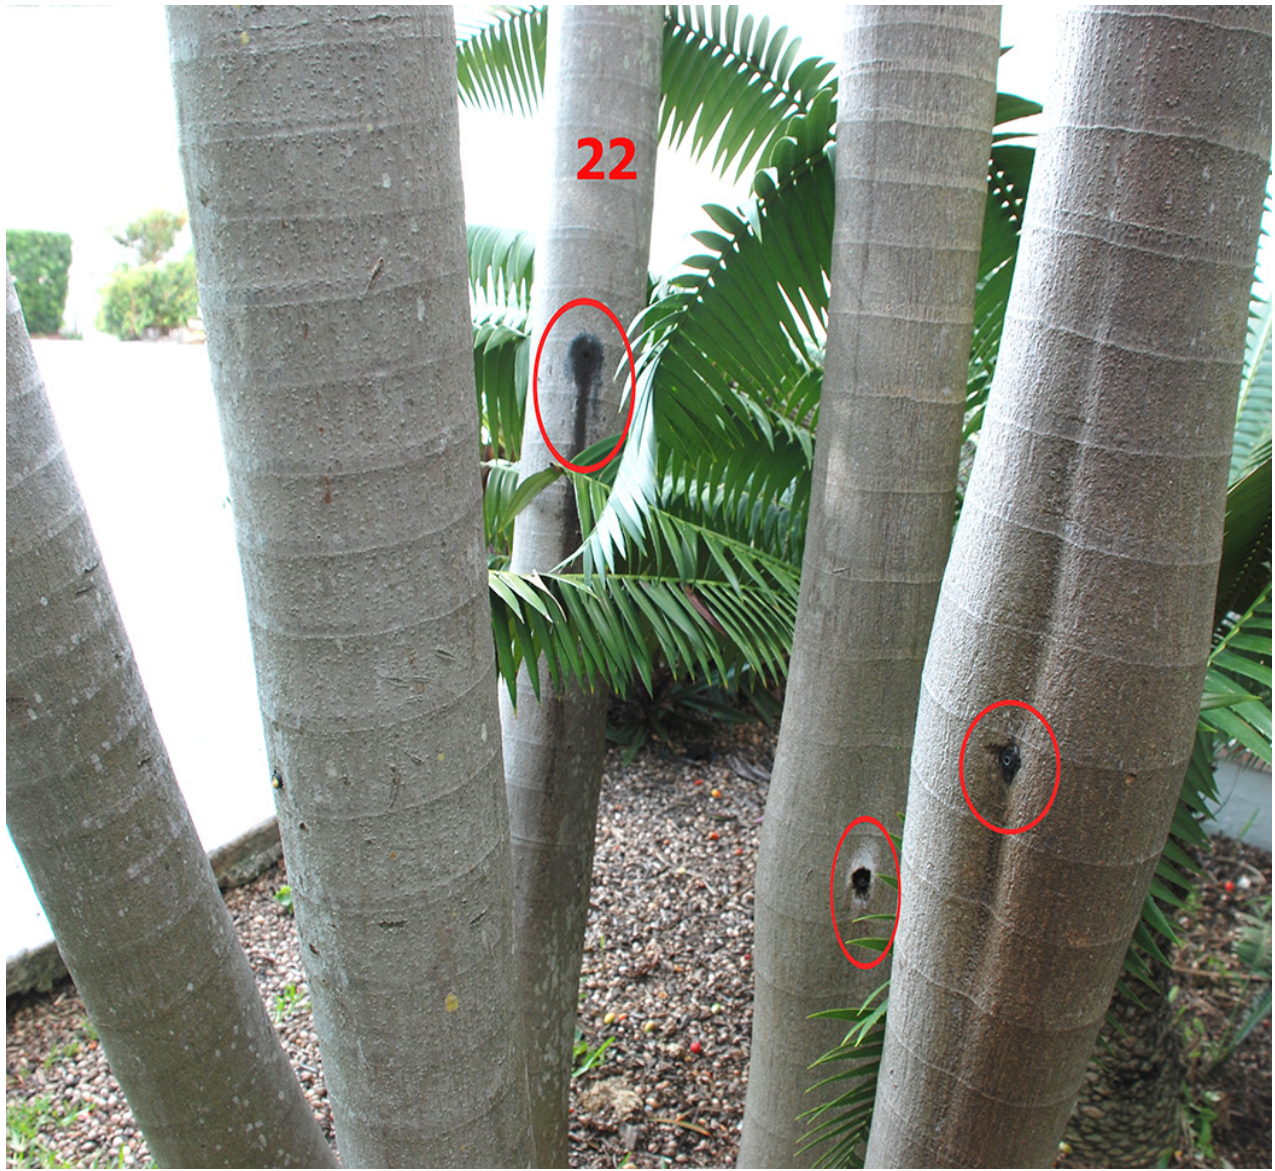
**Photo 20 above is multi-trunk palm 22 showing signs of damage. Some of the palms on this site have been climbed with spikes. This is against ANSI A300 Standards and ISA Best Management practices. I have rated all of the spiked palms, and palms that I found with oozing injection holes, as moderate and do not recommend their relocation.**

| | <b>Scientific name</b> | <b>Common name</b> | <b>DBH</b> | <b>H/Ct</b> | <b>Canopy</b> | <b>Condition</b> | <b>TPZ</b> |
|---|---|---|---|---|---|---|---|
| 22 | Adonidia merrillii | Christmas palm | 36" | 35' | 28' | Moderate | 4' |
