5840 North Bay Road Miami Beach, Florida Specimen Tree Arborist Report

5840 North Bay Road Miami Beach, Florida SPECIMEN TREE REPORT

May 6, 2018

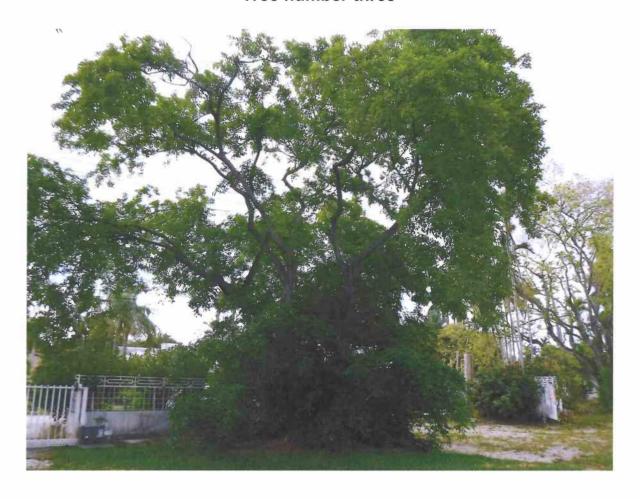
Tree number three

This Pongam is in fair condition with a 60% health condition. The tree is 35 feet tall and 46 feet wide. The diameter measured at two feet above grade was 40 inches. The tree has codominant stems and large pruning wounds on the south side. There is evidence of storm damage with broken limbs two to four inches in diameter within the canopy, and a chain girdling one of the main leaders.

View looking east Pongam, minor dieback within upper canopy

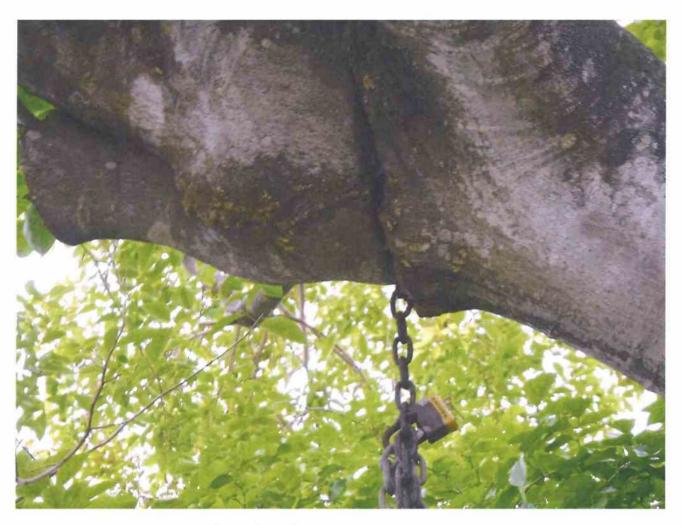
View of girdling material on east stem

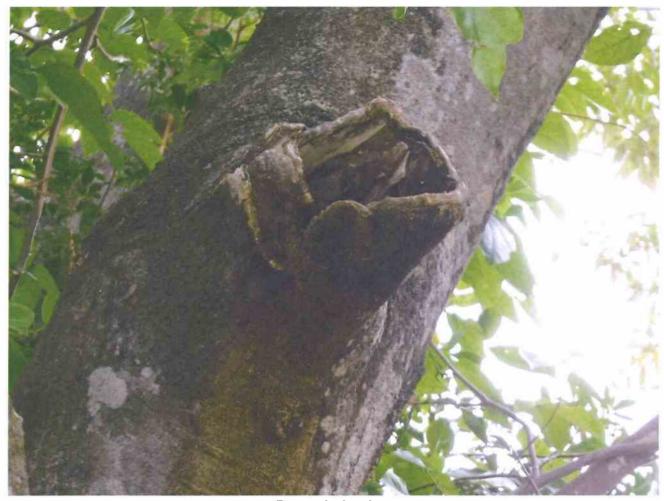
Decay in leader

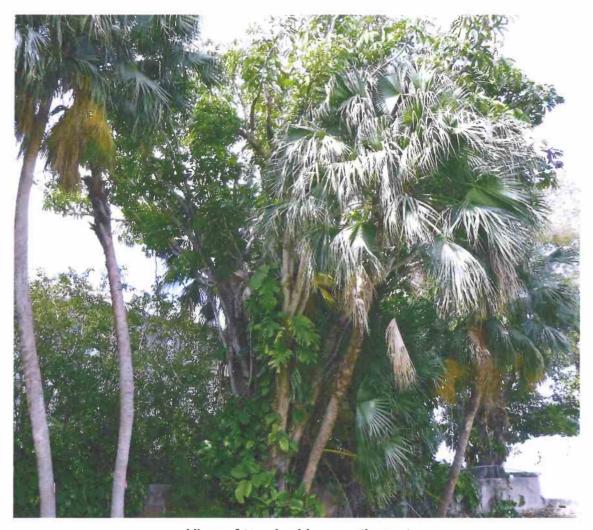
View of tree looking south west

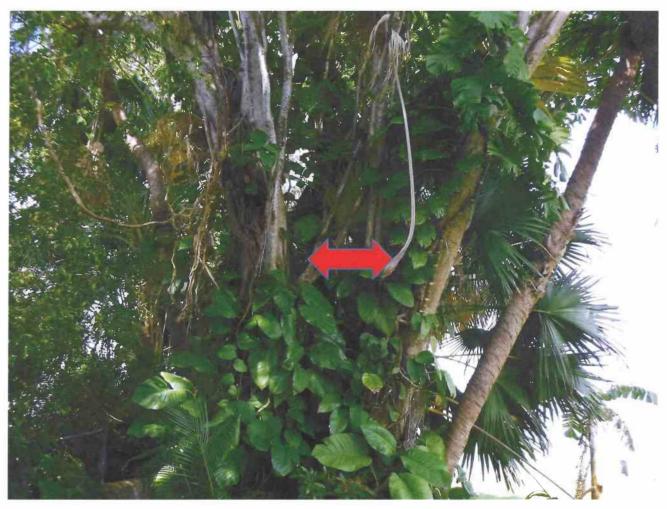
View of codominant leaders

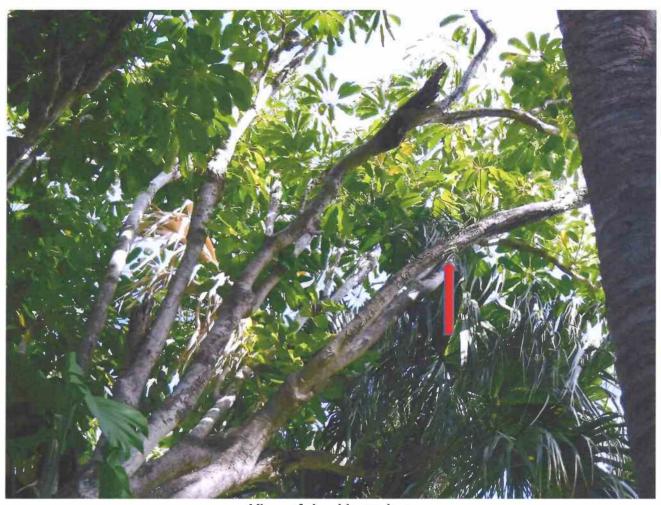
View of dead branches

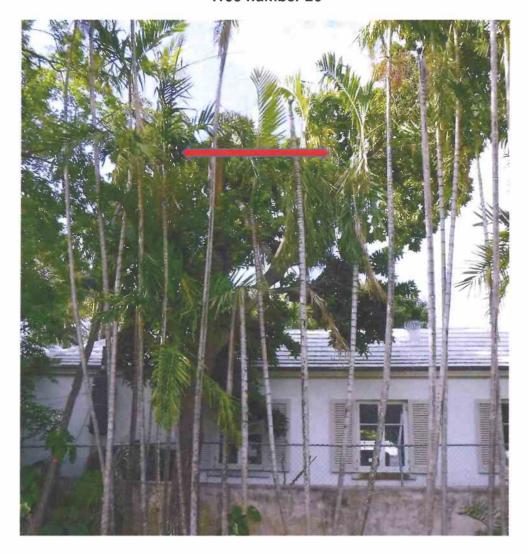
View looking south

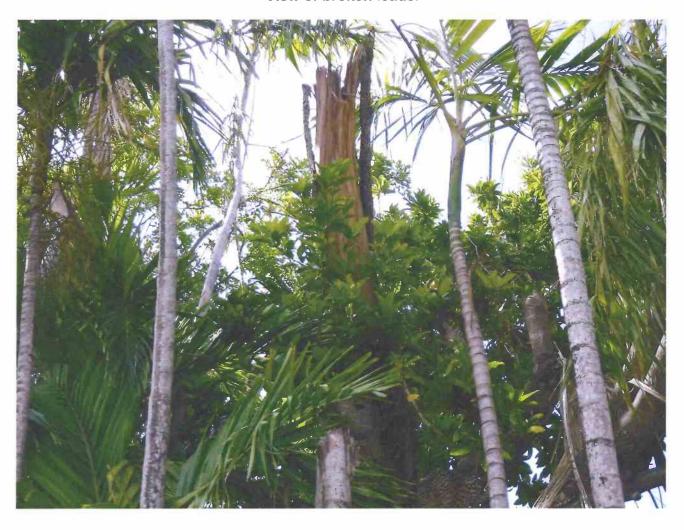
View of broken leader

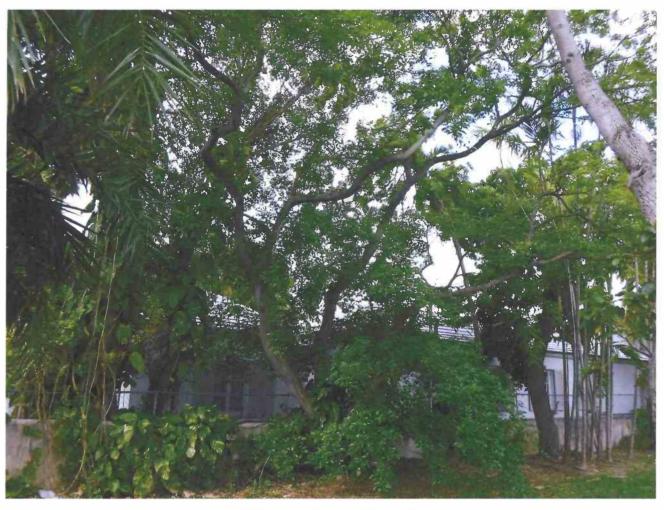
View looking south west

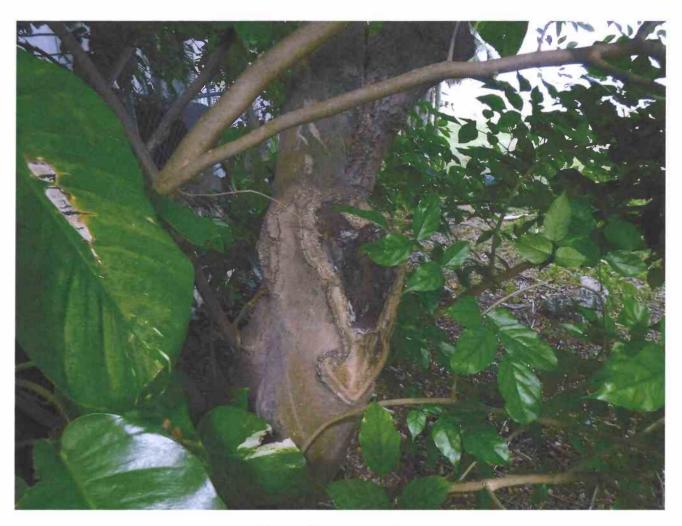
View of wound in stem

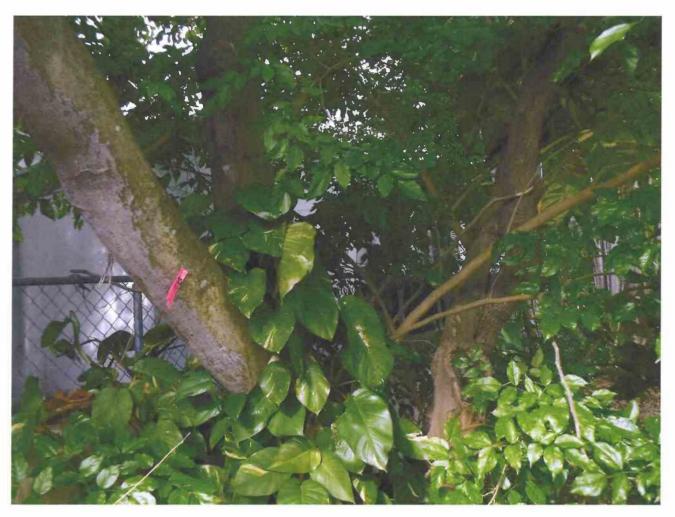
View of codominant leaders

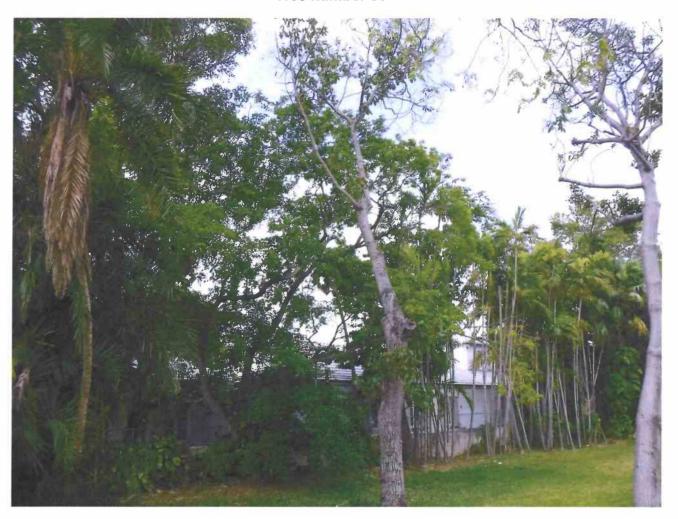
View looking south west

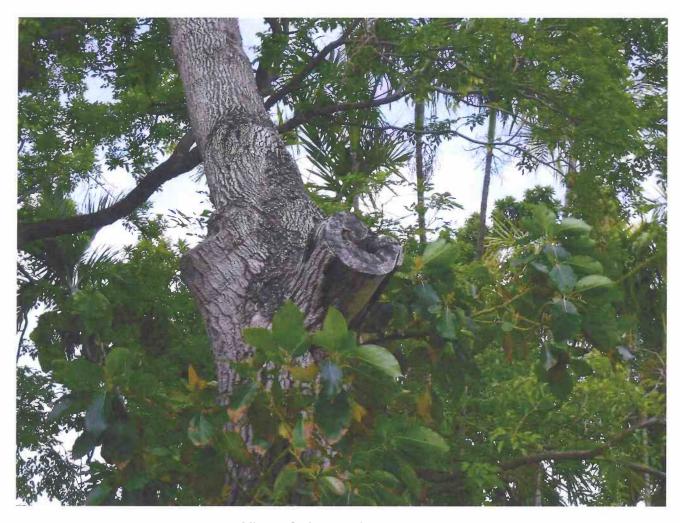
View of old pruning wounds

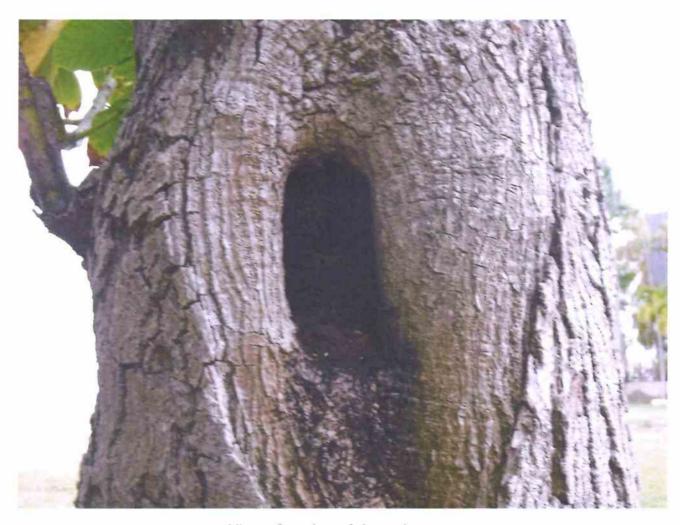
View of pocket of decay in stem

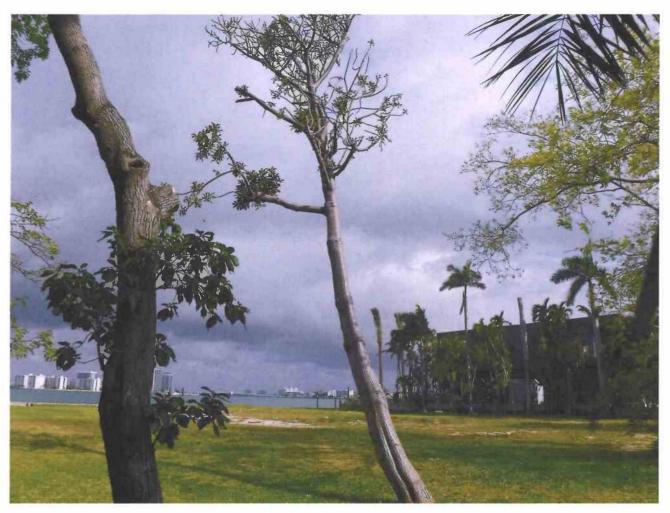
View looking North West

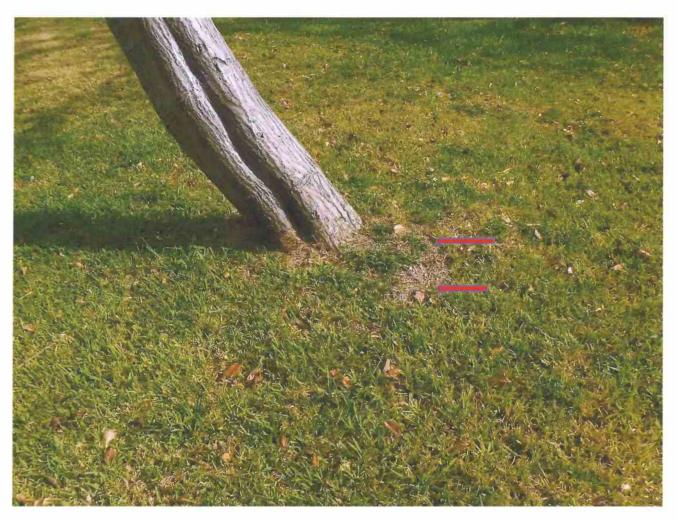
This is a Euphorbia species with a height of 30 feet as well as a width of 10 feet and a diameter of 16 inches measured at breast height. It has a health rating of 45% due to the fact that it has a severe lean and evidence of soil heaving as well as a low live crown ratio.

View of soil heaving

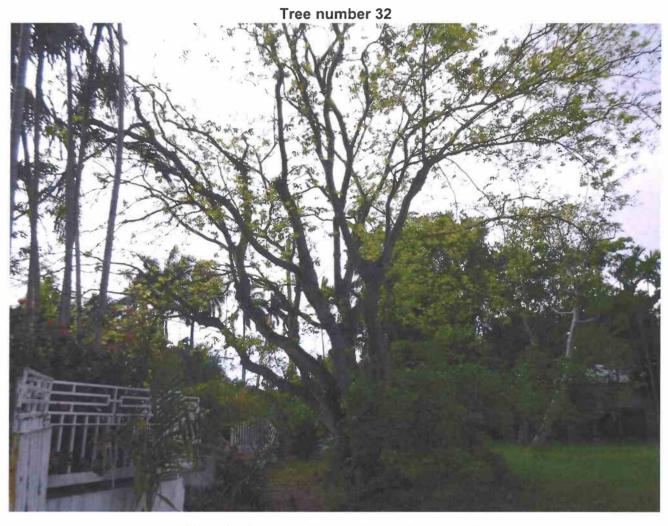
The Avocado has a height of 40 feet ,a width of 14 feet and a diameter of 17 inches measured at breast height as well as a health rating of 30% due to previous topping/heading cuts, as well as the column of decay in the stem and the low live crown ratio. There is also sings of dieback in the crown.

View looking south heading cuts evident

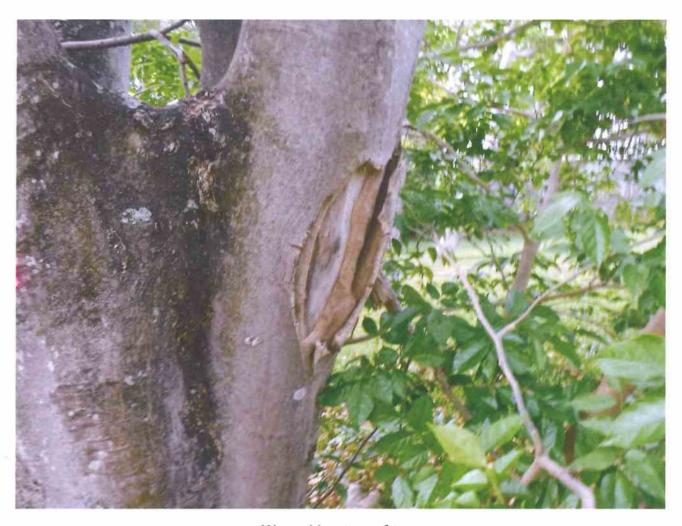
Wound in stem of tree

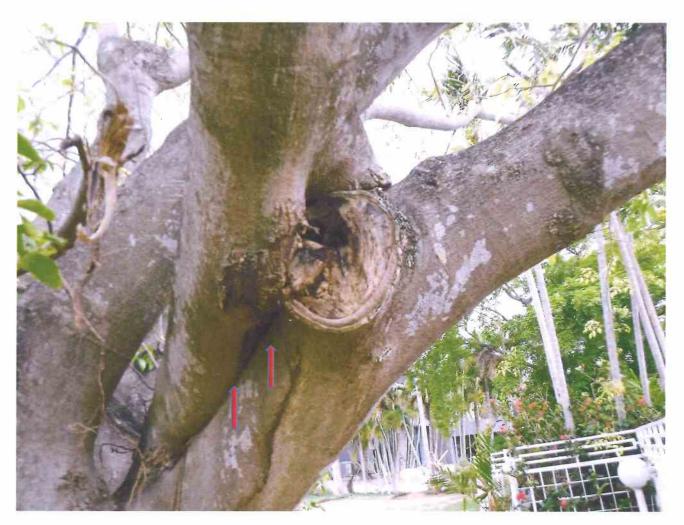
The Pongam is in fair condition with a 35% health condition. The tree is 35 feet tall and 48 feet wide. The diameter measured at breast height was 40 inches. The tree has included bark, as well as codominant leaders, a wound in the branch on the east side, poor structure, and girdling roots on the east side. The tree has minor storm damage and dieback of leaves present on the outer edge of the canopy.

Included bark and wound in branches
