# ***Tree Resource Evaluation for 2321 N. Bay Road, Miami Beach***

***Jeff Shimonski***

***President, Tropical Designs of Florida***

***November 26, 2019***

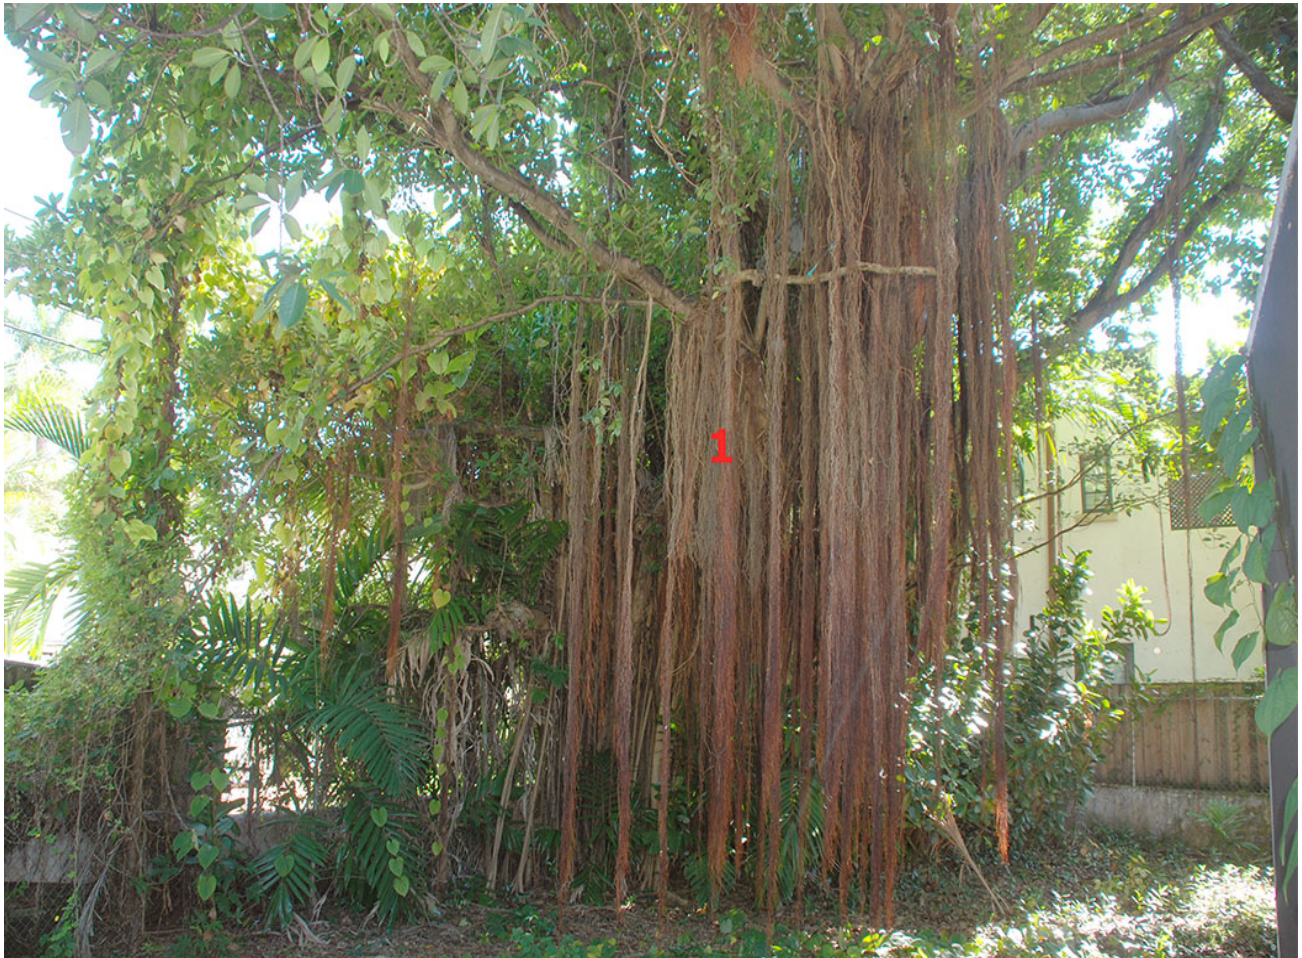
Photo 1 above is the trunk and aerial root mass of tree 1 viewed from the northeast. This tree should be considered for removal. See following photos.

| | <b>Scientific name</b> | <b>Common name</b> | <b>DBH</b> | <b>H/Ct</b> | <b>Canopy</b> | <b>Condition</b> | <b>TPZ</b> |
|---|---|---|---|---|---|---|---|
| 1 | Ficus aurea | Strangler fig | 60" | 90' | 90' | Moderate | 25' |

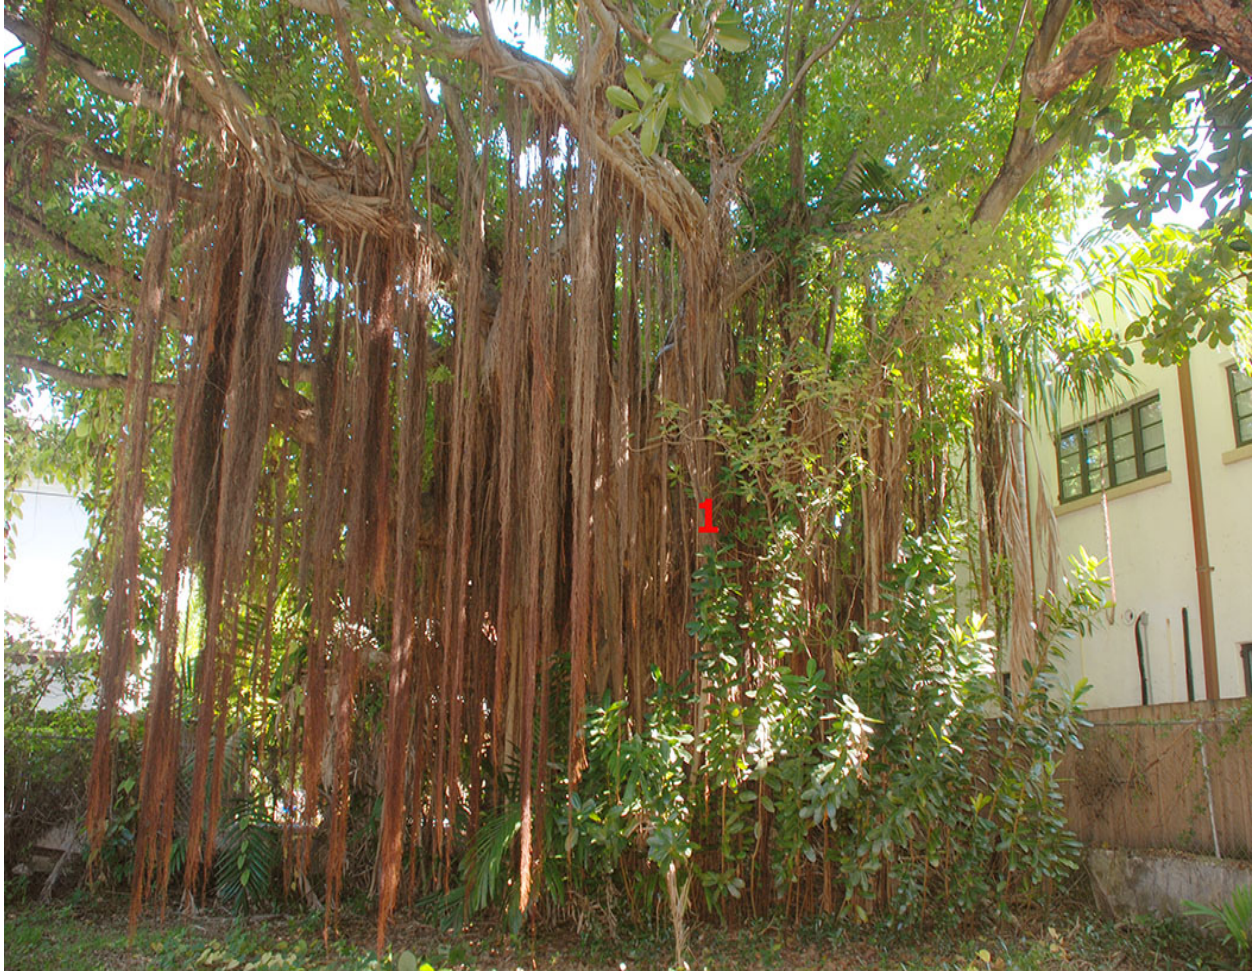
**Photo 2 above is the trunk and aerial root mass of tree 1 viewed from the north.**

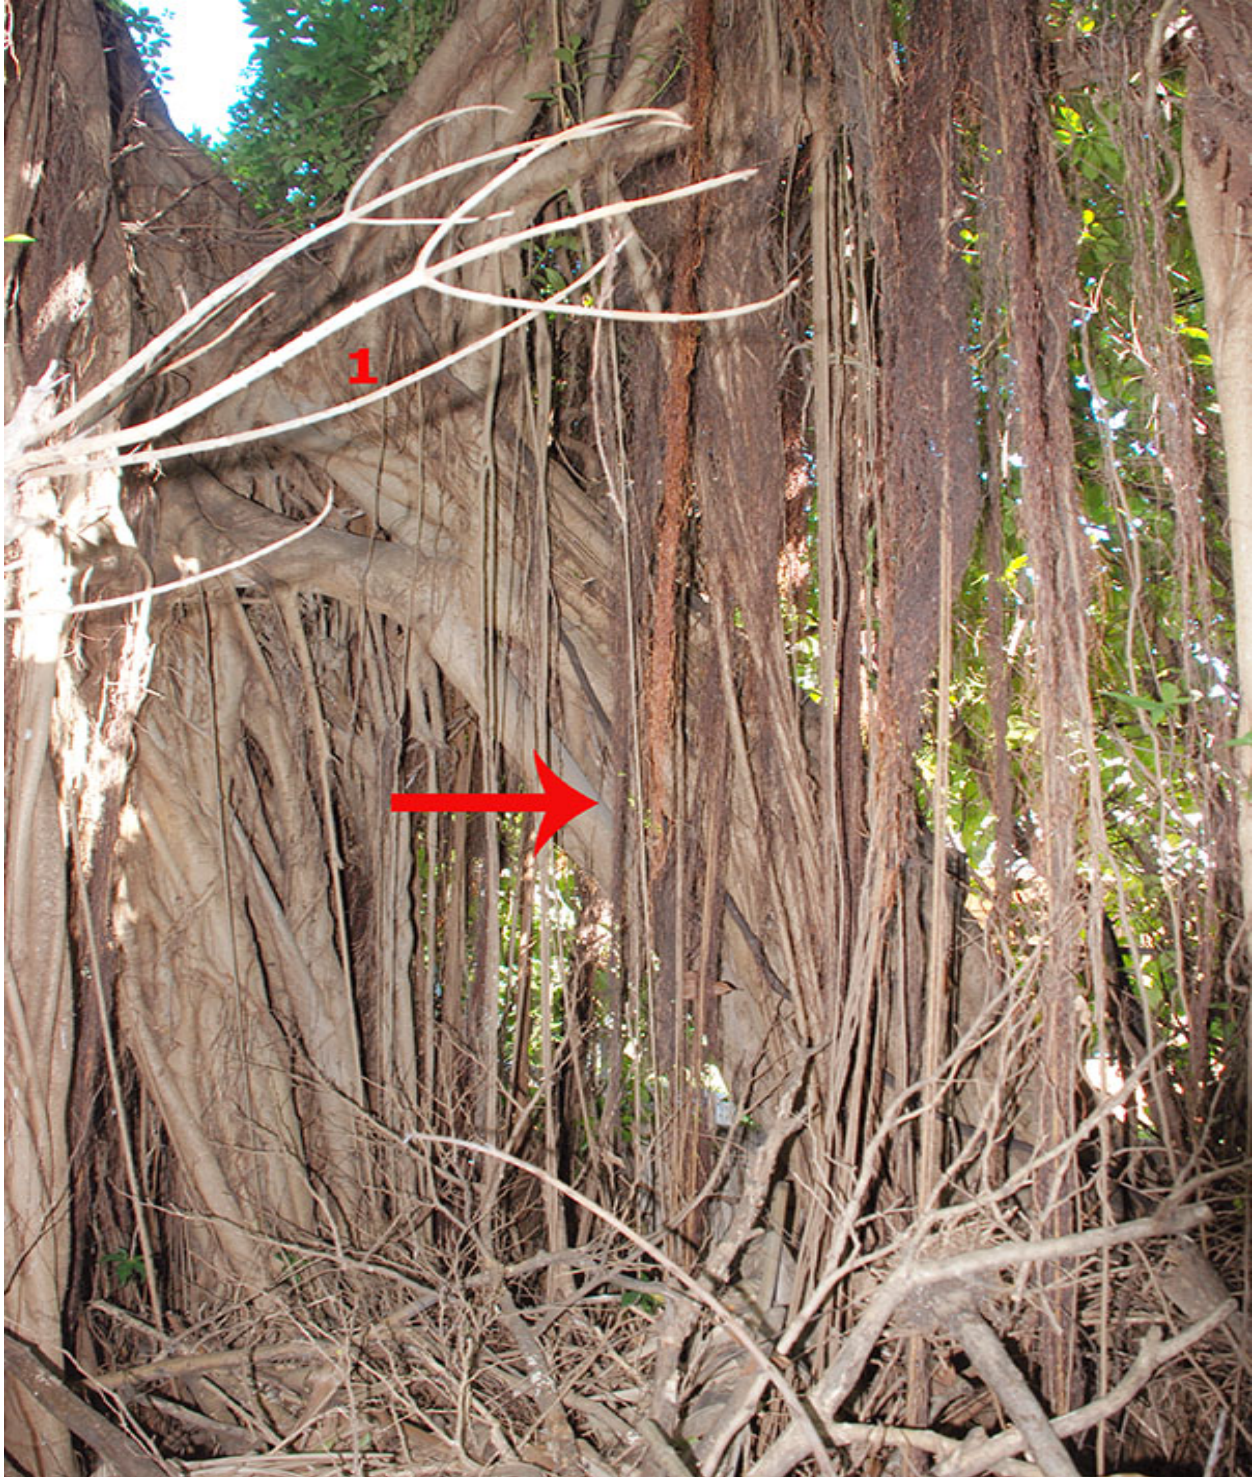
**Photo 3 above is what was originally the trunk, see arrow, that is now leaning to the east and supported by a large aerial root mass. This tree should be considered for removal. The DBH of this trunk is estimated.**

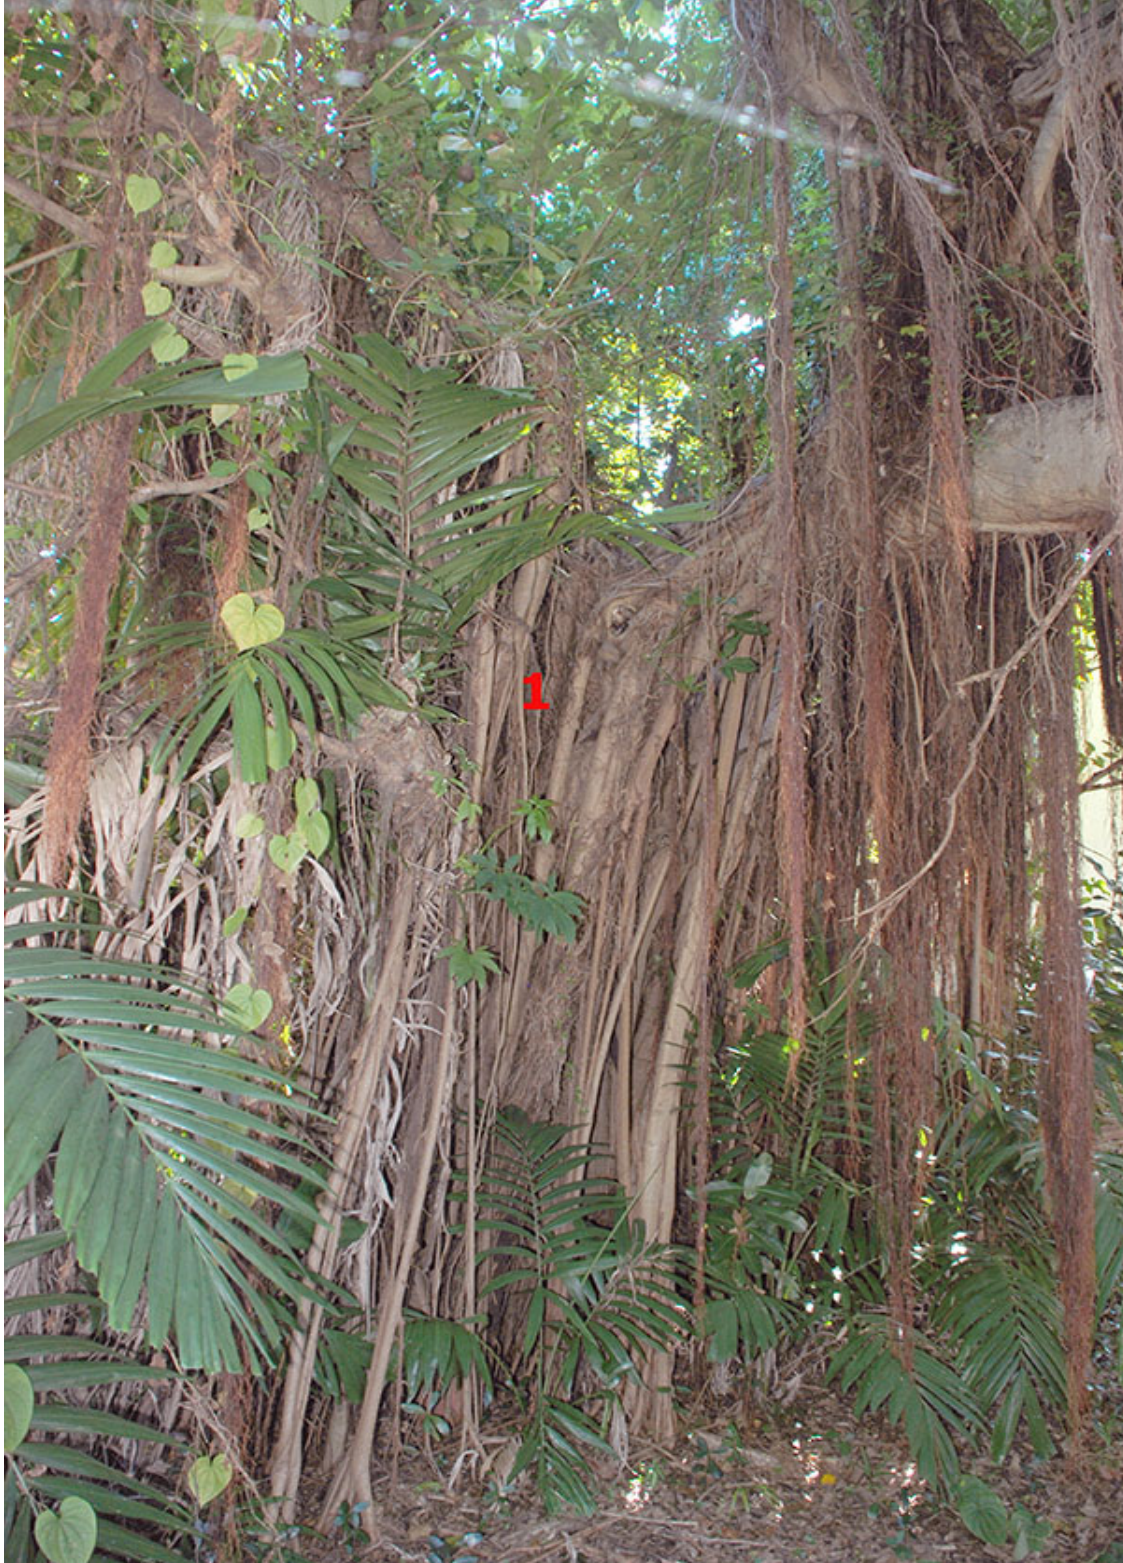
**Photo 4 above is the trunk and aerial root mass of tree 1 viewed from the east.**

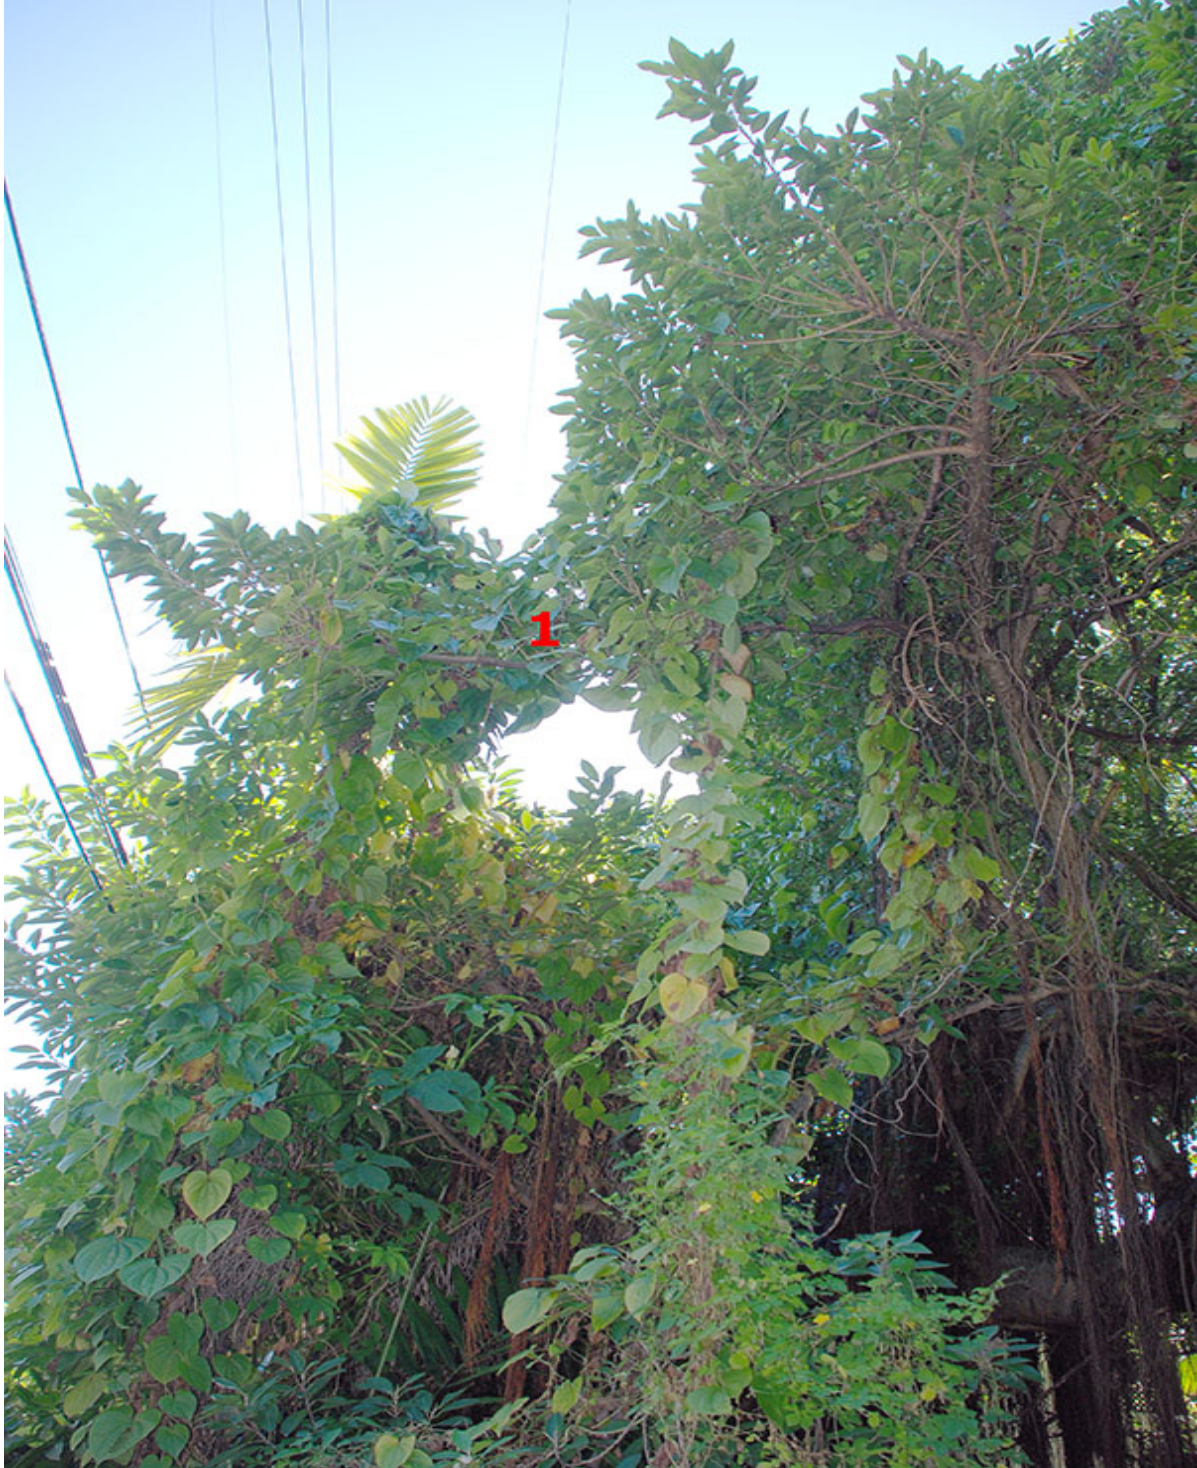
**Photo 5 above is the canopy of tree 1 viewed from the east. This canopy has received significant utility pruning. This tree should be considered for removal.**

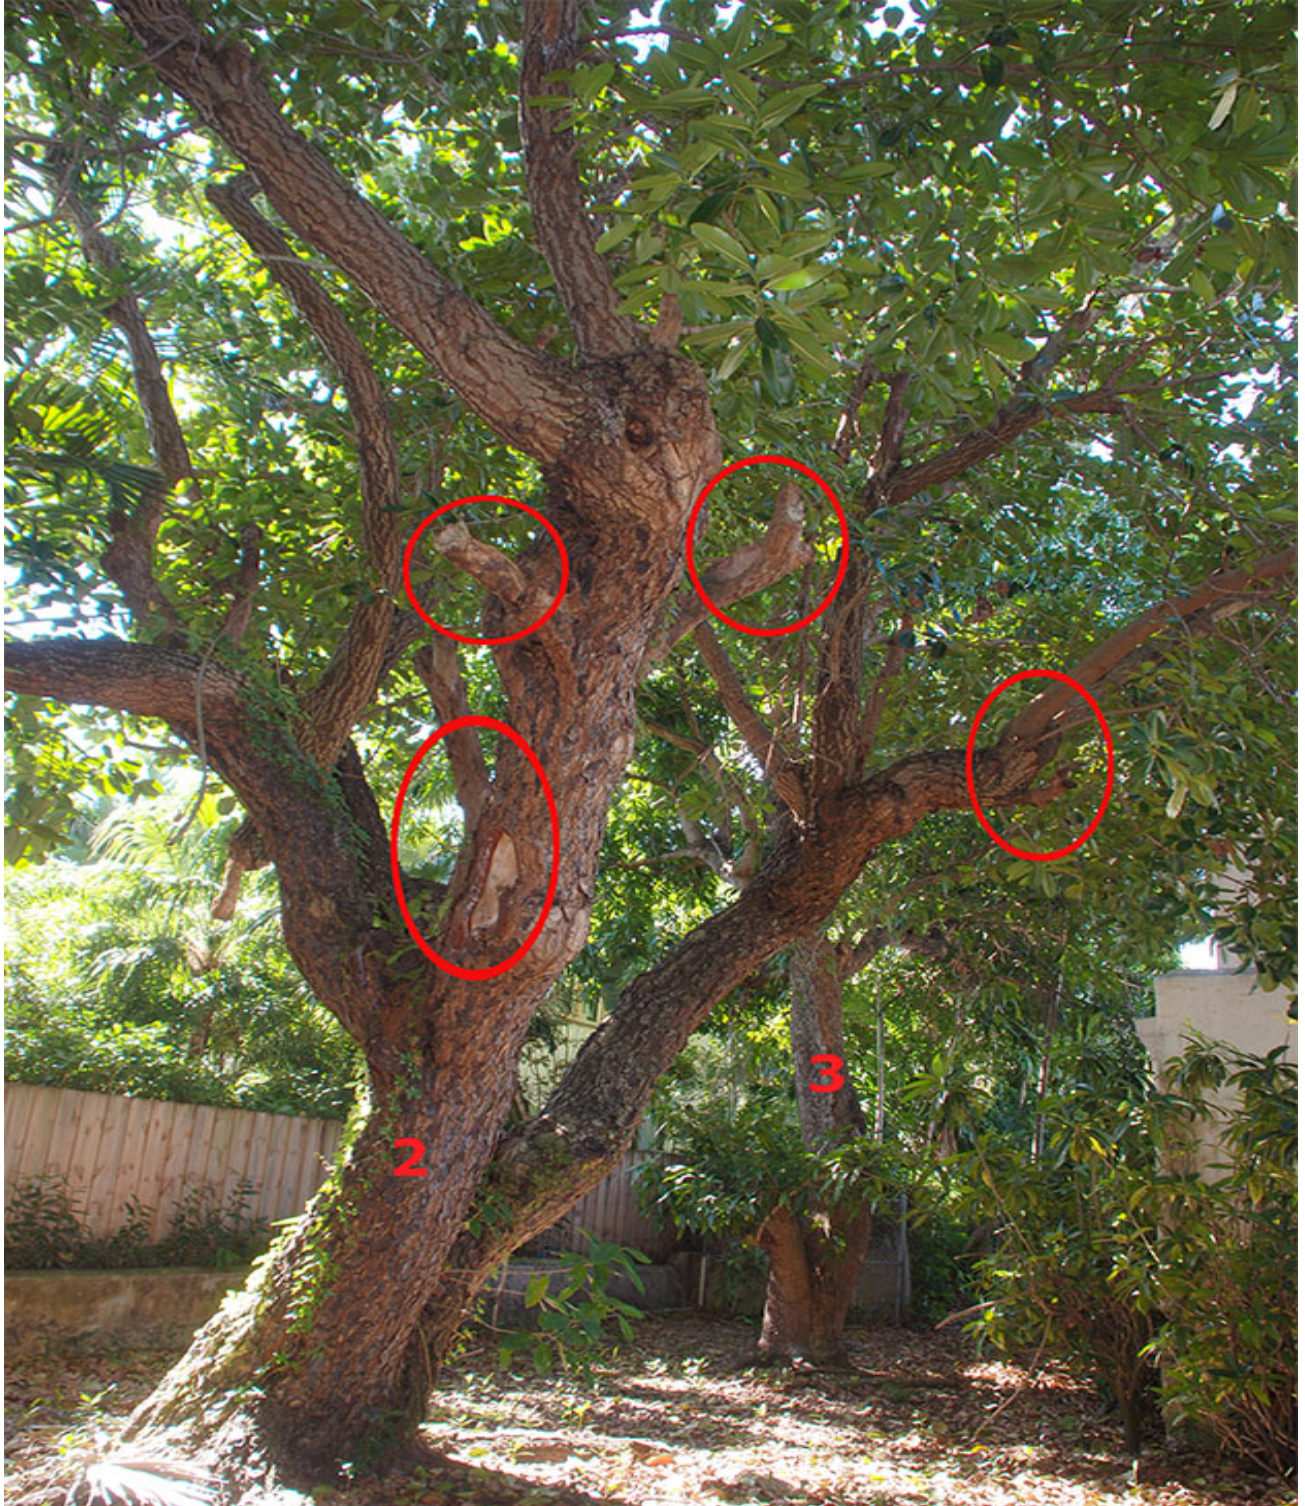
**Photo 6 above is tree 2 viewed from the southeast. The circles indicate a substantial amount of dead wood and some weak branch attachments.**

| | <b>Scientific name</b> | <b>Common name</b> | <b>DBH</b> | <b>H/Ct</b> | <b>Canopy</b> | <b>Condition</b> | <b>TPZ</b> |
|---|---|---|---|---|---|---|---|
| 2 | Calophyllum antillanum | Santa Maria | 57" | 70' | 55' | Moderate | 25' |

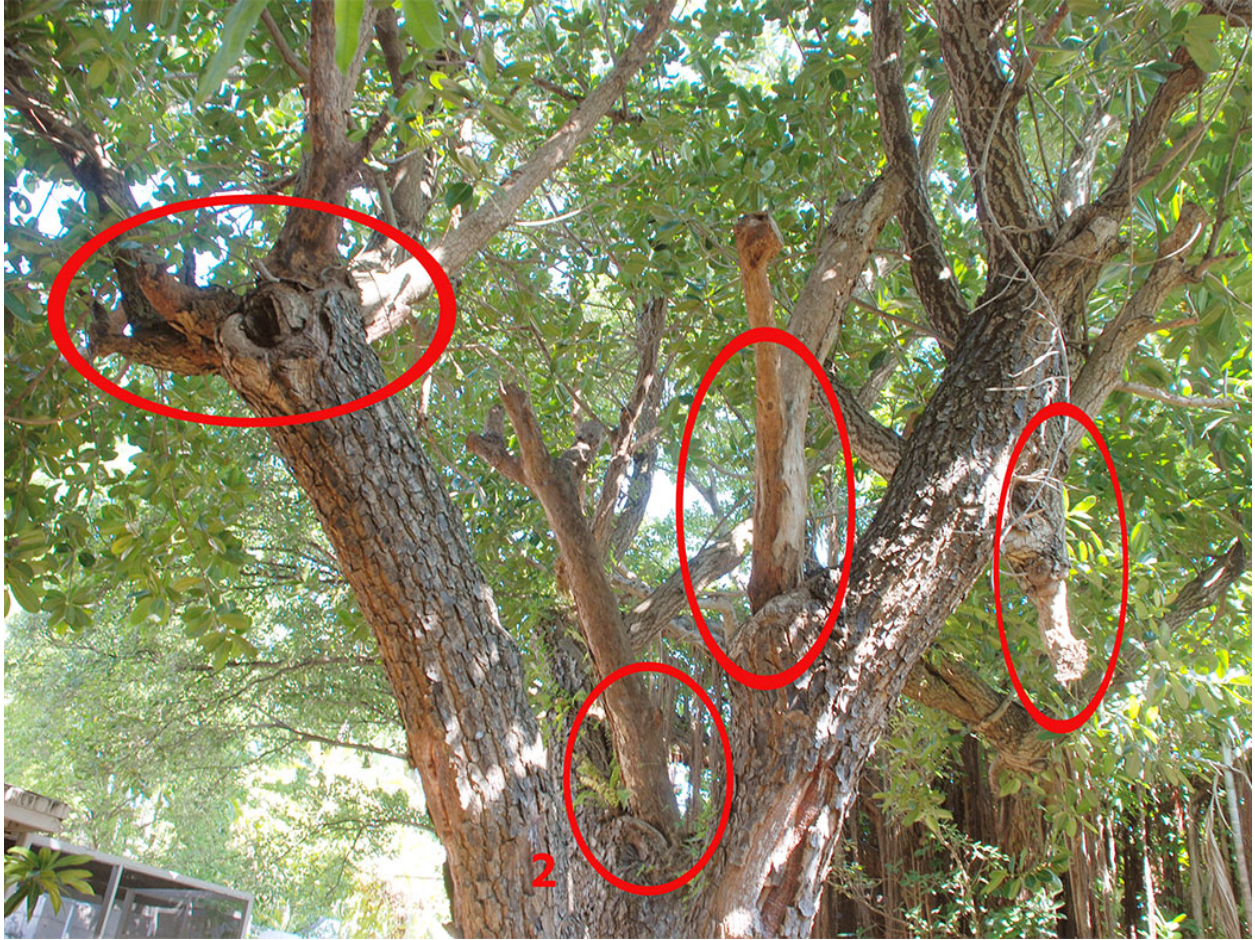
**Photo 7 above is tree 2 viewed from the north. The circles indicate a substantial amount of dead wood and some weak branch attachments. This tree should be considered for removal.**

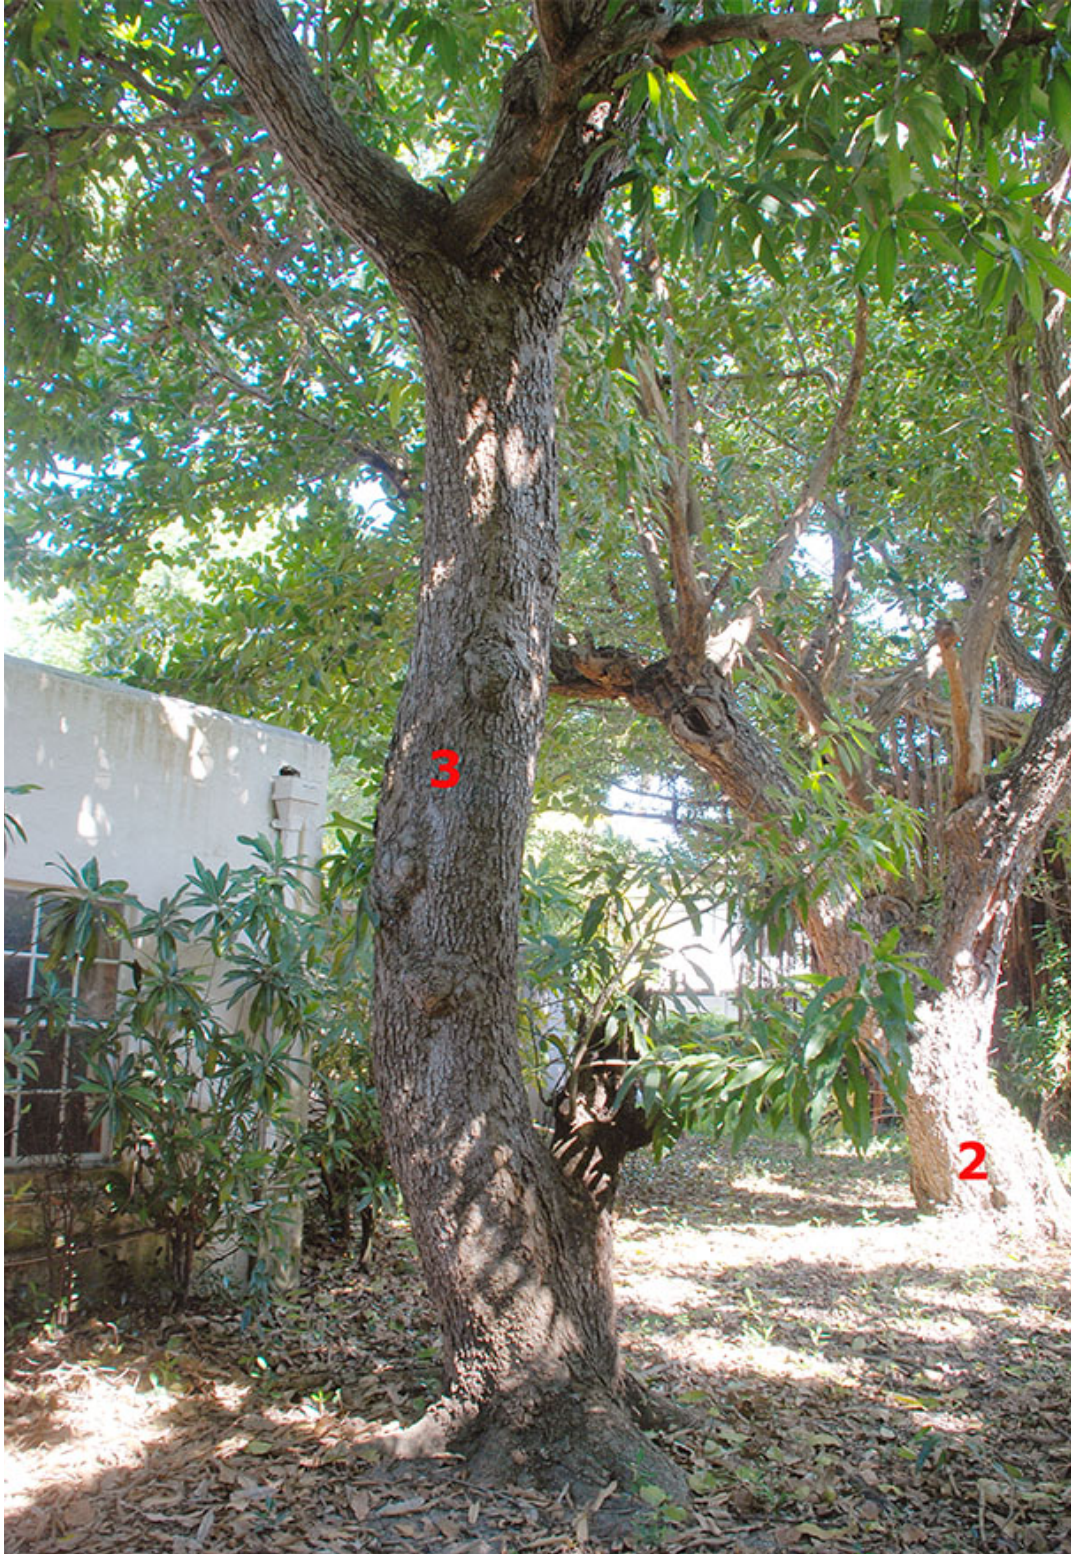
**Photo 8 above is tree 3 viewed from the north.**

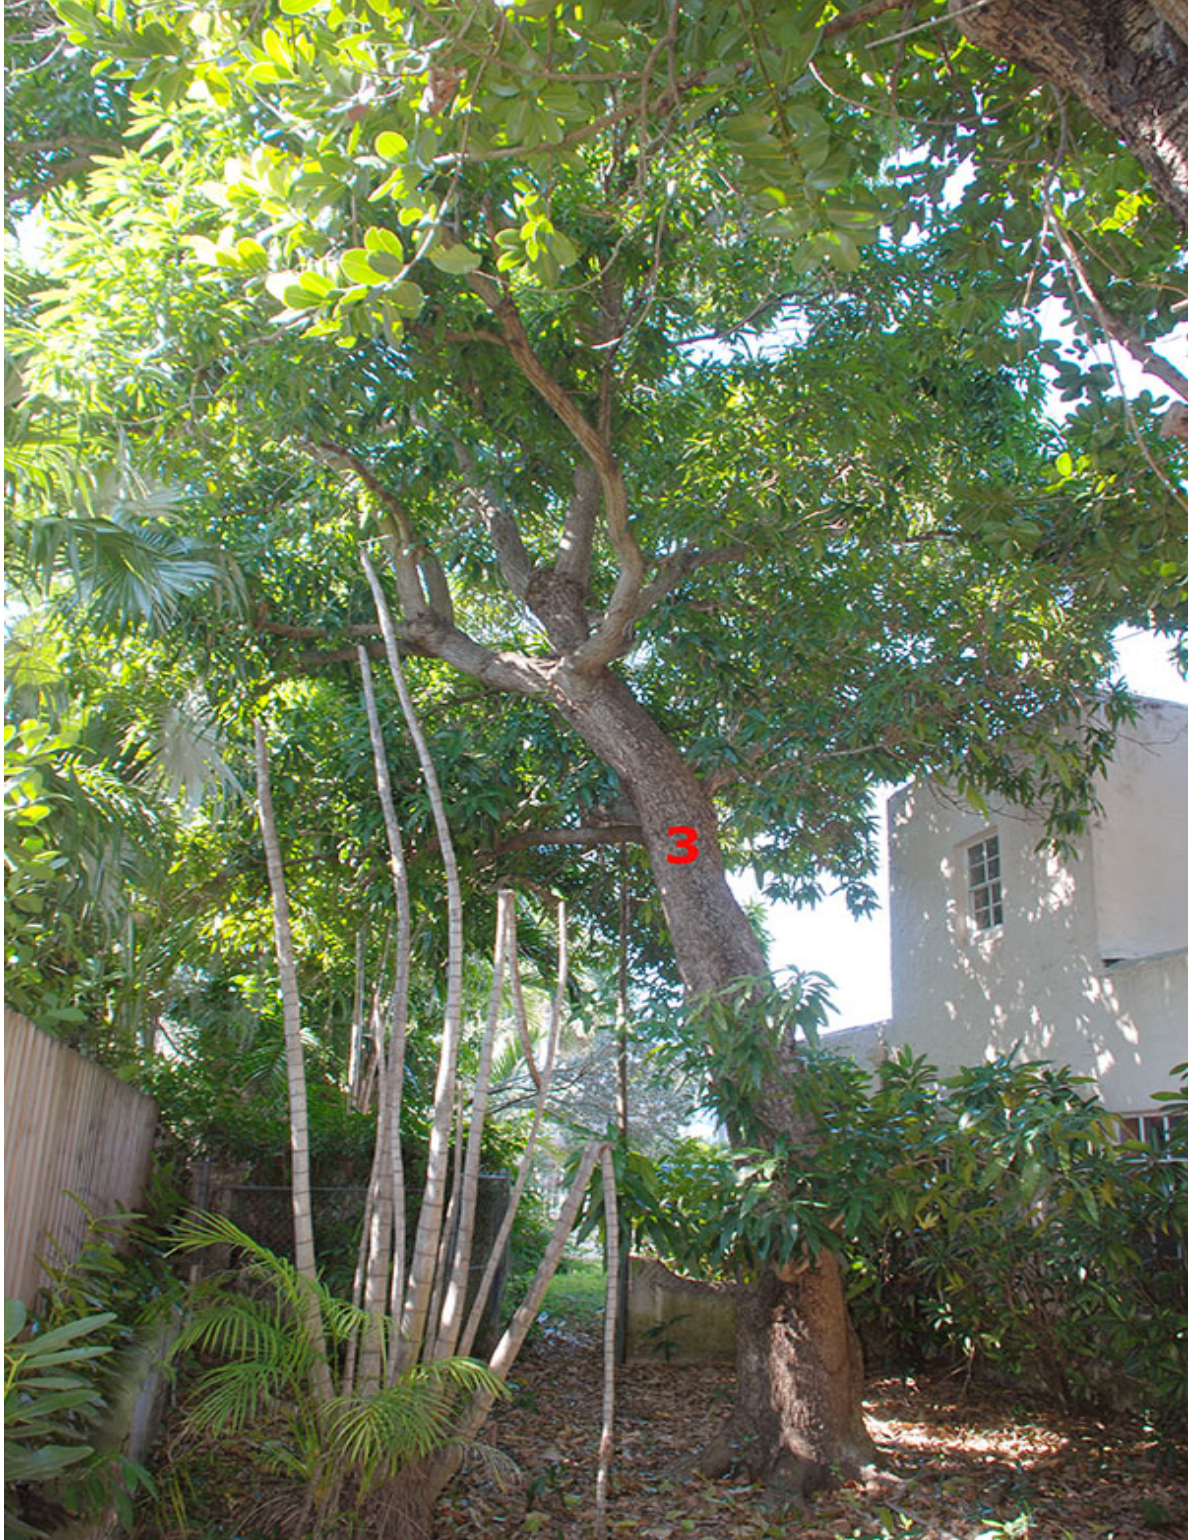
**Photo 9 above is tree 3 viewed from the south.**

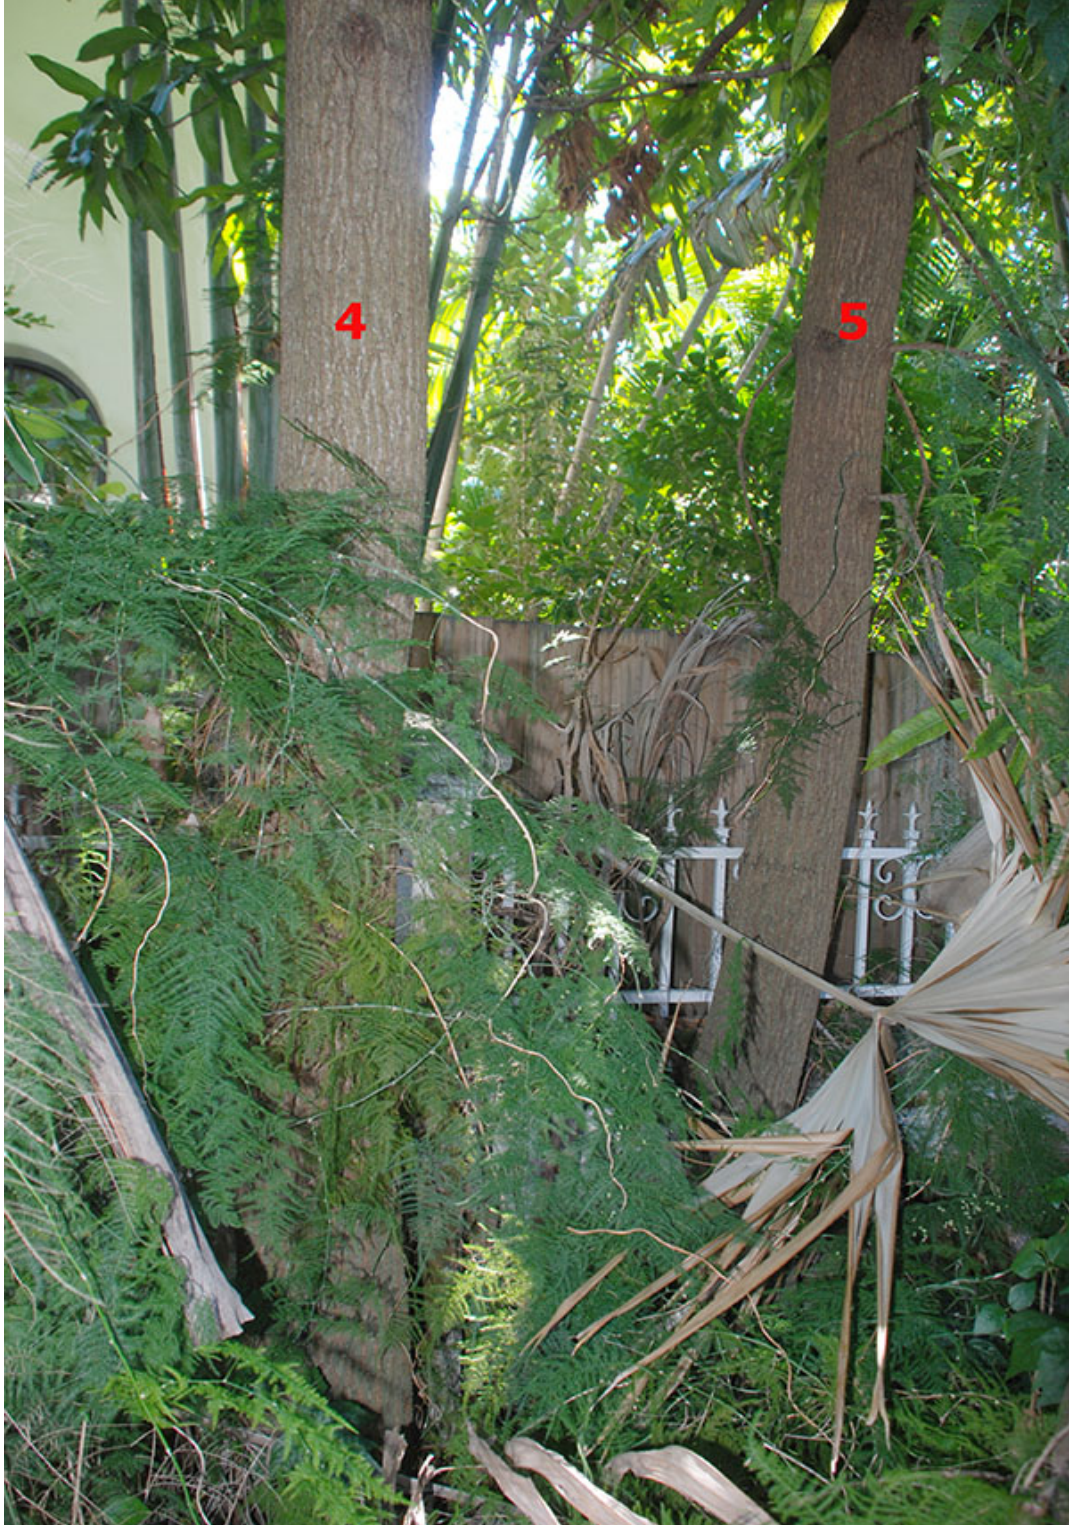
**Photo 10 above are the trunks of trees 4 & 5 viewed from the east growing almost against the wall on the western edge of the property.**

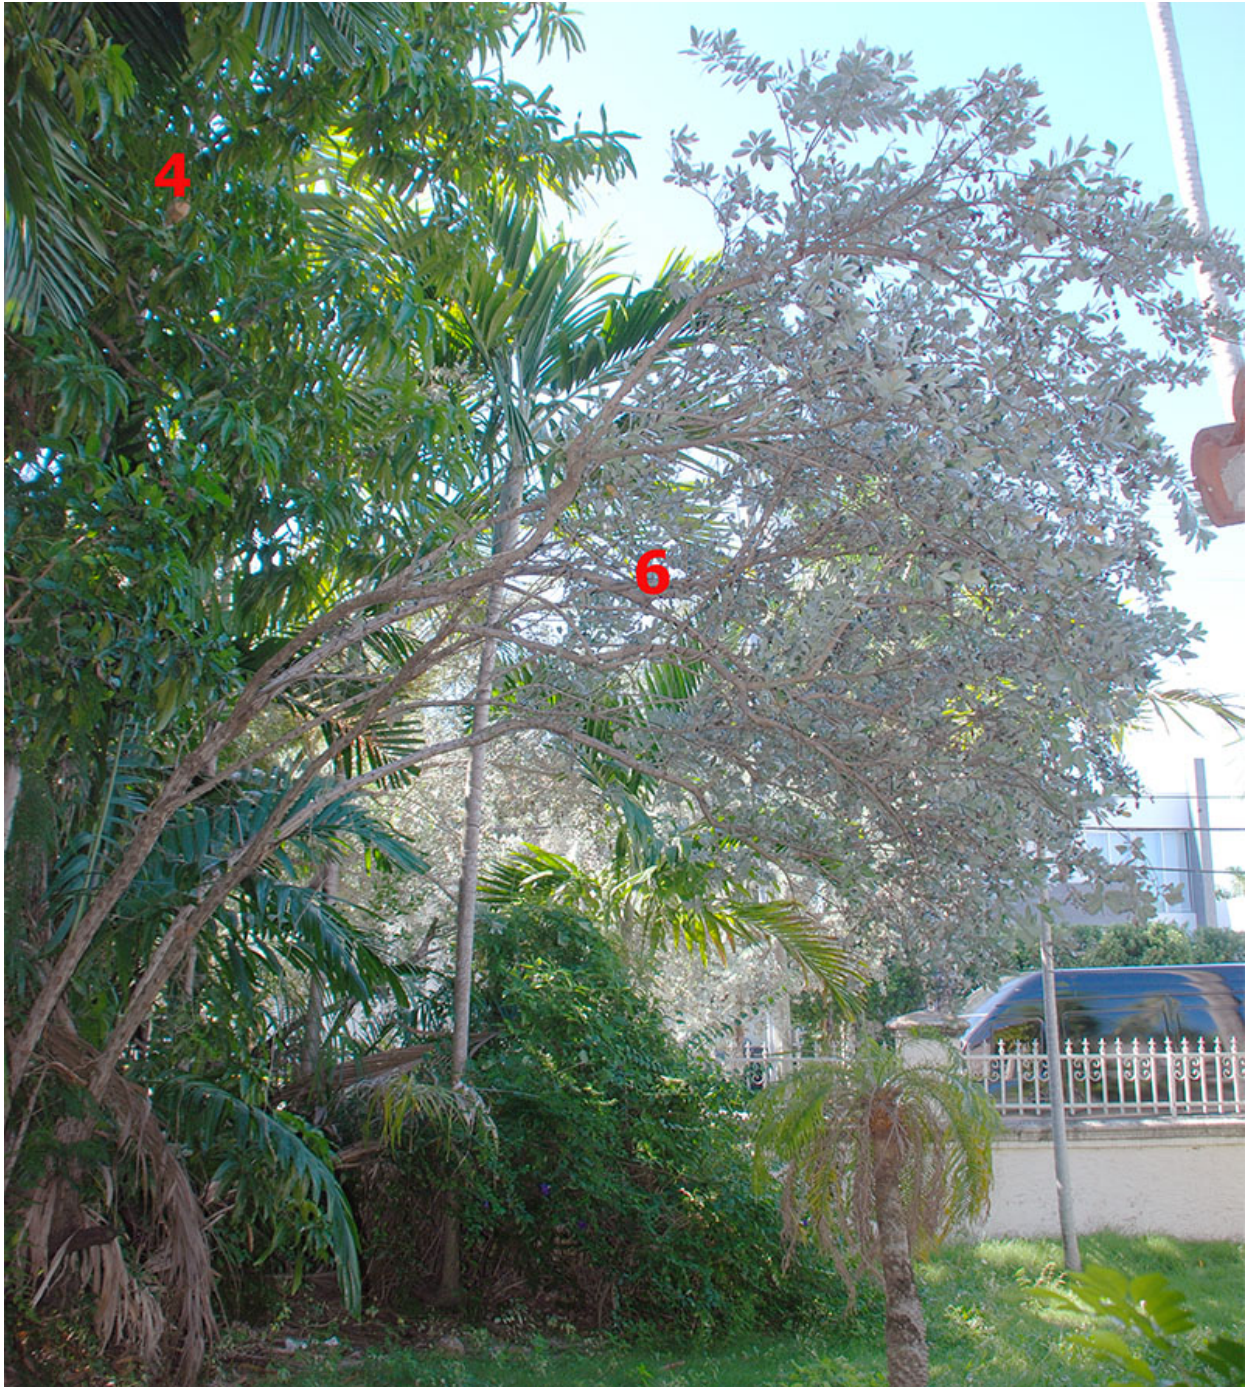
**Photo 11 above is tree 6 viewed from the south. This tree should be removed due to very poor branch/trunk taper and the one-sided canopy.**

| | <b>Scientific name</b> | <b>Common name</b> | <b>DBH</b> | <b>H/Ct</b> | <b>Canopy</b> | <b>Condition</b> | <b>TPZ</b> |
|---|---|---|---|---|---|---|---|
| 6 | Conocarpus erectus sericeus | Silver buttonwood | 6" | 15' | 18' | Poor | 5' |

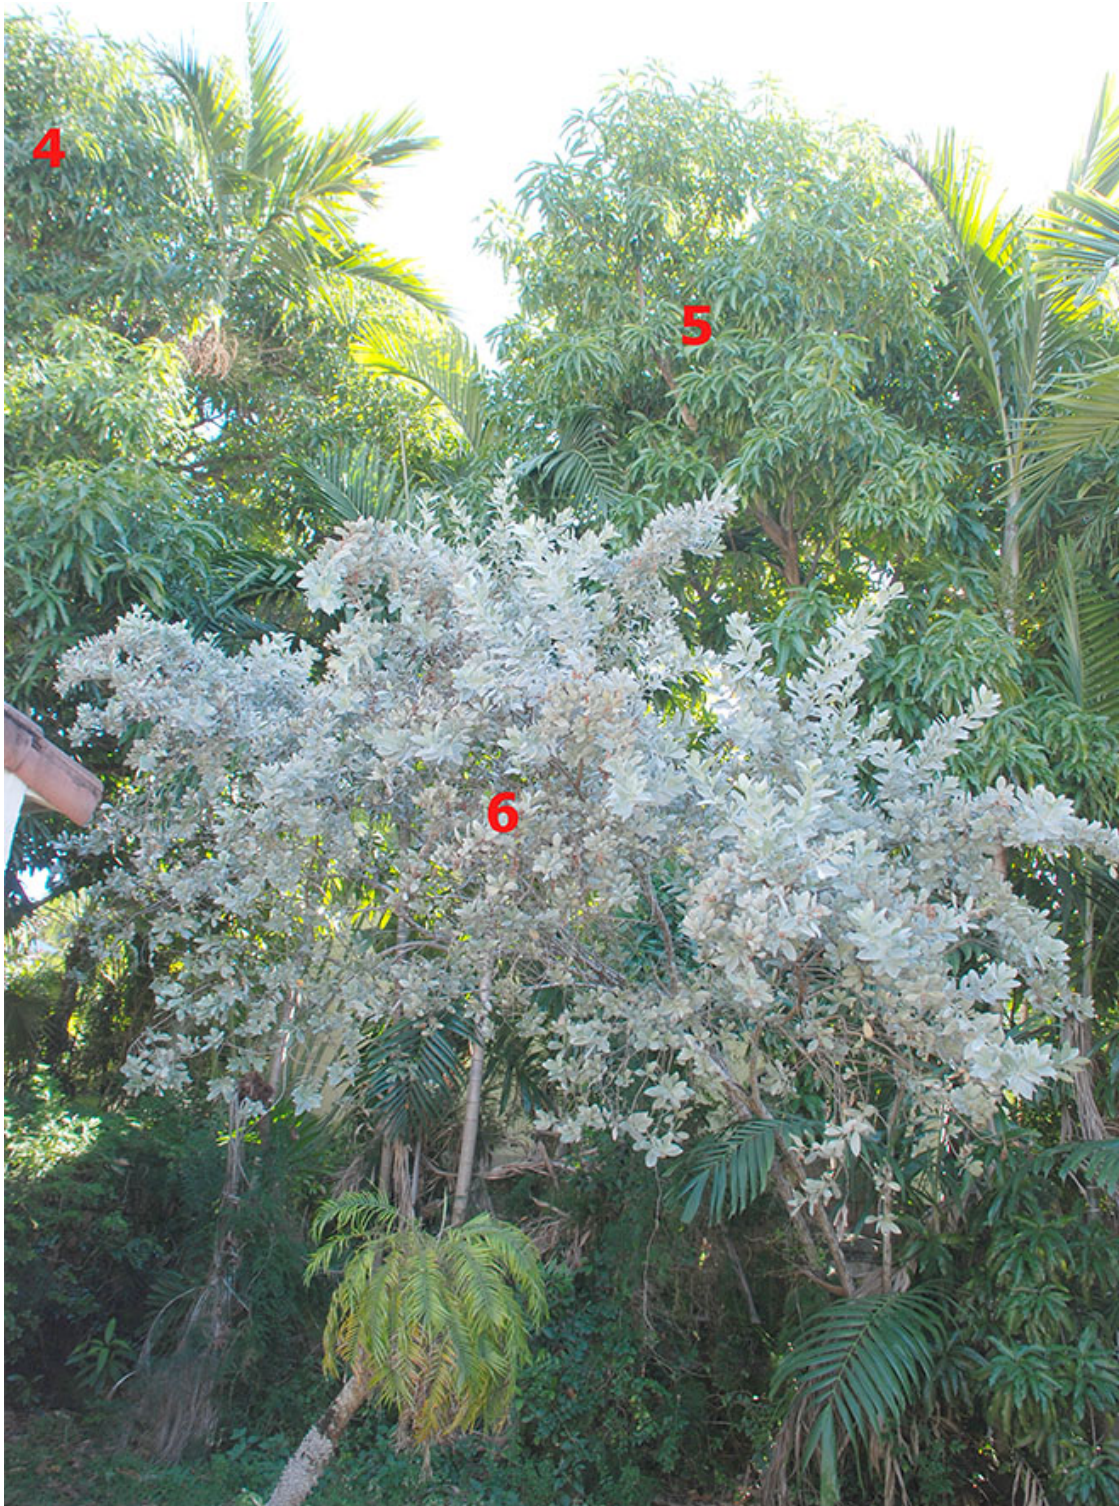
**Photo 12 above is trees 5 & 6 viewed from the east.**

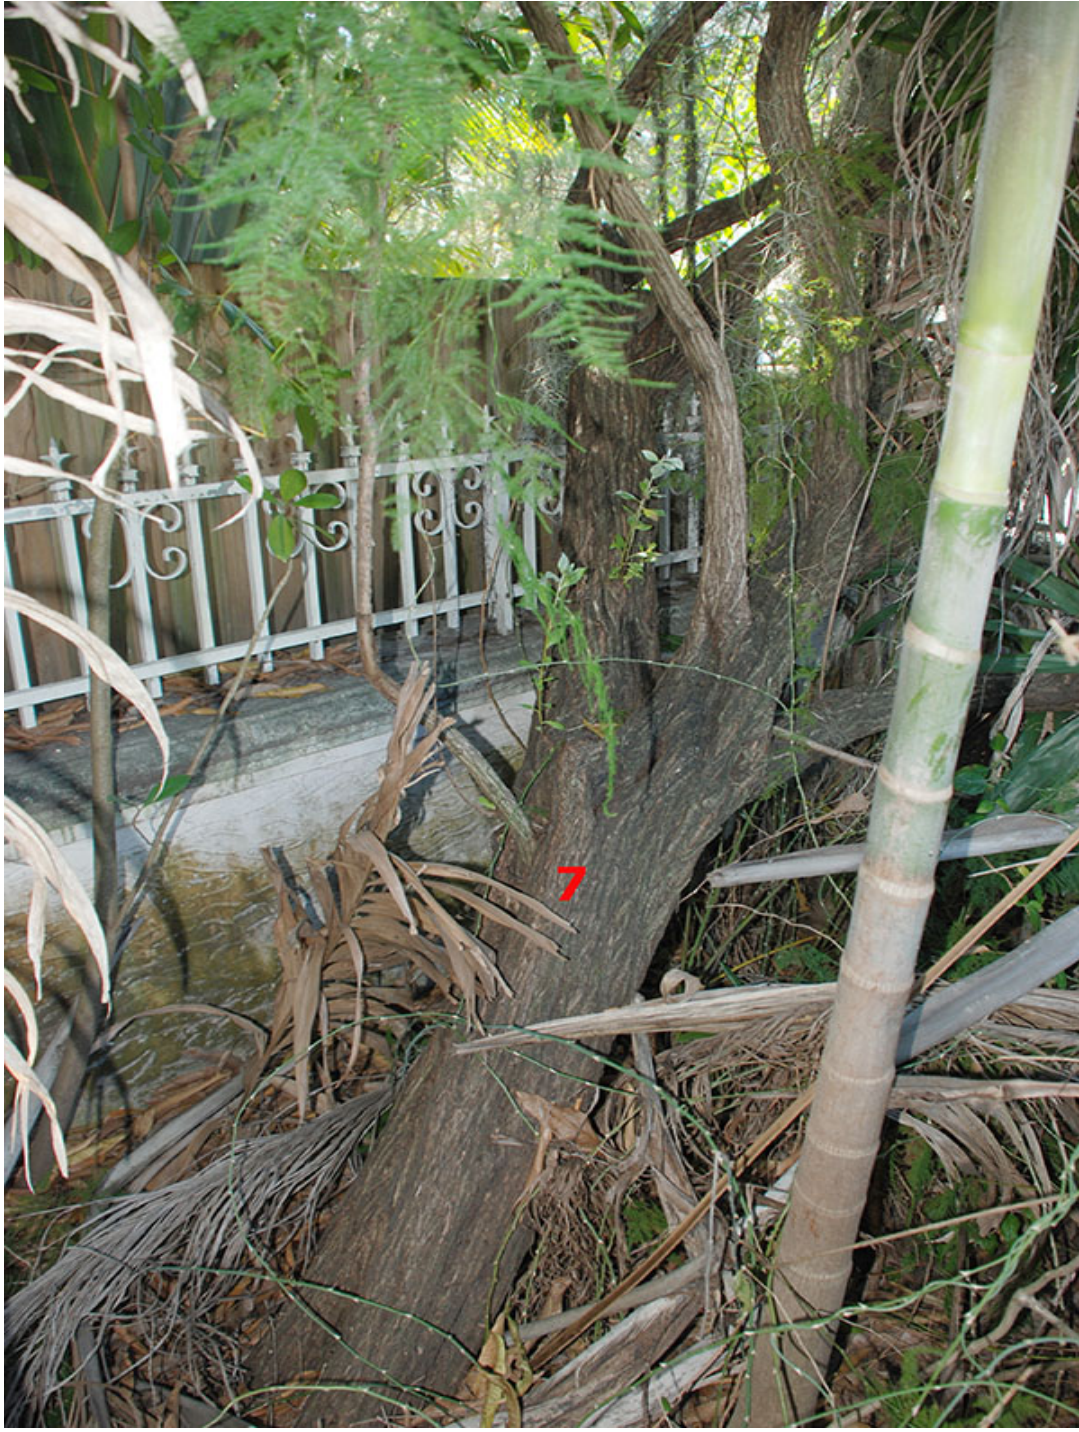
**Photo 13 above is the trunk of tree 7 almost against the wall along the western edge of the property.**
