# ***Tree Resource Evaluation for 2321 N. Bay Road, Miami Beach***

***Jeff Shimonski***

***President, Tropical Designs of Florida***

***November 26, 2019***

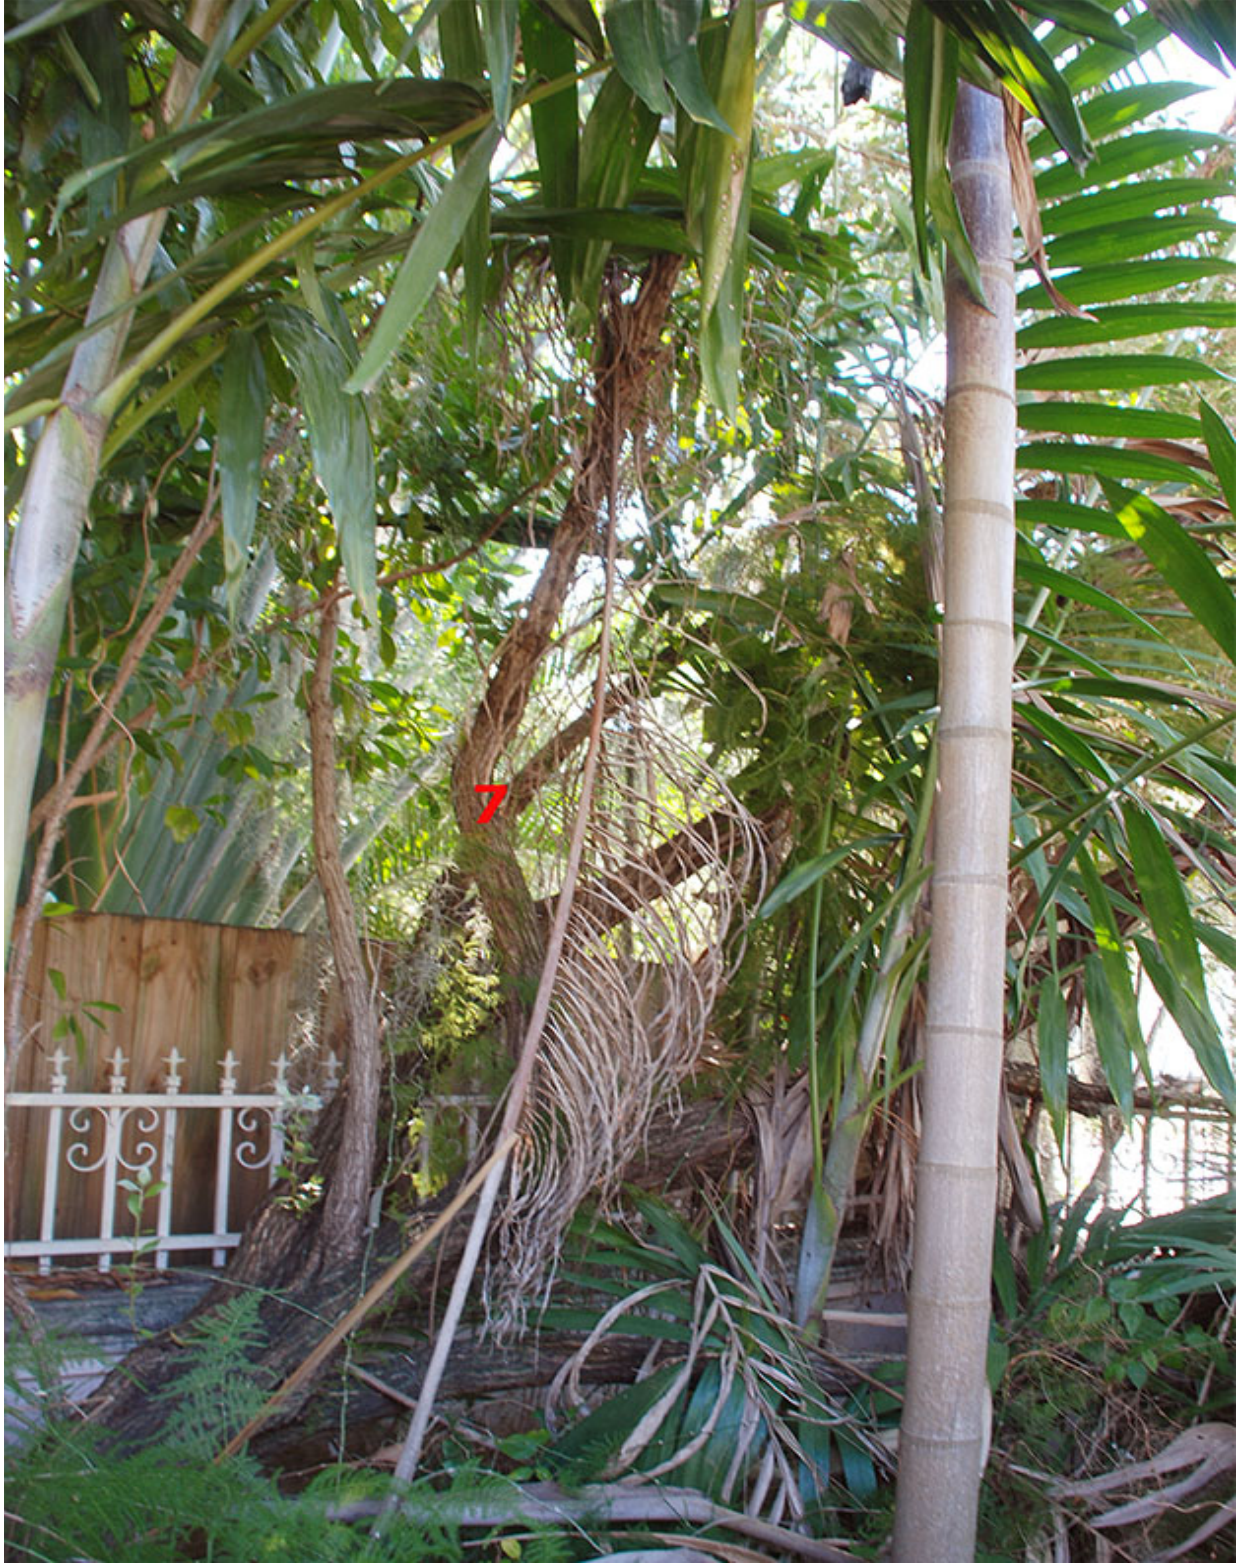
**Photo 14 above is tree 7 viewed from the east. This tree should be removed.**

| | <b>Scientific name</b> | <b>Common name</b> | <b>DBH</b> | <b>H/Ct</b> | <b>Canopy</b> | <b>Condition</b> | <b>TPZ</b> |
|---|---|---|---|---|---|---|---|
| 7 | Conocarpus erectus sericeus | Silver buttonwood | 18" | 18' | 24' | Poor | 10' |

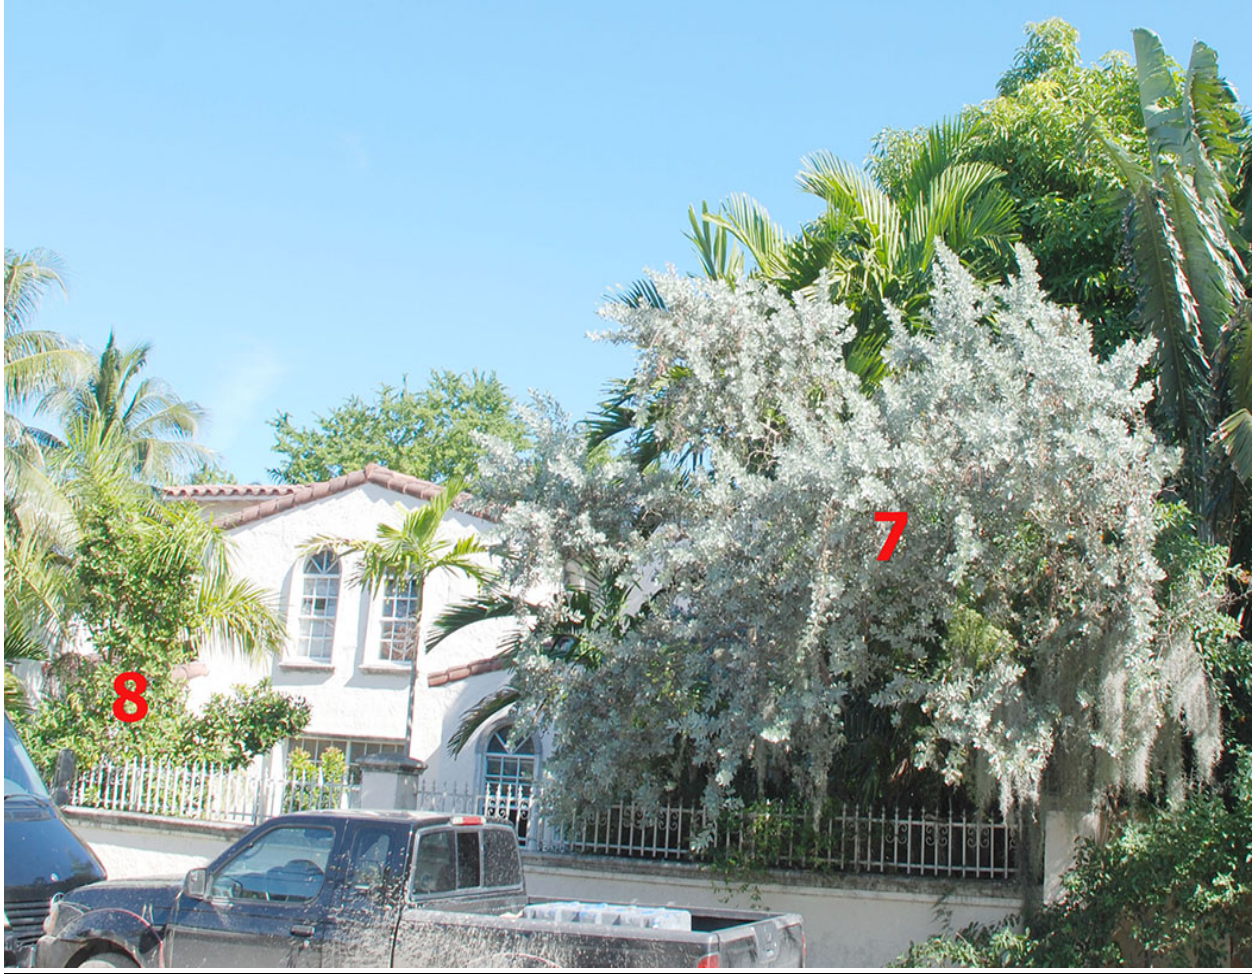
**Photo 15 above is tree 7 viewed from the north.**

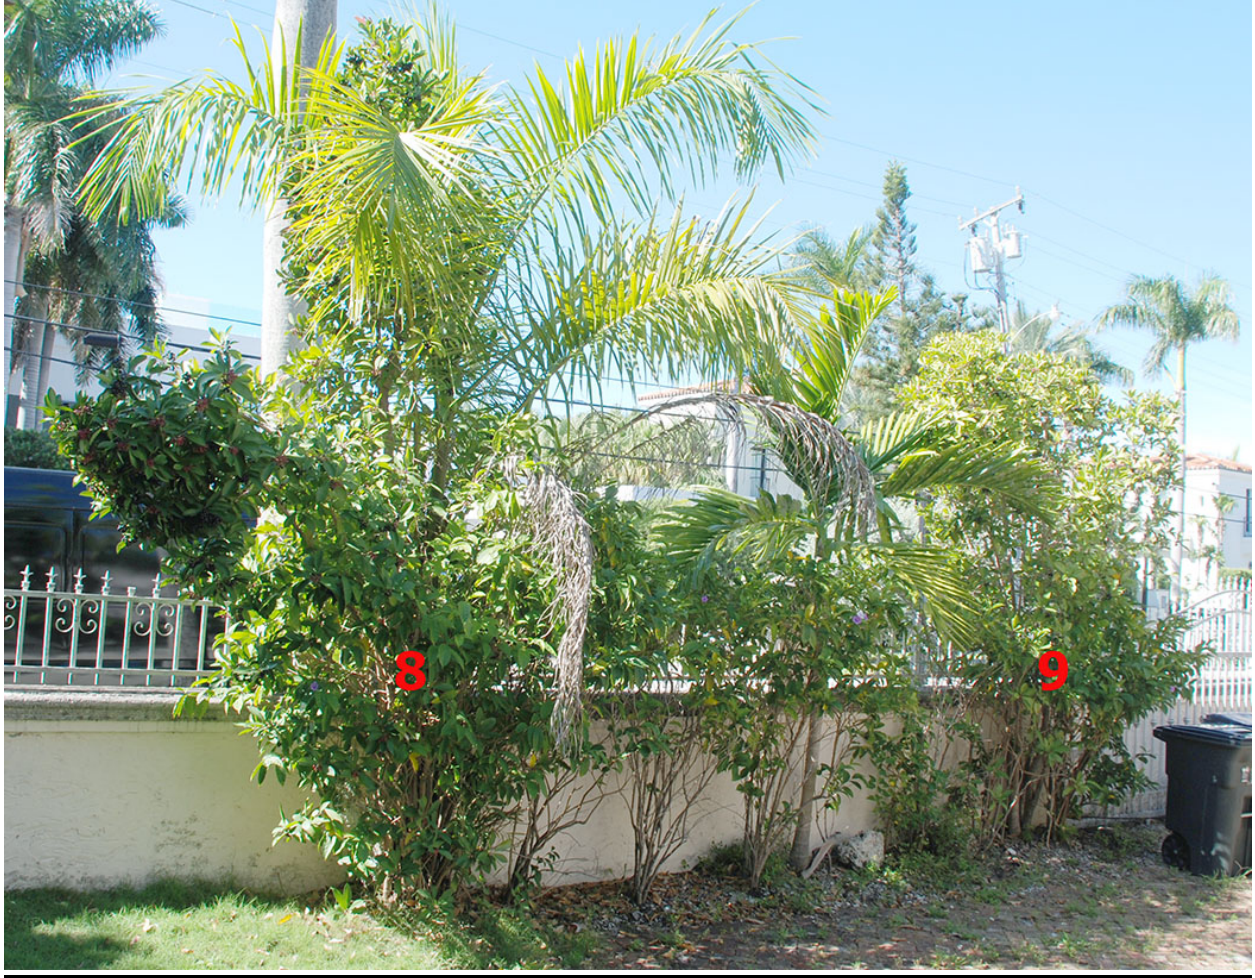
**Photo 16 above is trees 8 & 9 both invasive species that should be removed.**

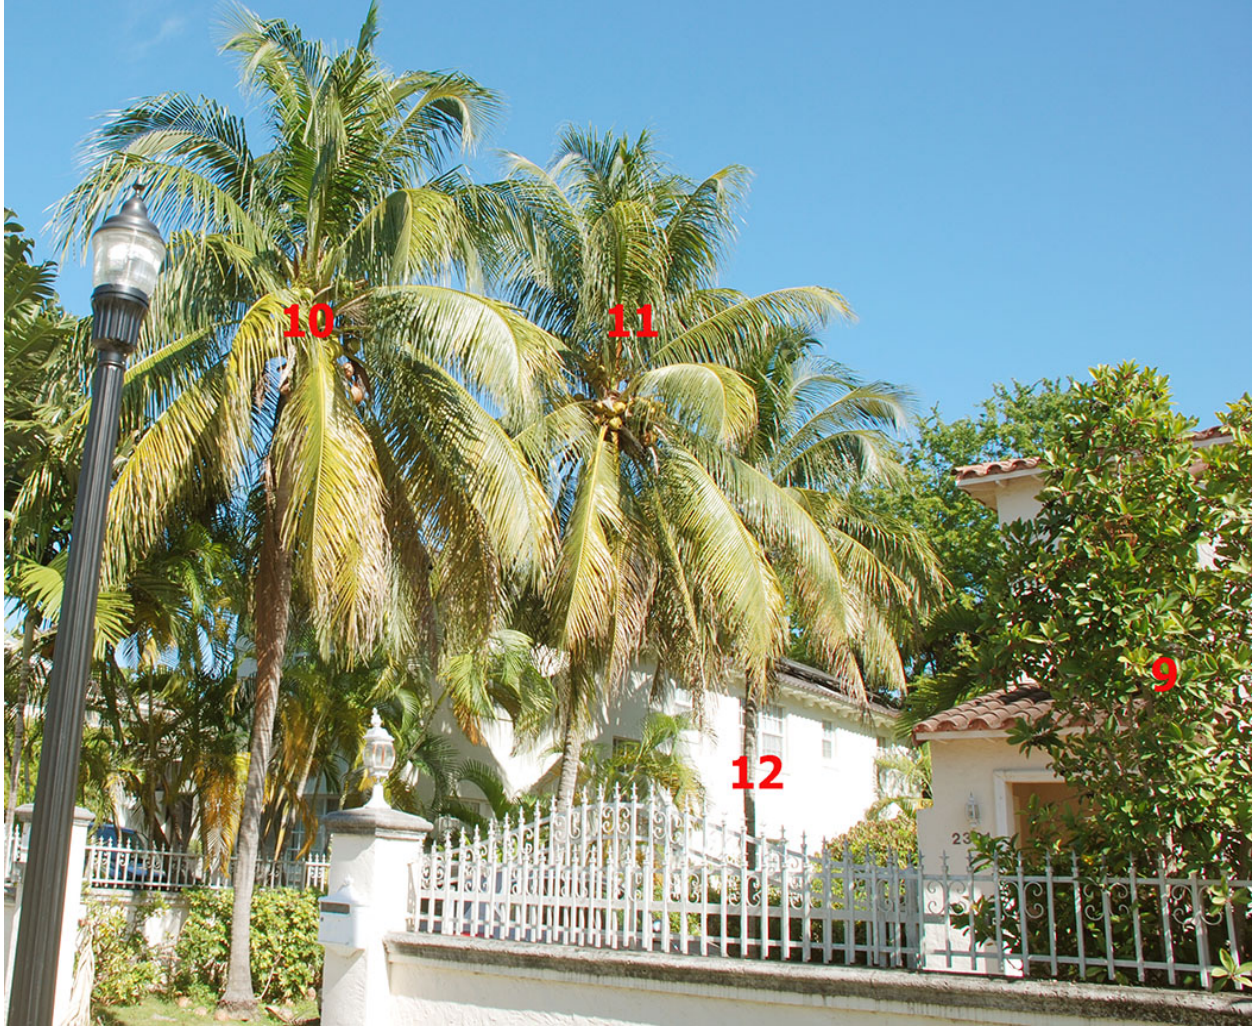
**Photo 17 above is palms 10, 11 & 12 along the eastern edge of the property.**

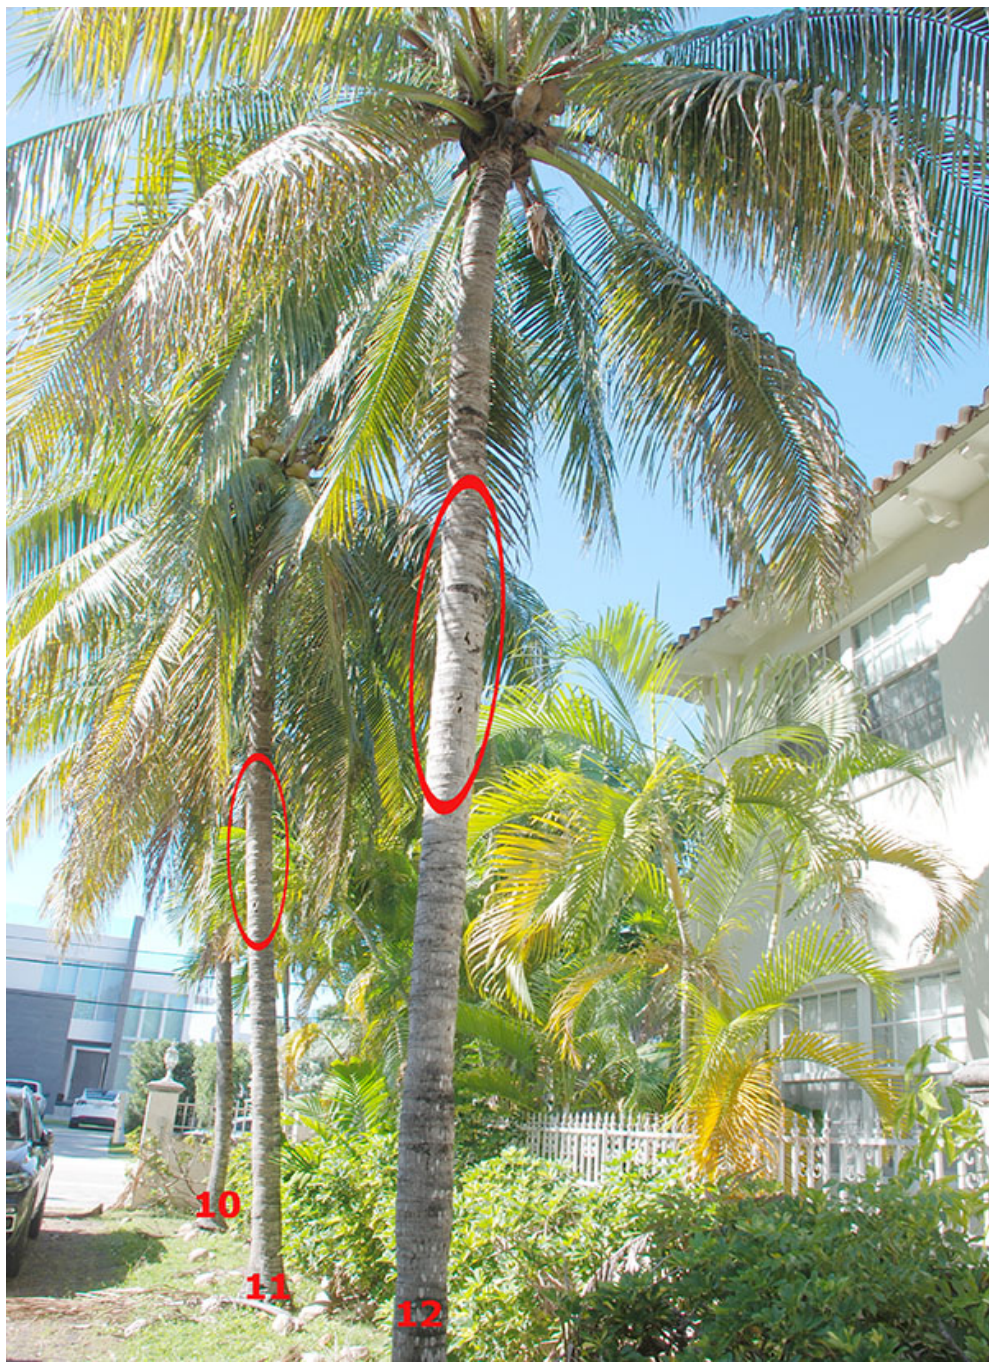
**Photo 18 above is the trunks of palms 10, 11 & 12 viewed from the south. The circles on the trunks indicate where they had once been climbed with spikes. These holes will never heal and can become an entry for pathogens and decay fungi. I have rated these palms to be in moderate condition due to this trunk damage and do not recommend the relocation of these palms.**

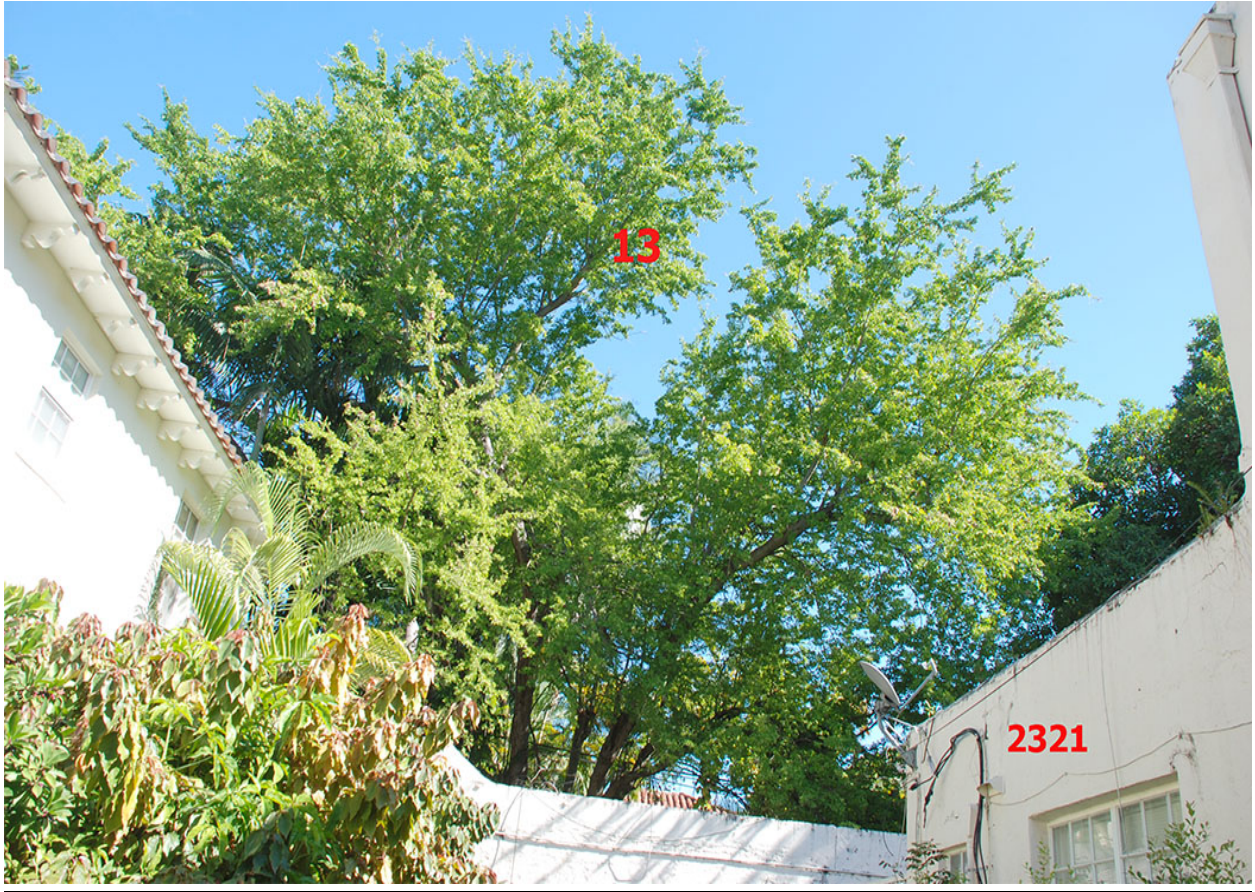
**Photo 19 above is the canopy of tree 13 viewed from the north. This is a very soft-wooded species and is very prone to decay and branch failure. This tree should be considered for removal. See following photos.**

| | <b>Scientific name</b> | <b>Common name</b> | <b>DBH</b> | <b>H/Ct</b> | <b>Canopy</b> | <b>Condition</b> | <b>TPZ</b> |
|---|---|---|---|---|---|---|---|
| 13 | Pithecellobium dulce | Madras thorn | 32" | 40' | 60' | Moderate | 20' |

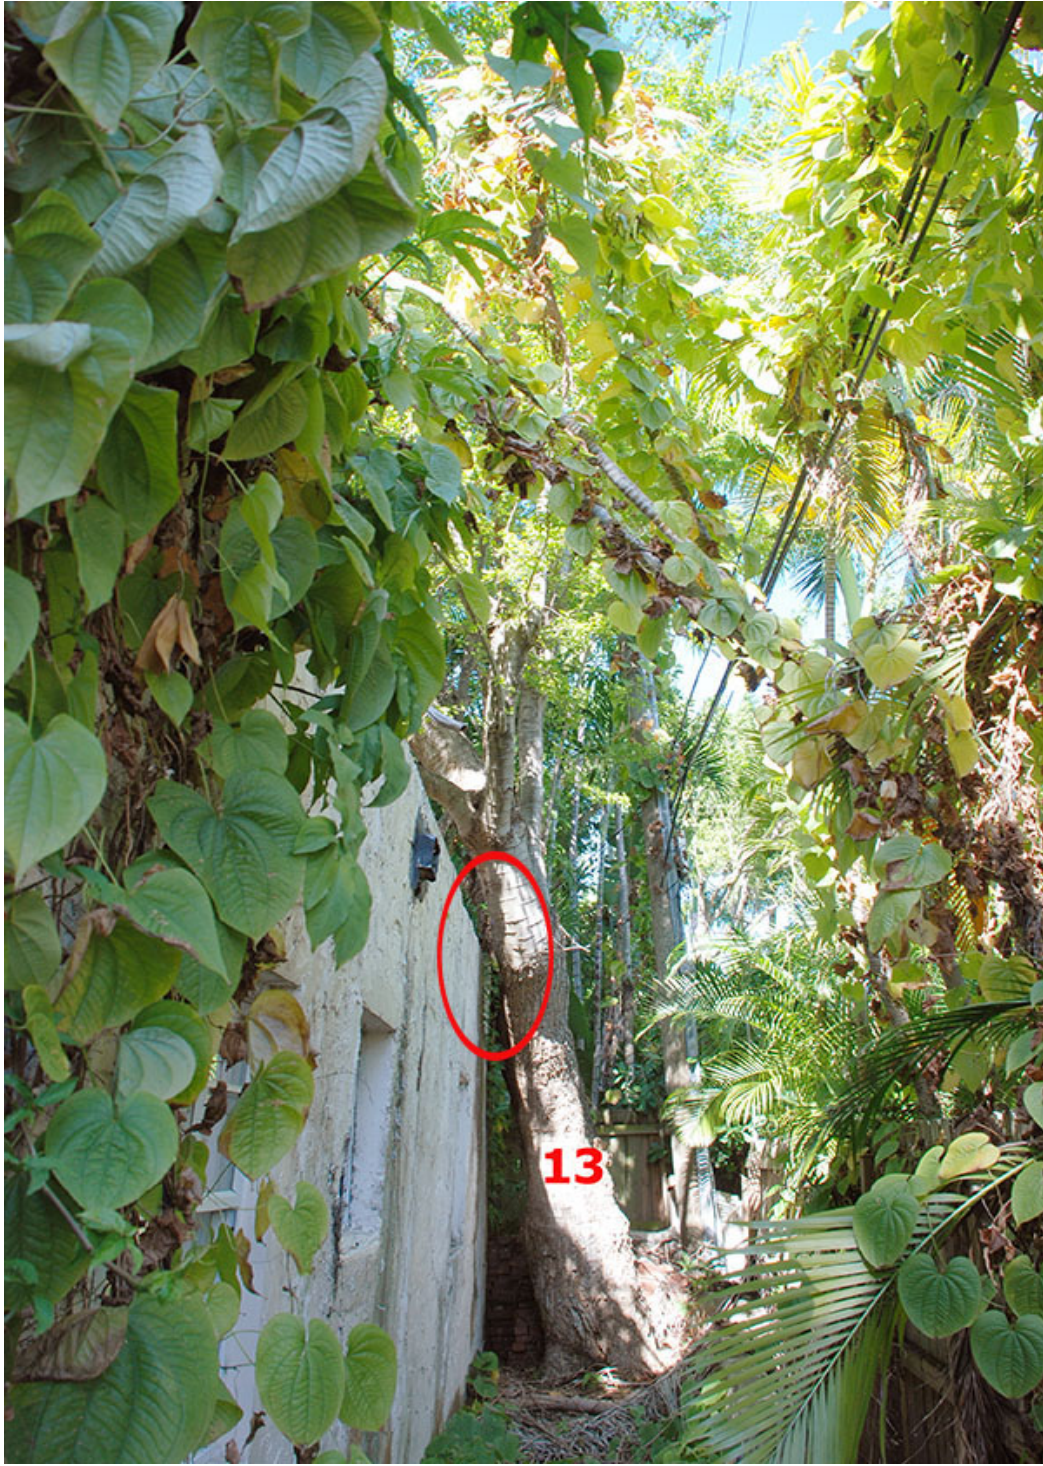
**Photo 20 above is the trunk of tree 13 viewed from the west. The circle indicates where the trunk appears to be leaning against the structure. This tree is likely to fail if the adjacent structure is removed.**

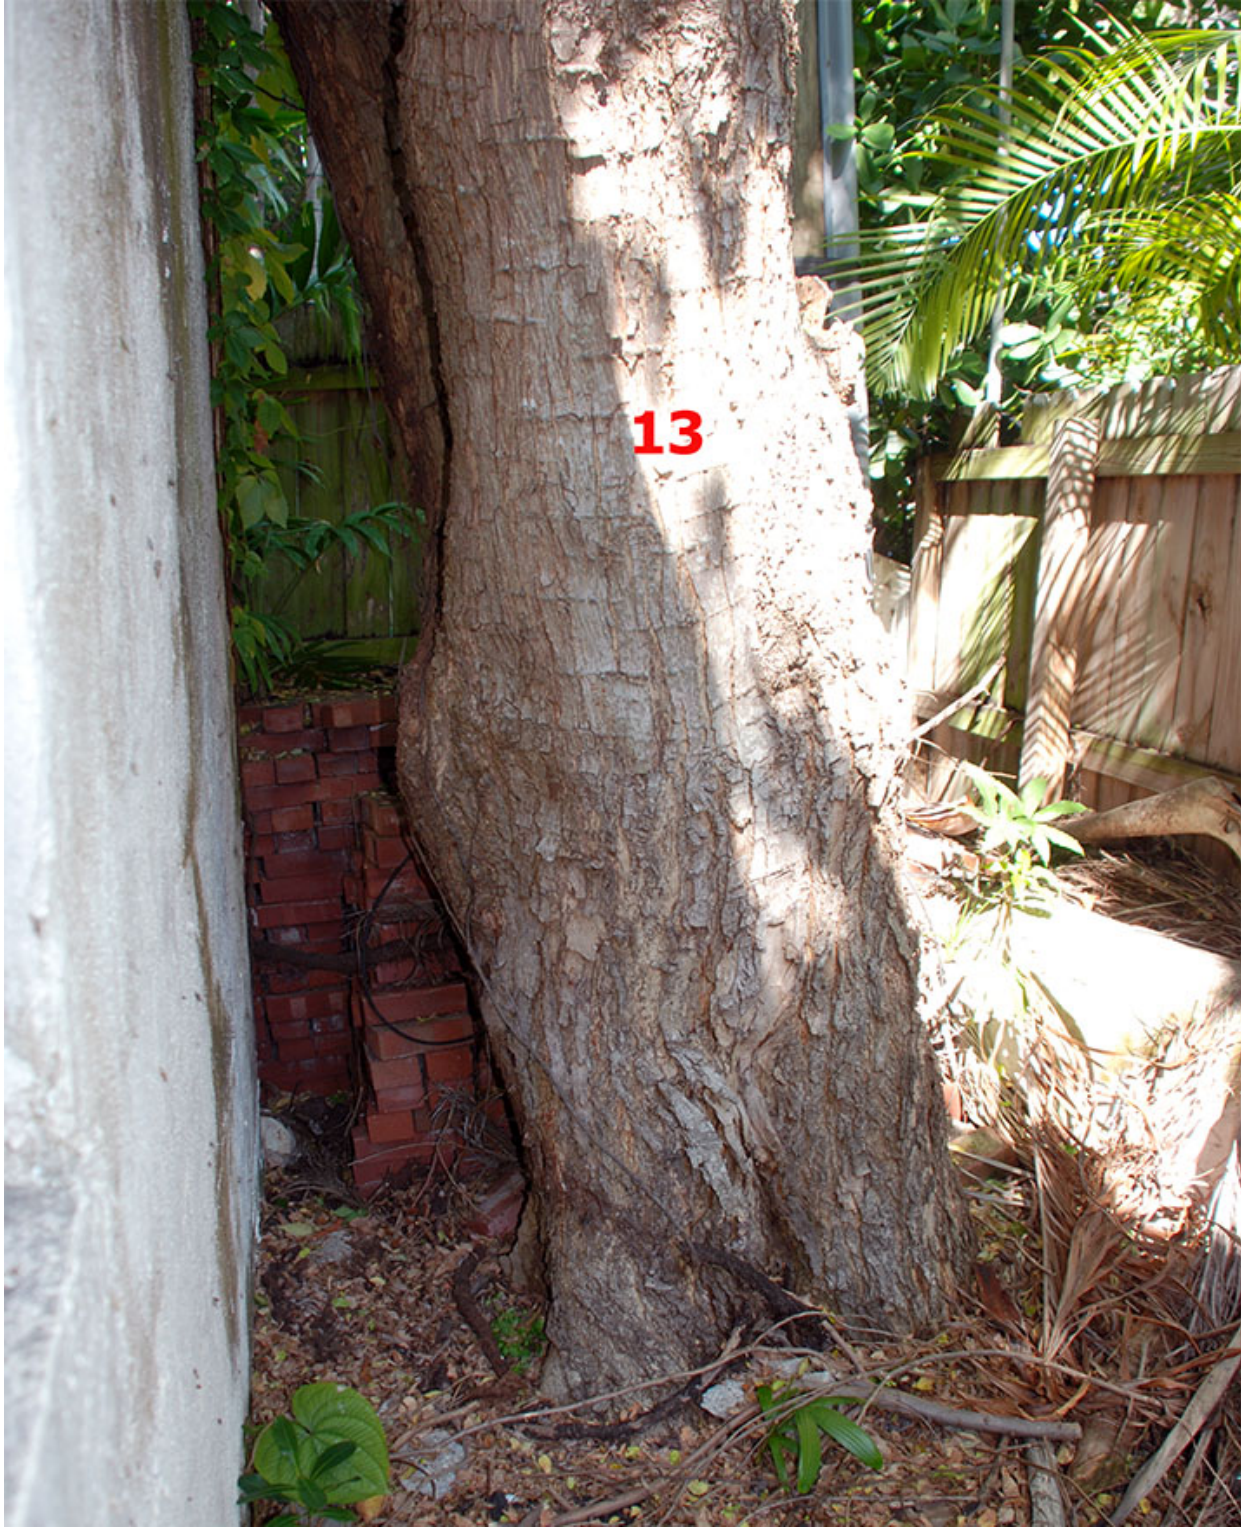
**Photo 21 is the trunk of tree 13 viewed from the west.**

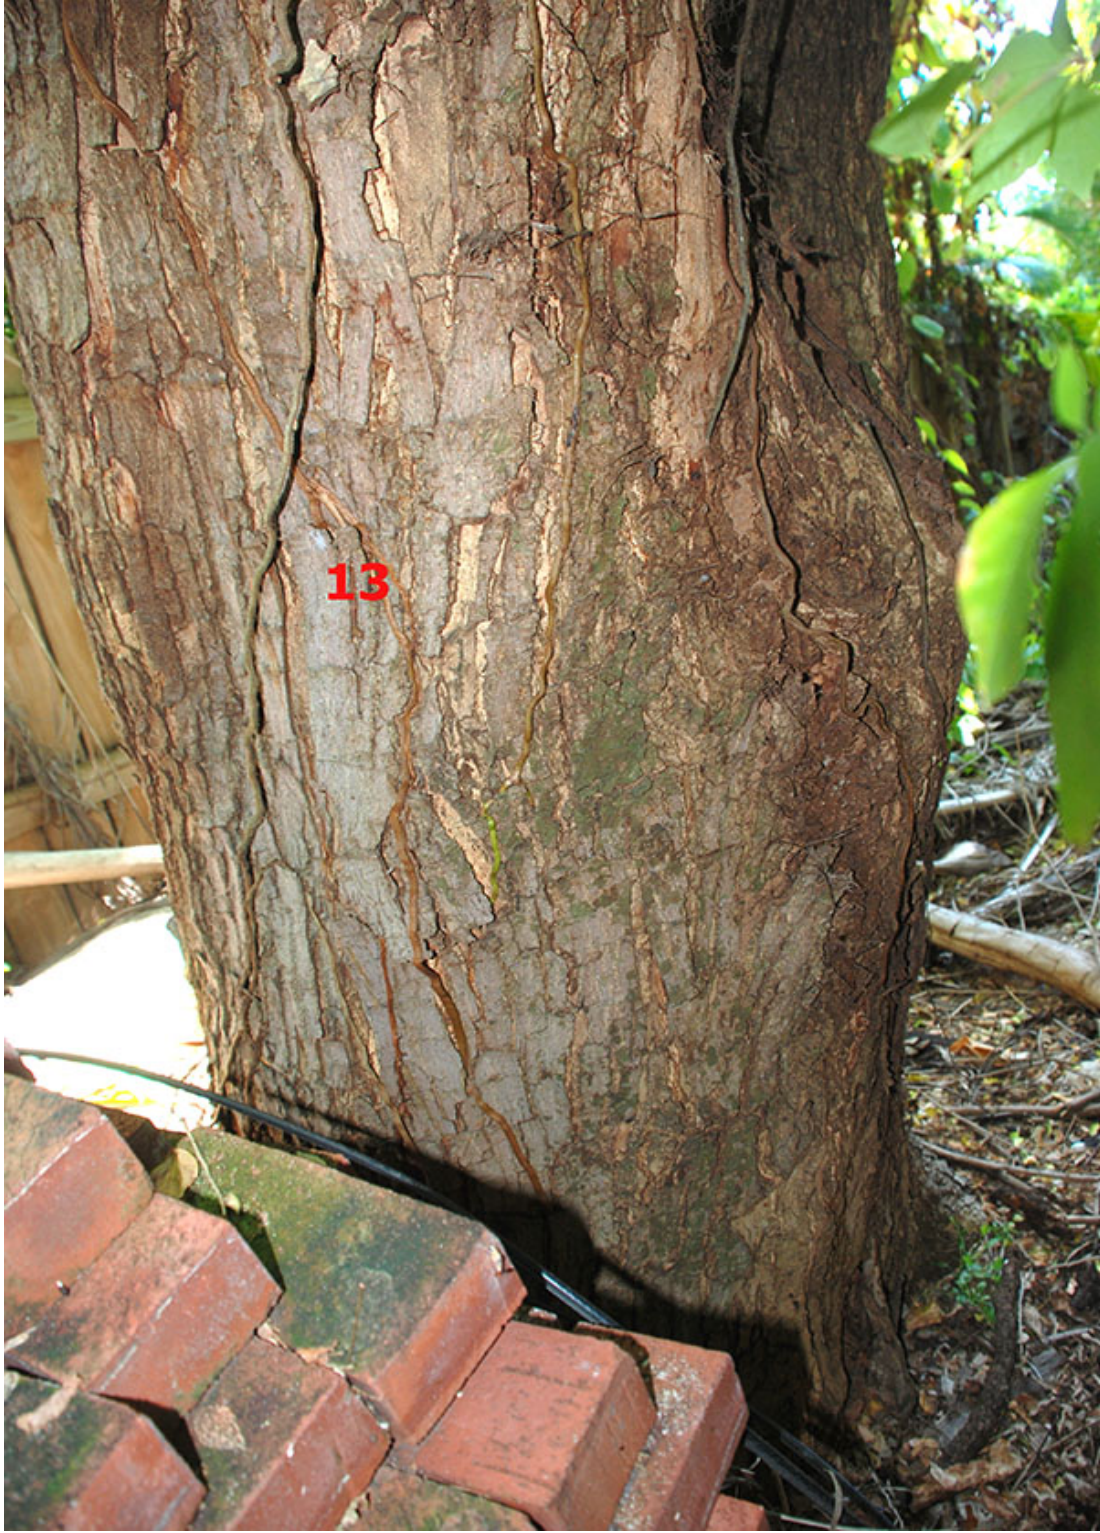
**Photo 22 is the trunk of tree 13 viewed from the east.**
