# Arborist Report

98 La Gorce Circle  
Miami Beach

12/16/2019

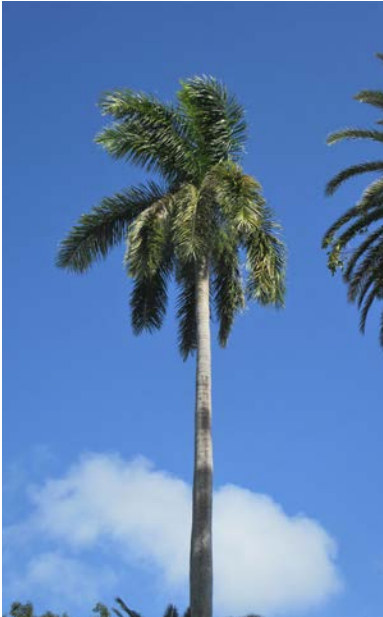
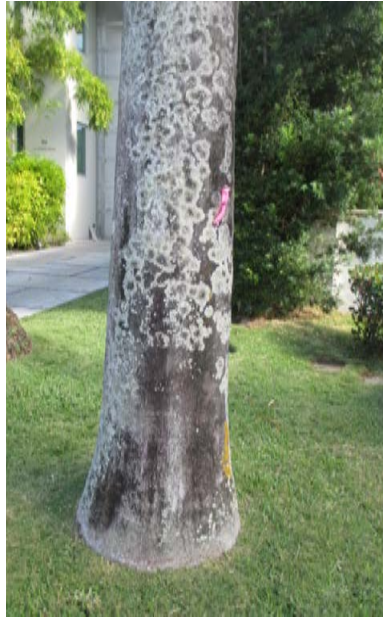
## Tree #1

**Condition -**  
Fair

Tree #1 is a Royal Palm street tree located along La Gorce Circle. It is in fair condition with a canopy on the small side and some trunk pencilling. This tree has not been incorporated into the landscape plan and will therefore be removed.

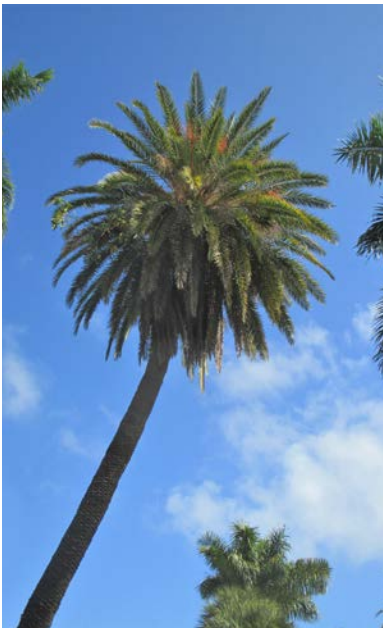
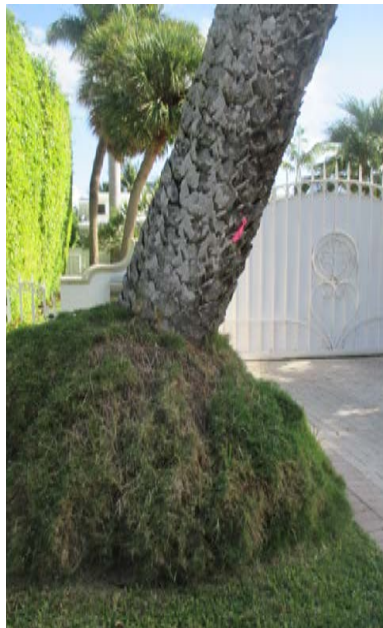
## Tree #2

Tree #2 is a Date Palm street tree located along La Gorce Circle. It is in good condition with a dense canopy. The soil is mounded at the base and the trunk curves. This tree directly conflicts with the proposed construction and will be removed.

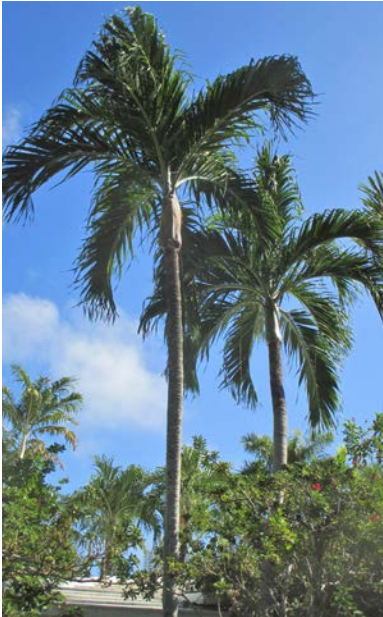
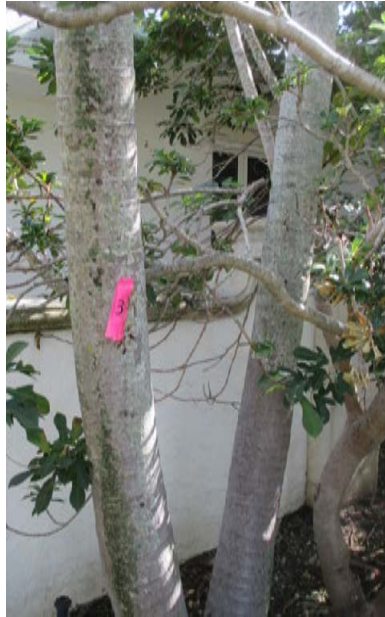
## Tree #3

Tree #3 is a double Christmas Palm located to the west of the front wall. It is in good condition with a dense, green canopy. This tree has not been incorporated into the landscape plan and will therefore be removed.

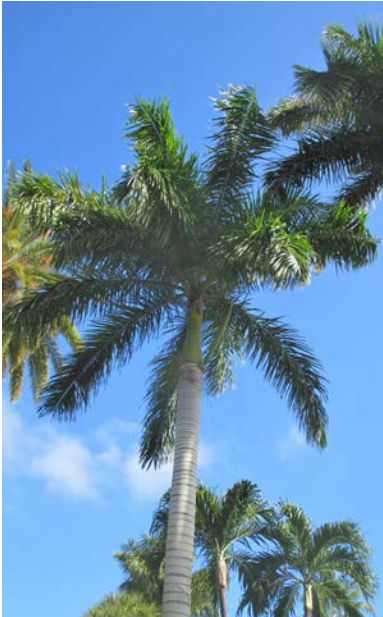
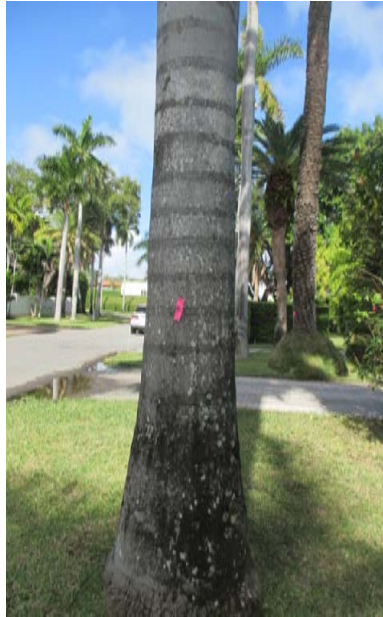
## Tree #5

Tree #5 is a Royal Palm street tree located along La Gorce Circle. It is in good condition with a full, green canopy and is growing vigorously. This tree has not been incorporated into the landscape plan and will therefore be removed.

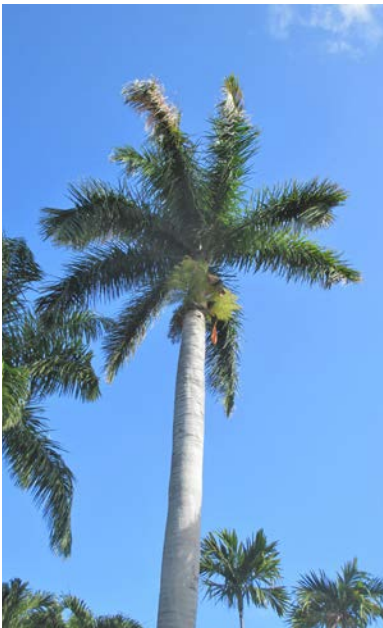
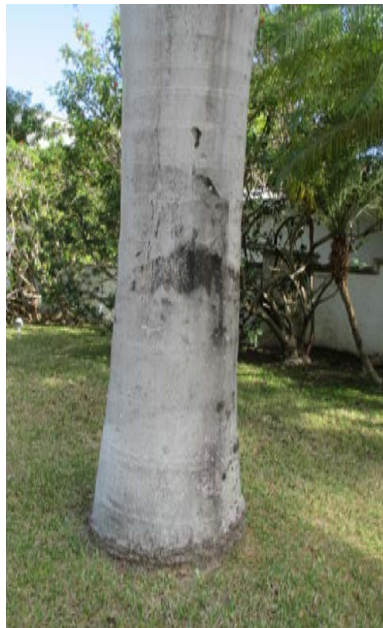
## Tree #6

Tree #6 is a Royal Palm street tree located along La Gorce Circle. It is in good condition with some frizzle at the ends of the fronds. This tree has not been incorporated into the landscape plan and will therefore be removed.

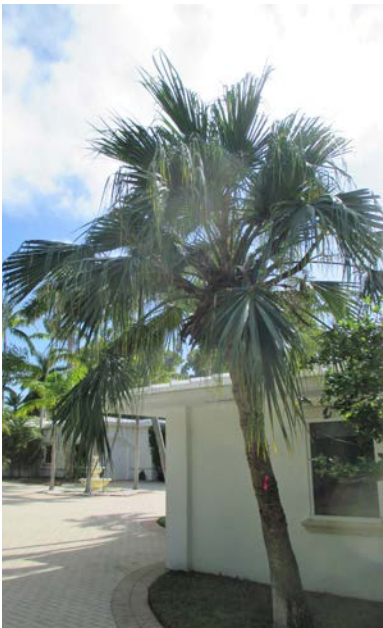
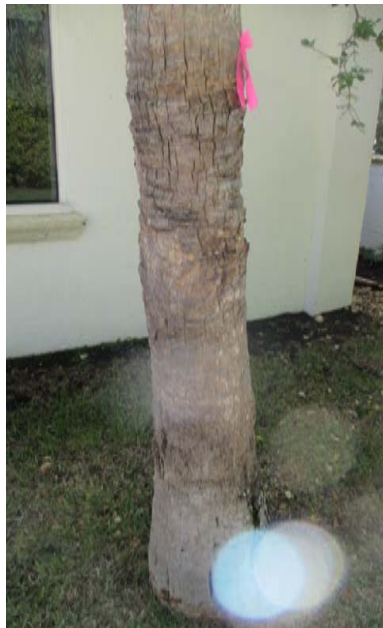
Tree #8 is a small Chinese Fan Palm located at the front of the property. It is in fair condition. This tree has not been incorporated into the landscape plan and will therefore be removed.

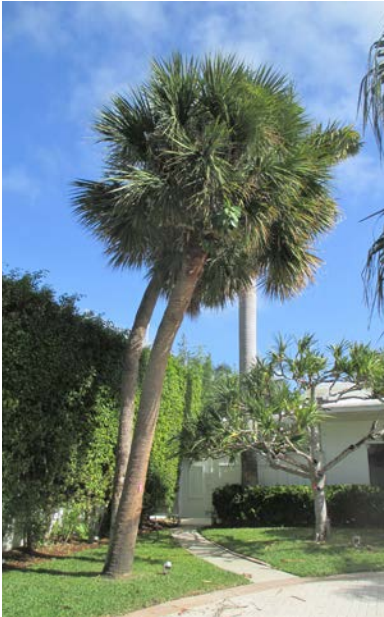
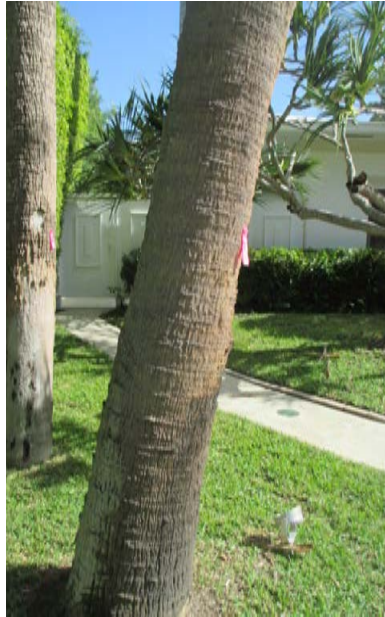
## Tree #9

Tree #9 is a Sabal Palm located on the north side of the front of the property. It is in good condition with a dense, green canopy. This tree directly conflicts with the proposed construction. If this tree is to be relocated, root pruning shall occur a minimum of 4-6 weeks prior to digging the palm and shall be performed or supervised by Certified Arborist. Minimum rootball measurement shall be based upon the most recent *Florida Grades & Standards for Nursery Plants*. Transplanting shall be performed or supervised by Certified Arborist. Prior to transplanting, the apical bud shall be protected by tying up palm fronds. Leaves shall be untied as soon as the palm is planted. When lifting the palm, a nylon sling with adequate padding shall be used and care shall be taken to not injure or compress the trunk. Plant at grade, with 2" of root initiation zone visible if applicable. Transplanting shall occur as soon as possible and no more than 24 hours after being dug for relocation. The backfill soil shall be irrigated during and following relocation. Wooden braces shall be installed to stabilize the tree.

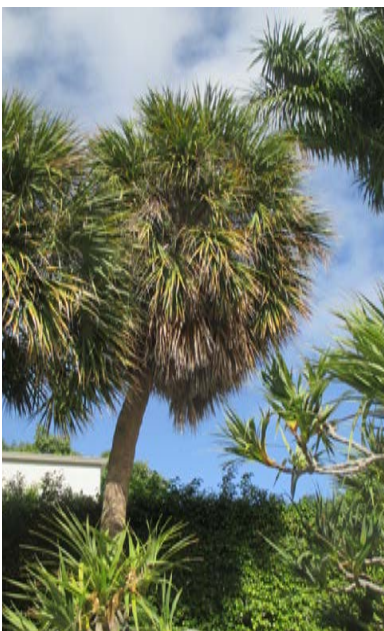
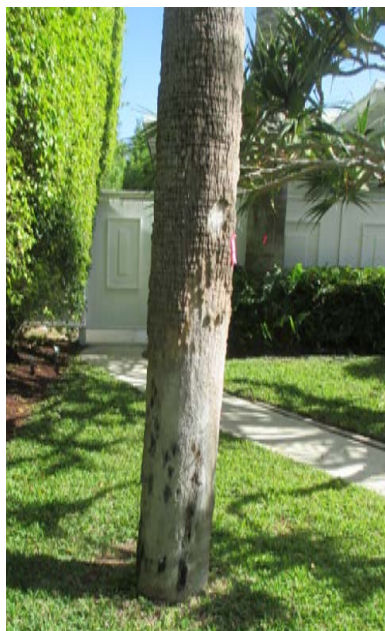
## Tree #10

Tree #10 is a Sabal Palm located on the north side of the front of the property. It is in fair condition with a number of trunk abnormalities. This tree directly conflicts with the proposed construction. If this tree is to be relocated, root pruning shall occur a minimum of 4-6 weeks prior to digging the palm and shall be performed or supervised by Certified Arborist. Minimum rootball measurement shall be based upon the most recent *Florida Grades & Standards for Nursery Plants*. Transplanting shall be performed or supervised by Certified Arborist. Prior to transplanting, the apical bud shall be protected by tying up palm fronds. Leaves shall be untied as soon as the palm is planted. When lifting the palm, a nylon sling with adequate padding shall be used and care shall be taken to not injure or compress the trunk. Plant at grade, with 2" of root initiation zone visible if applicable. Transplanting shall occur as soon as possible and no more than 24 hours after being dug for relocation. The backfill soil shall be irrigated during and following relocation. Wooden braces shall be installed to stabilize the tree.

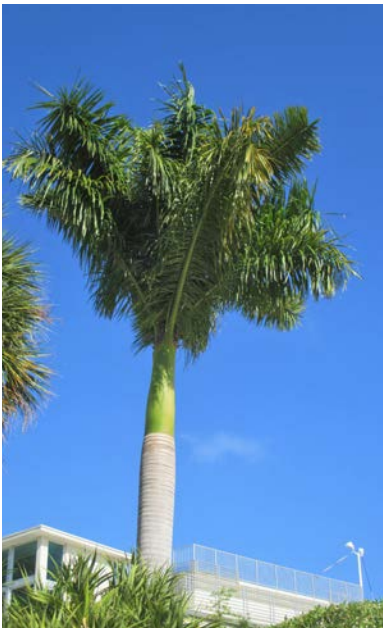
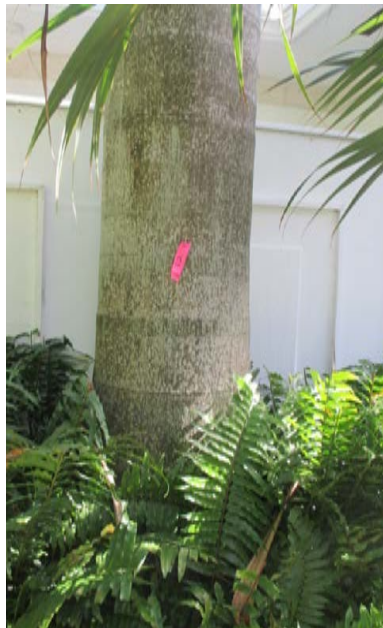
Tree #12 is a Royal Palm located on the north side of the front of the property. It is in good condition, although the canopy has been over-pruned. This tree directly conflicts with the proposed construction and will be removed.

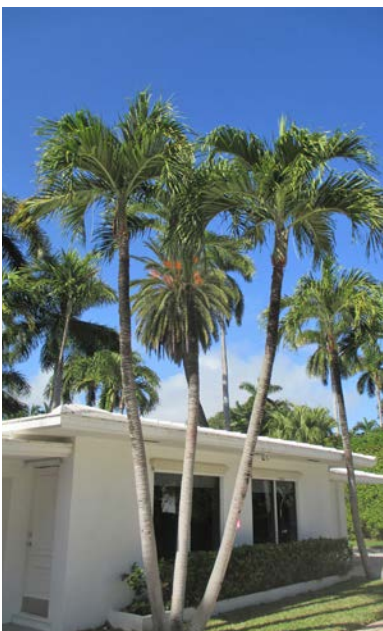
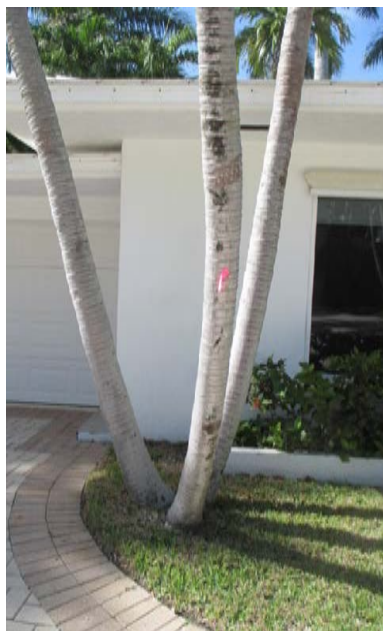
Tree #14 is a triple Christmas Palm located at the front of the property. It is in good condition with a bright green canopy. This tree directly conflicts with the proposed construction and will be removed.

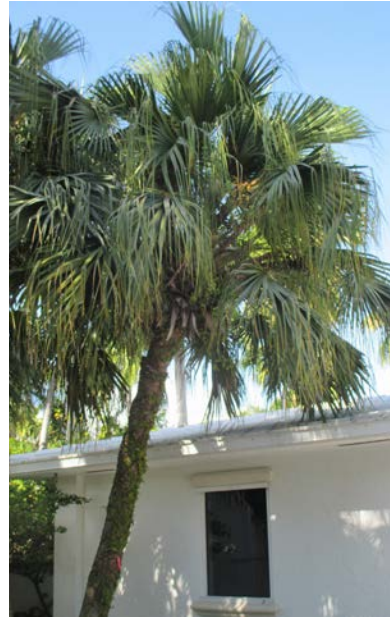
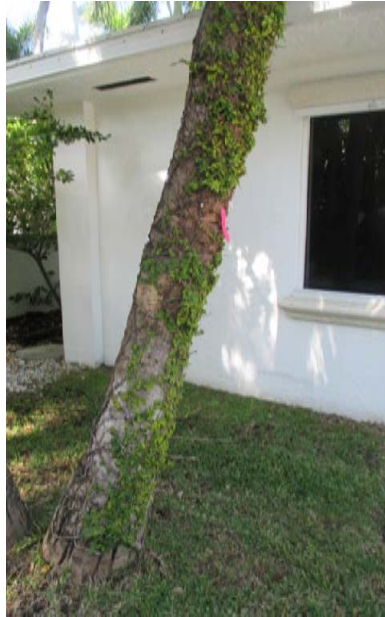
## Tree #15

Tree #15 is a Chinese Fan Palm located at the front of the property. It is in fair condition and vines are on the trunk. This tree directly conflicts with the proposed construction and will be removed.

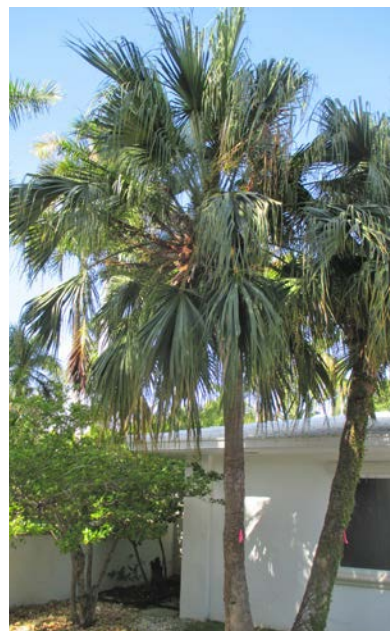
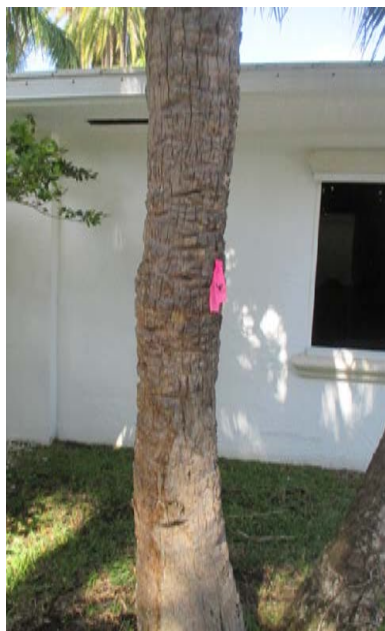
## Tree #16

Tree #16 is a Chinese Fan Palm located at the front of the property. It is in fair condition. This tree directly conflicts with the proposed construction and will be removed.

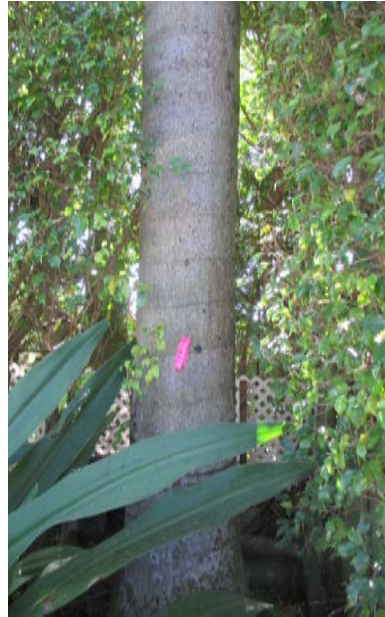
## Tree #17

Tree #17 is a Royal Palm located on the south side of the front of the property. It is in good condition with a full, green canopy. This tree has not been incorporated into the landscape plan and will therefore be removed.

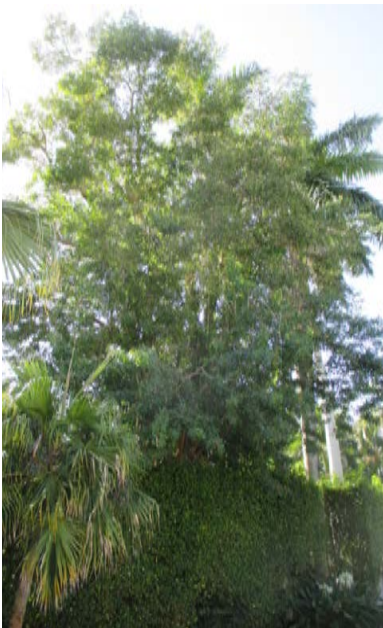
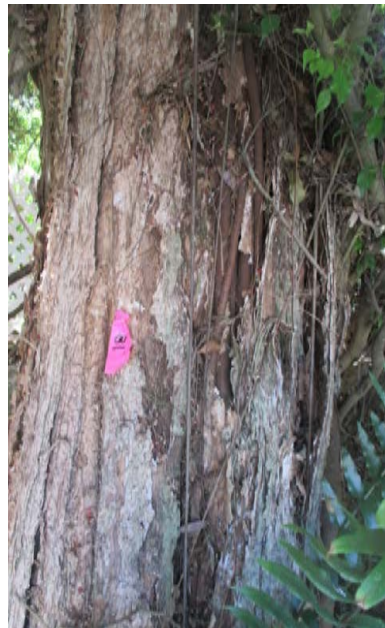
## Tree #18

Tree #18 is a Melaleuca located on the south side of the front of the property. It is in fair condition and is double-trunked with included bark. A Brazilian Pepper is growing on the tree. This species is highly invasive and is on the Miami-Dade County Prohibited Plant List. This tree will need to be removed.

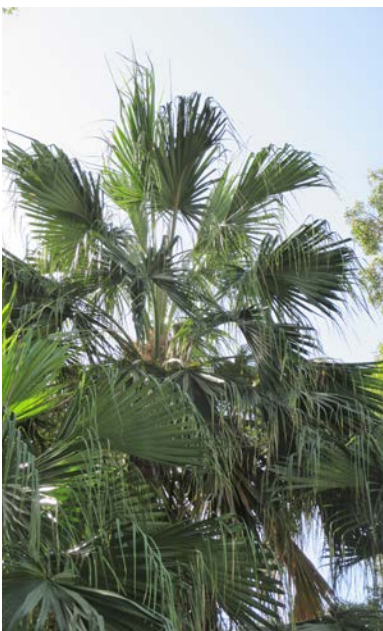
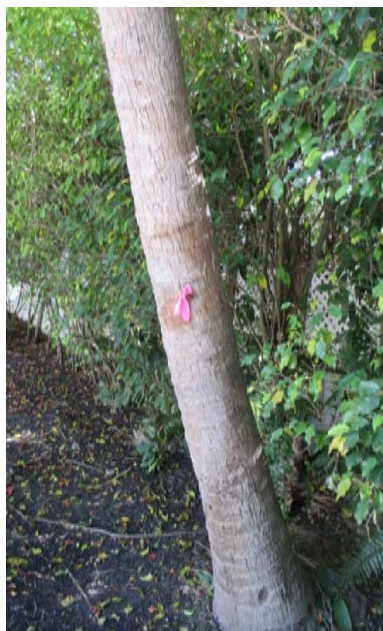
Tree #20 is a Chinese Fan Palm located on the south side of the property. It is in fair condition with some lower dead fronds.

This tree has not been incorporated into the landscape plan and will therefore be removed.

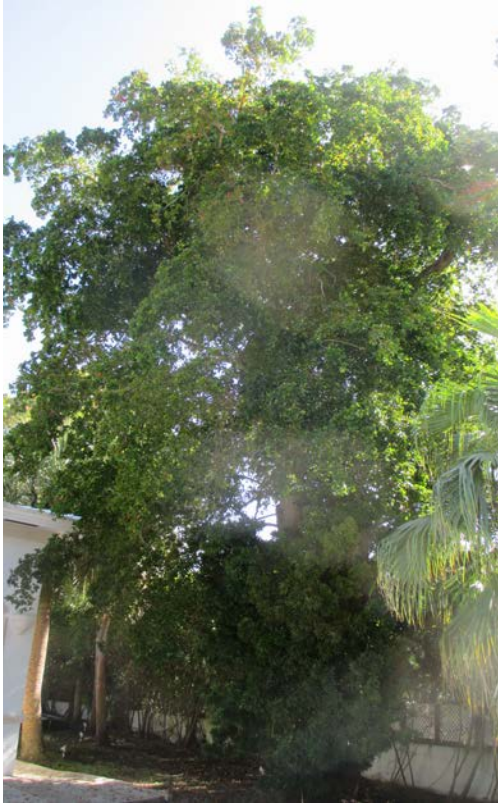
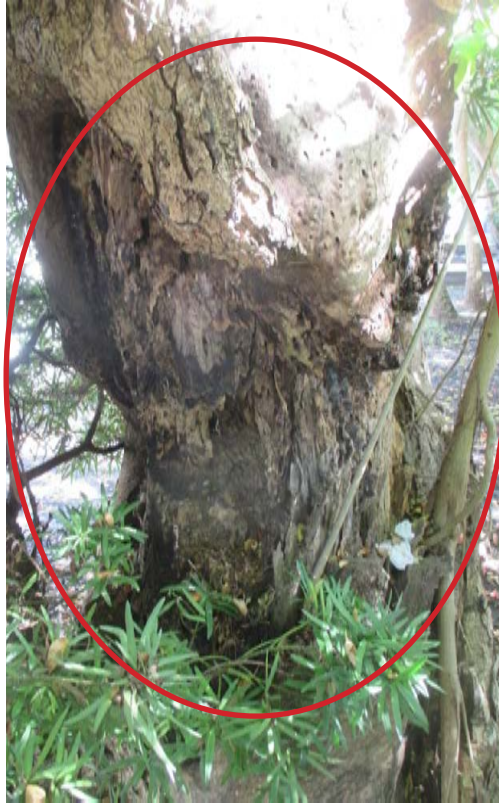
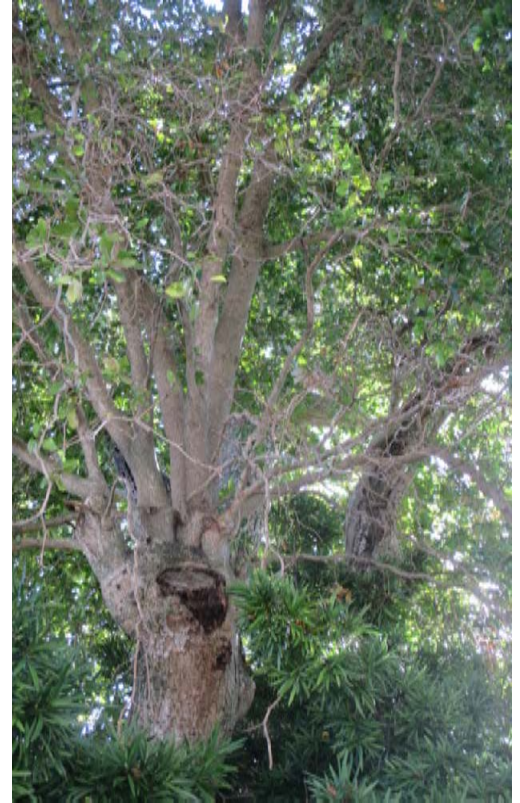
## Tree #22 contd.

Tree #22 is a large Black Olive located on the south side of the property, next to the existing house. The tree is in poor condition - approximately 75% of the circumference of the trunk has been wounded and there is extensive heartrot throughout the tree trunk (circled in red). The tree is structurally unsound, and it is surprising that the tree is still standing given the weight of the large, dense canopy. Numerous limbs have been hatracked and the canopy consists of shoot growth from these cut locations. This tree is hazardous and will need to be removed as soon as possible.

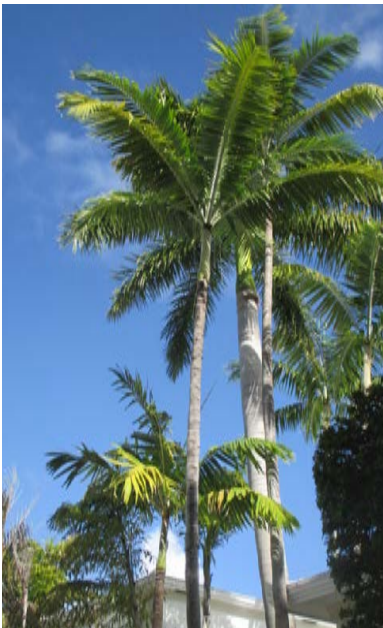
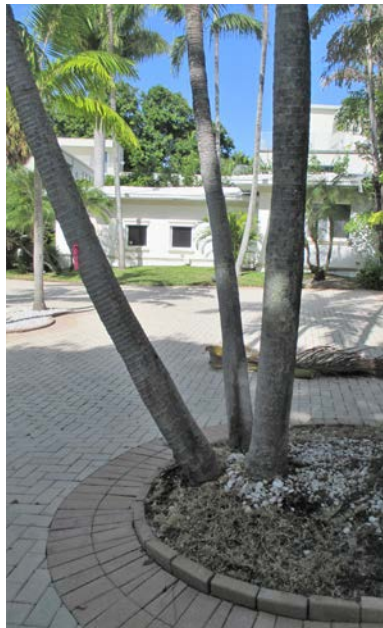
## Tree #23

Tree #23 is a triple Montgomery Palm located at the front of the existing house. It is in fair condition with a chlorotic canopy. This tree directly conflicts with the proposed construction. If this tree is to be relocated, root pruning shall occur a minimum of 4-6 weeks prior to digging the palm and shall be performed or supervised by Certified Arborist. Minimum rootball measurement shall be based upon the most recent *Florida Grades & Standards for Nursery Plants*. Transplanting shall be performed or supervised by Certified Arborist. Prior to transplanting, the apical bud shall be protected by tying up palm fronds. Leaves shall be untied as soon as the palm is planted. When lifting the palm, a nylon sling with adequate padding shall be used and care shall be taken to not injure or compress the trunk. Plant at grade, with 2" of root initiation zone visible if applicable. Transplanting shall occur as soon as possible and no more than 24 hours after being dug for relocation. The backfill soil shall be irrigated during and following relocation. Wooden braces shall be installed to stabilize the tree.

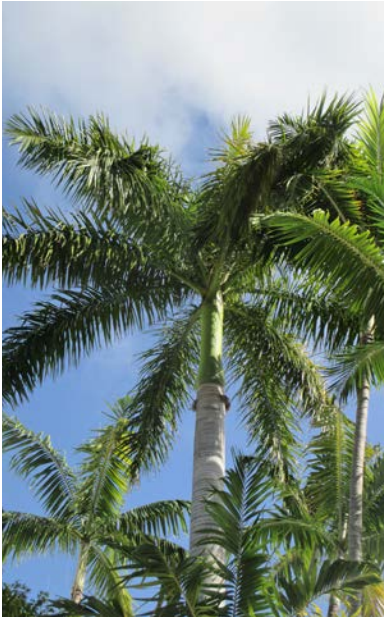
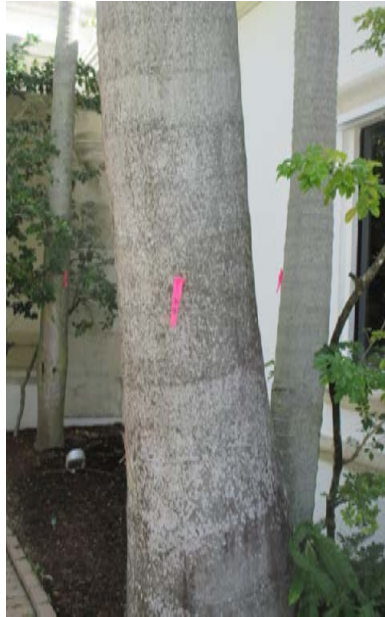
## Tree #24

Tree #24 is a Royal Palm located at the front of the existing house. It is in good condition with a healthy, green canopy. This tree directly conflicts with the proposed construction and will be removed.

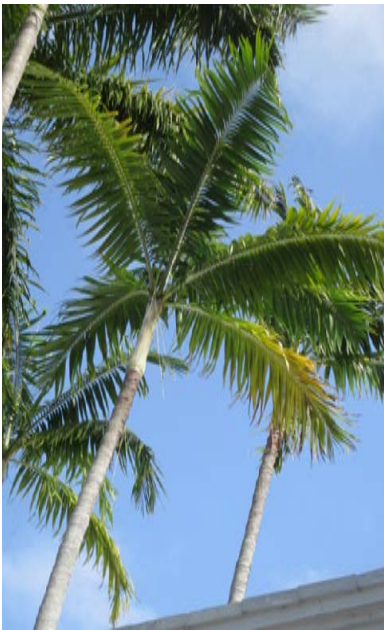
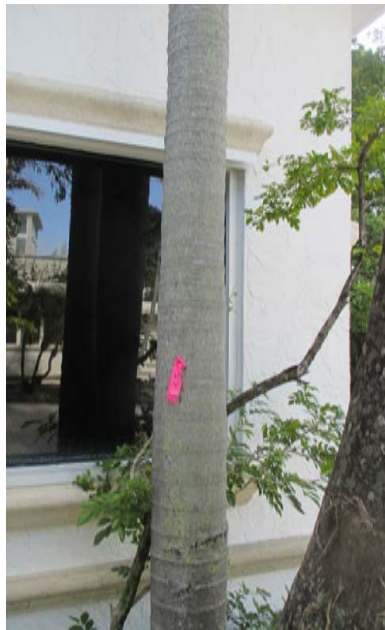
## Tree #25

Tree #25 is a Montgomery Palm located at the front of the existing house. It is in fair condition with a chlorotic canopy. This tree directly conflicts with the proposed construction. If this tree is to be relocated, root pruning shall occur a minimum of 4-6 weeks prior to digging the palm and shall be performed or supervised by Certified Arborist. Minimum rootball measurement shall be based upon the most recent *Florida Grades & Standards for Nursery Plants*. Transplanting shall be performed or supervised by Certified Arborist. Prior to transplanting, the apical bud shall be protected by tying up palm fronds. Leaves shall be untied as soon as the palm is planted. When lifting the palm, a nylon sling with adequate padding shall be used and care shall be taken to not injure or compress the trunk. Plant at grade, with 2" of root initiation zone visible if applicable. Transplanting shall occur as soon as possible and no more than 24 hours after being dug for relocation. The backfill soil shall be irrigated during and following relocation. Wooden braces shall be installed to stabilize the tree.

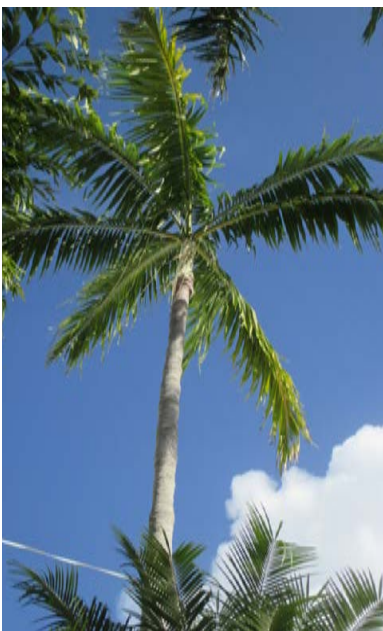
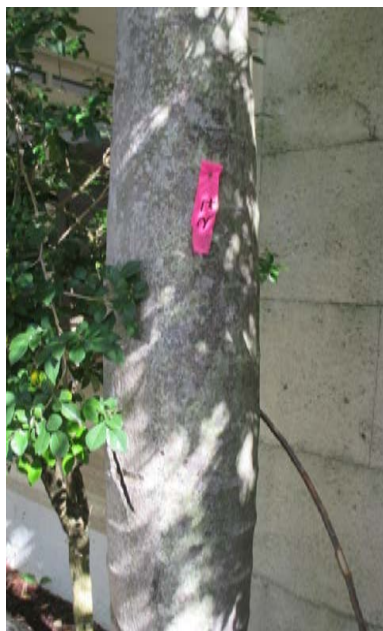
Tree #27 is a Montgomery Palm located at the front of the existing house. It is in fair condition with a chlorotic canopy. This tree directly conflicts with the proposed construction. If this tree is to be relocated, root pruning shall occur a minimum of 4-6 weeks prior to digging the palm and shall be performed or supervised by Certified Arborist. Minimum rootball measurement shall be based upon the most recent *Florida Grades & Standards for Nursery Plants*. Transplanting shall be performed or supervised by Certified Arborist. Prior to transplanting, the apical bud shall be protected by tying up palm fronds. Leaves shall be untied as soon as the palm is planted. When lifting the palm, a nylon sling with adequate padding shall be used and care shall be taken to not injure or compress the trunk. Plant at grade, with 2" of root initiation zone visible if applicable. Transplanting shall occur as soon as possible and no more than 24 hours after being dug for relocation. The backfill soil shall be irrigated during and following relocation. Wooden braces shall be installed to stabilize the tree.

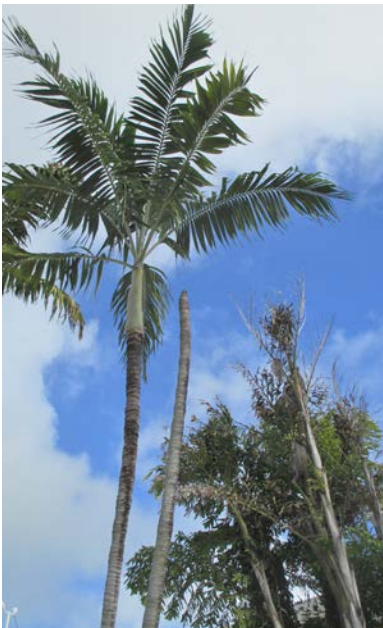
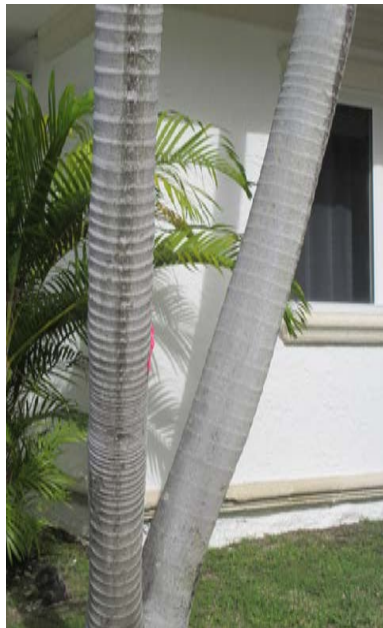
Tree #29 is a double Montgomery Palm located at the front of the existing house. It is in poor condition with one trunk dead. This tree will need to be removed. This tree directly conflicts with the proposed construction.

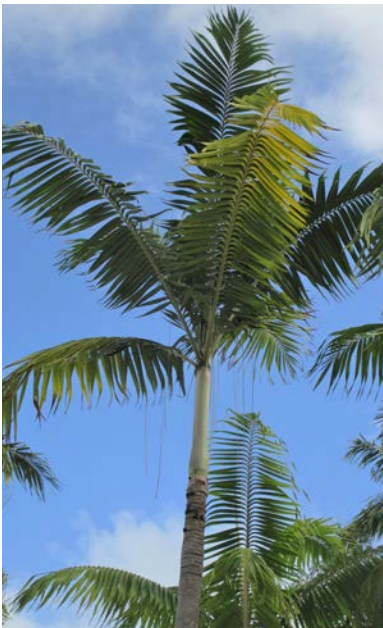
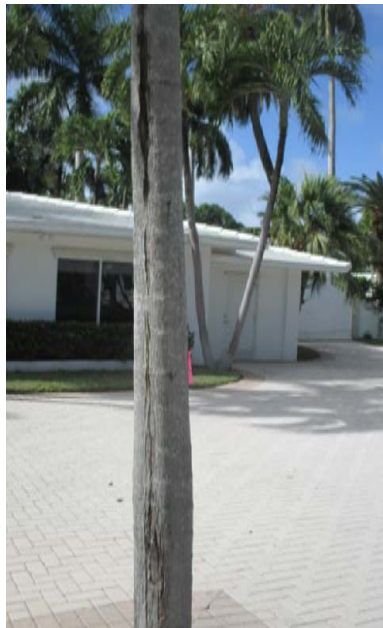
Tree #31 is a Montgomery Palm located around the front courtyard fountain. It is in poor condition with a chlorotic canopy and trunk splits. This tree will need to be removed.  
This tree directly conflicts with the proposed construction.

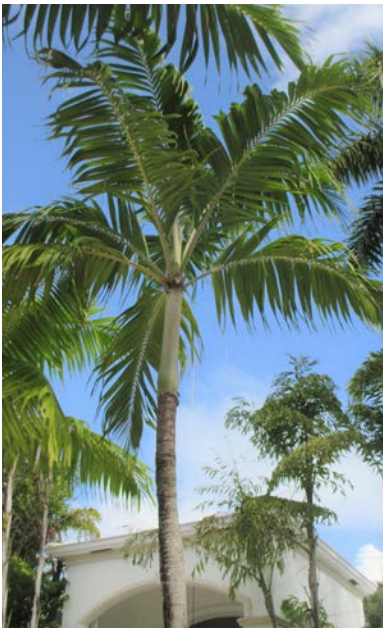
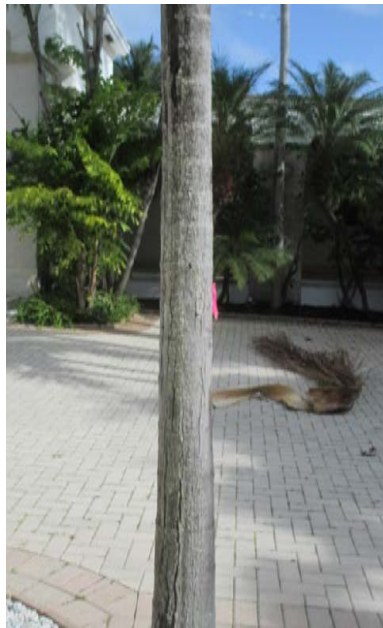
Tree #33 is a Montgomery Palm located around the front courtyard fountain. It is in poor condition with a chlorotic canopy and trunk splits. This tree will need to be removed.  
This tree directly conflicts with the proposed construction.

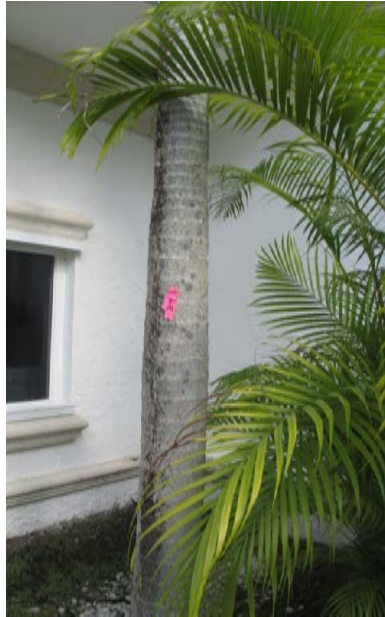
## Tree #34

Tree #34 is a Montgomery Palm located in front of the existing house. It is in fair condition with the tips of the fronds brown. This tree directly conflicts with the proposed construction. If this tree is to be relocated, root pruning shall occur a minimum of 4-6 weeks prior to digging the palm and shall be performed or supervised by Certified Arborist. Minimum rootball measurement shall be based upon the most recent *Florida Grades & Standards for Nursery Plants*. Transplanting shall be performed or supervised by Certified Arborist. Prior to transplanting, the apical bud shall be protected by tying up palm fronds. Leaves shall be untied as soon as the palm is planted. When lifting the palm, a nylon sling with adequate padding shall be used and care shall be taken to not injure or compress the trunk. Plant at grade, with 2" of root initiation zone visible if applicable. Transplanting shall occur as soon as possible and no more than 24 hours after being dug for relocation. The backfill soil shall be irrigated during and following relocation. Wooden braces shall be installed to stabilize the tree.

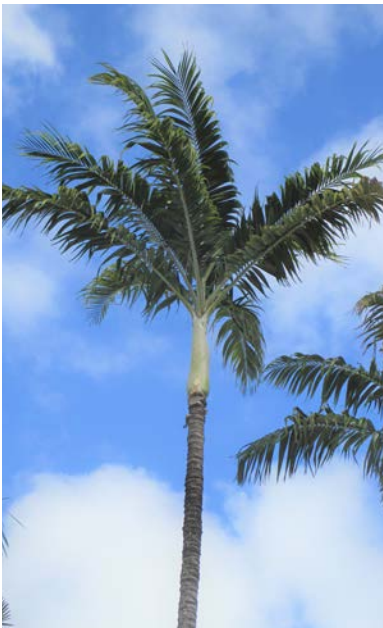
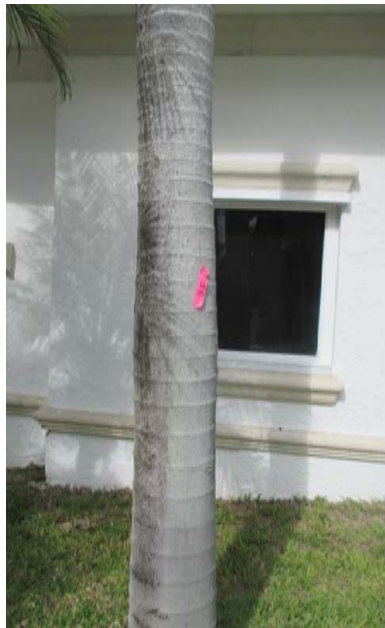
## Tree #35

Tree #35 is a Montgomery Palm located in front of the existing house. It is in fair condition with the tips of the fronds brown. This tree directly conflicts with the proposed construction. If this tree is to be relocated, root pruning shall occur a minimum of 4-6 weeks prior to digging the palm and shall be performed or supervised by Certified Arborist. Minimum rootball measurement shall be based upon the most recent *Florida Grades & Standards for Nursery Plants*. Transplanting shall be performed or supervised by Certified Arborist. Prior to transplanting, the apical bud shall be protected by tying up palm fronds. Leaves shall be untied as soon as the palm is planted. When lifting the palm, a nylon sling with adequate padding shall be used and care shall be taken to not injure or compress the trunk. Plant at grade, with 2" of root initiation zone visible if applicable. Transplanting shall occur as soon as possible and no more than 24 hours after being dug for relocation. The backfill soil shall be irrigated during and following relocation. Wooden braces shall be installed to stabilize the tree.

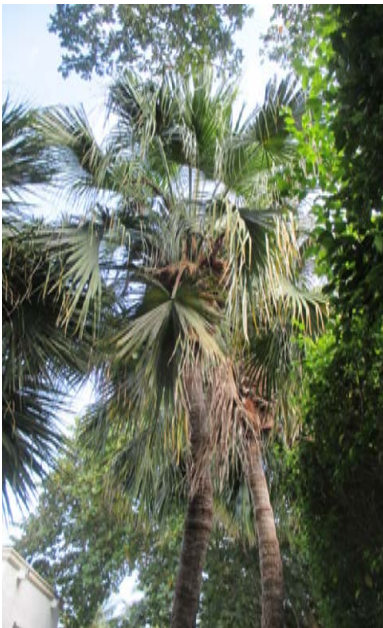
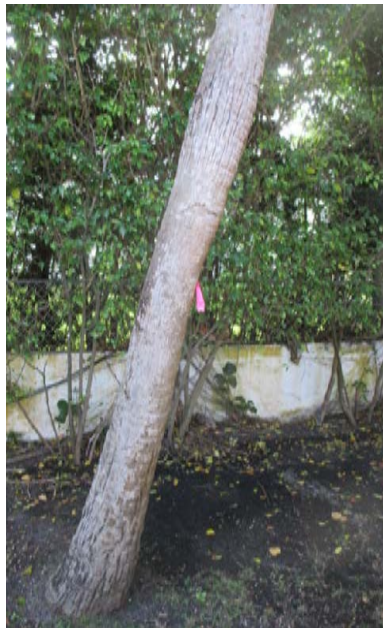
Tree #37 is a Chinese Fan Palm located on the south side of the property. It is in fair condition with some yellow spotting on the fronds. This tree has not been incorporated into the landscape plan and will therefore be removed.

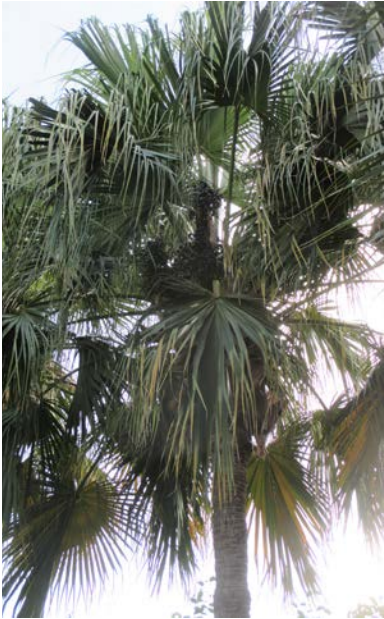
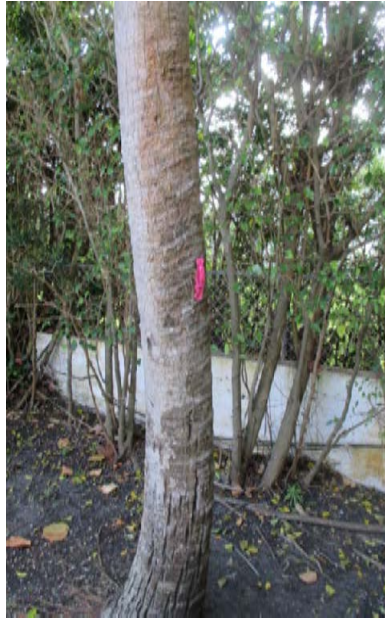
## Tree #38

Tree #38 is a Chinese Fan Palm located on the south side of the property. It is in fair condition with some yellow spotting on the fronds. This tree has not been incorporated into the landscape plan and will therefore be removed.

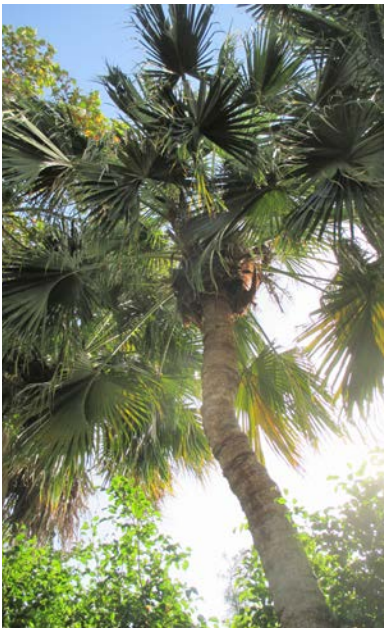
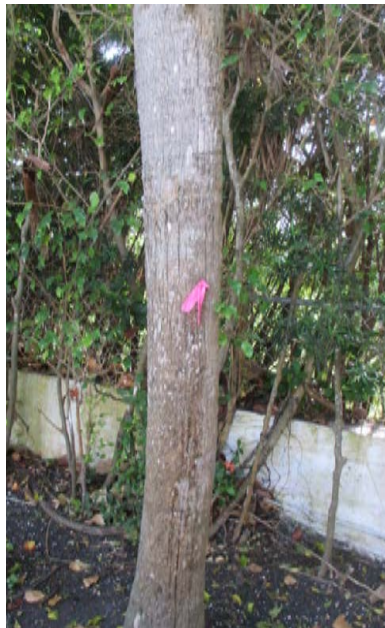
## Tree #39

Tree #39 is a Chinese Fan Palm located on the south side of the property. It is in fair condition with some yellow spotting on the fronds. The trunk is curved sharply. This tree has not been incorporated into the landscape plan and will therefore be removed.

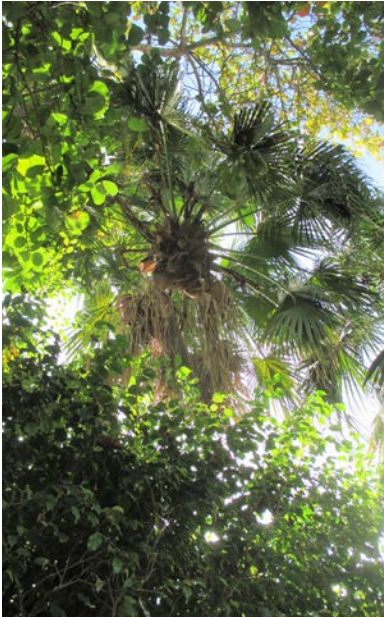
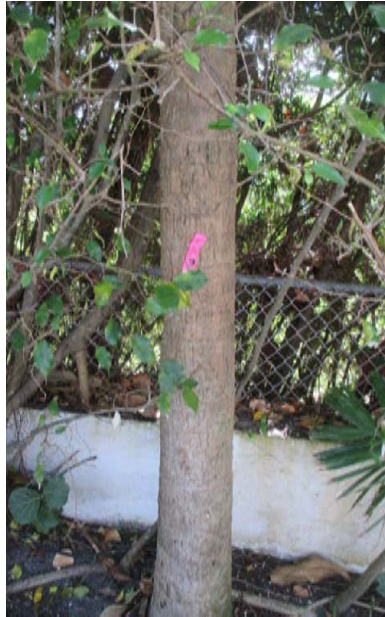
## Tree #40

Tree #40 is a Chinese Fan Palm located on the south side of the property. It is in fair condition and is competing with Tree #41 for light. This tree has not been incorporated into the landscape plan and will therefore be removed.

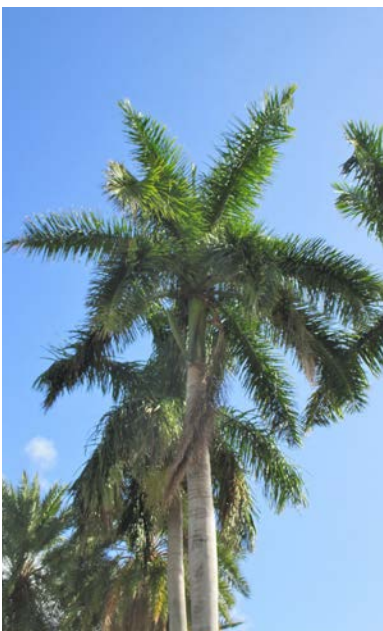
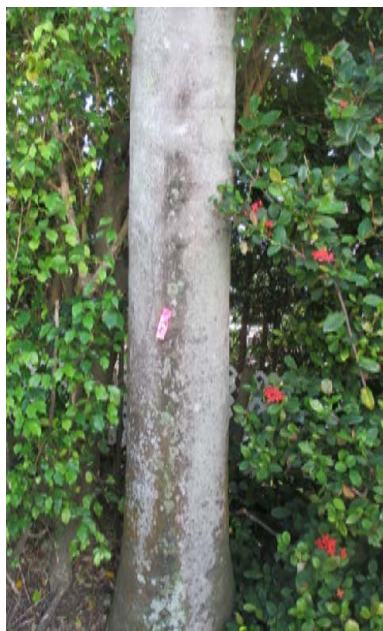
Tree #43 is a Royal Palm located on the south side of the backyard. It is in good condition with a bright green canopy. One lower dead frond is present. This tree has not been incorporated into the landscape plan and will therefore be removed.

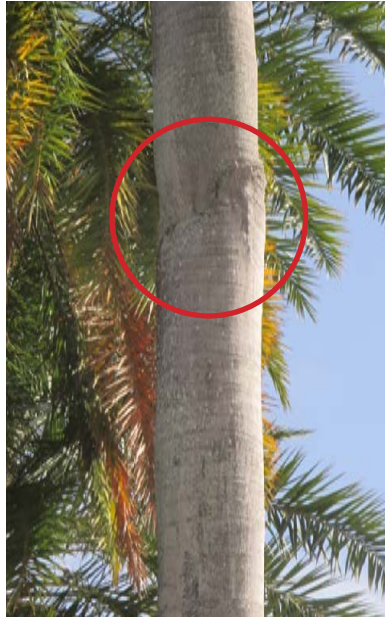
## Tree #44

Tree #44 is a Royal Palm located on the south side of the backyard. The trunk appears to be collapsing in one area (circled in red) which may be indicative of Thielaviopsis Trunk Rot. It is recommended that this tree be removed.

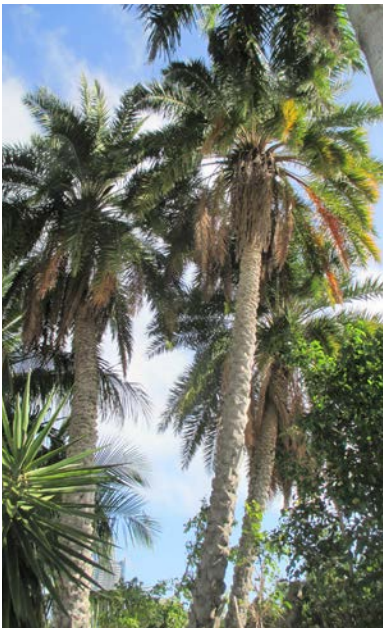
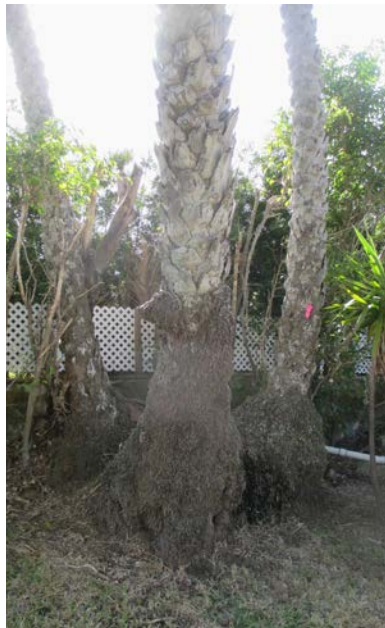
## Tree #45

Tree #45 is a triple Date Palm located on the south side of the backyard. The tree is in good condition. Some foliage is displaying chlorosis and lower dead fronds are present which can be pruned out. This tree has not been incorporated into the landscape plan and will therefore be removed.

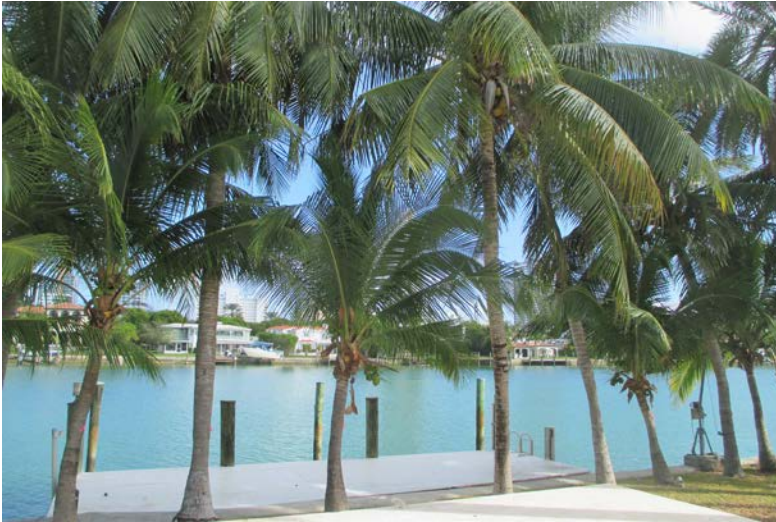
## Trees #46 - 53

Trees #46 - 53 are eight Coconut Palms located at the rear of the property along Indian Creek. They are in good condition with full, green canopies. Trees #49 and 50 are to be relocated, and the remainder are to be removed. For trees to be relocated, root pruning shall occur a minimum of 4-6 weeks prior to digging the palm and shall be performed or supervised by Certified Arborist. Minimum rootball measurement shall be based upon the most recent *Florida Grades & Standards for Nursery Plants*. Transplanting shall be performed or supervised by Certified Arborist. Prior to transplanting, the apical bud shall be protected by tying up palm fronds. Leaves shall be untied as soon as the palm is planted. When lifting the palm, a nylon sling with adequate padding shall be used and care shall be taken to not injure or compress the trunk. Plant at grade, with 2" of root initiation zone visible if applicable. Transplanting shall occur as soon as possible and no more than 24 hours after being dug for relocation. The backfill soil shall be irrigated during and following relocation. Wooden braces shall be installed to stabilize the tree.

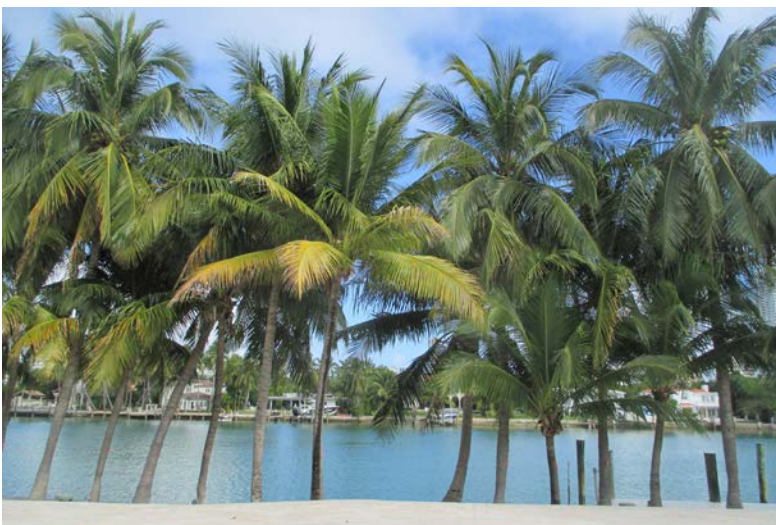
## Trees #54 - 65

Trees #54 - 65 are 12 Coconut Palms located at the rear of the property along Indian Creek. Overall, they are in good condition. Lower chlorotic fronds are present on a few trees. Trees #54, 56, 57, 58, 63, and 65 are to be relocated, and the remainder are to be removed. For trees to be relocated, root pruning shall occur a minimum of 4-6 weeks prior to digging the palm and shall be performed or supervised by Certified Arborist. Minimum rootball measurement shall be based upon the most recent *Florida Grades & Standards for Nursery Plants*. Transplanting shall be performed or supervised by Certified Arborist. Prior to transplanting, the apical bud shall be protected by tying up palm fronds. Leaves shall be untied as soon as the palm is planted. When lifting the palm, a nylon sling with adequate padding shall be used and care shall be taken to not injure or compress the trunk. Plant at grade, with 2" of root initiation zone visible if applicable. Transplanting shall occur as soon as possible and no more than 24 hours after being dug for relocation. The backfill soil shall be irrigated during and following relocation. Wooden braces shall be installed to stabilize the tree.

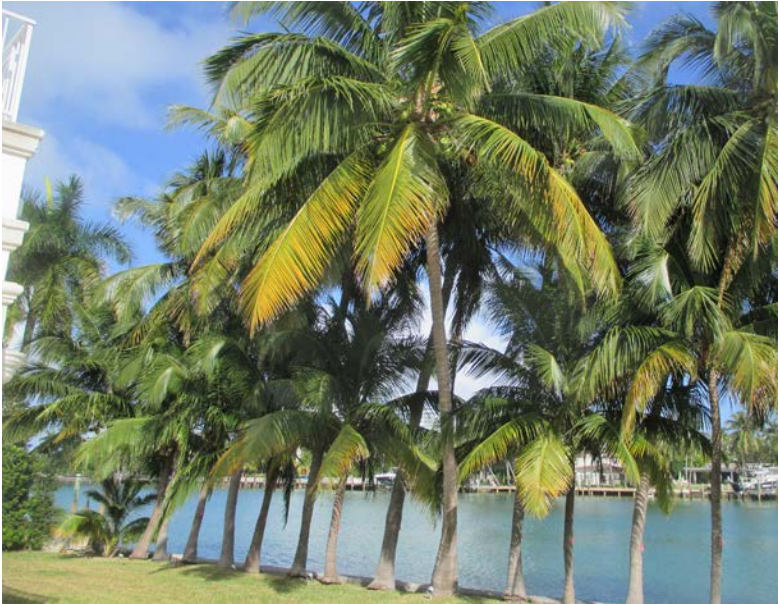
## Trees #66 - 77

Trees #66 - 77 are 12 Coconut Palms located at the rear of the property along Indian Creek. Overall, they are in good condition. Lower chlorotic fronds are present on a few trees. Trees #67, 68, 69, 71, and 73 are to be relocated, and the remainder are to be removed. For trees to be relocated, root pruning shall occur a minimum of 4-6 weeks prior to digging the palm and shall be performed or supervised by Certified Arborist. Minimum rootball measurement shall be based upon the most recent *Florida Grades & Standards for Nursery Plants*. Transplanting shall be performed or supervised by Certified Arborist. Prior to transplanting, the apical bud shall be protected by tying up palm fronds. Leaves shall be untied as soon as the palm is planted. When lifting the palm, a nylon sling with adequate padding shall be used and care shall be taken to not injure or compress the trunk. Plant at grade, with 2" of root initiation zone visible if applicable. Transplanting shall occur as soon as possible and no more than 24 hours after being dug for relocation. The backfill soil shall be irrigated during and following relocation. Wooden braces shall be installed to stabilize the tree.

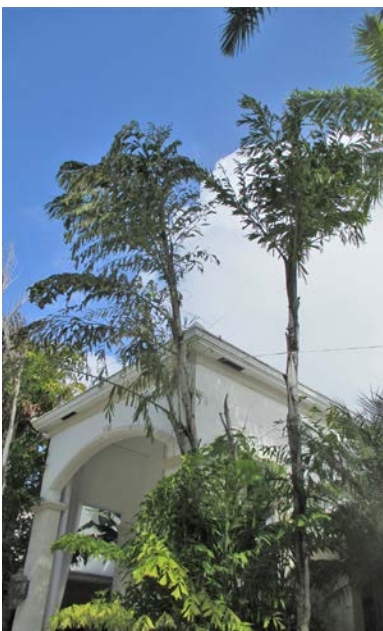
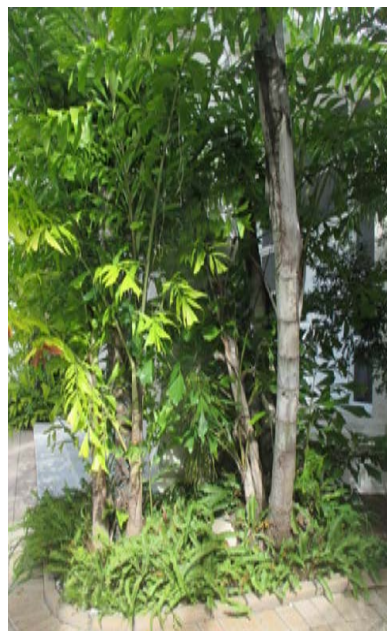
## Tree #78

Tree #78 is a Fishtail Palm cluster located at the front of the existing house. This tree is in poor condition with chlorotic and necrotic foliage and dead trunks. It is recommended that this tree be removed.
