ARTHUR J. MARCUS ARCHITECT P.A.

March 16, 2020

- to: City of Miami Beach Historic Preservation Board (HPB) Miami Beach City Hall 1700 Convention Center Drive Miami Beach, Florida 33139
- cc: Khera A. Osbourne Clemens Bruns Schaub Architect & Associates, P.A 3383 Ocean Drive Vero Beach, Florida 32963
- re: 1235 Lenox Avenue Miami Beach, Florida 33139

EXISTING RESIDENCE

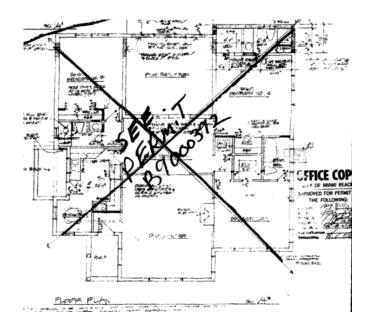
The only floor plan available for the house is a 1990 architectural permit plan of the residence prior to additions as shown above. Even though crossed out the plan of the house is quite legible - prior to the additions..
