Tree Resource Evaluation for 6988 Abbott Avenue, Miami Beach

North Beach Town Center Development, LLC

December 23, 2019

Summary

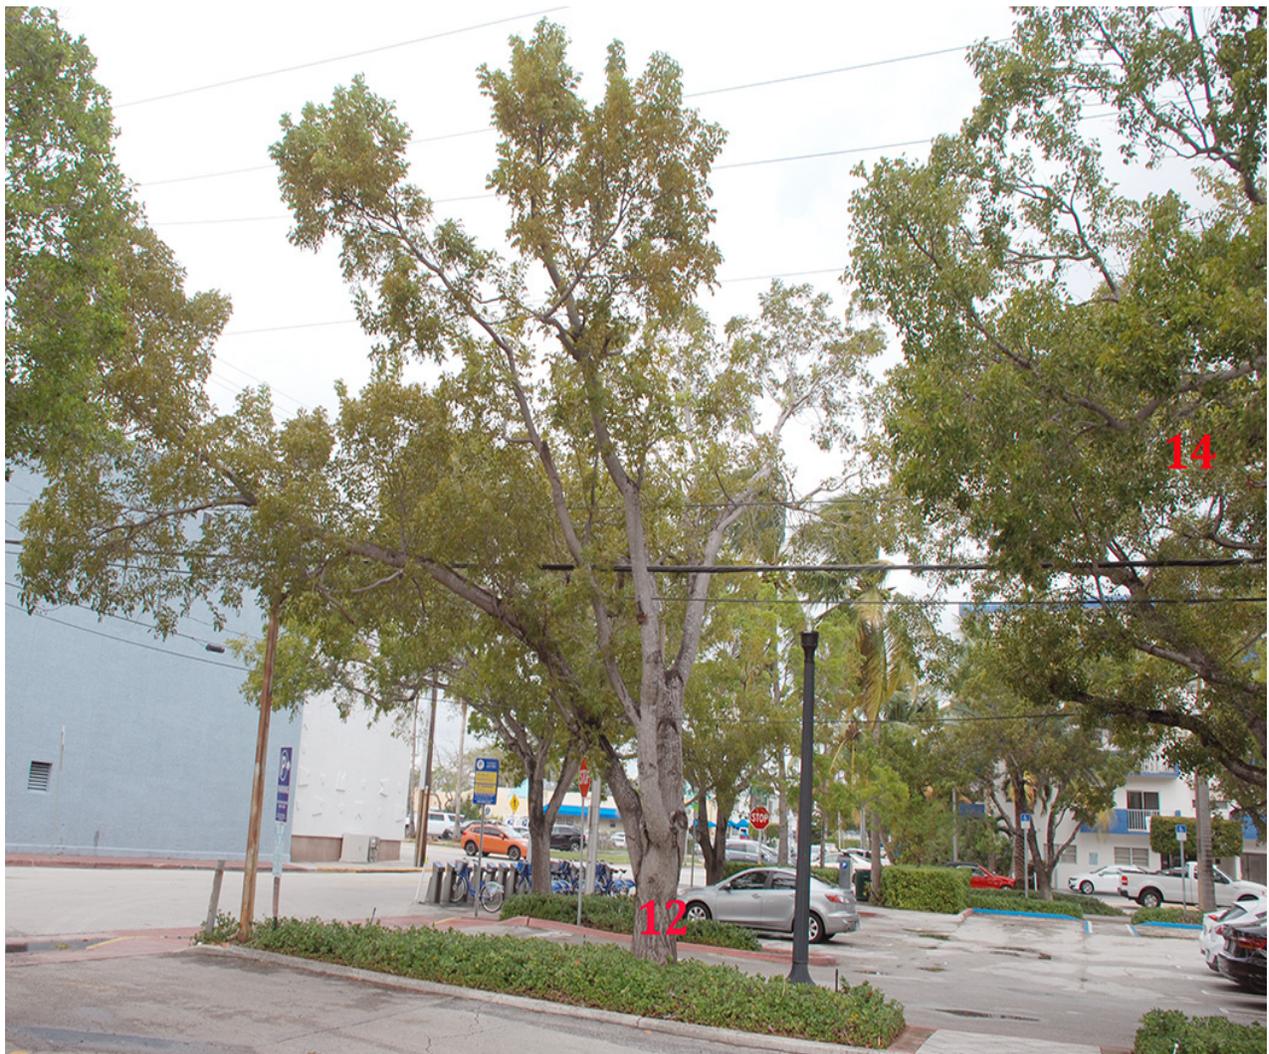
Photo 1 above is tree 12 viewed from the southeast. This tree is growing into the powerlines and has been utility pruned. See following photos.

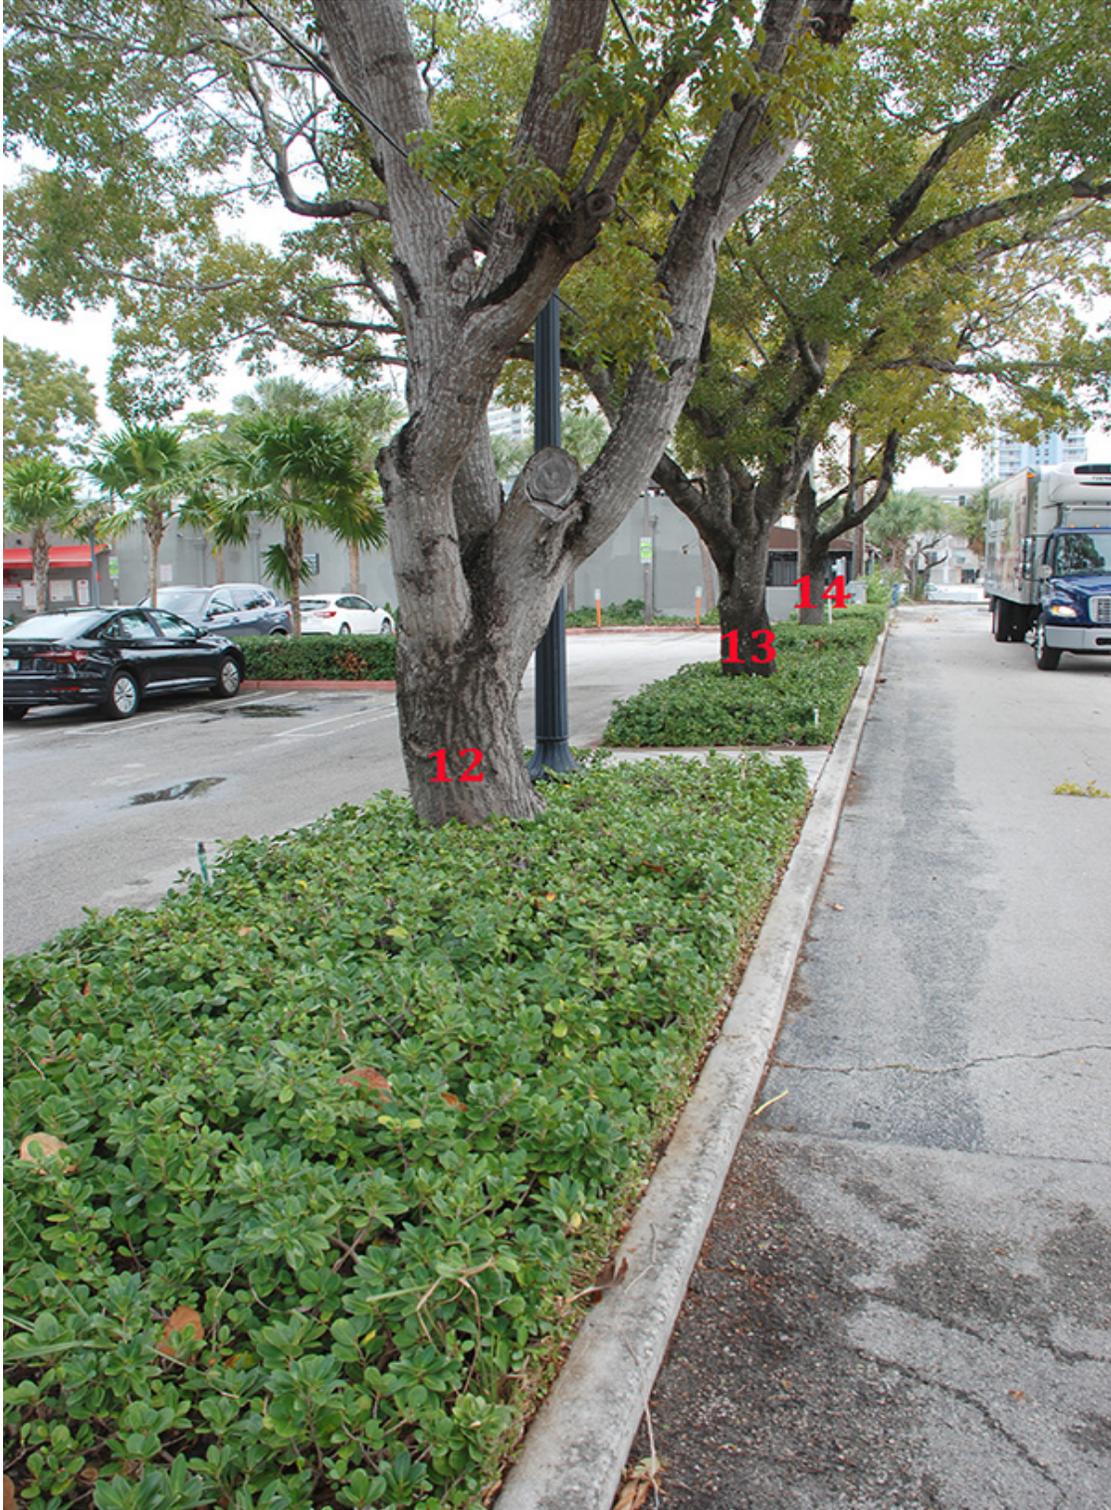
Photo 2 above is the very narrow planter looking to the west that trees 12, 13 & 14 are growing in. These trees are not good candidates for relocation.

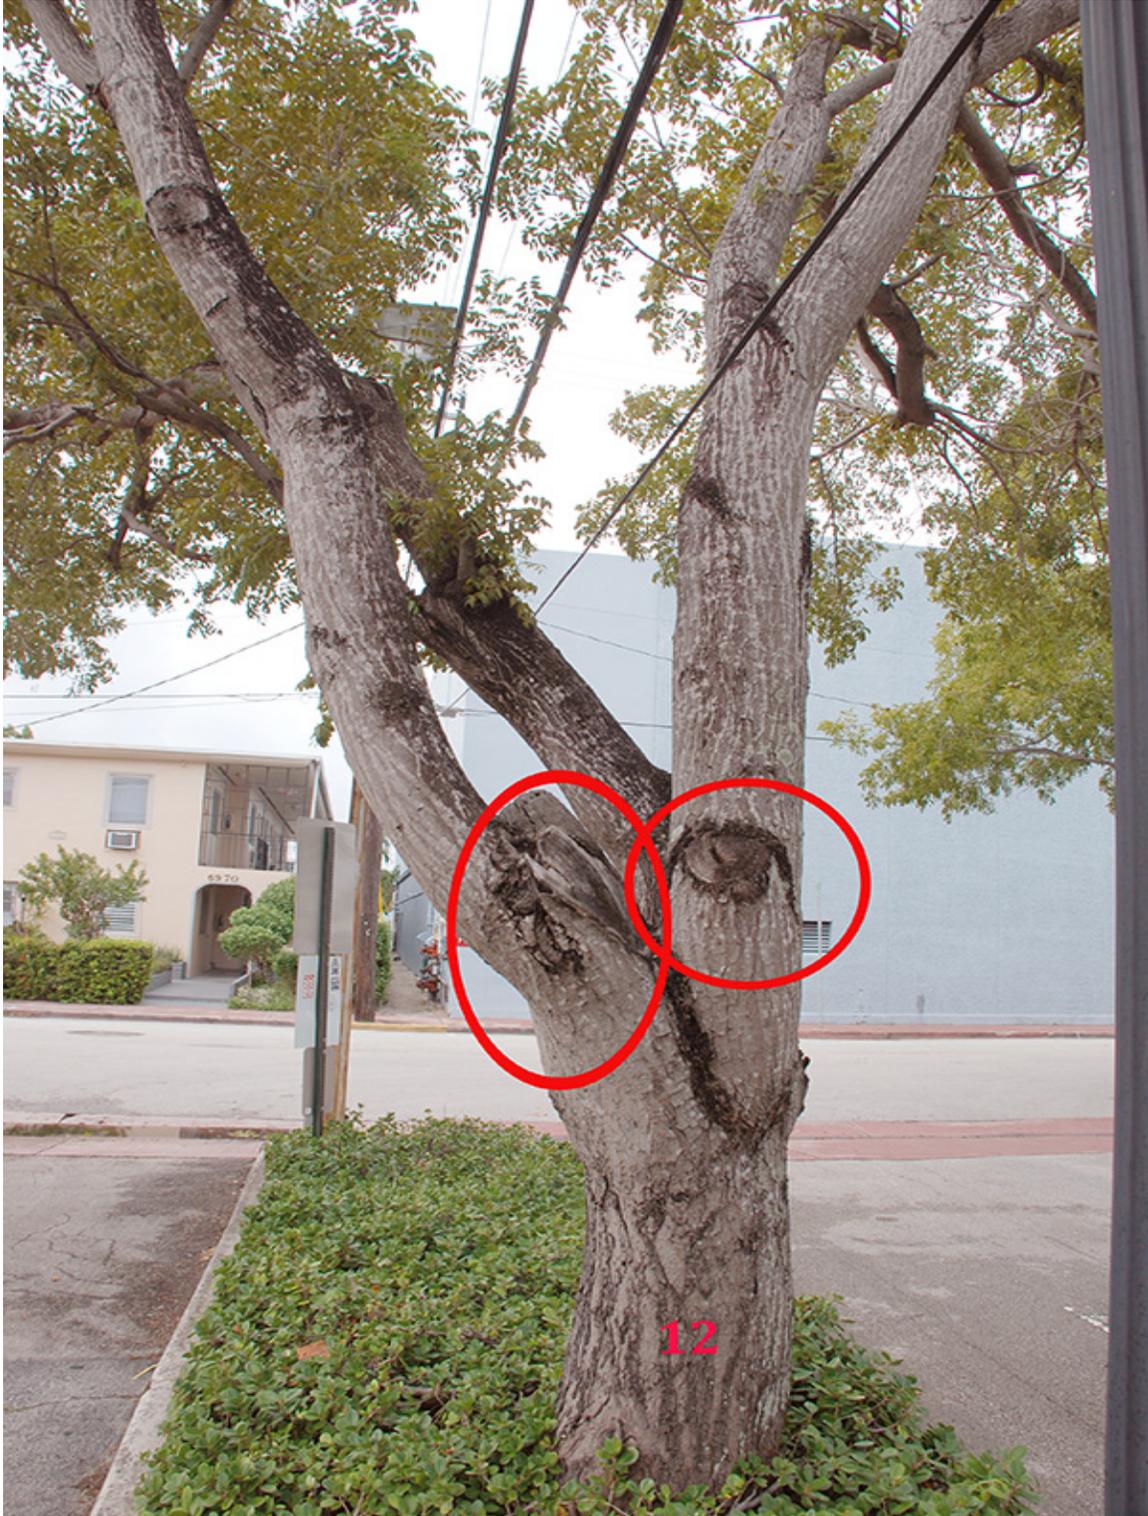
Photo 3 above is the trunk of tree 12 viewed from the east. The circles indicate poor pruning wounds with decay. This tree should be removed.

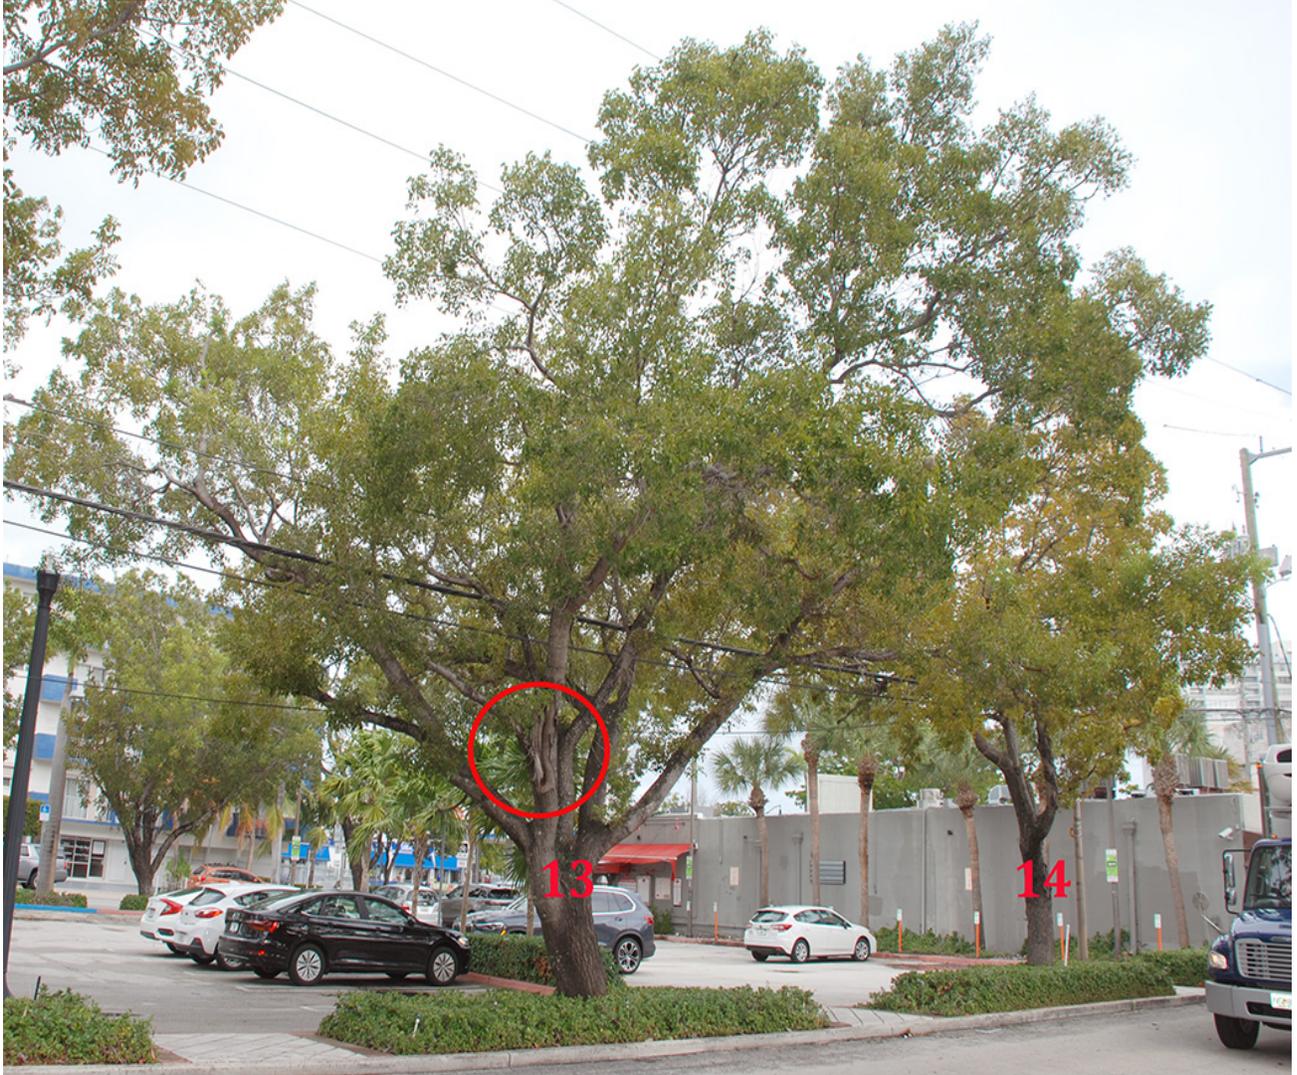
Photo 4 above is trees 13 & 14 viewed from the south. See following photos.

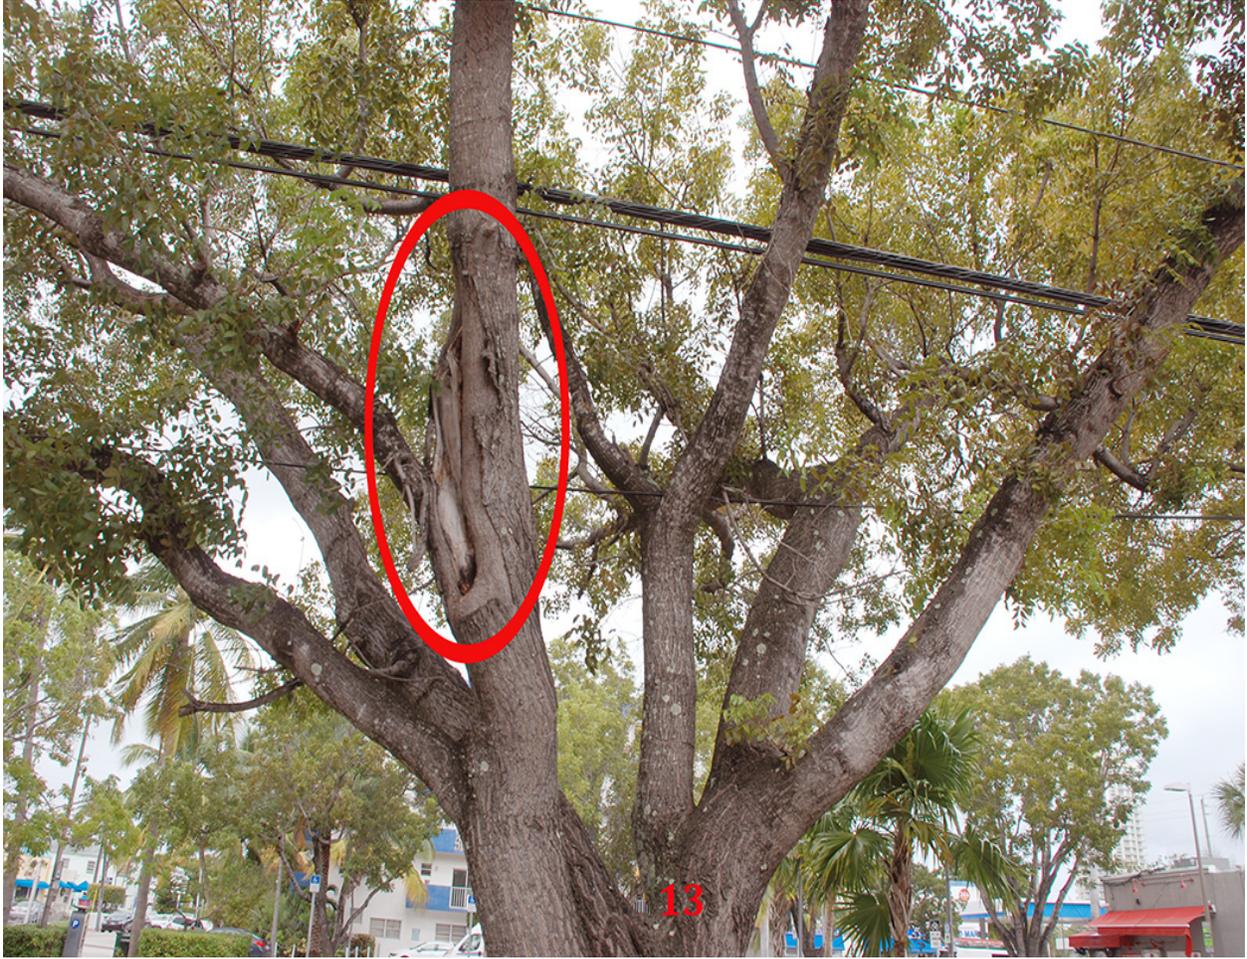
Photo 5 above is a closer view of the damage indicated in the previous photo.

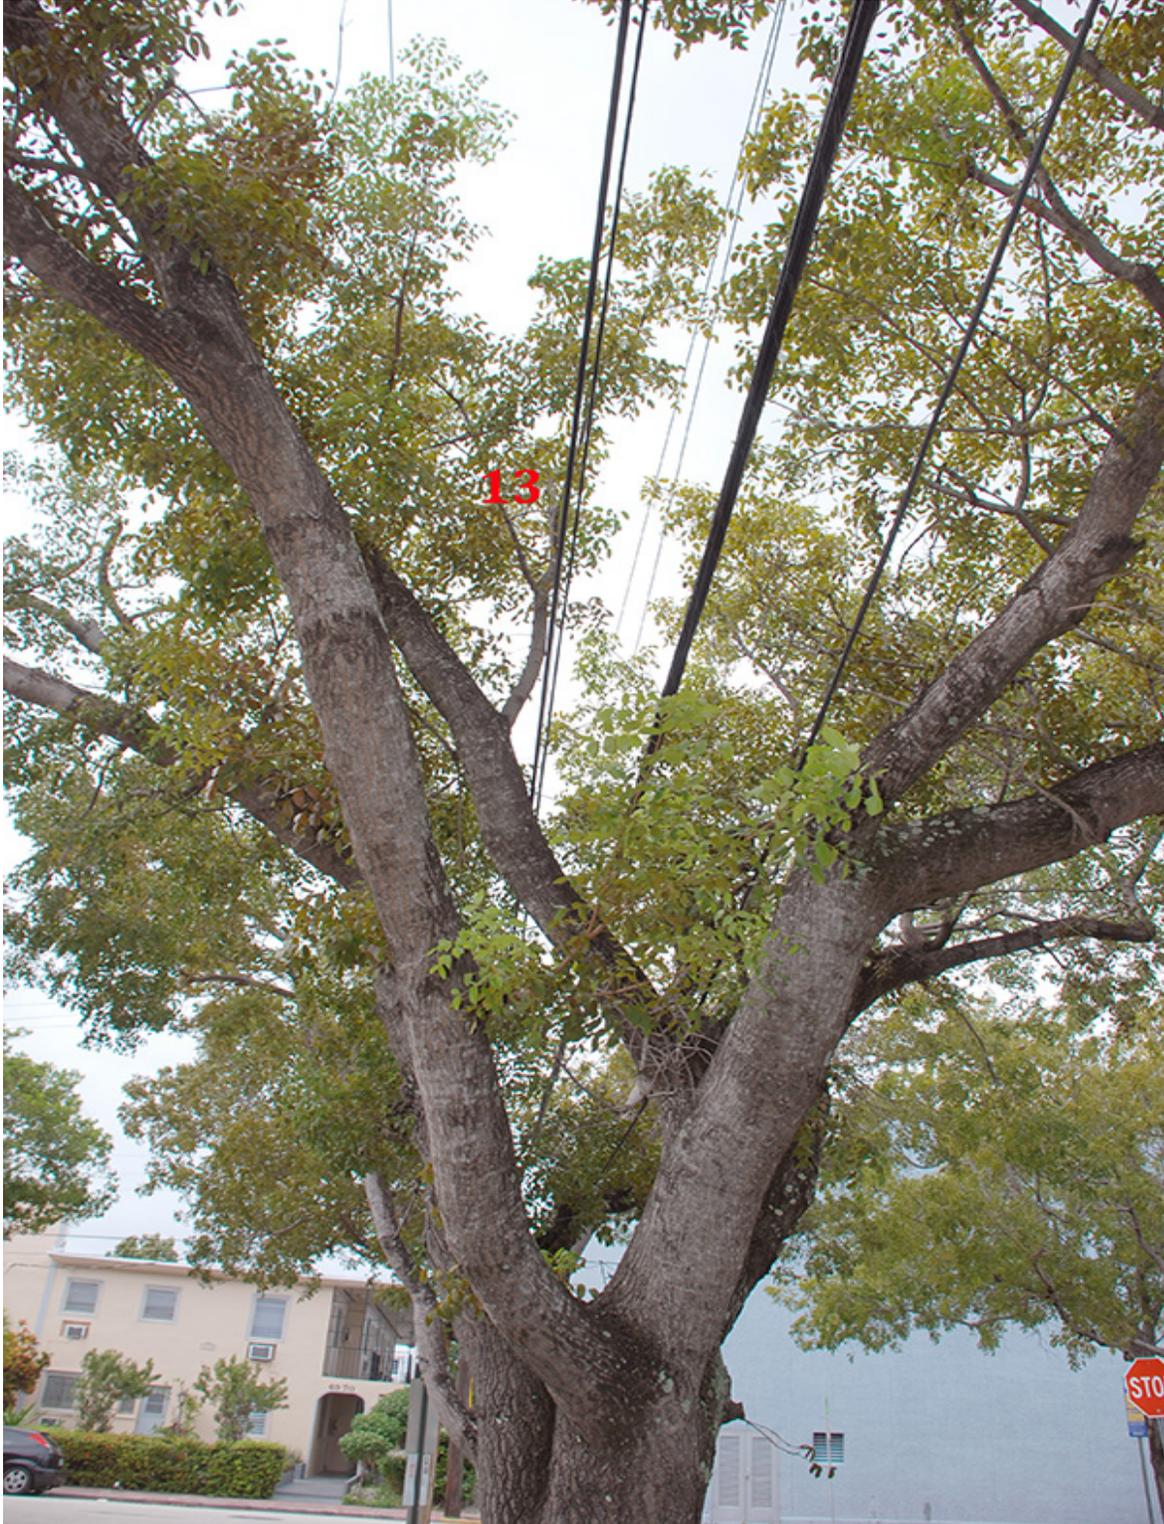
Photo 6 above is tree 13 viewed from the east. This tree should be removed due to its very poor branch structure.

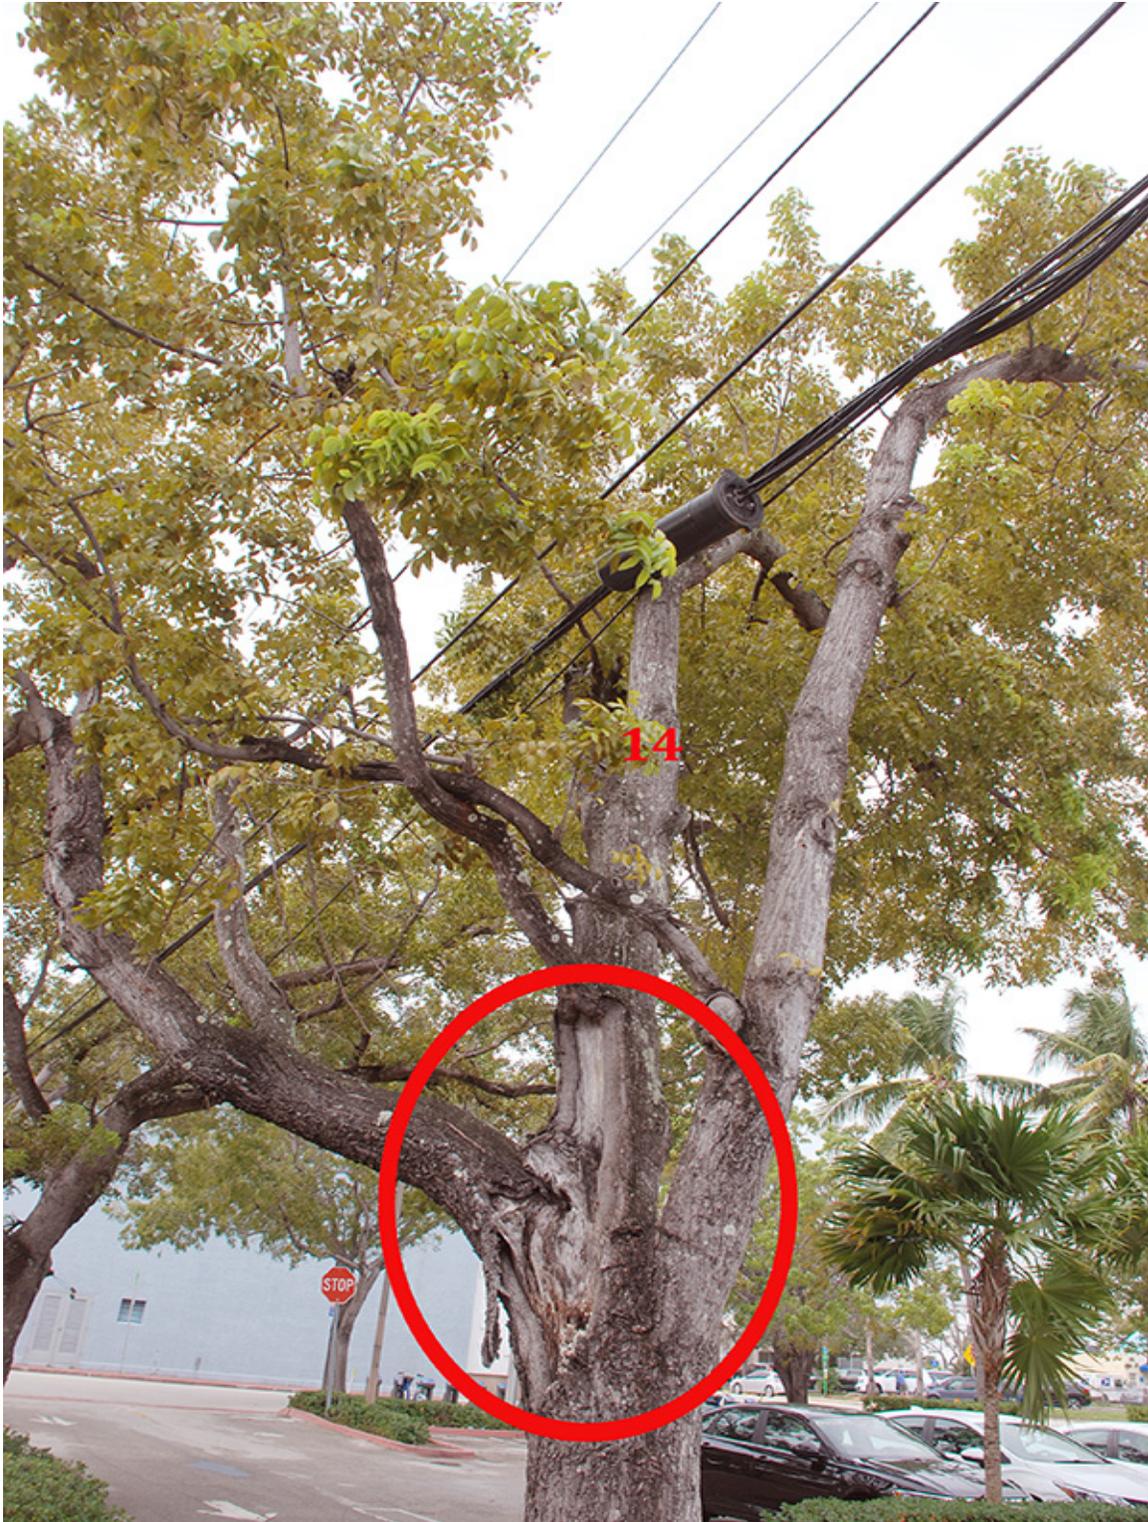
Photo 7 above is tree 14 viewed from the east. This tree should be removed due to its very poor branch structure and the circled damage indicated.

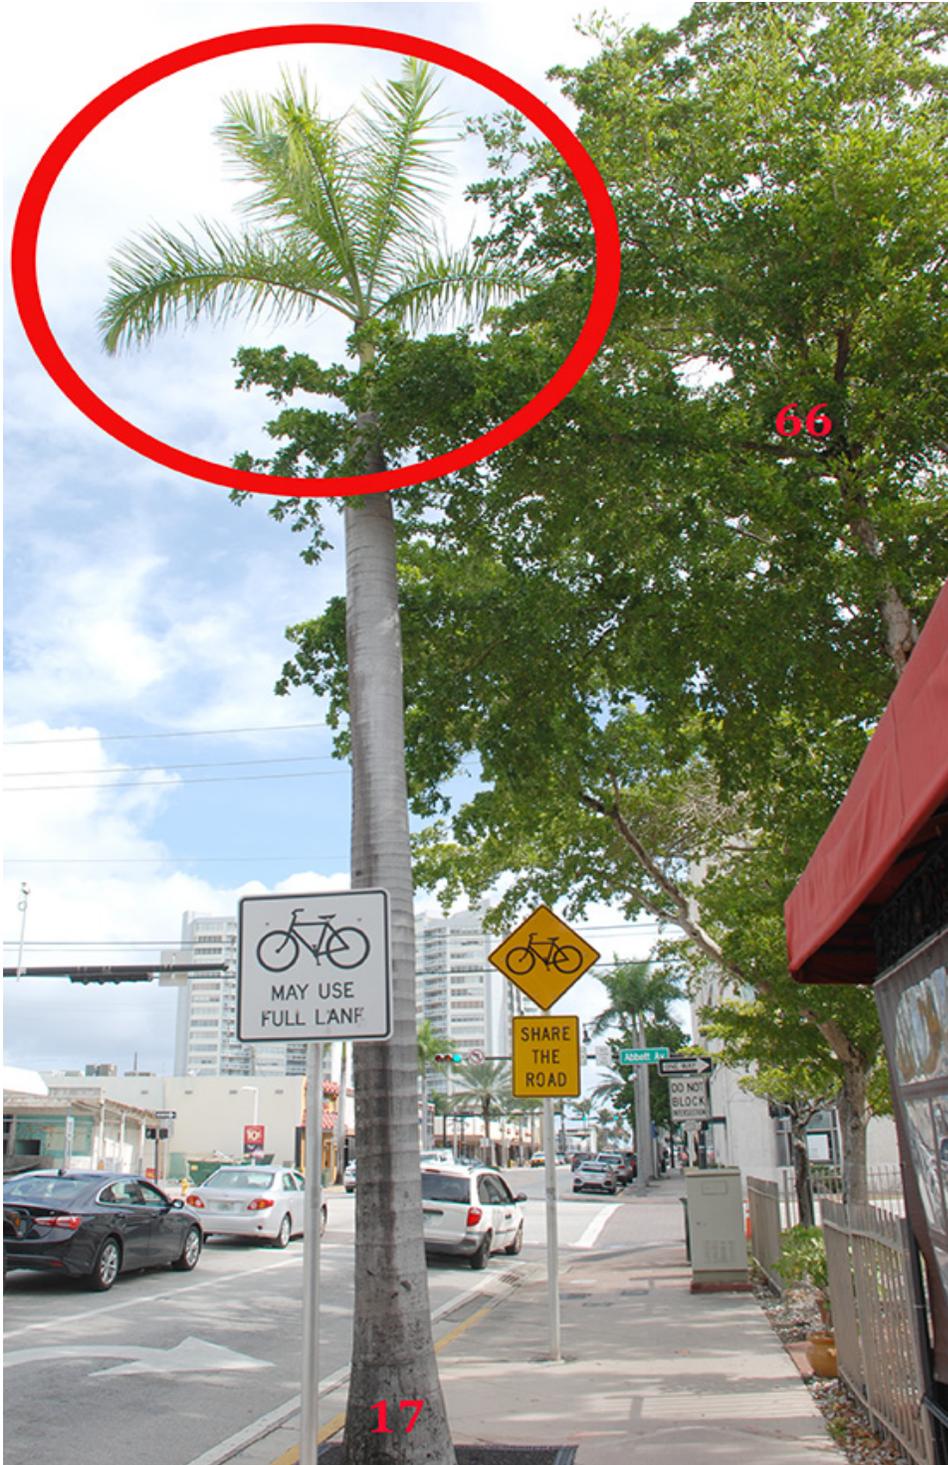
Photo 8 above is palm 17 viewed from the west. The circle indicates a very thin crownshaft and a severe nutrient deficiency in this palm. This palm should be removed.

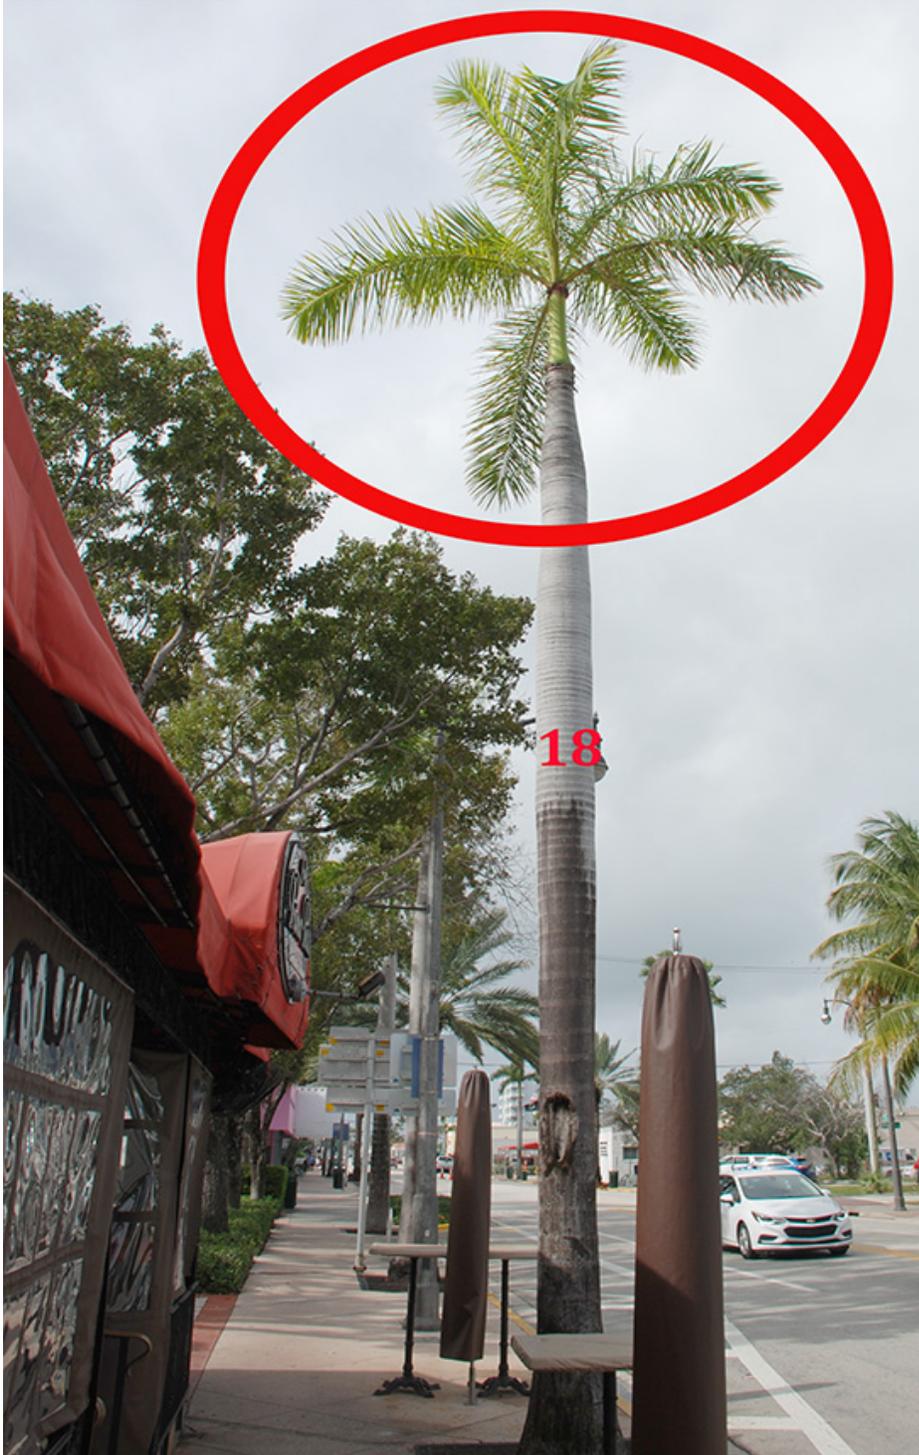
Photo 9 above is palm 18 viewed from the east. The circle indicates a very thin crownshaft and a severe nutrient deficiency in this palm. This palm should be removed.

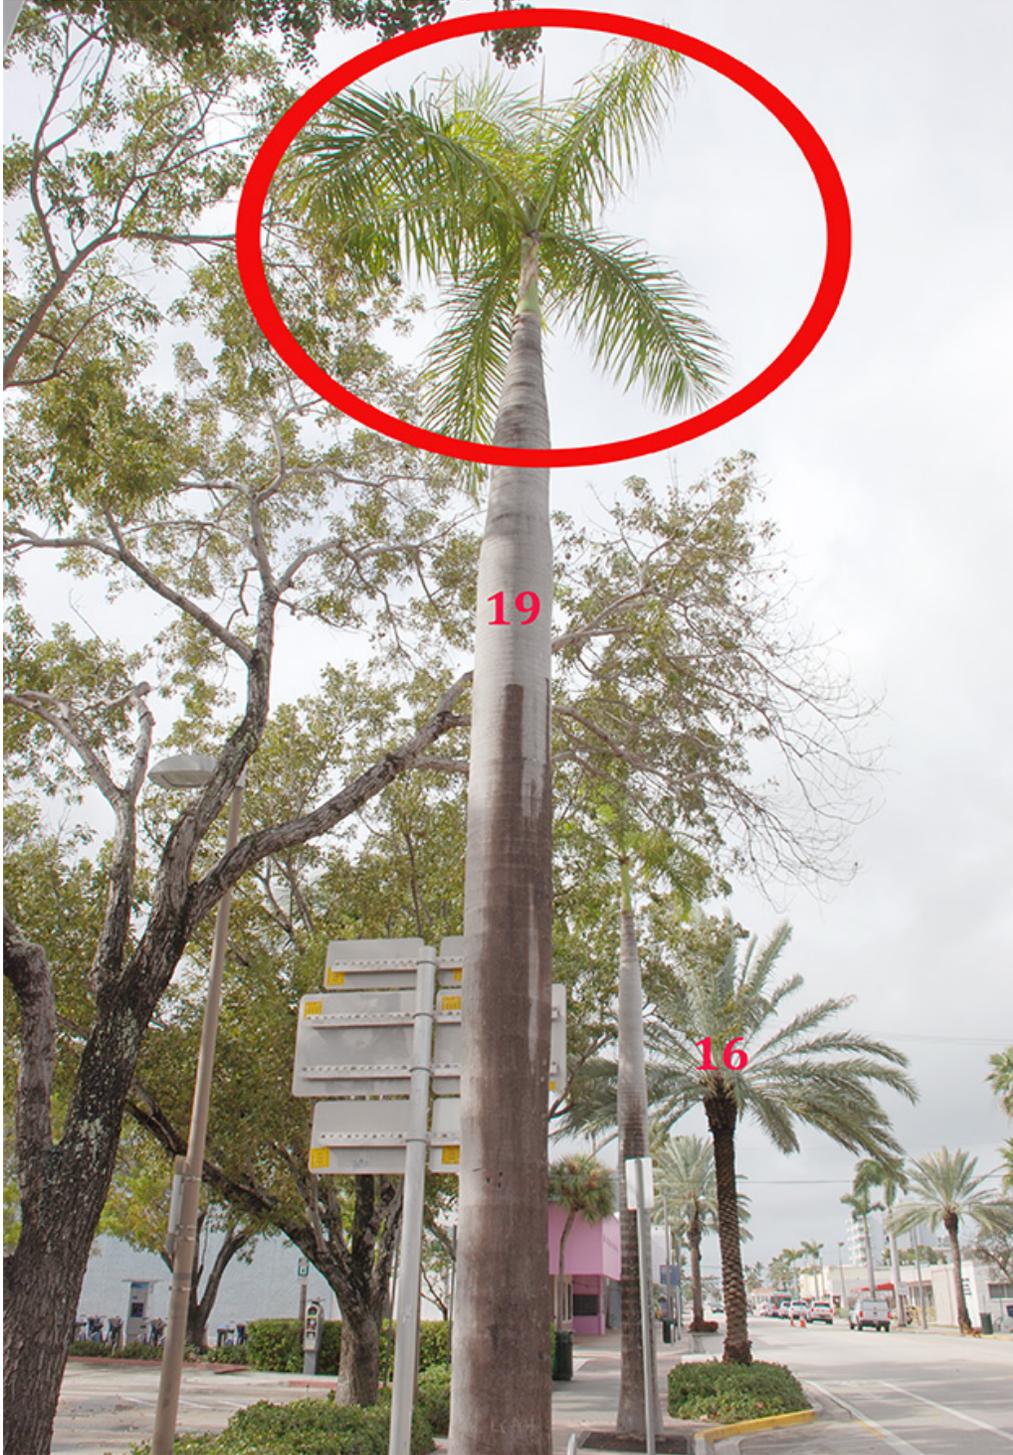
Photo 10 above is palm 19 viewed from the east. The circle indicates a very thin crownshaft and a severe nutrient deficiency in this palm. This palm should be removed.

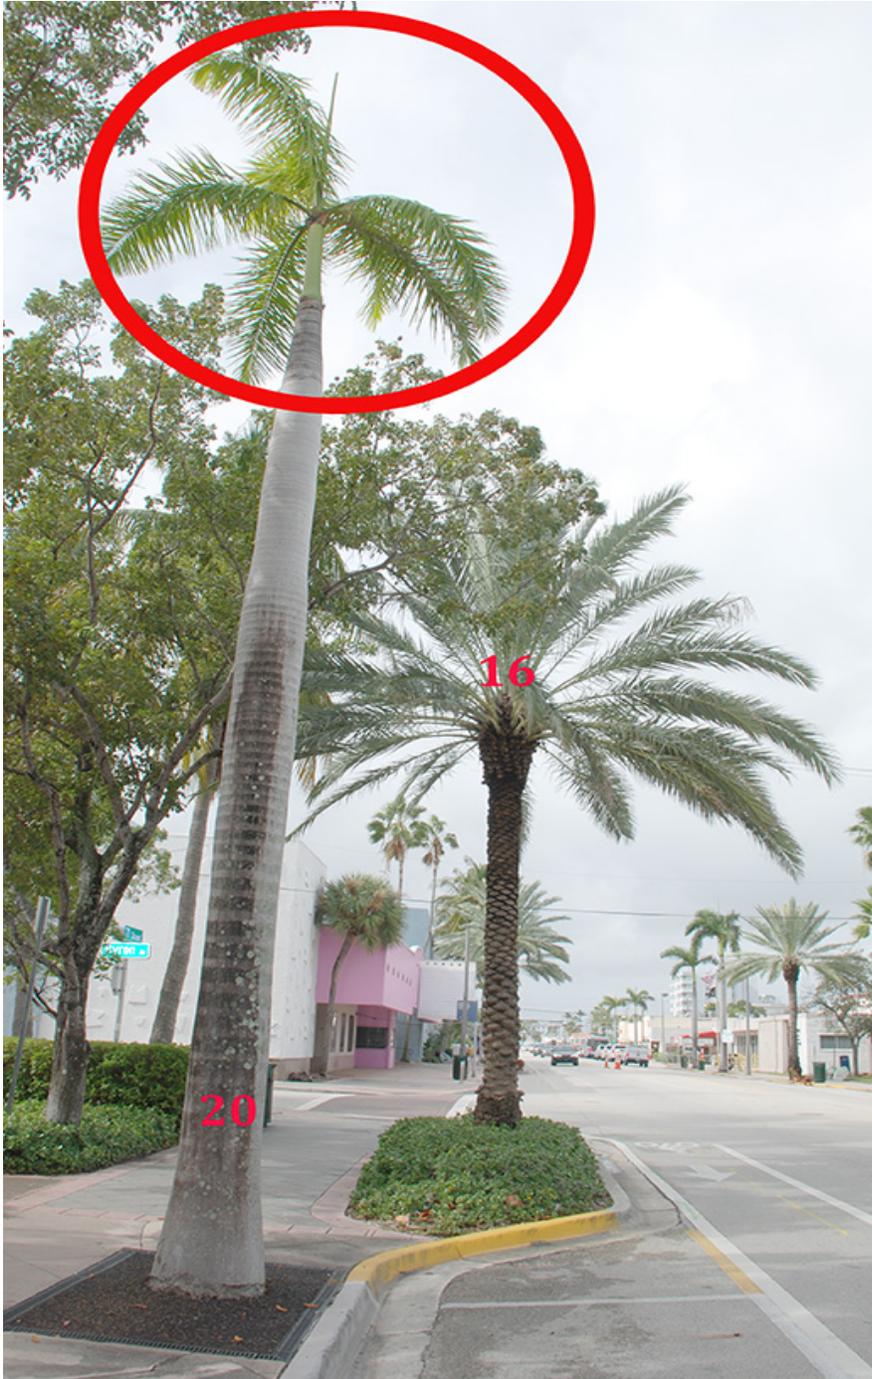
Photo 11 above is palm 20 viewed from the east. The circle indicates a very thin crownshaft and a severe nutrient deficiency in this palm. This palm should be removed.

Also note palm 16.

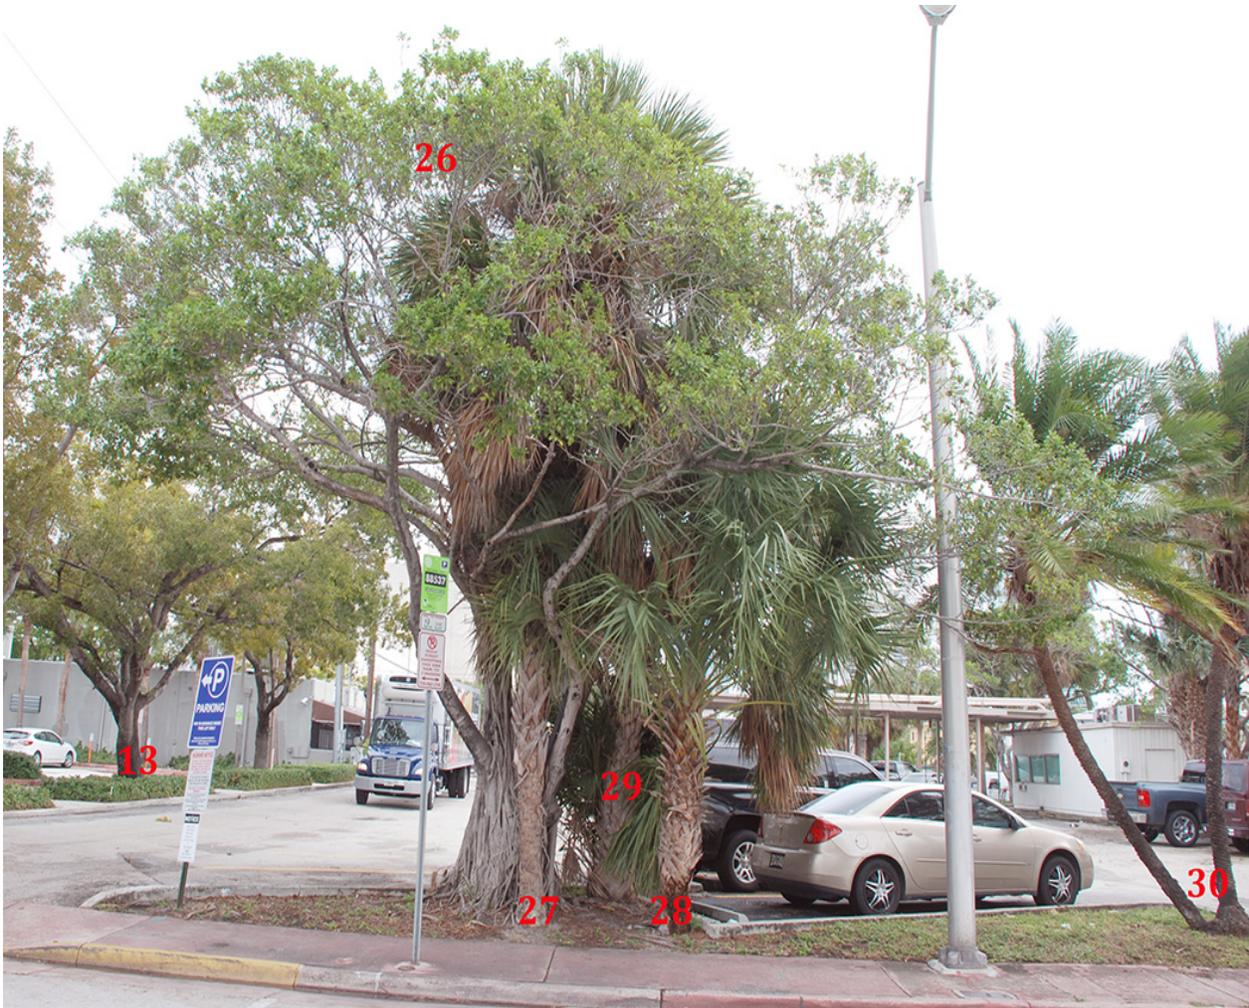
Photo 12 above is tree 26 and palms 27, 28 & 29 viewed from the west. Tree 26 is not a good candidate for relocation due to its very restricted root plate.

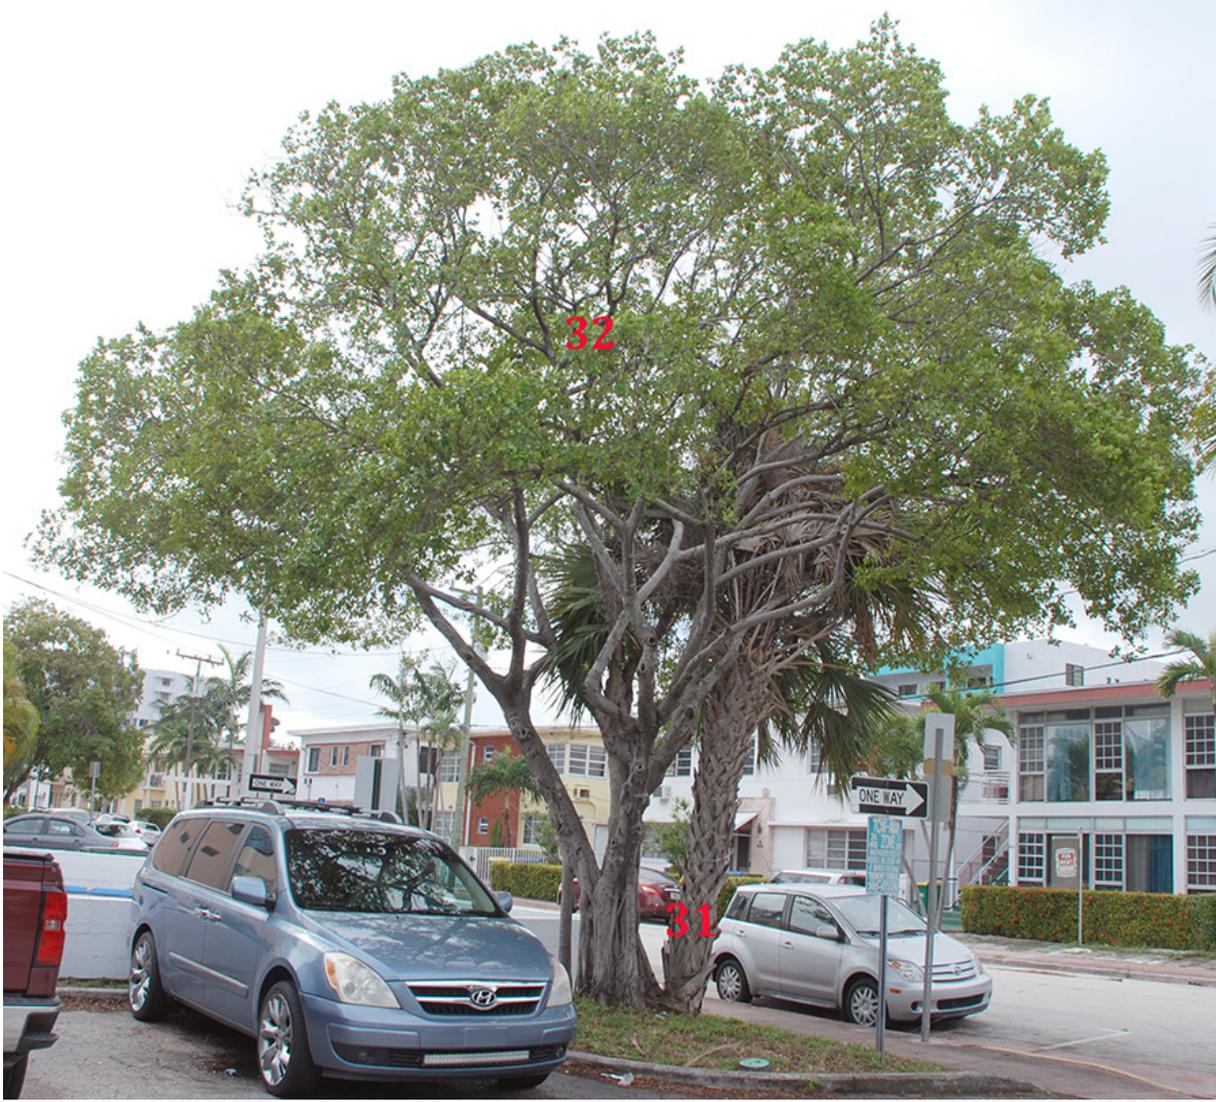
Photo 15 above is tree 32 viewed from the north. This tree should not be considered for relocation due to its restricted root plate.

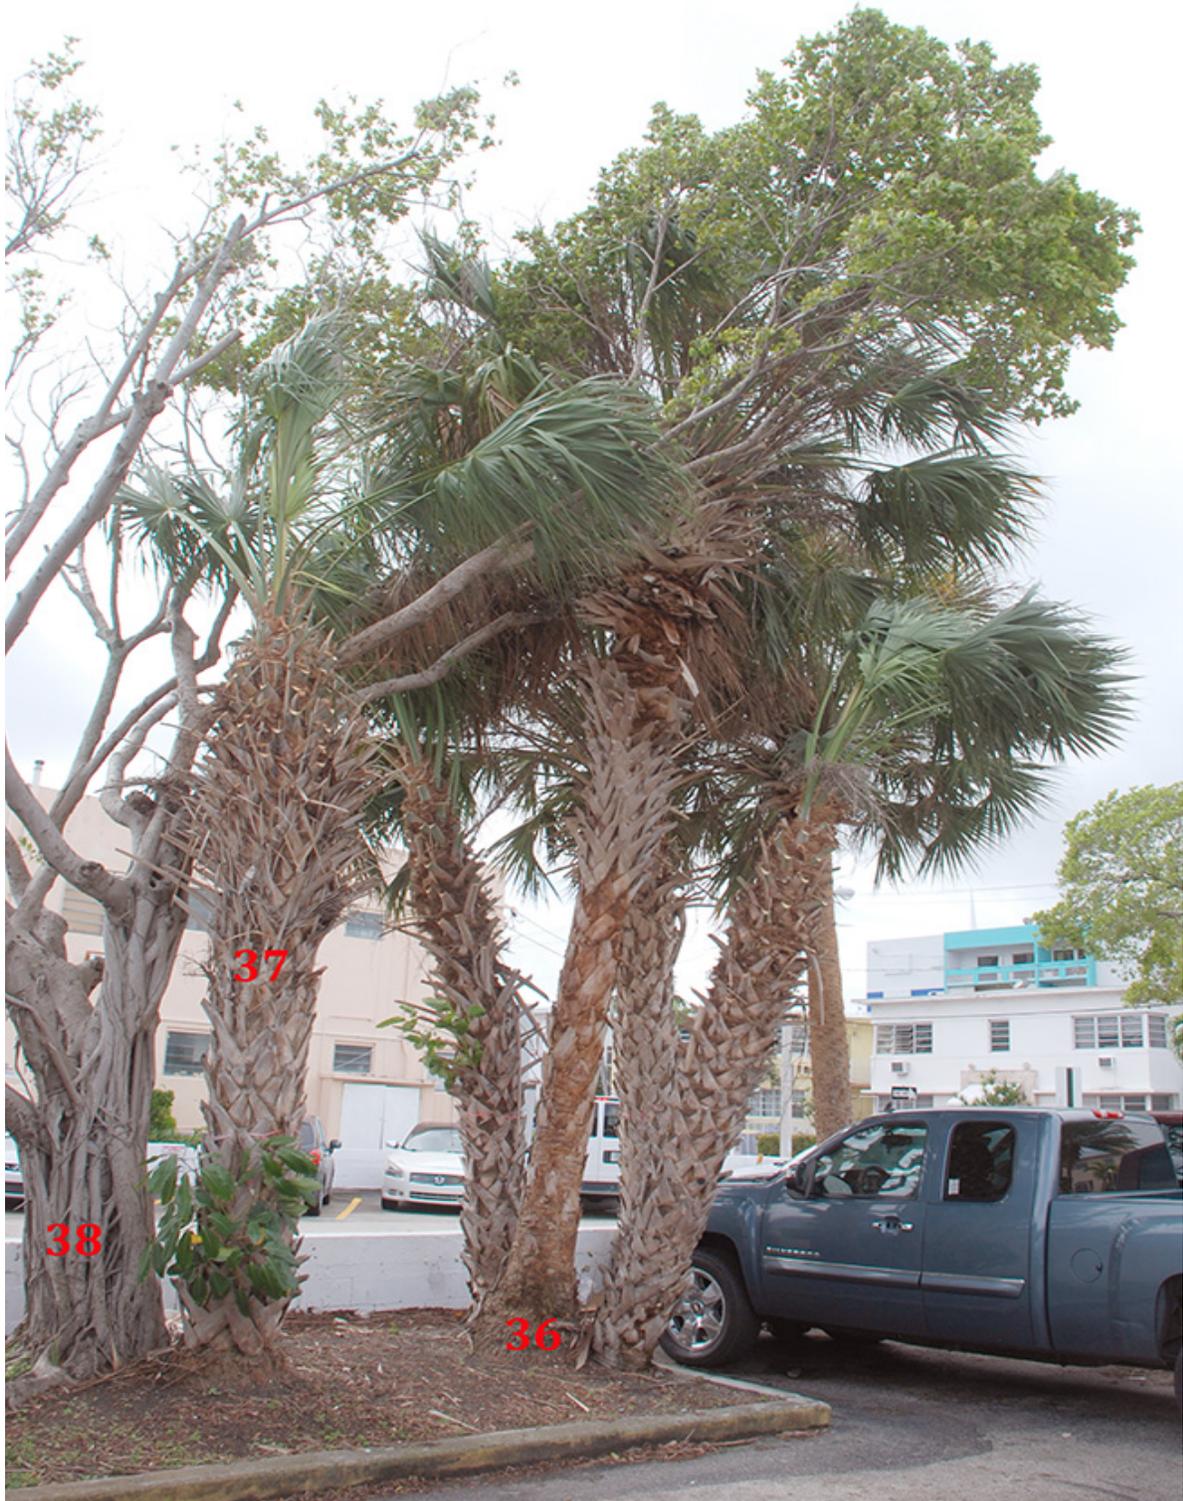
Photo 17 above is triple-trunked palm 36 and over-pruned palm 37 viewed from the north.

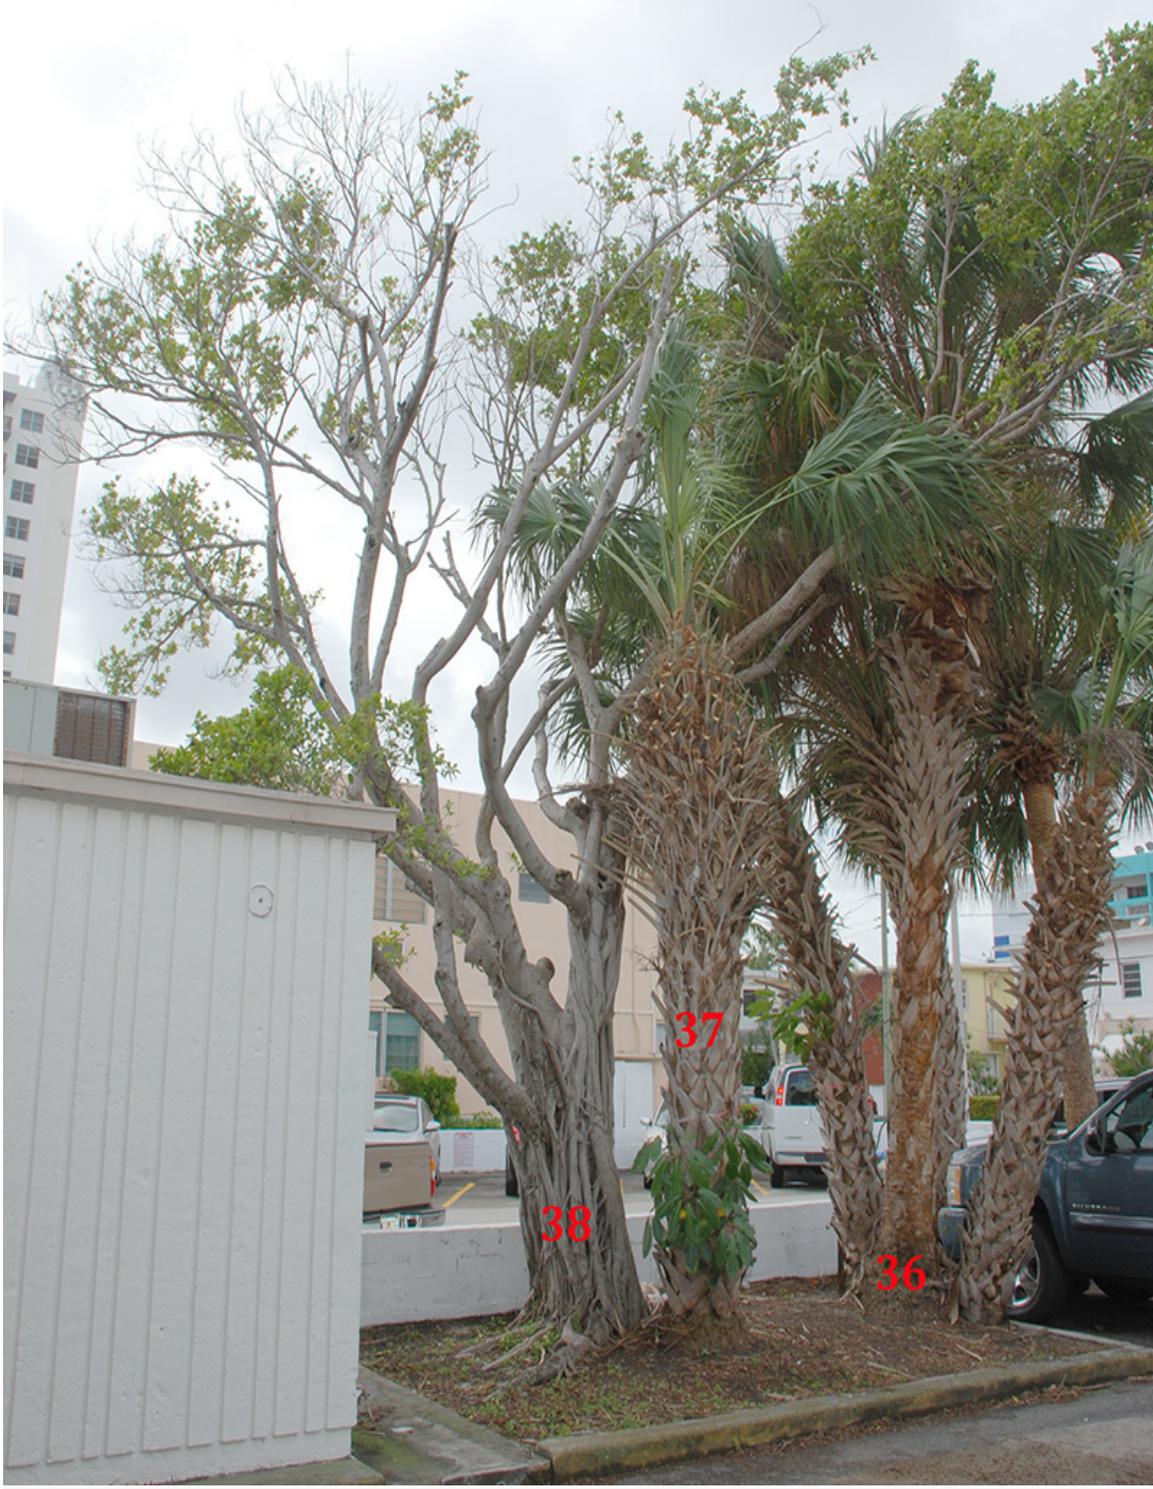
Photo 18 above is tree 38 viewed from the north. Note the extensive branch die-back in the canopy. This tree should be removed.
