Tree Resource Evaluation for 6988 Abbott Avenue, Miami Beach

North Beach Town Center Development, LLC

December 23, 2019

Summary

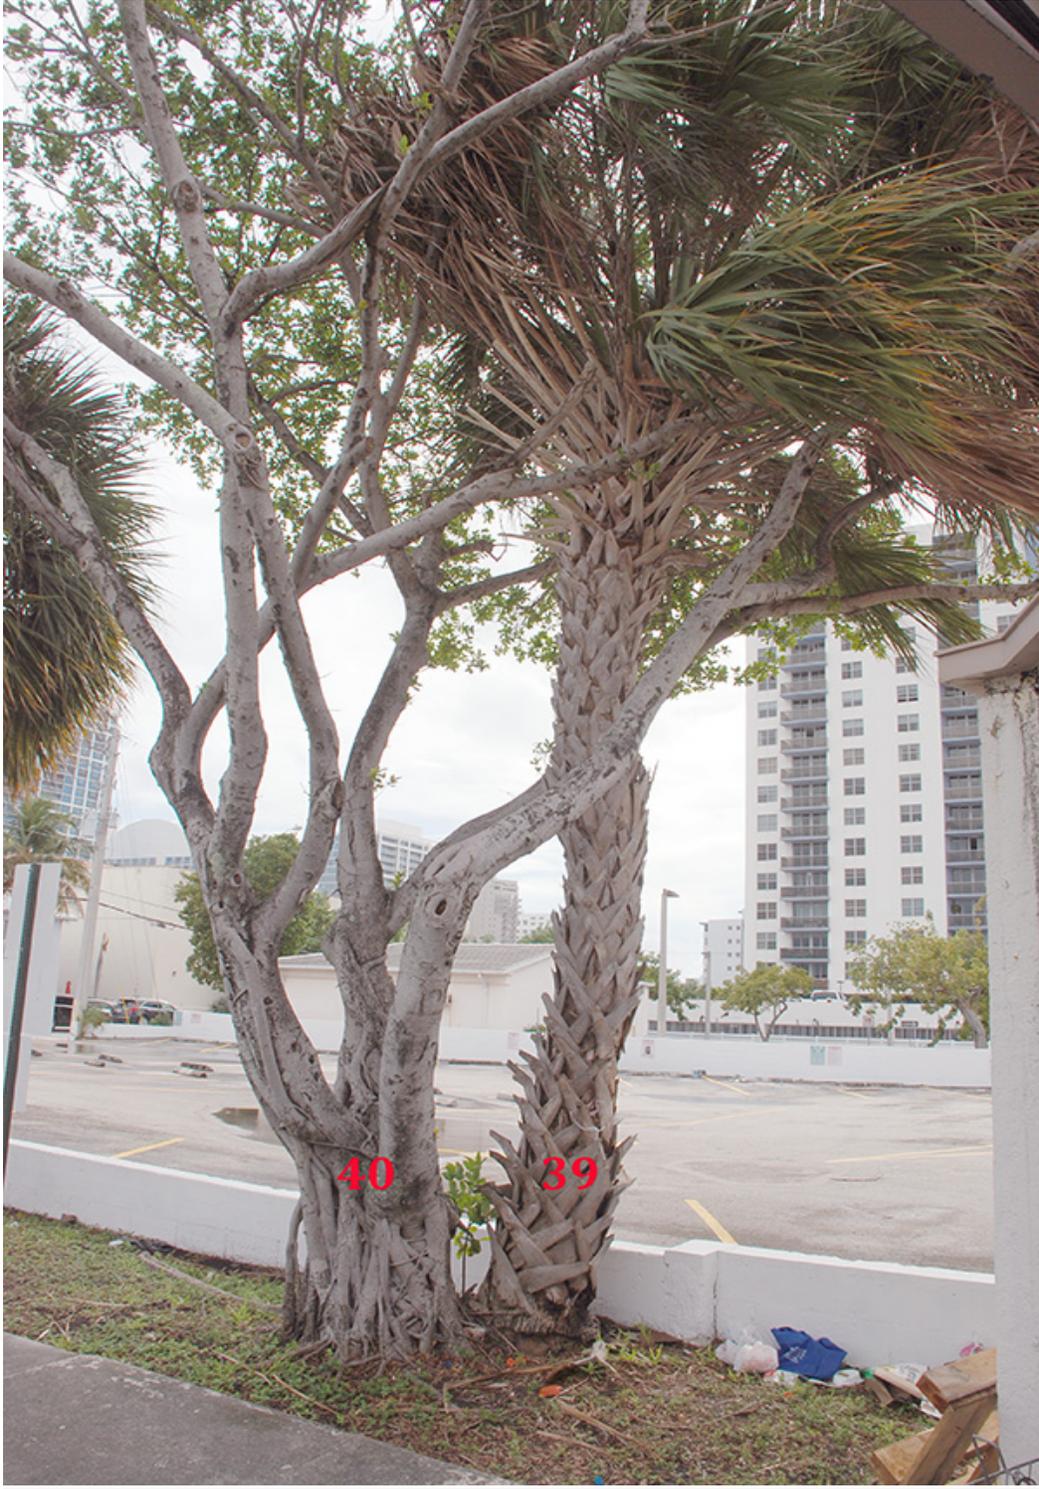
Photo 19 above is a view of the trunks of palm 39 and tree 40. The root plate of tree 40 is very restricted. This tree is not a good candidate for relocation.

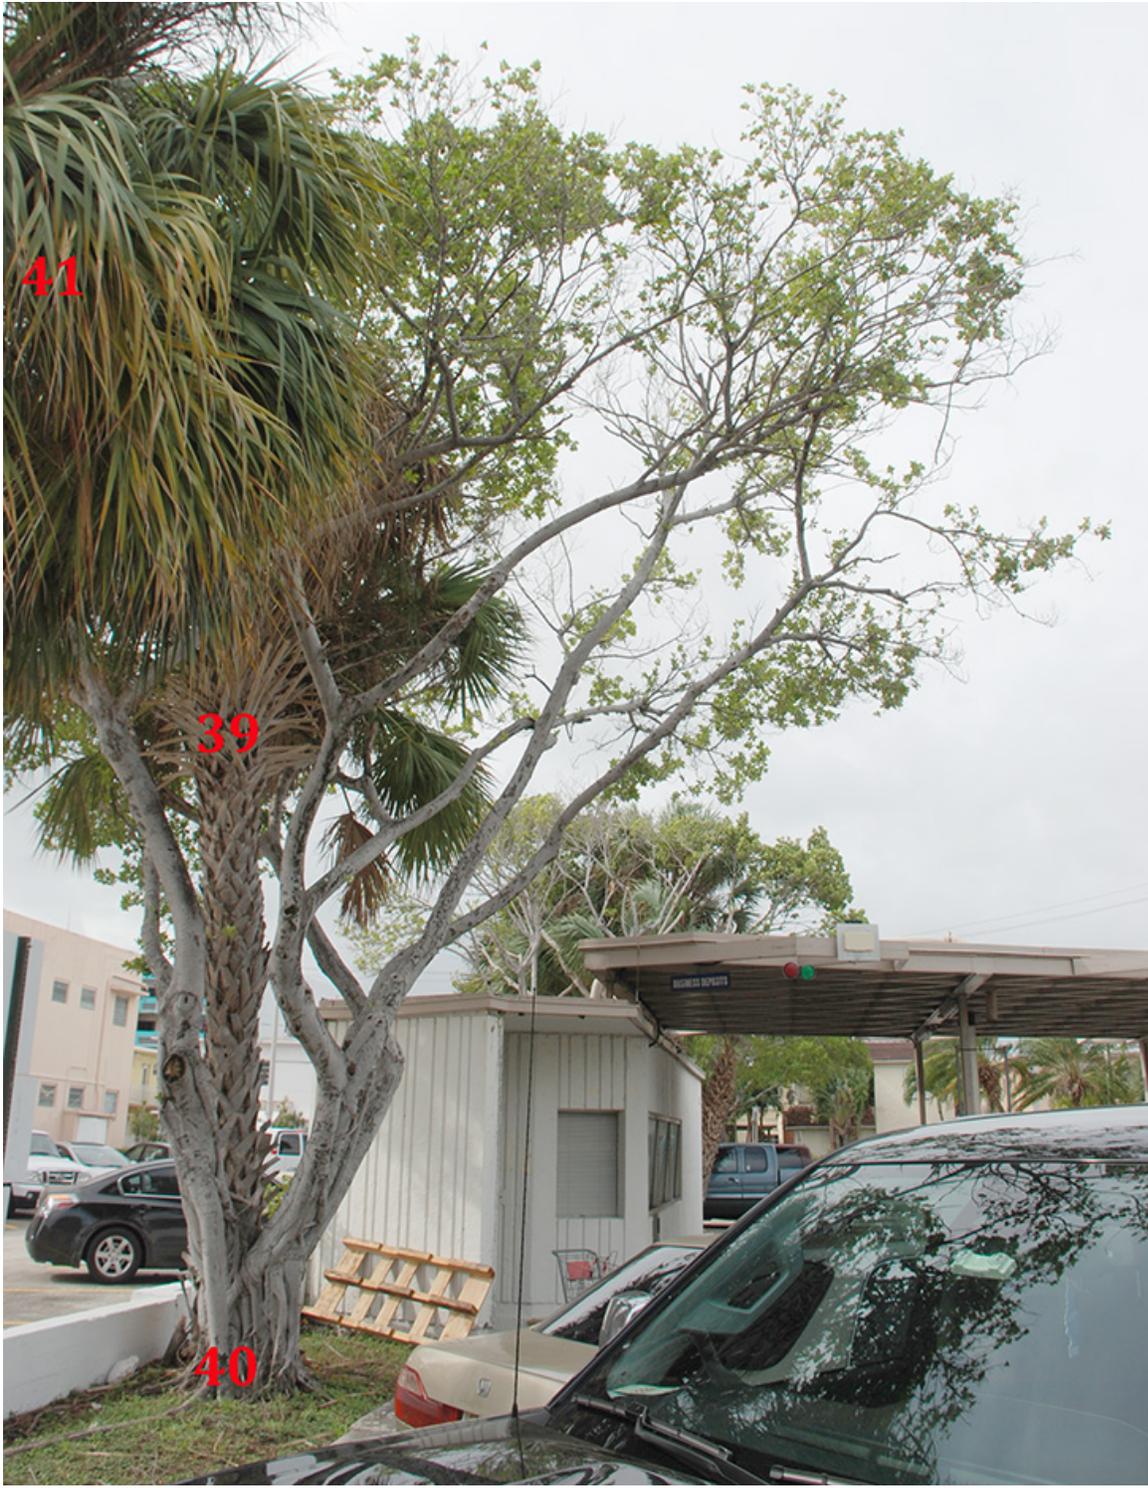
Photo 20 above is tree 40 viewed from the east. Note some branch die-back and the sparse foliage in the canopy. This tree should be removed.

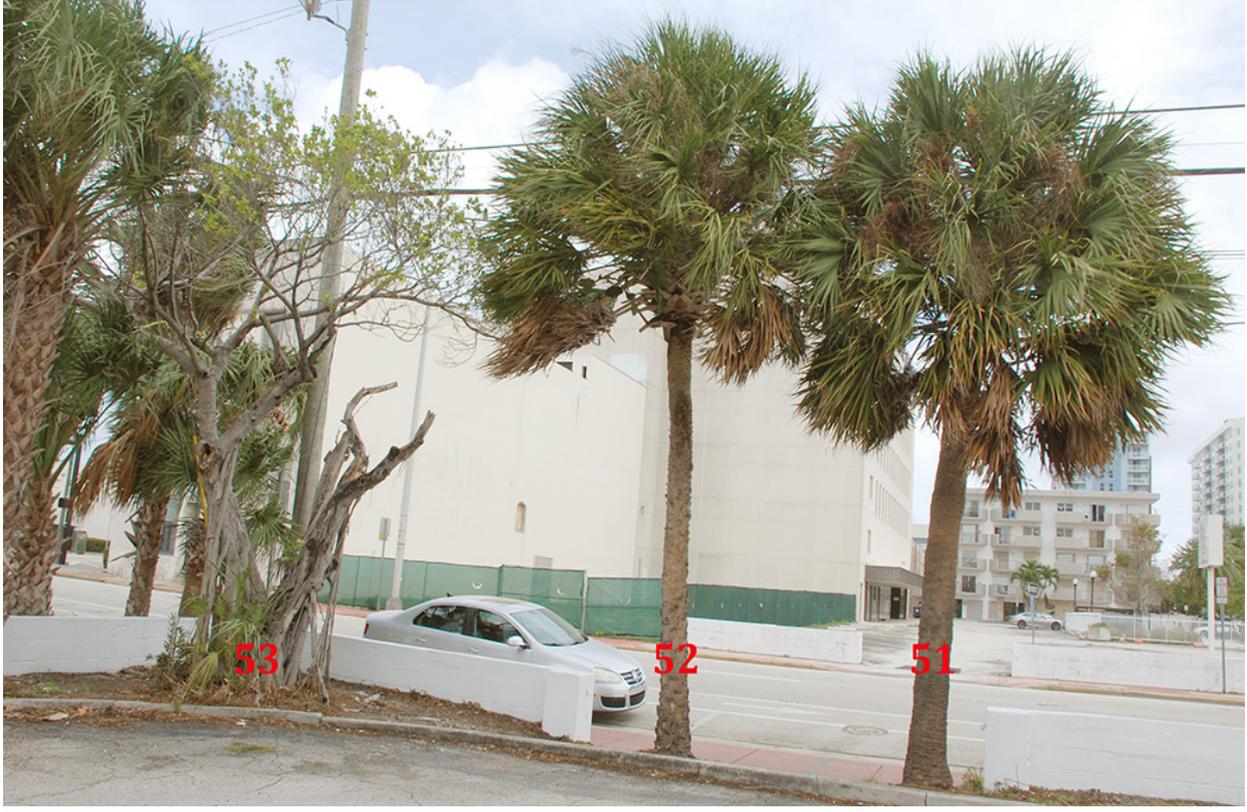
Photo 24 above is tree 53 viewed from the southwest. This tree is almost dead and should be removed as soon as possible.

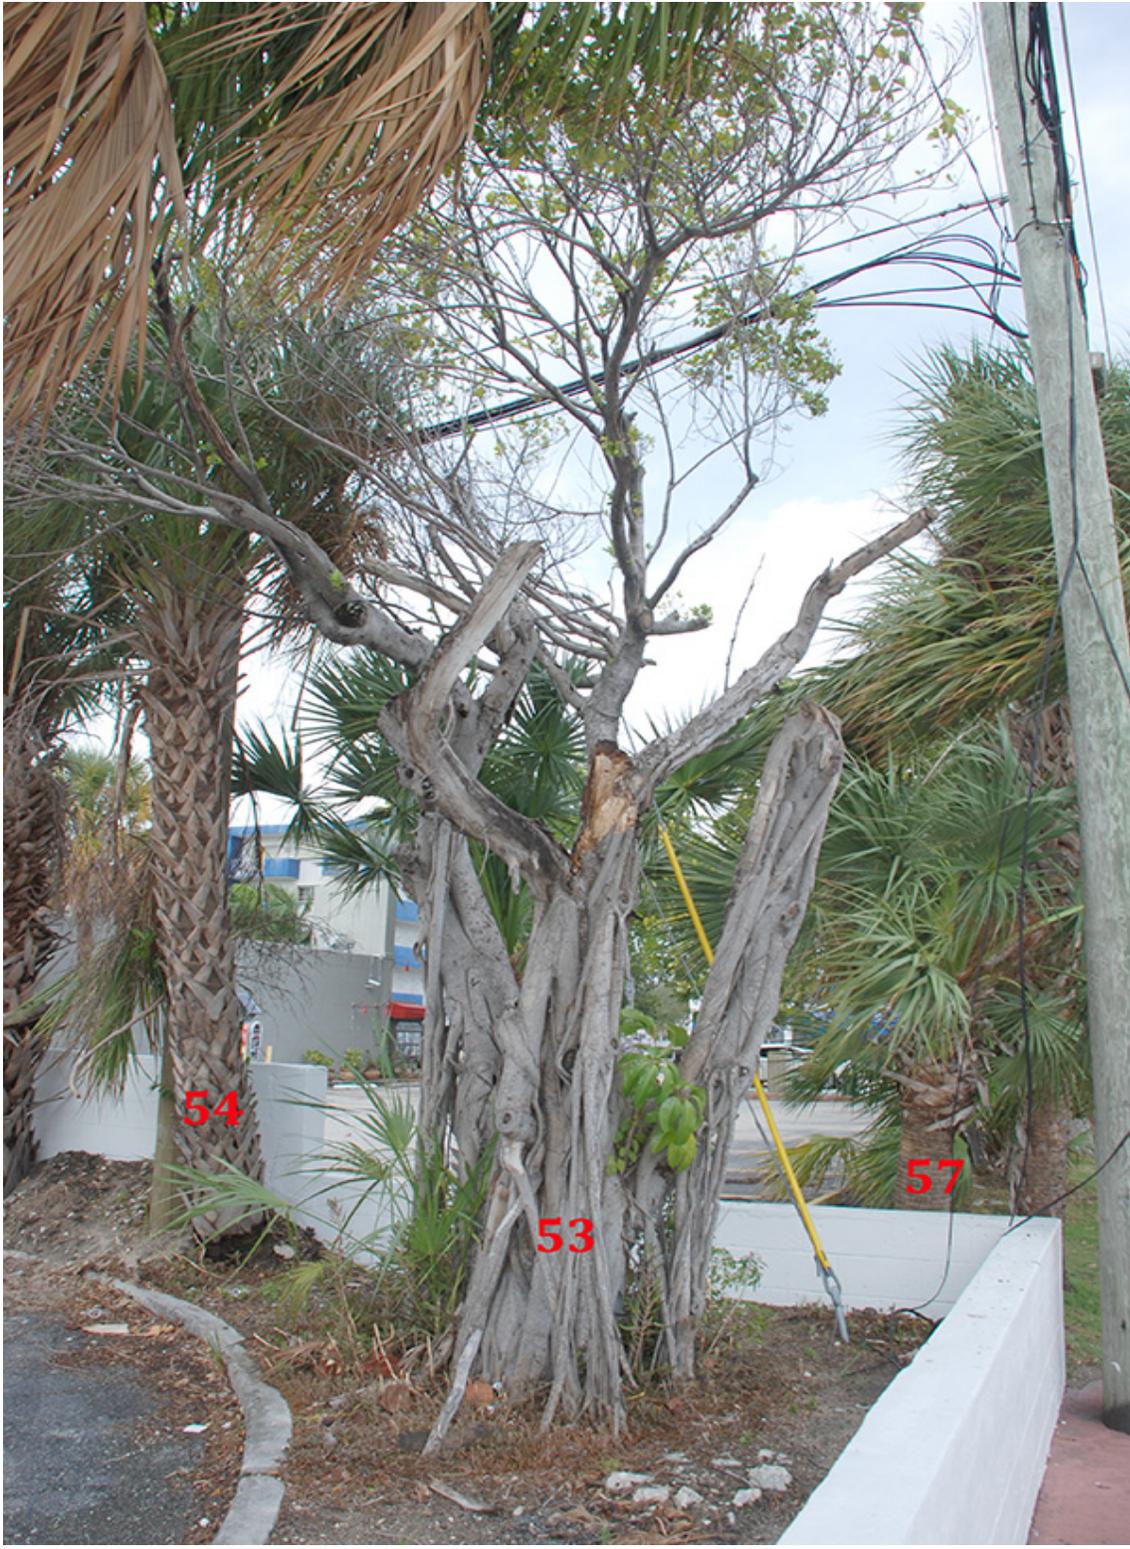
Photo 25 above is another view of tree 53.

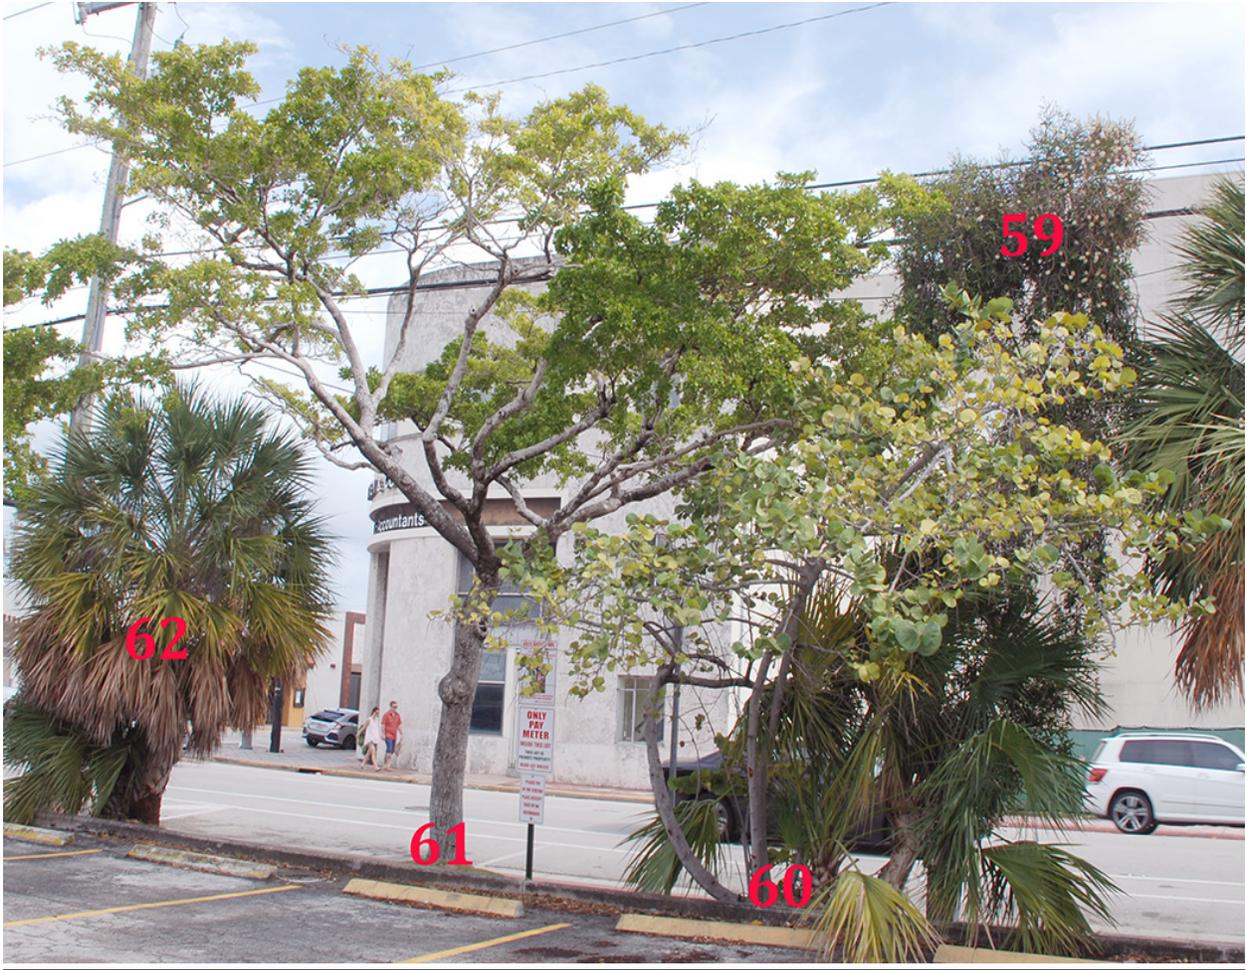
Photo 28 above is tree 59 an invasive species, tree 60 with poor trunk structure, see following photo, and tree 61 with very weak canopy growth and a very restricted root plate.

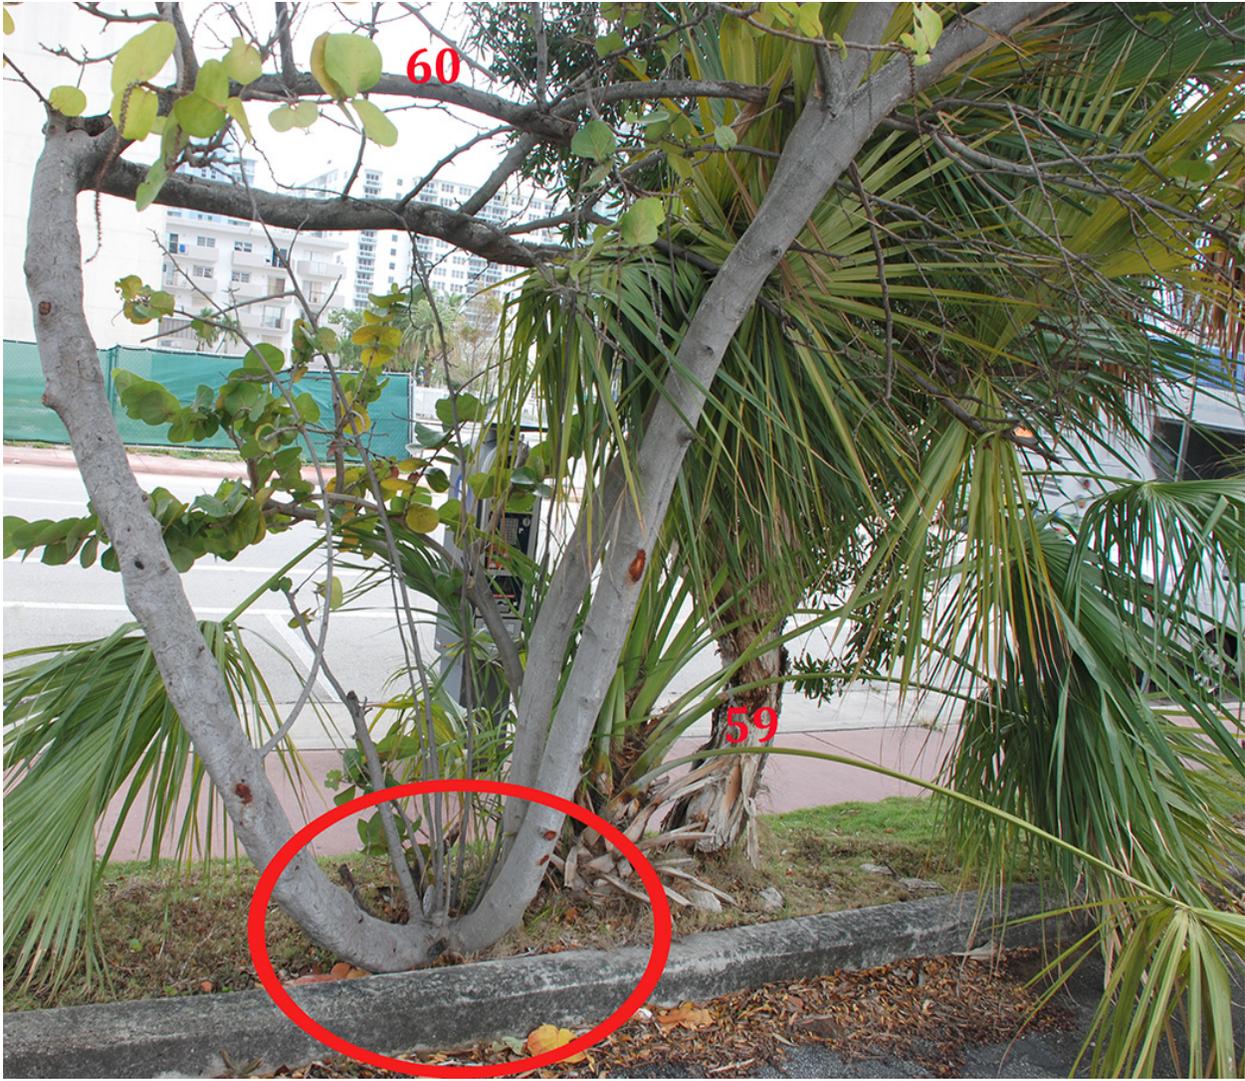
Photo 29 above is a closer view of the weak branch structure of tree 60. This tree should be removed.

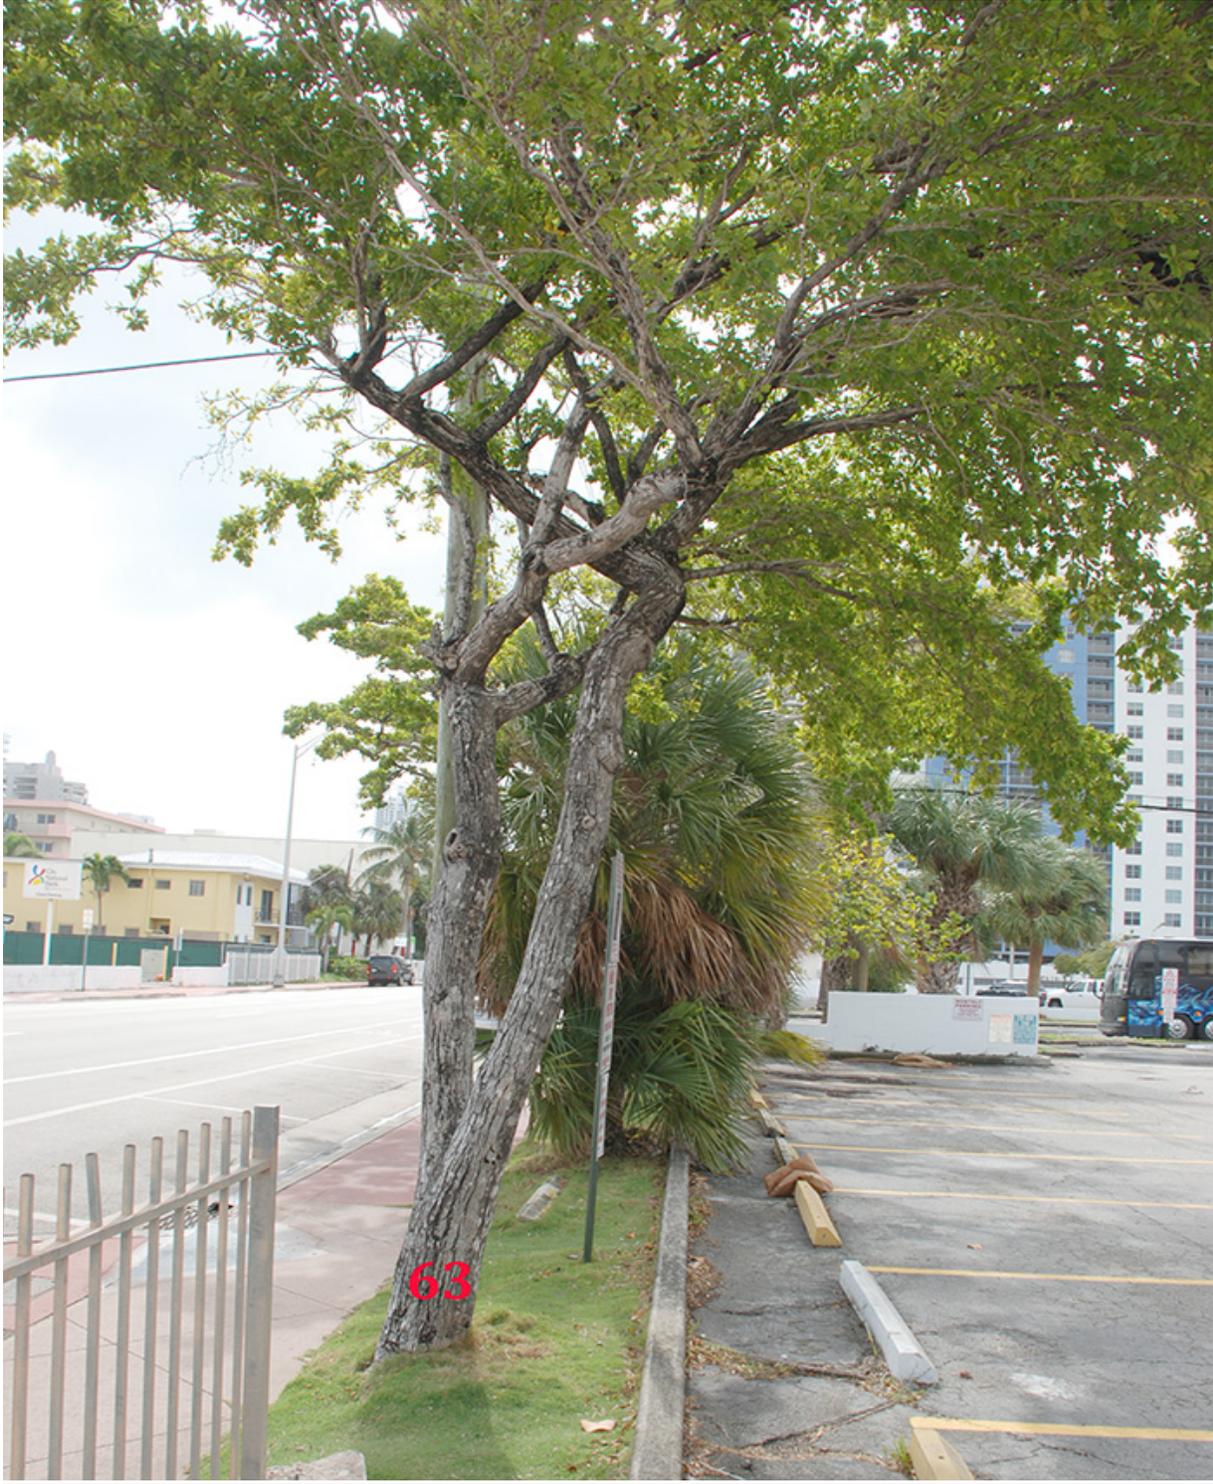
Photo 31 above is tree 63 viewed from the north. Note the very restricted root plate. This tree is not a good candidate for relocation.

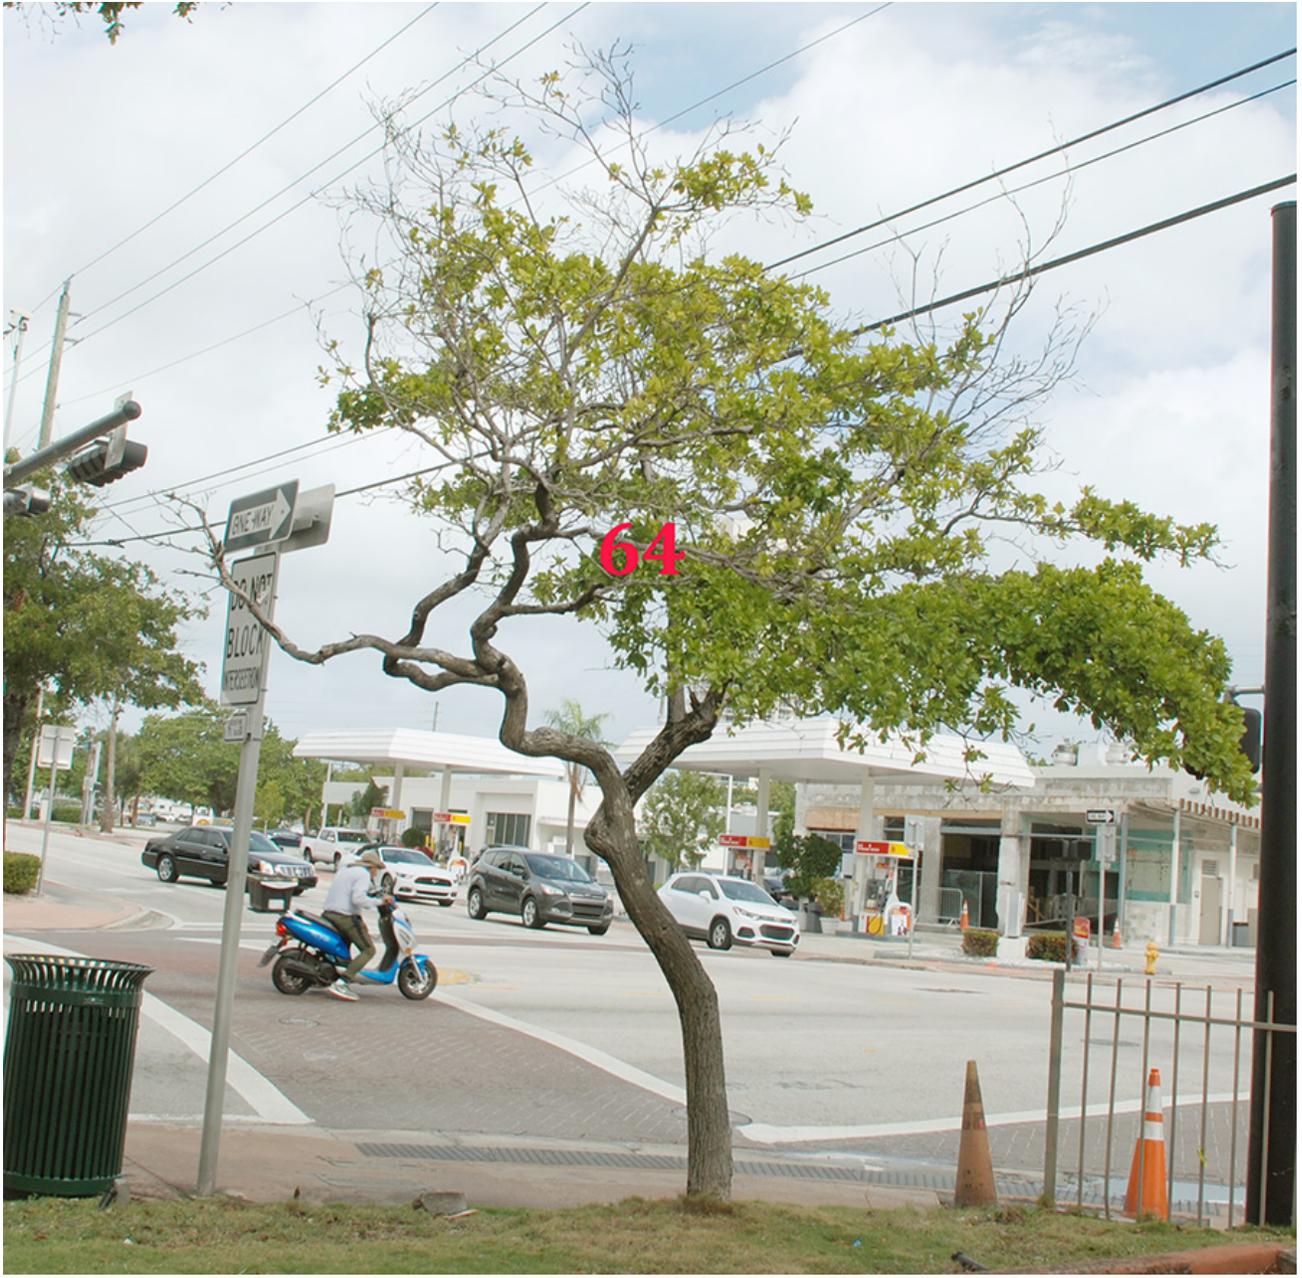
Photo 32 above is tree 64 viewed from the south. This tree has extensive canopy branch die-back. This tree should be removed.

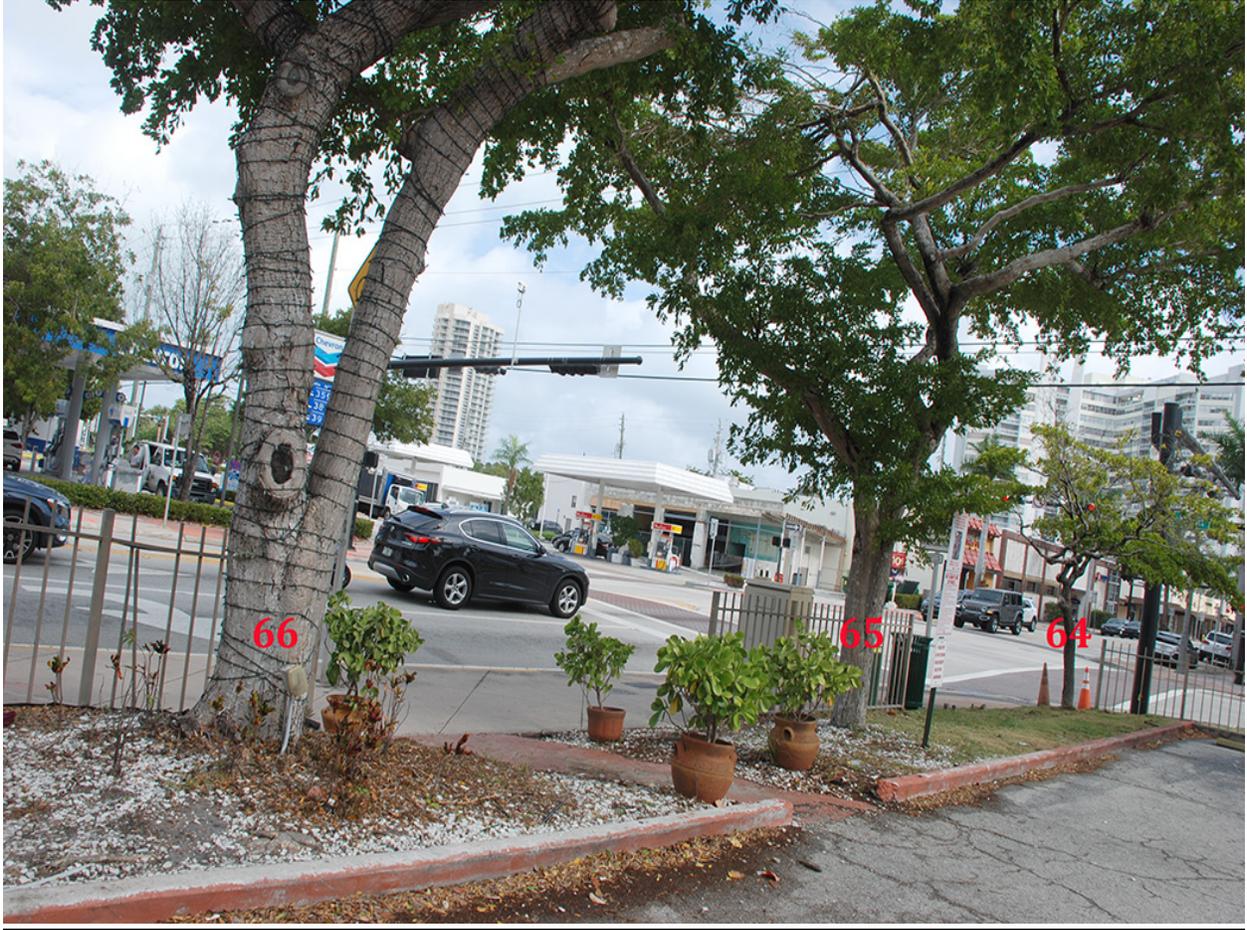
Photo 34 above is a closer view of the very restricted root plates of trees 65 & 66. These trees are not good candidates for relocation.
