Arborist Report

450 W DiLido Drive

Miami Beach

4/3/2020

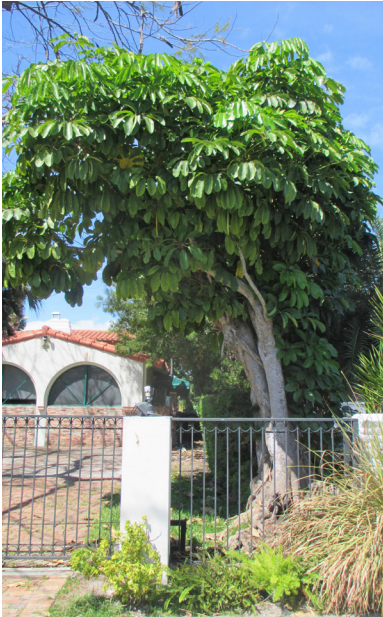
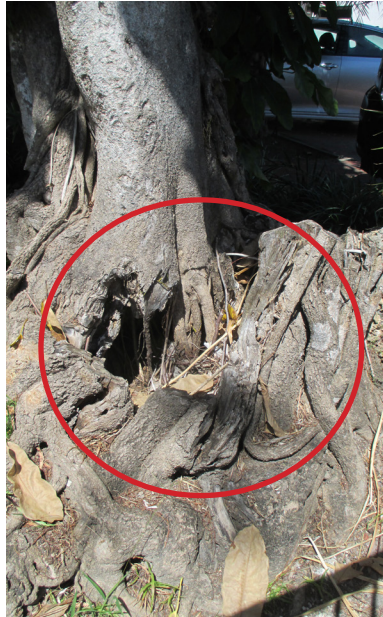
Condition -
Poor

Tree #1 is an Umbrella Tree located on the northern side of the front yard. It is in poor condition with a cavity and decay at the base (circled in red). This species is highly invasive and is listed on the Miami-Dade County Prohibited Plant List. This tree will need to be removed.

Disposition -
Remove

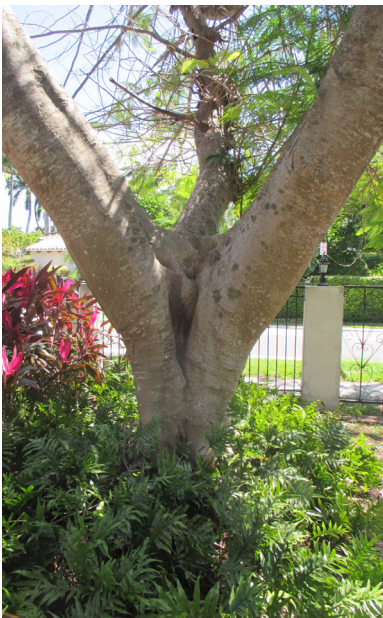
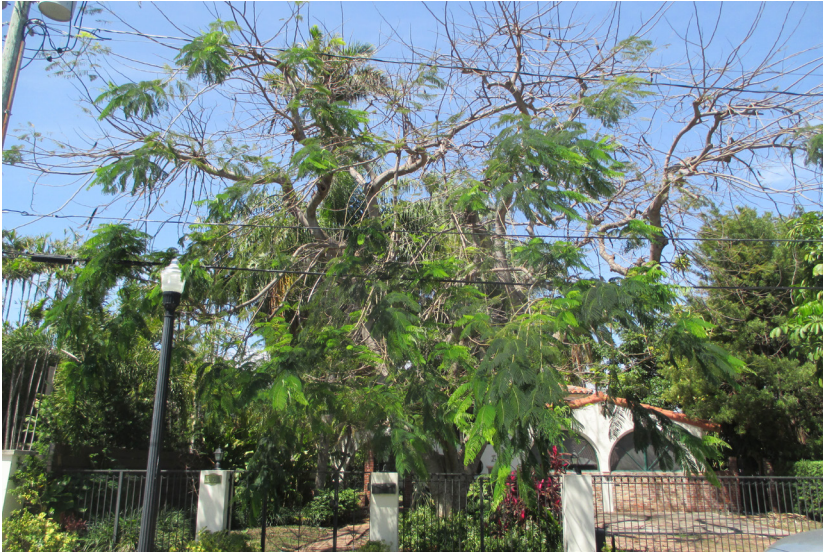
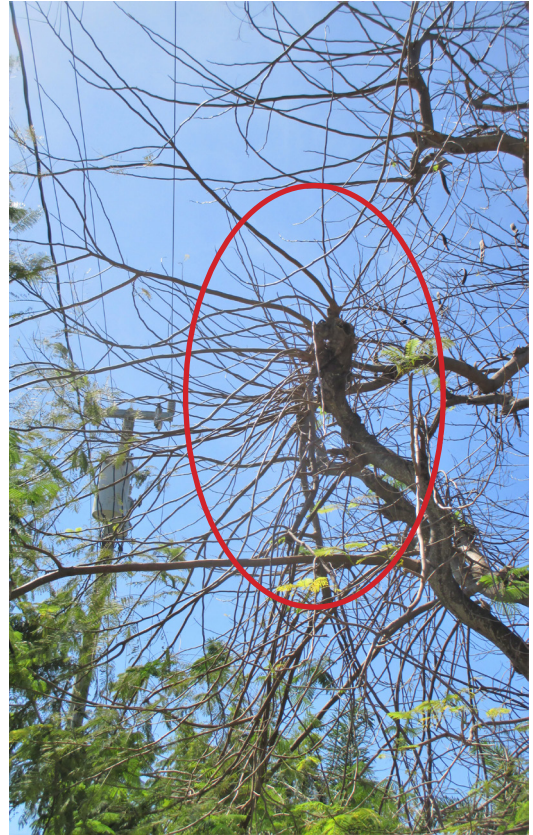
Condition -
Fair

Tree #2 is a large Royal Poinciana located in the front yard. It is in fair condition. The canopy is wide-spreading and extends nearly the full width of the front yard. Limbs that have grown into the overhead utility lines have been repeatedly pruned back, and decay has formed at these cut locations as well as much sucker growth (circled in red). The trunk divides into three main limbs with no included bark. The foliage is emerging at this time of year. Prune to remove deadwood and to maintain clearance of the overhead utility lines and over the sidewalk.

Disposition -
Remain - 27.5ft radius TPZ

This tree is to remain, and protective barriers shall be placed at the dripline, in this case, 27.5ft from the tree trunk. Barriers shall be installed prior to the start of construction and demolition, and shall remain in place until development is completed and until the department authorizes their removal. Barriers shall be a minimum of 4ft high, and shall be constructed of continuous chain link fence with metal posts at 8ft spacing, or of 2x4 posts with three equally spaced 2x4 rails. Posts may be shifted to avoid roots. No materials shall be placed or disposed of within the TPZ. Natural grade shall be maintained within the TPZ.

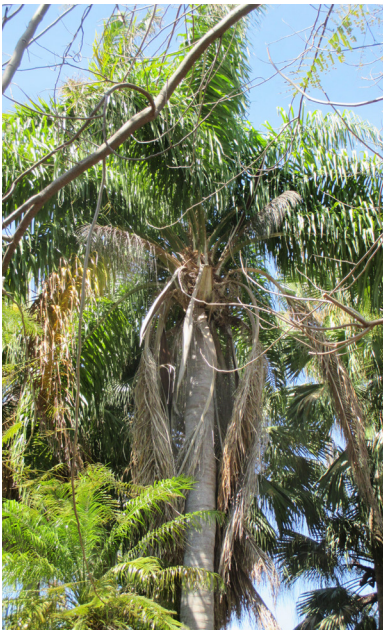
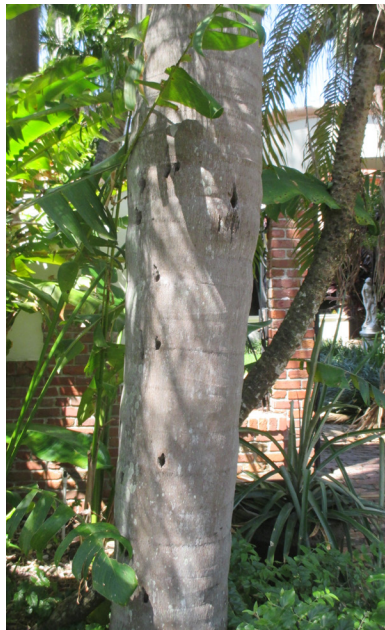
Tree #3 is a Queen Palm located on the south side of the front yard. It is in good condition with a full green canopy. Lower dead fronds are present.

This tree has not been incorporated into the landscape plan and will therefore be removed.

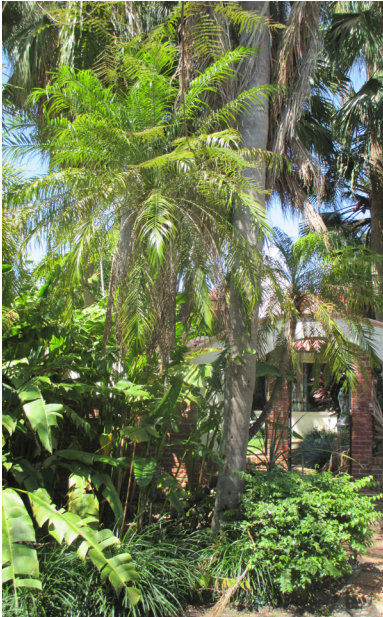
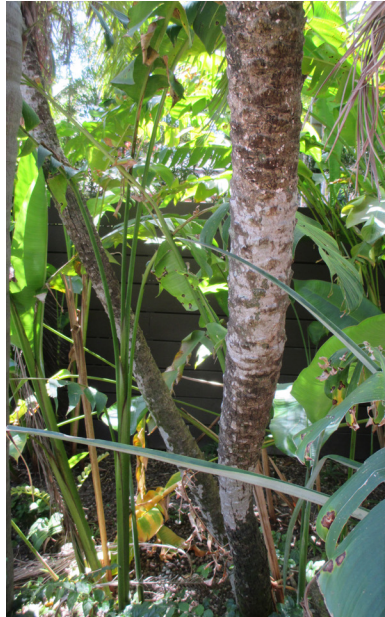
Condition -
Poor

Tree #4 is a double Pygmy Date Palm located on the south side of the front yard. It is in poor condition with a thin, chlorotic canopy. This tree has not been incorporated into the landscape plan and will therefore be removed.

Disposition -
Remove

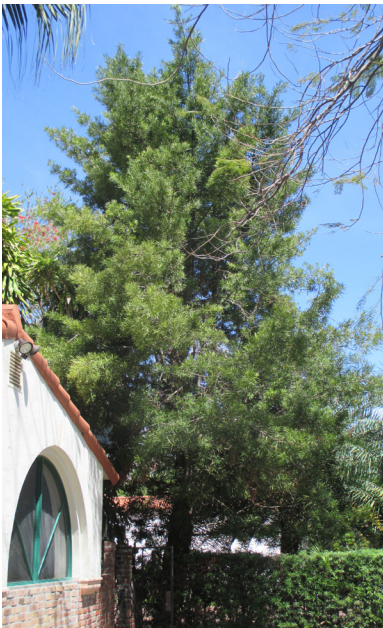
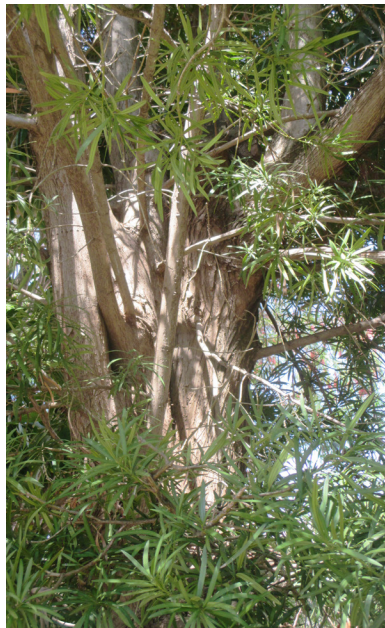
Tree #5 is a Podocarpus located on the northern boundary of the front yard. It is in good condition with a dense, green canopy. The trunk divides into two with included bark.

This tree is to remain, and protective barriers shall be placed 10ft from the tree trunk. Barriers shall be installed prior to the start of construction and demolition, and shall remain in place until development is completed and until the department authorizes their removal. Barriers shall be a minimum of 4ft high, and shall be constructed of continuous chain link fence with metal posts at 8ft spacing, or of 2x4 posts with three equally spaced 2x4 rails. Posts may be shifted to avoid roots. No materials shall be placed or disposed of within the TPZ. Natural grade shall be maintained within the TPZ.

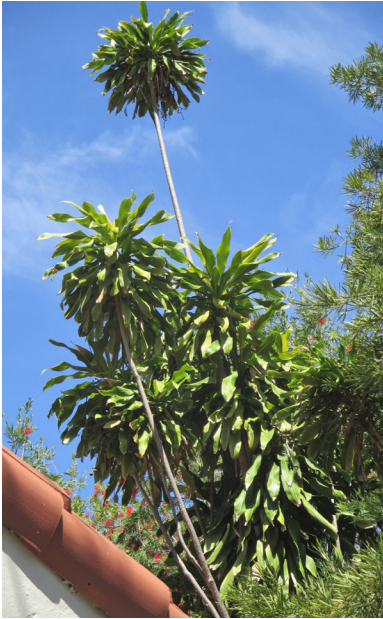
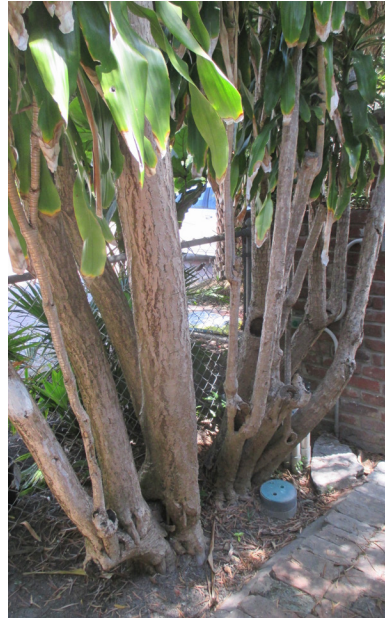
Condition -
Poor

Tree #6 is a Corn Plant located on the north side of the property. It is multi-trunked and in poor condition. Some limbs have been hatracked and there are multiple small cavities with decay. The foliage is chlorotic with necrotic margins.

This tree is to remain, and protective barriers shall be placed 10ft from the tree trunk. Barriers shall be installed prior to the start of construction and demolition, and shall remain in place until development is completed and until the department authorizes their removal. Barriers shall be a minimum of 4ft high, and shall be constructed of continuous chain link fence with metal posts at 8ft spacing, or of 2x4 posts with three equally spaced 2x4 rails. Posts may be shifted to avoid roots. No materials shall be placed or disposed of within the TPZ. Natural grade shall be maintained within the TPZ.

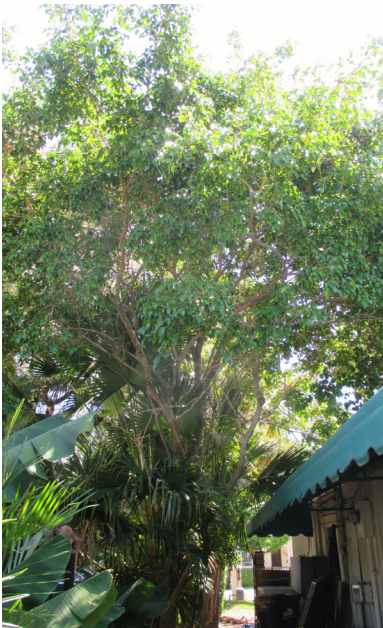
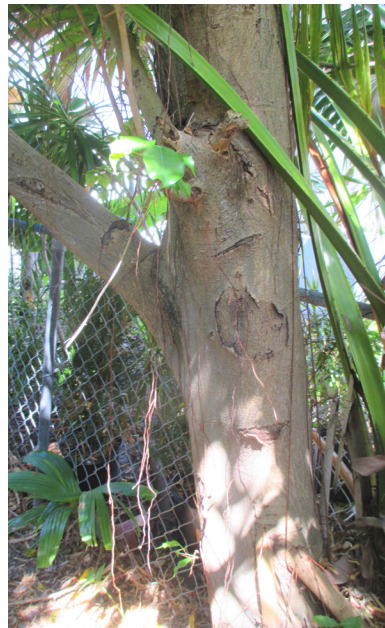
Tree #7 is a Weeping Fig located on the north side of the property. It is in good condition with a dense, healthy green canopy. Some interior small deadwood is present which can be pruned out.

This tree is to remain, and protective barriers shall be placed at the dripline, which is 11ft from the tree trunk. Barriers shall be installed prior to the start of construction and demolition, and shall remain in place until development is completed and until the department authorizes their removal. Barriers shall be a minimum of 4ft high, and shall be constructed of continuous chain link fence with metal posts at 8ft spacing, or of 2x4 posts with three equally spaced 2x4 rails. Posts may be shifted to avoid roots. No materials shall be placed or disposed of within the TPZ. Natural grade shall be maintained within the TPZ.

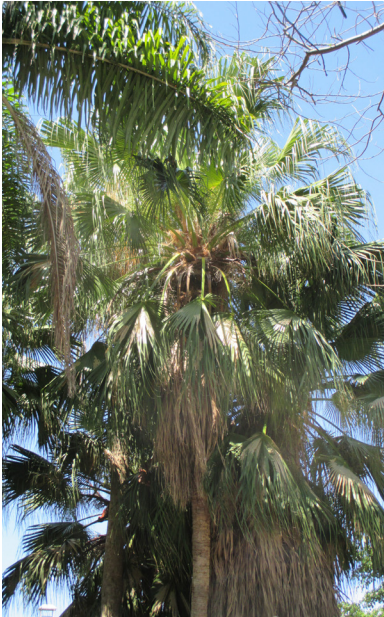
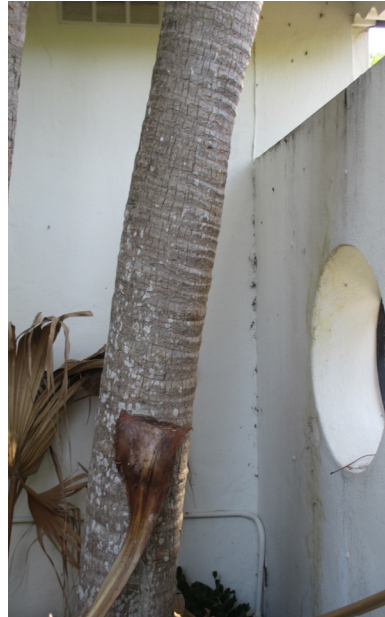
Tree #8 is a Chinese Fan Palm located towards the front of the property. It is in fair condition - there are lower dead fronds as well as palm leaf skeletonizer damage to some of the live fronds.

This tree has not been incorporated into the landscape plan and will therefore be removed.

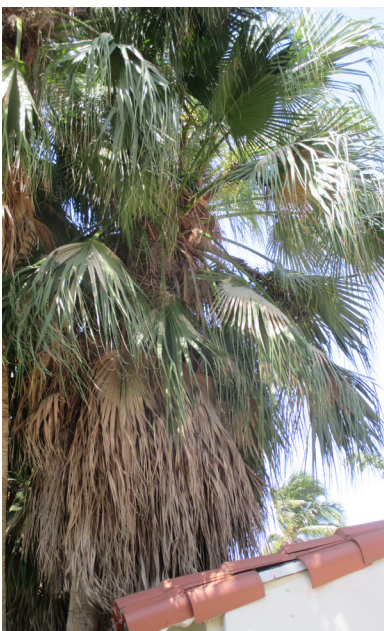
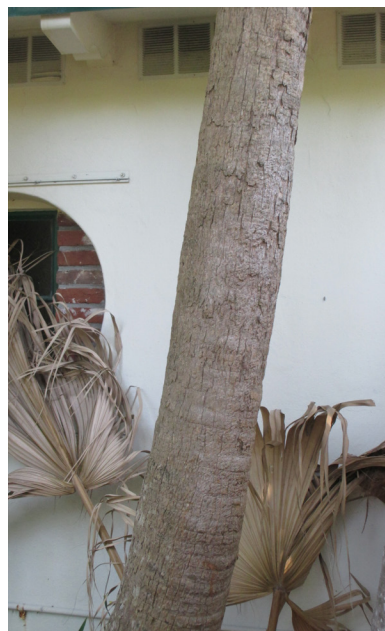
Tree #9 is a Chinese Fan Palm located towards the front of the property. It is in fair condition - there are lower dead fronds as well as palm leaf skeletonizer damage to some of the live fronds.

This tree has not been incorporated into the landscape plan and will therefore be removed.

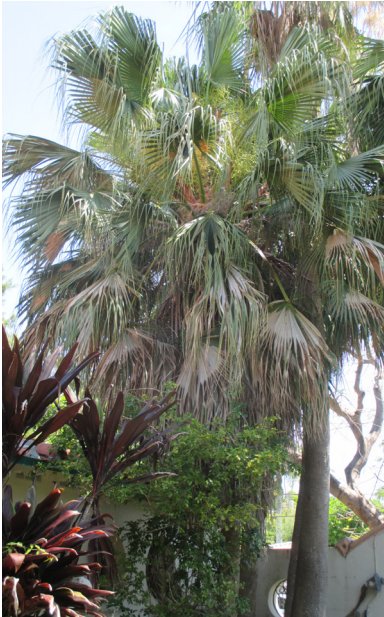
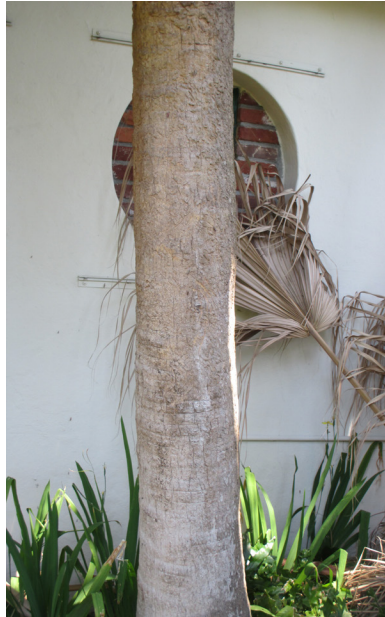
Tree #10 is a Chinese Fan Palm located towards the front of the property. It is in fair condition - there are lower dead fronds as well as palm leaf skeletonizer damage to some of the live fronds.

This tree has not been incorporated into the landscape plan and will therefore be removed.

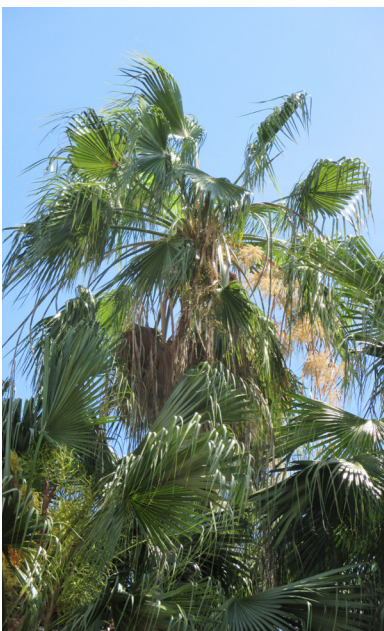
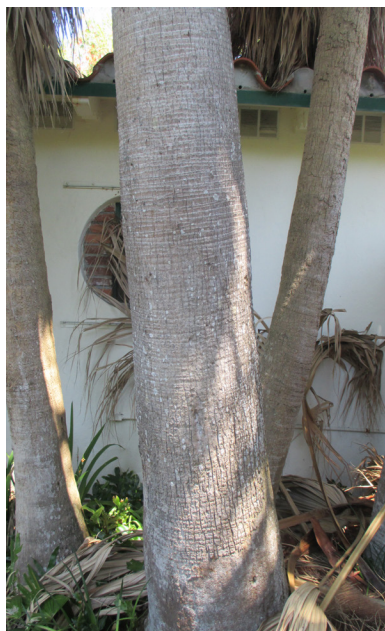
Tree #11 is a Chinese Fan Palm located towards the front of the property. It is in fair condition - the canopy is on the thinner side and lower dead fronds are present.

This tree has not been incorporated into the landscape plan and will therefore be removed.

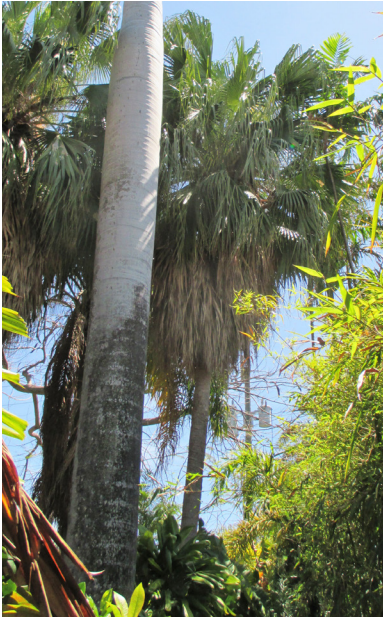
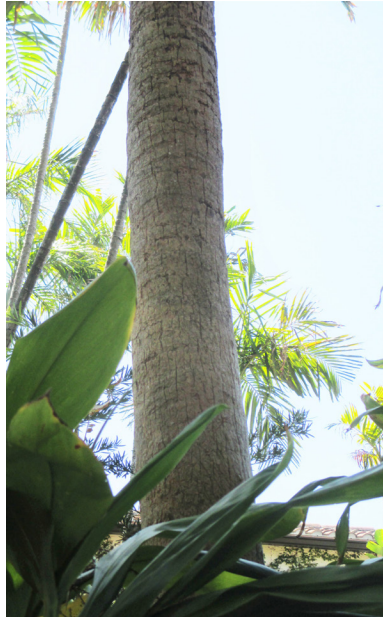
Tree #12 is a Chinese Fan Palm located on the south side of the property. It is in fair condition - there are lower dead fronds as well as palm leaf skeletonizer damage to some of the live fronds.

This tree is to remain, and protective barriers shall be placed 10ft from the tree trunk. Barriers shall be installed prior to the start of construction and demolition, and shall remain in place until development is completed and until the department authorizes their removal. Barriers shall be a minimum of 4ft high, and shall be constructed of continuous chain link fence with metal posts at 8ft spacing, or of 2x4 posts with three equally spaced 2x4 rails. Posts may be shifted to avoid roots. No materials shall be placed or disposed of within the TPZ. Natural grade shall be maintained within the TPZ.

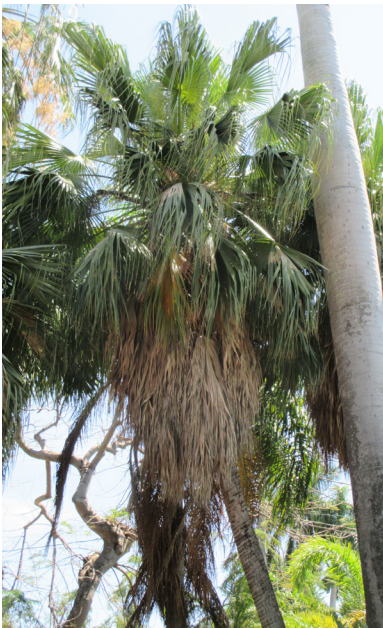
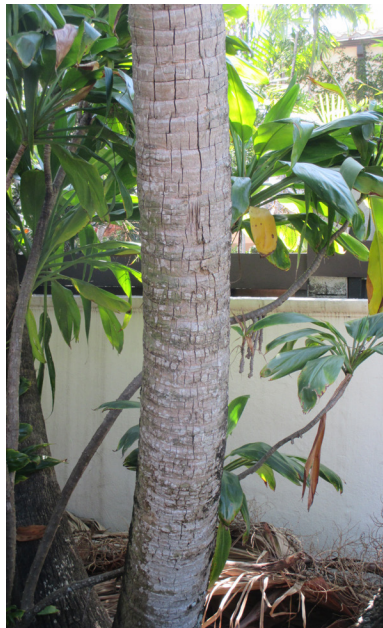
Tree #13 is a Chinese Fan Palm located on the south side of the property. It is in fair condition - there are lower dead fronds as well as palm leaf skeletonizer damage to some of the live fronds.

This tree has not been incorporated into the landscape plan and will therefore be removed.
