PALAU SUNSET HARBOR

"FIRST SUBMITTAL", JULY 07,2020

- (1) FAÇADE TILE CHANGE TO A SMOOTH DESIGNER CEMENT PLASTER (STUCCO)**
- (2) INSTALL ARCHITECTURAL GUTTERS OVER RETAIL**

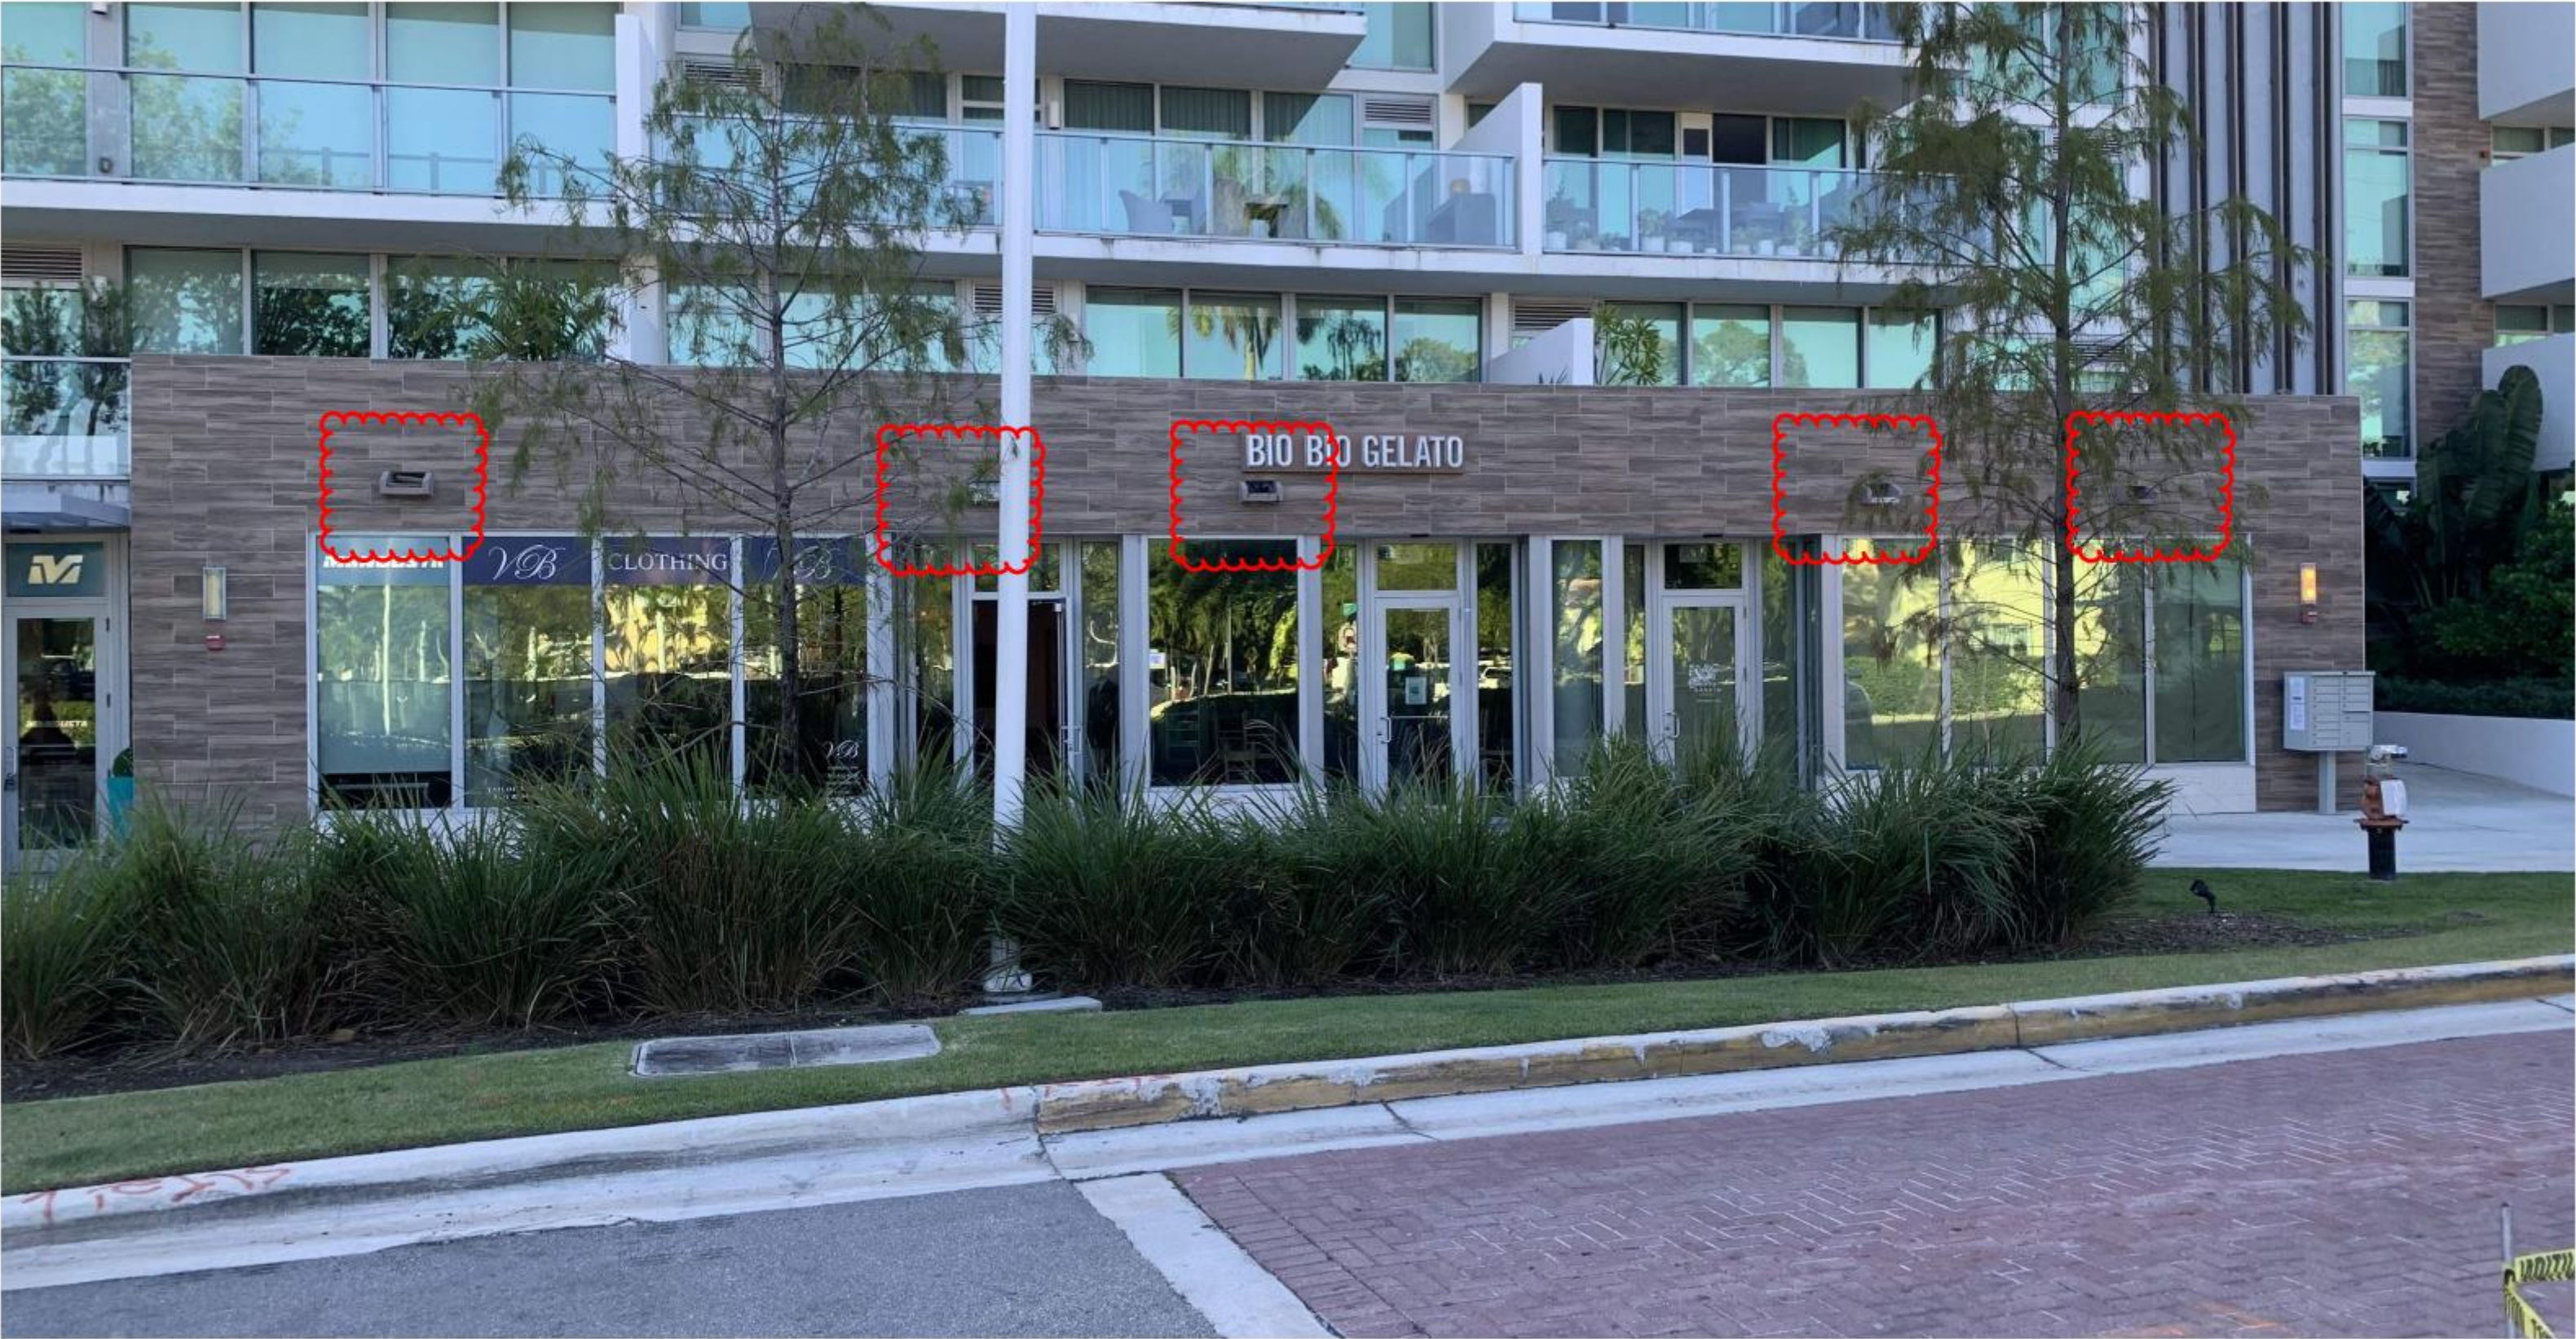
EXISTING SCUPPER CONDITION

(2) INSTALL ARCHITECTURAL GUTTERS OVER RETAIL: We would like to install an architectural gutter over the retail units on the east side of Palau. Currently, five scuppers pour out water during rainfall, and every time a unit owner washes their balcony. The gutters sit above the retail units storefront, thus the water pours out on the shops' patrons and employees. We want to install painted aluminum gutters, which will be powder coated in a color that will match the adjacent painted stucco closely. There are two existing storm drains that will drain the water.
