Boyd Residence 31 LaGorce Cir. Miami Beach, FL 33141

March 31, 2020

Bartlett Tree Experts
560 NW 42nd Court
Oakland Park, FL 33334

Juan C. Carrasco
ISA Board Certified Master Arborist #WE-3576B
ISA Tree Risk Assessment Qualified

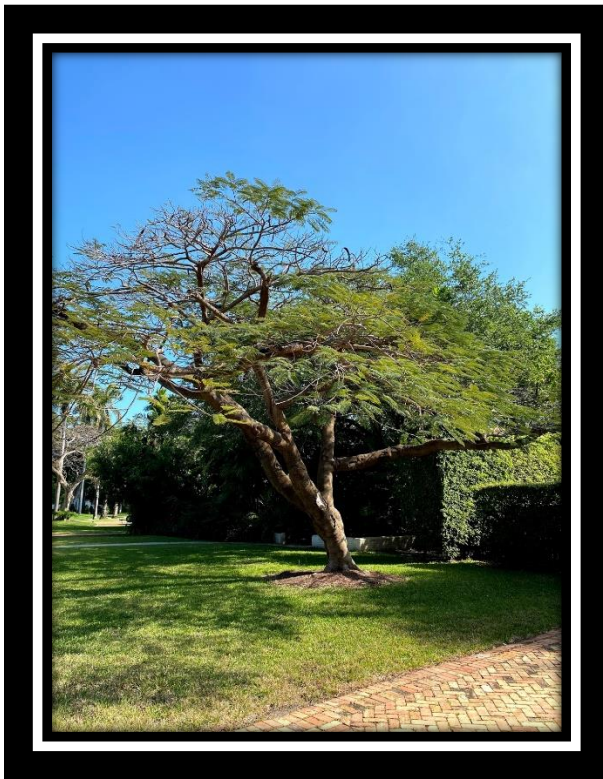
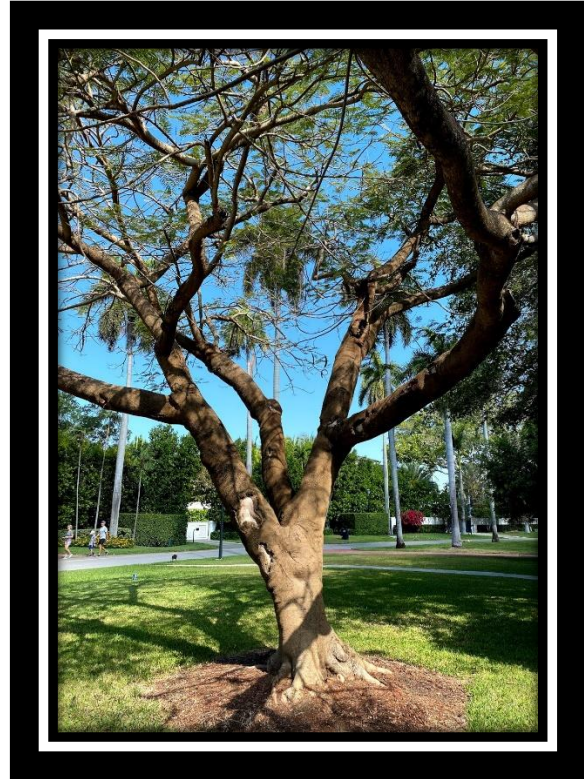
Tree # 752 Royal Poinciana, this tree has some decay in the main trunk and branches, there is good closing tissue (callus) around the decay areas. In the lower trunk included bark is present, included bark can cause a weak attachment prone to failure during storms.

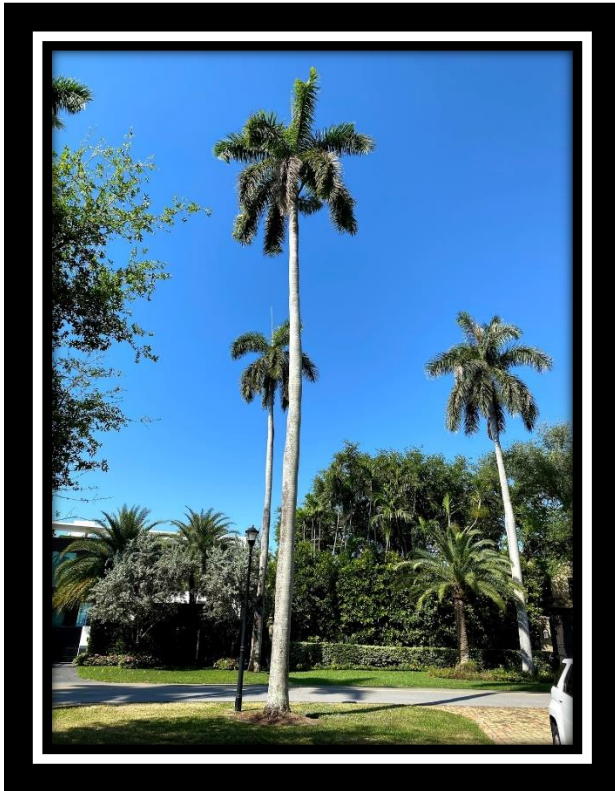
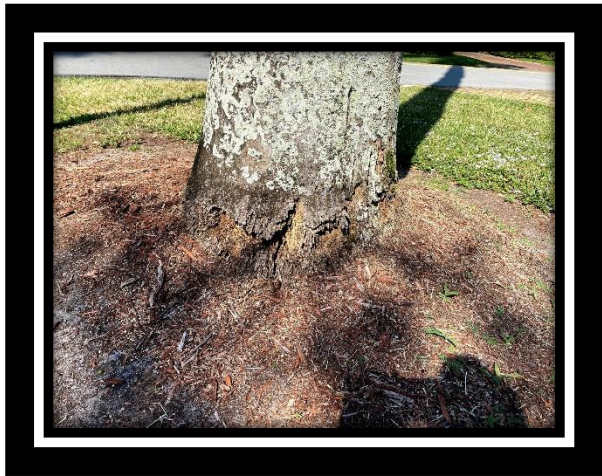
Palm # 756 Royal Palm, this palm is a large specimen. It presents decay in approximately 35% of the trunk. The decay represents a structural weakness specially at the base of mature large trees and/or palms.

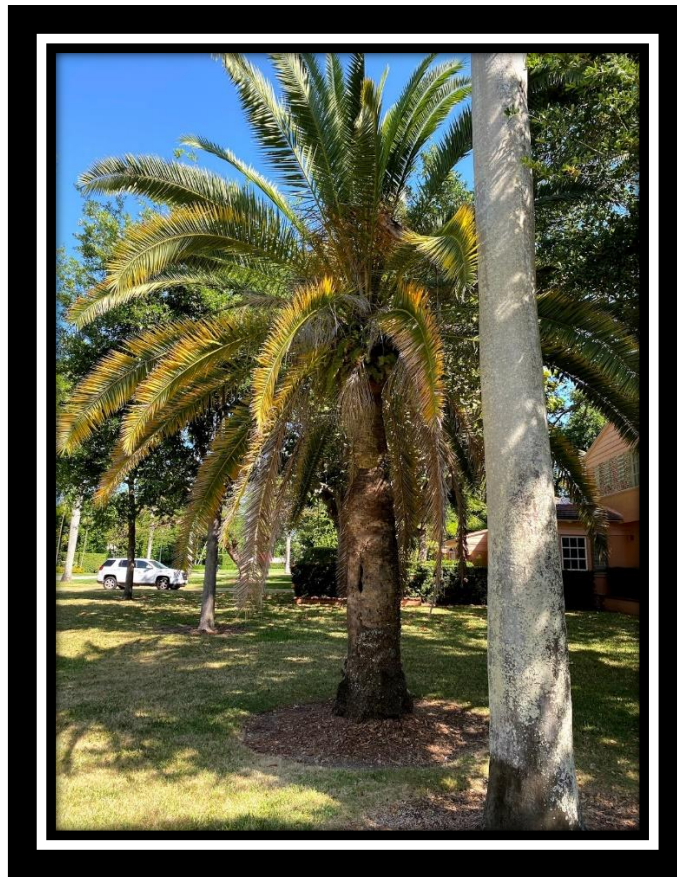
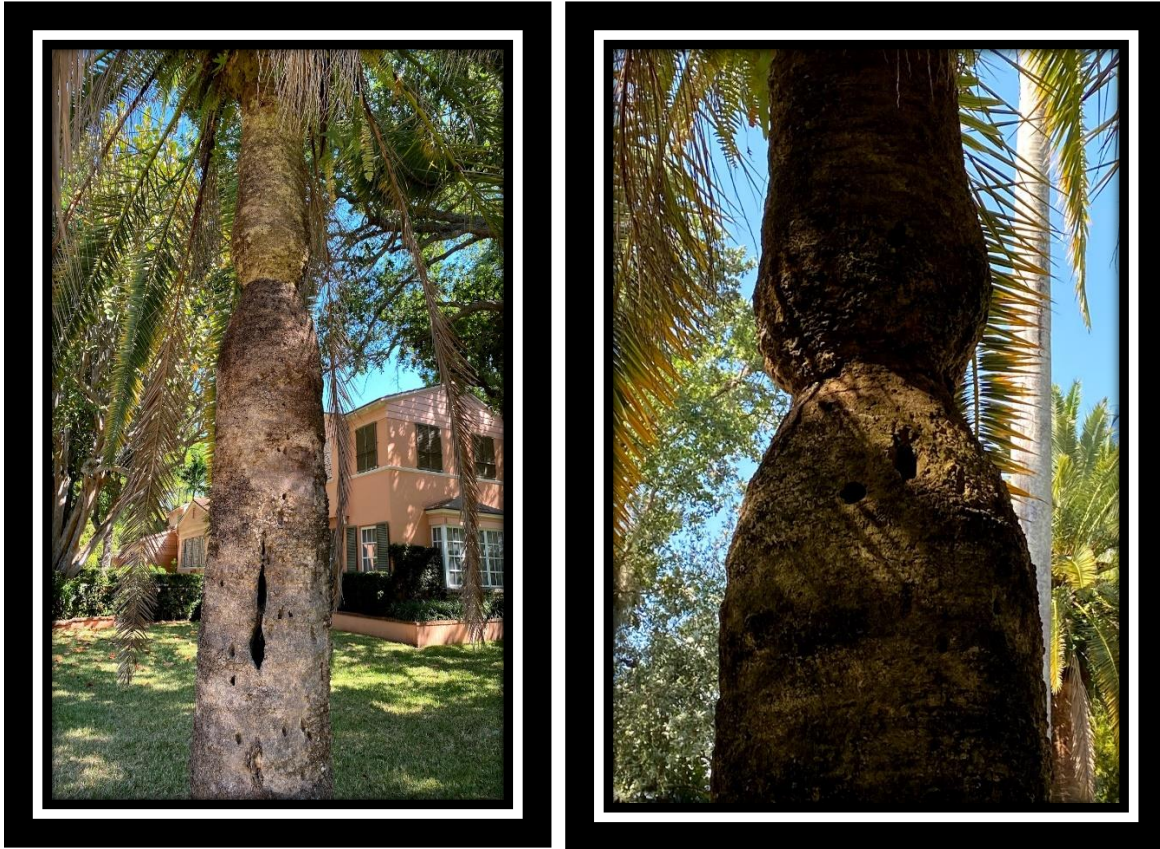
Palm # 759 Canary Palm, this palm has a cavity in the trunk and several holes along the trunk. It's possible that the trunk has a column of decay. At the upper trunk there is a constriction with holes below the constriction creating a weakness and a likelihood of failure especially during storm conditions. The palm is also showing symptoms of what appears to be *Fusarium* sp. a fungal disease that causes the fronds to die slowly and causes an irreversible decline without treatment alternatives.

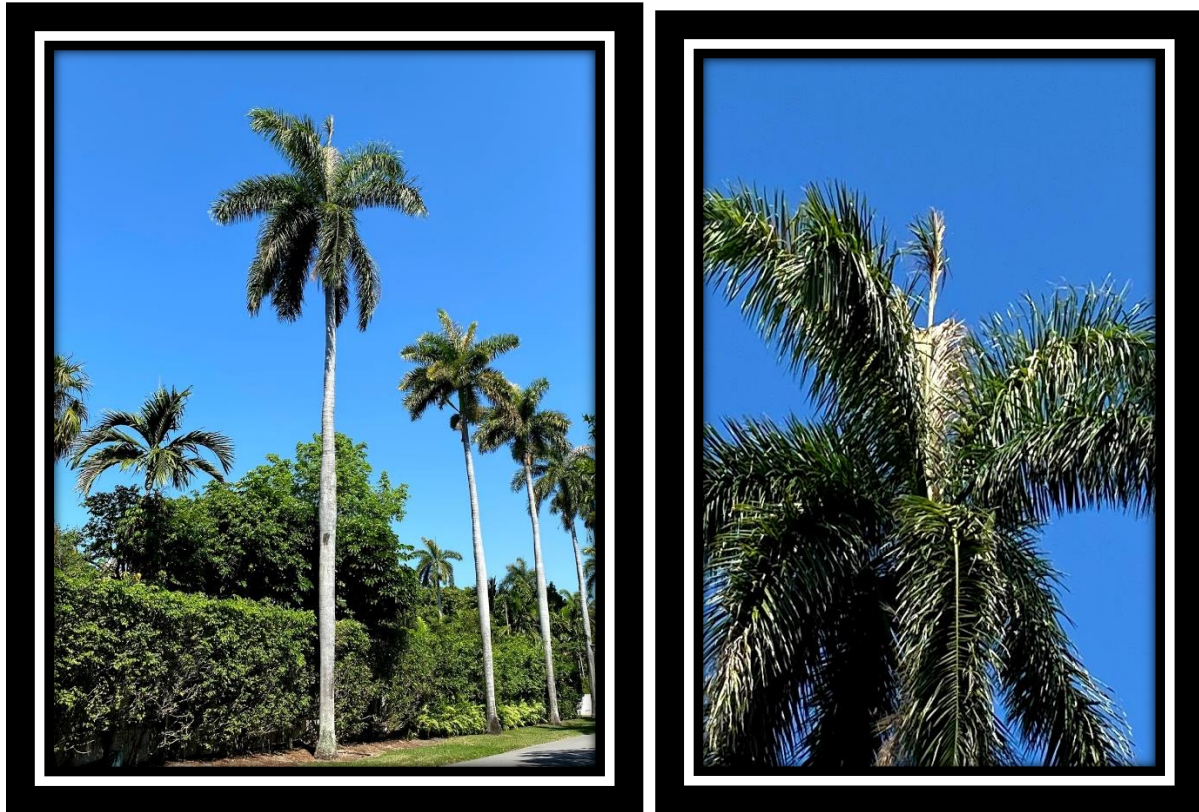
Palm # 782 Royal Palm, this palm presents yellow and brown new fronds, the main bud also appears to be yellowing. The change of color on the new growth and main bud can be an indication of an insect or disease. It's not possible to determine the cause by looking the tree from the ground. It's possible that this palm may be in decline.

- Remove all trees and palms that are in poor condition, present a risk, don't have the proper space to continue to grow, and/or are invasive species.
- Inspect Royal Palm #782 to try to determine the cause of the yellowing and browning of the main bud and new growth.

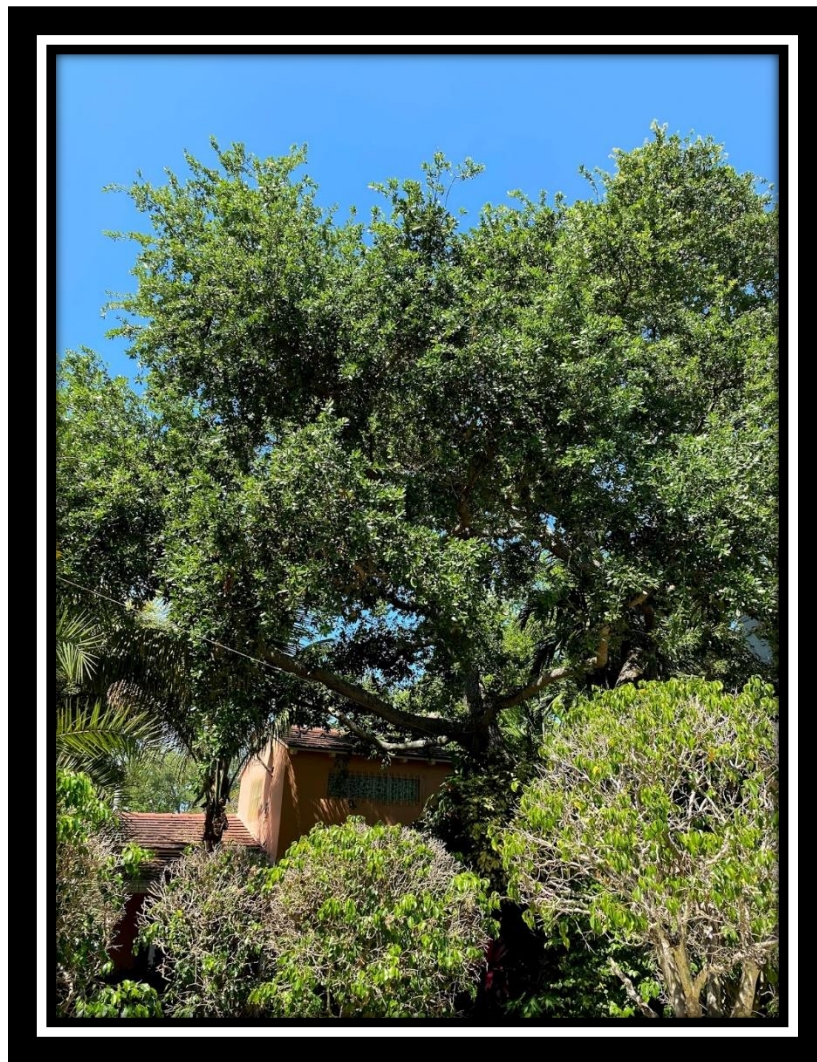
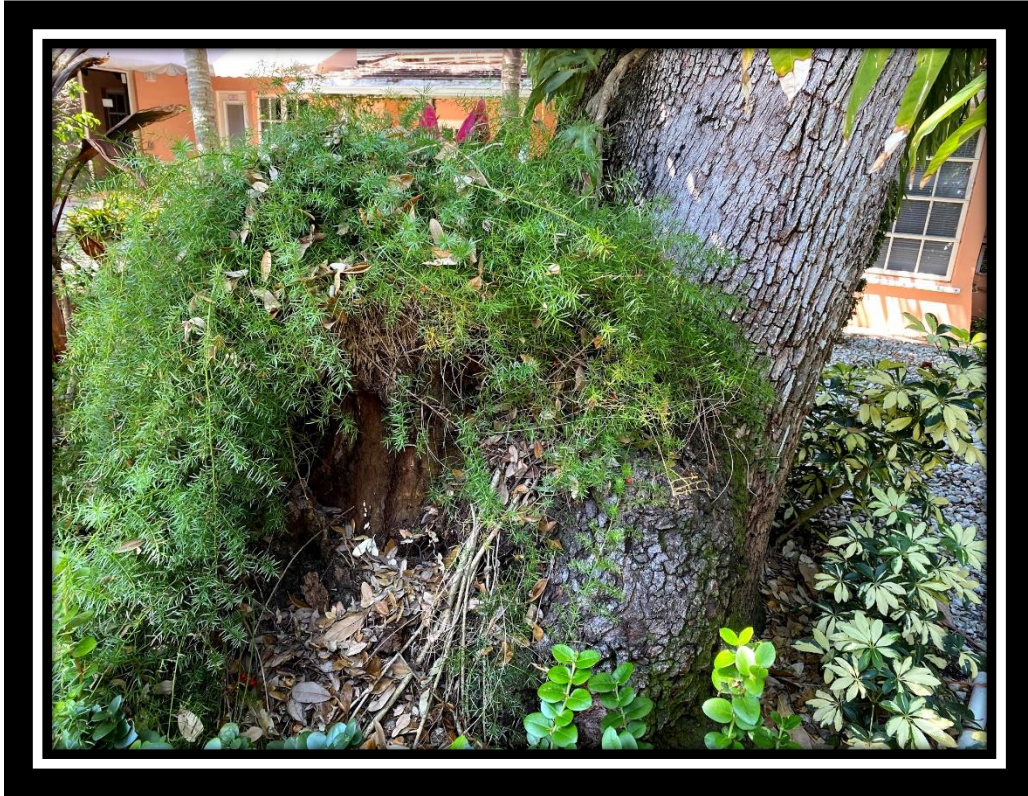
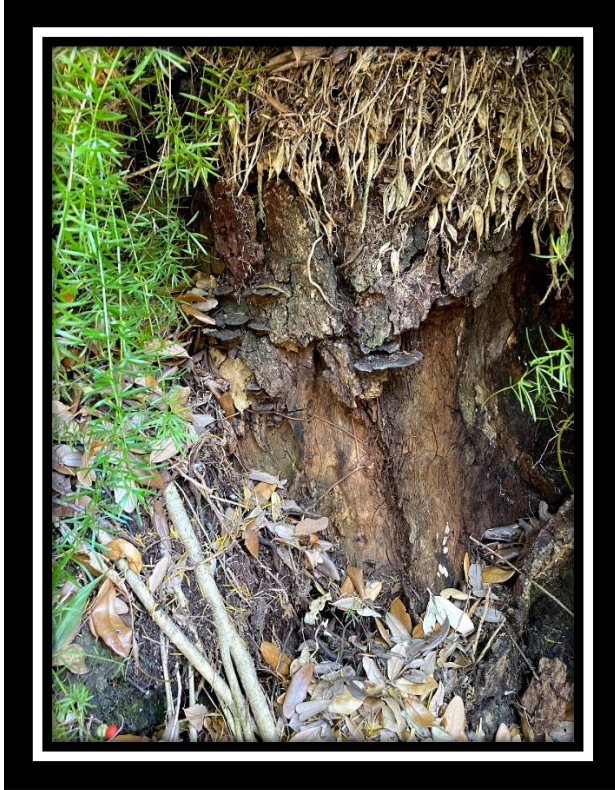
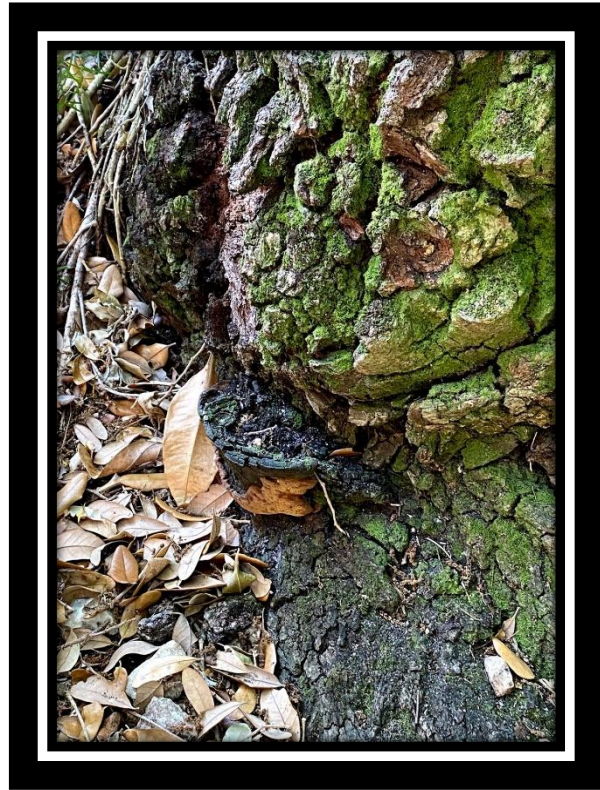
Tree # 804 Live Oak, this large specimen tree located at the back of the property, provides a good shade and aesthetic contribution to the rear patio. At the base of the tree a large stump was left from what looks was a large stem (removed many years ago), this stump is decayed extensively and still attached to the main trunk of the tree, conks (fruiting body of a fungus) are visible in the stump, it looks like Ganoderma root rot. Another conk is visible in the main supporting trunk near the base, this can indicate interior decay into the trunk that is alive. Interior decay caused by Ganoderma can compromised the structure stability and support of the tree causing the tree to be a risk to the people and the property.

- Perform *Level 3 Advanced Assessment* of risk (as defined in the *International Society of Arboriculture's BMP for Tree Risk Assessment*) on Live Oak #804.
