June 7, 2020

**Certified Arborist Assessment  
2138 Bay Ave, Miami Beach, Florida  
NLE Project No. 18220001**

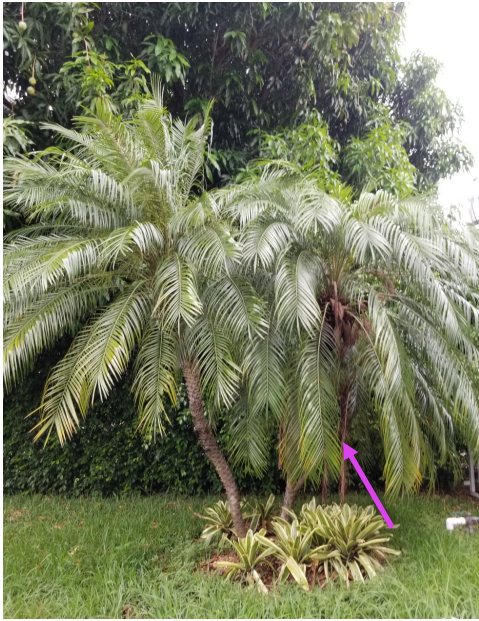
<p>Tree 1 pygmy date palm (Phoenix roebelinii) 3 inch DBH, Good condition 10 foot height, 6 foot spread</p>

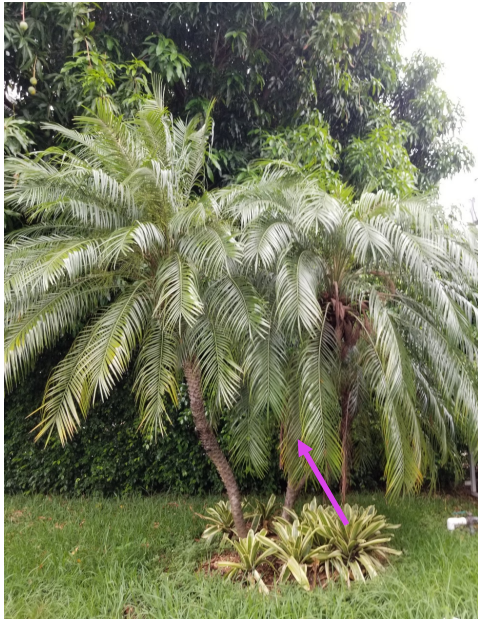
<p>Tree 2A pygmy date palm (Phoenix roebelinii) 4 inch DBH Good condition 8 foot height, 6 foot spread</p>

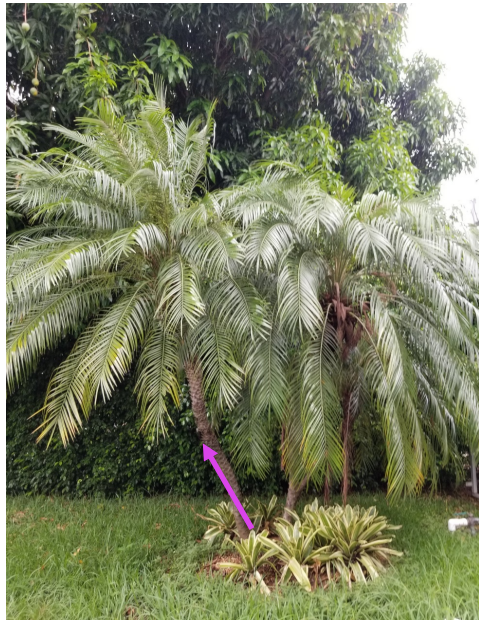
<p>Tree 2B pygmy date palm (Phoenix roebelinii) 2 inch DBH Fair condition 6 foot height, 6 foot spread</p>

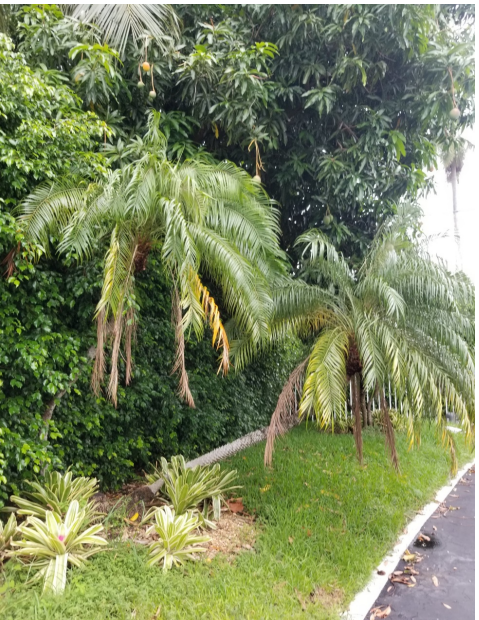
<p>Tree 3 pygmy date palm (Phoenix roebelinii) 3 inch DBH, Good condition 8 foot height, 6 foot spread</p>

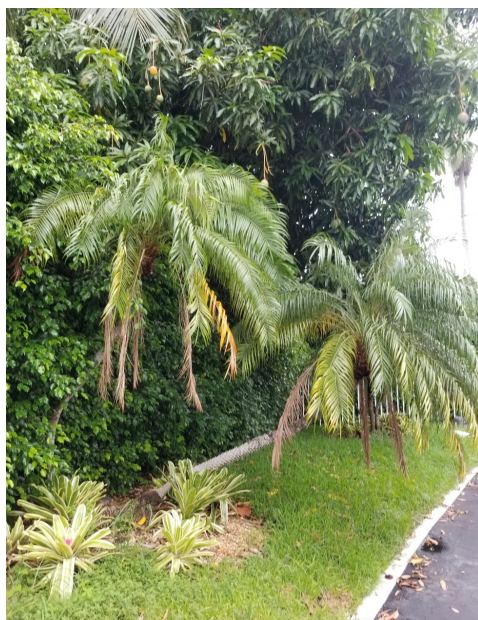
<p>Tree 4 pygmy date palm (Phoenix roebelinii) 4 inch DBH Good condition 8 foot height, 6 foot spread</p>

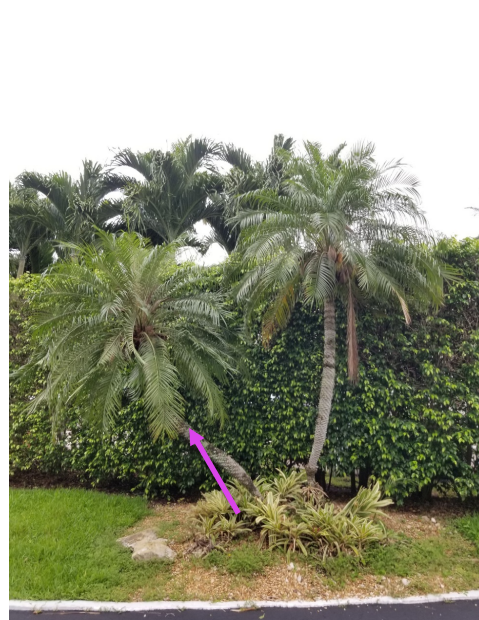
<p>Tree 5 pygmy date palm (Phoenix roebelinii) 4 inch DBH Good condition 10 foot height, 8 foot spread</p>

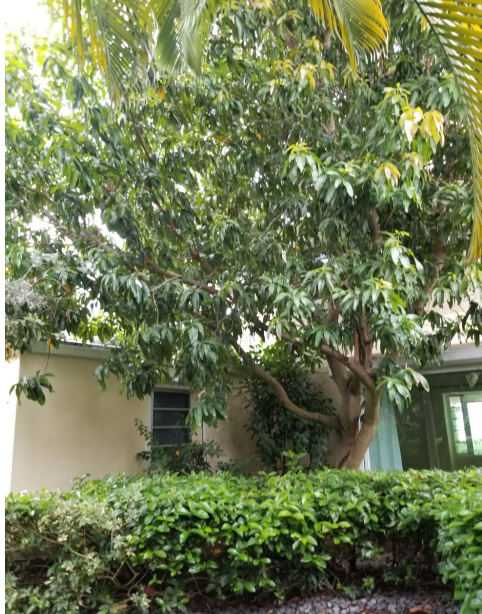
<p>Tree 6 pygmy date palm (Phoenix roebelinii) 4 inch DBH, Good condition 8 foot height, 8 foot spread</p>	<p>Tree 7 mango (Mangifera indica) 12 inch DBH Good condition 30 foot height, 25 foot spread</p>	<p>Tree 8 montgomery palm (Veitchia arecina) 4 inch DBH Dead condition 18 foot height, 5 foot spread</p>

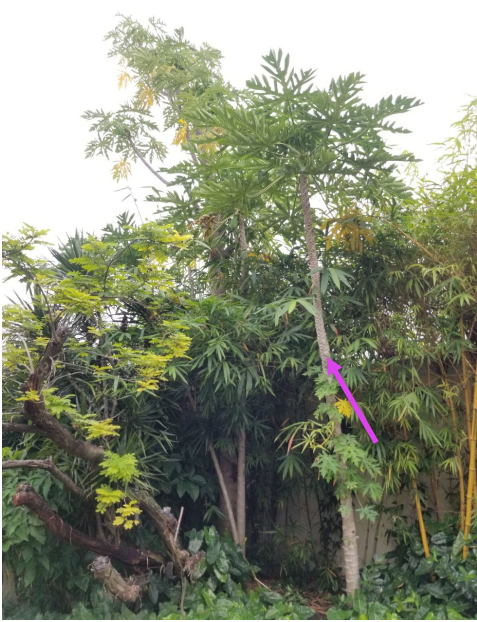
<p>Tree 12A papaya (<i>Carica papaya</i>) 4 inch DBH, Good condition 15 foot height, 8 foot spread</p>

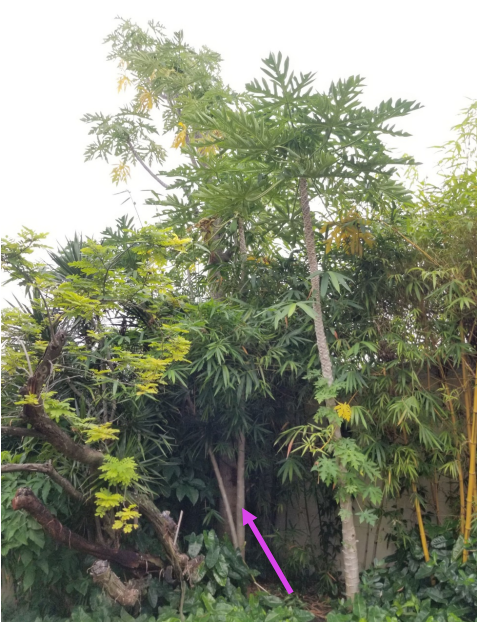
<p>Tree 12B papaya (<i>Carica papaya</i>) 3 inch DBH Fair condition 25 foot height, 8 foot spread</p>

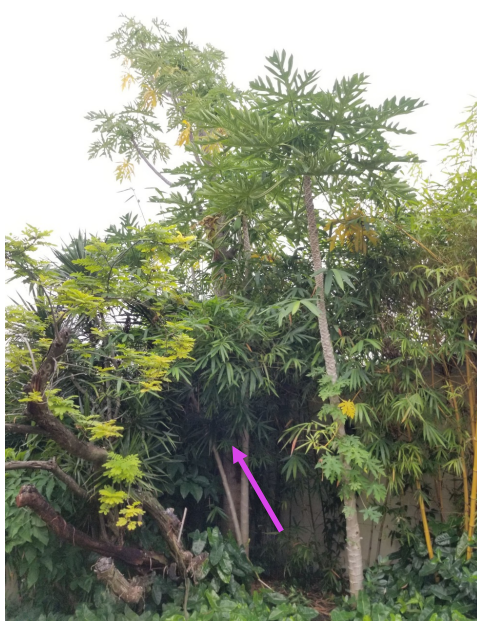
<p>Tree 12C papaya (<i>Carica papaya</i>) 9 inch DBH Good condition 25 foot height, 20 foot spread</p>

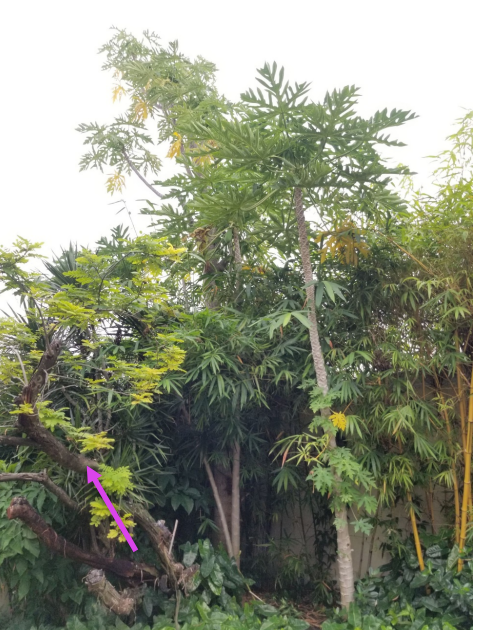
<p>Tree 12D glaucous cassia (<i>Senna surattensis</i>) 4 inch DBH, Very Poor condition 10 foot height, 6 foot spread</p>

<p>four dead stems, one living, all leaves chlorotic, decay in all stems</p>	<p>Tree 13 Canary island date palm (<i>Phoenix canariensis</i>) 36 inch DBH Good condition 25 foot height, 20 foot spread</p>

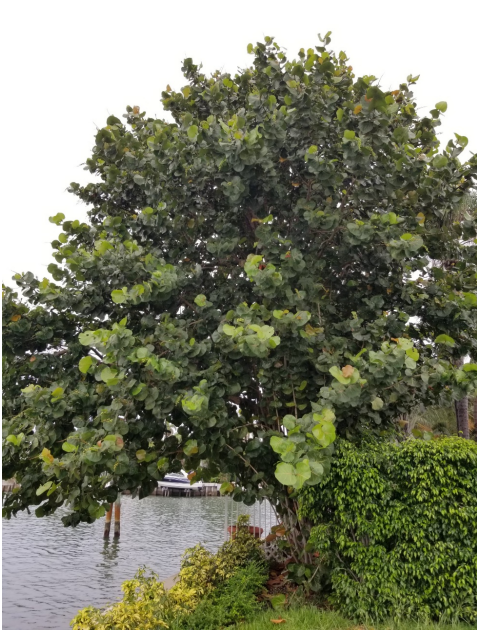
<p>Tree 14 seagrape (<i>Coccoloba uvifera</i>) 21 inch DBH Good condition 25 foot height, 20 foot spread</p>

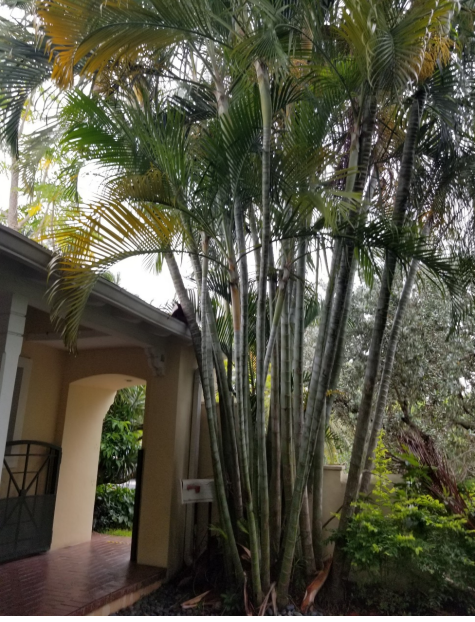
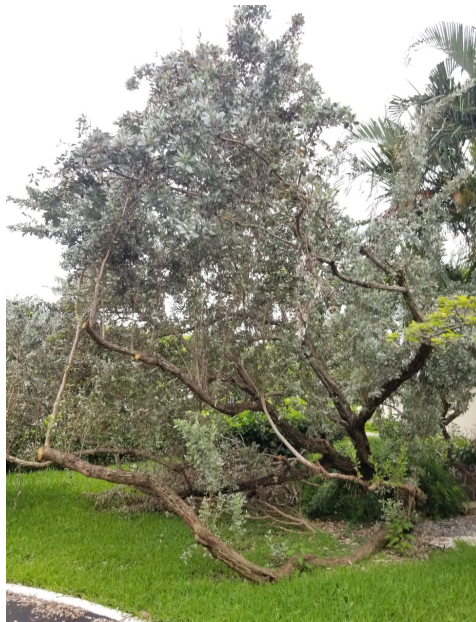
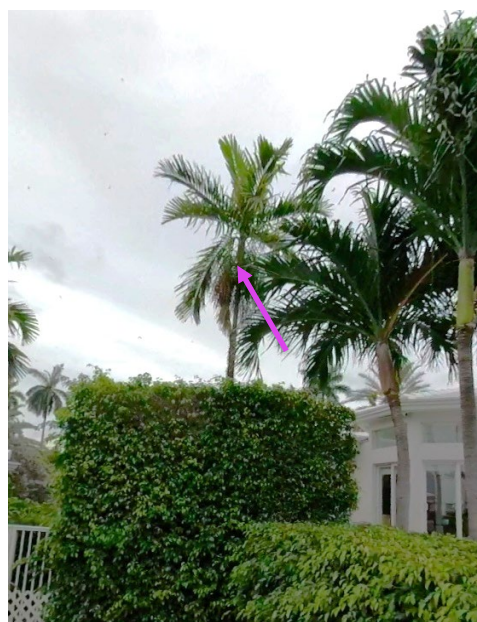
<p>Tree 15 areca palm (Dypsis lutescens) cluster inch DBH, Good condition 30 foot height, 20 foot spread</p>	<p>Tree 16 silver buttonwood (Conocarpus erectus var. sericeus) 13 inch DBH Poor condition 20 foot height, 20 foot spread</p>	<p>Tree 17 montgomery palm (Veitchia arecina) 4 inch DBH Good condition 25 foot height, 8 foot spread</p>

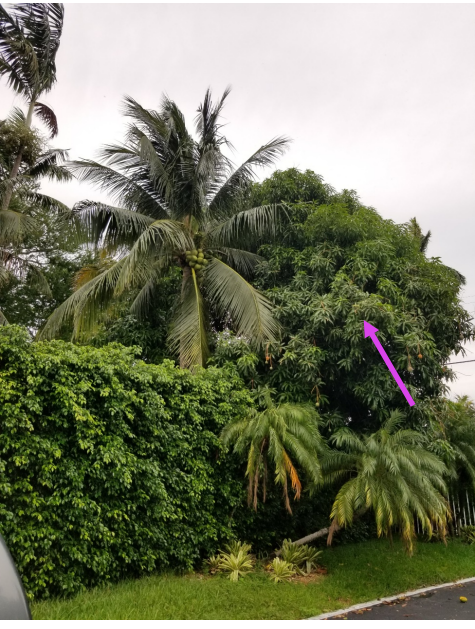
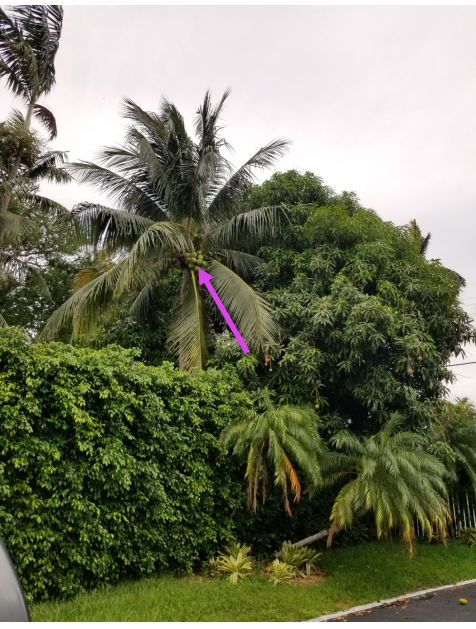
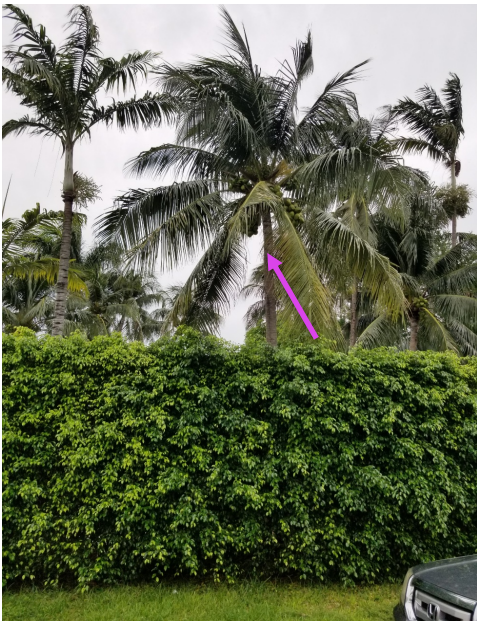
<p>Tree 18* mango (Mangifera indica) 20 inch DBH, Good condition 25 foot height, 30 foot spread</p>	<p>Tree previously fell, branches are regrowth</p> <p>Tree 19* coconut palm (Cocos nucifera) 11 inch DBH Good condition 25 foot height, 20 foot spread</p>	<p>Tree 20* coconut palm (Cocos nucifera) 11 inch DBH Good condition 20 foot height, 20 foot spread</p>

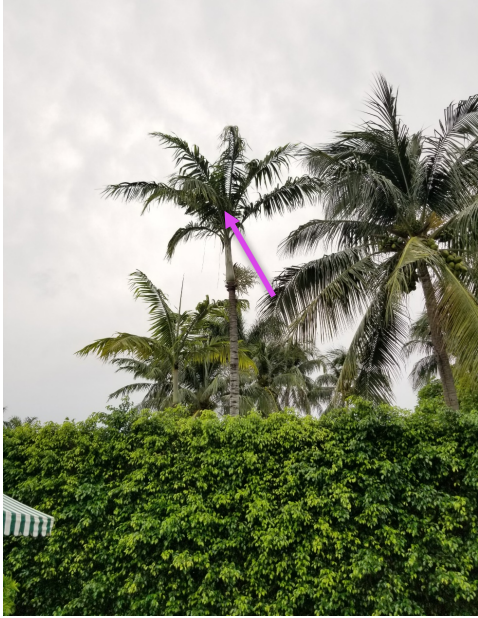
Tree 21\* montgomery palm  
(*Veitchia arecina*)  
6 inch DBH, Good condition  
30 foot height, 12 foot spread

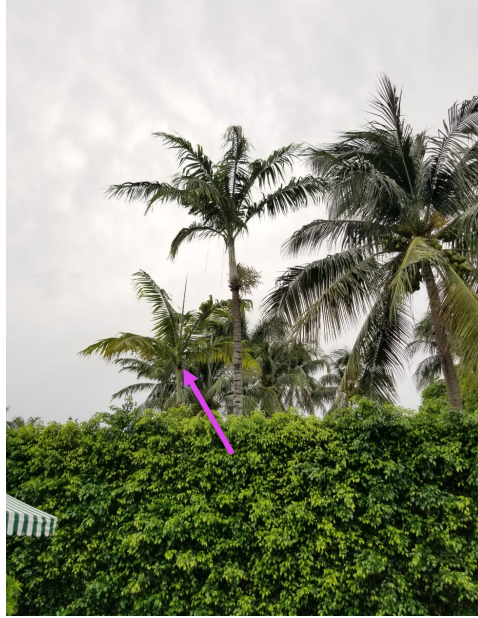
Tree 22\* montgomery palm  
(*Veitchia arecina*)  
6 inch DBH Good condition  
20 foot height, 12 foot spread

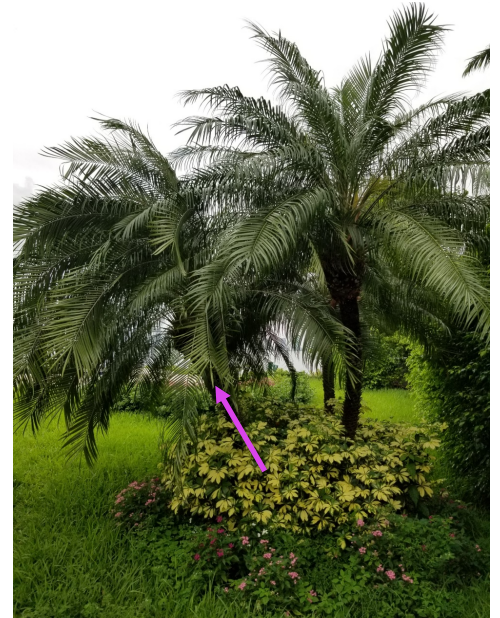
Tree 23A pygmy date palm  
(*Phoenix roebelinii*)  
4 inch DBH Good condition  
9 foot height, 6 foot spread

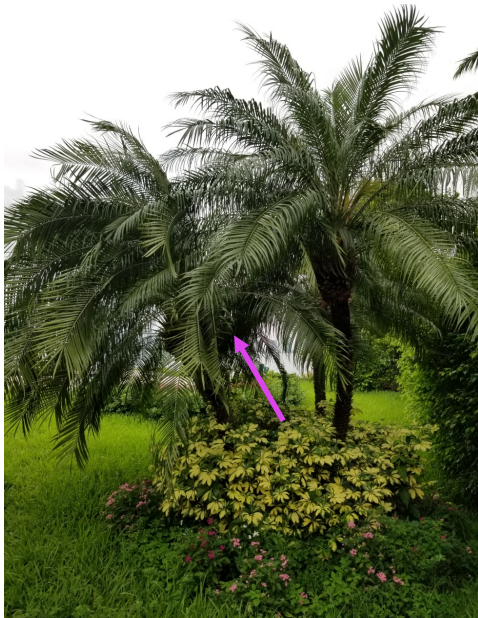
Tree 23B pygmy date palm  
(*Phoenix roebelinii*)  
4 inch DBH, Good condition  
9 foot height, 6 foot spread

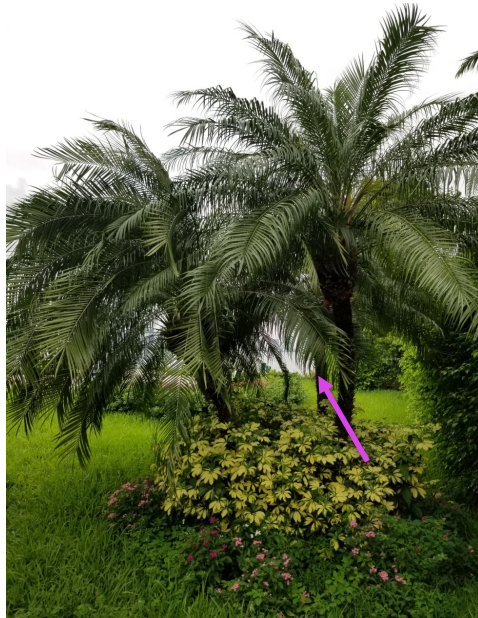
Tree 24A pygmy date palm  
(*Phoenix roebelinii*)  
4 inch DBH Good condition  
9 foot height, 6 foot spread

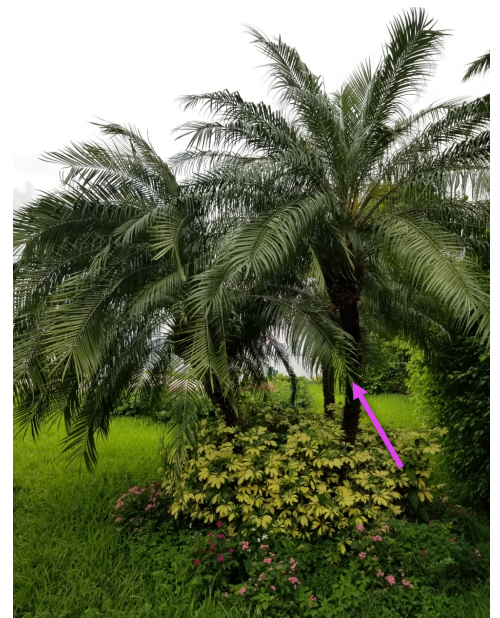
Tree 24B pygmy date palm  
(*Phoenix roebelinii*)  
4 inch DBH Good condition  
9 foot height, 6 foot spread

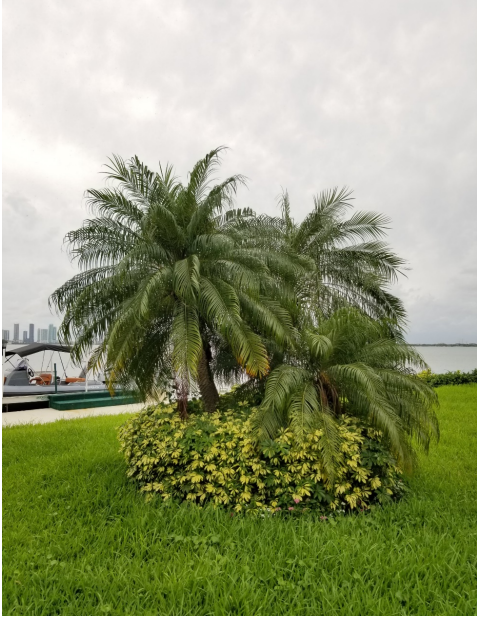
Tree 25A pygmy date palm  
(Phoenix roebelinii)  
4 inch DBH, Good condition  
5 foot height, 8 foot spread

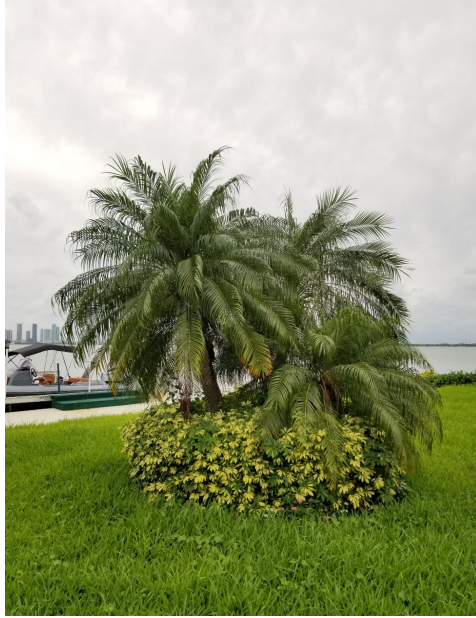
Tree 25B pygmy date palm  
(Phoenix roebelinii)  
4 inch DBH Good condition  
5 foot height, 8 foot spread

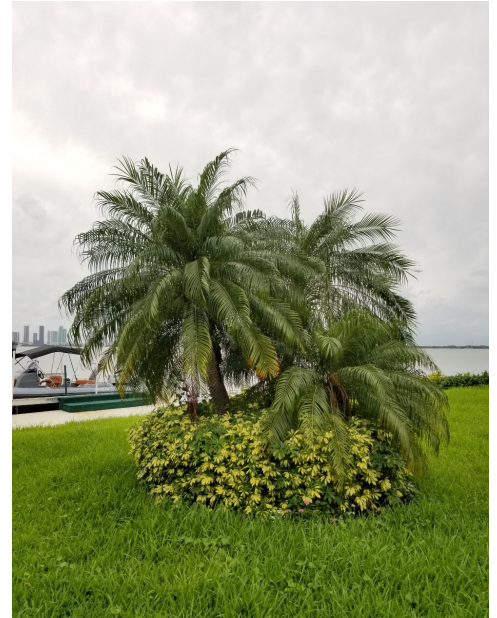
Tree 25C pygmy date palm  
(Phoenix roebelinii)  
4 inch DBH Good condition  
8 foot height, 8 foot spread

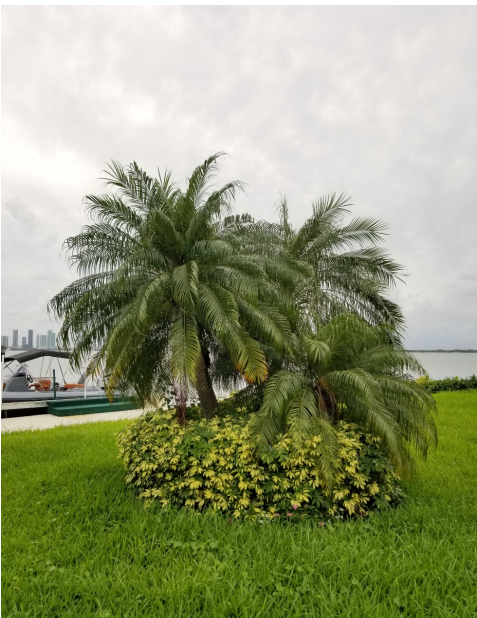
Tree 25D pygmy date palm  
(Phoenix roebelinii)  
4 inch DBH, Good condition  
10 foot height, 8 foot spread

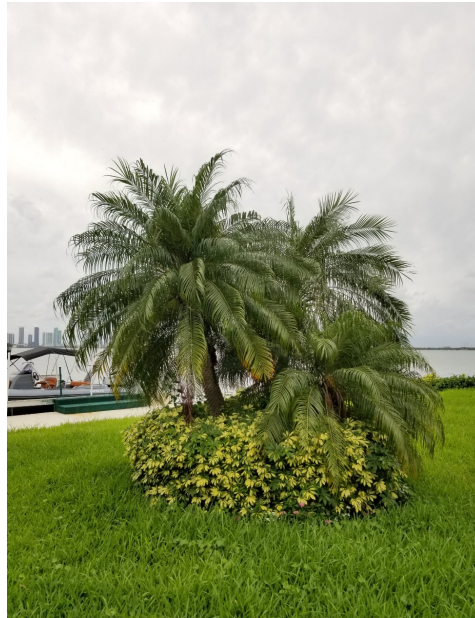
Tree 25E pygmy date palm  
(Phoenix roebelinii)  
4 inch DBH Good condition  
10 foot height, 8 foot spread

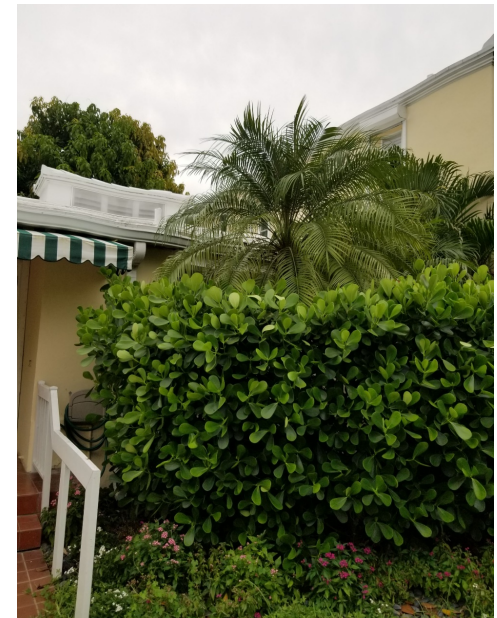
Tree 26 pygmy date palm  
(Phoenix roebelinii)  
4 inch DBH Good condition  
9 foot height, 8 foot spread

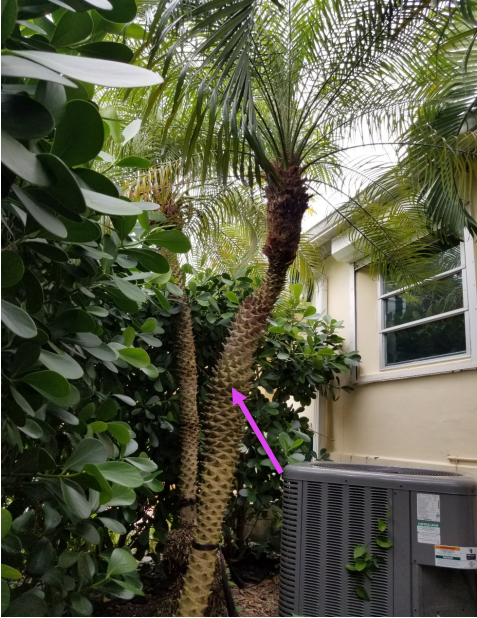
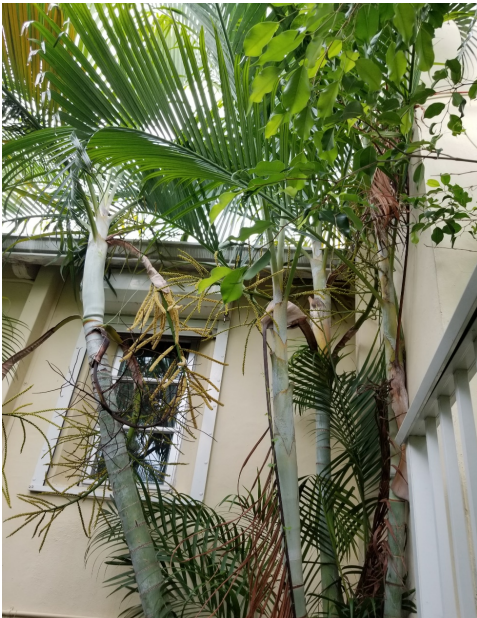
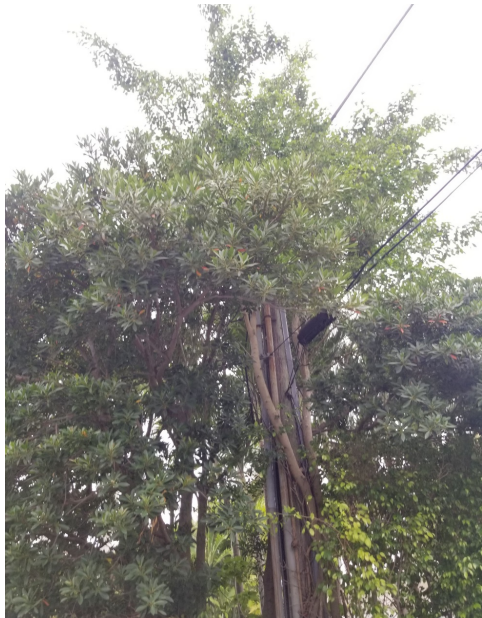
<p>Tree 27 pygmy date palm (Phoenix roebelinii) 4 inch DBH, Good condition 9 foot height, 8 foot spread</p>	<p>Tree 28 areca palm (Dypsis lutescens) cluster inch DBH Good condition 10 foot height, 10 foot spread</p>	<p>Tree 29 weeping fig (Ficus benjamina) 8 inch DBH Non-viable condition 30 foot height, 15 foot spread</p>

<p>tree is growing by attaching to active utility pole</p>
<p>Tree 16 Additional Photo</p>

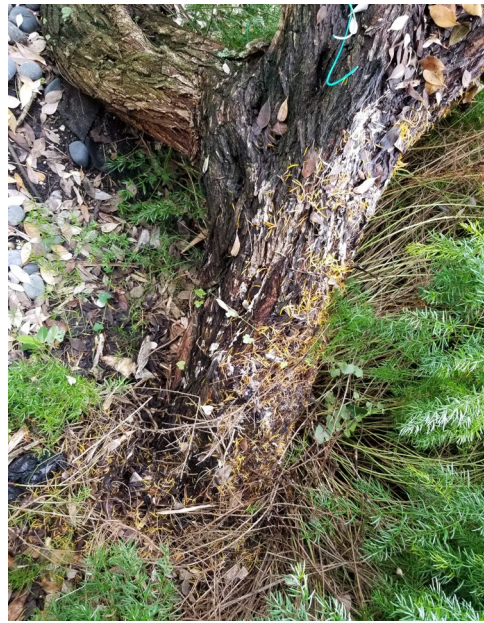
<p>White rot visible at base, trunk laying on ground</p>
