# ***Tree Resource Evaluation for the site to the east of 6988 Abbott Avenue, Miami Beach***

***North Beach Town Center Development, LLC***

***December 23, 2019***

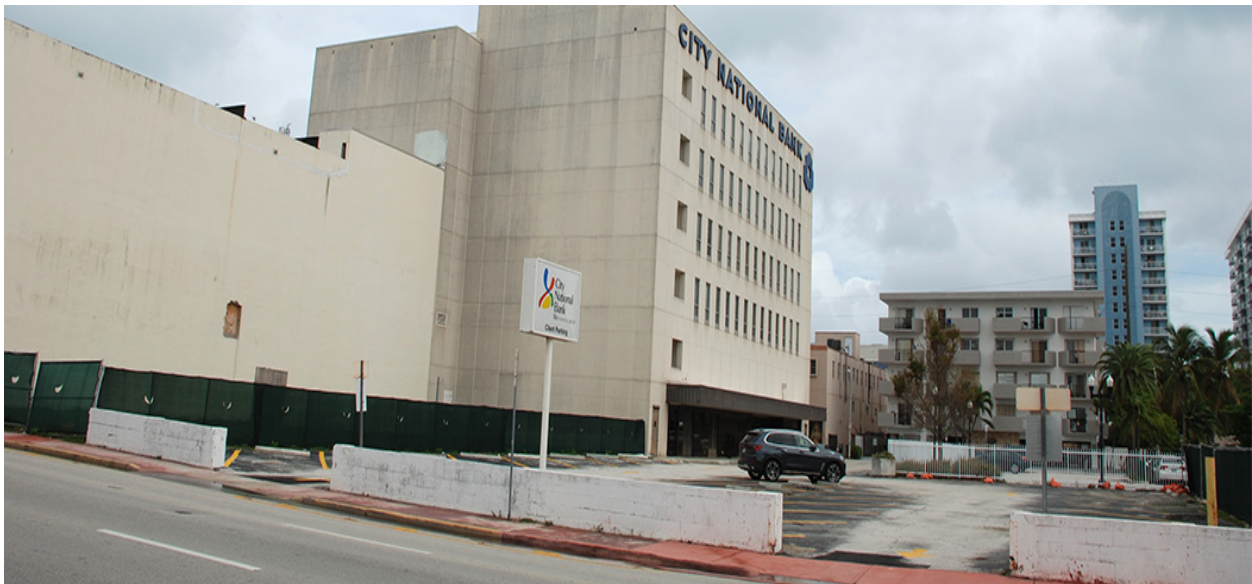
**Photo 1 above is the site viewed from Abbott Avenue looking east.**

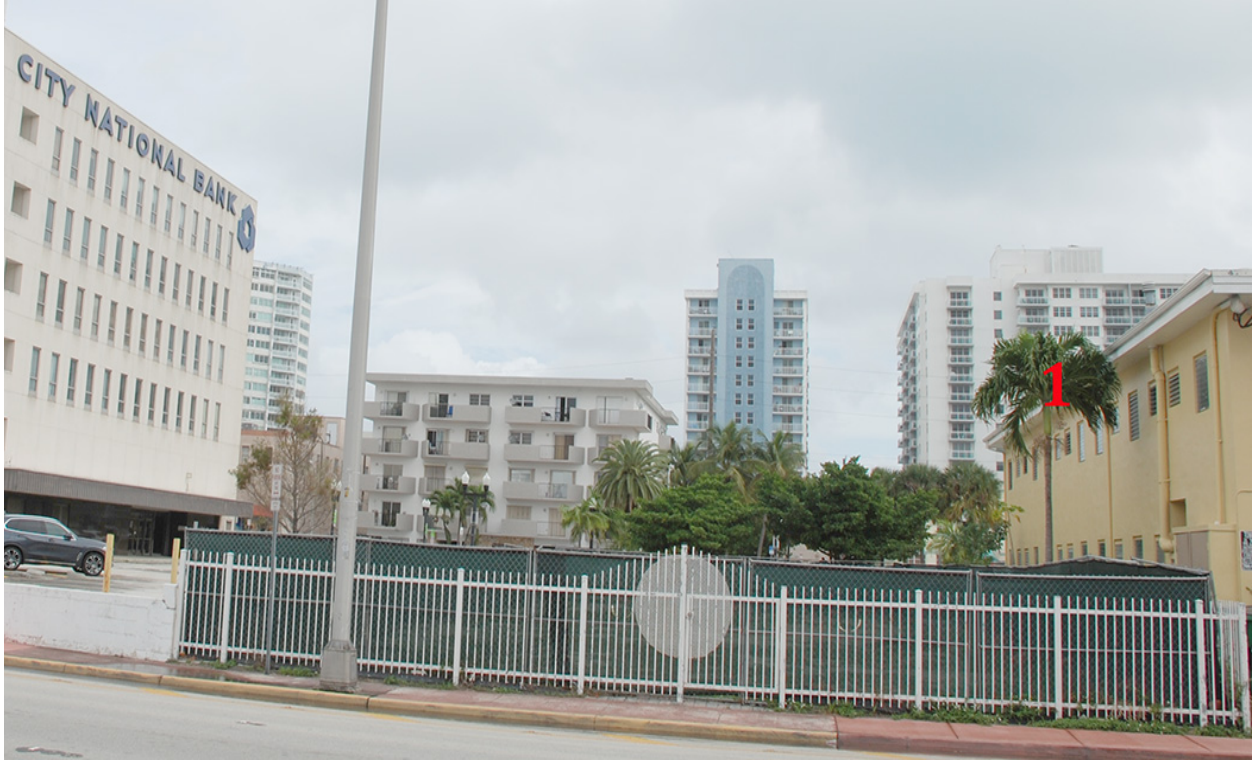
**Photo 2 above is the site viewed from Abbott Avenue looking east.**

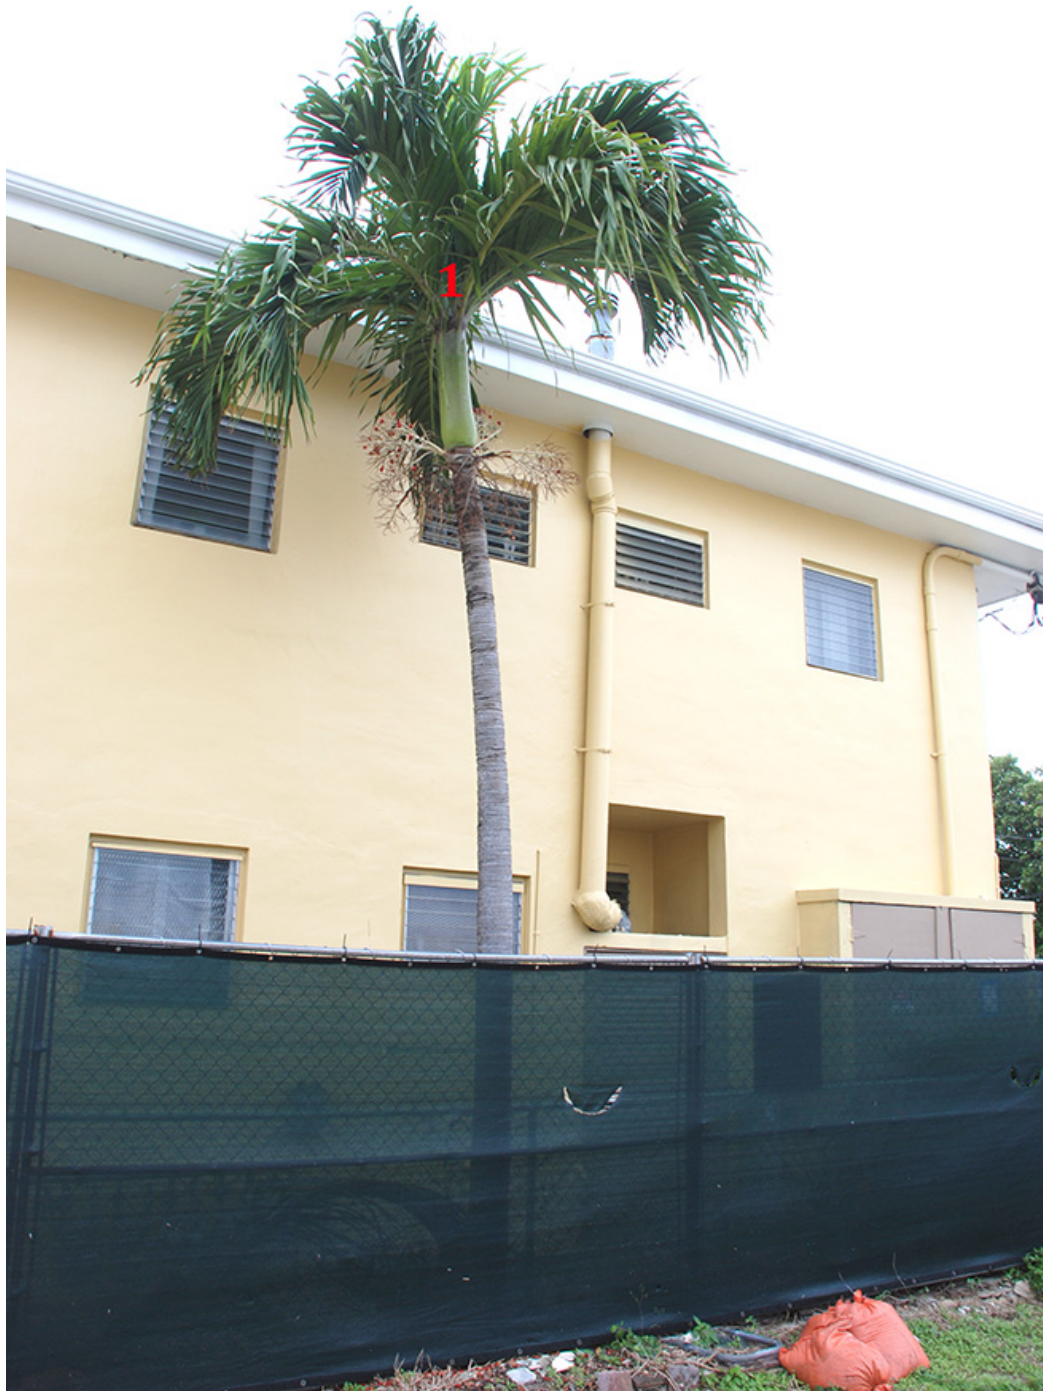
**Photo 3 above is palm 1 viewed from the northeast.**

Scientific name	Common name	DBH	H/Ct	Canopy	Condition	TPZ
1	Adonidia merrillii	Christmas palm	6"	16'	14'	Good	3'
2	Ficus aurea	Strangler fig	2"	12'	10'	Poor	3'

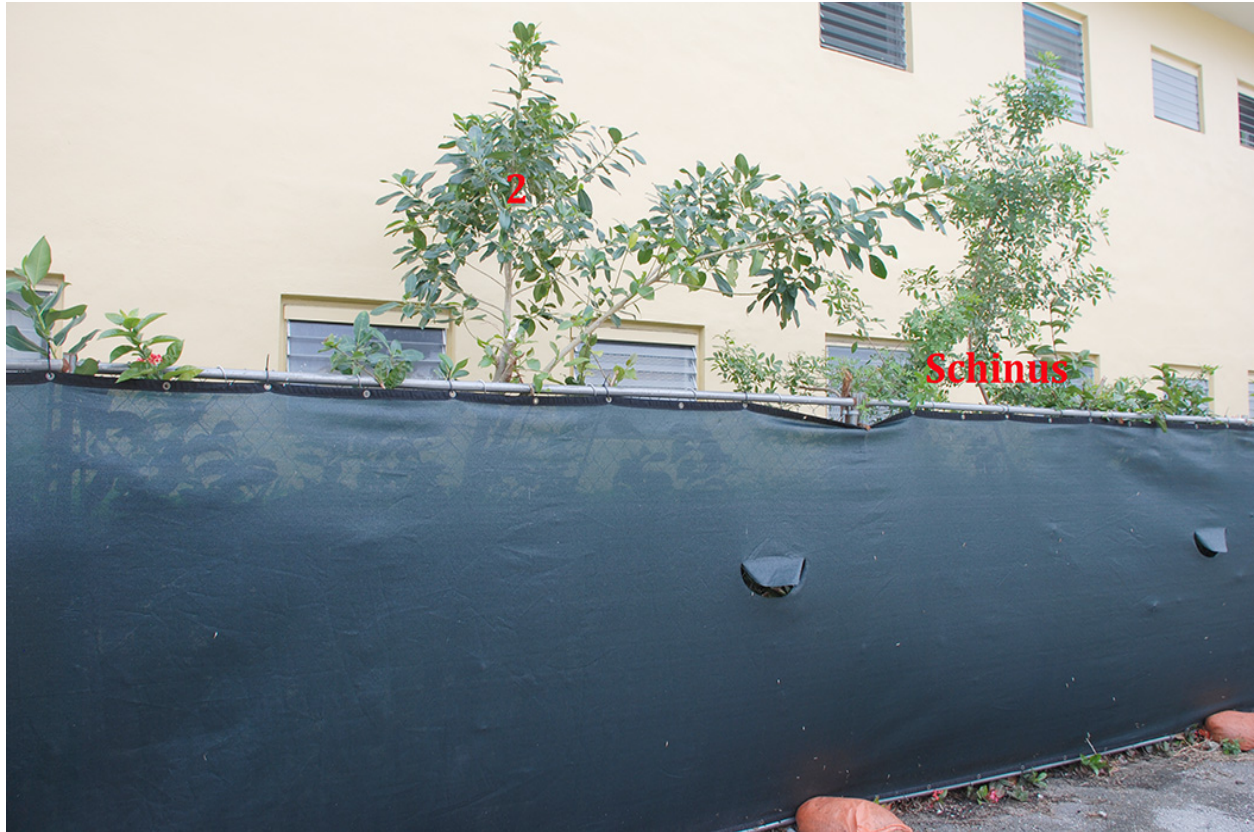
Photo 4 above is tree 2 viewed from the north. Note the *Schinus terebinthifolius*, Brazilian pepper an invasive species to the right/west of tree 2.

- I recommend the removal of trees and palms that I rated to be in poor condition.
- DBH is taken to the closest inch measurement.
- Canopy diameter is measured in one direction and is approximate.
- The “H/Ct” column denotes approximate overall height for trees and approximate clear trunk or gray wood for palms.
- TPZ is a radius measurement from the outside of the trunk.
- The TPZ/CRZ will be limited to adjacent curbs, flatwork, or asphalt on the sides of those palms or trees.

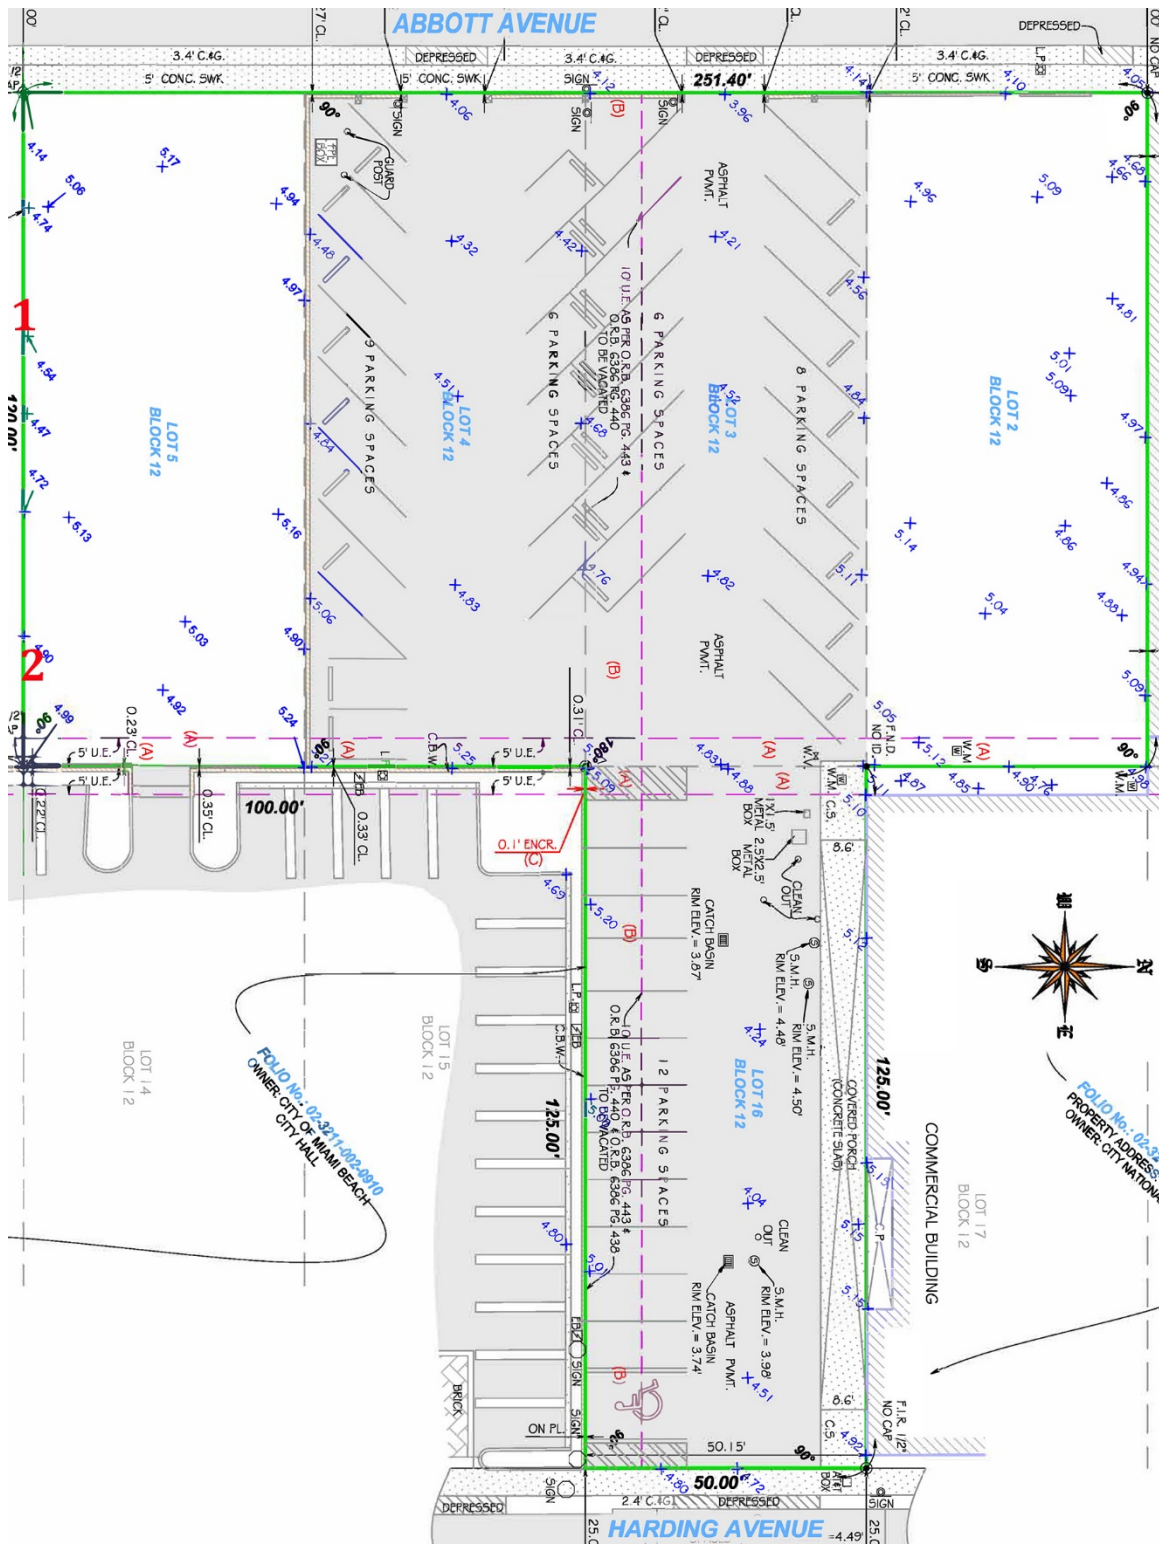
## Appendix – B - Approximate location of trees and palms onsite

**I performed a tree resource evaluation on a site to the east of 6988 Abbott Avenue, Miami Beach on December 21, 2019. The approximate locations of these trees and palms can be found on the schematic in Appendix B.**
