Tree Resource Evaluation for Three Trees at 2050 N. Bay Road, Miami Beach

October 9, 2020

Summary

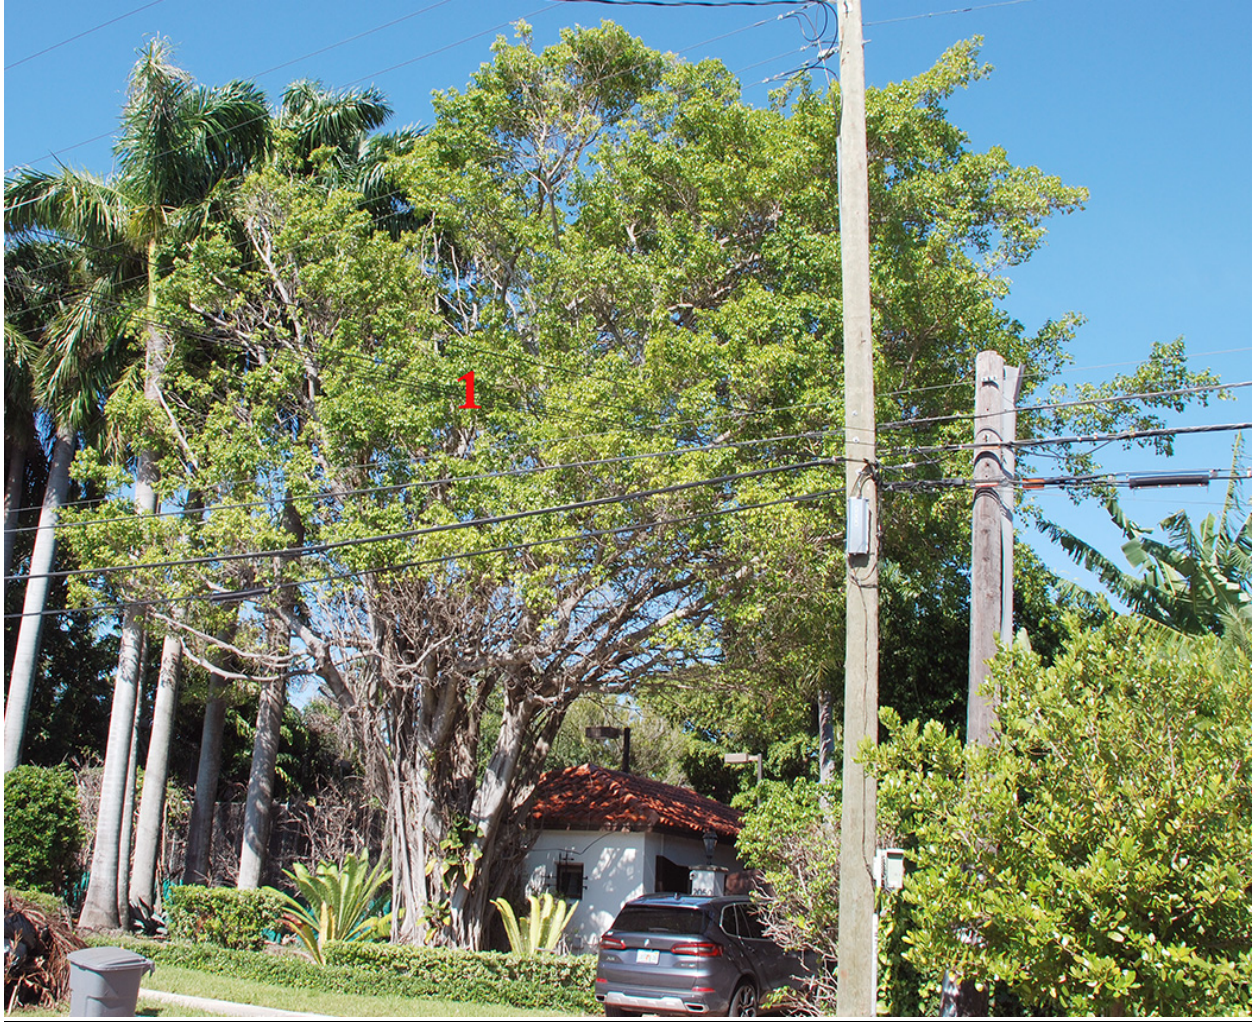
Photo 1 above is tree 1 viewed from the southeast. Note the proximity of the powerlines.

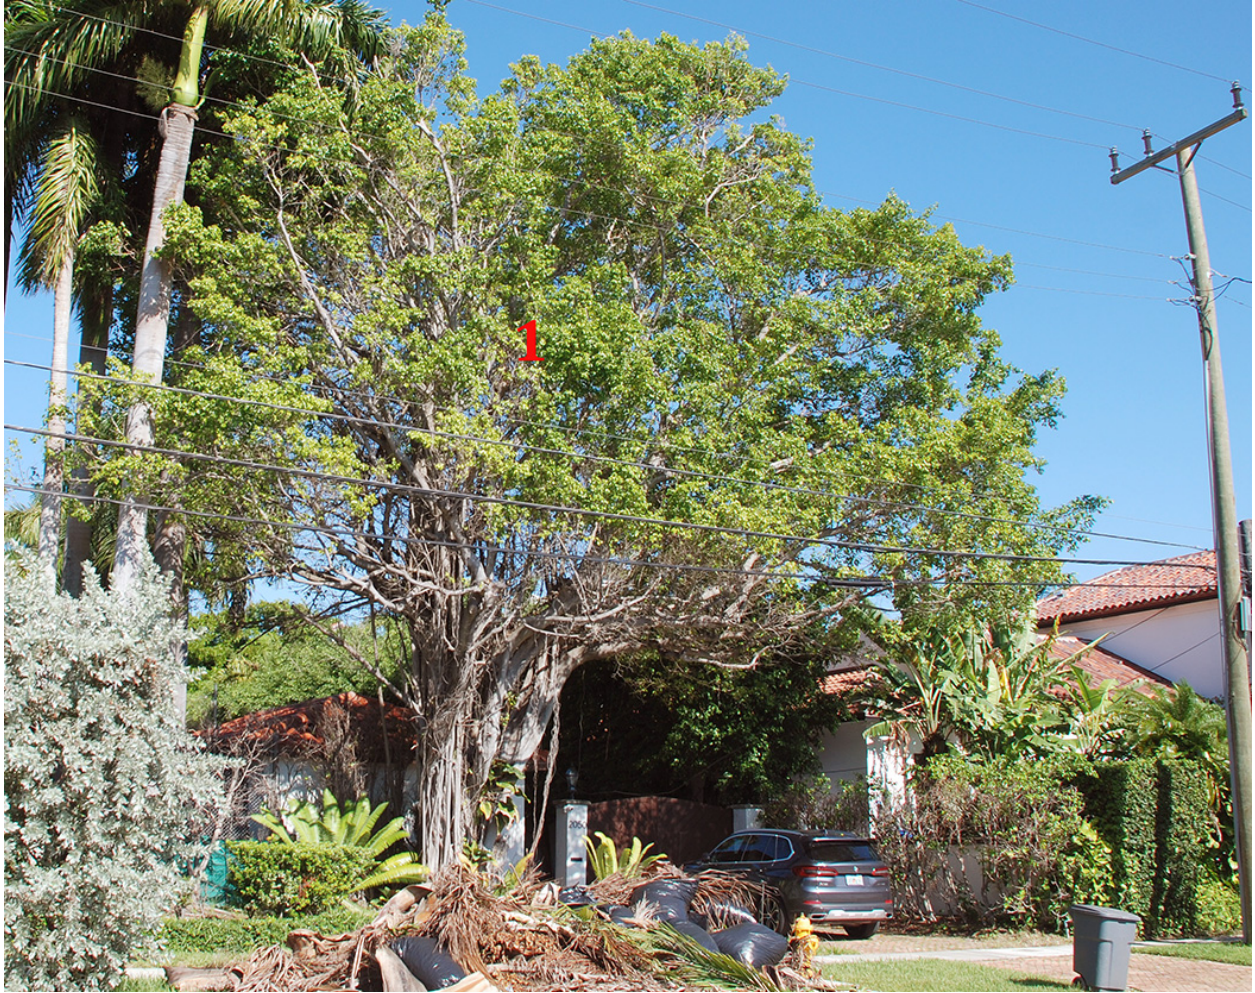
Photo 2 above is tree 1 viewed from the southwest. The canopy of this tree is not as vigorous and dense as a normal healthy tree of this species.

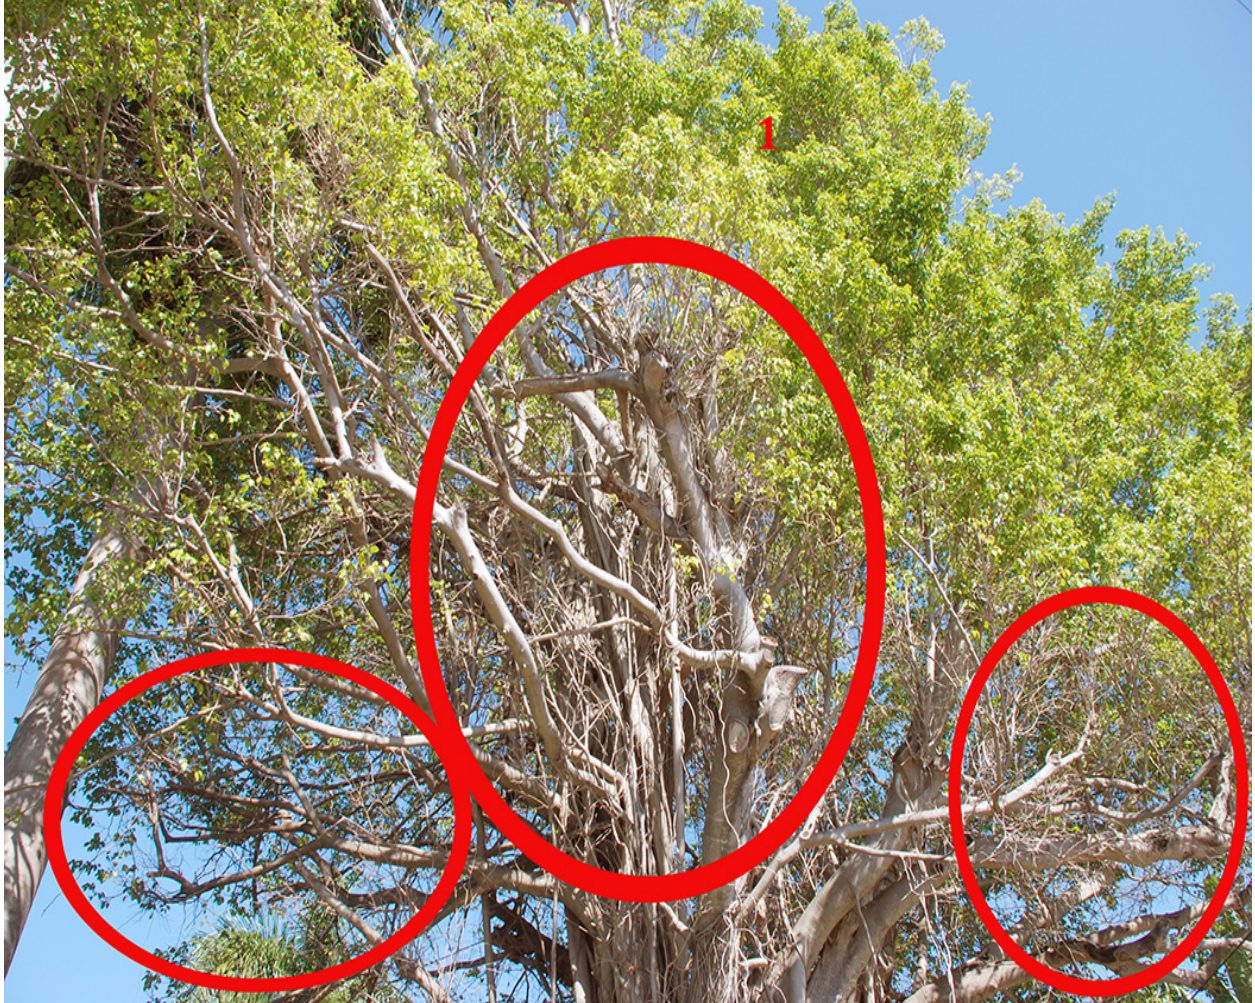
Photo 3 above is the east side of the canopy that has been continuously utility pruned. The circles indicate a significant amount of small dead branches that should be removed.

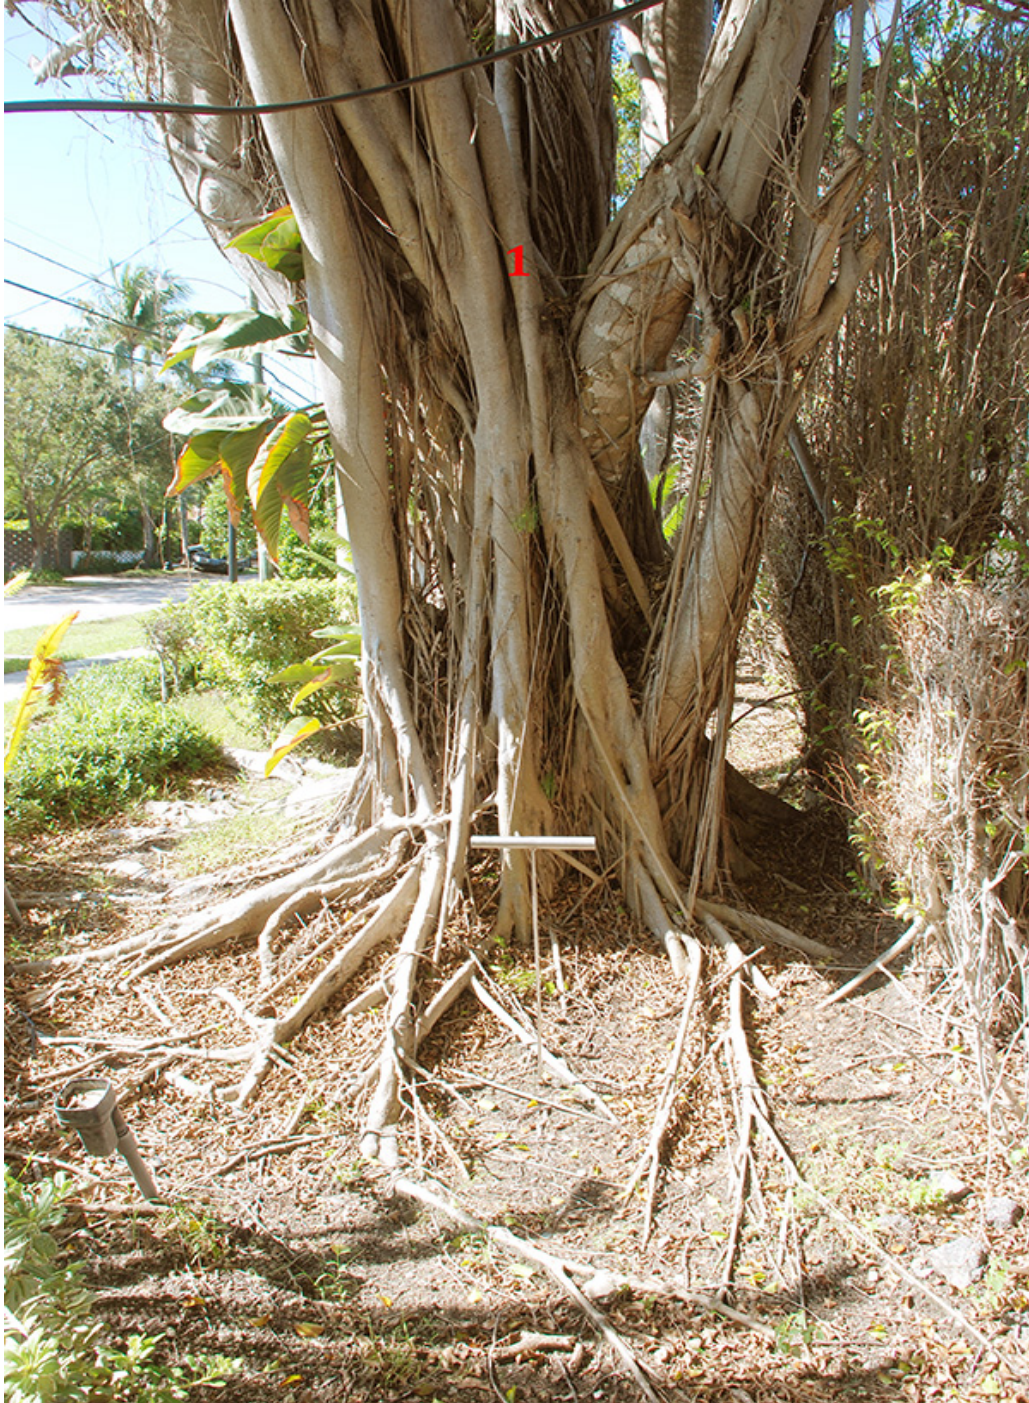
Photo 3 above is the northeast side of tree 1. I tested the soil compaction around the root plate of this tree and found the soil to be very compacted and difficult to pierce with a steel spike beyond 4 or 5 inches. Also note how close the adjacent wall is to the right/west of the trunk. This limits the CRZ of this tree to the edge of the wall.

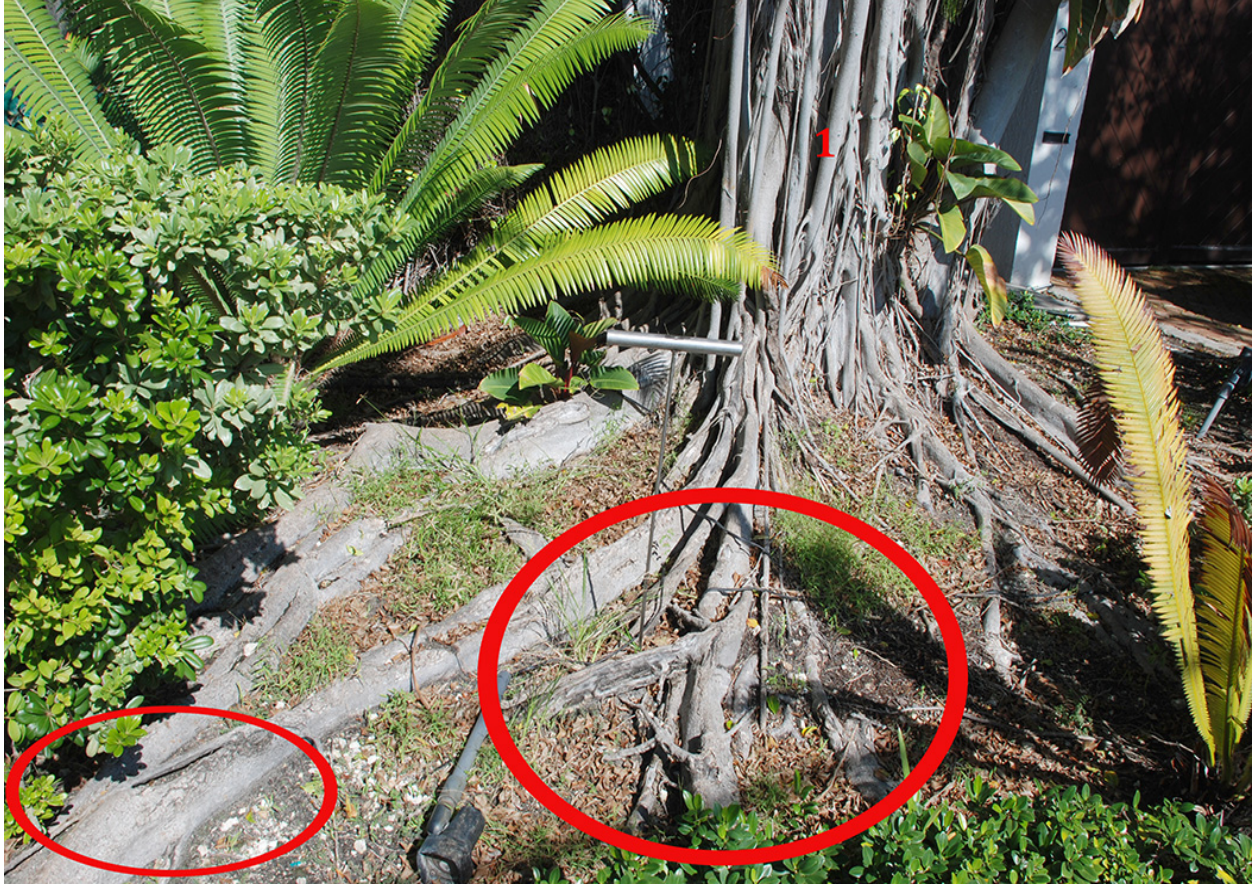
Photo 4 above is the east side of tree 1. I tested the soil compaction around the root plate of this tree and found the soil to be very compacted and difficult to pierce with the steel spike beyond 4 or 5 inches. There are numerous surface roots around this tree, normally an indication of very compacted soil or rock. The circles indicate damaged and decaying roots.

This tree will not tolerate 3 or more feet of additional soil over the root plate.

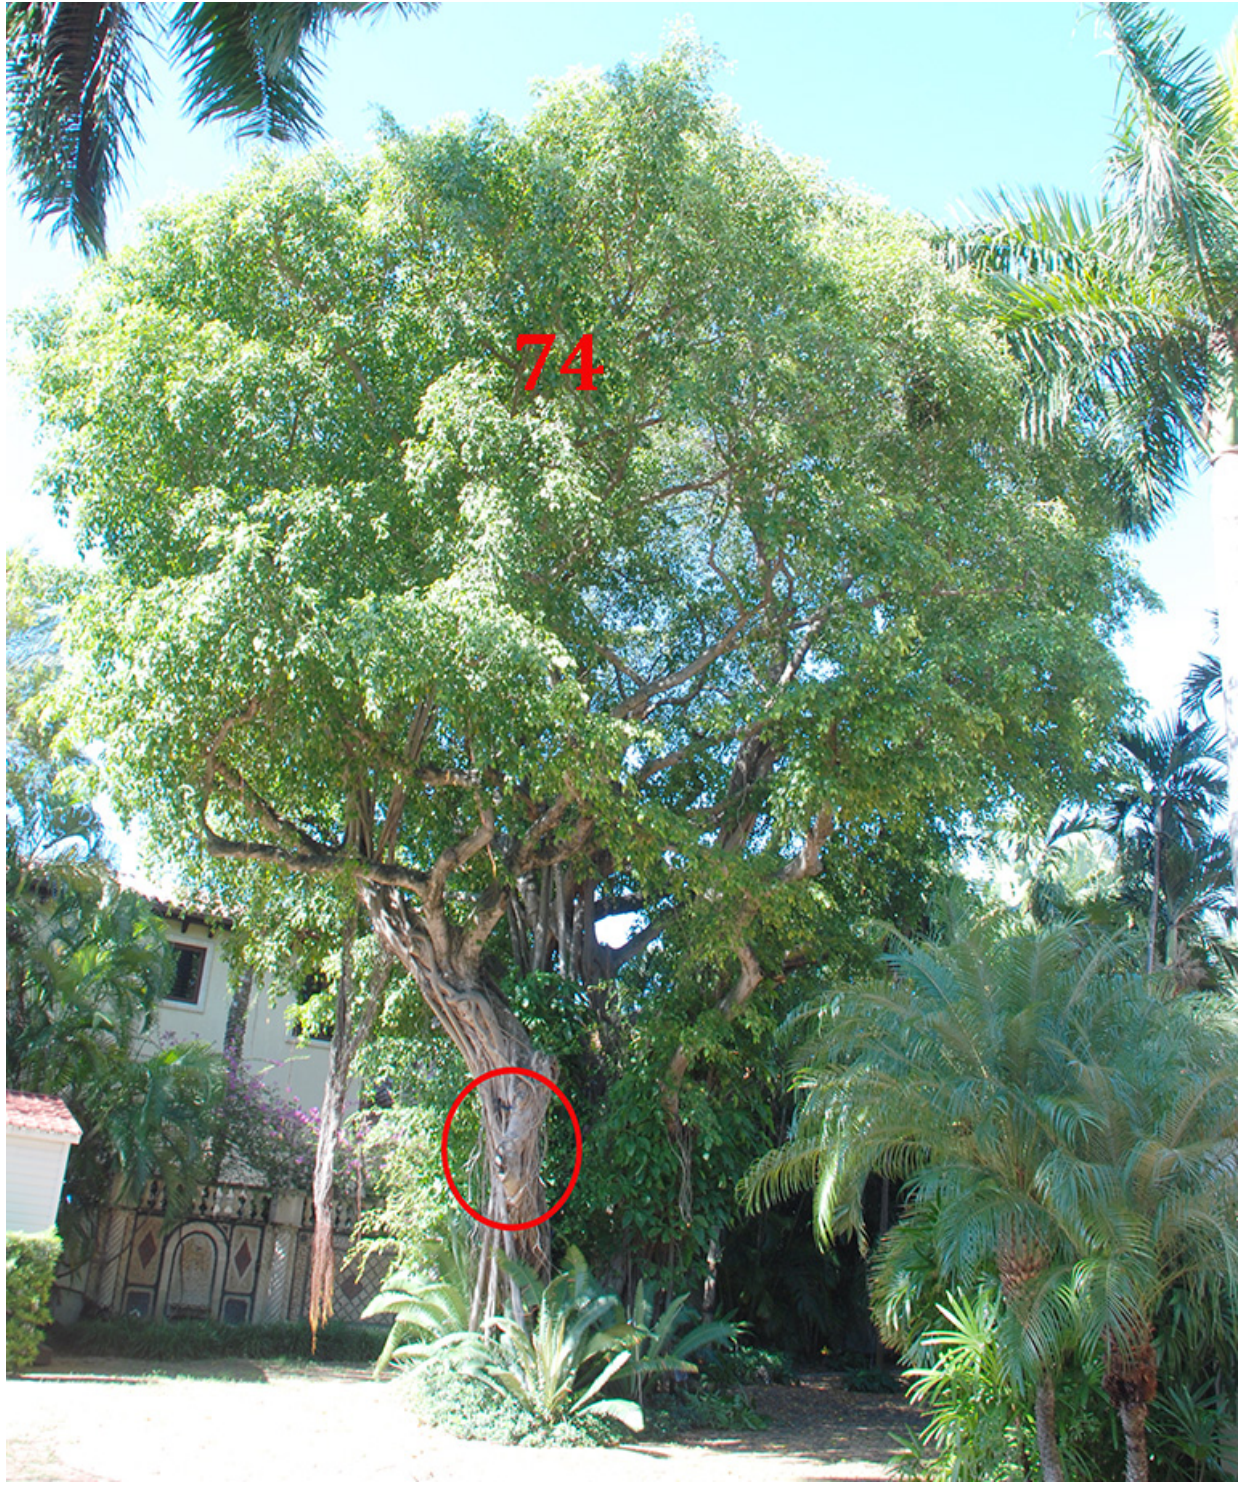
Photo 5 above is tree 74 viewed from the east. See following photo for a closer view of the circled area.

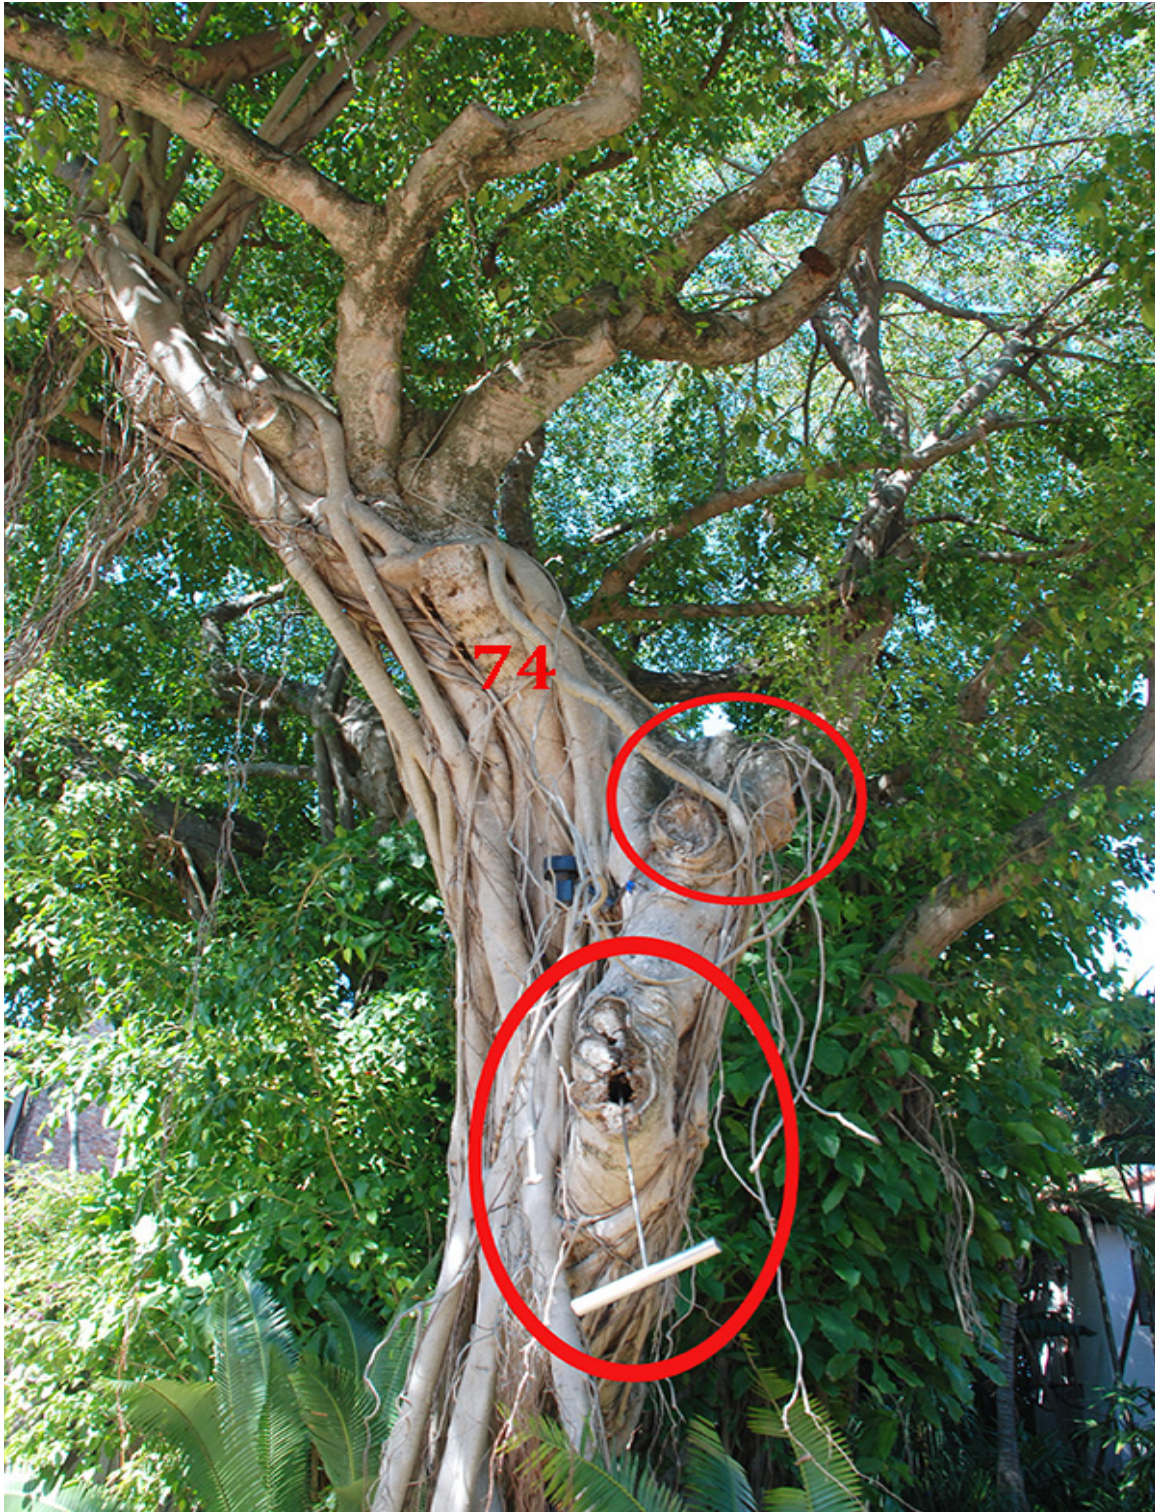
Photo 6 above shows cavities and decay from old pruning flush cuts. This decay is in a critical area. The decay will increase over time.

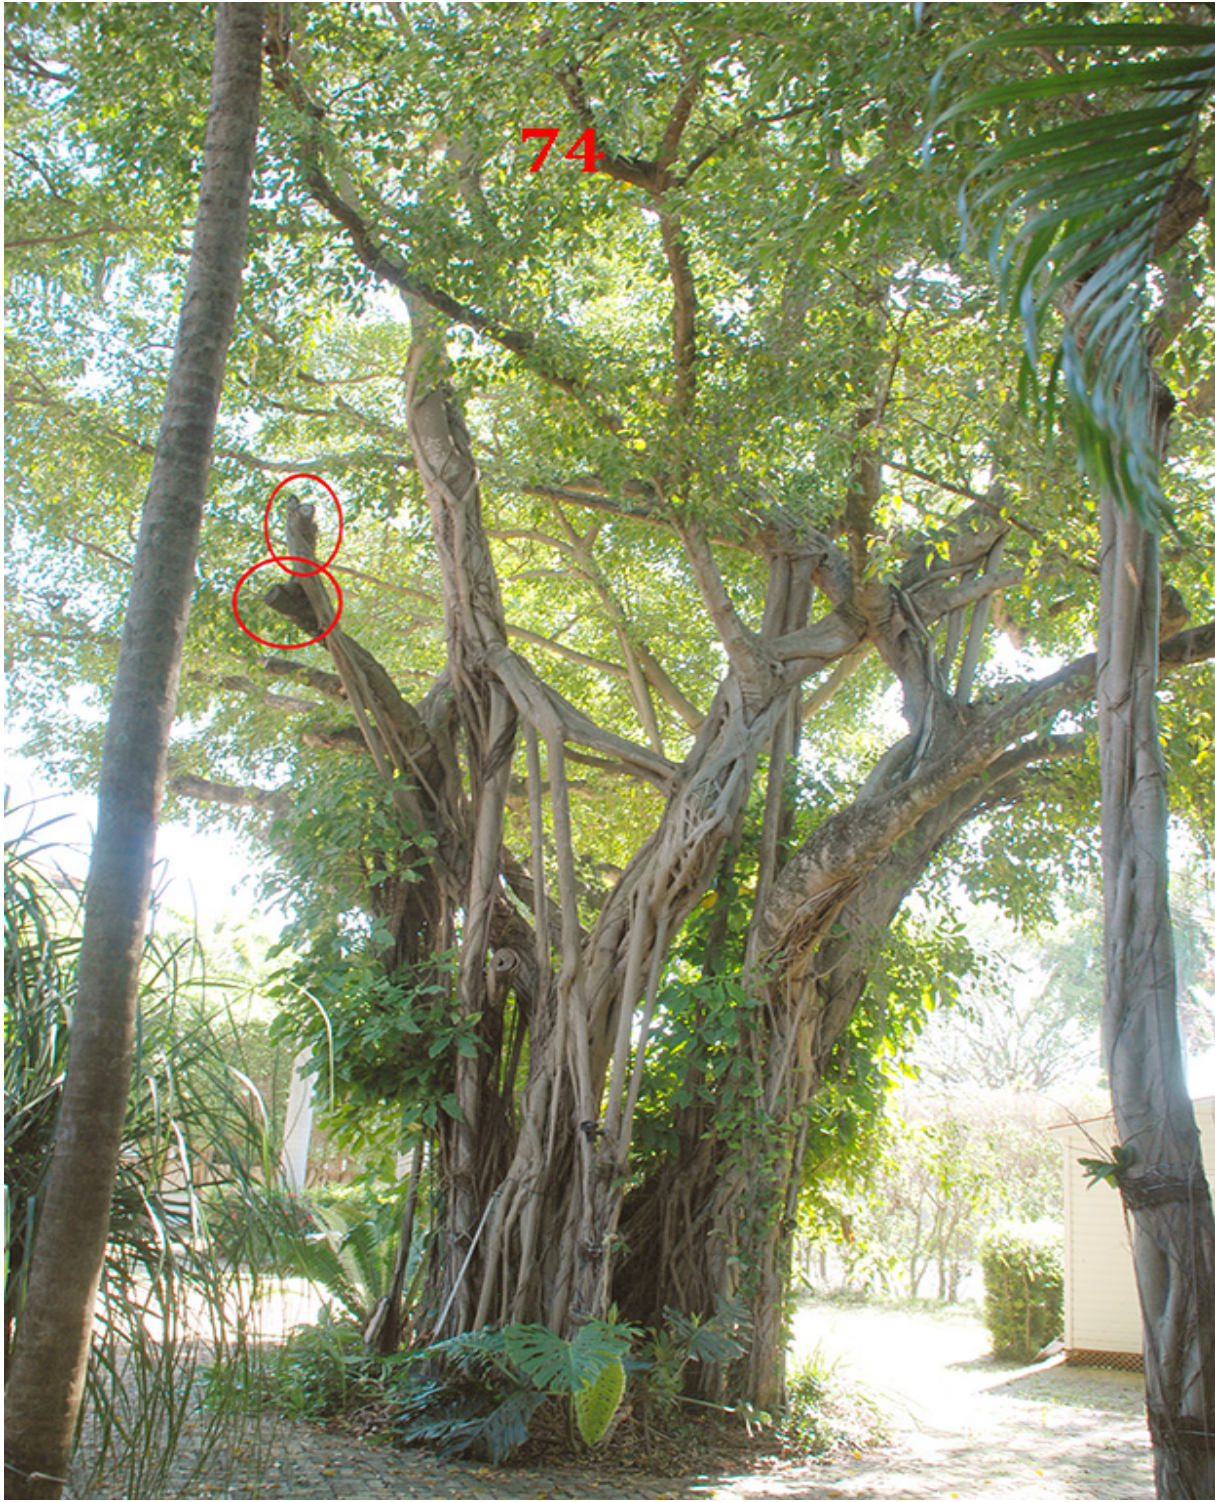
Photo 7 above is tree 74 viewed from the northwest. The circles indicate old pruning removal cuts that are decaying.

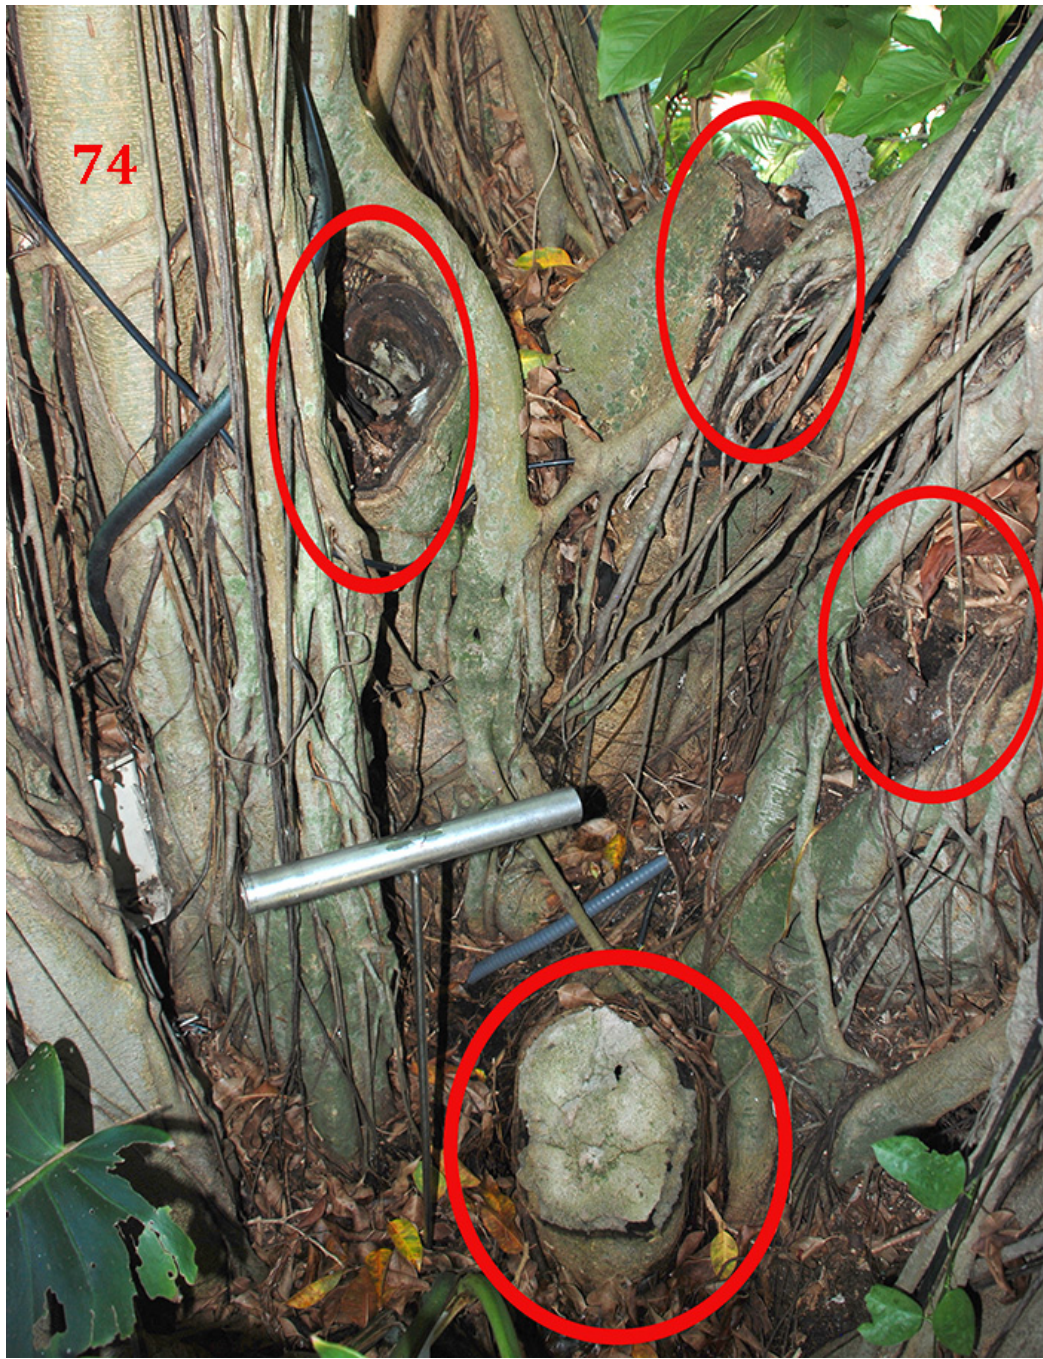
Photo 8 above is a closer view of the trunk(s) on the northwest side of tree 74. The circles indicate old pruning flush cuts that are decaying. The bottom cut is covered in old concrete. This spreading decay is in a critical structural location. This tree should be considered for removal.

This tree will not tolerate its root plate being covered with 3 or more feet of fill.

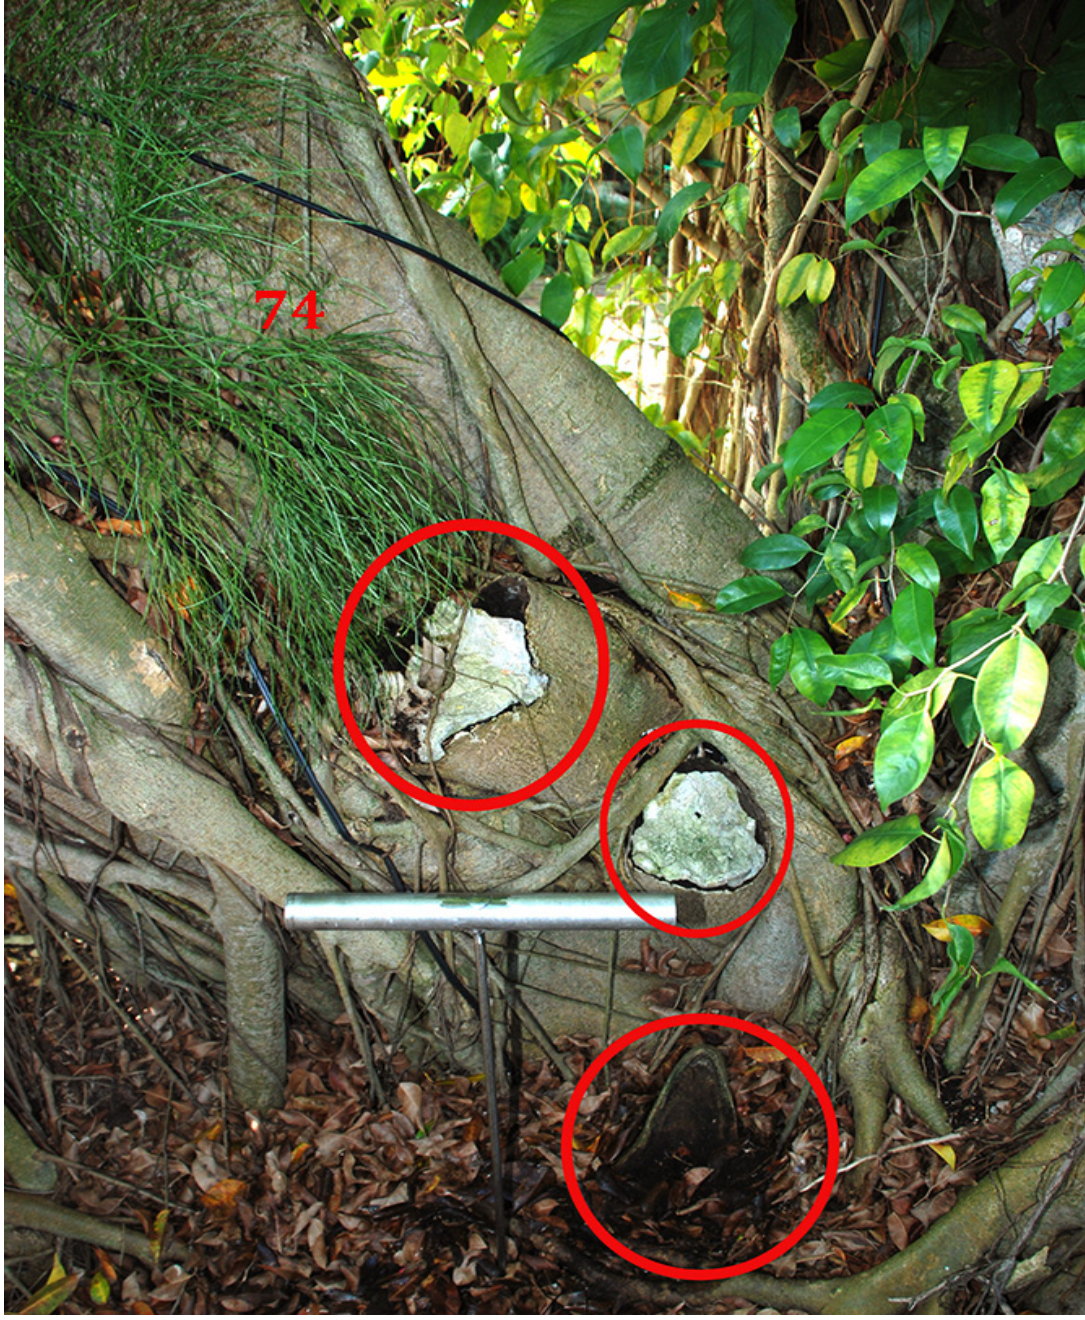
Photo 9 above is a closer view of the trunk(s) on the northeast side of tree 74. The circles indicate old pruning flush cuts that are decaying. The two upper cuts are covered in old concrete. This spreading decay is in a critical structural location. This tree should be considered for removal.

This tree will not tolerate its root plate being covered with 3 or more feet of fill.

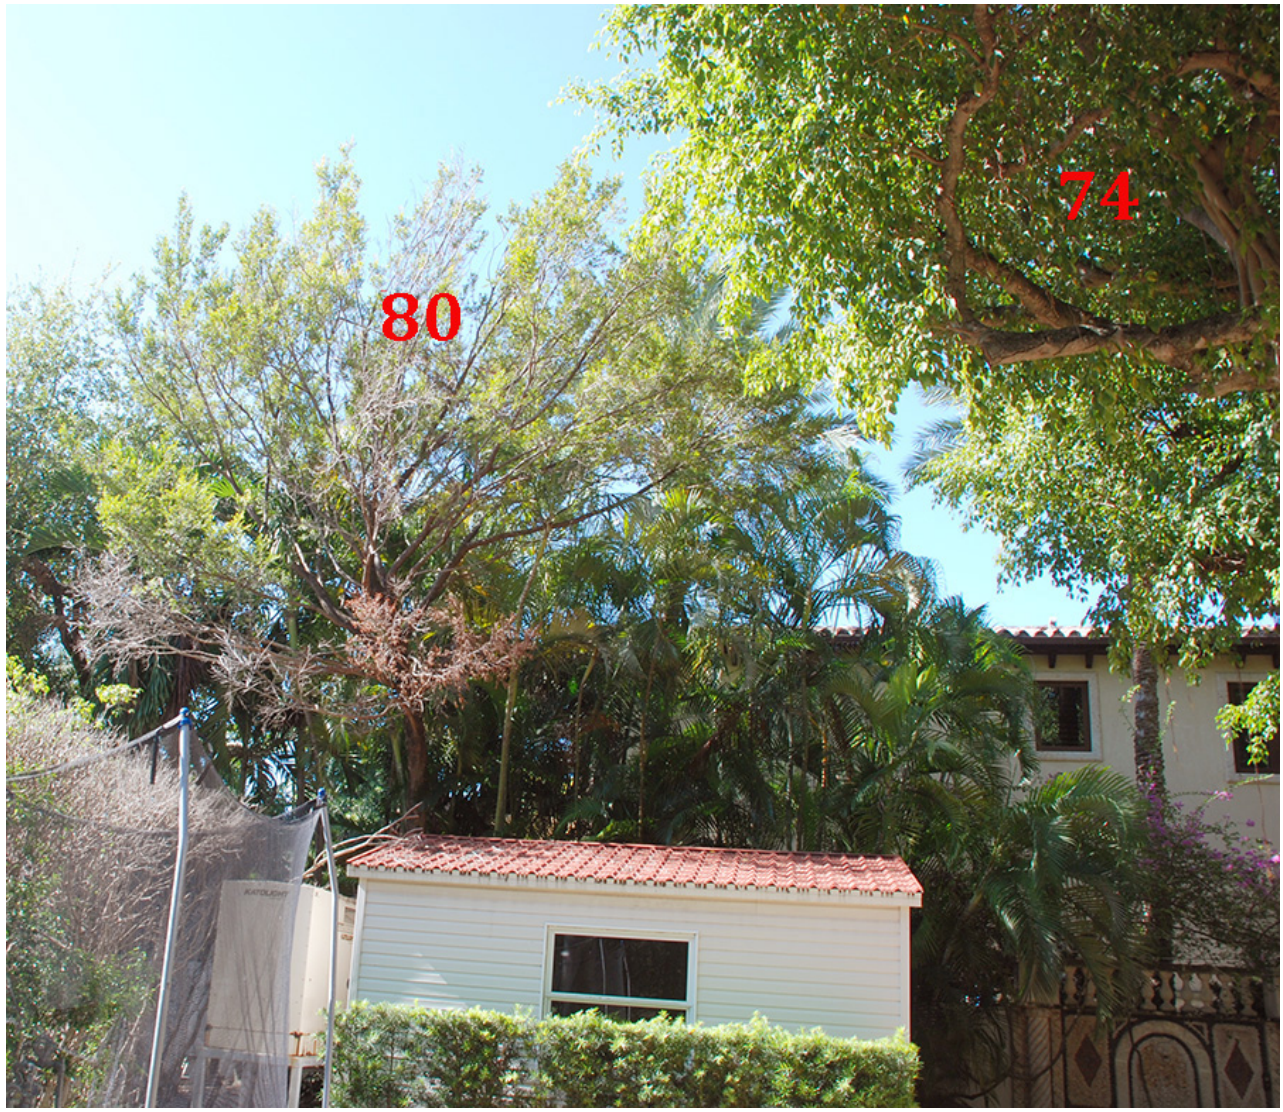
Photo 10 above is tree 80 viewed from the northeast.

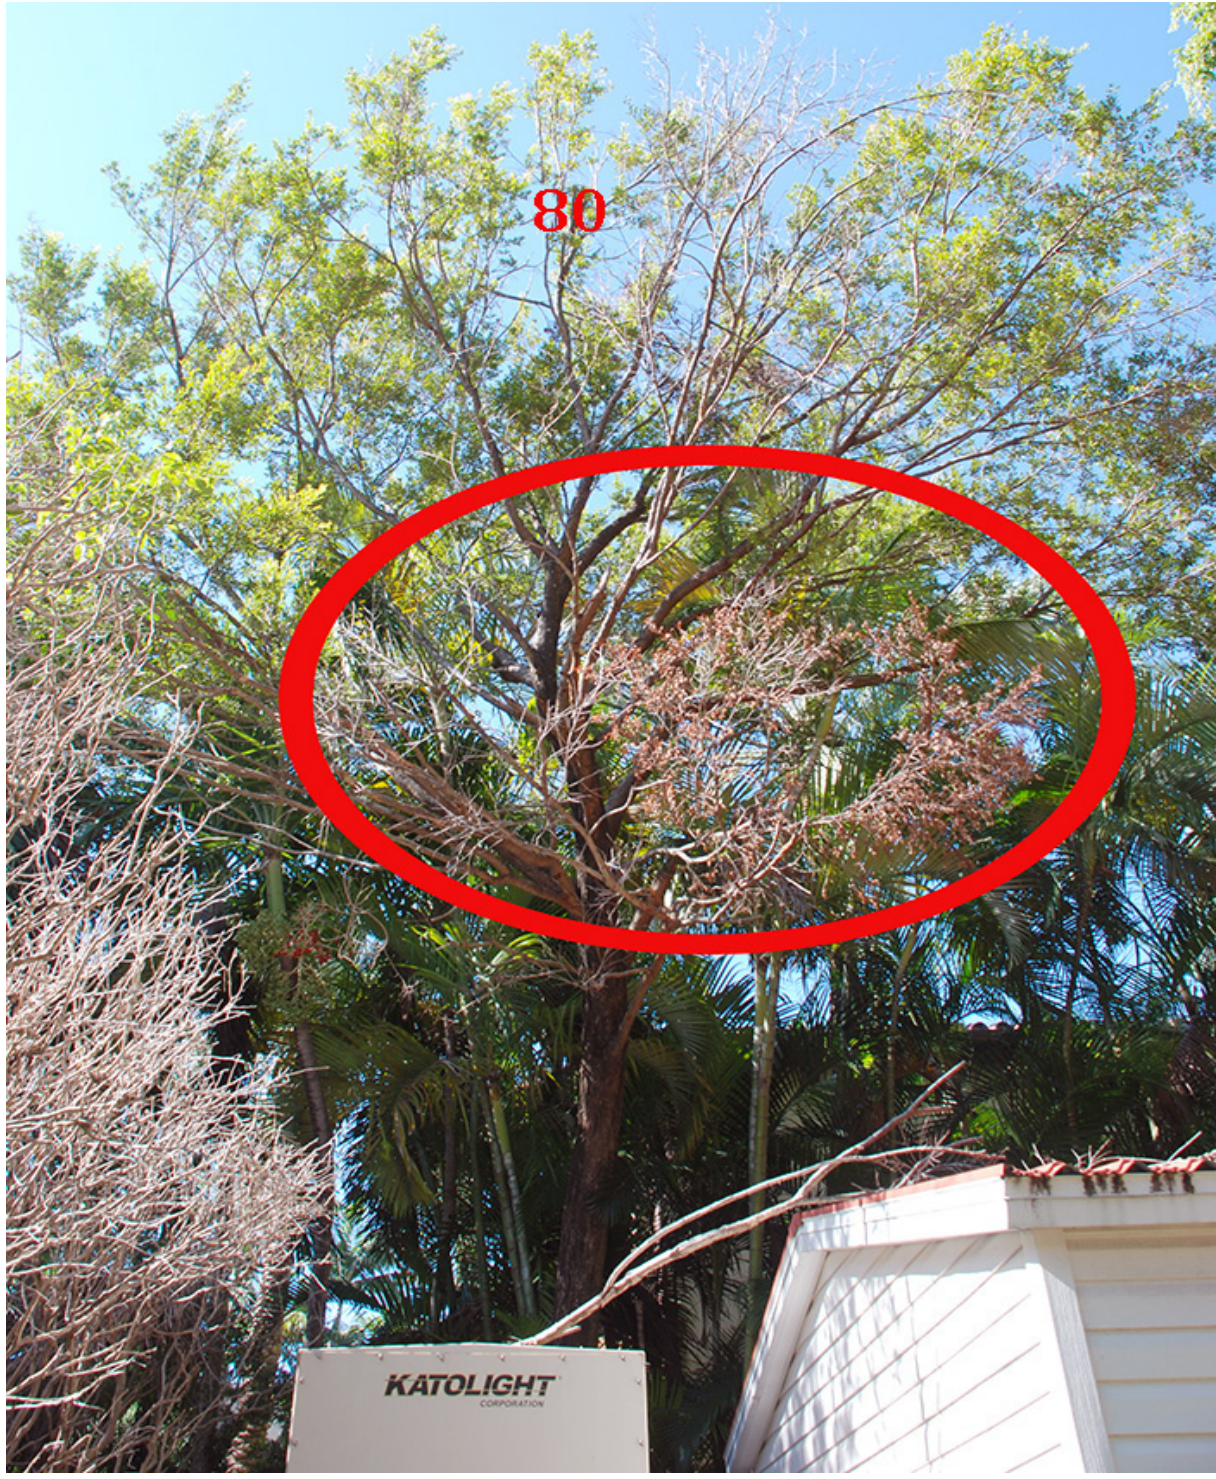
Photo 11 above is a closer view of tree 80. The dead and burnt-looking foliage is likely an abiotic issue. It was possibly caused by heat and exhaust from the generator below.

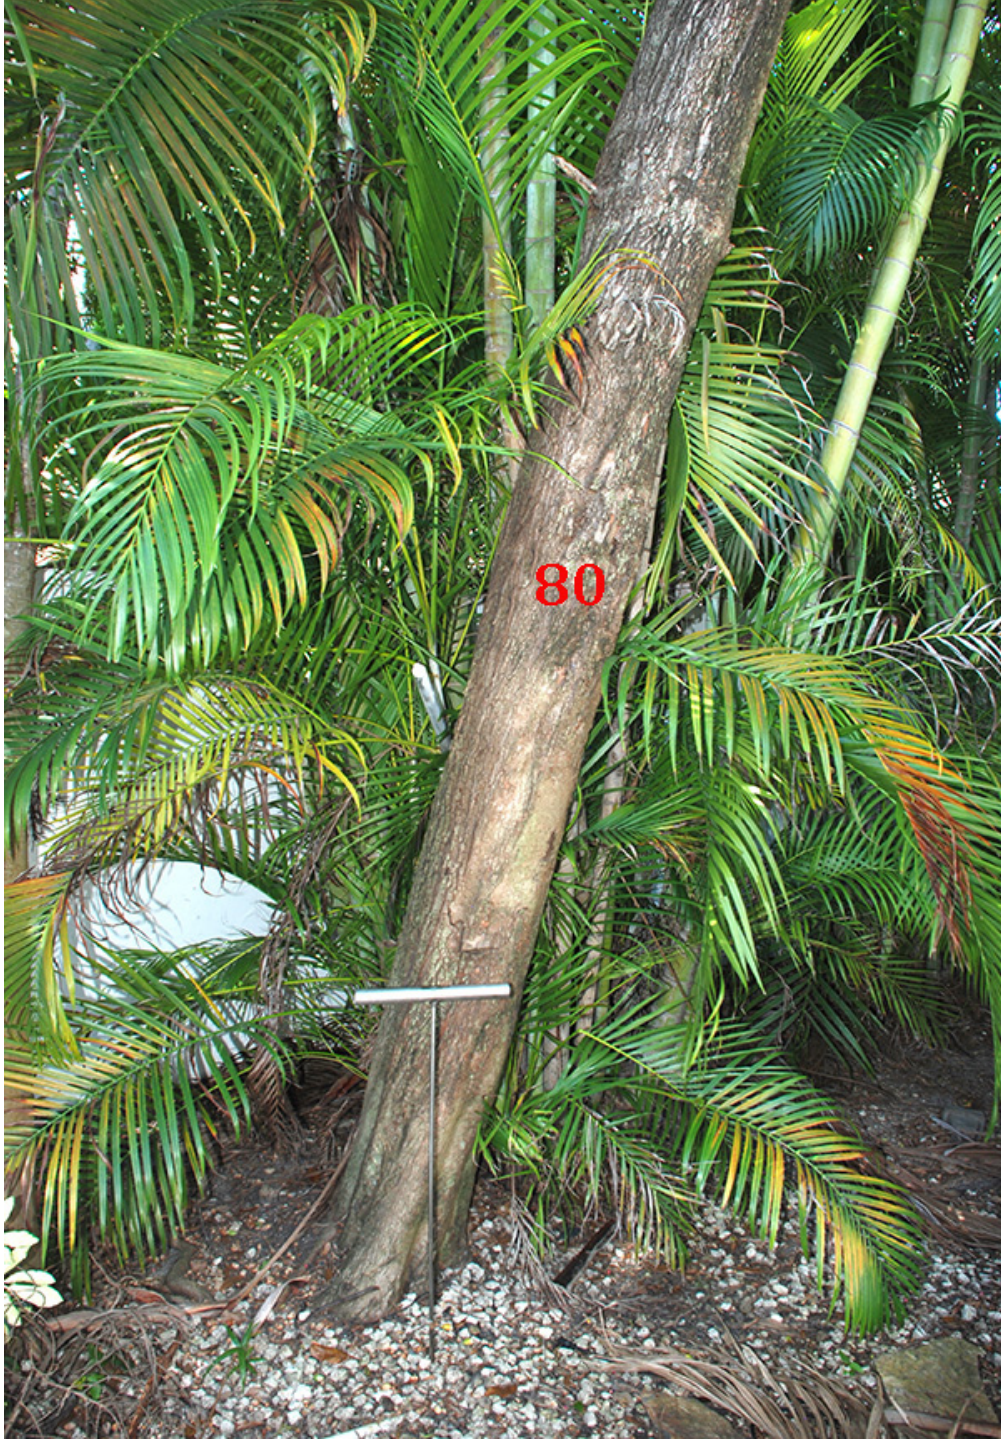
Photo 12 above is the trunk of tree 80. Note how close the wall is to the trunk. The CRZ of this tree ends at the edge of the wall.

This tree will not tolerate 3 or more feet of fill on top of the root plate.
