Tree Inventory

14 November 2020

RE: 2687 Flamingo Dr. Miami Beach, FL. 33140

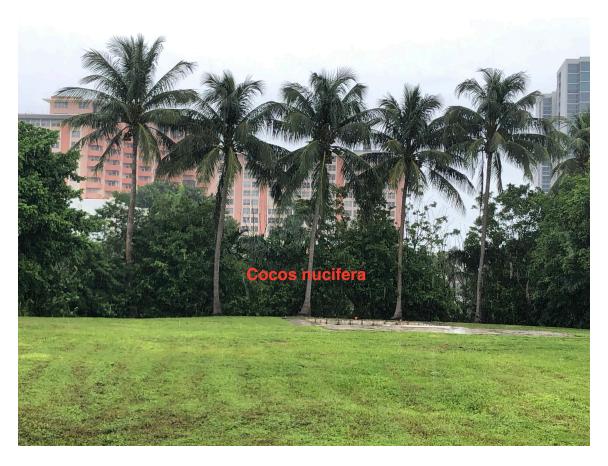
On the east perimeter of the property are five (5) Cocos nucifera (Coconut palm) with an OAH of 35'-40' x 25'-30' SP with an average DBH of 11". Photo attached below.

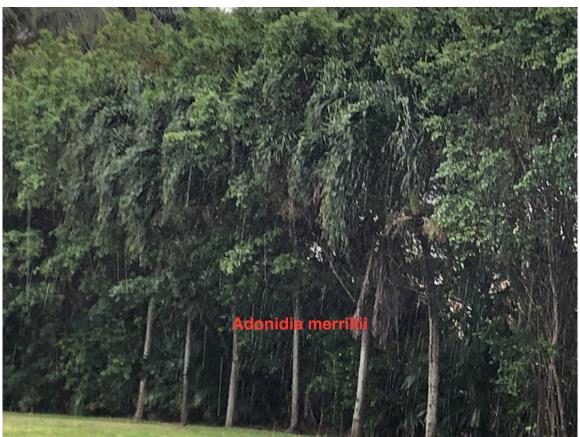
On the eastern end of the south perimeter there are six (6) *Adonidia merrillii* (Christmas palm) with an OAH of 20'-22' x 12'-14' SP with an average DBH of 5.5". Photo attached below.
