# ***Tree Resource Evaluation for 1753 & 1771 N. View Drive, Miami Beach***

***Sunset Islands Land Trust  
1771 North View Drive  
Miami Beach, FL 33140***

***Jeff Shimonski  
President, Tropical Designs of Florida  
Member, American Society of Consulting Arborists  
ISA Certified Arborist Municipal Specialist FL-1052AM  
ISA Tree Risk Assessment Qualification  
LIAF Florida Certified Landscape Inspector 2016-0175  
305-773-9406  
Jeff@TropicalArboriculture.com***

***October 29, 2020***

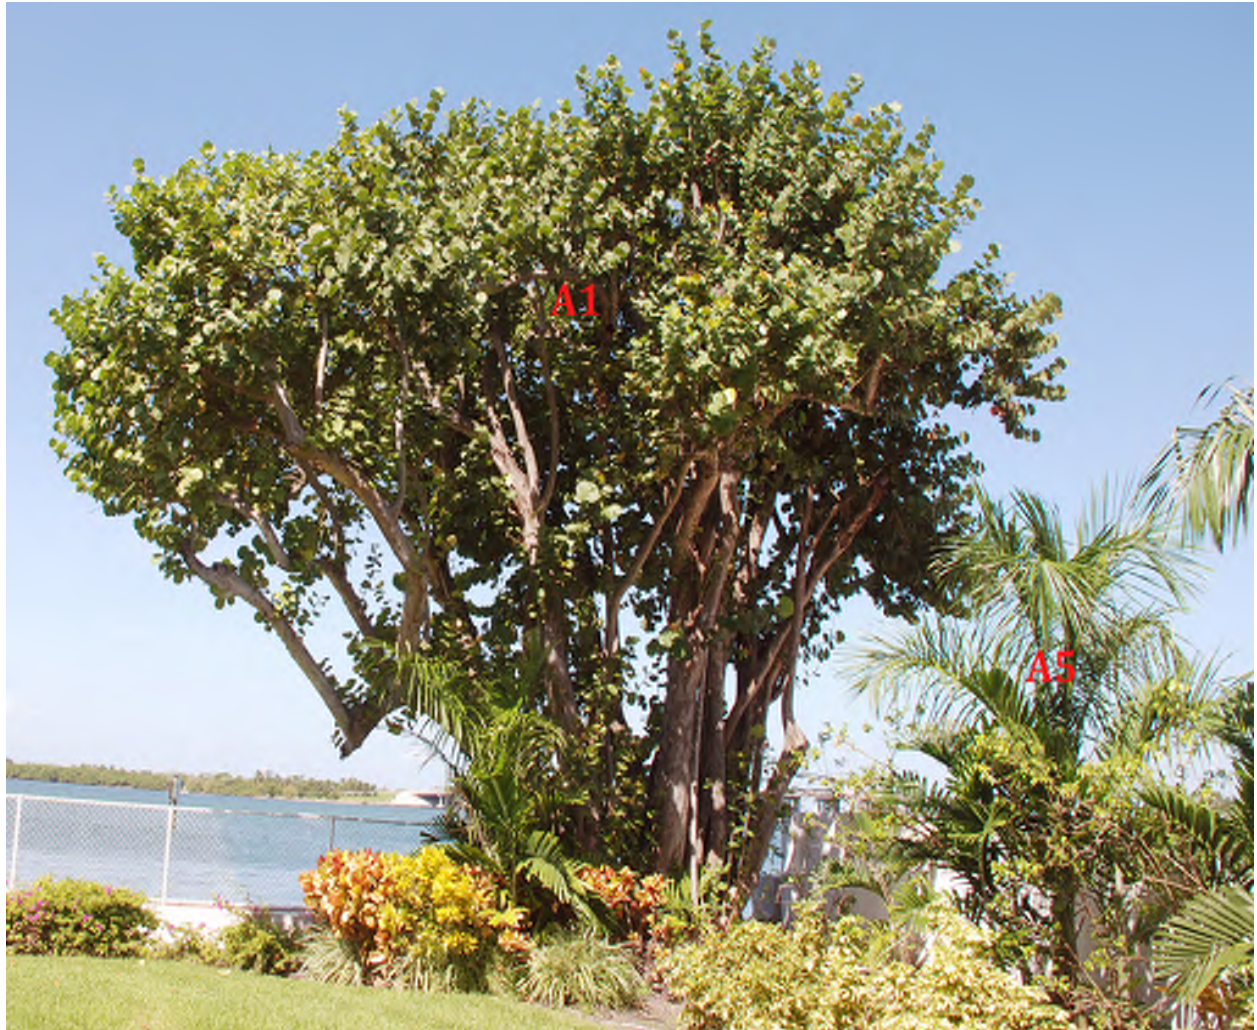
**Photo 1 above is tree A1. This tree has multiple trunks that all seem to be fused together therefore this is being documented as a single tree.**

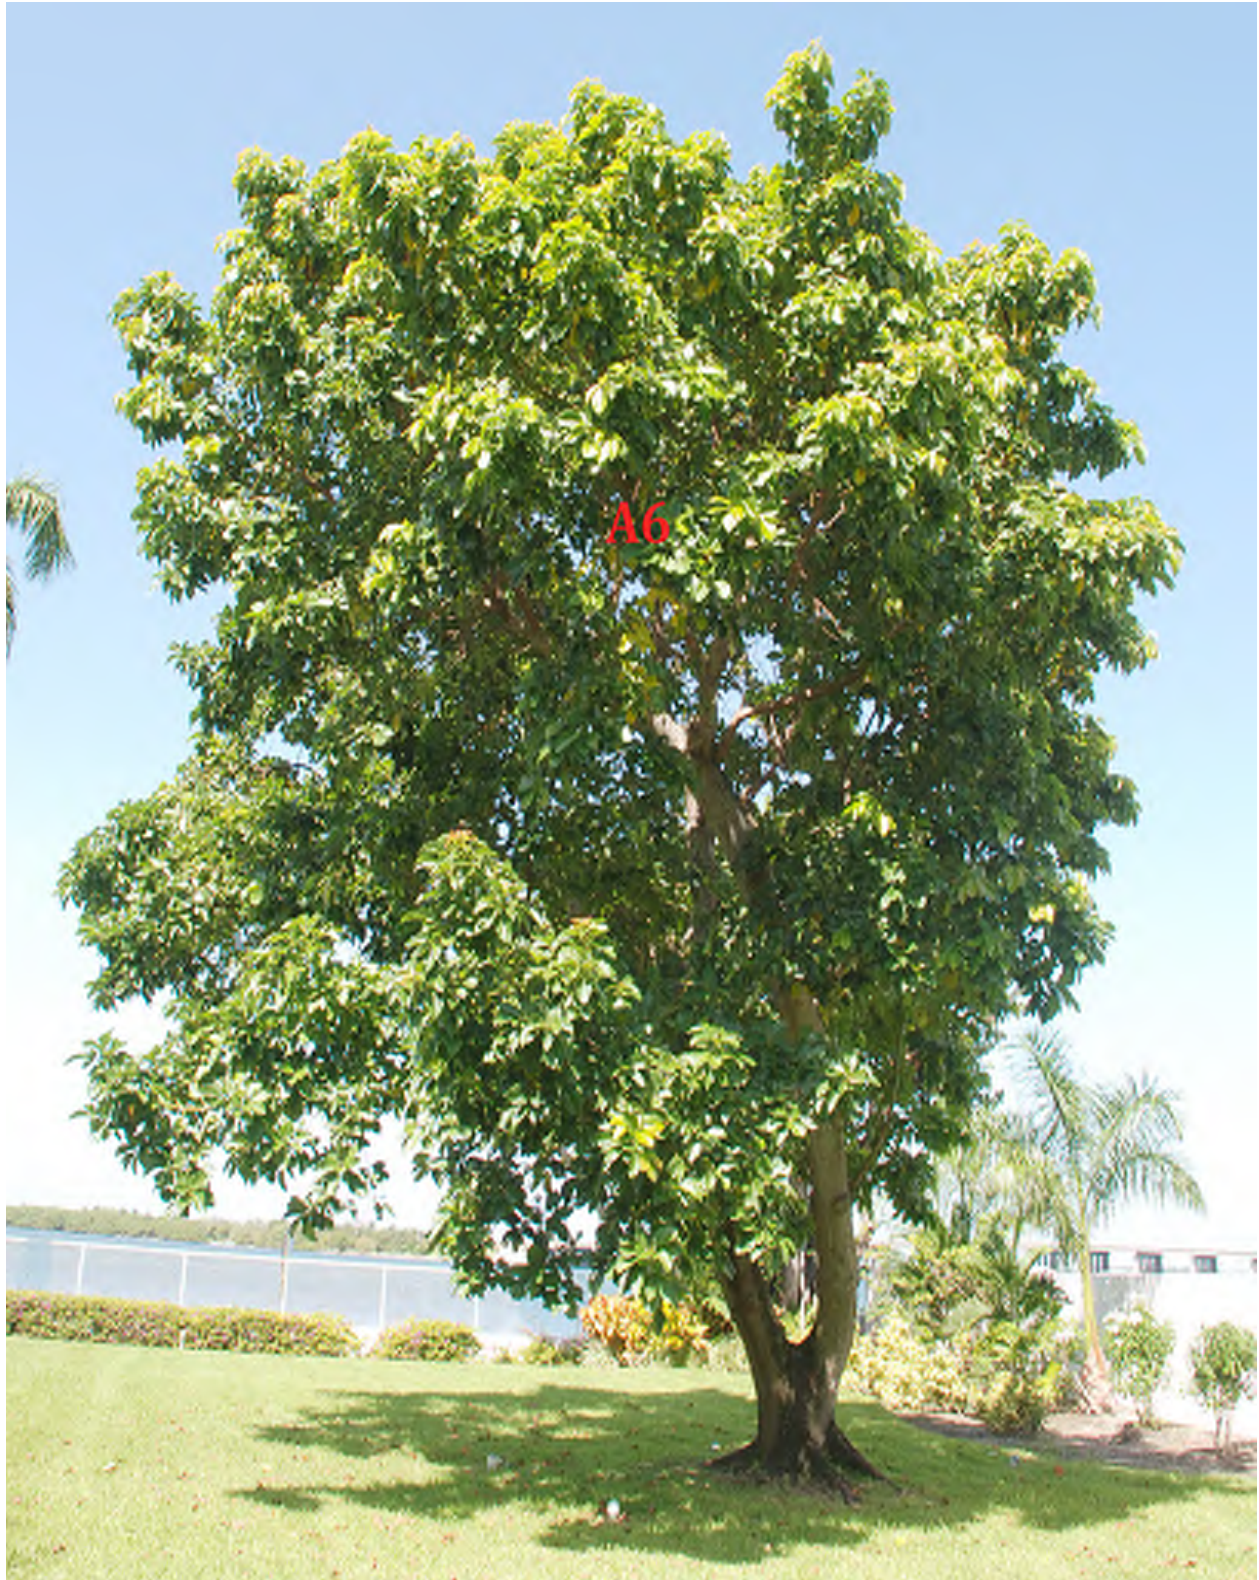
**Photo 3 above is tree A6.**

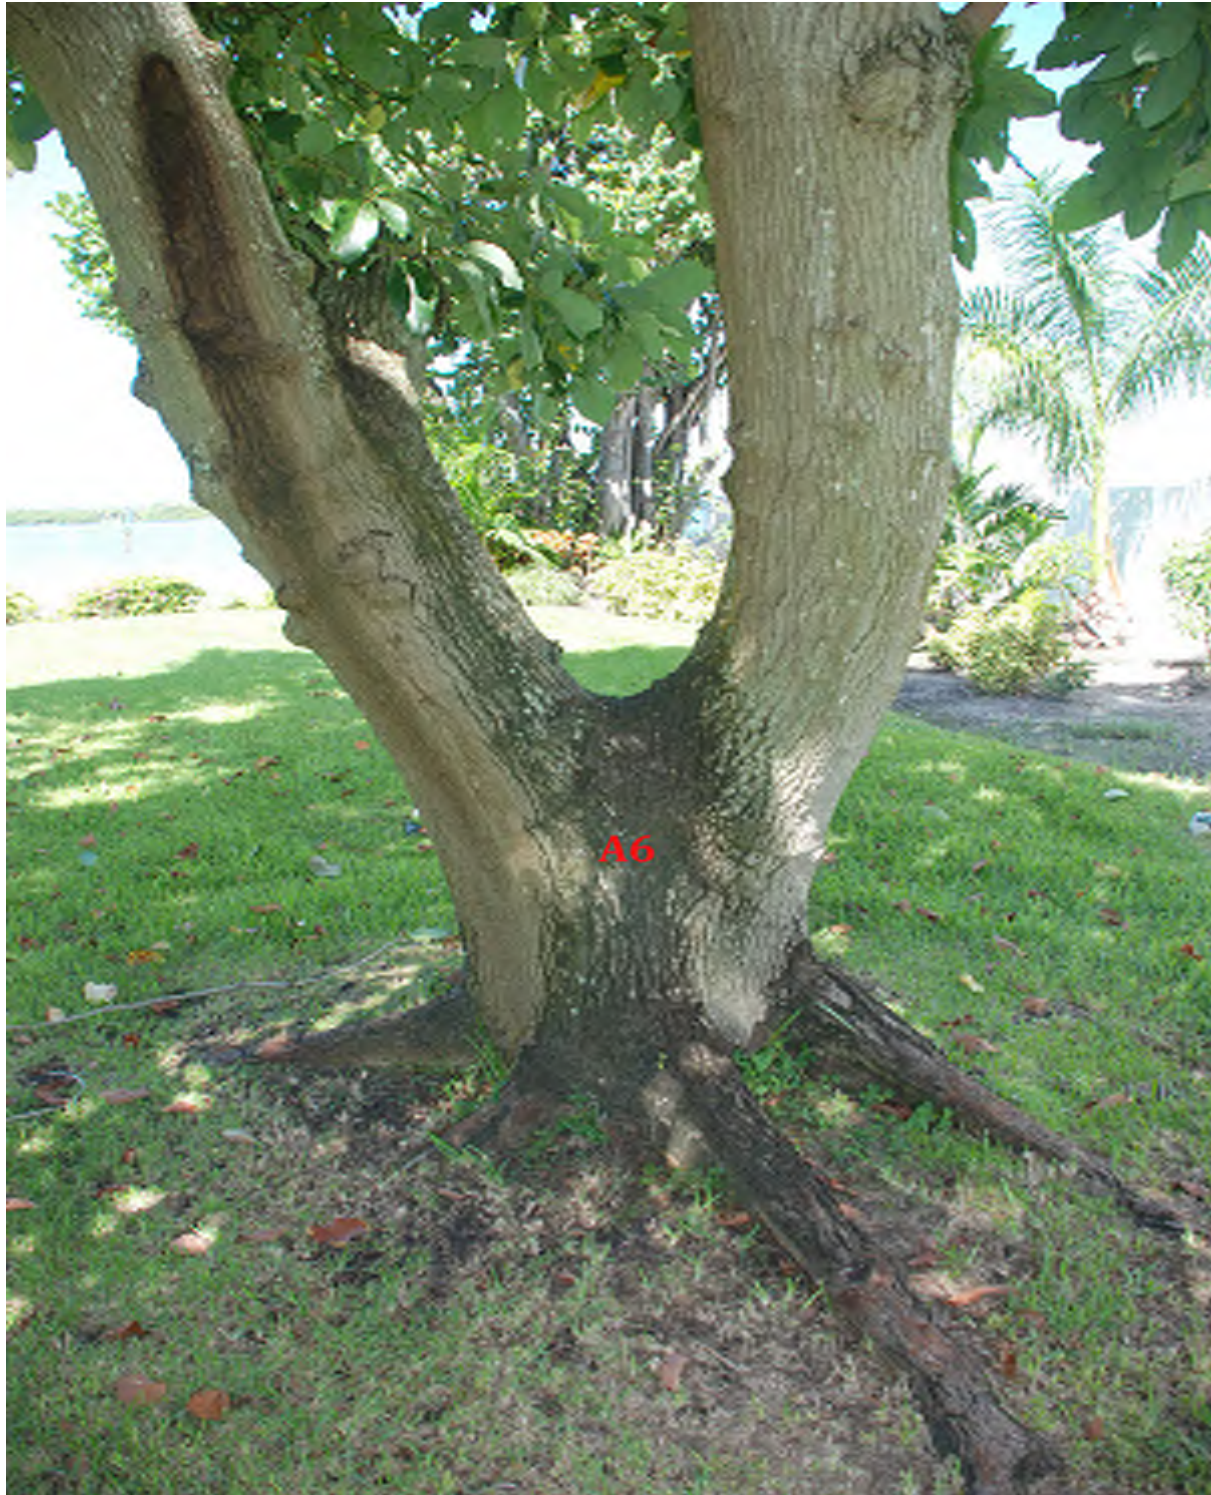
**Photo 4 above is the trunk of A6 with no signs of decay, cavities, or fungal fruiting bodies on the root collar or trunk.**

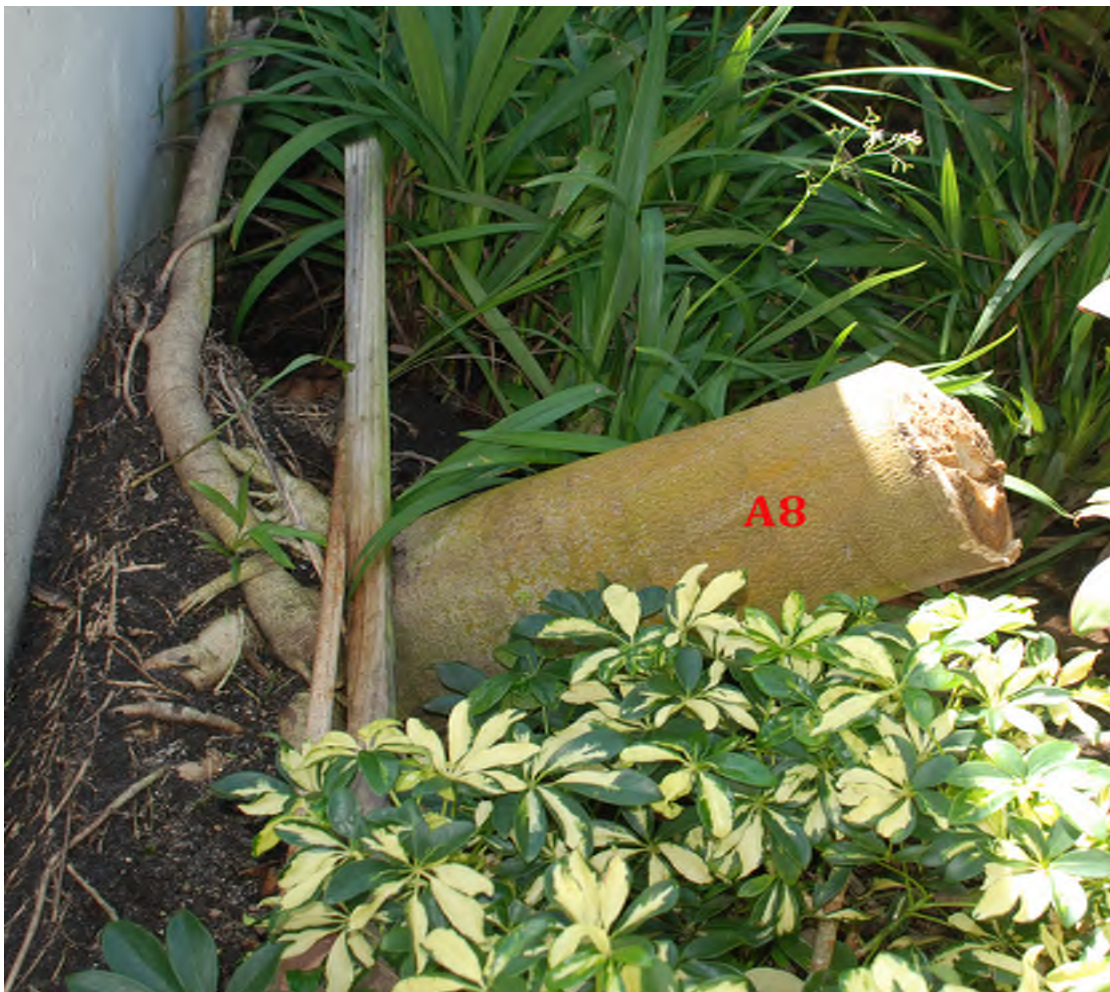
**Photo 6 above is the cut trunk of papaya A8.**

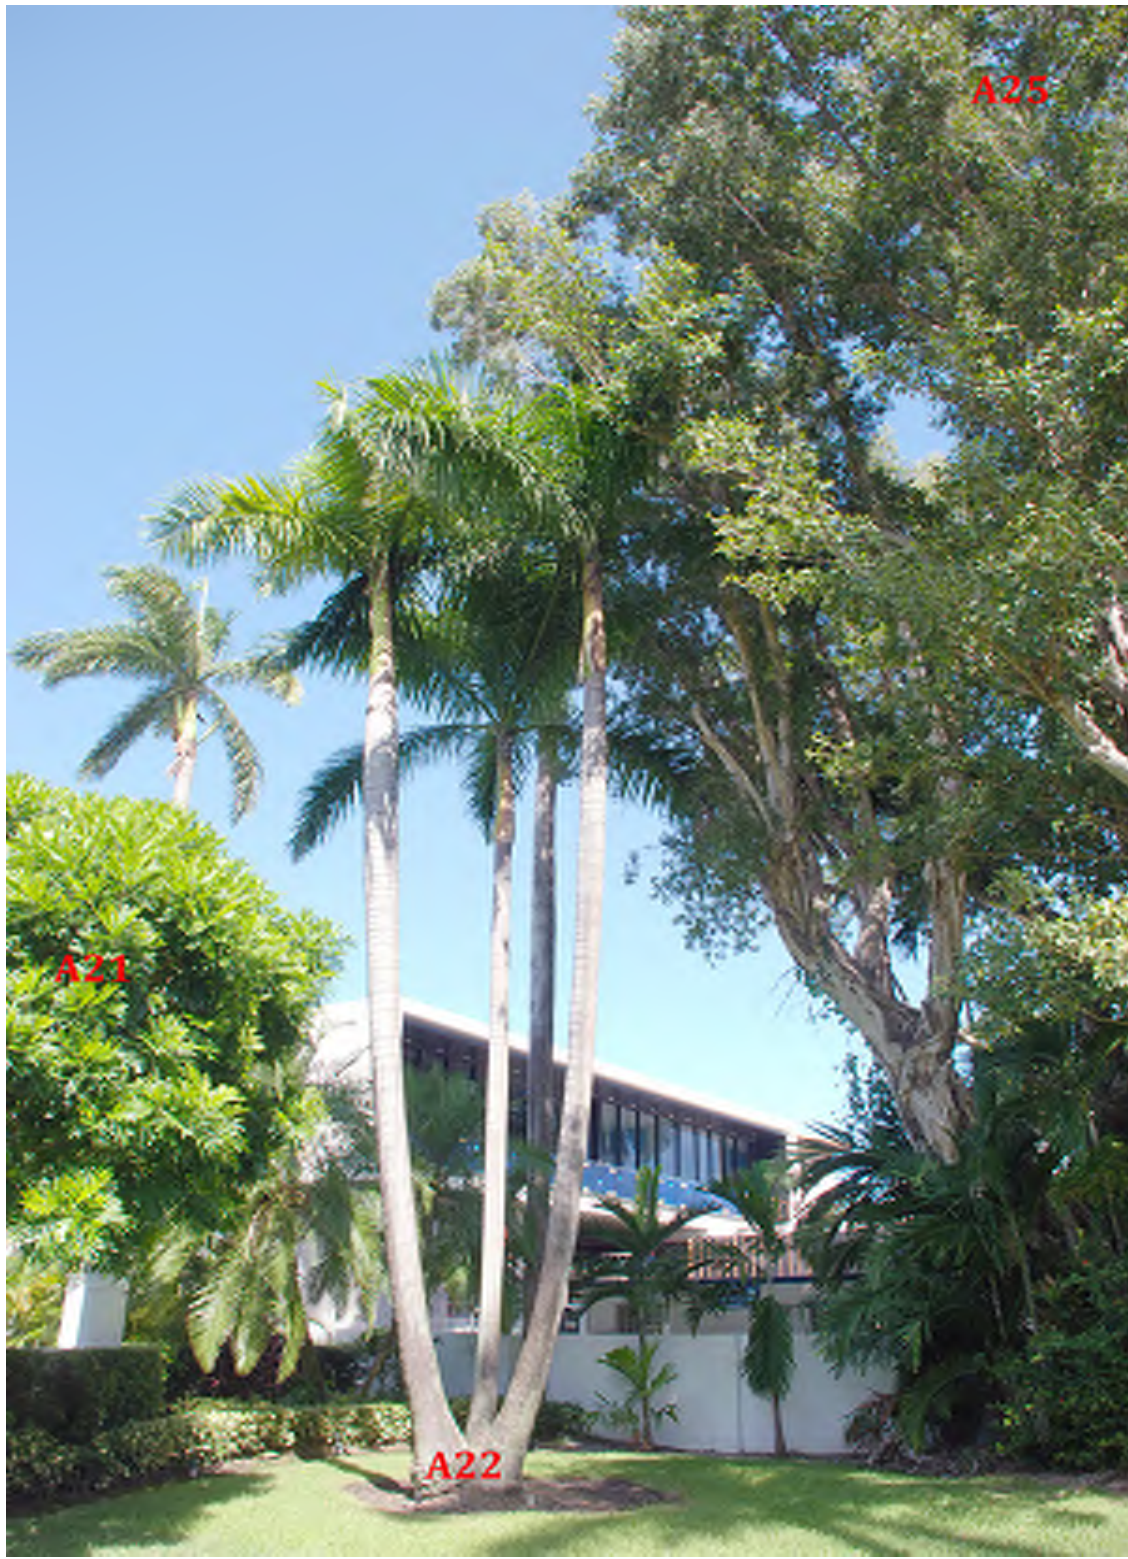
**Photo 14 above is palm A22 with three trunks growing together.**

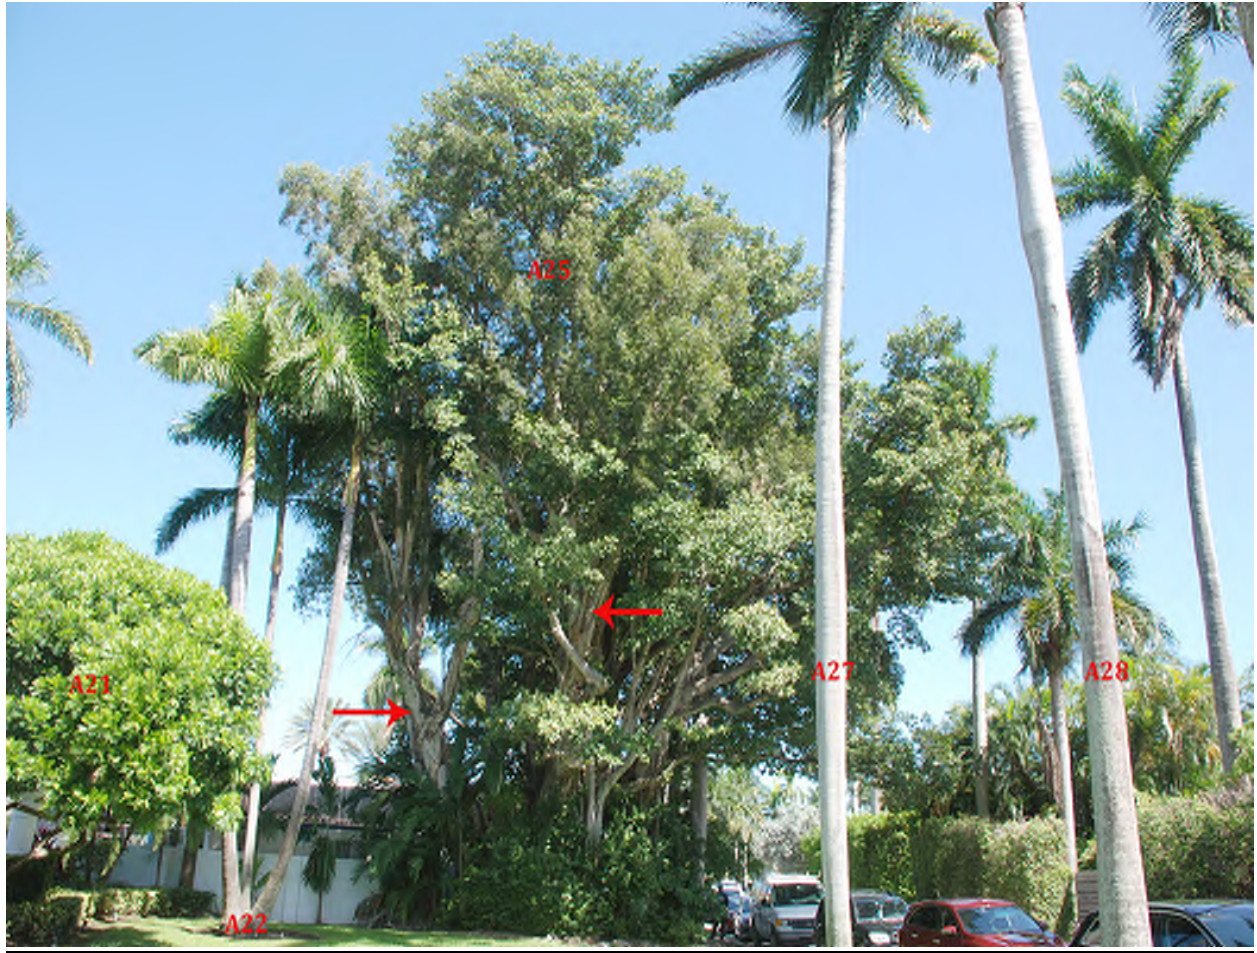
Photo 15 above is tree A25 with the arrows indicating two *Melaleuca quinquenervia* trees (an invasive species) that are both being enveloped by the aerial roots of tree A25.

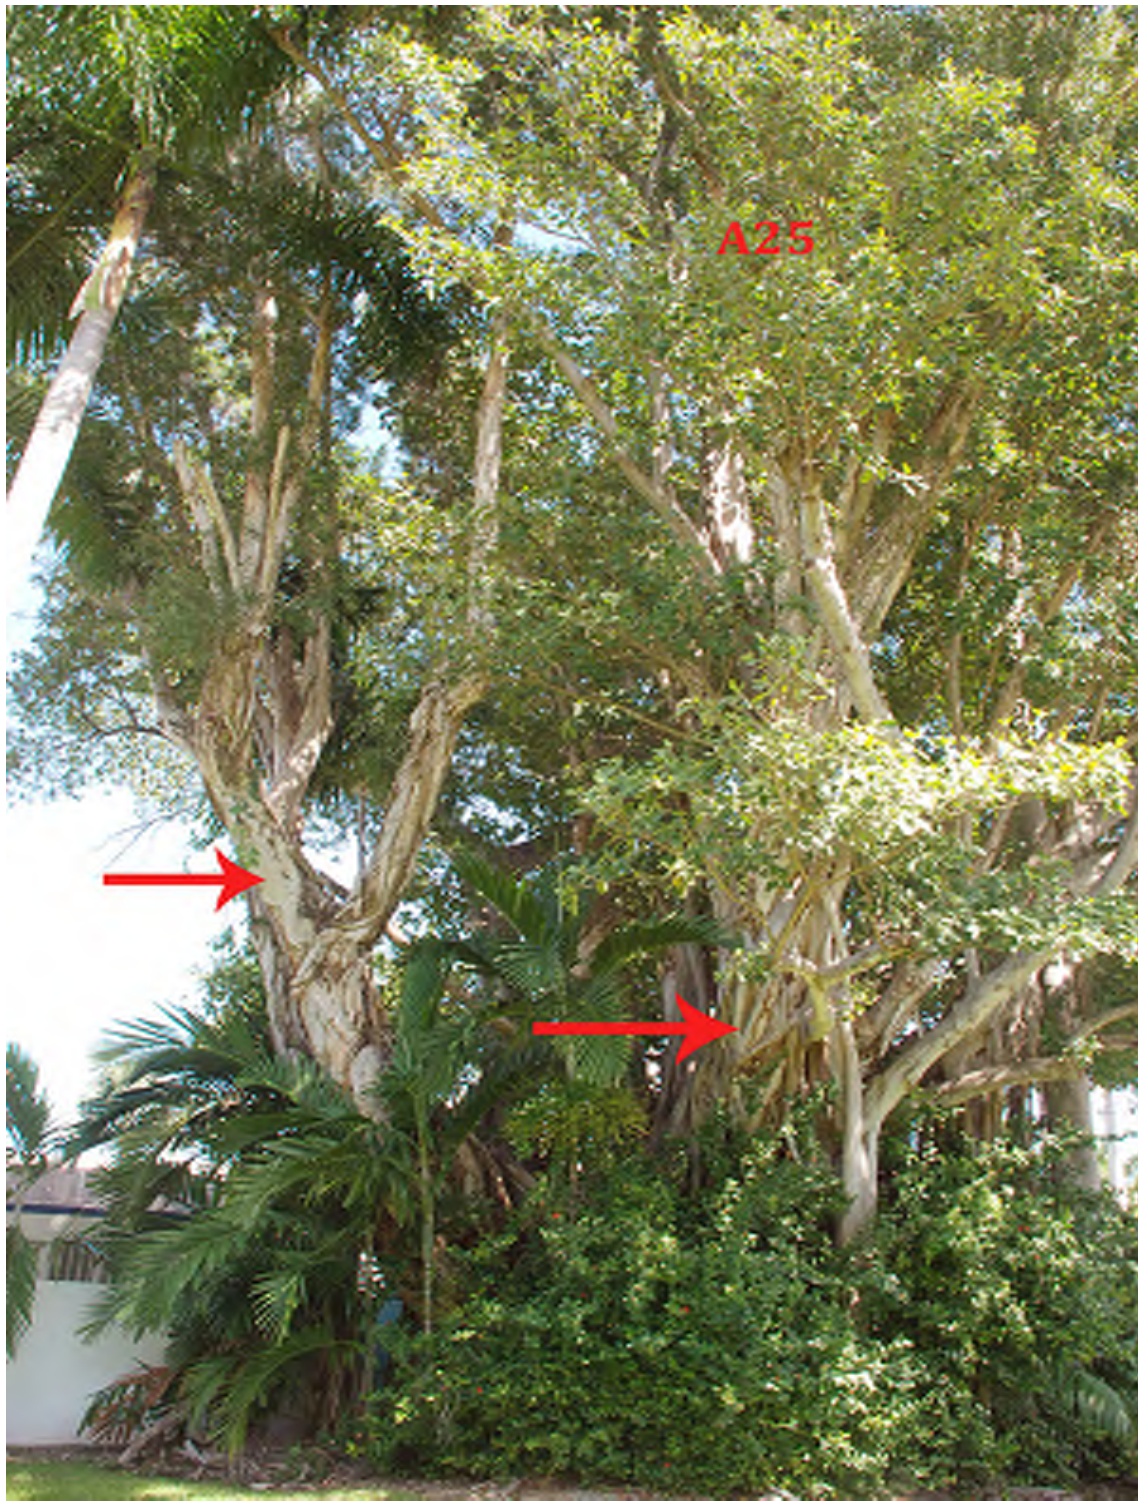
**Photo 16 above is a closer view of the melaleuca trunks being enveloped by tree A25.**

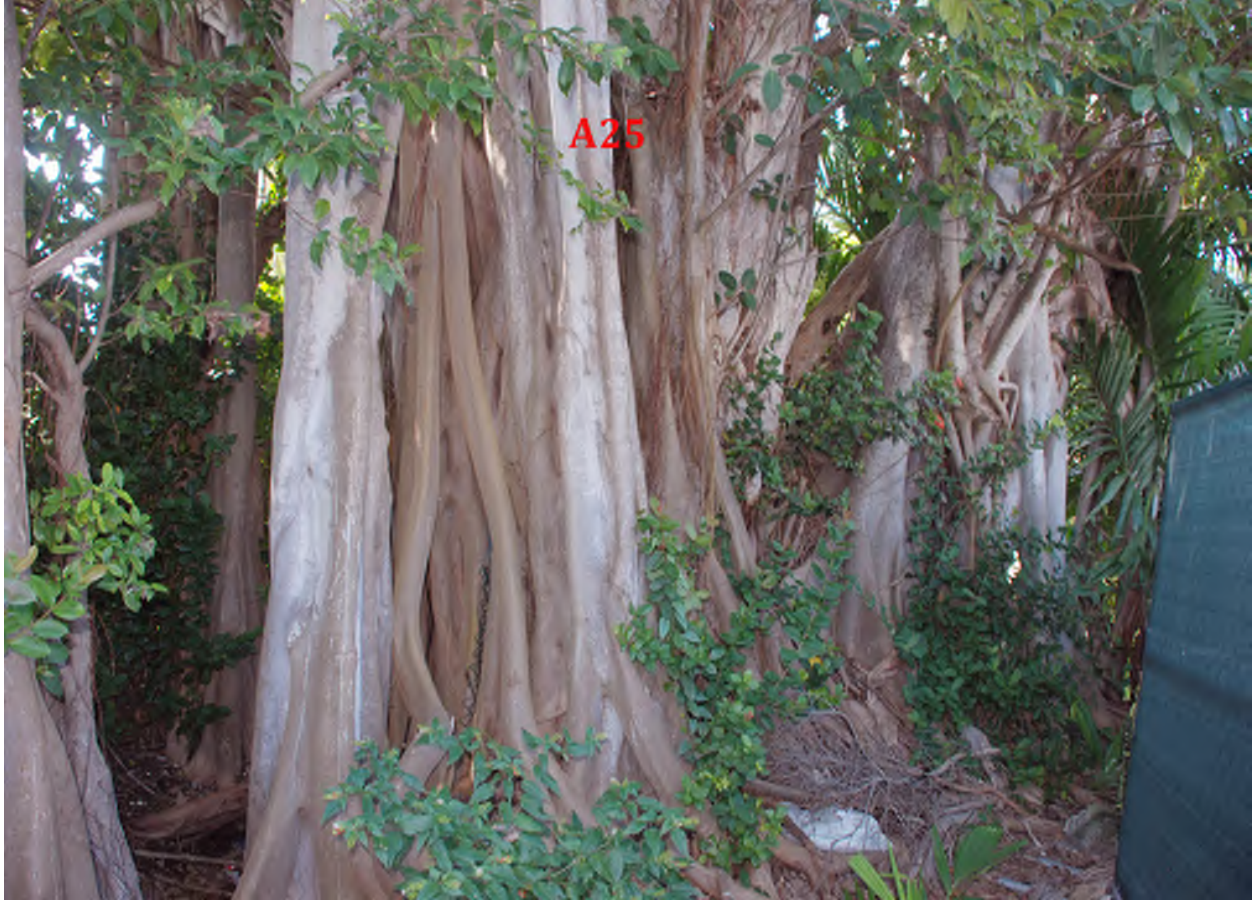
**Photo 17 above is northeast side of the trunk(s) of tree A25. I noted no signs of decay, cavities, or fungal fruiting bodies on the root collar or trunk.**

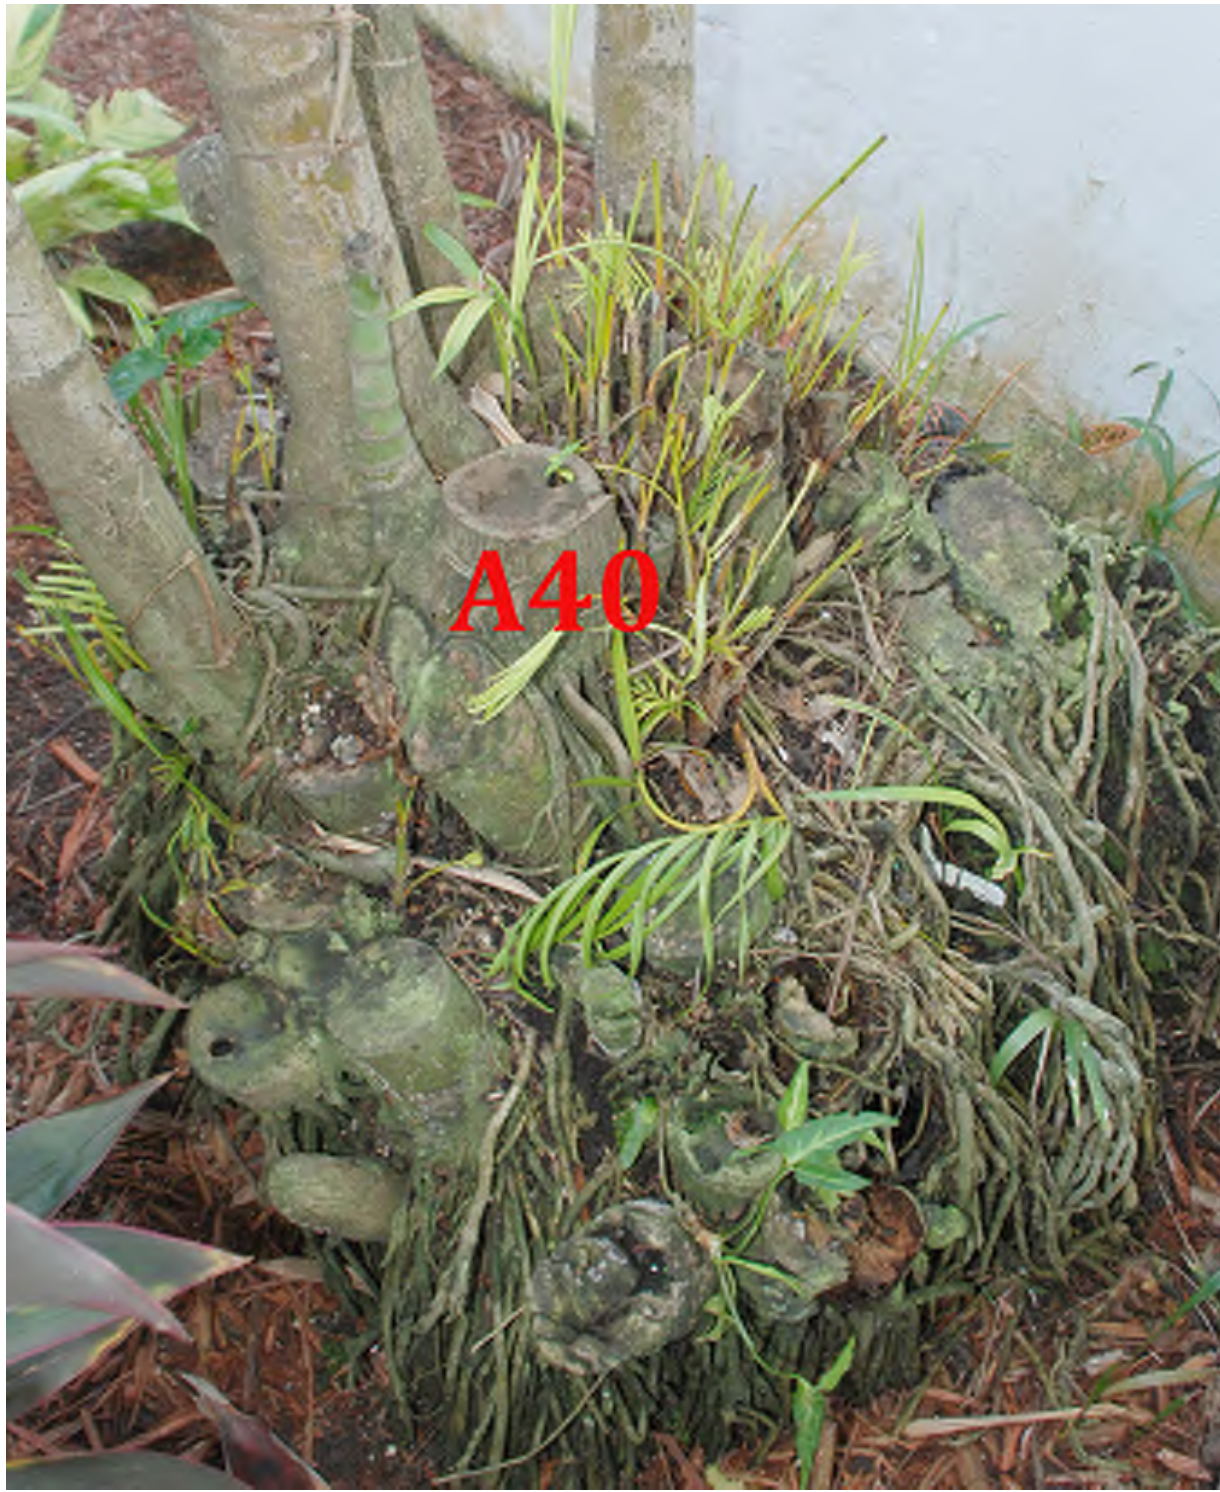
Photo 25 above is the base of palm A40 showing numerous cut trunks. This is a very common egress for *Ganoderma zonatum*, a virulent palm pathogen. This palm should be removed.

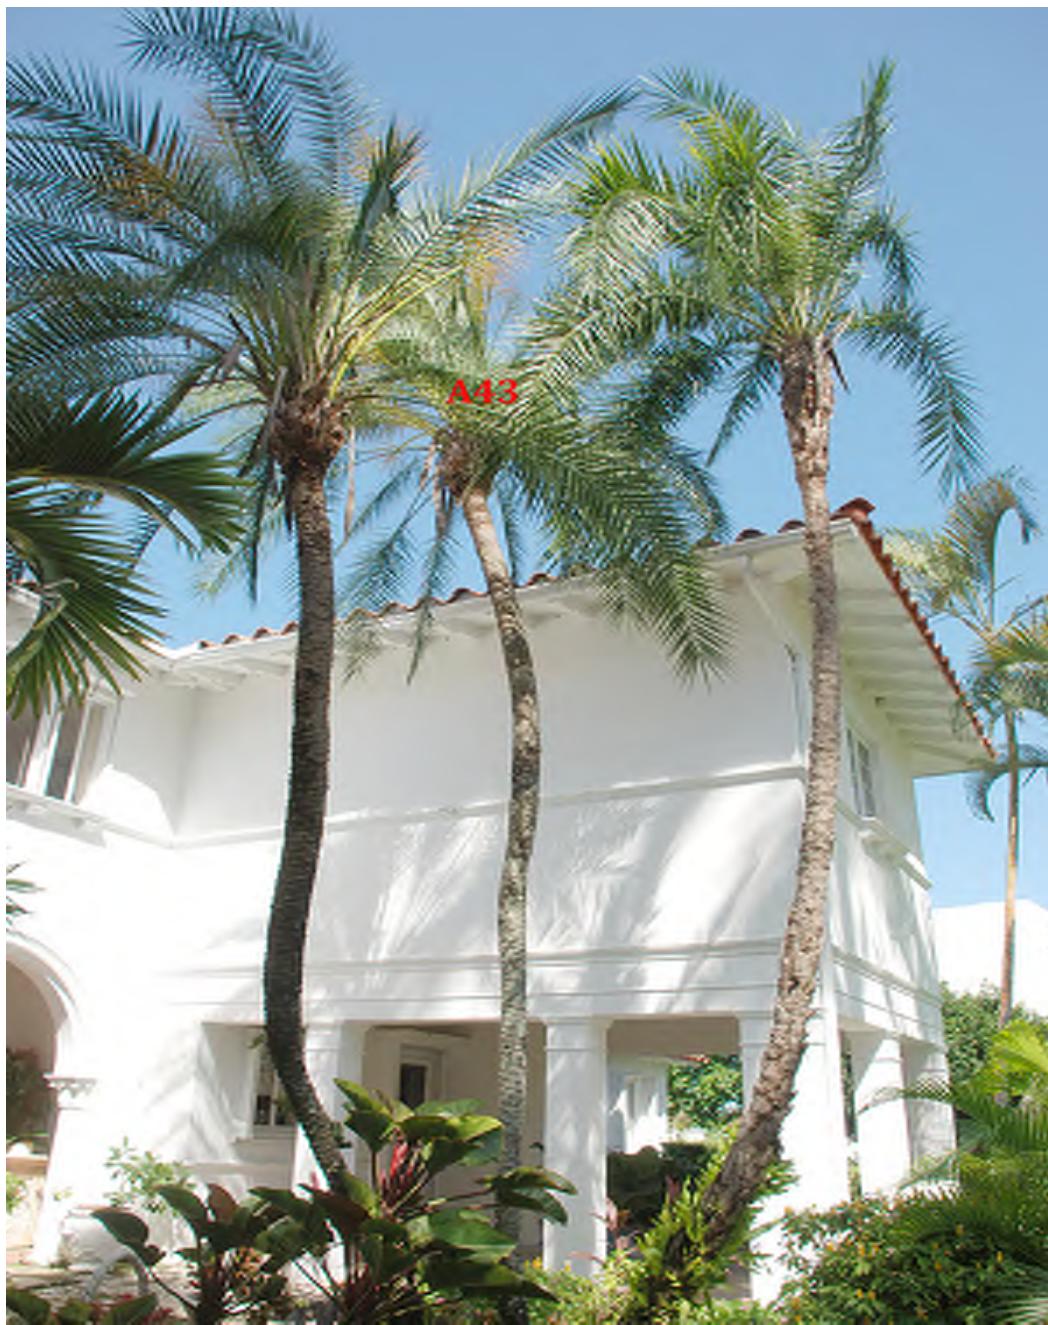
**Photo 28 above is multi-trunked palm A 43. Many trunks of this palm have been severed at the base. This palm should not be relocated or utilized further in the landscape.**

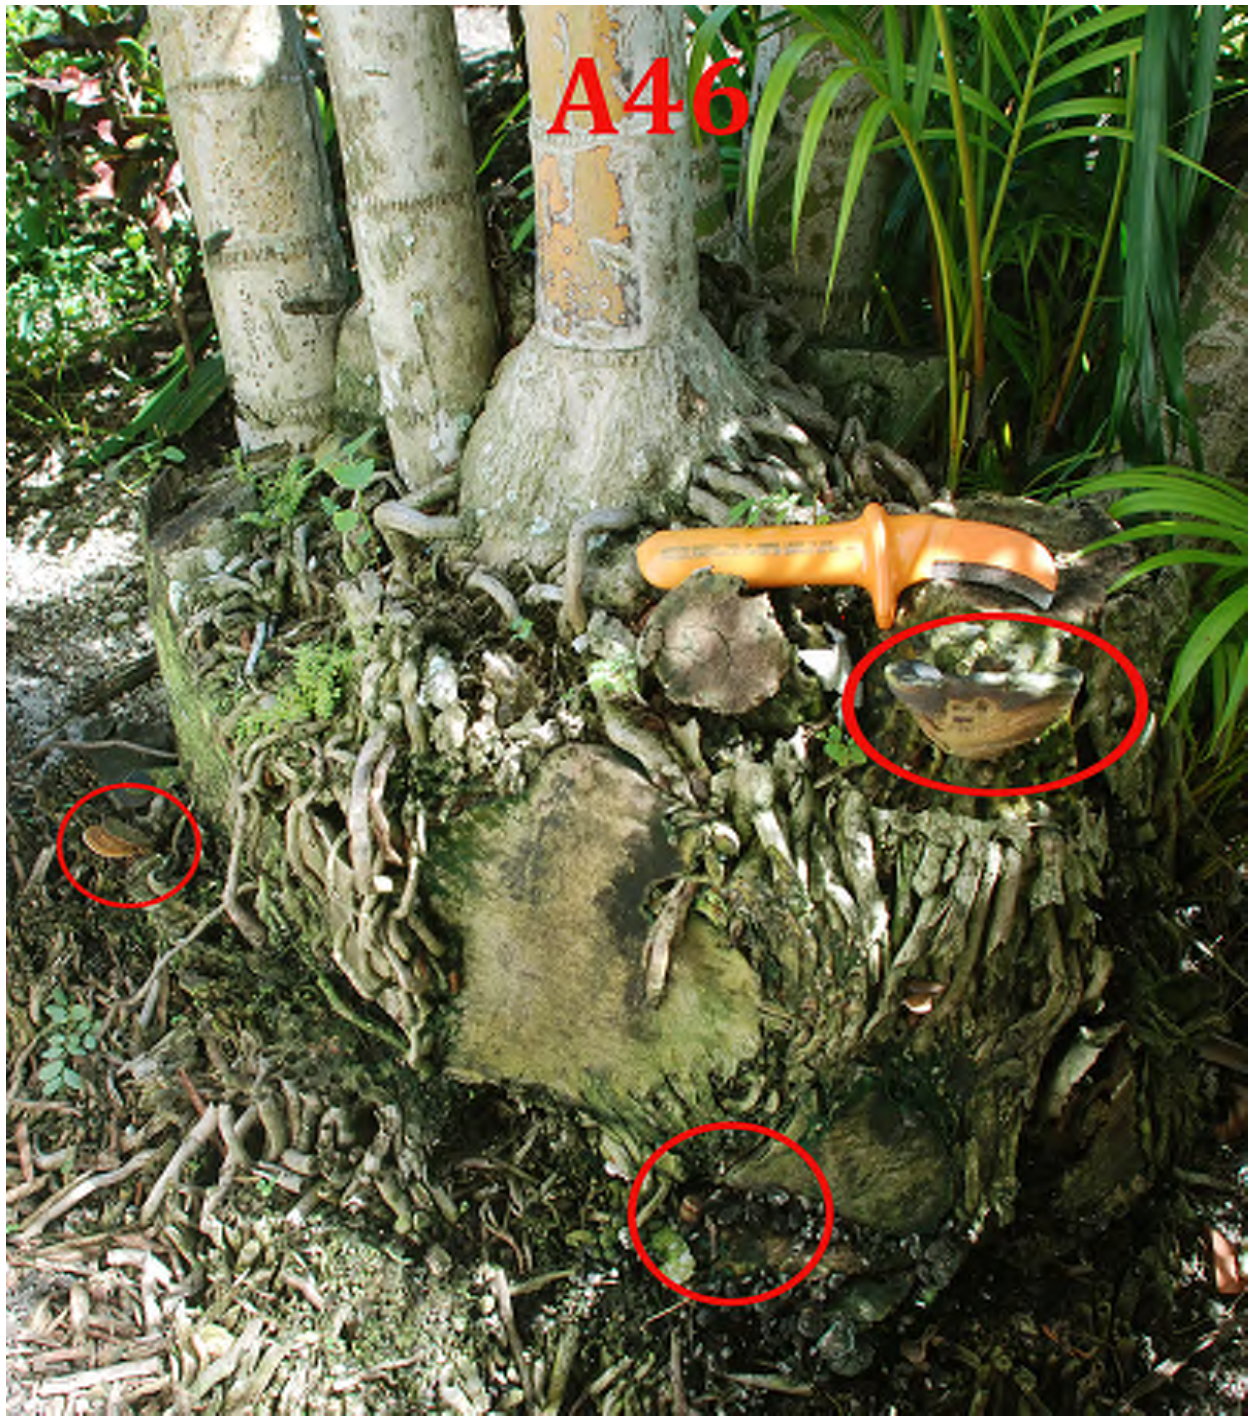
Photo 30 above is the base of palm A46 with fruiting bodies of *Ganoderma zonatum*, a virulent palm pathogen. This palm should be removed. The orange knife is 7 inches in length.

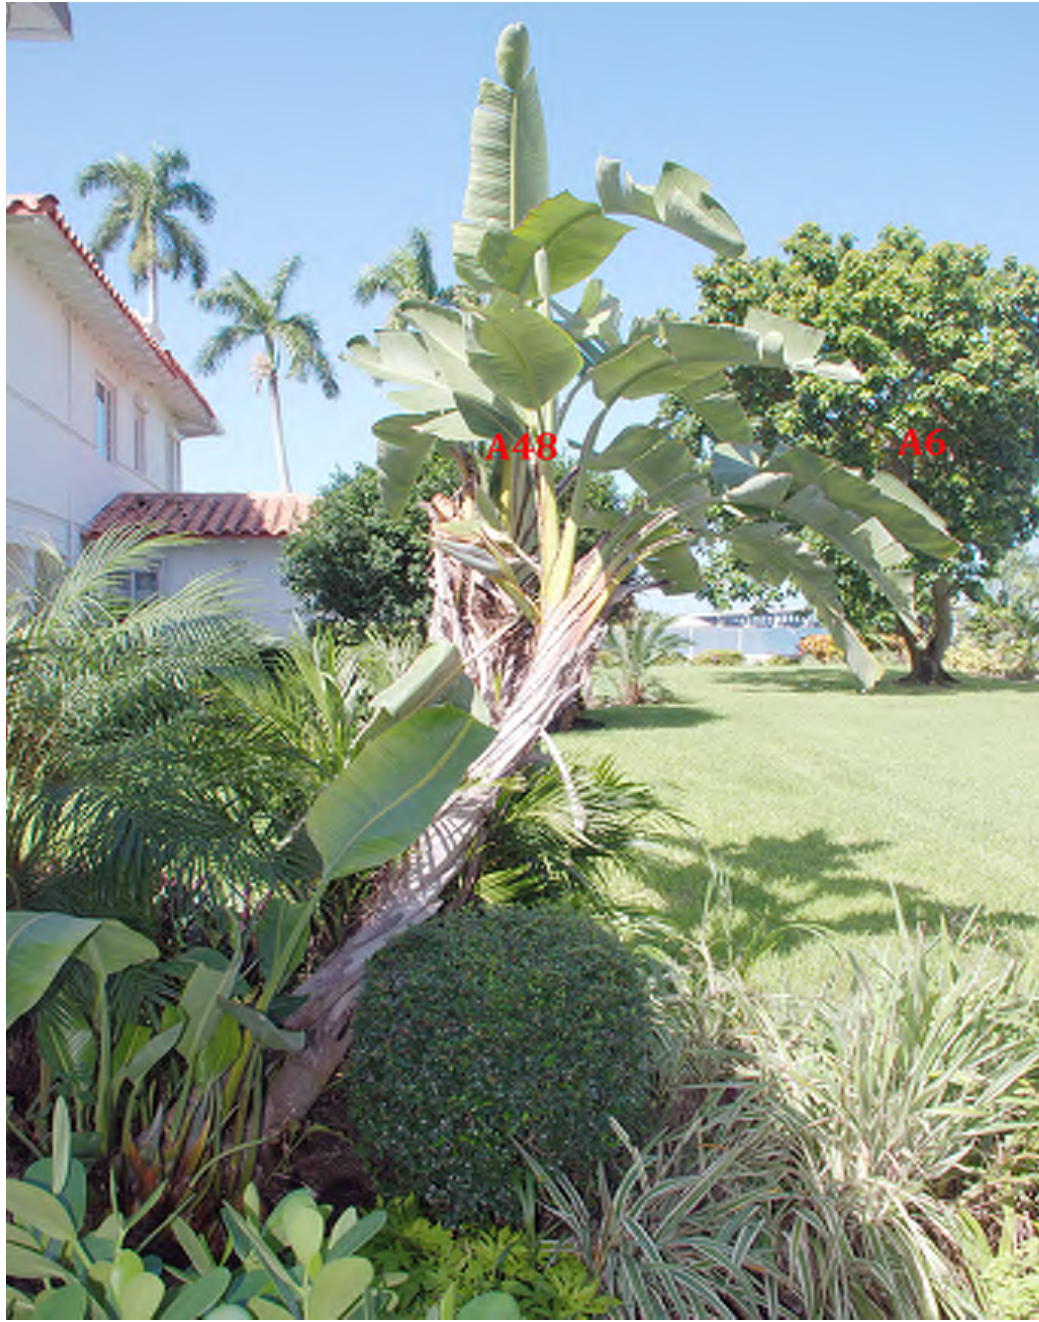
**Photo 32 above is white bird of paradise A48 with two fallen trunks.**

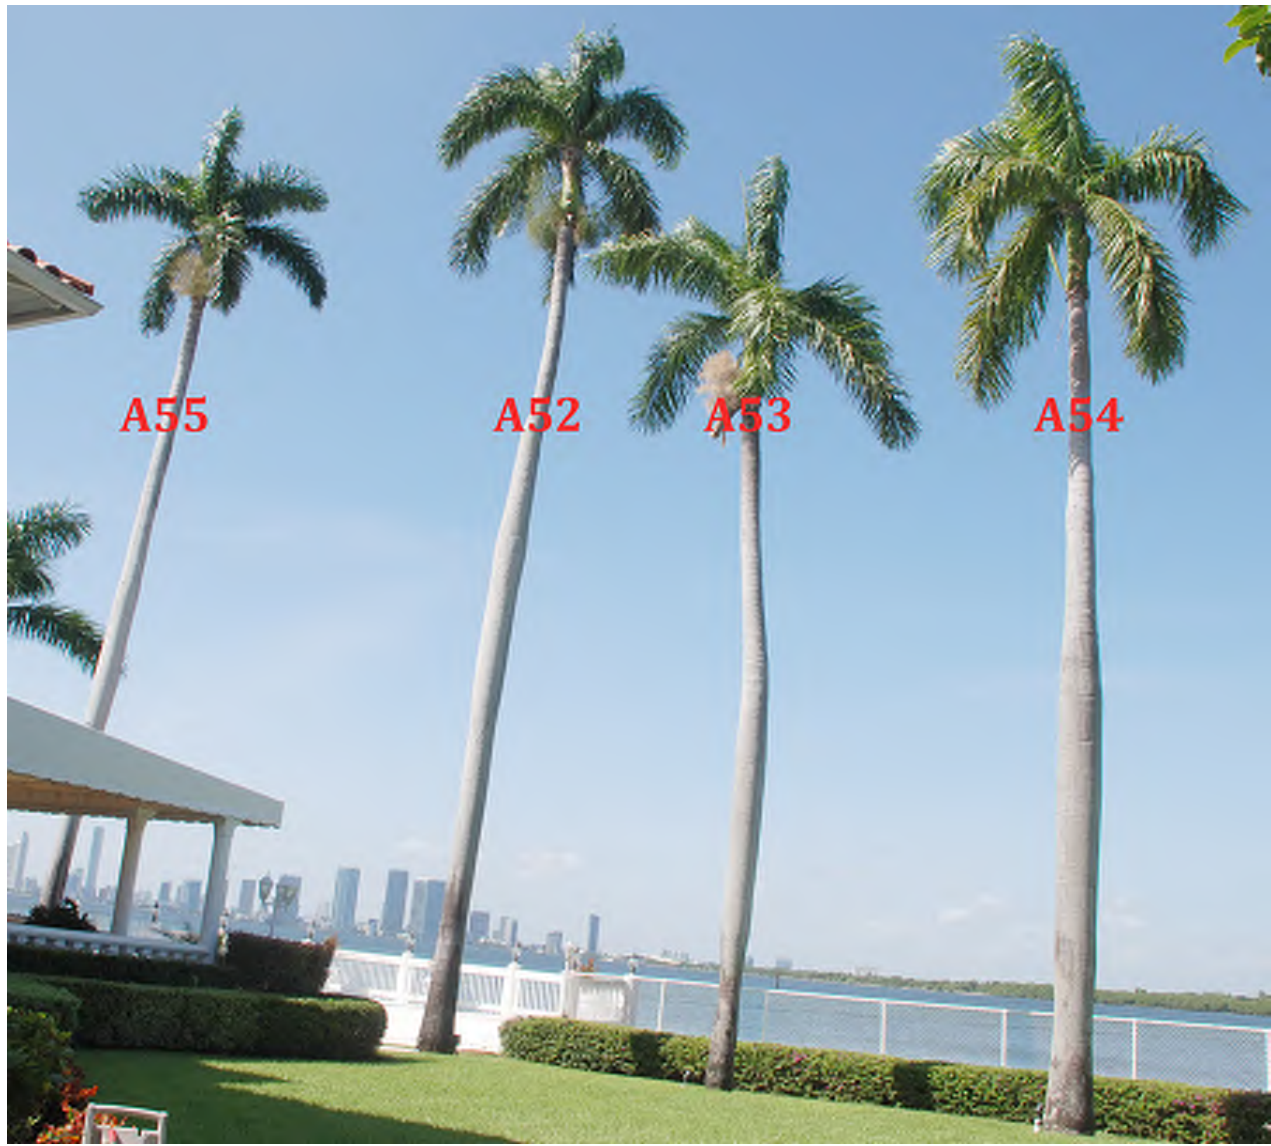
**Photo 34 above is palms A52, A53, A54 & A55. I have rated some of the royal palms to be in moderate condition because of evidence of being climbed with spikes. This is not an acceptable arboricultural practice as these holes never heal and can become an egress for pathogens.**

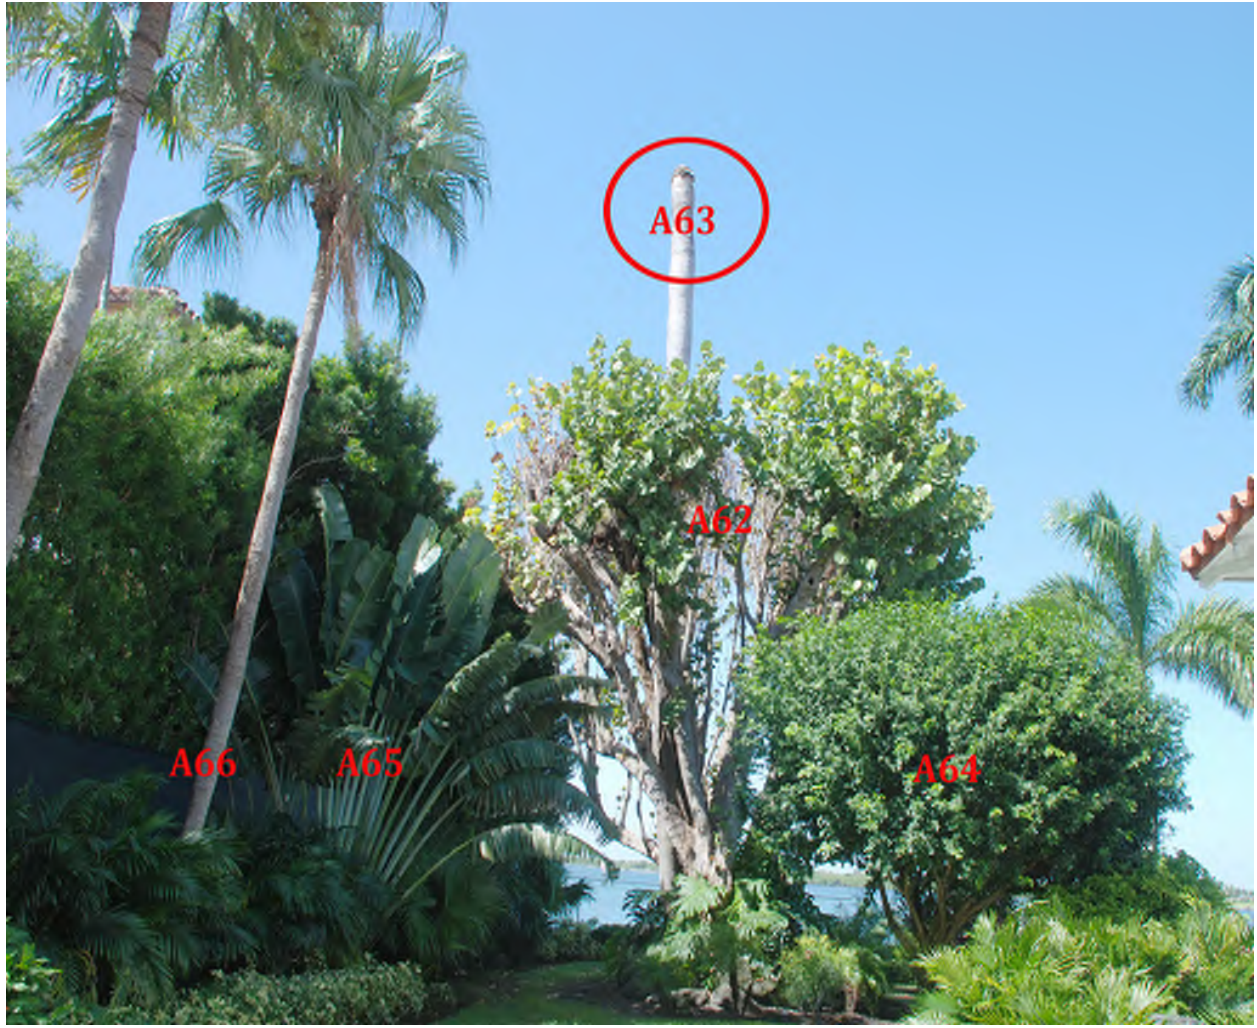
**Photo 37 above is palms A63 & A66, traveller's tree A65, and trees A62 & A64.  
Palm A63 is dead.**
