# ***Tree Resource Evaluation for 1753 & 1771 N. View Drive, Miami Beach***

***Sunset Islands Land Trust  
1771 North View Drive  
Miami Beach, FL 33140***

***Jeff Shimonski  
President, Tropical Designs of Florida  
Member, American Society of Consulting Arborists  
ISA Certified Arborist Municipal Specialist FL-1052AM  
ISA Tree Risk Assessment Qualification  
LIAF Florida Certified Landscape Inspector 2016-0175  
305-773-9406  
Jeff@TropicalArboriculture.com***

***October 29, 2020***

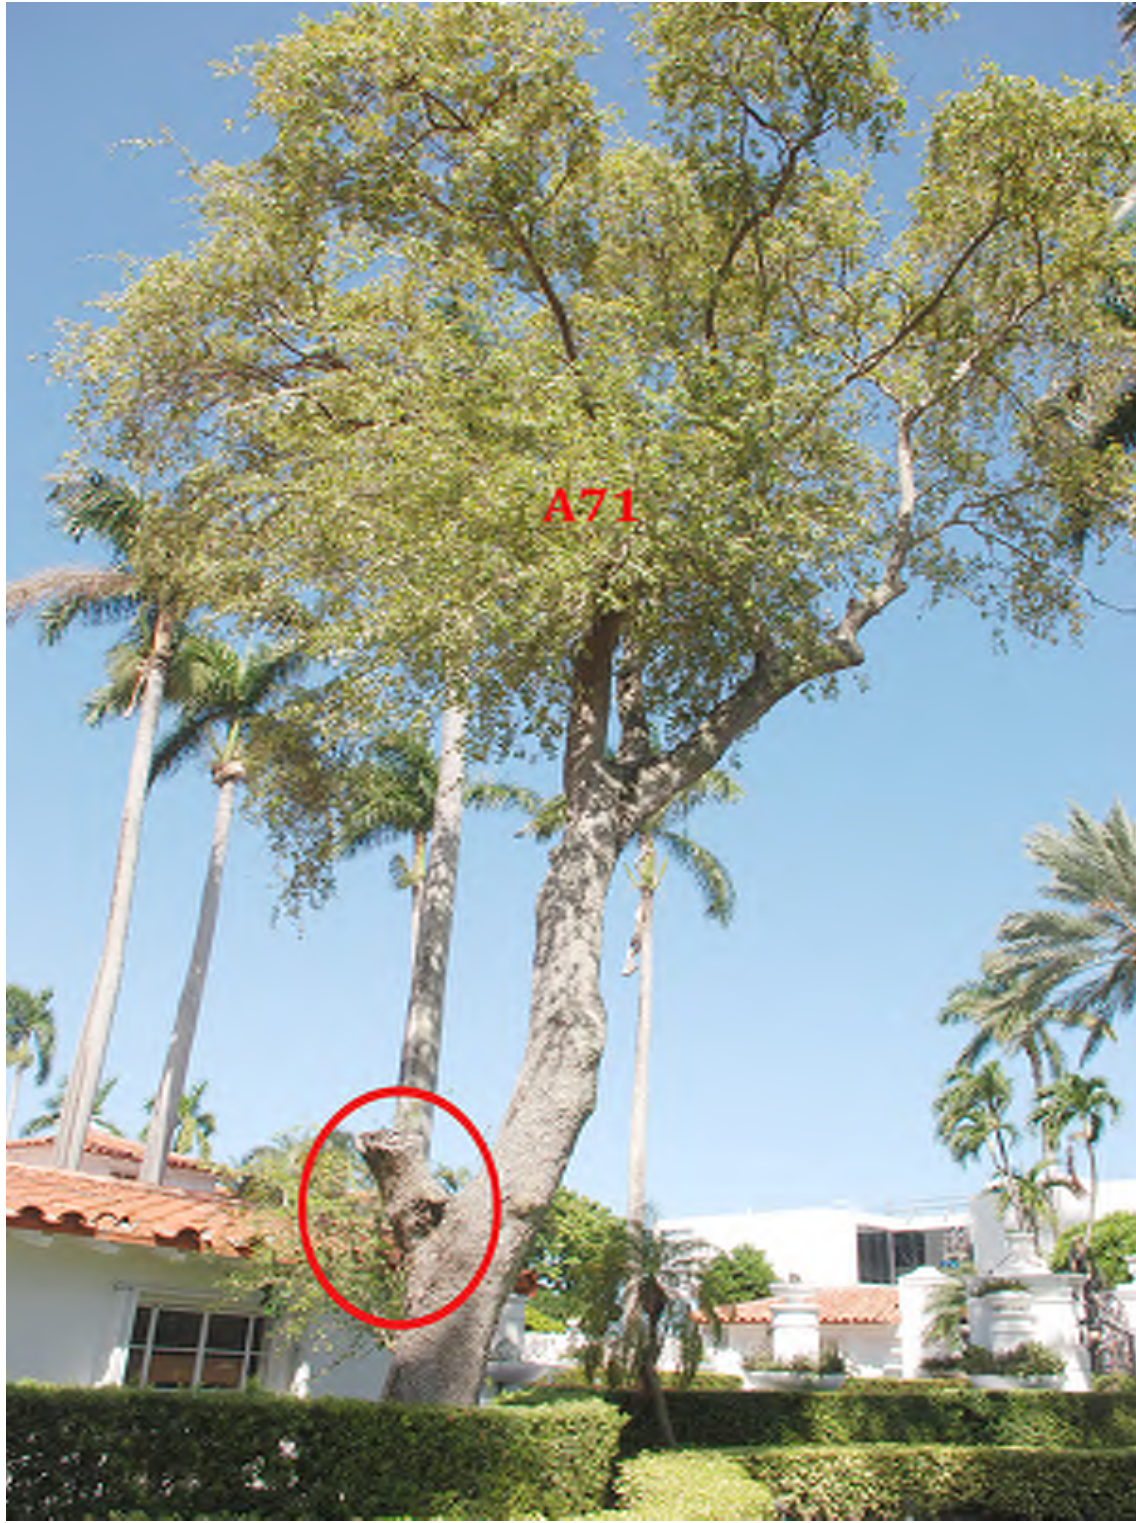
**Photo 43 above is tree A71 with the circle indicating a very large decaying pruning cut. This tree should be removed. See following photos.**

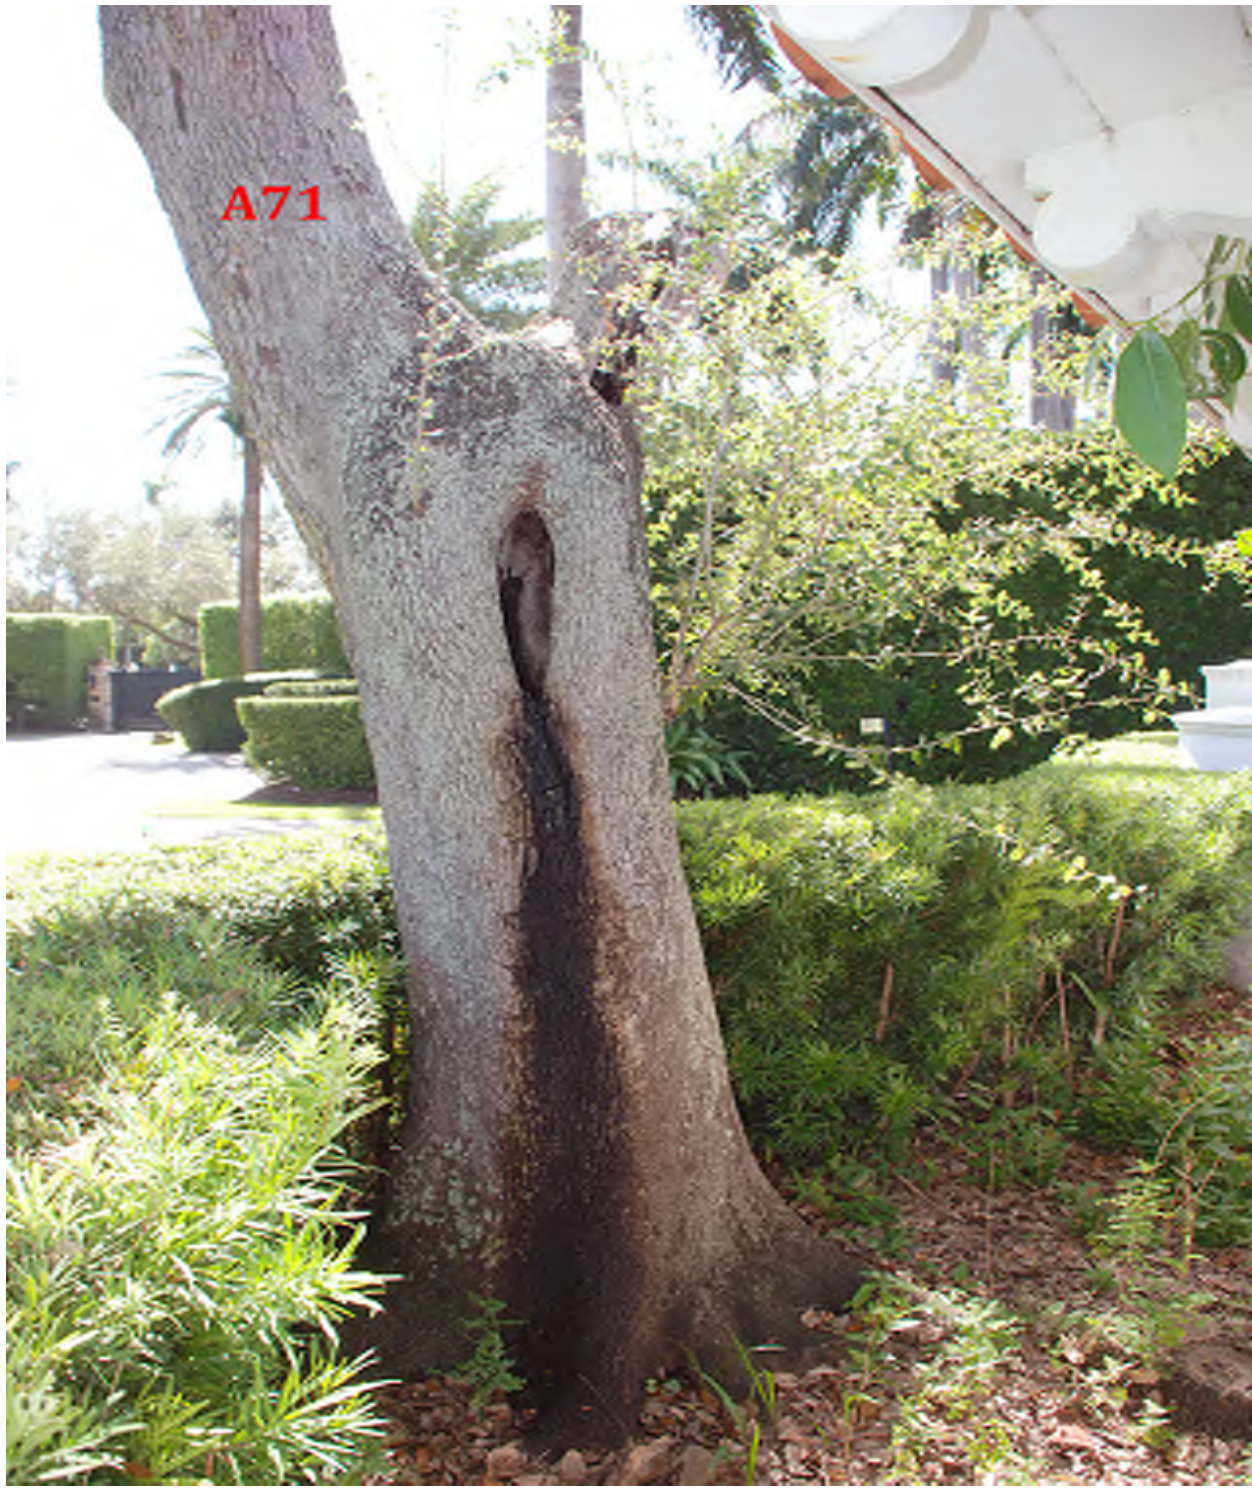
**Photo 44 above is tree A71 with a very large cavity at a critical structural juncture on this tree. Note the oozing from the cavity. See following photo.**

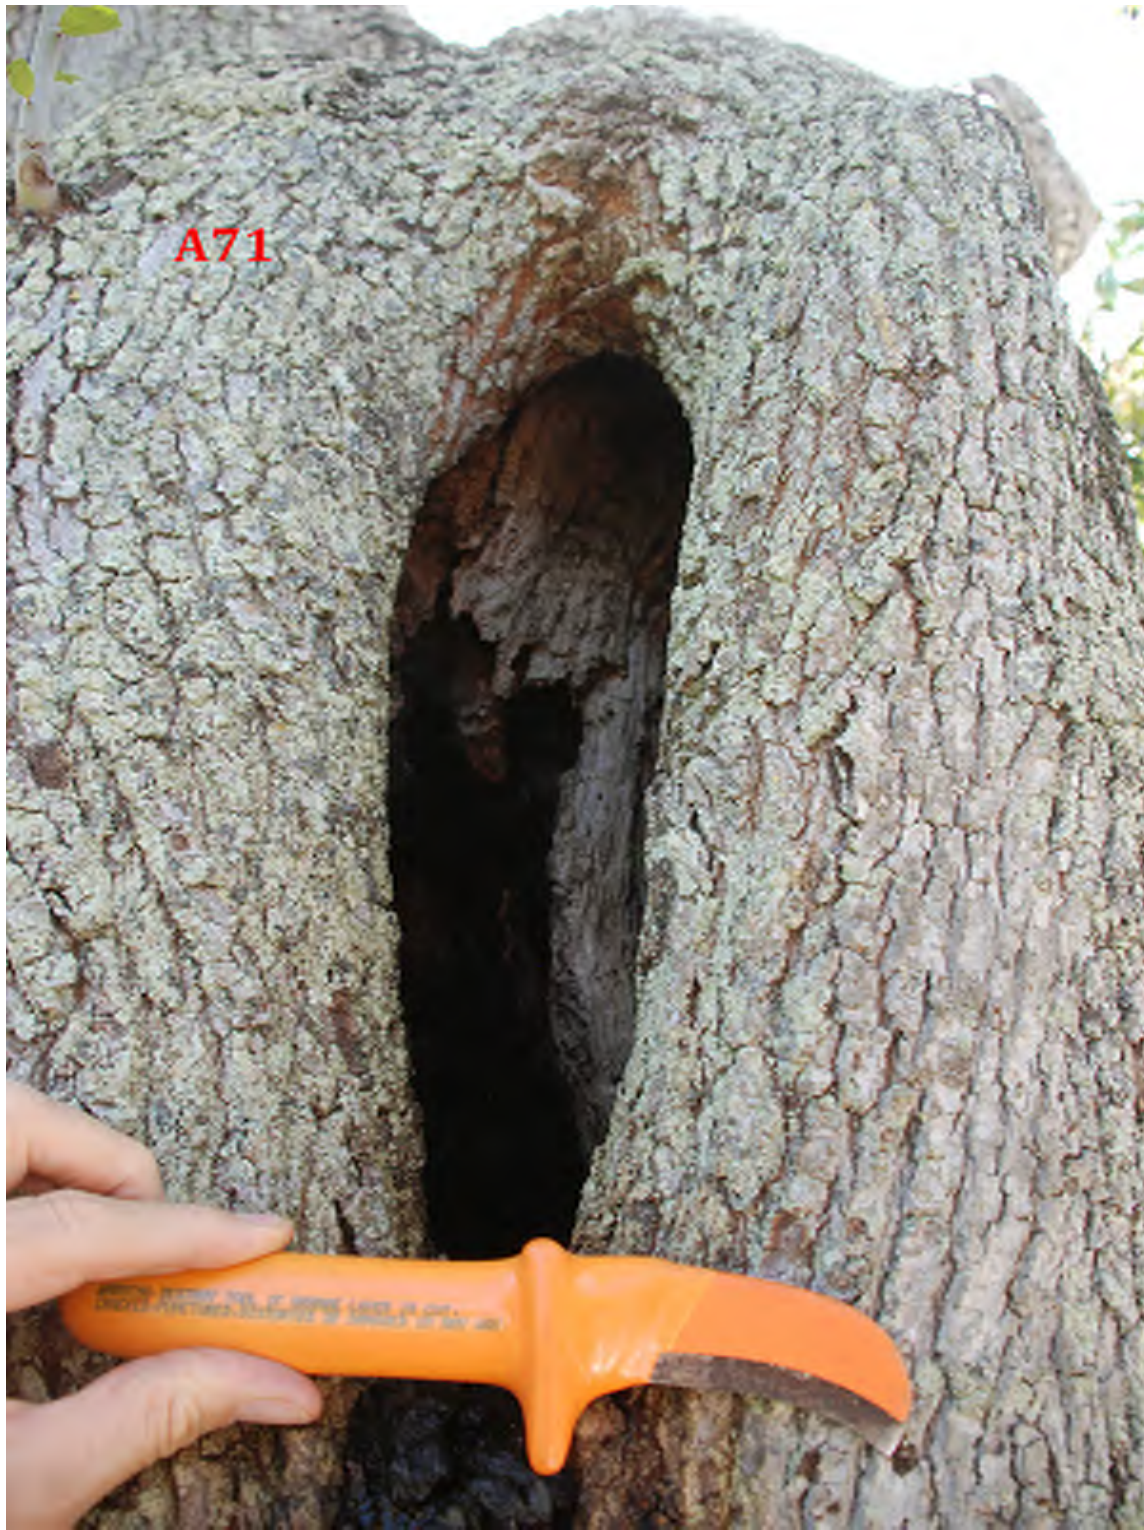
**Photo 45 above is a closer view of the deep cavity in the trunk of tree A71. This tree should be removed. The orange knife is 7 inches in length.**

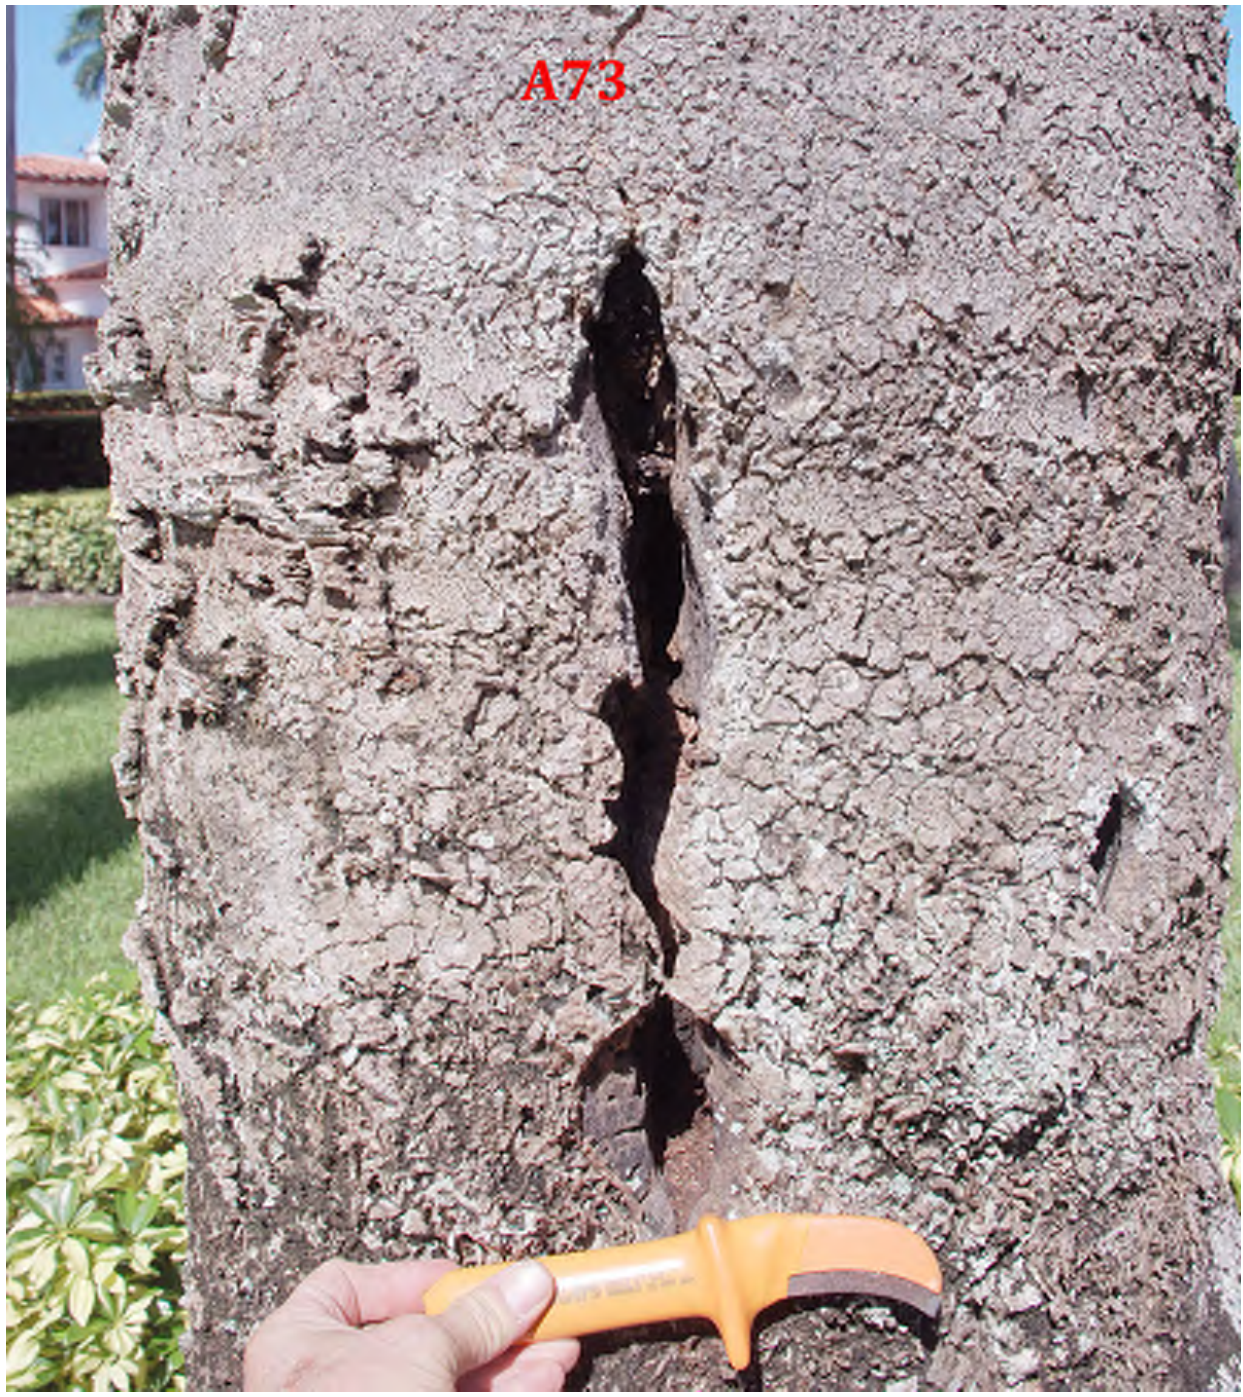
**Photo 47 above is a deep cavity in the trunk of palm A73. This palm is not a good candidate for relocation. The orange knife is 7 inches in length.**

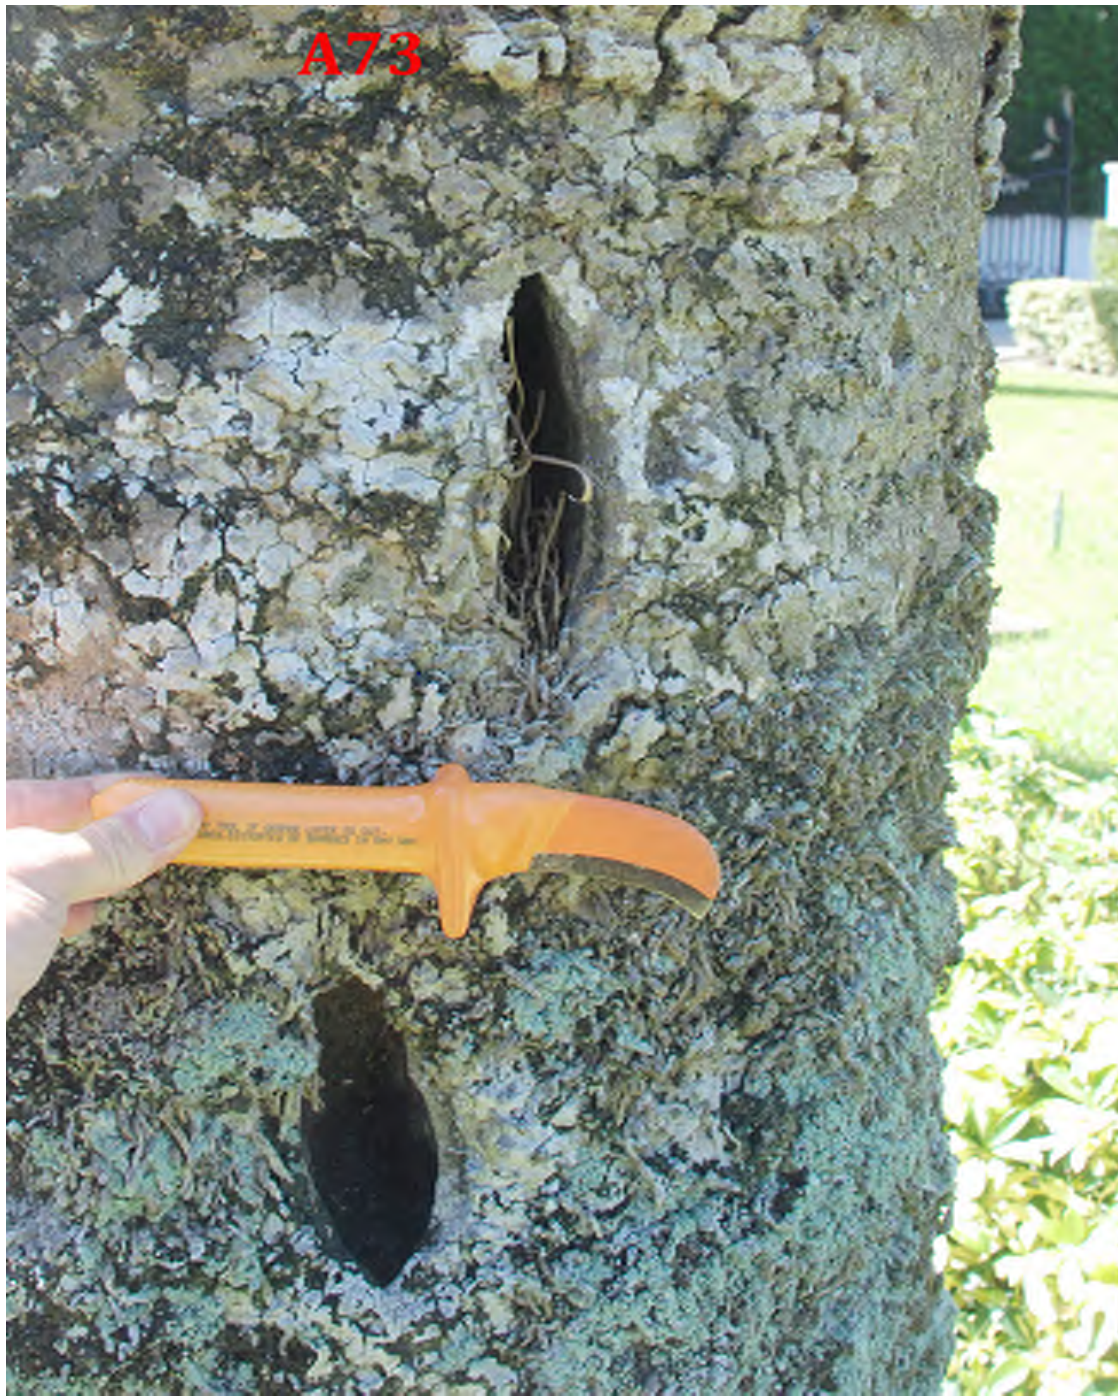
**Photo 48 above are deep cavities in the trunk of palm A73. This palm is not a good candidate for relocation. The orange knife is 7 inches in length.**

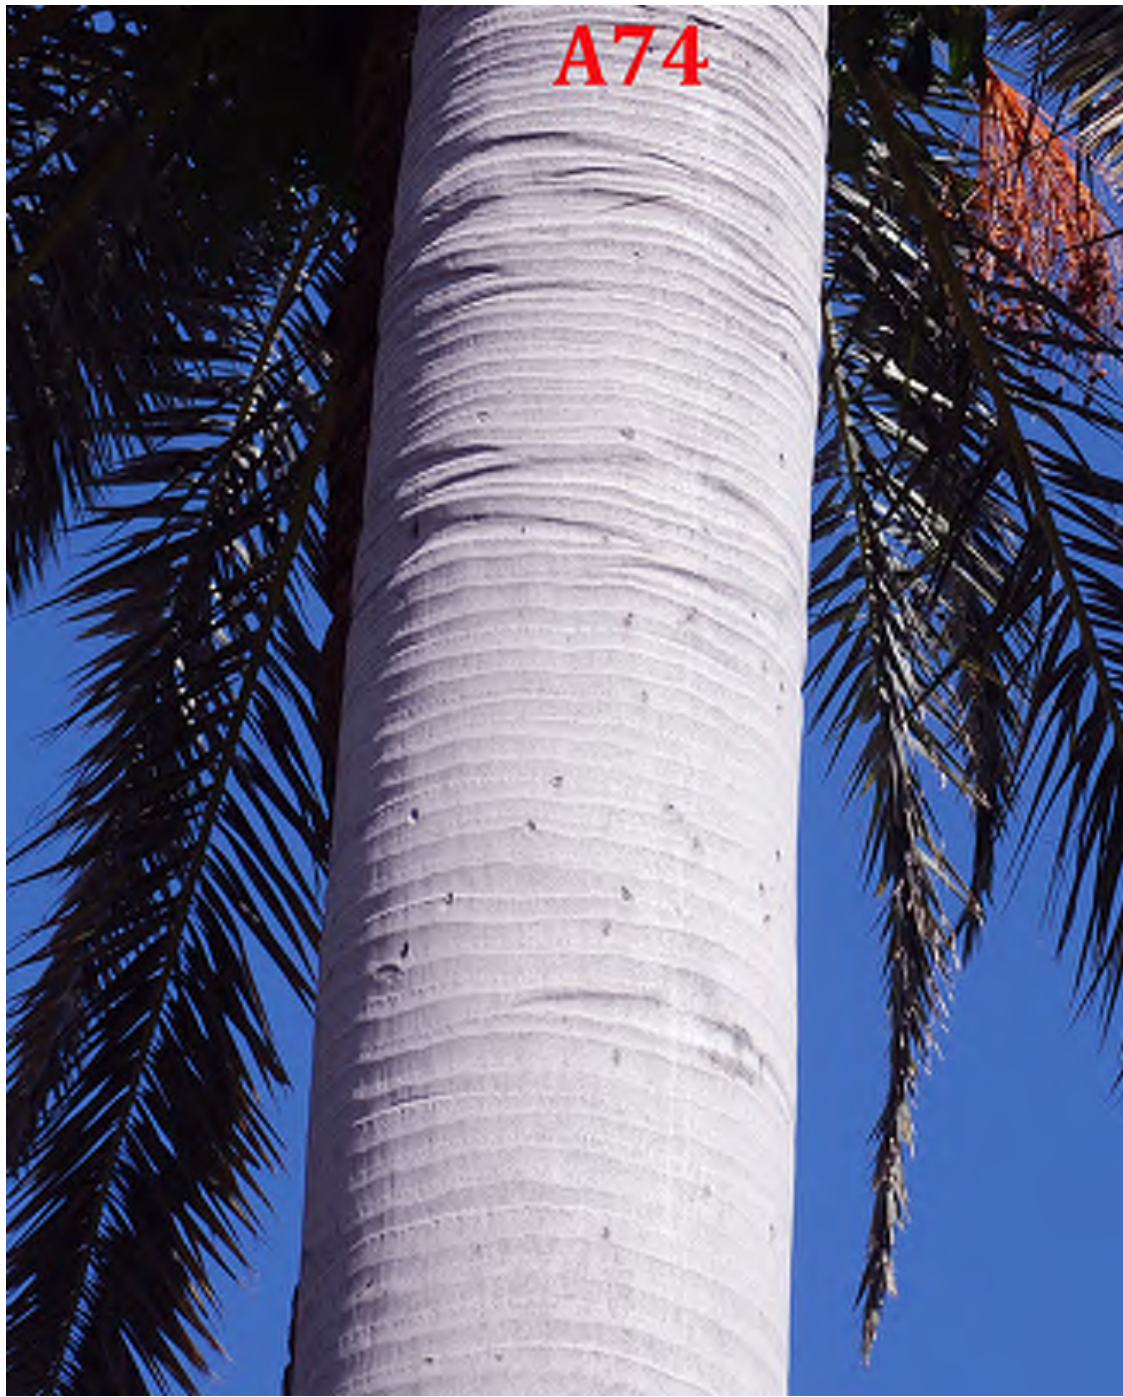
**Photo 50 above is a closer view of the trunk of palm A74 that has been climbed with spikes. I have rated some of the royal palms to be in moderate condition because of evidence of being climbed with spikes. This is not an acceptable arboricultural practice as these holes never heal and can become an egress for pathogens.**

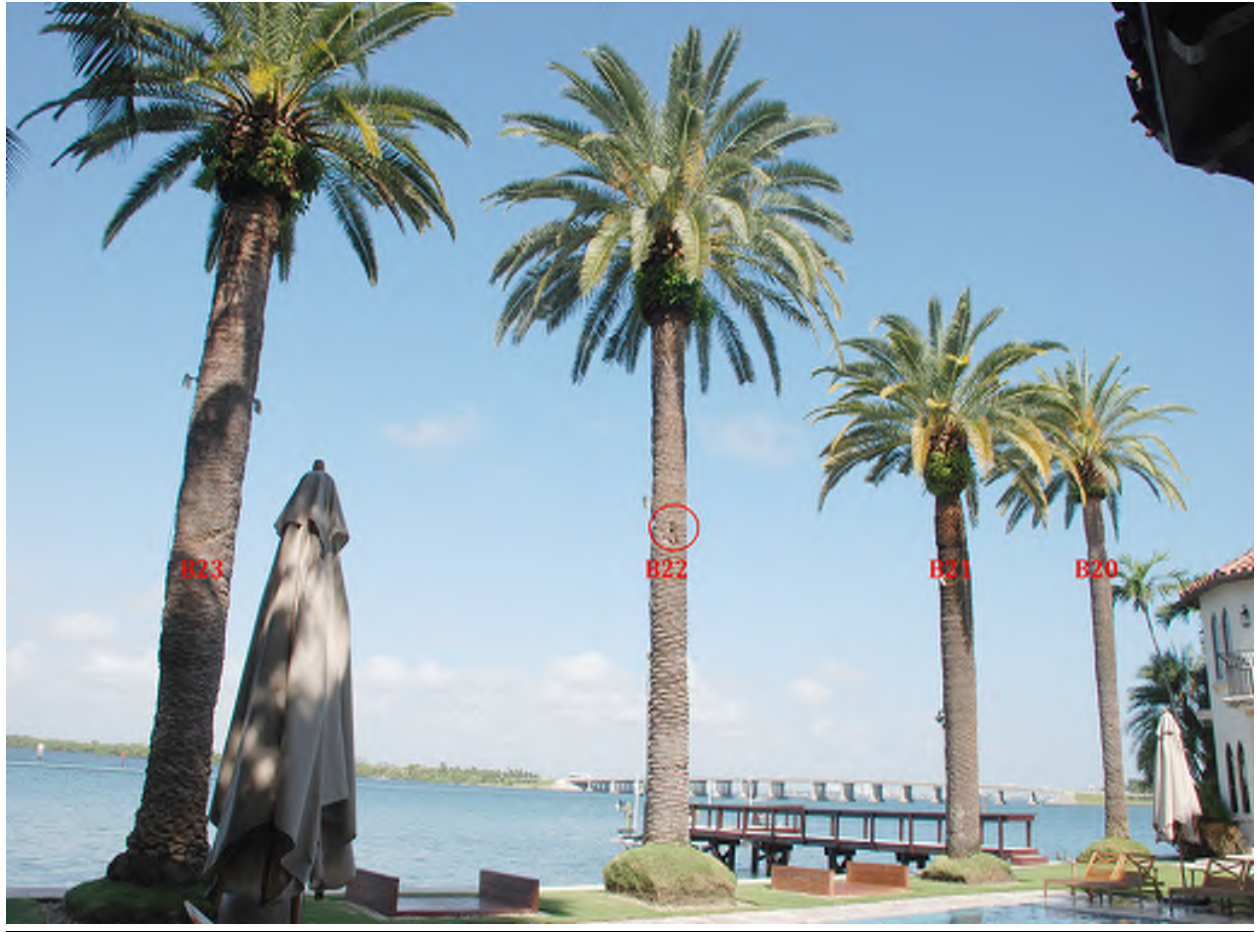
**Photo 60 above is palms B20, B21, B22 & B23. There is a hole indicated in the trunk of B22 that should be investigated if this palm is to be relocated.**

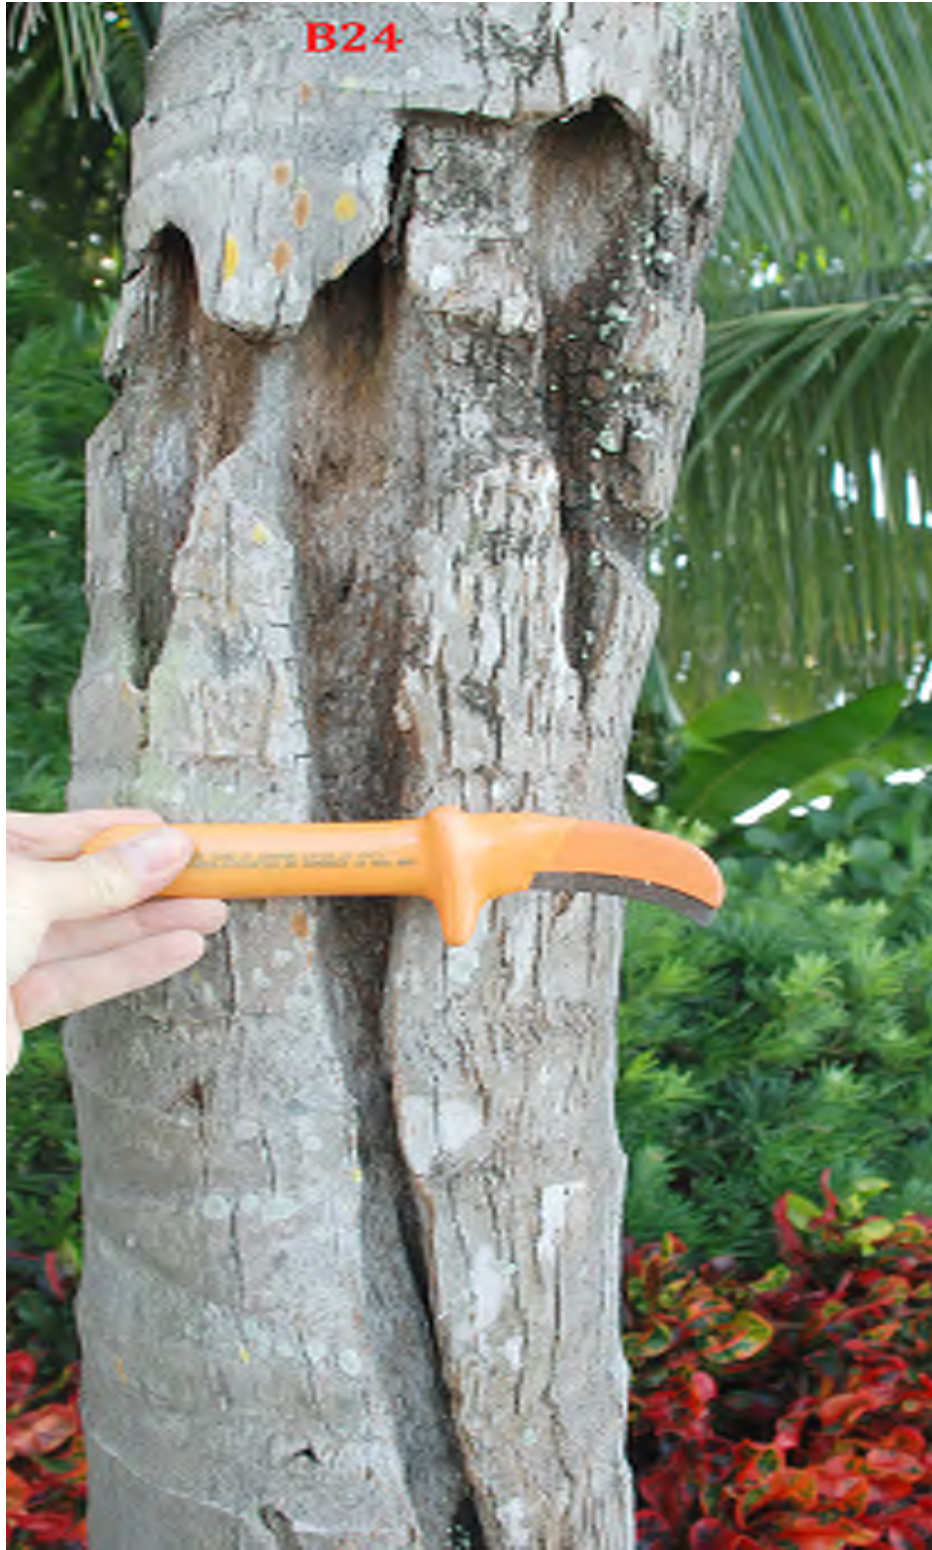
**Photo 62 above is the damaged trunk of palm B24. This palm is not a good candidate for relocation.**

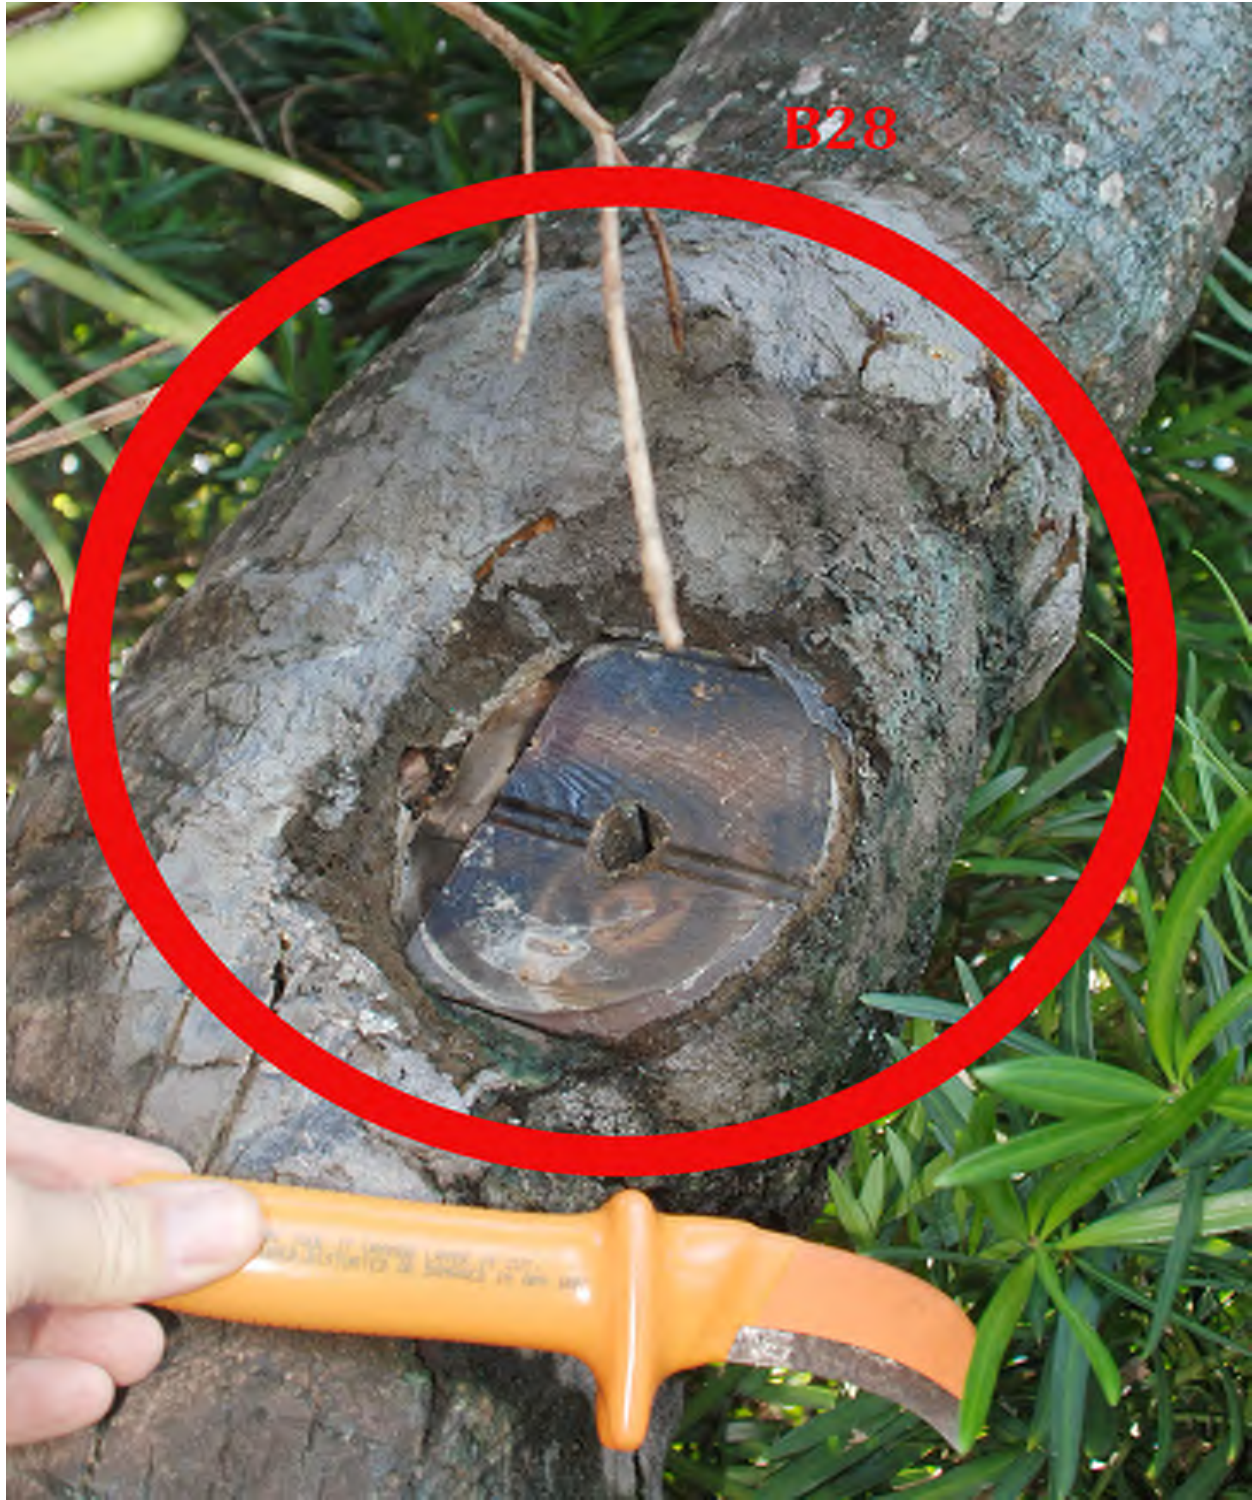
**Photo 64 above is the trunk of palm B28. This area of the trunk sounds hollow. This palm should be removed.**

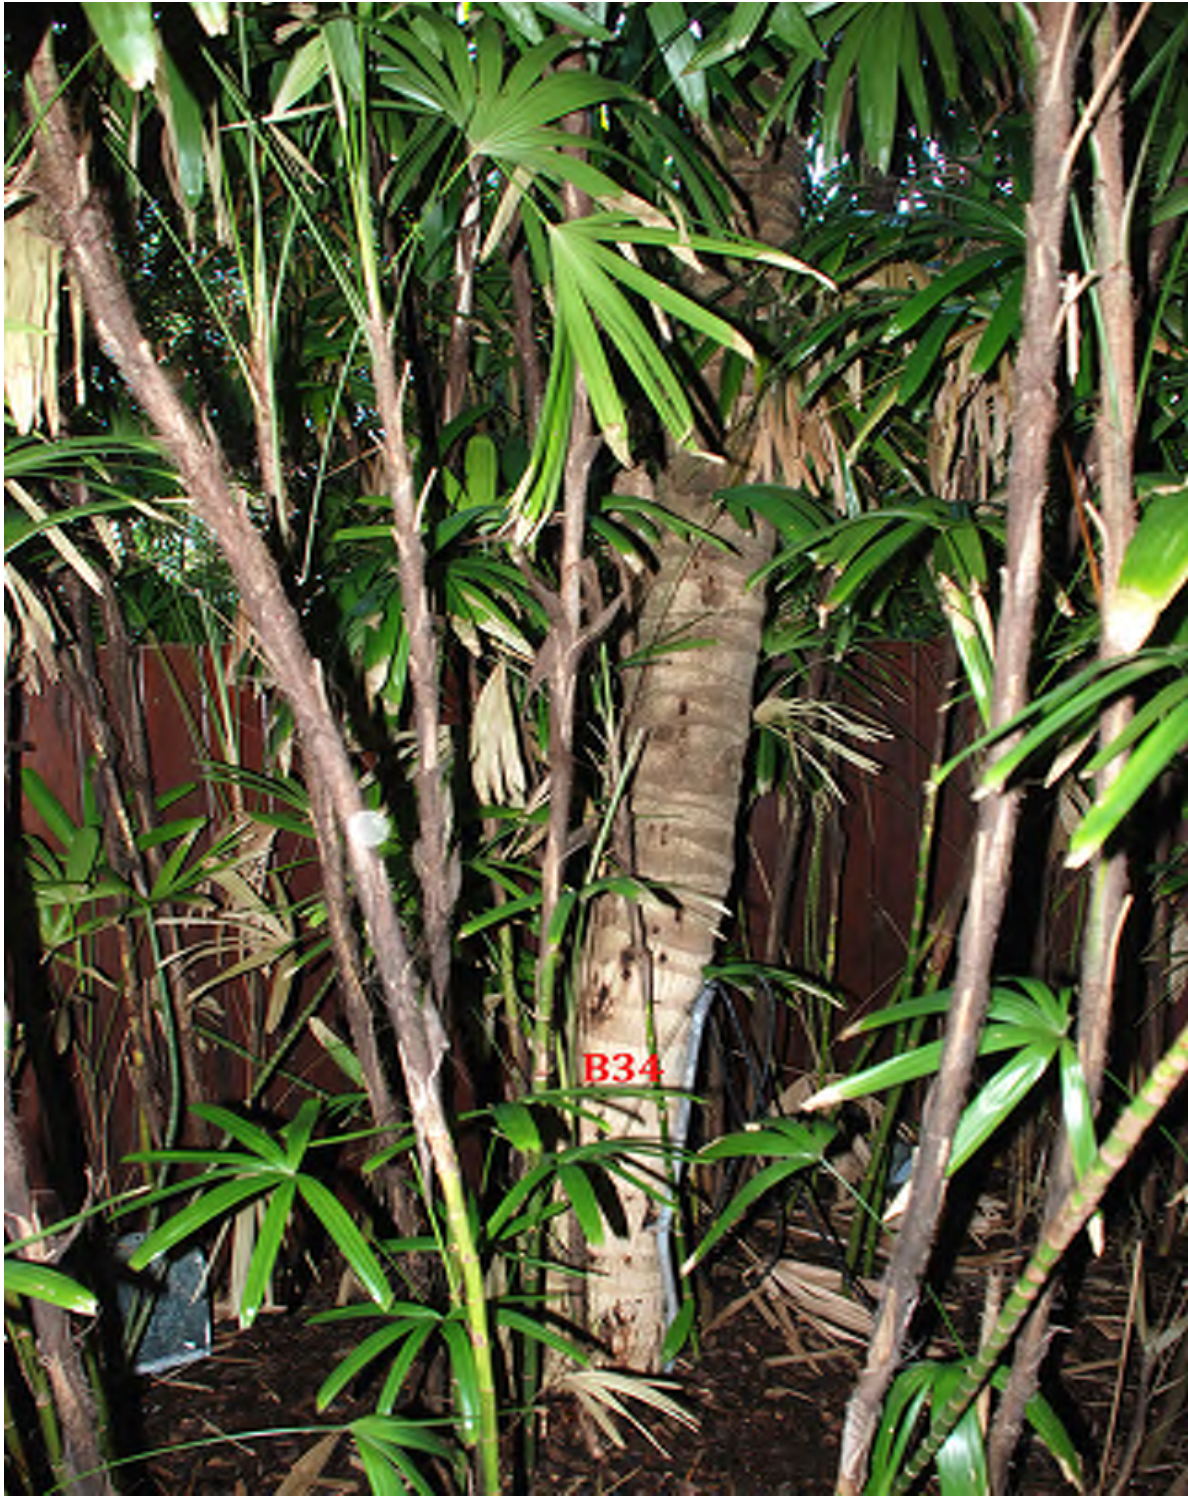
**Photo 69 above is the trunk of palm B34 with noticeable holes from climbing spikes that are oozing.**

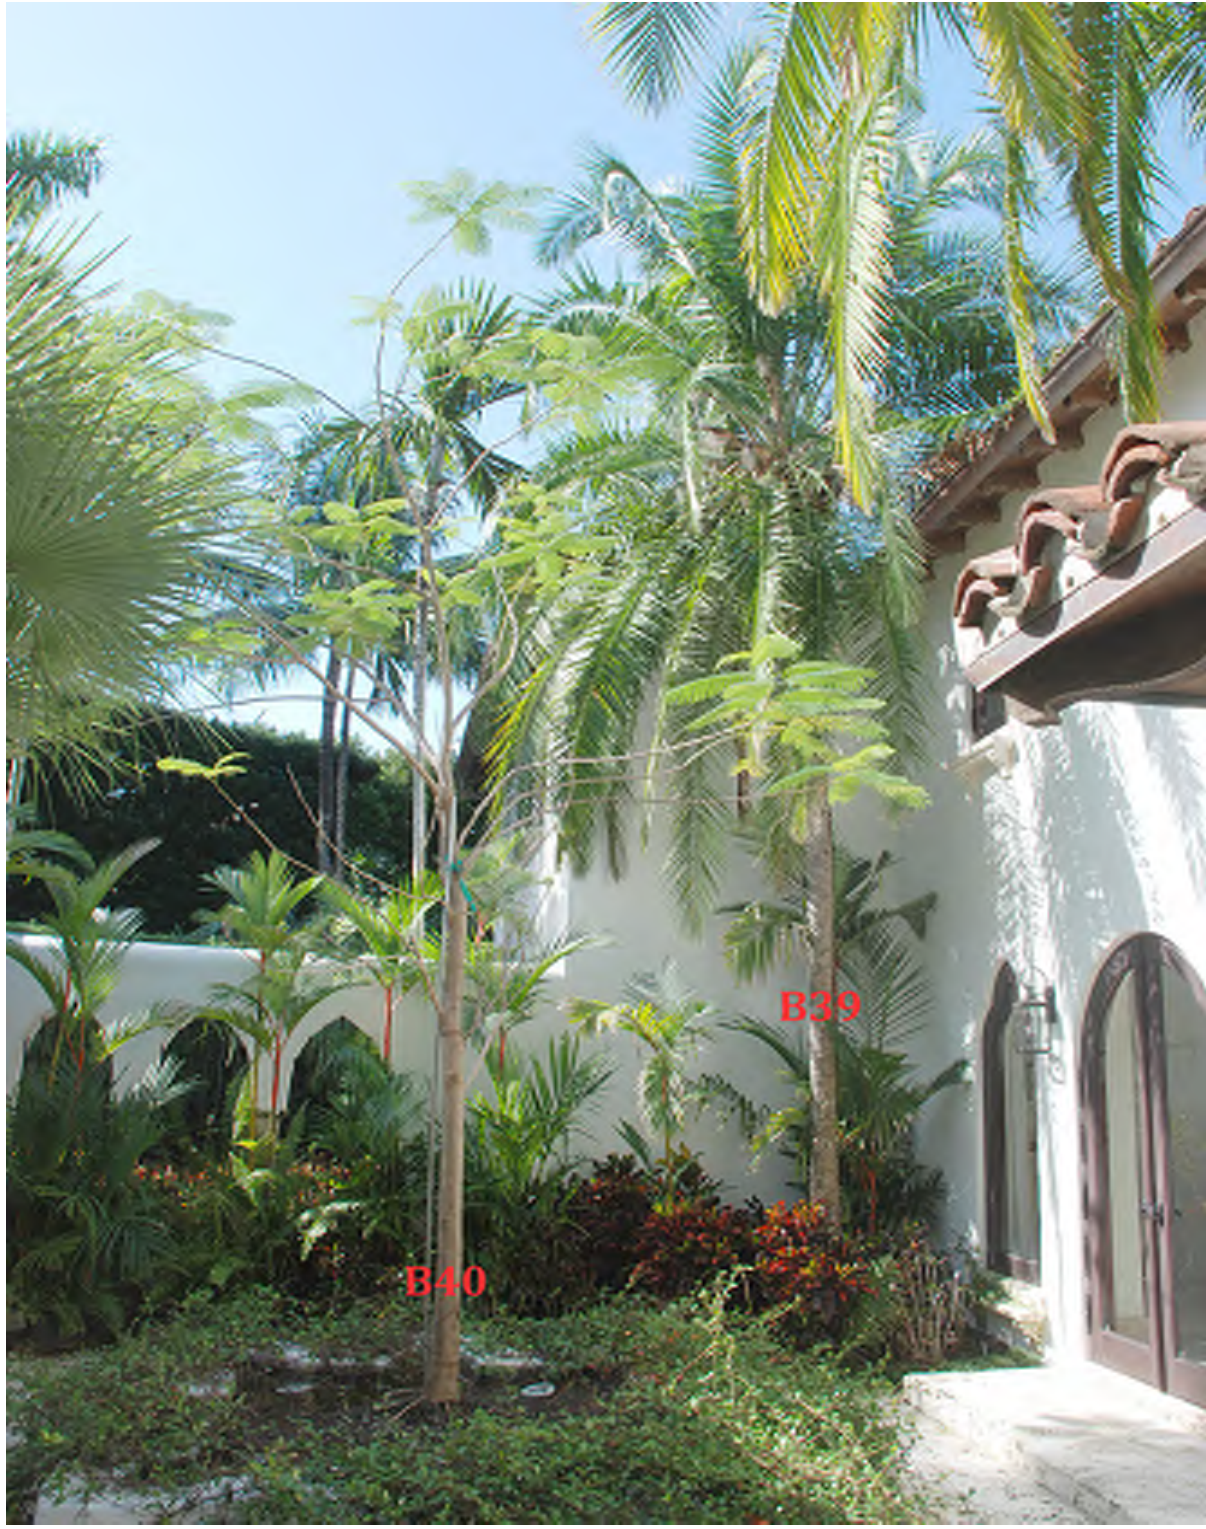
**Photo 73 above is palm B39 and tree B40. This tree is planted in a very wet area. It should be removed.**

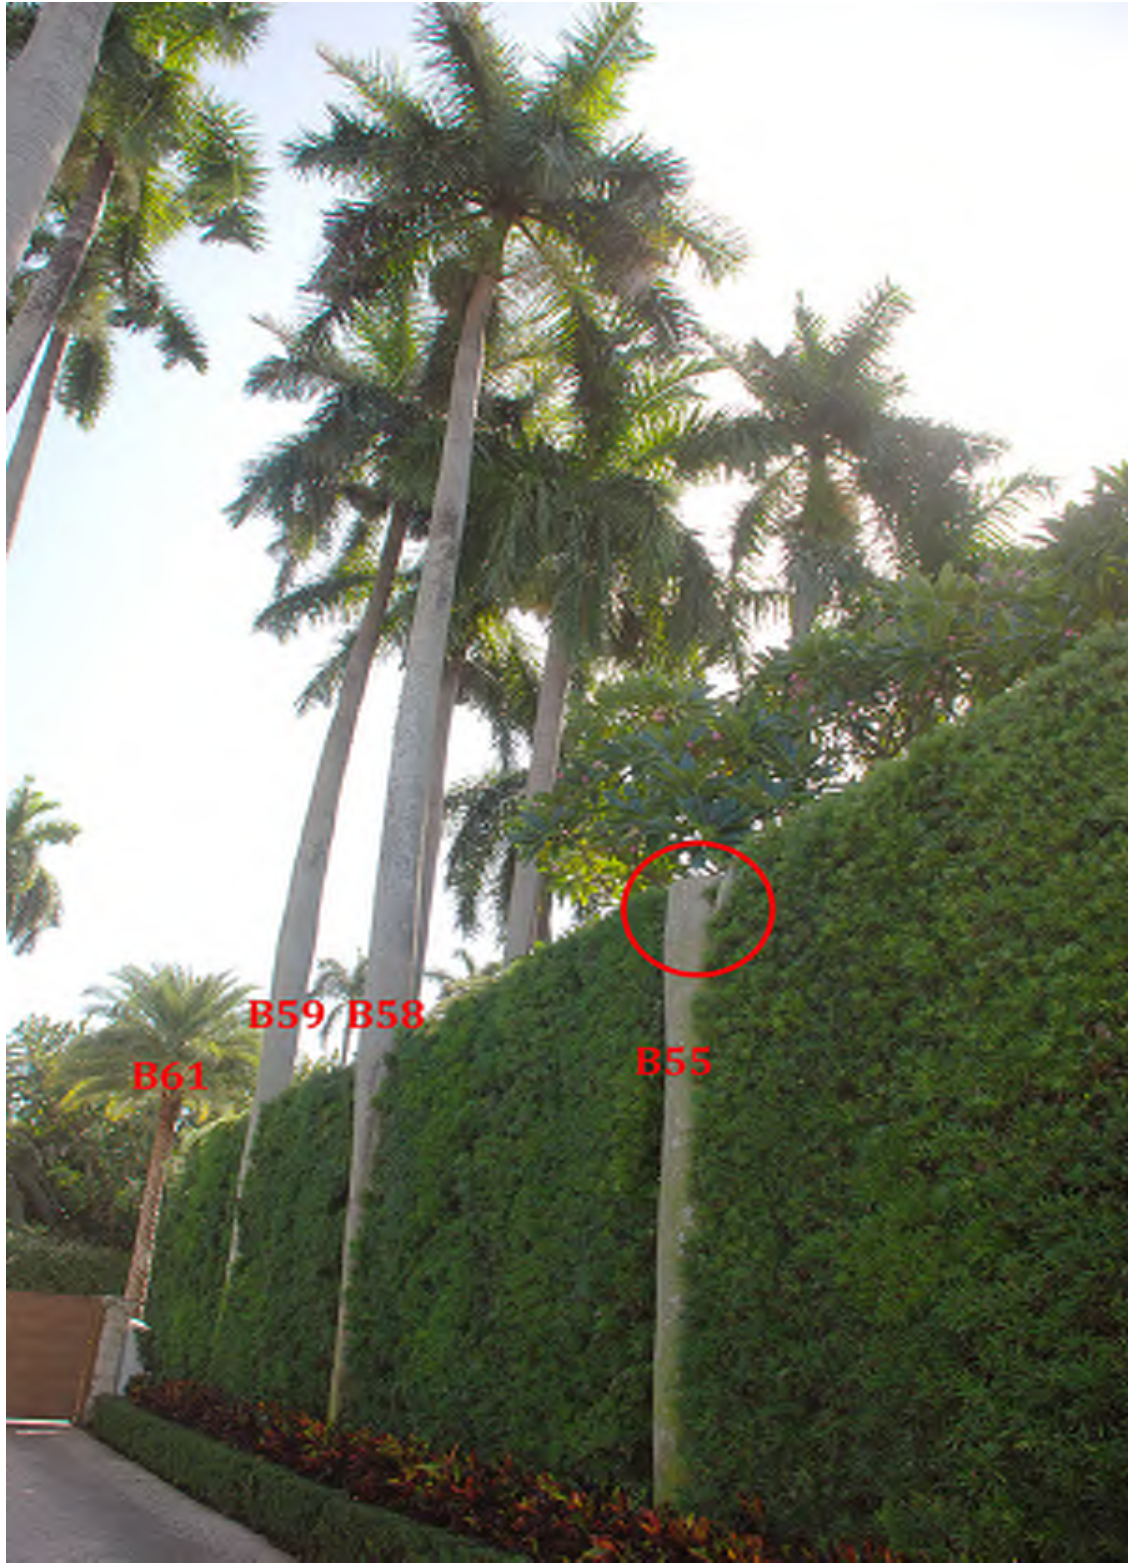
**Photo 81 above is palms B55 (with cut trunk), B58, B59 & B61.**
