Tree Resource Evaluation for 1515 W 22nd Street, Miami Beach

November 4, 2020

Summary

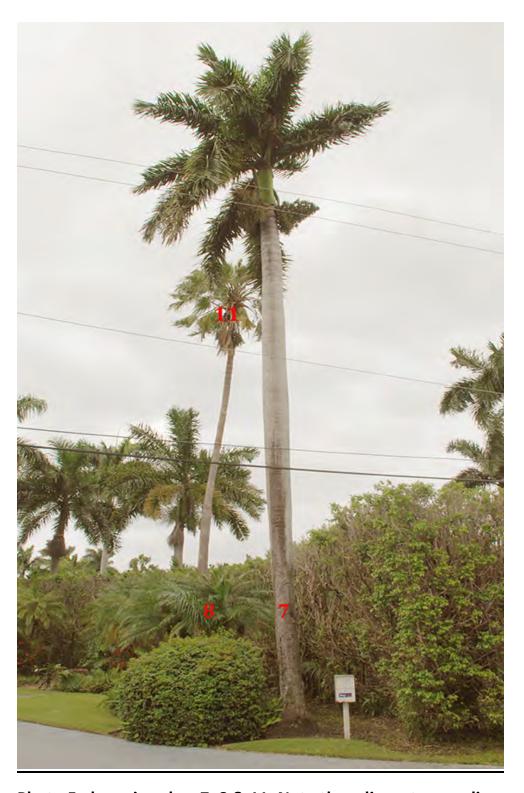
Photo 5 above is palms 7, 8 & 11. Note the adjacent powerlines.

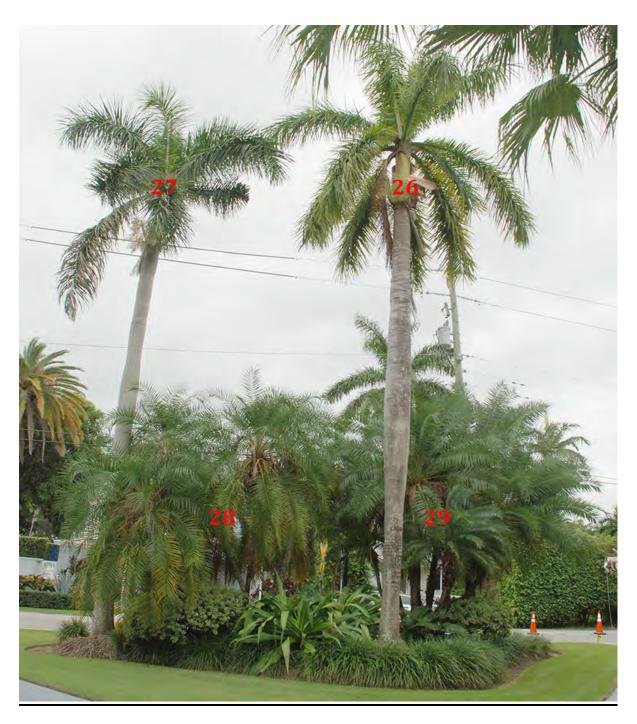
Photo 9 above is palms 26, 27, 28 & 29. Note the adjacent powerlines.

Palms 28 & 29 are listed as *Phoenix reclinata* in Appendix A however these are probably hybrids of *P. reclinata*.

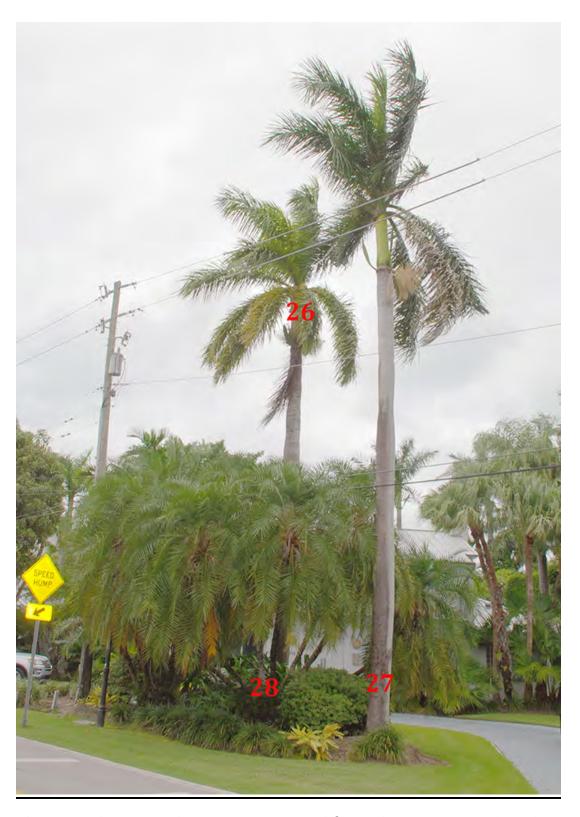
Photo 10 above is palms 27 & 28 viewed from the east. Note the adjacent powerlines.

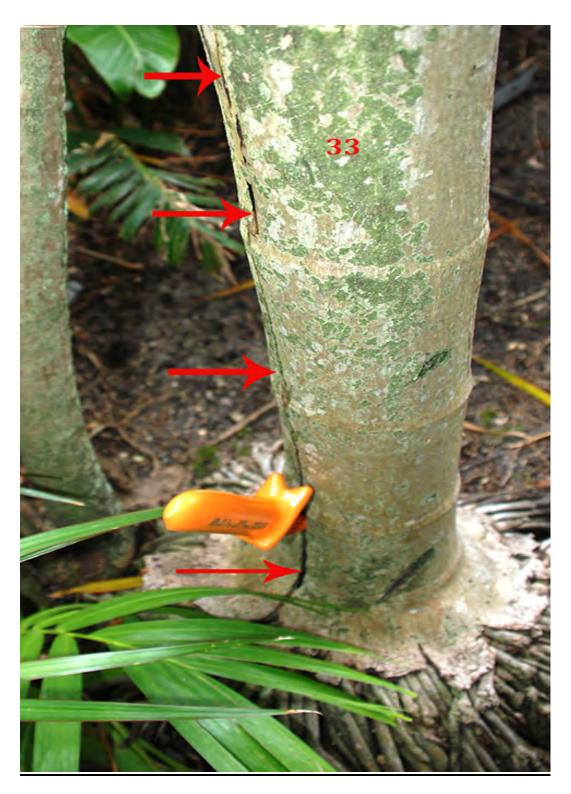
Photo 14 above is the trunk of palm 33 with cracks on both sides of the trunk. The arrows indicate one crack with the blade of the orange knife inserted about 3 inches. This palm should be removed.

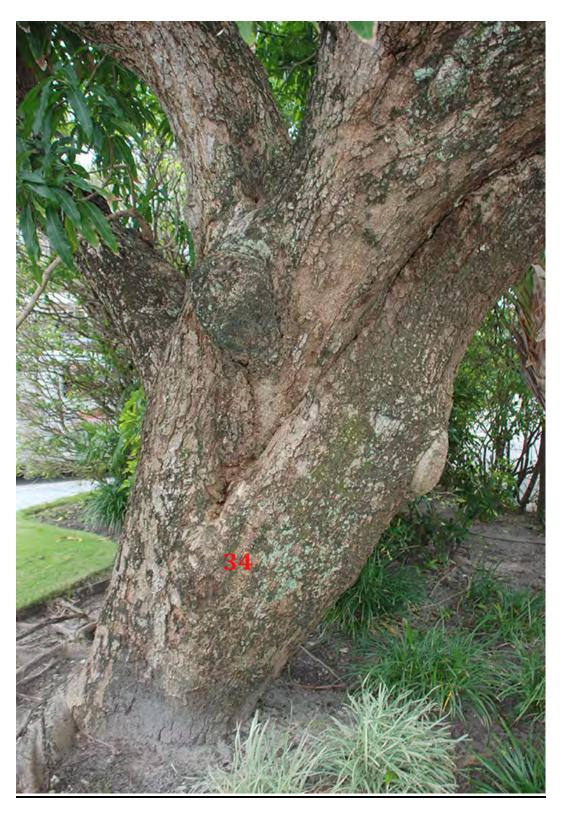
Photo 16 above is the trunk of tree 34. I found no signs of decay, cavities, or fungal fruiting bodies on the root collar or trunk.

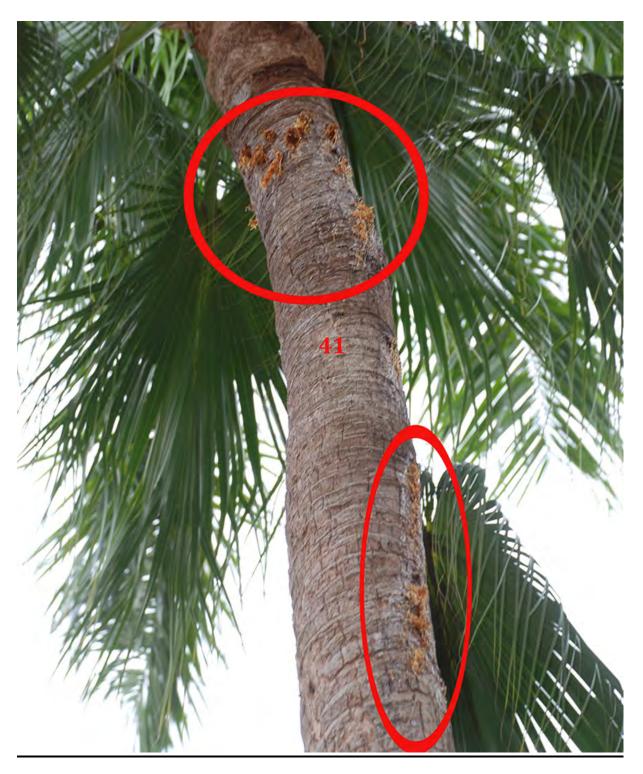
Photo 20 above is palm 41 that had recently been climbed with spikes. Note the ooze coming out of the spike holes. This palm should be removed.

Climbing palm trunks with spikes is not an acceptable horticultural practice.

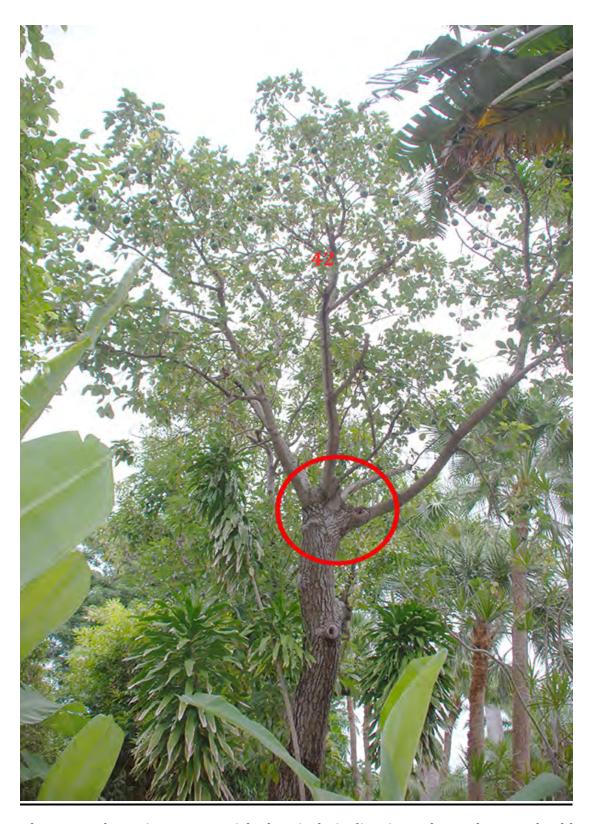
Photo 21 above is tree 42 with the circle indicating where the tree had been topped resulting in new branches with weak attachments to the trunk.

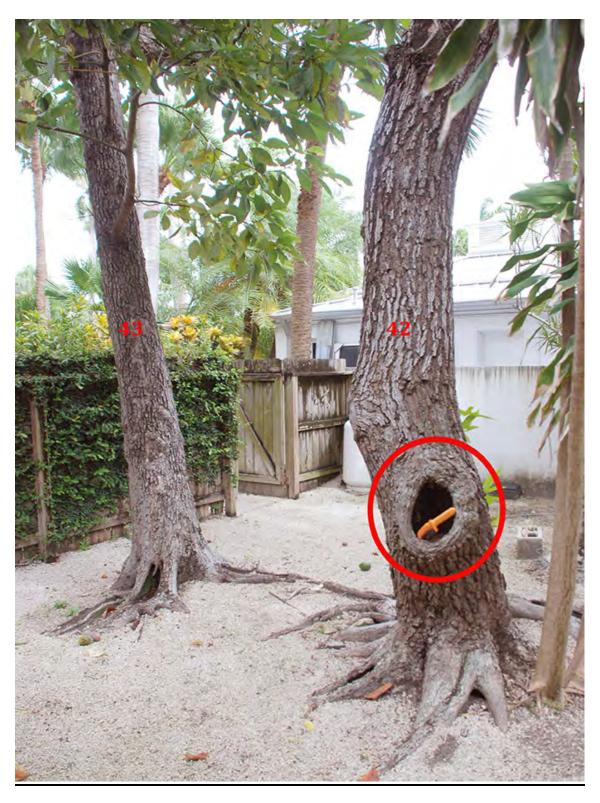
Photo 22 above is trees 42 & 43. Note the large cavity on tree 42.

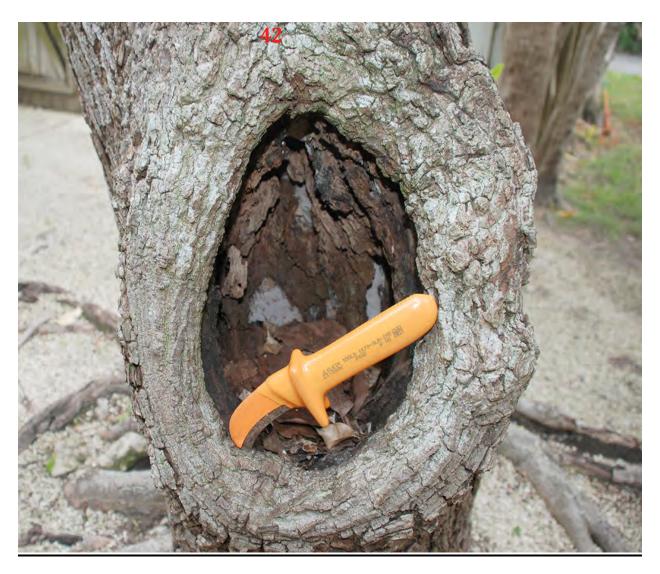
Photo 23 above is a closer view of the large cavity on tree 42. The orange knife is 7 inches in length. This tree should be considered for removal.

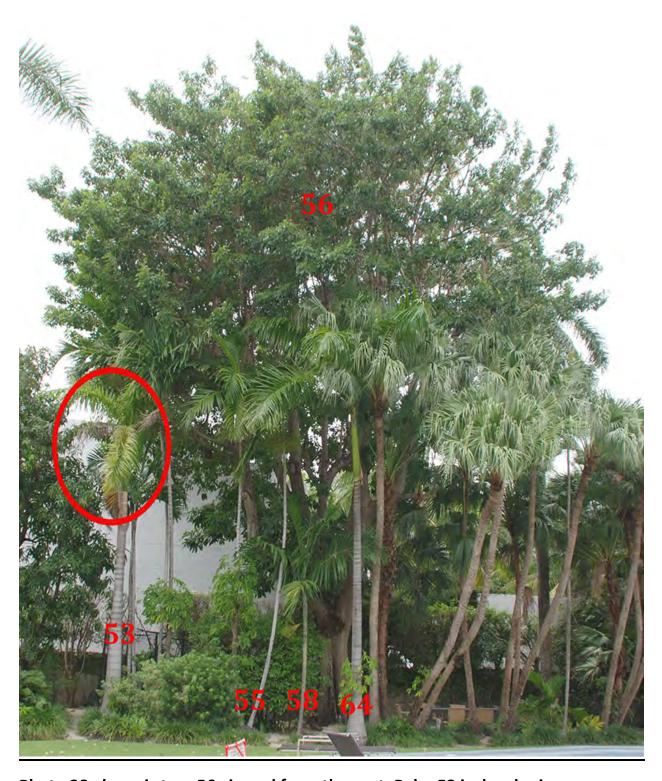
Photo 28 above is tree 56 viewed from the east. Palm 53 is developing a severe nutrient deficiency and should be removed.

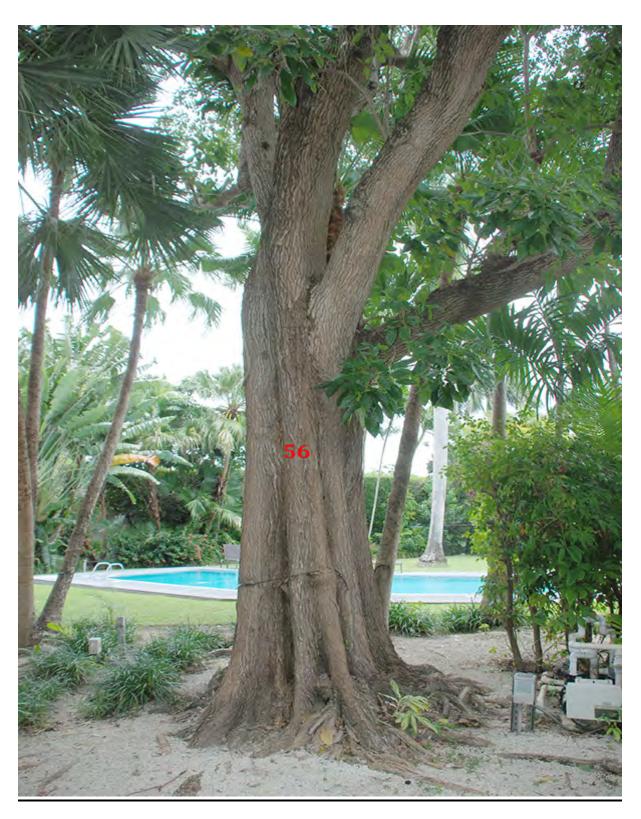
Photo 30 above is the trunk of tree 56. I found no signs of decay, cavities, or fungal fruiting bodies on the root collar or trunk.

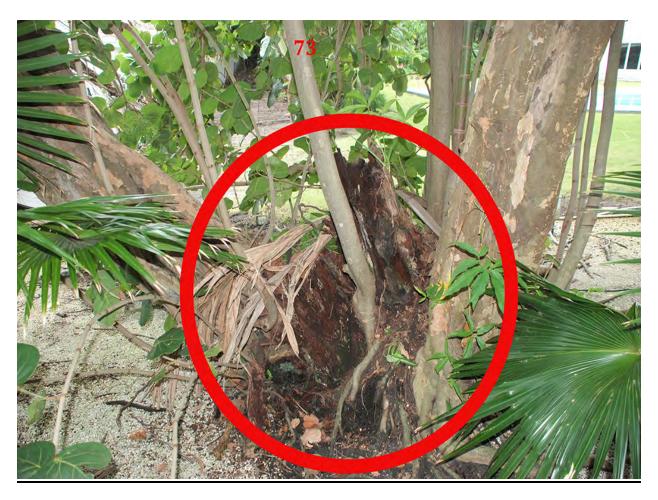
Photo 37 above is the west side of the trunk(s) of tree 73. The circle indicates a large section of decay between the two trunks. This tree should not be considered for relocation.

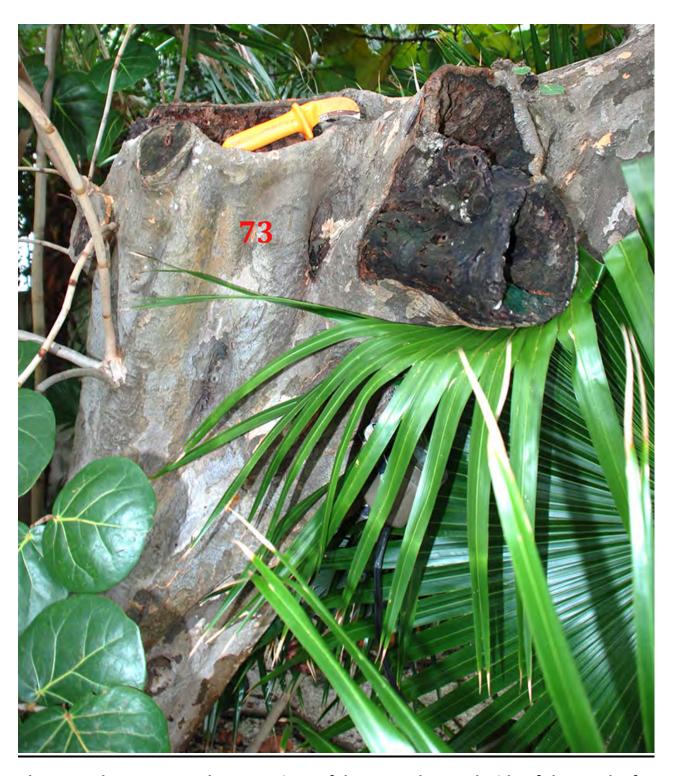
Photo 38 above are two large sections of decay on the north side of the trunk of tree 73 caused by large pruning wounds. This tree should not be considered for relocation.

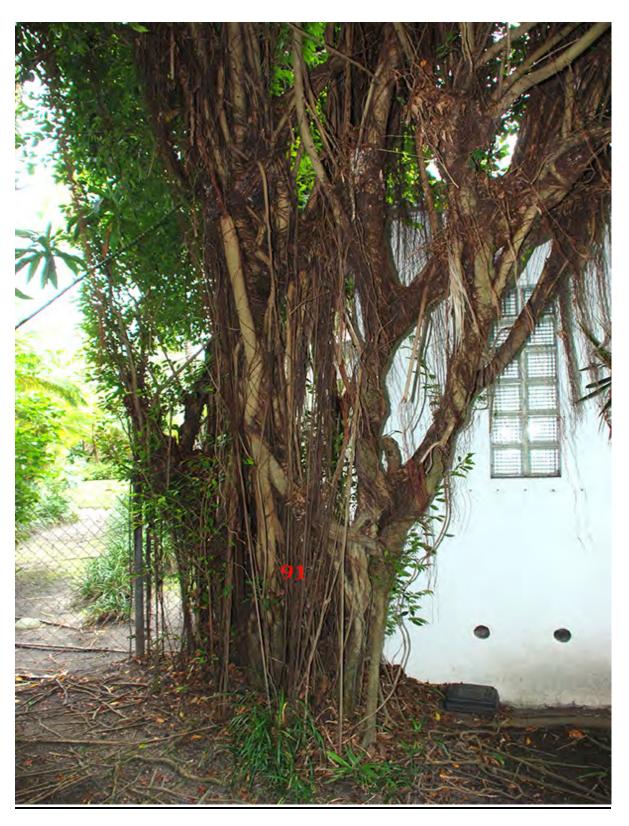
Photo 45 above is a closer view of tree 91 with poor branch and trunk taper.

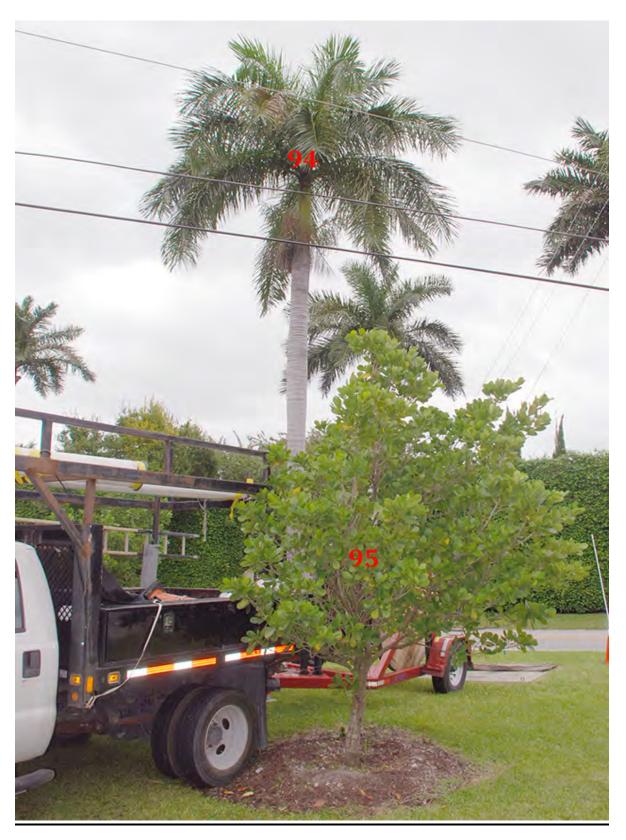
Photo 46 above is tree 95 competing for space with a public works vehicle.
