Tree Resource Evaluation for 248 W. Rivo Alto Drive, Miami Beach

December 10, 2020

I performed a tree resource evaluation on the property located at 248 W. Rivo Alto Drive, Miami Beach on December 9, 2020. The approximate locations of these trees and palms can be found on the schematic in Appendix B.

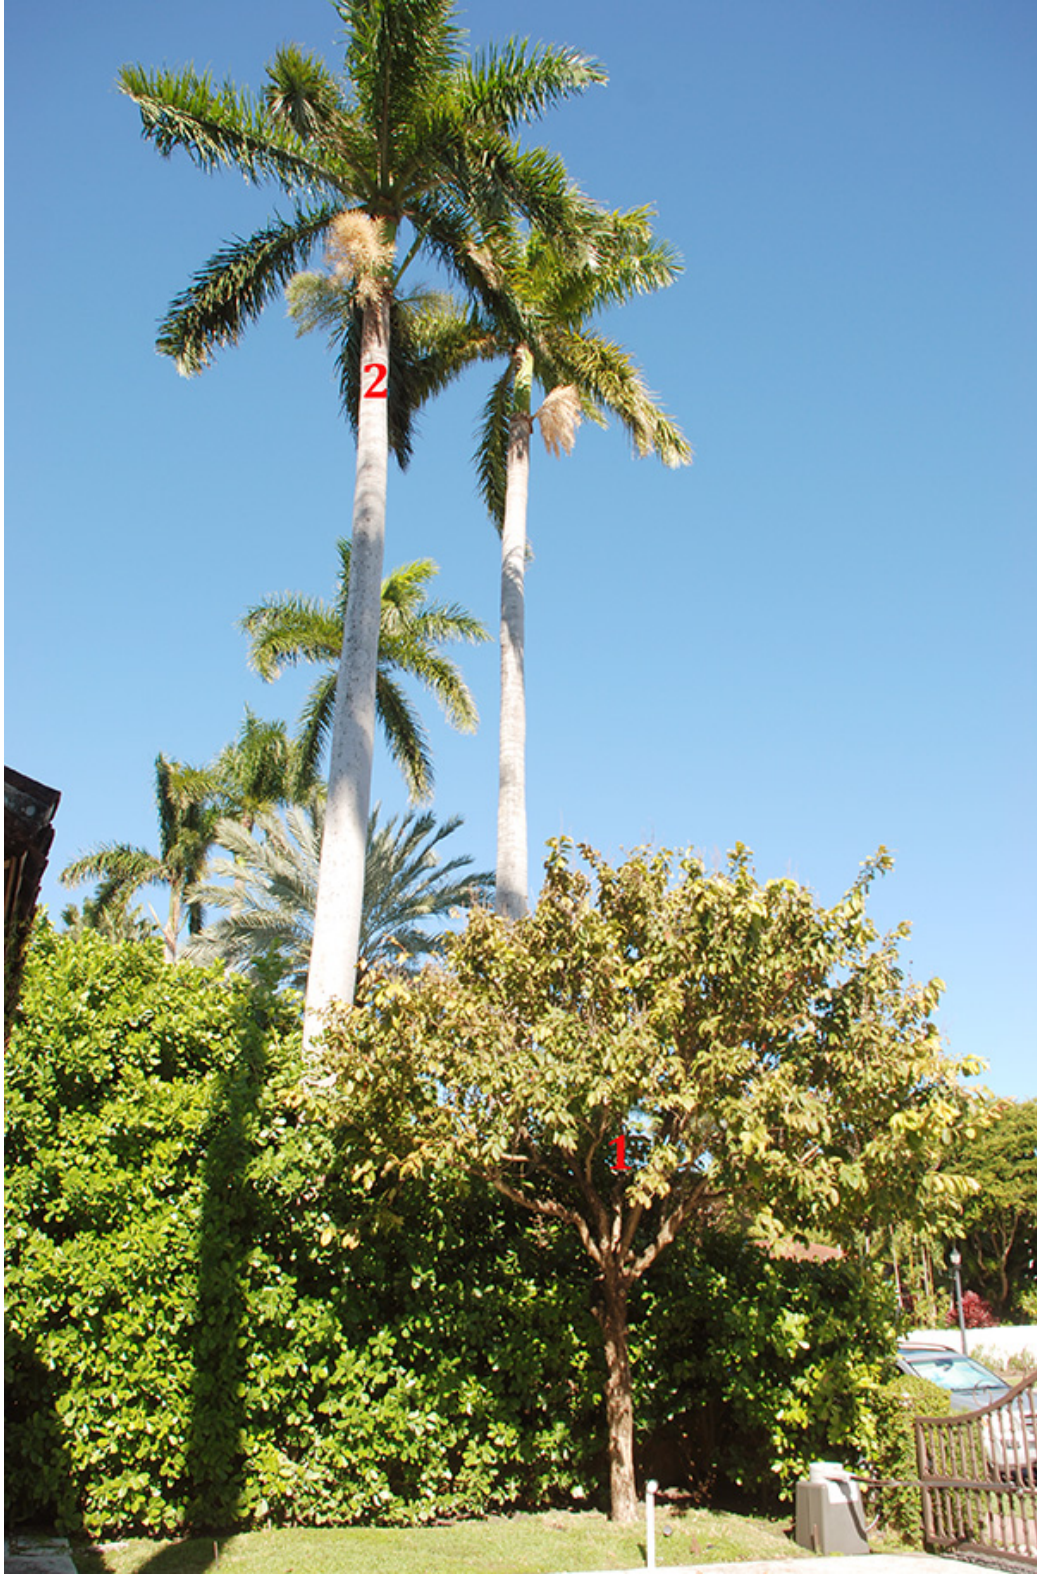
Photo 1 above is tree 1 & palm 2 near the northeast corner of the property.

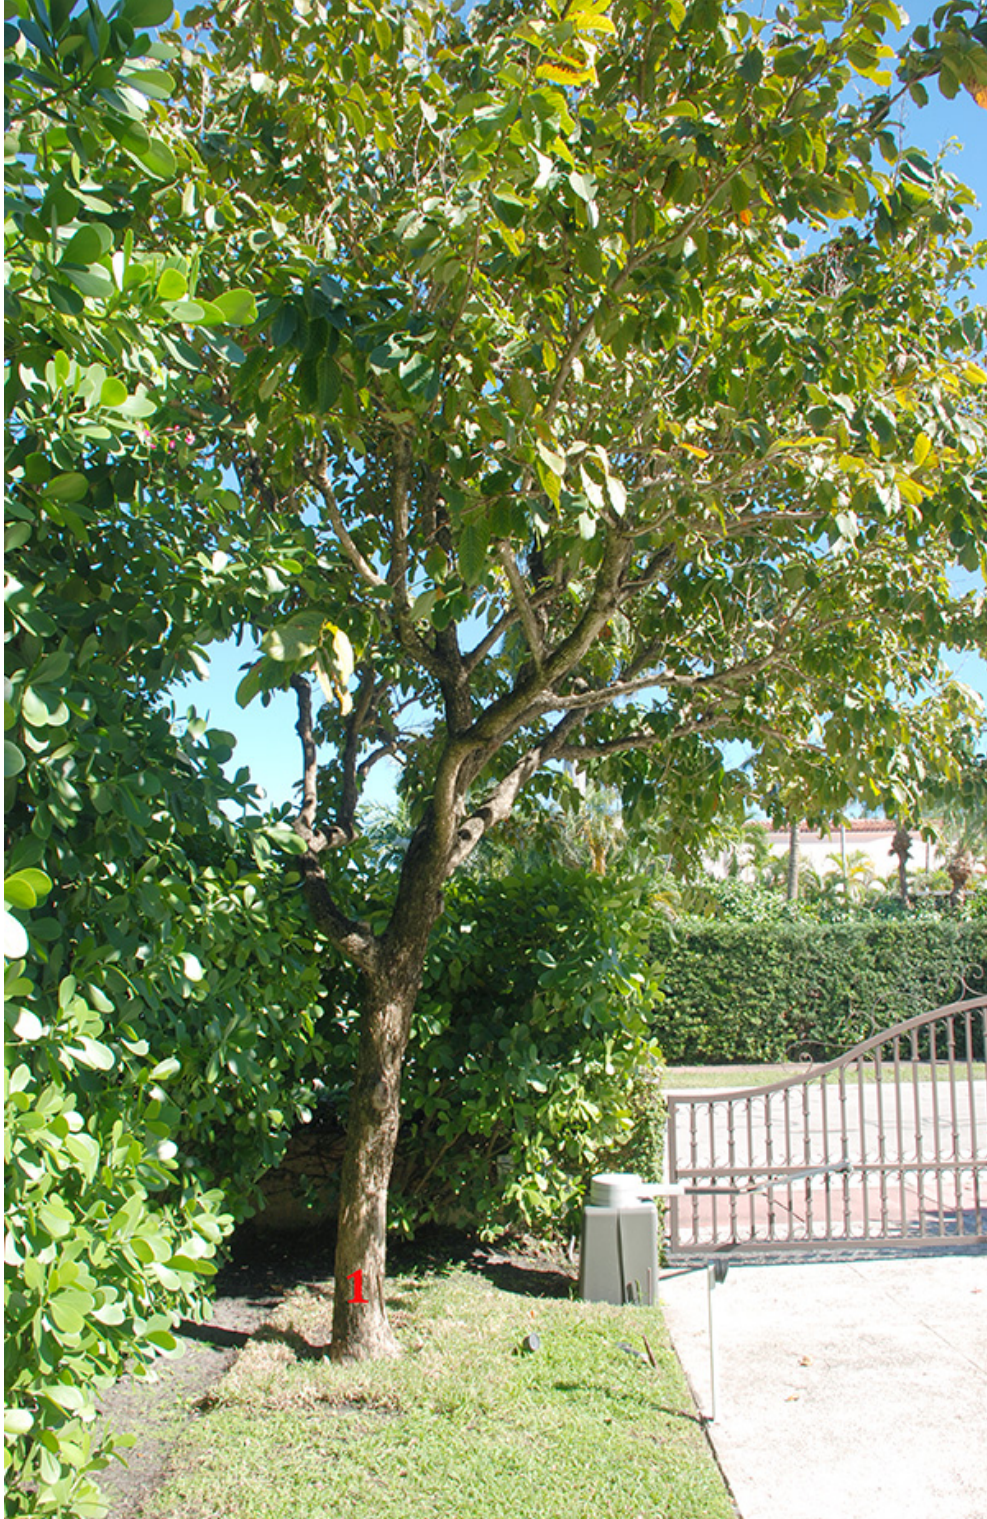
Photo 2 above is tree 1 viewed from the west. The CRZ/root plate of this tree will be limited by the adjacent wall to the east and driveway to the south.

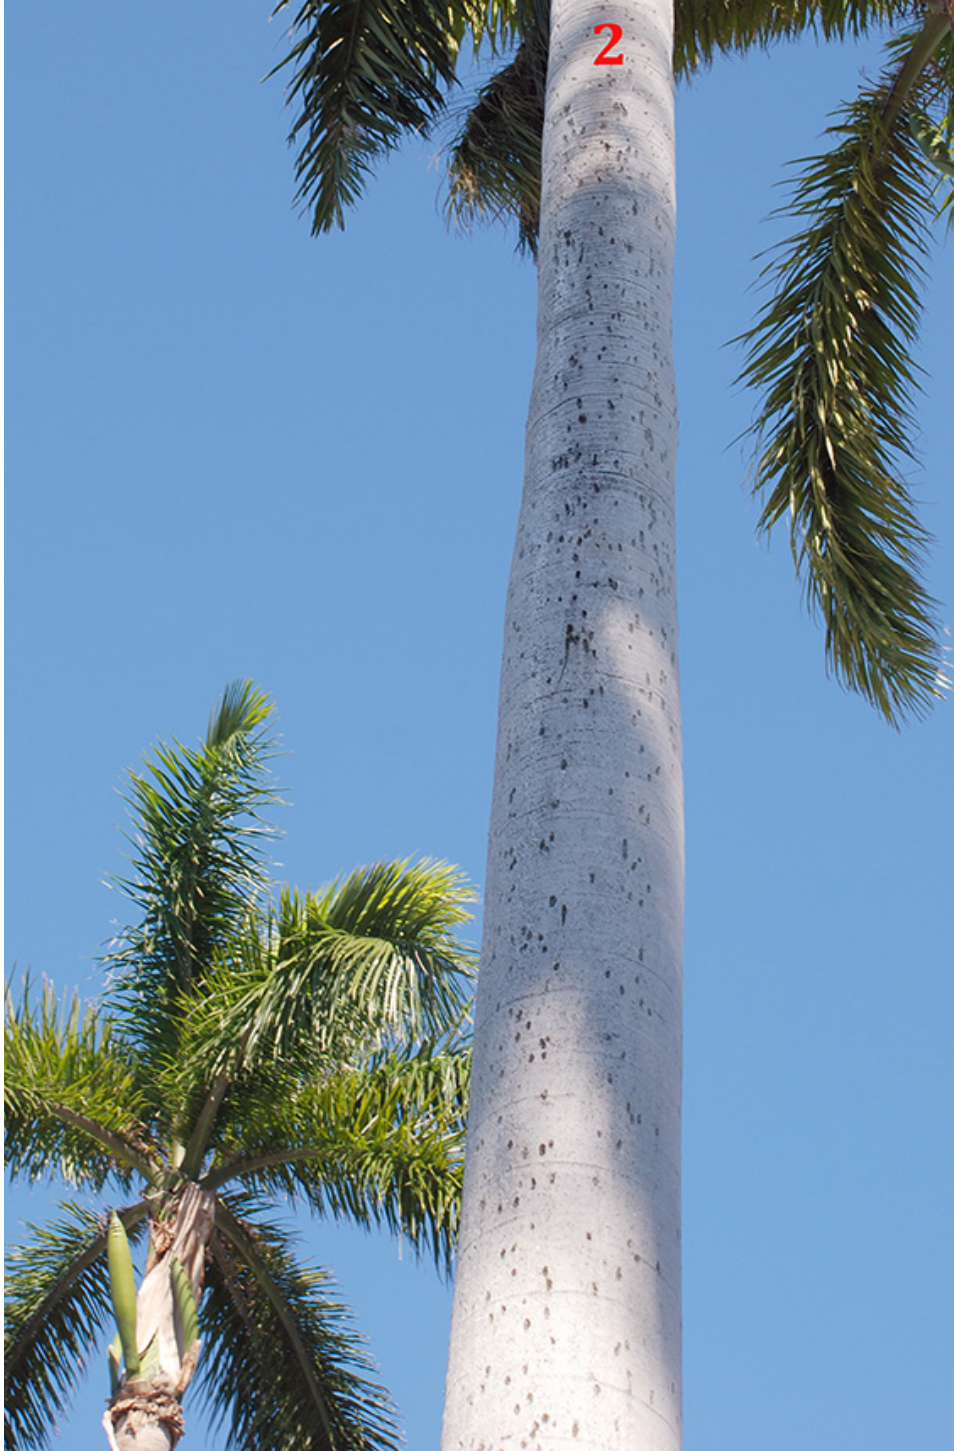
I noted on the trunks of the royal palms onsite that they have been climbed with spikes. This is an unacceptable practice as the holes made in the trunks will never heal and may become an infection court for disease and pathogens.

I have rated these palms to be in moderate condition and do not recommend them for relocation.

Photo 3 above is palm 2 showing signs of damage from tree climbing spikes. This is an unacceptable practice as the holes made in the trunks will never heal and may become an infection court for disease and pathogens.

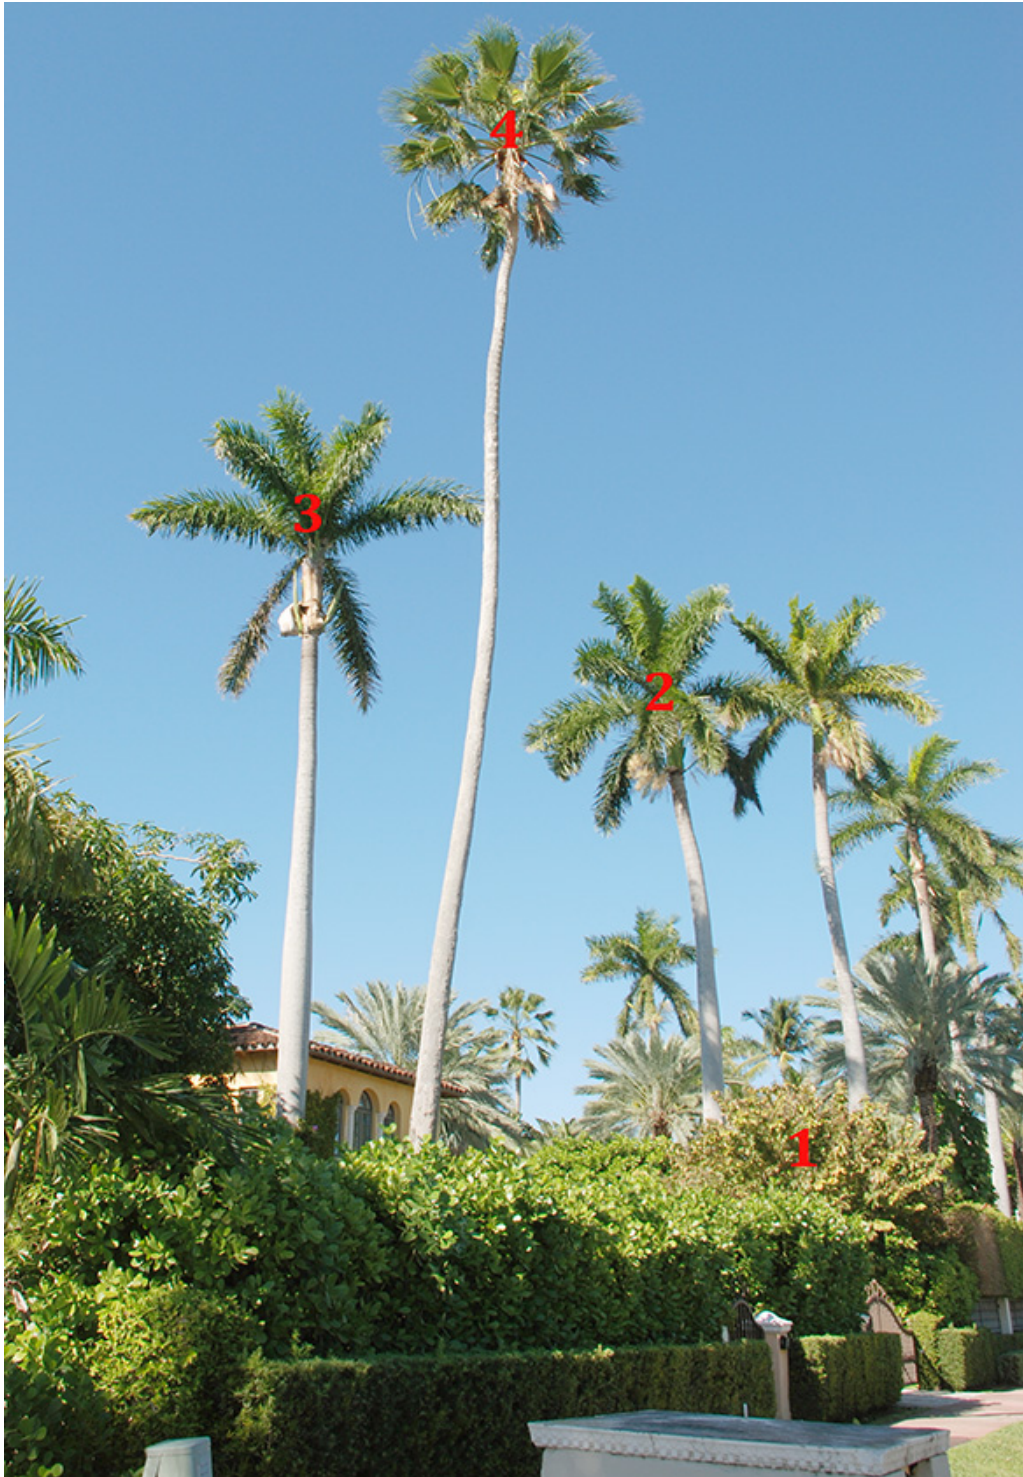
Photo 3 above is palms 2, 3 & 4 viewed from the southeast.

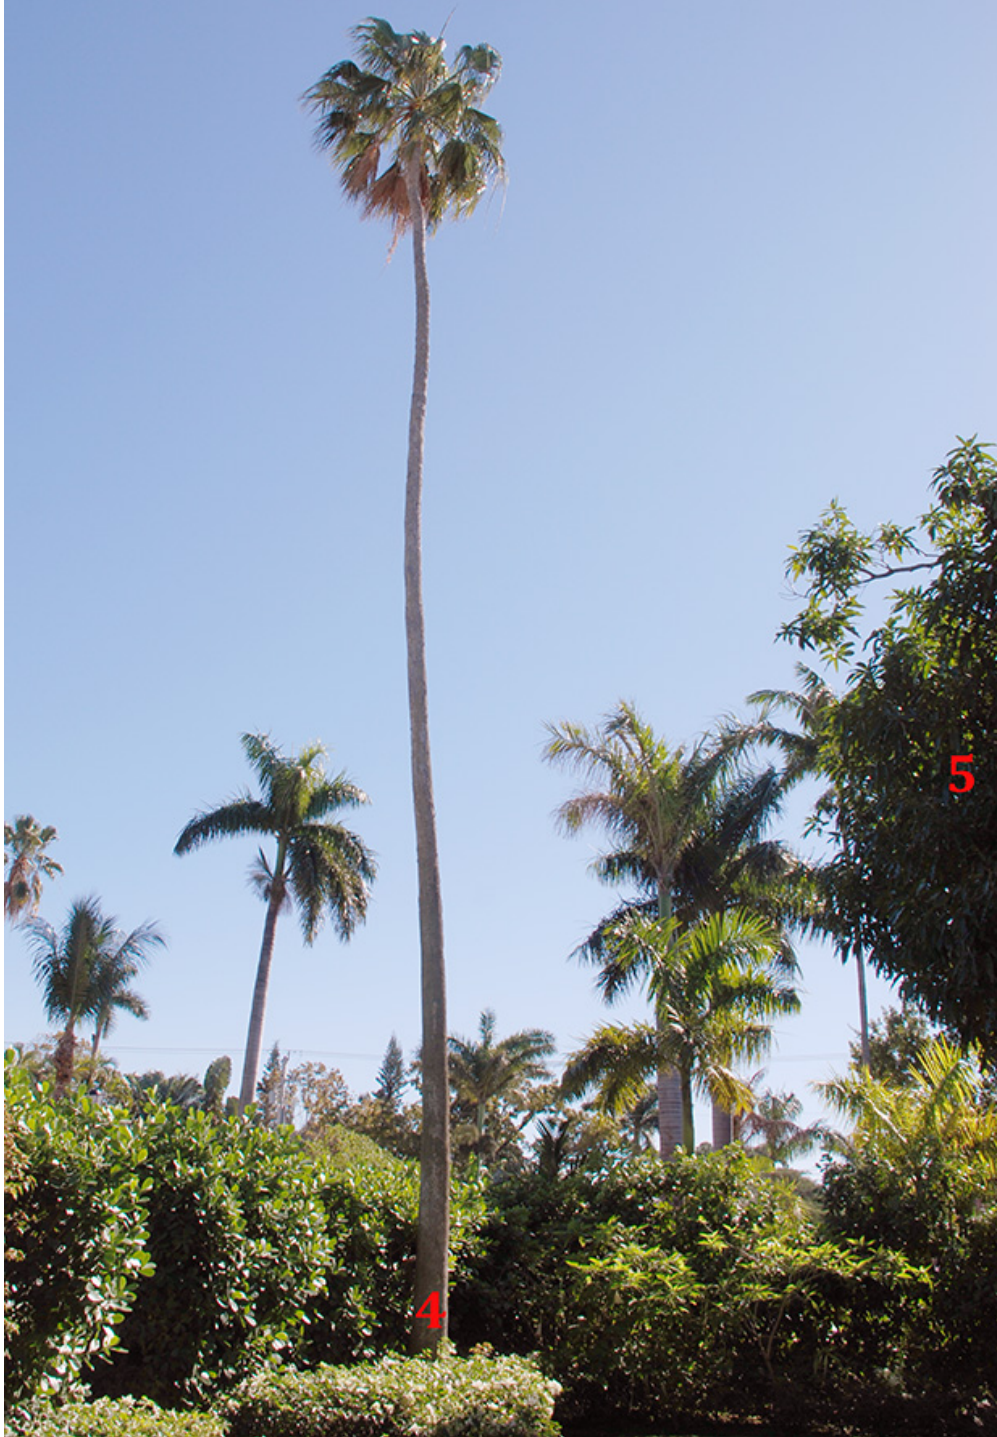
Photo 4 above is a view of the trunk of palm 4.

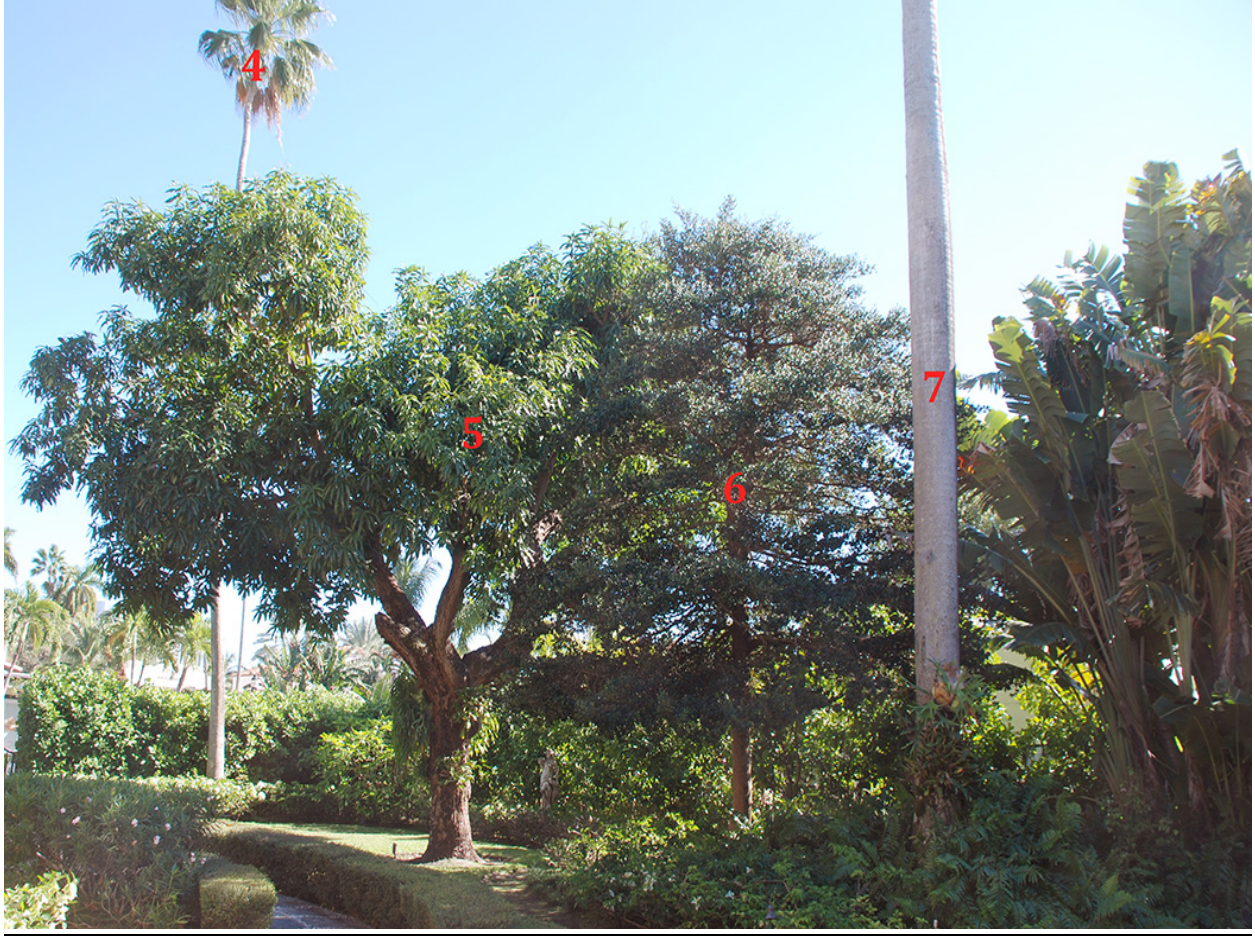
Photo 5 above is trees 5 & 6 and palm 7.

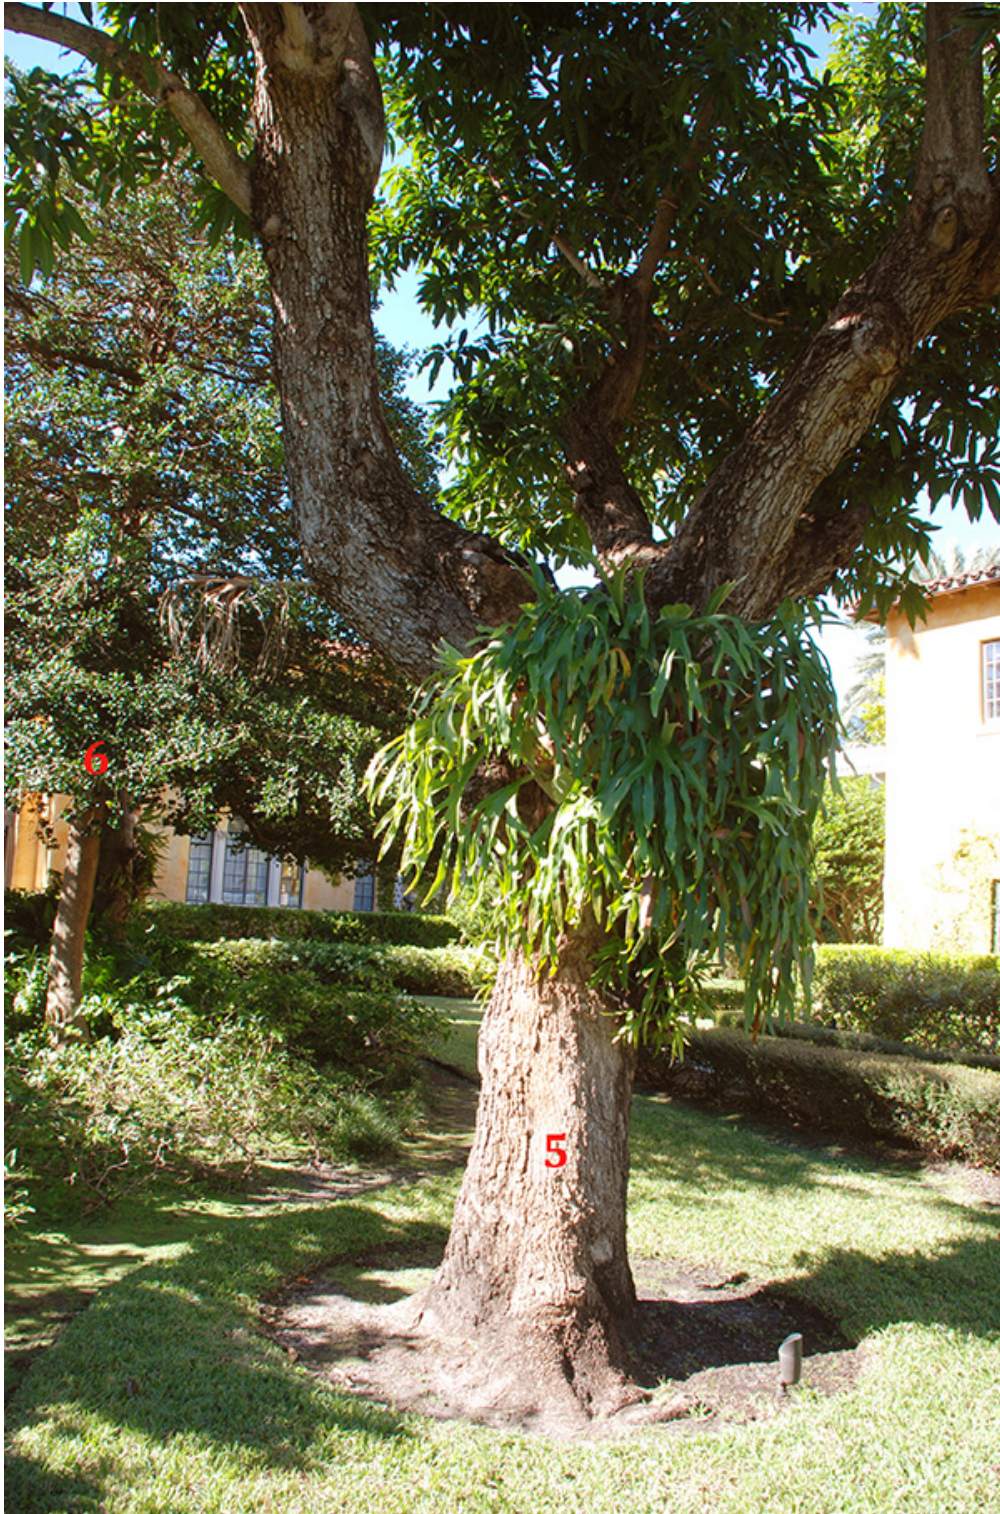
Photo 6 above is the trunk of tree 5 with no signs of decay, cavities, or fungal fruiting bodies on the root collar or trunk.

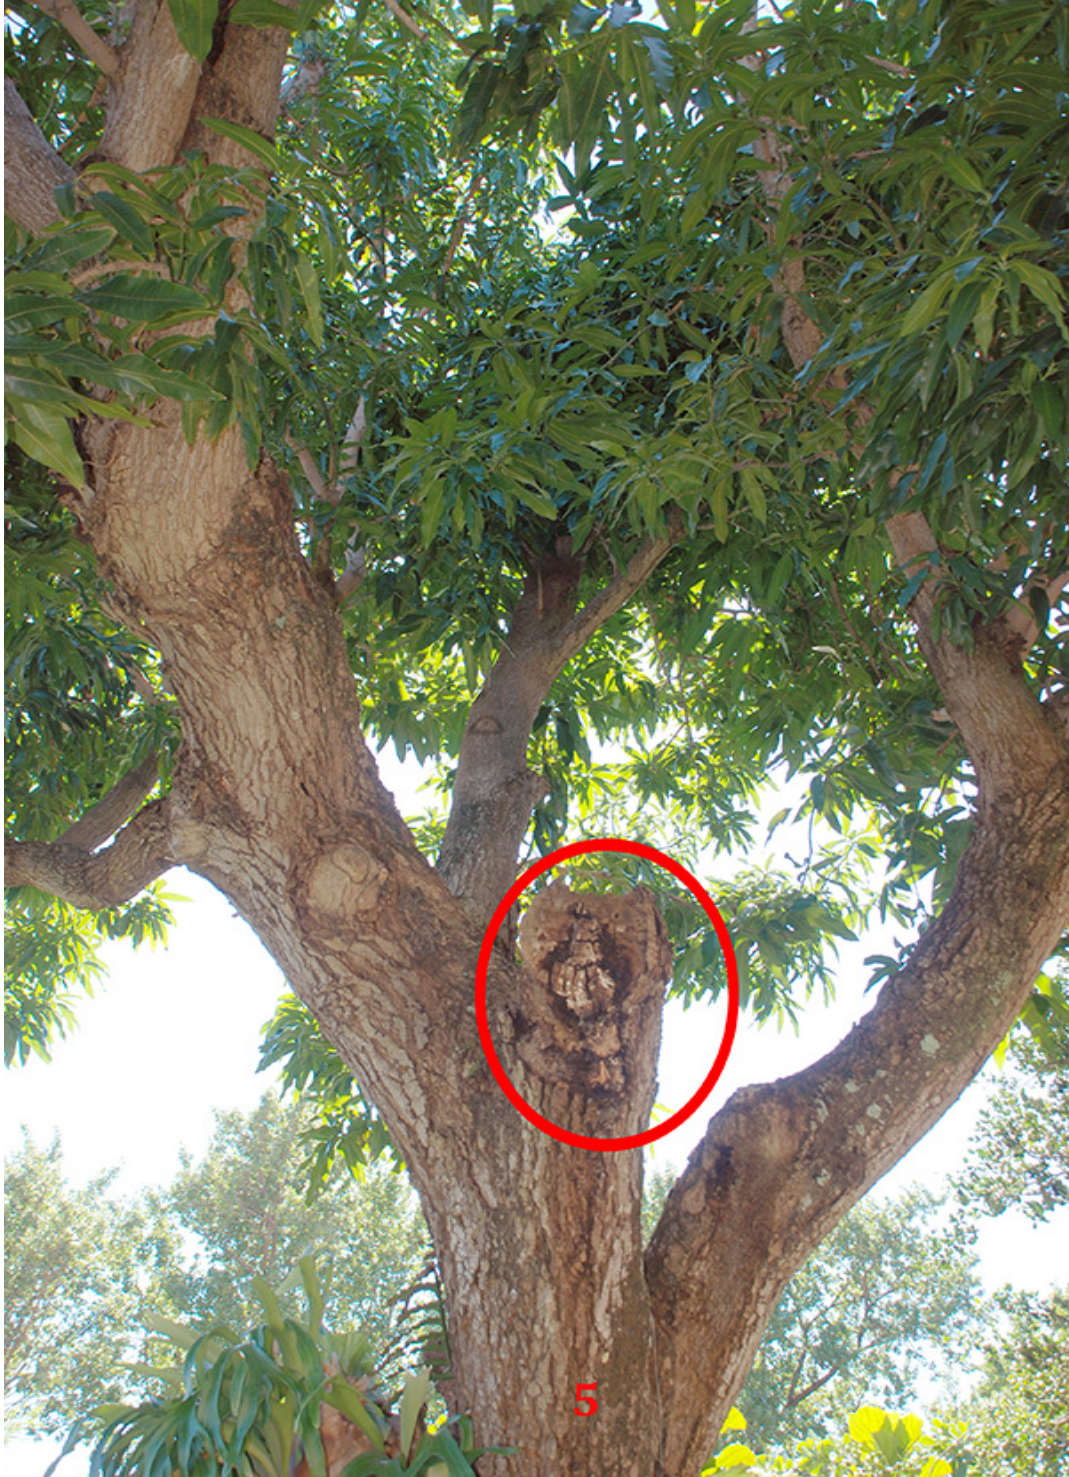
Photo 7 above is a large decaying wound from an old pruning cut on tree 5.

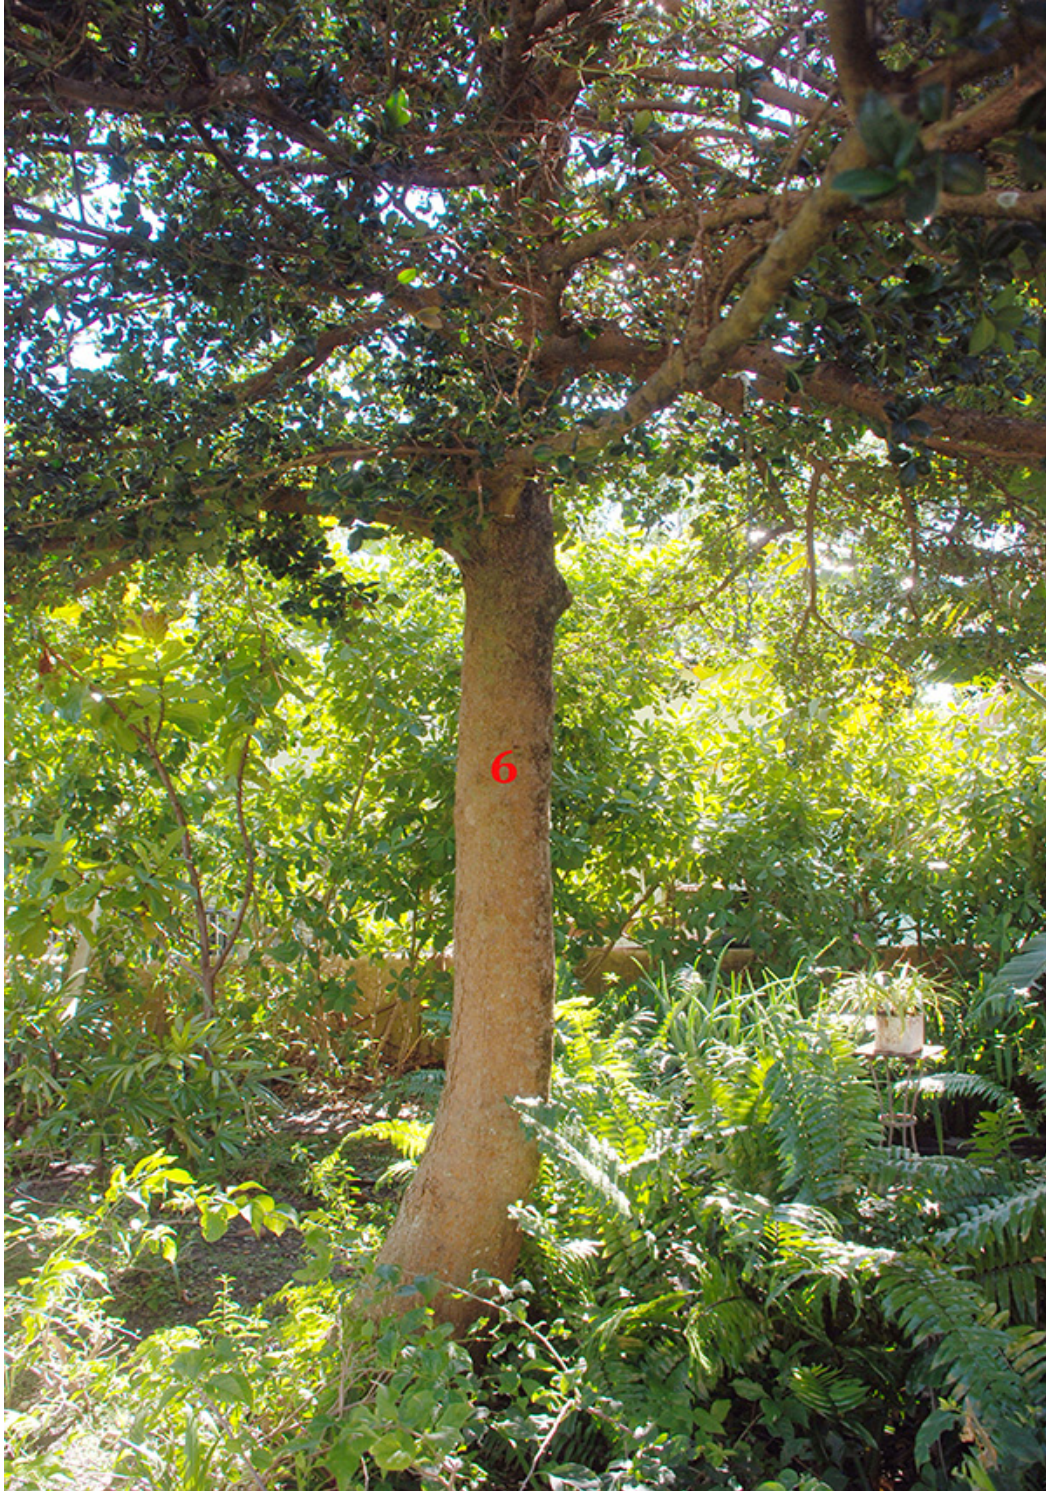
Photo 8 above is the trunk of tree 6. I have tentatively identified tree 6 as a *Carissa* species pending the review of flowers and/or fruit of this tree.

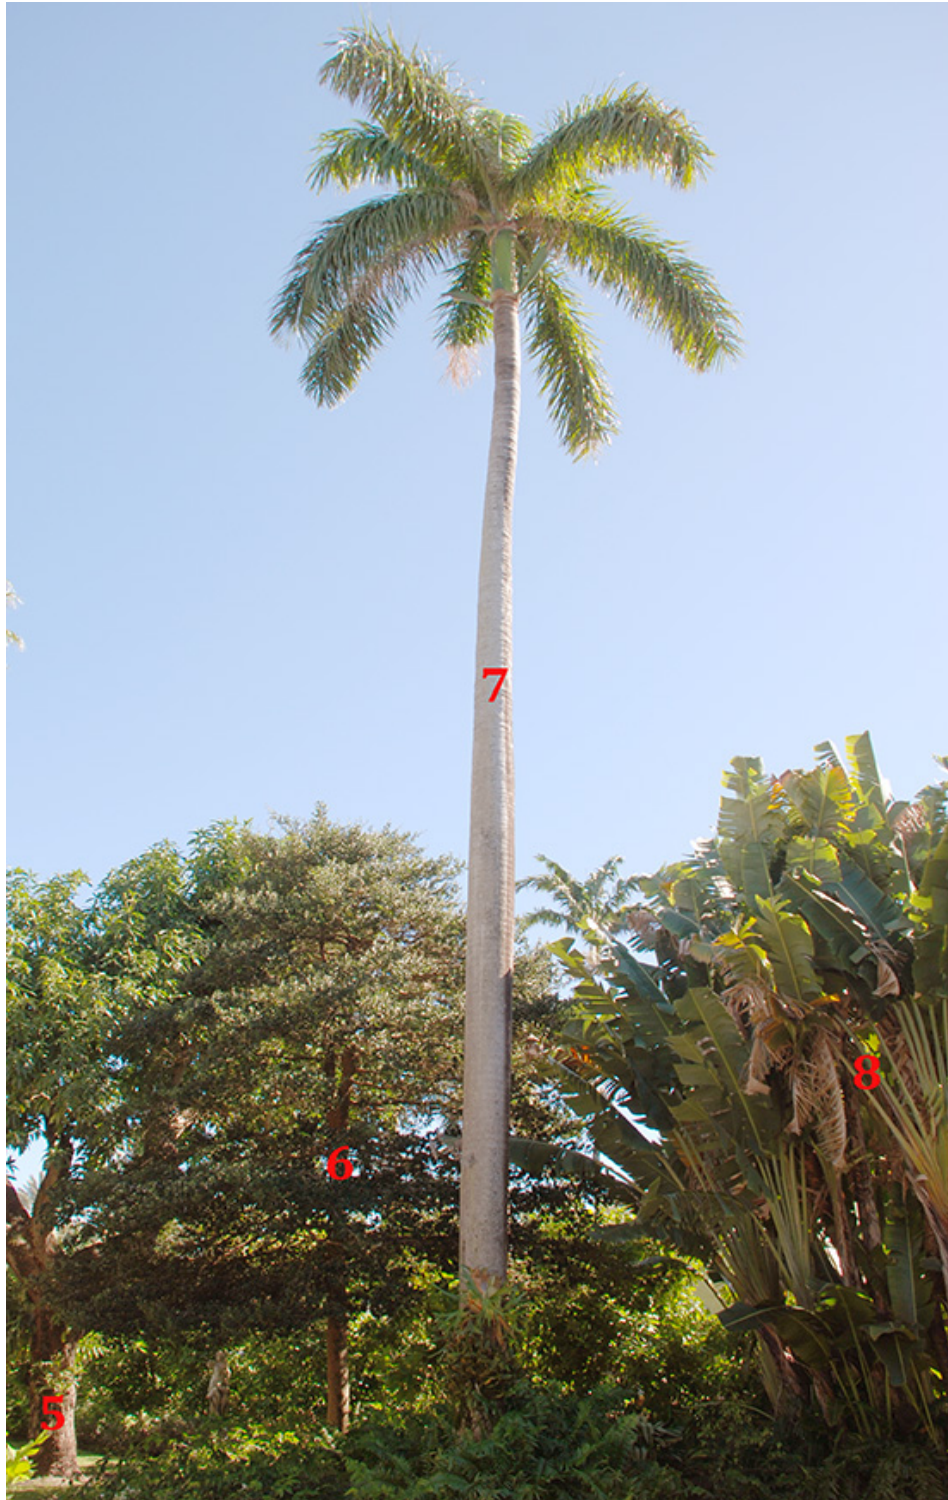
Photo 9 above is palm 7.

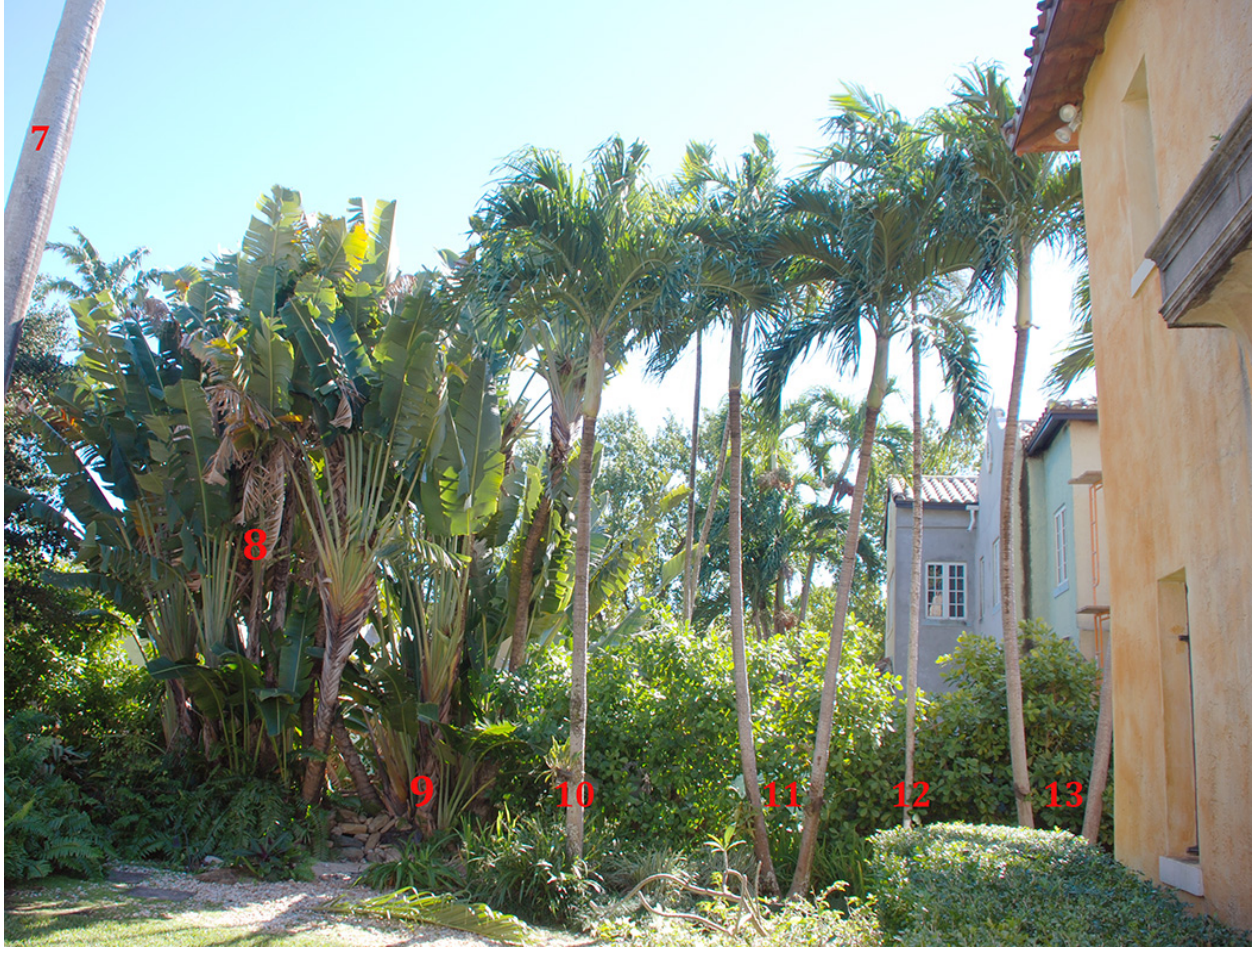
Photo 10 above is traveller's tree clumps 8 & 9 and palms 10, 11, 12 & 13 along the southern edge of the property.

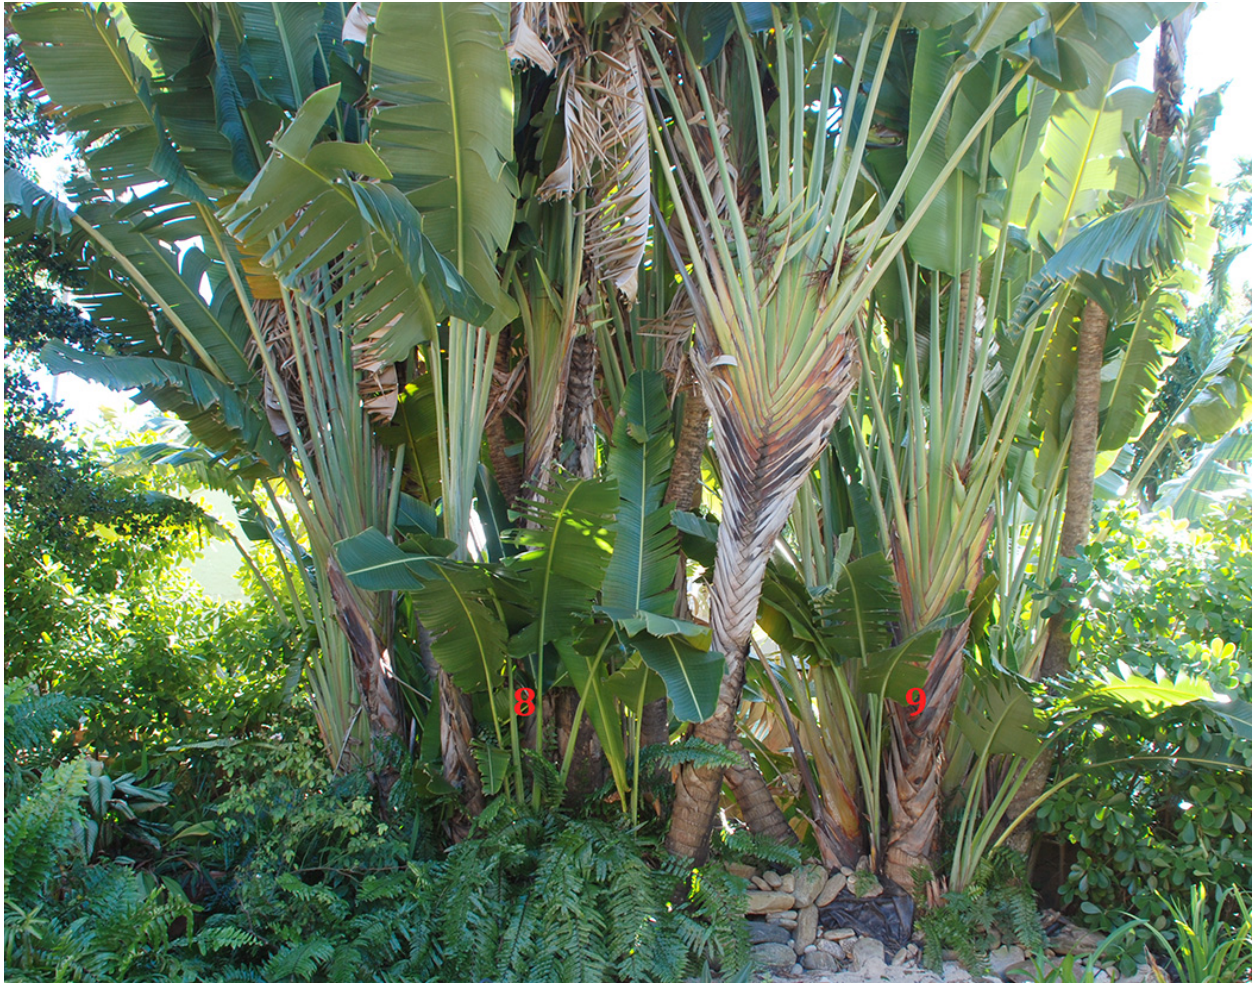
Photo 11 above is a closer view of the two traveller's tree clumps 8 & 9.

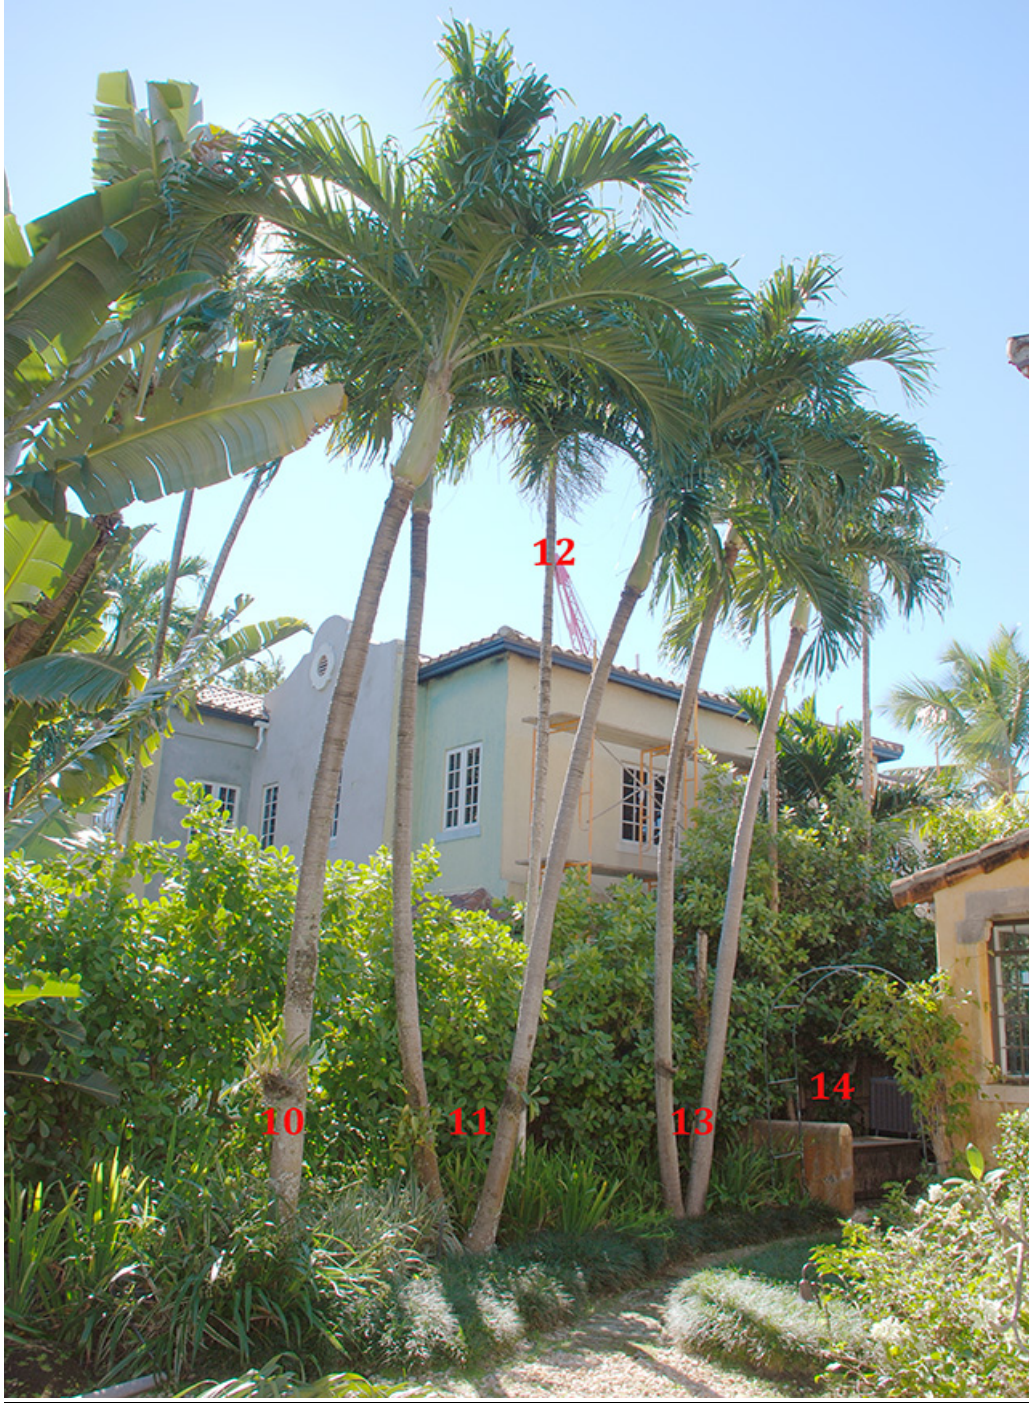
Photo 12 above is single-trunked palms 10 & 12 and double-trunked palms 11, 13 & 14.

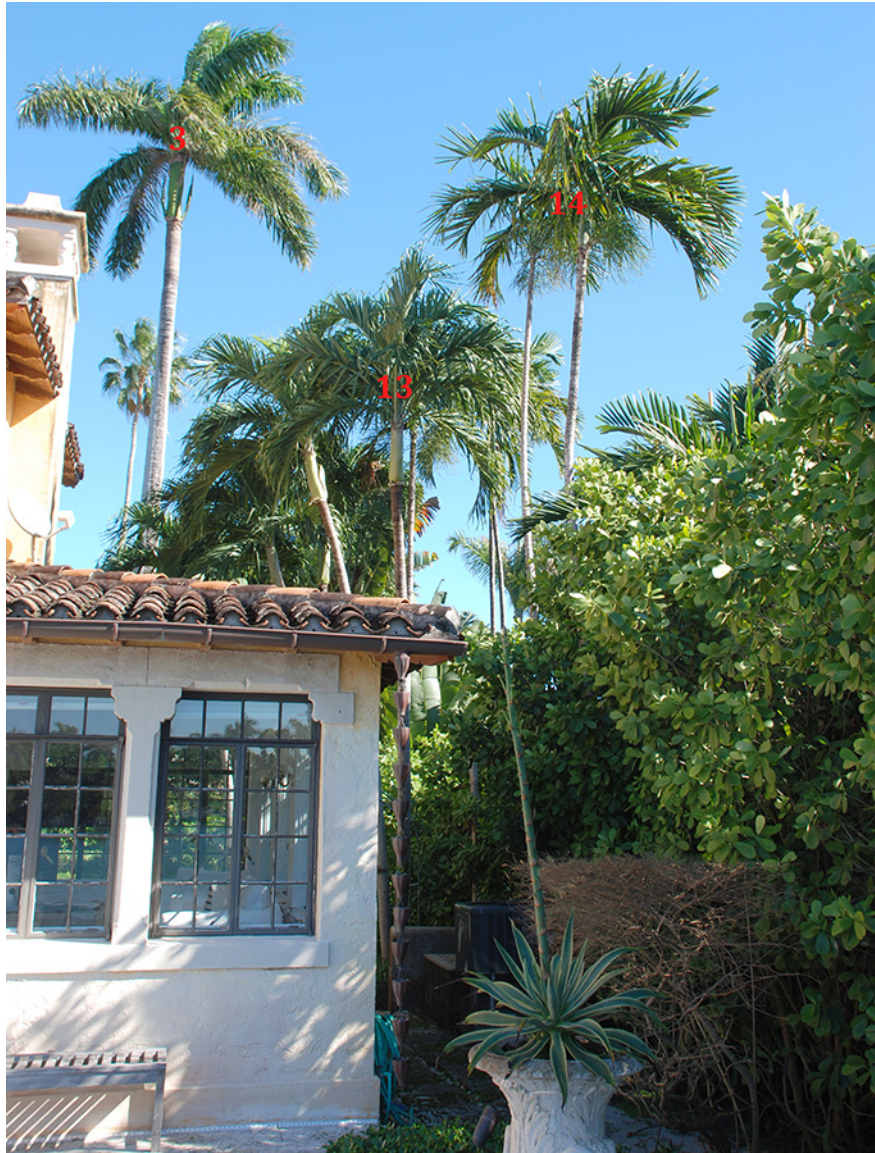
Photo 13 above is palms 3, 13 & 14 viewed from the west.

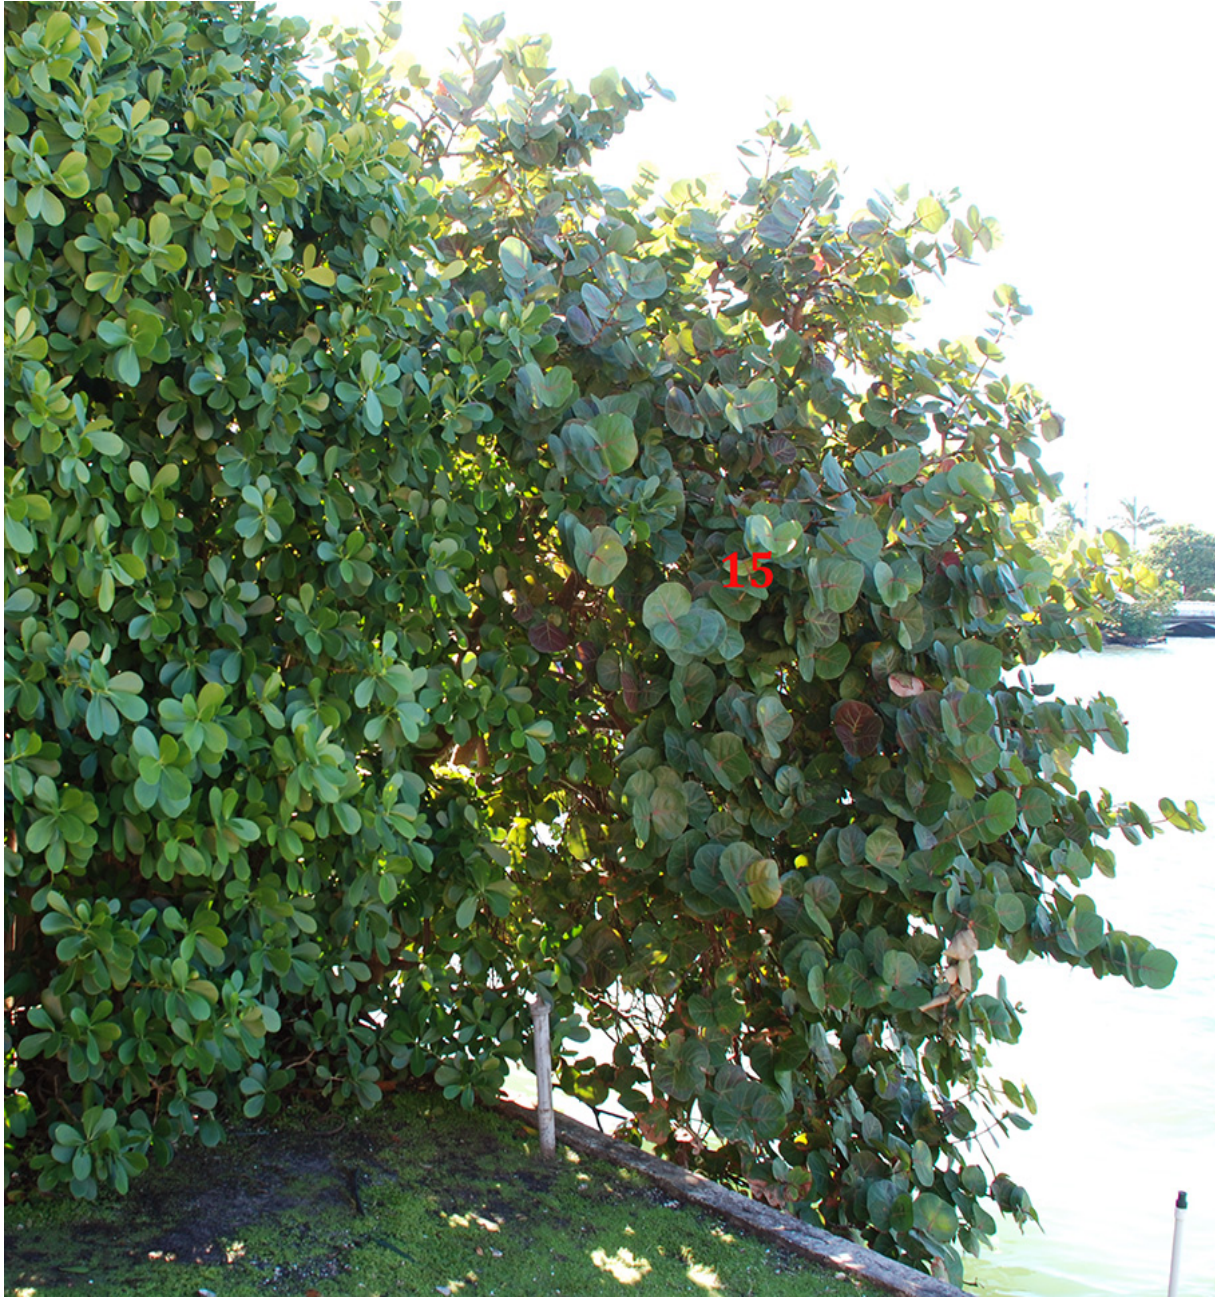
Photo 14 above is tree 15 near the southwest corner of the site. The adjacent Clusia hedge is growing into the seagrape (tree 15) creating the seagrape canopy over the water. See following photo.

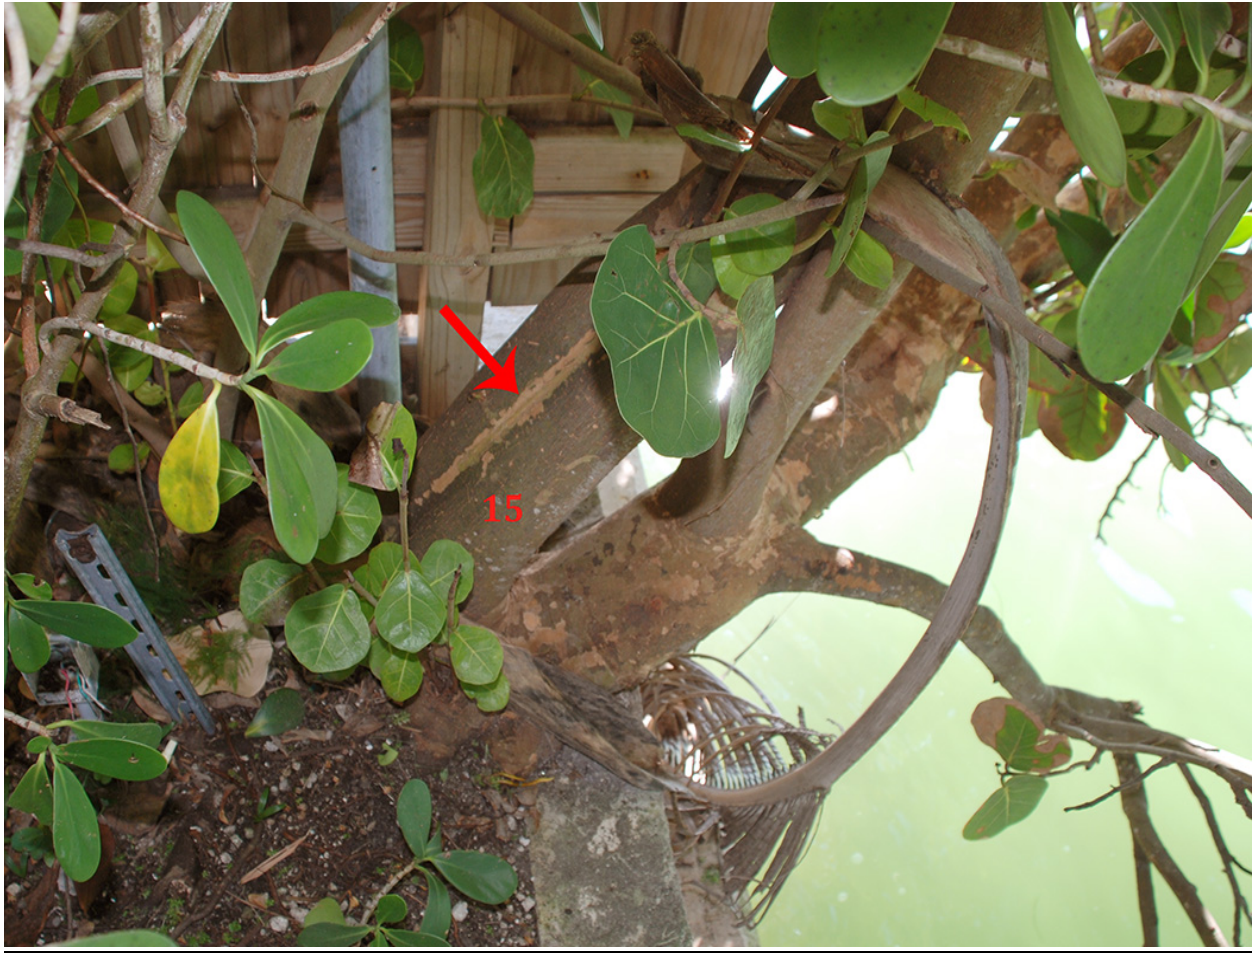
Photo 15 above is a closer view of the two trunks of tree 15 laying on the seawall and growing out over the water. The arrow indicates what appears to be a shear crack in that trunk. This tree should be considered for removal or otherwise greatly reduced in canopy size to lessen the weight stress on the two trunks.
