Tree Resource Evaluation for 248 W. Rivo Alto Drive, Miami Beach

December 10, 2020

I performed a tree resource evaluation on the property located at 248 W. Rivo Alto Drive, Miami Beach on December 9, 2020. The approximate locations of these trees and palms can be found on the schematic in Appendix B.

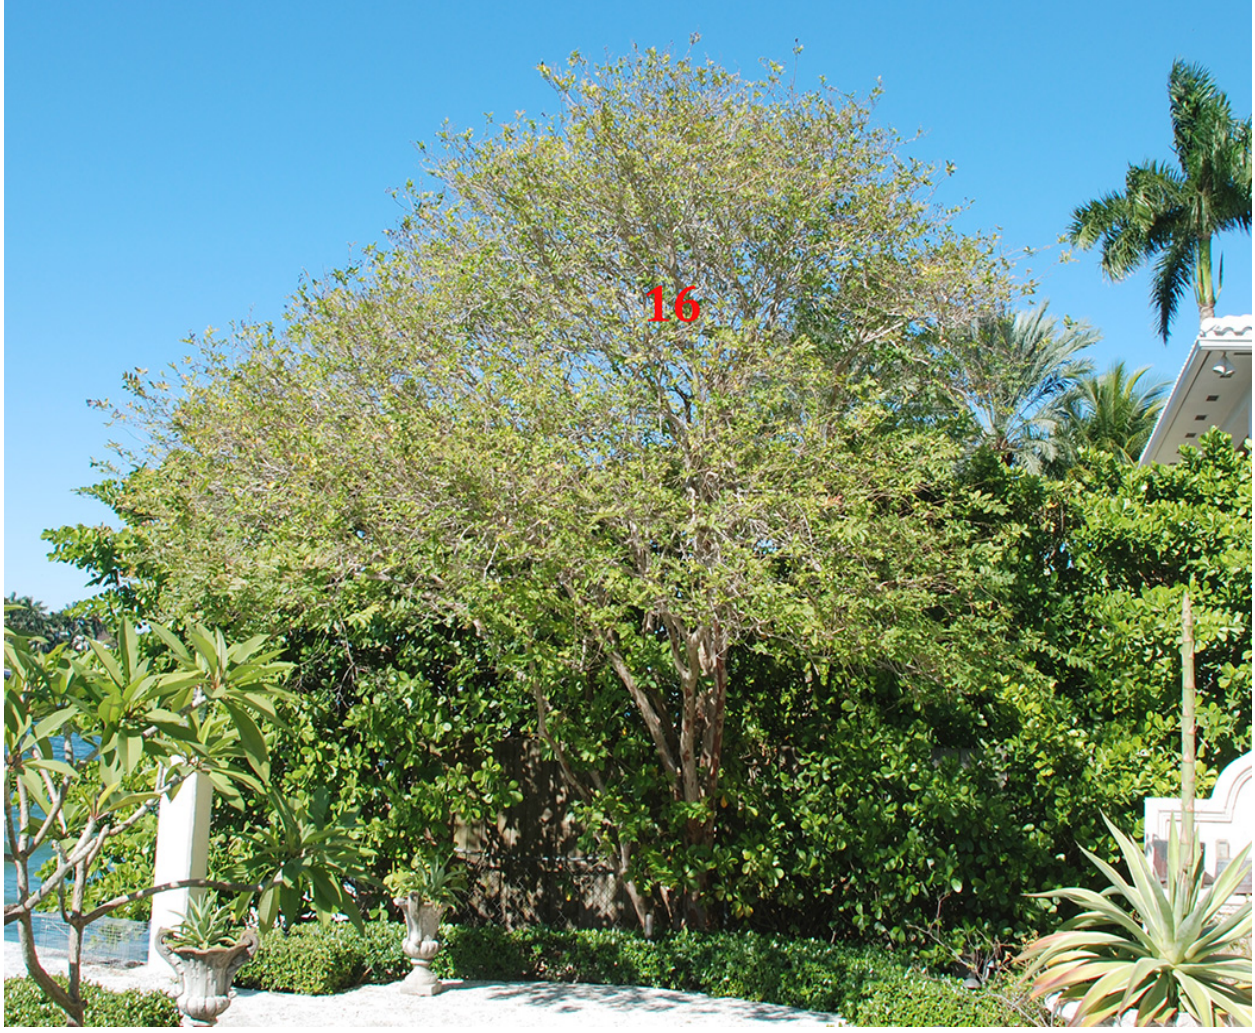
Photo 16 above is tree 16 near the northwest corner of the site.

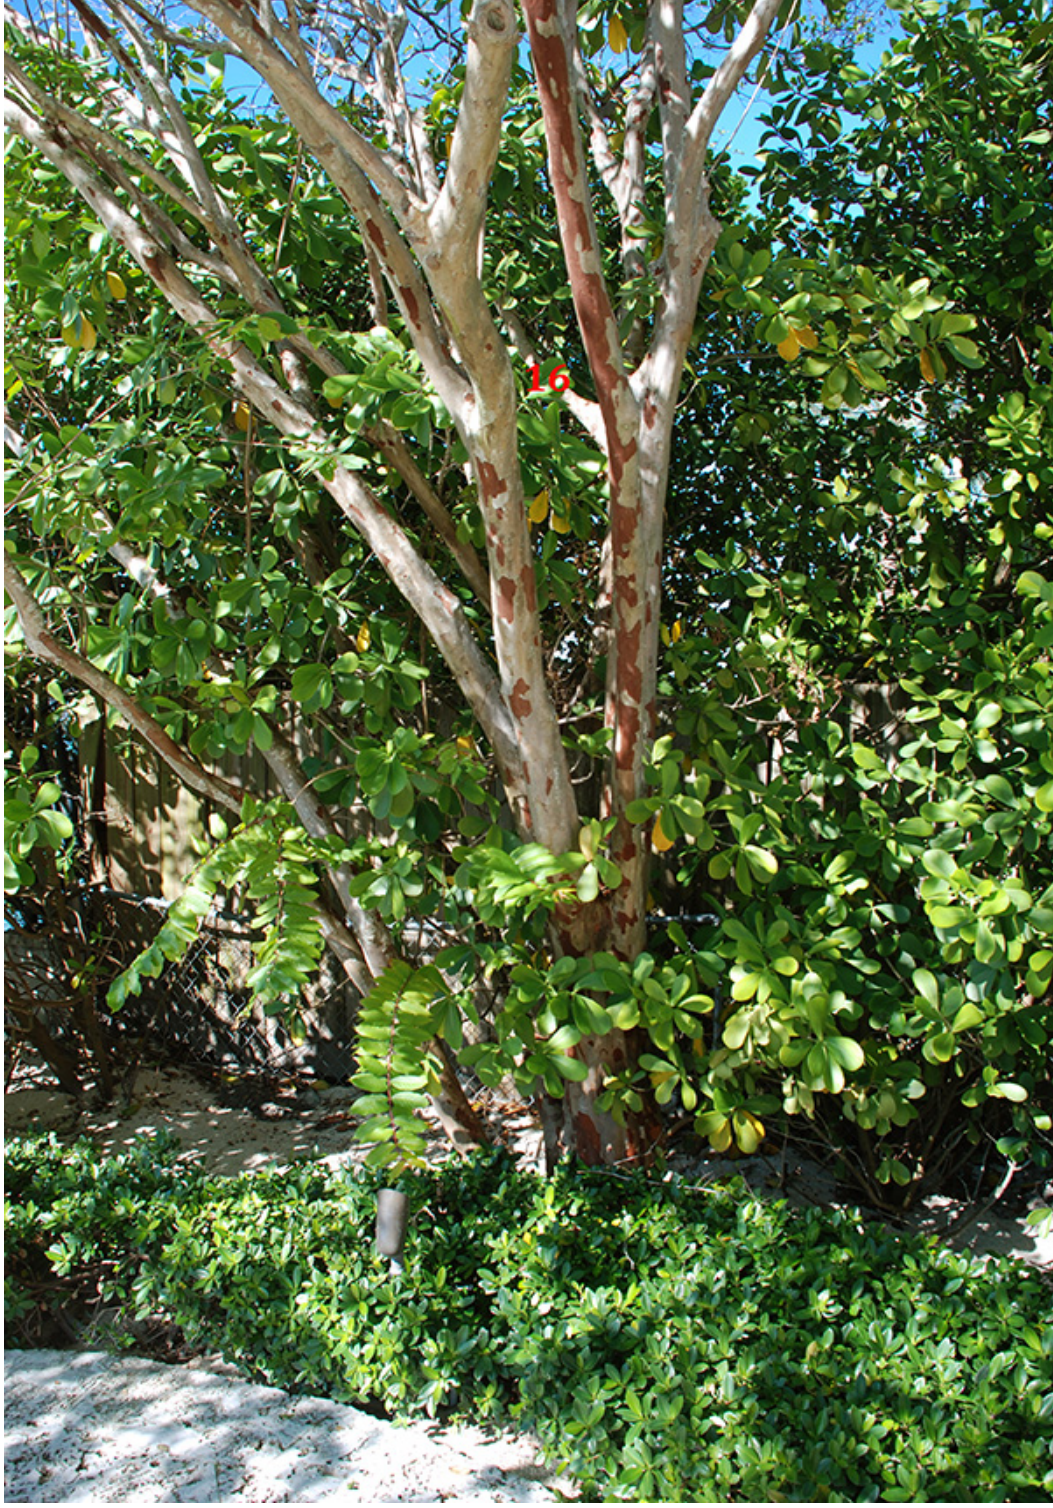
Photo 17 above is a closer view of the trunks of tree 16. The CRZ/root plate of this tree appears to be limited on the south by the adjacent walkway.

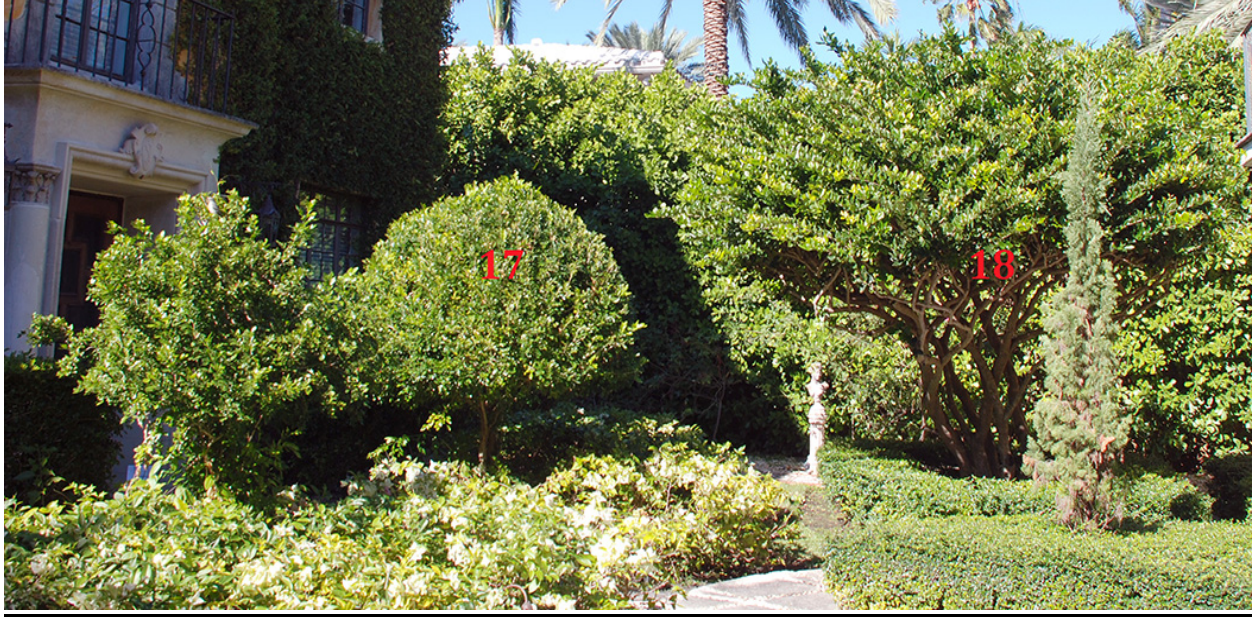
Photo 18 above is tree 17 which is too small to be documented and tree 18.

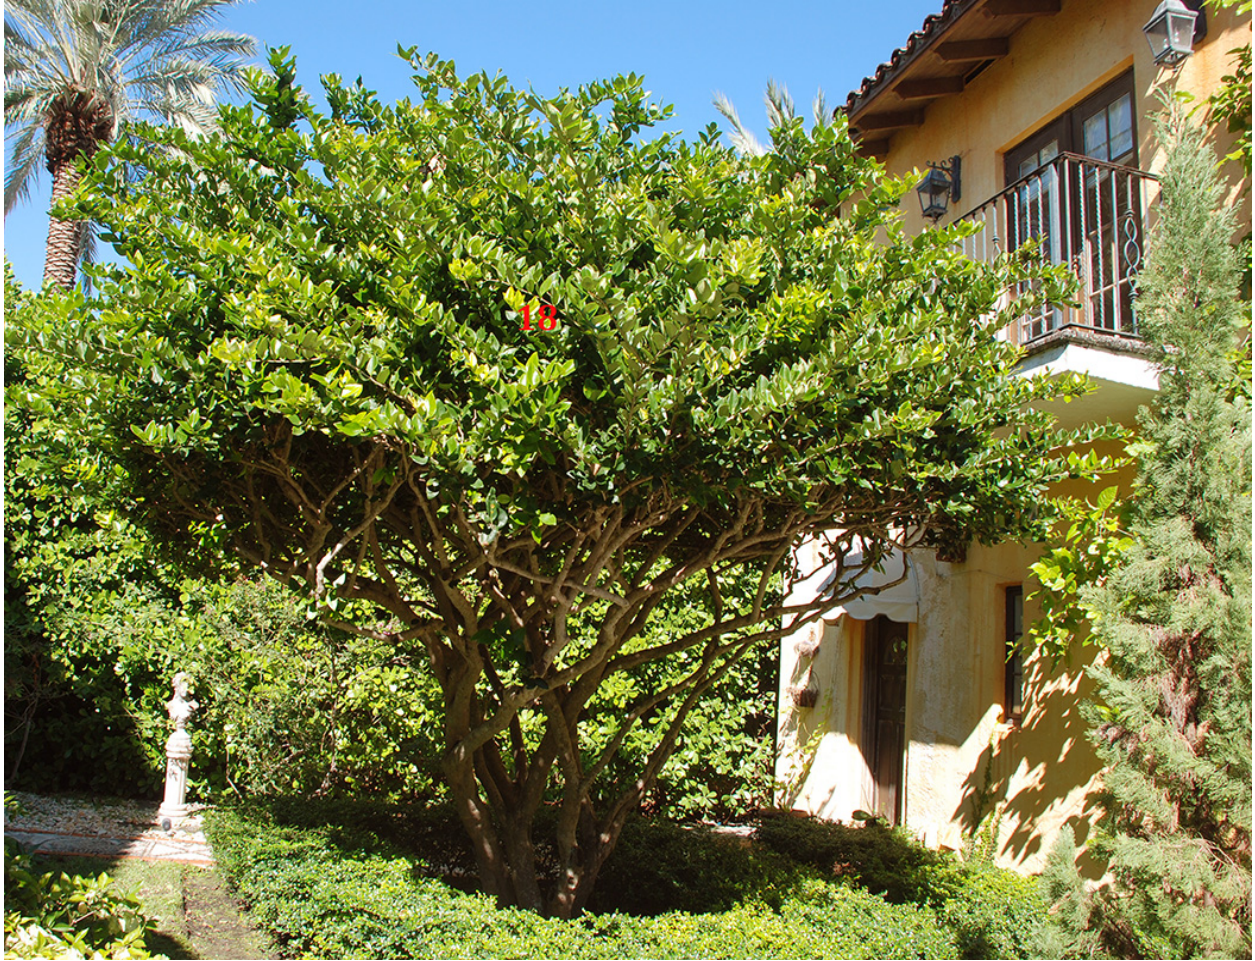
Photo 19 above is tree 18 viewed from the south.
