ALVEY TREE CONSULTING LLC

450 W DiLido Drive  
Miami Beach

# Arborist Report

2/23/2021

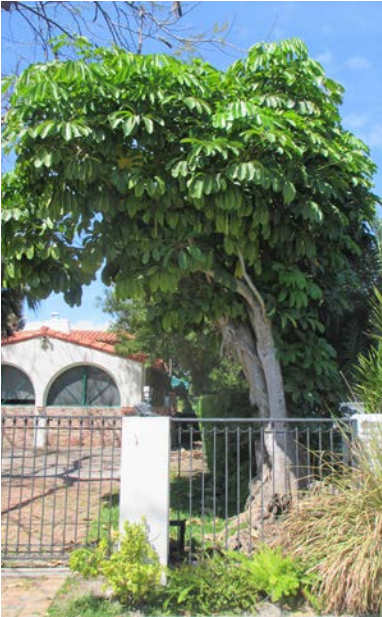
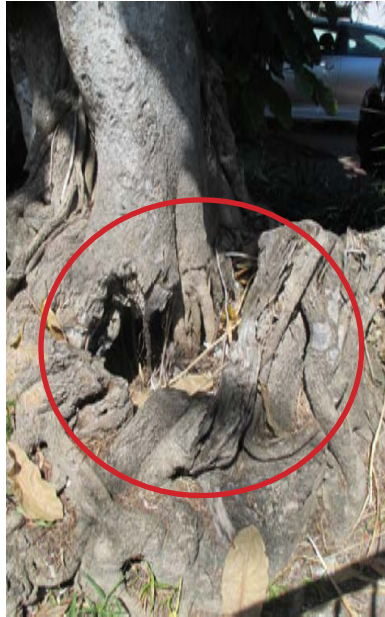
**Condition -**  
Poor

Tree #1 is an Umbrella Tree located on the northern side of the front yard. It is in poor condition with a cavity and decay at the base (circled in red). This species is highly invasive in South Florida and this tree will therefore need to be removed.

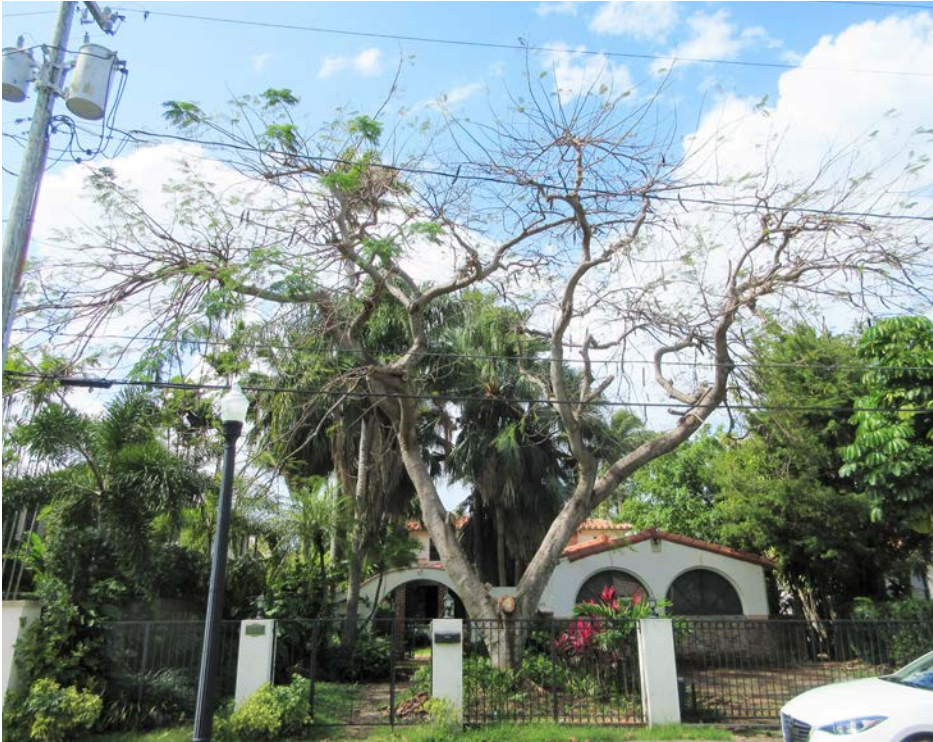
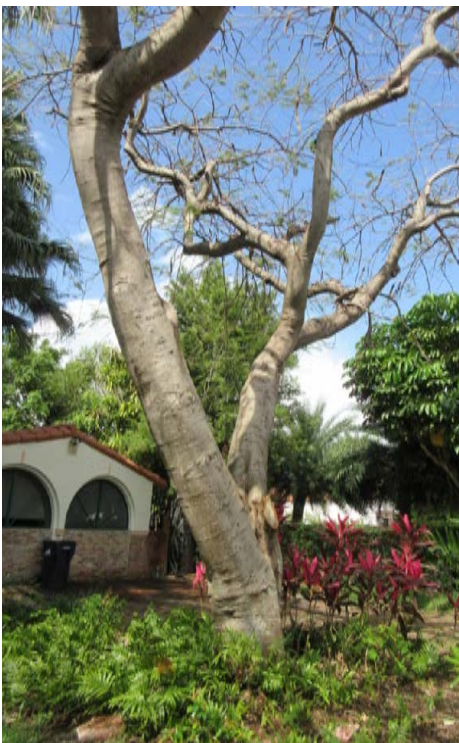
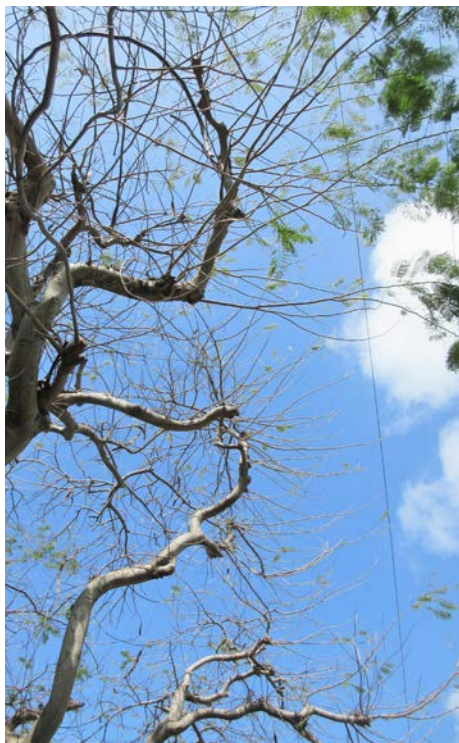
## Tree #2

Tree #2 is a large Royal Poinciana located in the front yard. It is in fair condition. The canopy is wide-spreading and extends nearly the full width of the front yard. Limbs that have grown into the overhead utility lines have been repeatedly pruned back, and some decay has formed at these cut locations as well as much sucker growth. Three limbs have recently been reduced from the overhead lines. Additional pruning to maintain clearance of the utility lines is recommended.

The trunk divides into two main limbs with no included bark. There is little foliage at this time of year. Two broken limbs were observed in the canopy. Prune to remove deadwood and broken limbs. Two lower limbs have recently been removed. Two about 10 inch diameter cuts were created. This has improved the view of the house and the tree appears less overgrown.

Roots are lifting the brick driveway. 0.5 inch diameter surface roots were observed 15ft from the tree. Larger diameter surface roots are closer. Because the tree canopy spans the width of the property, the TPZ will need to be modified to allow for construction access. The Critical Root Zone could be considered 6 inches of radius per inch of DBH, which for this tree would be a 15ft radius CRZ.

This tree is to remain and protective barriers shall be placed 27.5ft from the tree trunk. Barriers shall be installed prior to the start of construction, and shall remain in place until development is completed and until the department authorizes their removal. Barriers shall be a minimum of 4ft high, and shall be constructed of continuous chain link fence with metal posts at 8ft spacing, or of 2x4 posts with three equally spaced 2x4 rails. Posts may be shifted to avoid roots. No materials shall be placed or disposed of within the TPZ. Natural grade shall be maintained within the TPZ.

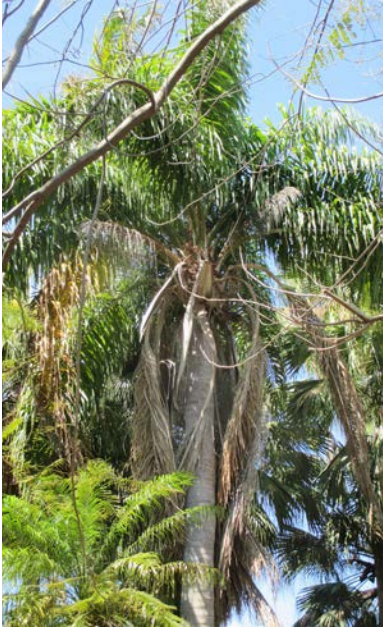
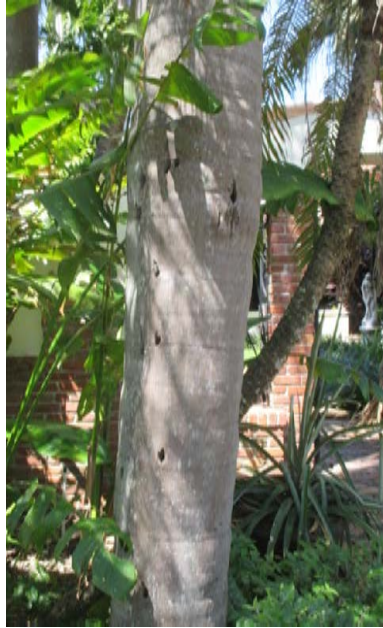
### Tree #3

Tree #3 is a Queen Palm located on the south side of the front yard. It is in good condition with a full green canopy. Lower dead fronds are present. This tree has not been incorporated into the landscape plan and will therefore need to be removed.

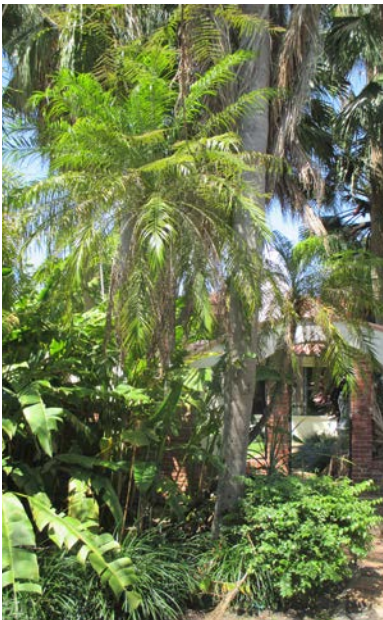
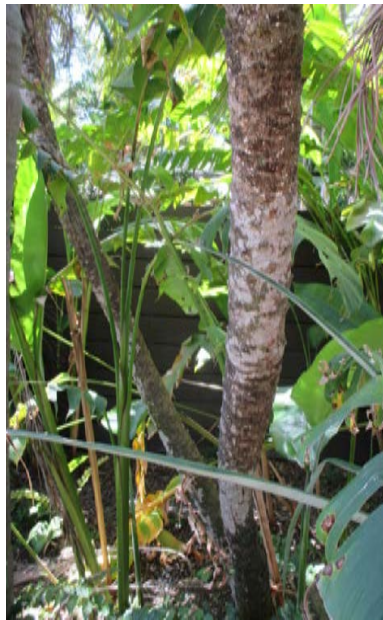
### Tree #4

Tree #4 is a double Pygmy Date Palm located on the south side of the front yard. It is in poor condition with a thin, chlorotic canopy. This tree has not been incorporated into the landscape plan and will therefore need to be removed.

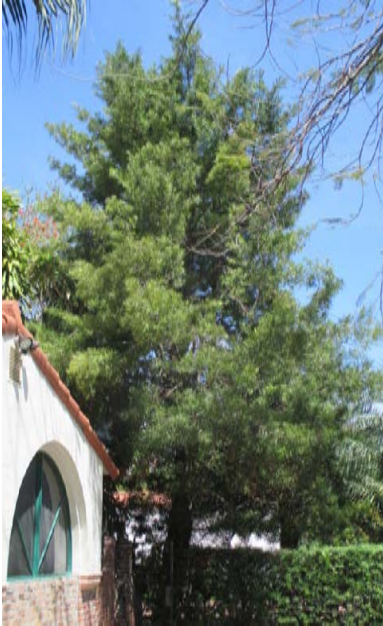
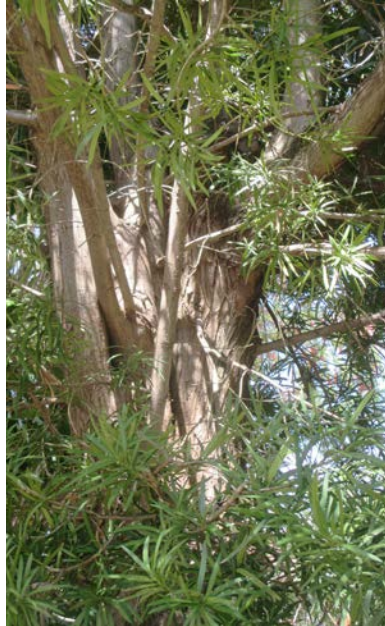
## Tree #5

Tree #5 is a Podocarpus located on the northern boundary of the front yard. It is in good condition with a dense, green canopy. The trunk divides into two with included bark.

This tree has not been incorporated into the landscape plan and will therefore need to be removed.

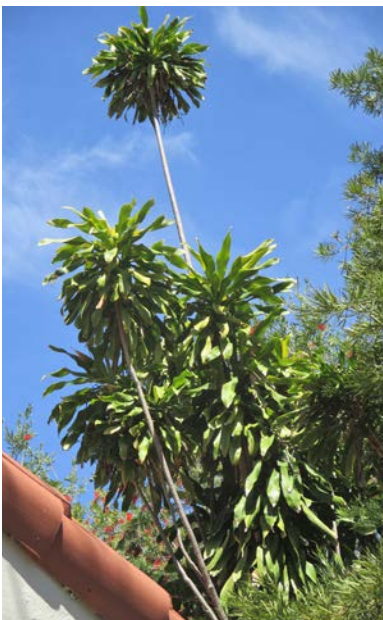
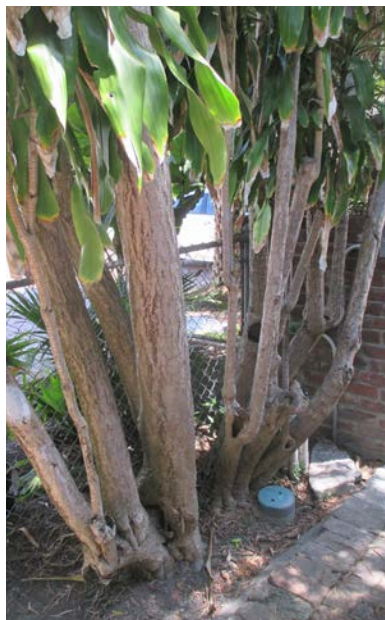
Tree #6 is a Corn Plant located on the north side of the property. It is multi-trunked and in poor condition. Some limbs have been hatracked and there are multiple small cavities with decay. The foliage is chlorotic with necrotic margins.

This tree has not been incorporated into the landscape plan and will therefore need to be removed.

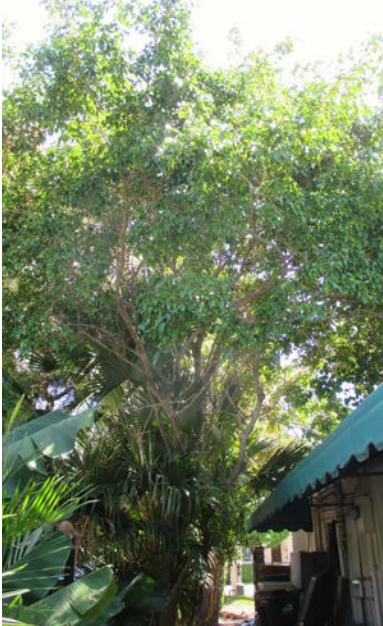
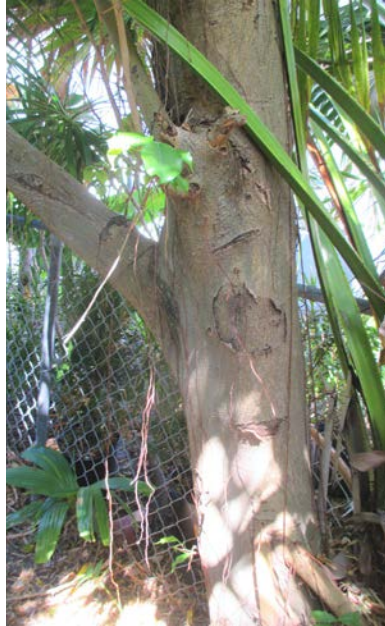
Tree #7 is a Weeping Fig located on the north side of the property. It is in good condition with a dense, healthy green canopy. Some interior small deadwood is present. This tree has not been incorporated into the landscape plan and will therefore need to be removed.

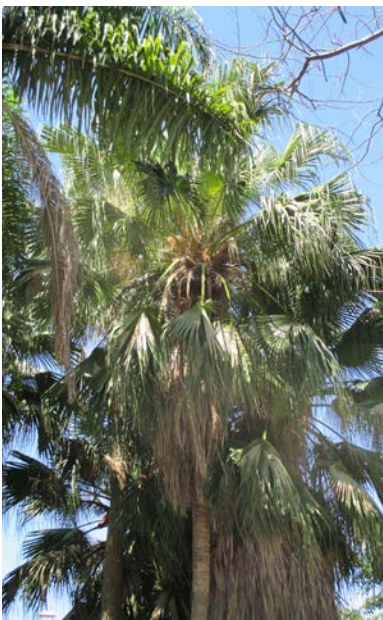
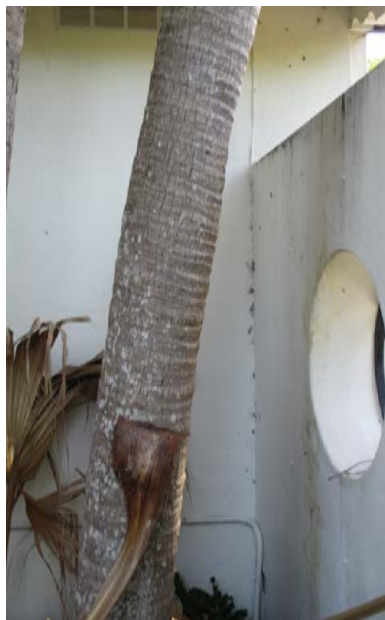
## Tree #8

Tree #8 is a Chinese Fan Palm located towards the front of the property. It is in fair condition - there are lower dead fronds as well as palm leaf skeletonizer damage to some of the live fronds. This tree has not been incorporated into the landscape plan and will therefore need to be removed.

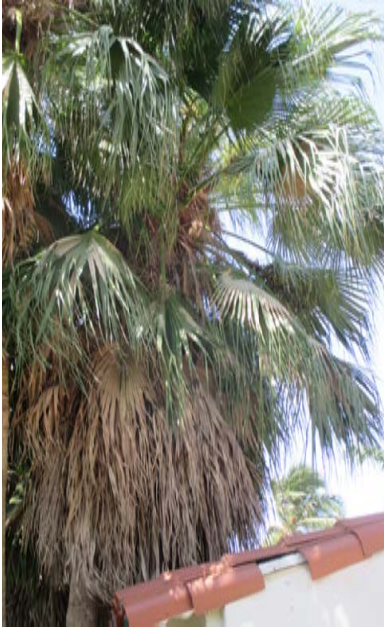
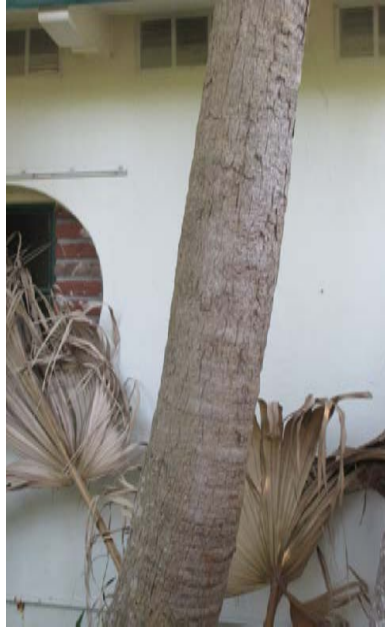
## Tree #9

Tree #9 is a Chinese Fan Palm located towards the front of the property. It is in fair condition - there are lower dead fronds as well as palm leaf skeletonizer damage to some of the live fronds.

This tree has not been incorporated into the landscape plan and will therefore need to be removed.

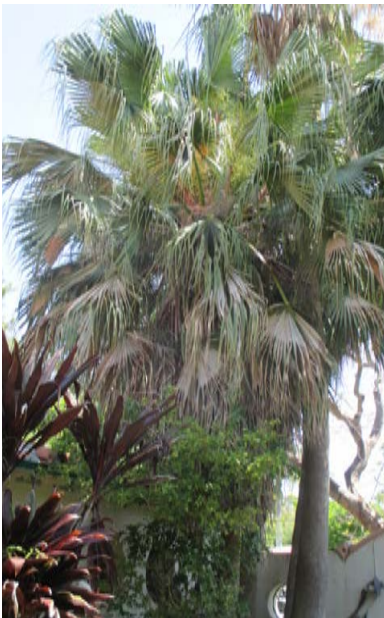
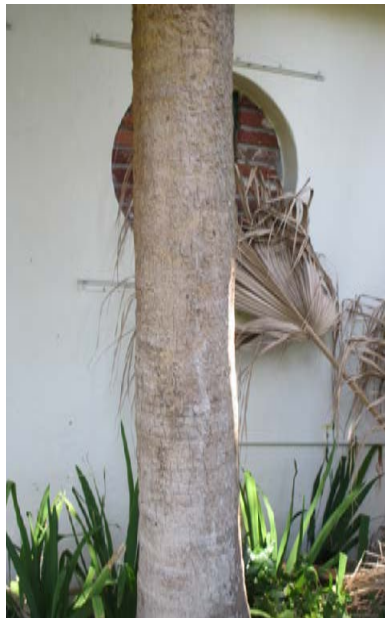
Tree #10 is a Chinese Fan Palm located towards the front of the property. It is in fair condition - there are lower dead fronds as well as palm leaf skeletonizer damage to some of the live fronds.

This tree has not been incorporated into the landscape plan and will therefore need to be removed.

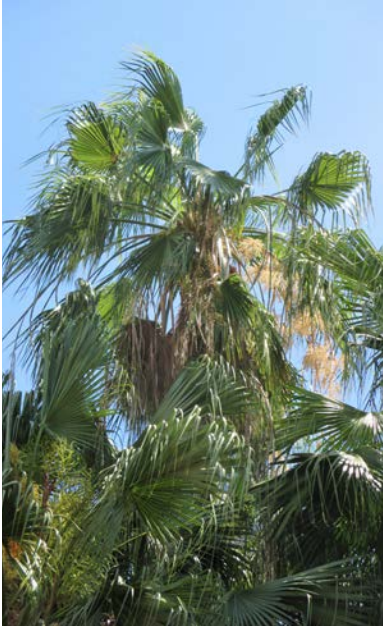
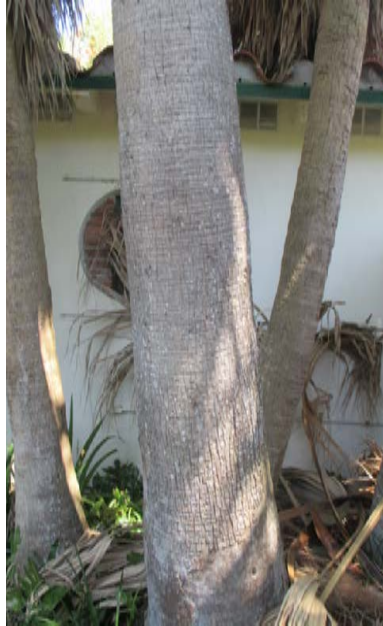
Tree #11 is a Chinese Fan Palm located towards the front of the property. It is in fair condition - the canopy is on the thinner side and lower dead fronds are present. This tree has not been incorporated into the landscape plan and will therefore need to be removed.

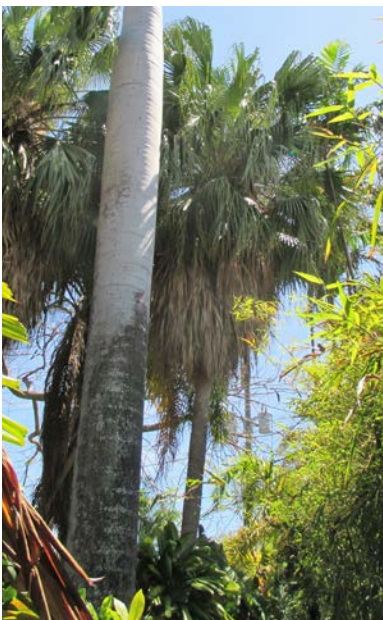
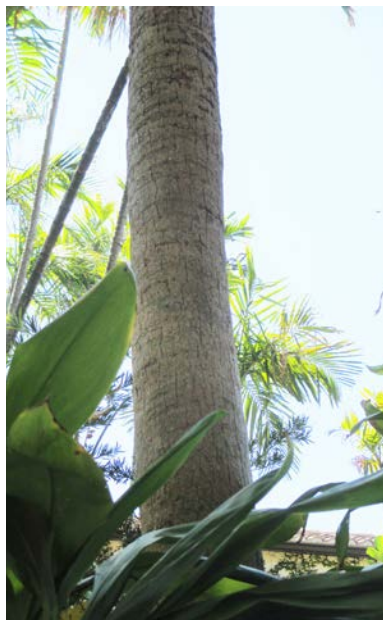
## Tree #12

Tree #12 is a Chinese Fan Palm located on the south side of the property. It is in fair condition - there are lower dead fronds as well as palm leaf skeletonizer damage to some of the live fronds. This tree has not been incorporated into the landscape plan and will therefore need to be removed.

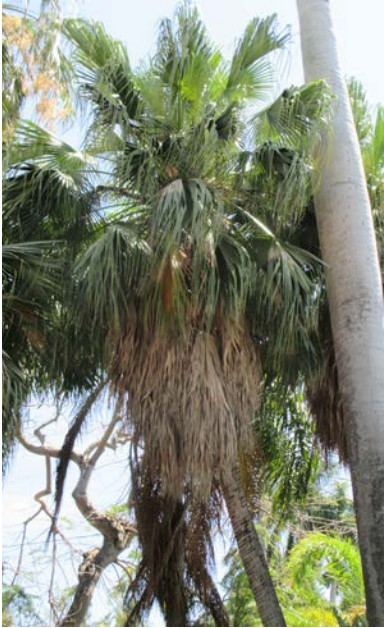
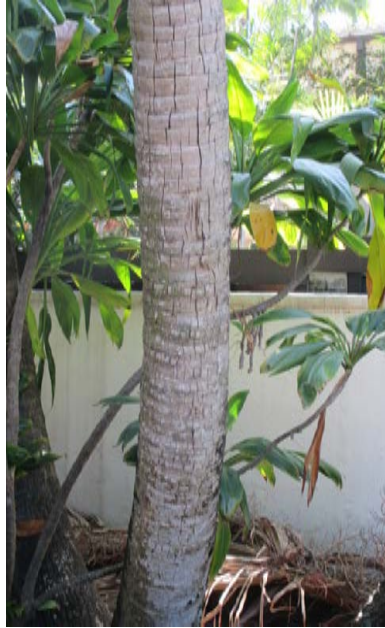
## Tree #13

Tree #13 is a Chinese Fan Palm located on the south side of the property. It is in fair condition - there are lower dead fronds as well as palm leaf skeletonizer damage to some of the live fronds.

This tree has not been incorporated into the landscape plan and will therefore need to be removed.

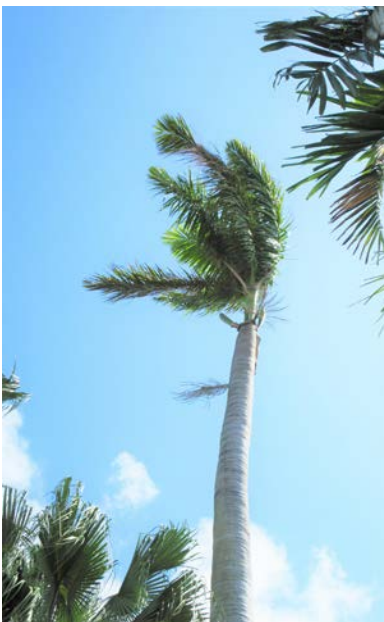
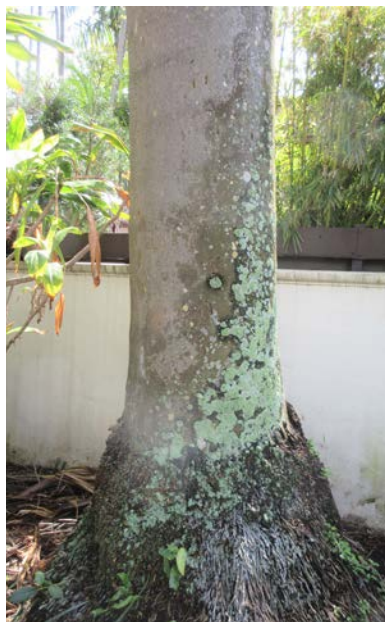
Tree #14 is a Royal Palm located on the south side of the property. It is in poor condition with a small canopy that is chlorotic. The trunk is pencilling.

This tree has not been incorporated into the landscape plan and will therefore need to be removed.

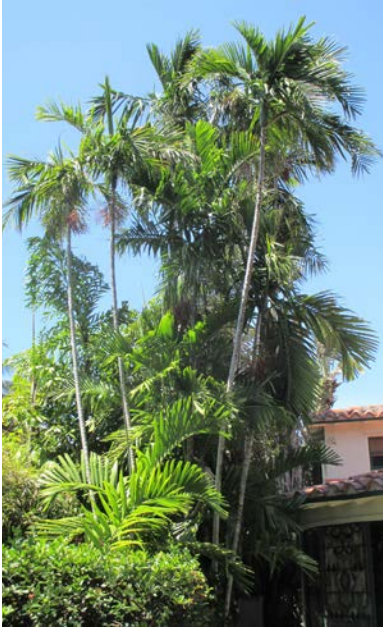
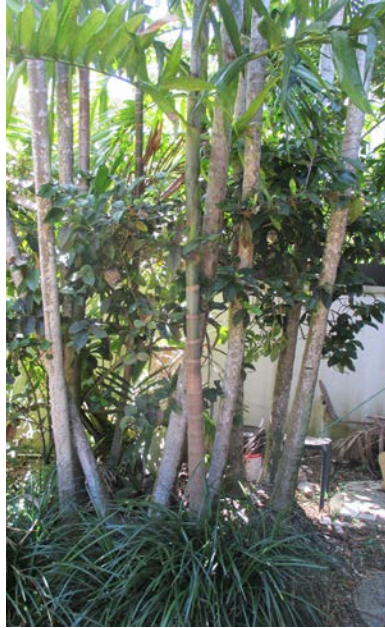
Trees #15 - 17 are a cluster of about 10 Solitaire Palms located on the south side of the property. They are in fair condition with some foliage that is chlorotic. These trees have not been incorporated into the landscape plan and will therefore need to be removed.

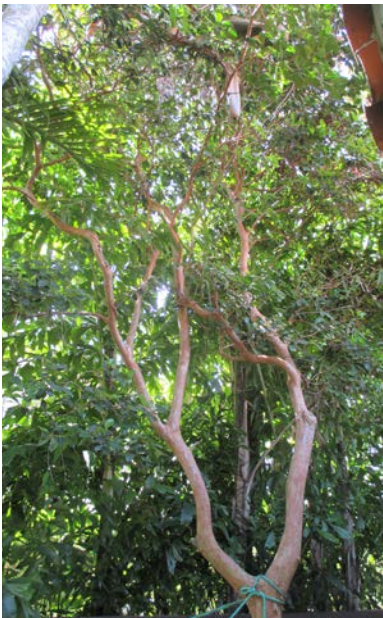
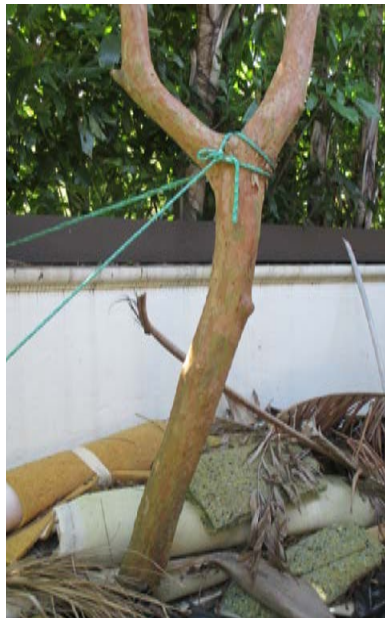
## Tree #18

Tree #18 is a Strawberry Guava located on the south side of the property. It is in fair condition. It has ropes around the trunk, presumably to keep it upright, which are girdling the trunk. The tree has a full, healthy green canopy. This tree has not been incorporated into the landscape plan and will therefore need to be removed.

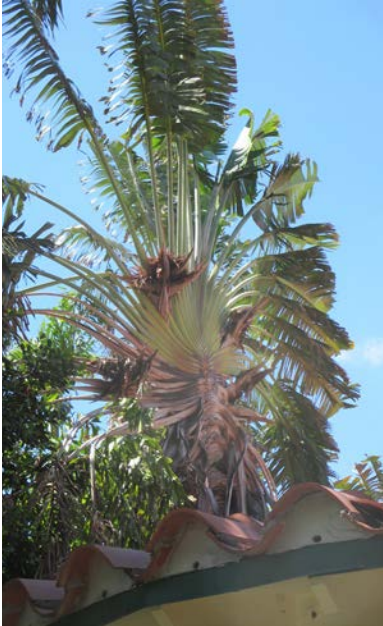
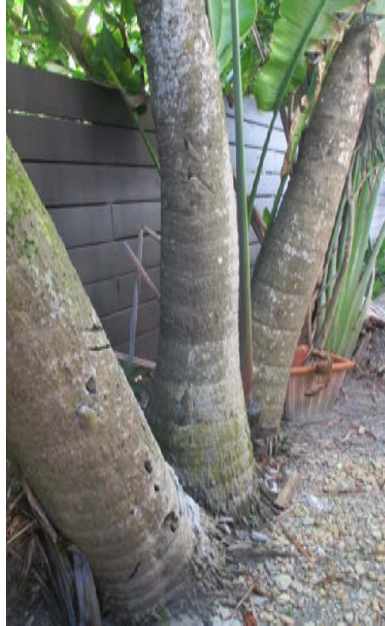
## Trees #19 - 21

Trees #19 - 21 are a triple-trunked Traveler's Palm located on the south side of the property. It is in fair condition with some lower dead fronds and live fronds that are tattered.

This tree has not been incorporated into the landscape plan and will therefore need to be removed.

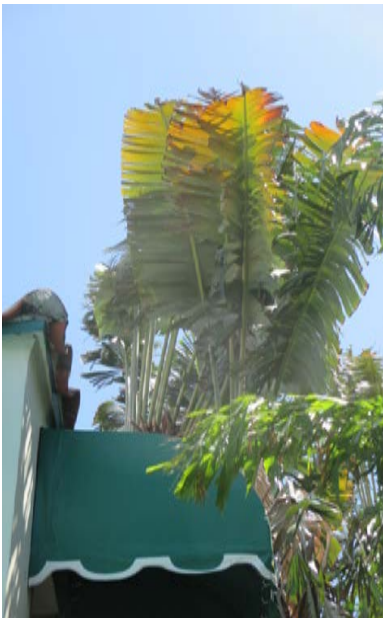
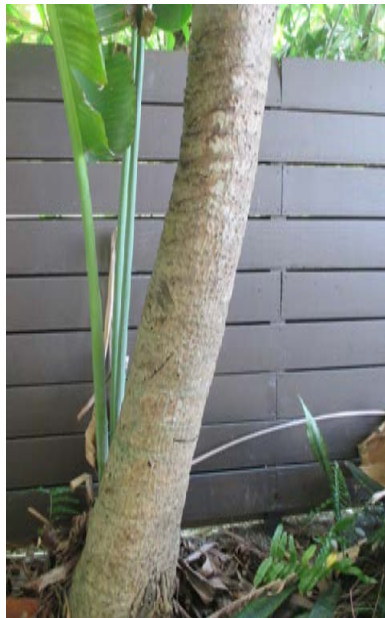
Tree #22 is a Traveler's Palm located on the south side of the property. It is in poor condition with lower dead fronds, and tattered live fronds that are chlorotic.

This tree has not been incorporated into the landscape plan and will therefore need to be removed.

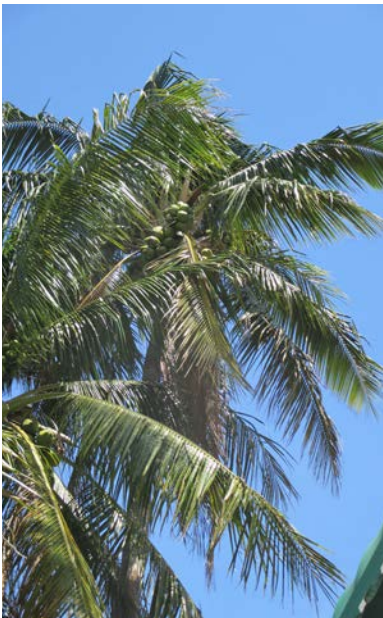
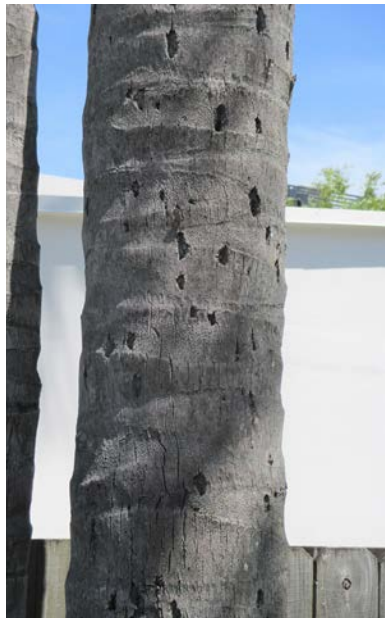
## Tree #24

Tree #24 is a Coconut Palm located on the north side of the backyard. It is in fair condition with multiple small injuries to the trunk and lower dead fronds. This tree has not been incorporated into the landscape plan and will therefore need to be removed.

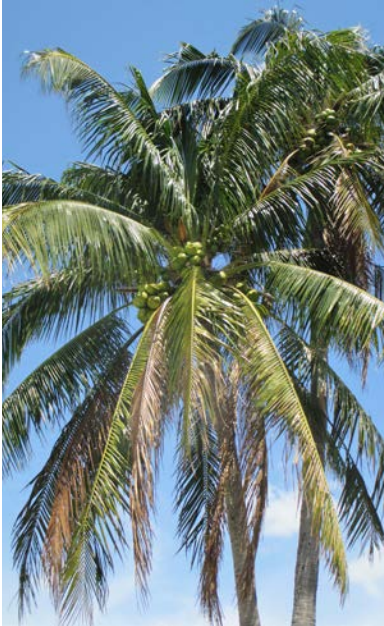
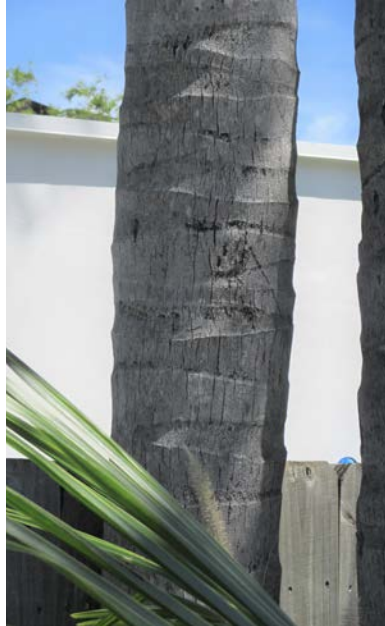
## Tree #25

Tree #25 is a Coconut Palm located on the north side of the backyard. It is in fair condition with some yellowing of the foliage and lower dead fronds. This tree has not been incorporated into the landscape plan and will therefore need to be removed.

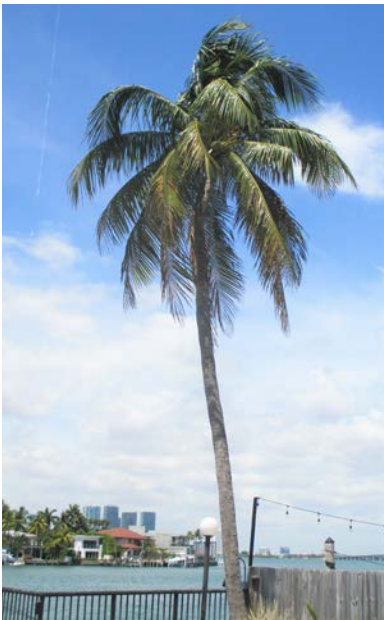
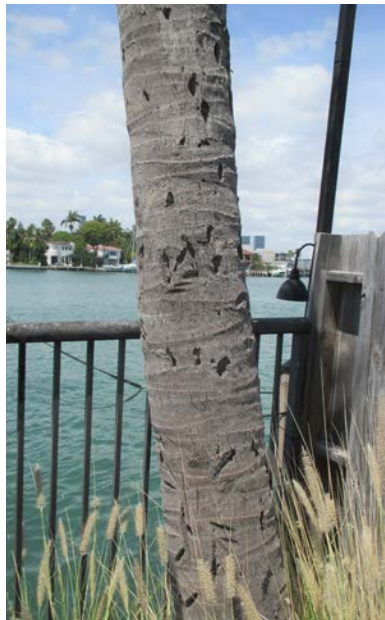
## Tree #26

Tree #26 is a Coconut Palm located in the rear northwest corner of the property. It is in fair condition with numerous small trunk injuries and some yellowing of the foliage. A trunk constriction is present as well. This tree has not been incorporated into the landscape plan and will therefore need to be removed.

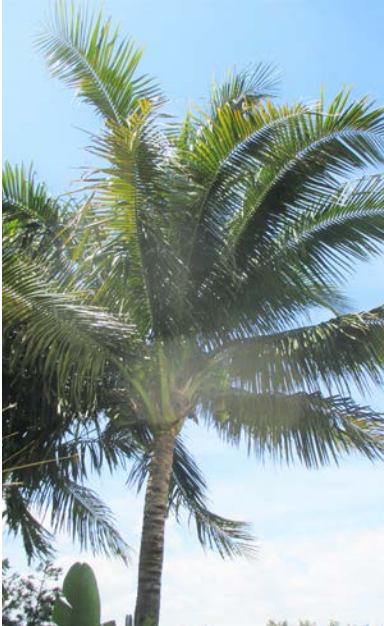
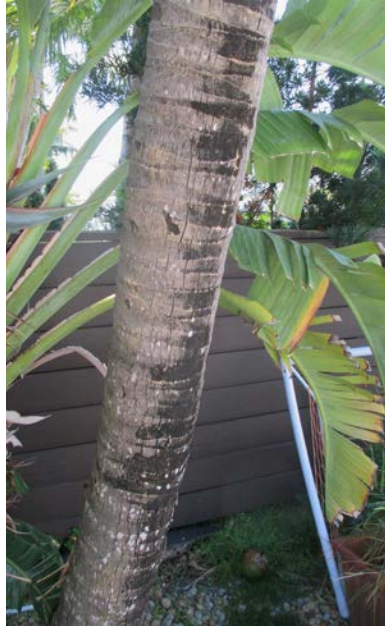
## Tree #27

Tree #27 is a Coconut Palm located in the southwest corner of the backyard. It is in good condition with a full, green canopy. This tree has not been incorporated into the landscape plan and will therefore need to be removed.
