Arborist Report

6342-6360 North Bay Road
Miami Beach

11/9/2020

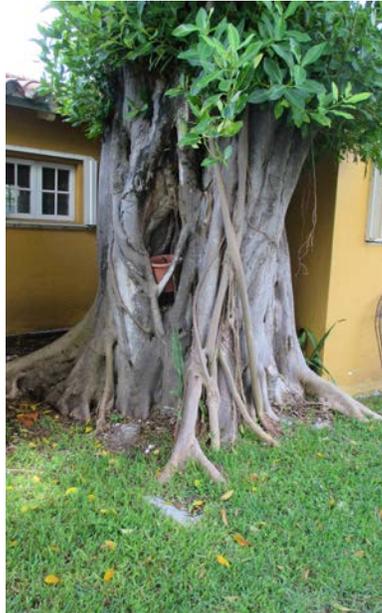
Condition -
Good

Tree #1 is a large Chinese Banyan located next to the guest house at the front of the property. It is in good condition with a dense, symmetrical canopy. The root flare is clearly visible. The canopy has been reduction pruned and raised recently, and new vigorous shoot growth is occurring from these cuts and along the main limbs and trunk. There is little deadwood and few aerial roots. This tree is to be relocated and root pruning shall occur a minimum of 8 weeks prior to digging the tree and shall be performed or supervised by Certified Arborist. Minimum rootball measurement shall be based upon the most recent *Florida Grades & Standards for Nursery Plants*. Transplanting shall be performed or supervised by Certified Arborist. Prior to transplanting, only branches that are dead or broken are to be removed; no live foliage is to be pruned off. When lifting the tree, ensure that the trunk is not damaged. The diameter of the planting hole shall be twice the root ball diameter. Plant at grade, with the trunk flare visible. Transplanting shall occur as soon as possible and no more than 24 hours after being dug for relocation. Proper irrigation shall be provided during and after transplanting. Following relocation, a 20ft radius TPZ shall be erected.

Disposition -
Relocate - 20ft radius TPZ

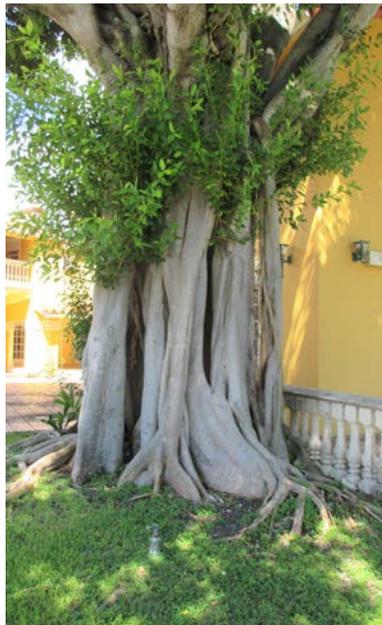
Condition -
Good

Tree #2 is a large Chinese Banyan located in front of the main house. It is in good condition with a dense, symmetrical canopy. The root flare is clearly visible. The canopy has been reduction pruned and raised recently, and new vigorous shoot growth is occurring from these cuts and along the main limbs and trunk. There is little deadwood and few aerial roots. This tree is to be relocated and root pruning shall occur a minimum of 8 weeks prior to digging the tree and shall be performed or supervised by Certified Arborist. Minimum rootball measurement shall be based upon the most recent *Florida Grades & Standards for Nursery Plants*. Transplanting shall be performed or supervised by Certified Arborist. Prior to transplanting, only branches that are dead or broken are to be removed; no live foliage is to be pruned off. When lifting the tree, ensure that the trunk is not damaged. The diameter of the planting hole shall be twice the root ball diameter. Plant at grade, with the trunk flare visible. Transplanting shall occur as soon as possible and no more than 24 hours after being dug for relocation. Proper irrigation shall be provided during and after transplanting. Following relocation, a 25ft radius TPZ shall be erected.

Disposition -
Relocate - 25ft radius TPZ

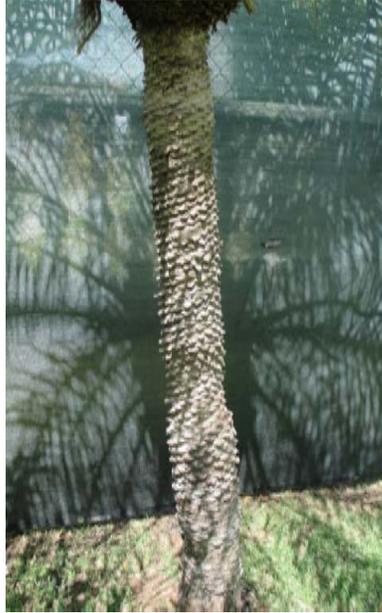
Tree #3 is a Pygmy Date Palm street tree located along North Bay Road. Overhead wires are above. It is in good condition with a healthy green canopy. This tree has not been incorporated into the landscape plan and will therefore be removed.

Disposition -
Remove

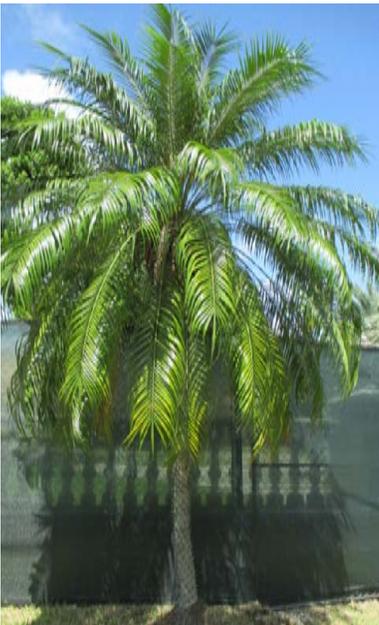
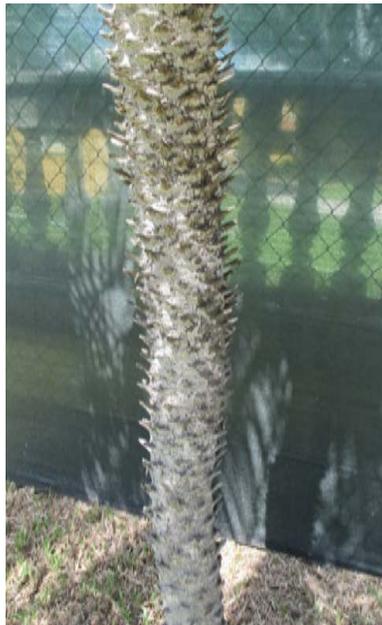
Tree #4 is a Pygmy Date Palm street tree located along North Bay Road. Overhead wires are above. It is in good condition with a healthy green canopy. This tree has not been incorporated into the landscape plan and will therefore be removed.

Disposition -
Remove

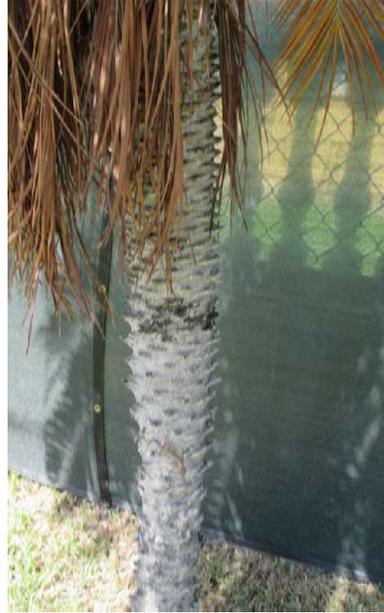
Tree #5 is a Pygmy Date Palm street tree located along North Bay Road. Overhead wires are above. It is in fair condition with some lower dead fronds. This tree has not been incorporated into the landscape plan and will therefore be removed.

Disposition -
Remove

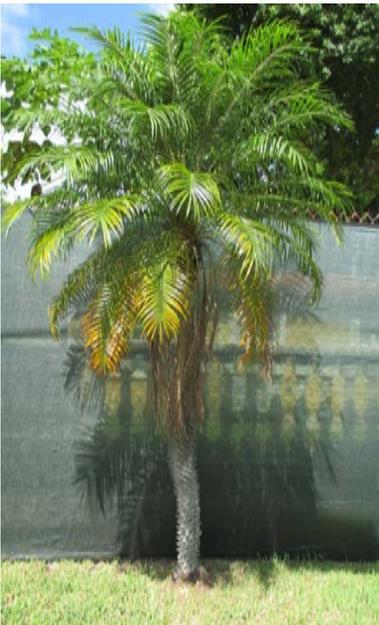
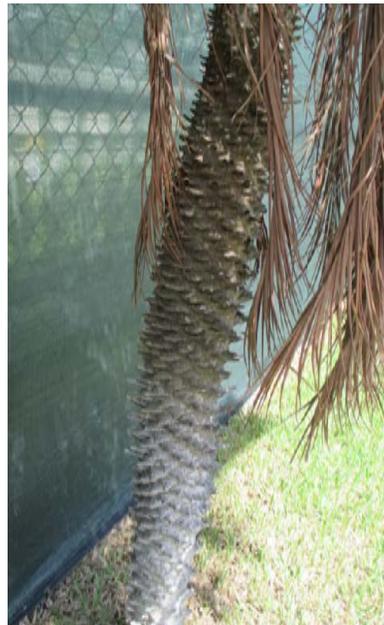
Tree #6 is a Pygmy Date Palm street tree located along North Bay Road. Overhead wires are above. It is in fair condition with some lower dead fronds. This tree has not been incorporated into the landscape plan and will therefore be removed.

Disposition -
Remove

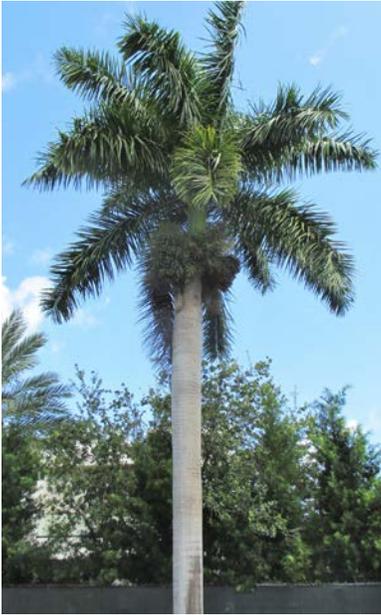
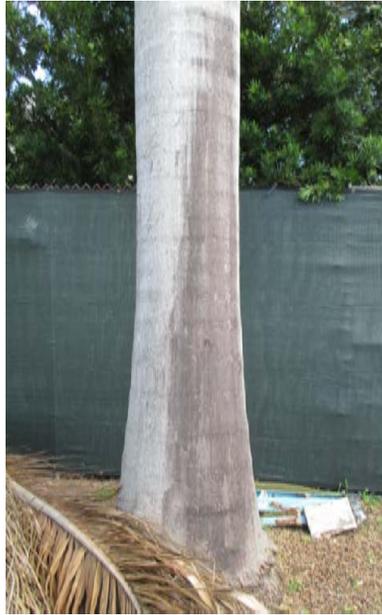
Tree #7 is a Royal Palm located on the east side of the front yard. It is in good condition with a healthy green canopy. Some trunk pencilling is occurring. This tree has not been incorporated into the landscape plan and will therefore be removed.

Disposition -
Remove

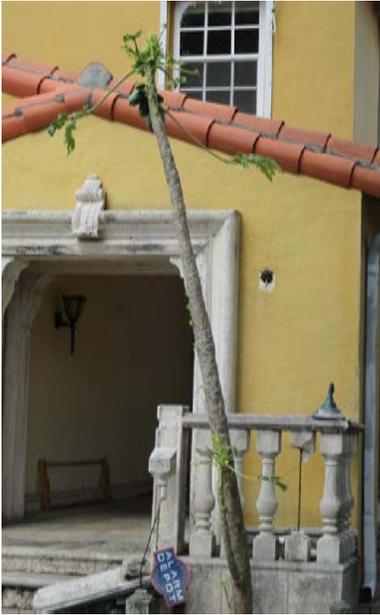
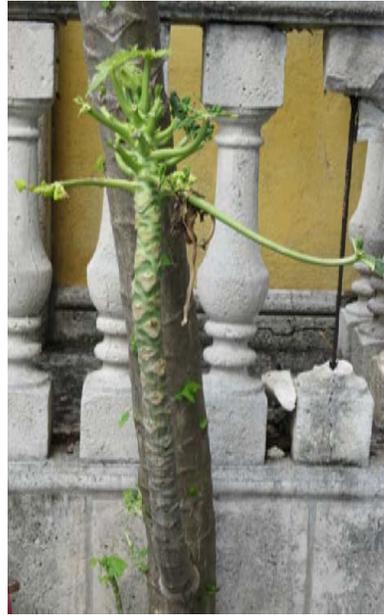
Tree #9 is a Papaya located in front of the main house. It is in poor condition with little foliage remaining. This tree has not been incorporated into the landscape plan and will therefore be removed.

Disposition -
Remove

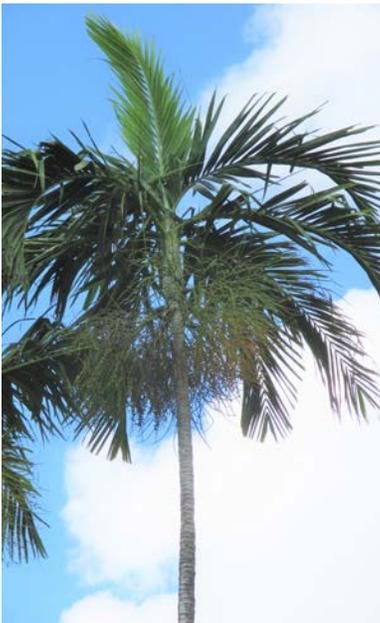
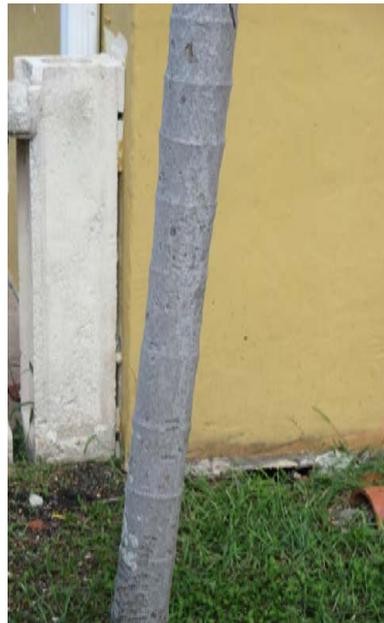
Tree #10 is a Solitaire Palm located in front of the main house. It is in fair condition with some fronds that are tattered.

This tree has not been incorporated into the landscape plan and will therefore be removed.

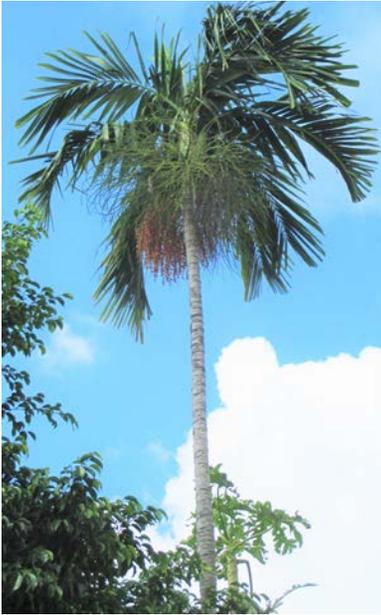
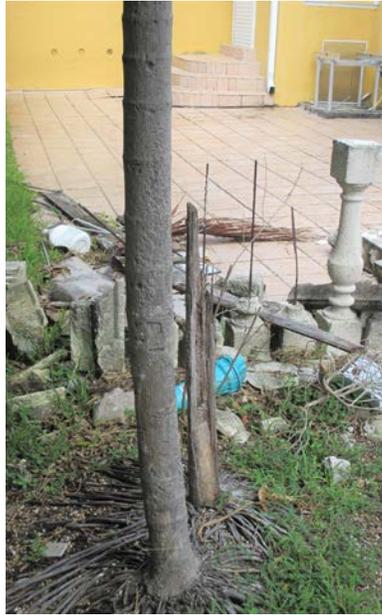
Tree #11 is a Solitaire Palm located on the west side of the property. It is in fair condition with some fronds that are tattered. This tree has not been incorporated into the landscape plan and will therefore be removed.

Disposition -
Remove

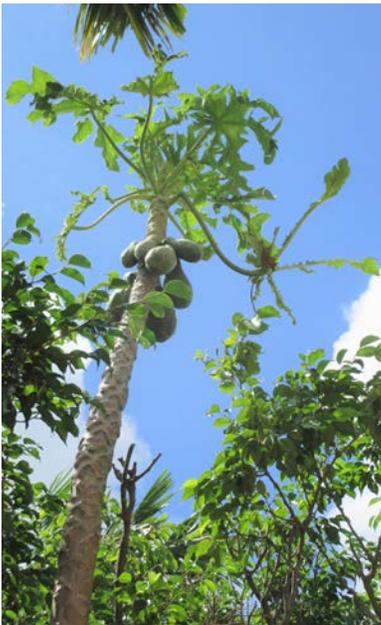
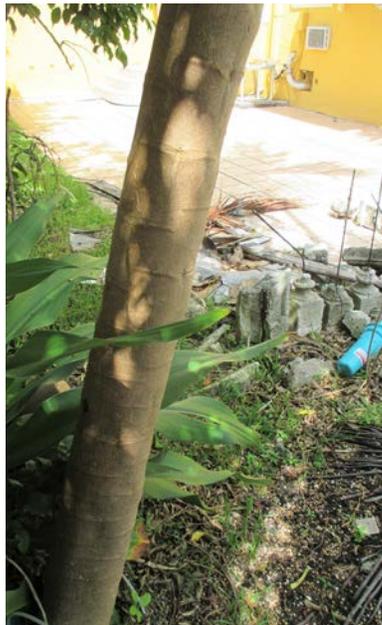
Tree #12 is a Papaya located on the west side of the property. It is in poor condition with little foliage remaining. This tree has not been incorporated into the landscape plan and will therefore be removed.

Disposition -
Remove

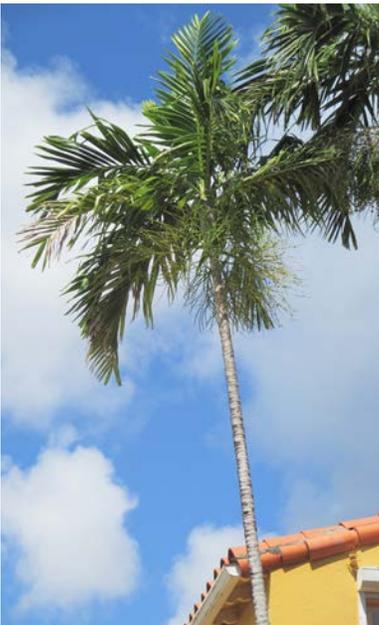
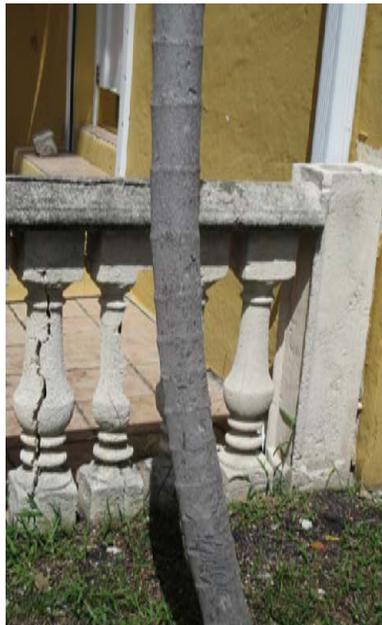
Tree #14 is a Solitaire Palm located at the front of the main house. It is in fair condition with some fronds that are tattered. This tree has not been incorporated into the landscape plan and will therefore be removed.

Disposition -
Remove

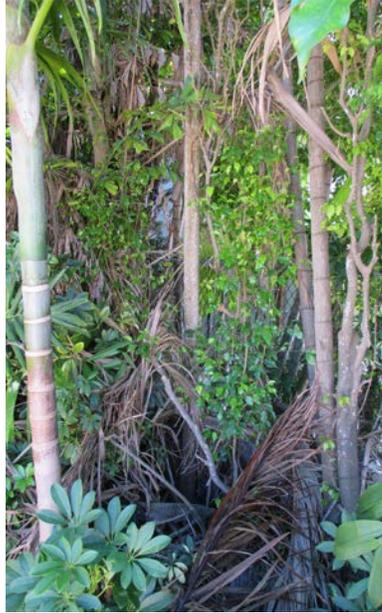
Tree #15 is a cluster of seven Solitaire Palms located on the west side of the backyard. They are in good condition with mostly green foliage. This tree has not been incorporated into the landscape plan and will therefore be removed.

Disposition -
Remove

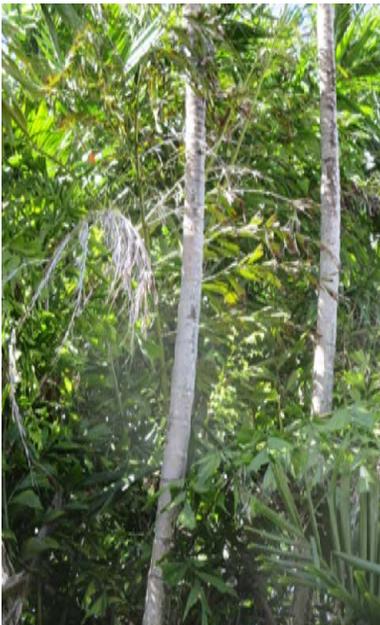
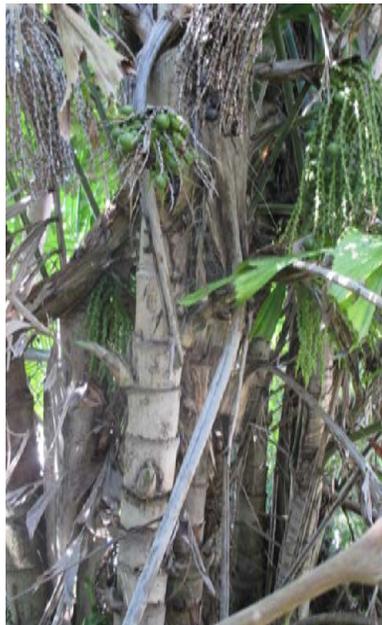
Tree #16 is a Fishtail Palm located on the west side of the backyard. It is in poor condition with foliage that is chlorotic and browning. This tree has not been incorporated into the landscape plan and will therefore be removed.

Disposition -
Remove

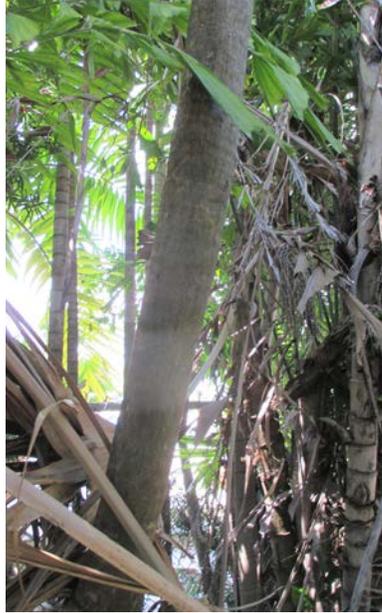
Tree #17 is a Florida Thatch Palm located on the west side of the backyard. It is in fair condition with a chlorotic canopy. This tree has not been incorporated into the landscape plan and will therefore be removed.

Disposition -
Remove

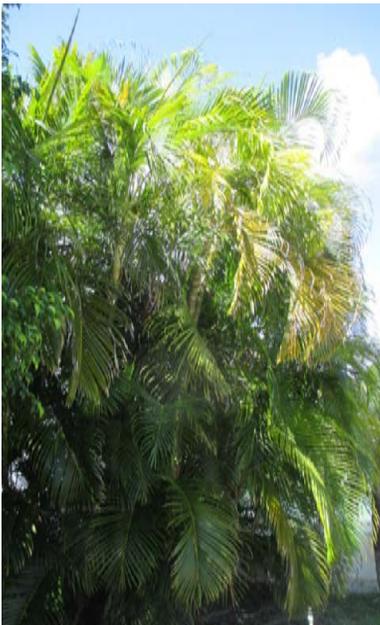
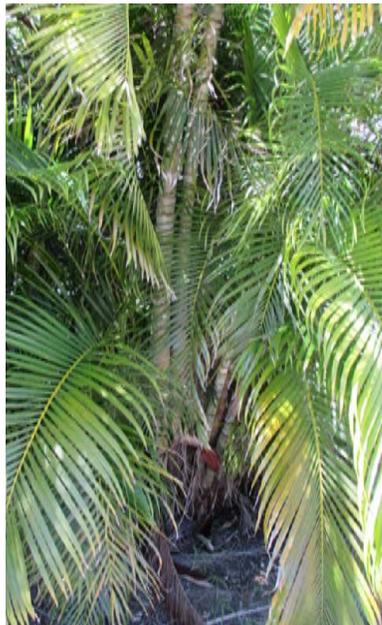
Tree #18 is an Areca Palm located in the northwest corner of the backyard. It is in fair condition with many fronds that are chlorotic. This tree has not been incorporated into the landscape plan and will therefore be removed.

Disposition -
Remove

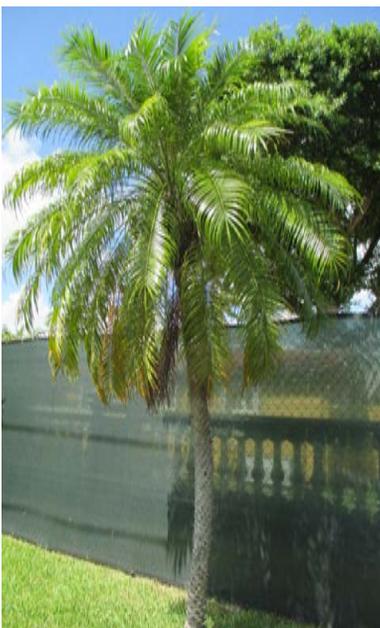
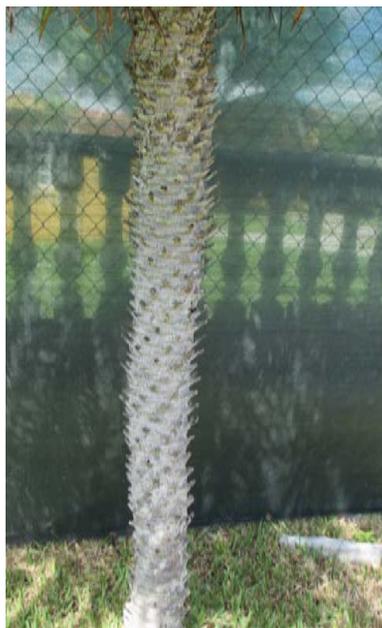
Tree #20 is a Pygmy Date Palm street tree located along North Bay Road. Overhead wires are above. It is in fair condition with some lower dead fronds.

This tree has not been incorporated into the landscape plan and will therefore be removed.

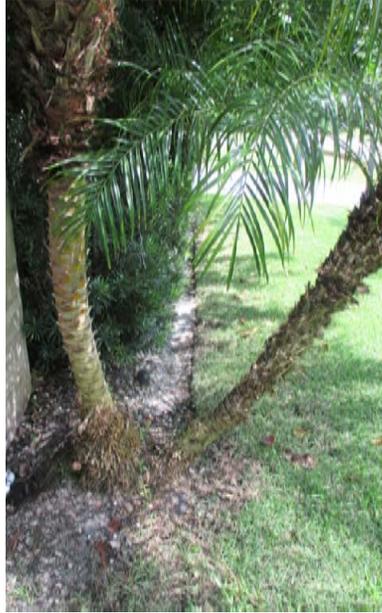
Tree #21 is a double Pygmy Date Palm street tree located along North Bay Road. Overhead wires are above. It is in good condition with a mostly green canopy. This tree has not been incorporated into the landscape plan and will therefore be removed.

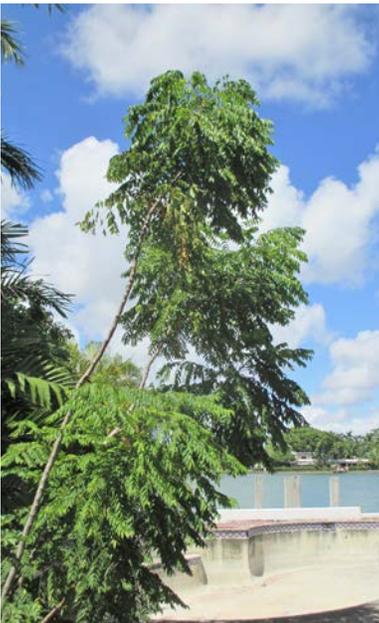
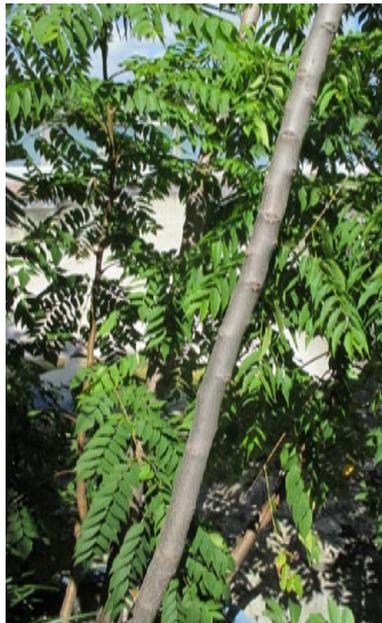
Tree #22 is a Goldenrain Tree seedling growing in the backyard next to the pool. It is in fair condition with poor form. This tree has not been incorporated into the landscape plan and will therefore be removed.

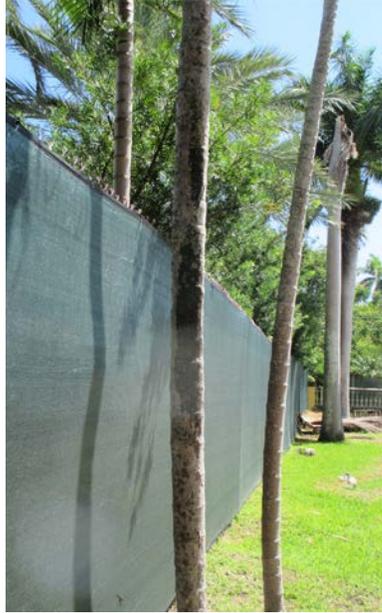
Tree #23 is two Solitaire Palms located on the east side of the front yard. They are in fair condition with some tattered fronds.

This tree has not been incorporated into the landscape plan and will therefore be removed.

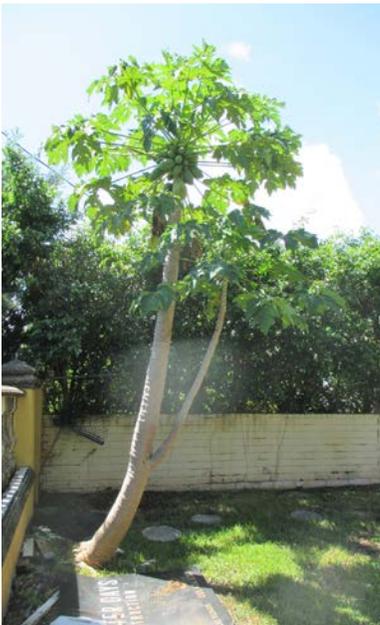
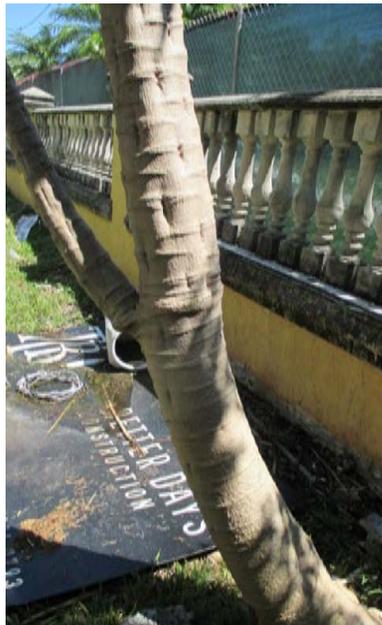
Tree #24 is a Papaya located towards the front of the property. It is in good condition.

This tree has not been incorporated into the landscape plan and will therefore be removed.

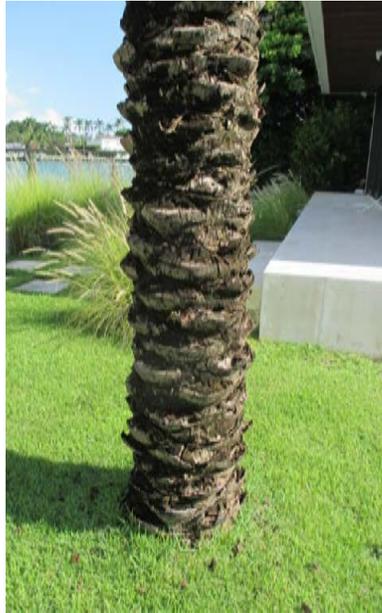
Tree #25 is a Date Palm located at the rear of the property. It is in good condition with a healthy green canopy.

This tree is to remain and protective barriers shall be placed 10ft from the tree trunk. Barriers shall be installed prior to the start of construction, and shall remain in place until development is completed and the department authorizes their removal. Barriers shall be a minimum of 4ft high, and shall be constructed of continuous chain link fence with metal posts at 8ft spacing, or of 2x4 posts with three equally spaced 2x4 rails. Posts may be shifted to avoid roots. No materials shall be placed or disposed of within the TPZ. Natural grade shall be maintained within the TPZ.

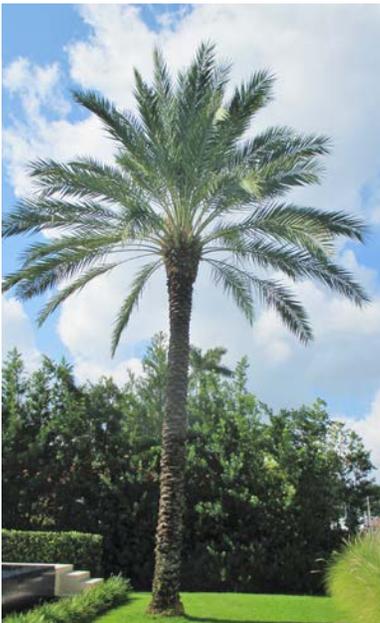
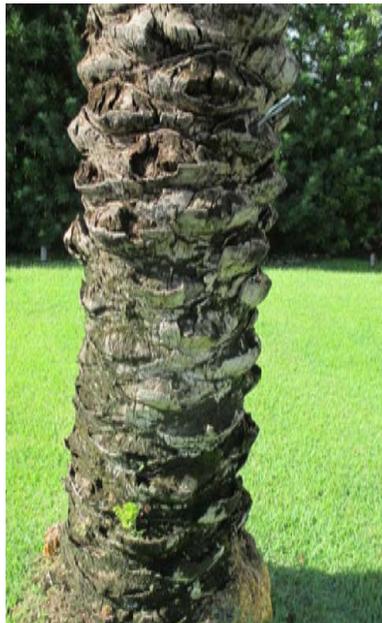
Tree #26 is a Date Palm located at the rear of the property. It is in good condition with a healthy green canopy.

This tree is to remain and protective barriers shall be placed 10ft from the tree trunk. Barriers shall be installed prior to the start of construction, and shall remain in place until development is completed and the department authorizes their removal. Barriers shall be a minimum of 4ft high, and shall be constructed of continuous chain link fence with metal posts at 8ft spacing, or of 2x4 posts with three equally spaced 2x4 rails. Posts may be shifted to avoid roots. No materials shall be placed or disposed of within the TPZ. Natural grade shall be maintained within the TPZ.

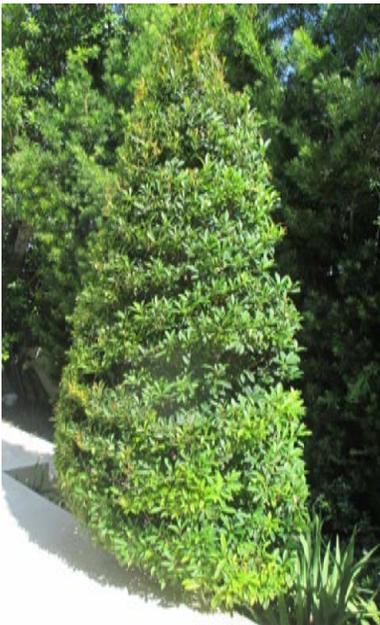
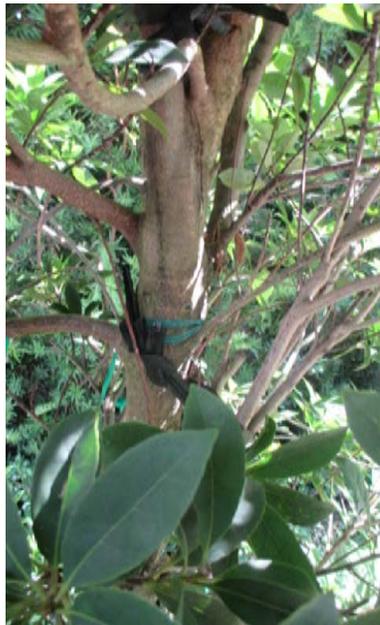
Tree #28 is a Japanese Blueberry located on the eastern side of the house. It is in good condition with a dense green canopy.

This tree is to remain and protective barriers shall be placed 10ft from the tree trunk. Barriers shall be installed prior to the start of construction, and shall remain in place until development is completed and the department authorizes their removal. Barriers shall be a minimum of 4ft high, and shall be constructed of continuous chain link fence with metal posts at 8ft spacing, or of 2x4 posts with three equally spaced 2x4 rails. Posts may be shifted to avoid roots. No materials shall be placed or disposed of within the TPZ. Natural grade shall be maintained within the TPZ.

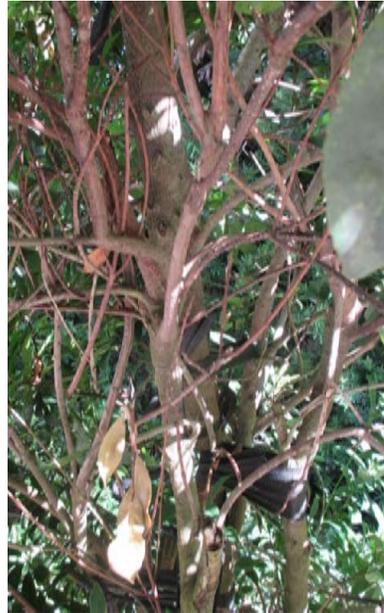
Tree #29 is a Japanese Blueberry located on the eastern side of the house. It is in good condition with a dense green canopy.

This tree is to remain and protective barriers shall be placed 10ft from the tree trunk. Barriers shall be installed prior to the start of construction, and shall remain in place until development is completed and the department authorizes their removal. Barriers shall be a minimum of 4ft high, and shall be constructed of continuous chain link fence with metal posts at 8ft spacing, or of 2x4 posts with three equally spaced 2x4 rails. Posts may be shifted to avoid roots. No materials shall be placed or disposed of within the TPZ. Natural grade shall be maintained within the TPZ.

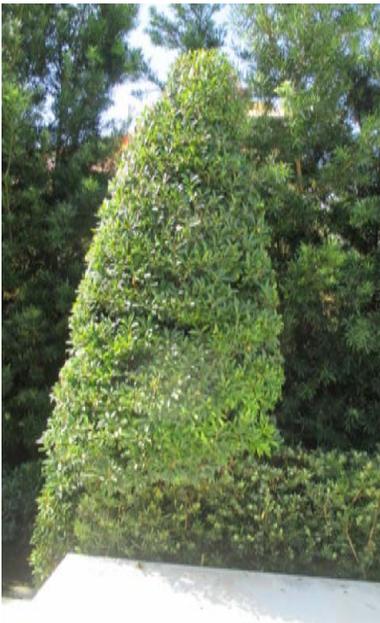
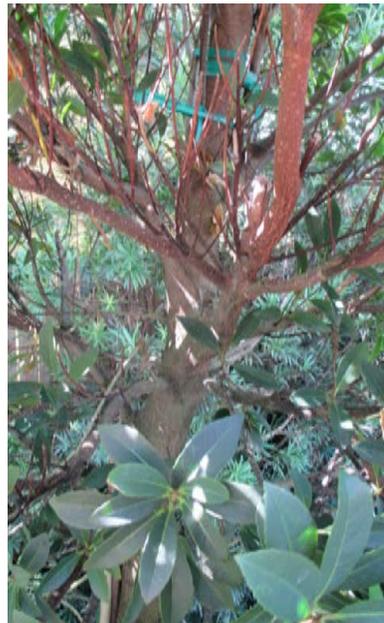
Tree #30 is a Japanese Blueberry located on the west side of the property. It is in good condition with a dense green canopy. This tree is to be relocated and root pruning shall occur a minimum of 8 weeks prior to digging the tree and shall be performed or supervised by Certified Arborist. Minimum rootball measurement shall be based upon the most recent *Florida Grades & Standards for Nursery Plants*. Transplanting shall be performed or supervised by Certified Arborist. Prior to transplanting, only branches that are dead or broken are to be removed; no live foliage is to be pruned off. When lifting the tree, ensure that the trunk is not damaged. The diameter of the planting hole shall be twice the root ball diameter. Plant at grade, with the trunk flare visible. Transplanting shall occur as soon as possible and no more than 24 hours after being dug for relocation. Proper irrigation shall be provided during and after transplanting. Following relocation, a 3ft radius TPZ shall be erected.

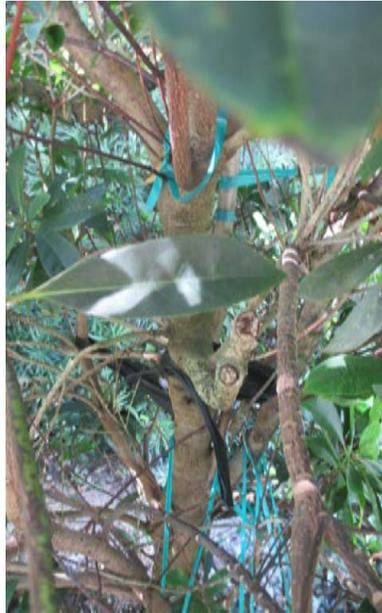
Tree #31 is a Japanese Blueberry located on the west side of the property. It is in good condition with a dense green canopy. This tree is to be relocated and root pruning shall occur a minimum of 8 weeks prior to digging the tree and shall be performed or supervised by Certified Arborist. Minimum rootball measurement shall be based upon the most recent *Florida Grades & Standards for Nursery Plants*. Transplanting shall be performed or supervised by Certified Arborist. Prior to transplanting, only branches that are dead or broken are to be removed; no live foliage is to be pruned off. When lifting the tree, ensure that the trunk is not damaged. The diameter of the planting hole shall be twice the root ball diameter. Plant at grade, with the trunk flare visible. Transplanting shall occur as soon as possible and no more than 24 hours after being dug for relocation. Proper irrigation shall be provided during and after transplanting. Following relocation, a 3ft radius TPZ shall be erected.

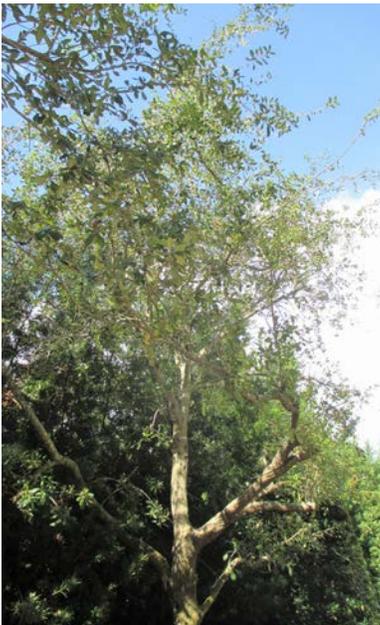
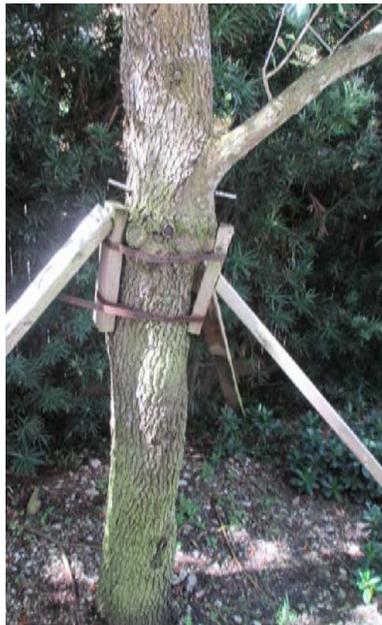
Tree #32 is a Live Oak located on the west side of the house. It is in fair condition with a canopy on the thinner side. A number of limbs have been pruned back to provide clearance for the house. Remove the stakes before they girdle the tree. This tree is to be relocated and root pruning shall occur a minimum of 8 weeks prior to digging the tree and shall be performed or supervised by Certified Arborist. Minimum rootball measurement shall be based upon the most recent *Florida Grades & Standards for Nursery Plants*. Transplanting shall be performed or supervised by Certified Arborist. Prior to transplanting, only branches that are dead or broken are to be removed; no live foliage is to be pruned off. When lifting the tree, ensure that the trunk is not damaged. The diameter of the planting hole shall be twice the root ball diameter. Plant at grade, with the trunk flare visible. Transplanting shall occur as soon as possible and no more than 24 hours after being dug for relocation. Proper irrigation shall be provided during and after transplanting. Following relocation, a 10ft radius TPZ shall be erected.

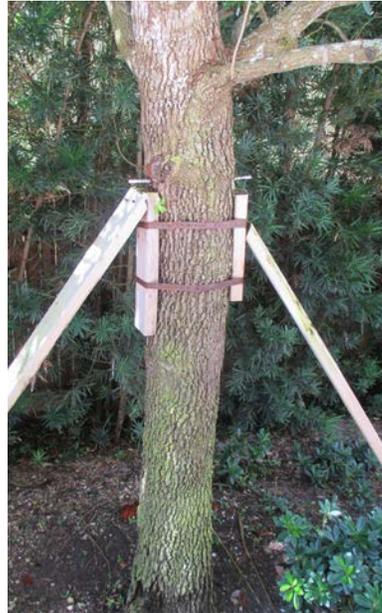
Tree #33 is a Live Oak located on the west side of the house. It is in good condition. There is a lot of sucker growth along the limbs and branches. Remove the stakes before they girdle the tree. This tree is to be relocated and root pruning shall occur a minimum of 8 weeks prior to digging the tree and shall be performed or supervised by Certified Arborist. Minimum rootball measurement shall be based upon the most recent *Florida Grades & Standards for Nursery Plants*. Transplanting shall be performed or supervised by Certified Arborist. Prior to transplanting, only branches that are dead or broken are to be removed; no live foliage is to be pruned off. When lifting the tree, ensure that the trunk is not damaged. The diameter of the planting hole shall be twice the root ball diameter. Plant at grade, with the trunk flare visible. Transplanting shall occur as soon as possible and no more than 24 hours after being dug for relocation. Proper irrigation shall be provided during and after transplanting. Following relocation, a 10ft radius TPZ shall be erected.

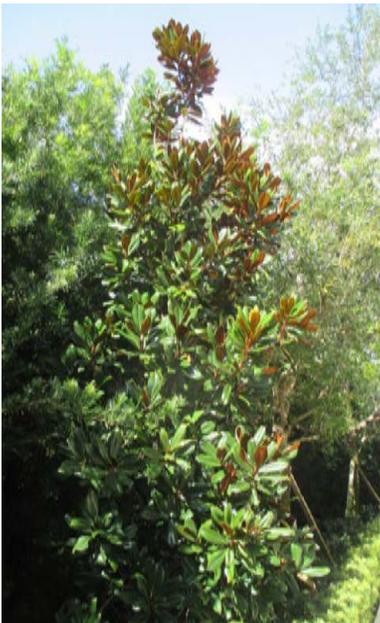
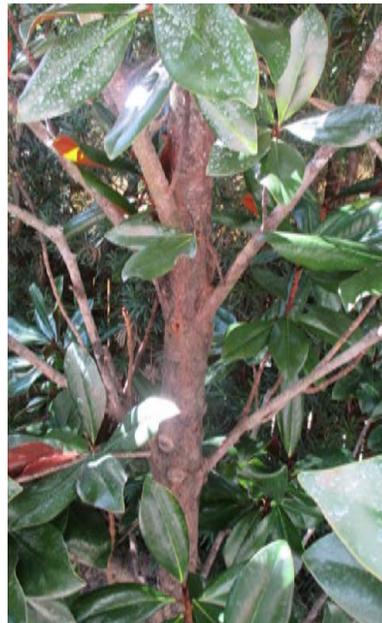
Tree #34 is a Southern Magnolia located on the west side of the house. It is in good condition with a dense, healthy canopy. This tree is to be relocated and root pruning shall occur a minimum of 8 weeks prior to digging the tree and shall be performed or supervised by Certified Arborist. Minimum rootball measurement shall be based upon the most recent *Florida Grades & Standards for Nursery Plants*. Transplanting shall be performed or supervised by Certified Arborist. Prior to transplanting, only branches that are dead or broken are to be removed; no live foliage is to be pruned off. When lifting the tree, ensure that the trunk is not damaged. The diameter of the planting hole shall be twice the root ball diameter. Plant at grade, with the trunk flare visible. Transplanting shall occur as soon as possible and no more than 24 hours after being dug for relocation. Proper irrigation shall be provided during and after transplanting. Following relocation, a 4ft radius TPZ shall be erected.

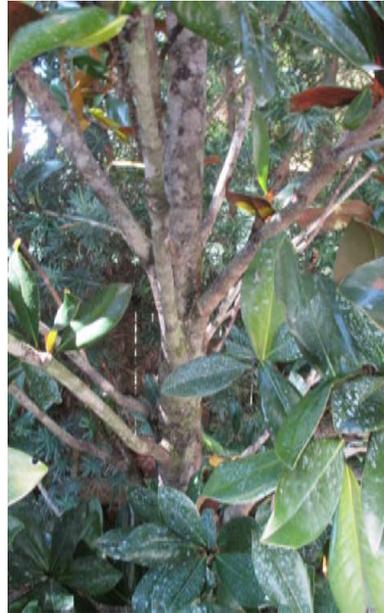
Tree #35 is a Southern Magnolia located on the west side of the house. It is in good condition with a dense, healthy canopy. This tree is to be relocated and root pruning shall occur a minimum of 8 weeks prior to digging the tree and shall be performed or supervised by Certified Arborist. Minimum rootball measurement shall be based upon the most recent *Florida Grades & Standards for Nursery Plants*. Transplanting shall be performed or supervised by Certified Arborist. Prior to transplanting, only branches that are dead or broken are to be removed; no live foliage is to be pruned off. When lifting the tree, ensure that the trunk is not damaged. The diameter of the planting hole shall be twice the root ball diameter. Plant at grade, with the trunk flare visible. Transplanting shall occur as soon as possible and no more than 24 hours after being dug for relocation. Proper irrigation shall be provided during and after transplanting. Following relocation, a 4ft radius TPZ shall be erected.

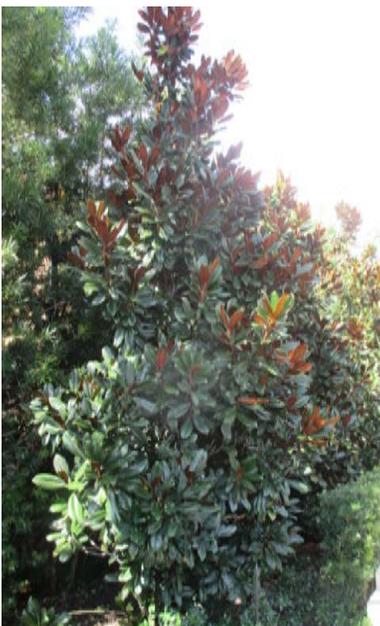
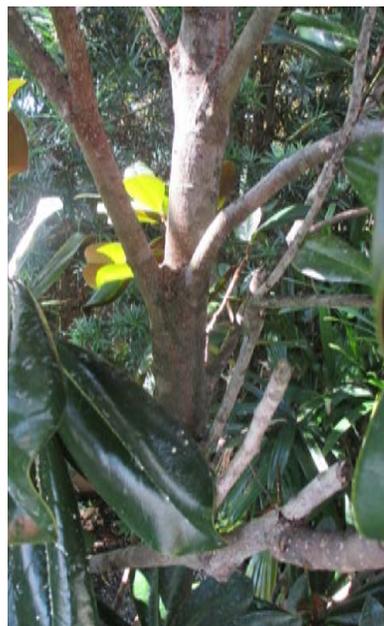
Tree #36 is a Southern Magnolia located on the west side of the house. It is in good condition with a dense, healthy canopy. This tree is to be relocated and root pruning shall occur a minimum of 8 weeks prior to digging the tree and shall be performed or supervised by Certified Arborist. Minimum rootball measurement shall be based upon the most recent *Florida Grades & Standards for Nursery Plants*. Transplanting shall be performed or supervised by Certified Arborist. Prior to transplanting, only branches that are dead or broken are to be removed; no live foliage is to be pruned off. When lifting the tree, ensure that the trunk is not damaged. The diameter of the planting hole shall be twice the root ball diameter. Plant at grade, with the trunk flare visible. Transplanting shall occur as soon as possible and no more than 24 hours after being dug for relocation. Proper irrigation shall be provided during and after transplanting. Following relocation, a 4ft radius TPZ shall be erected.

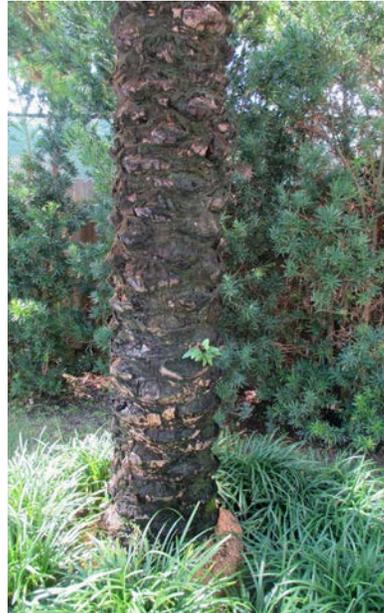
Tree #37 is a Date Palm located to the west of the driveway. It is in good condition with a healthy green canopy. This tree is to be relocated and root pruning shall occur a minimum of 4-6 weeks prior to digging the palm and shall be performed or supervised by Certified Arborist. Minimum rootball measurement shall be based upon the most recent *Florida Grades & Standards for Nursery Plants*. Prior to transplanting, the apical bud shall be protected by tying up palm fronds. Leaves shall be untied as soon as the palm is planted. When lifting the palm, a nylon sling with adequate padding shall be used and care shall be taken to not injure or compress the trunk. Plant at grade, with 2" of root initiation zone visible if applicable. Transplanting shall occur as soon as possible and no more than 24 hours after being dug for relocation. The backfill soil shall be irrigated during and following relocation. Wooden braces shall be installed to stabilize the tree. Following relocation, a 7.5ft radius TPZ shall be erected.

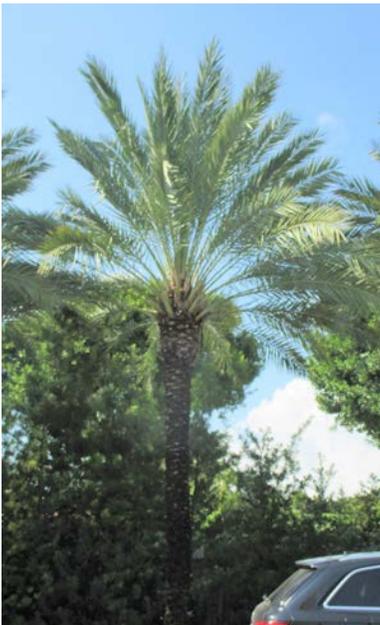
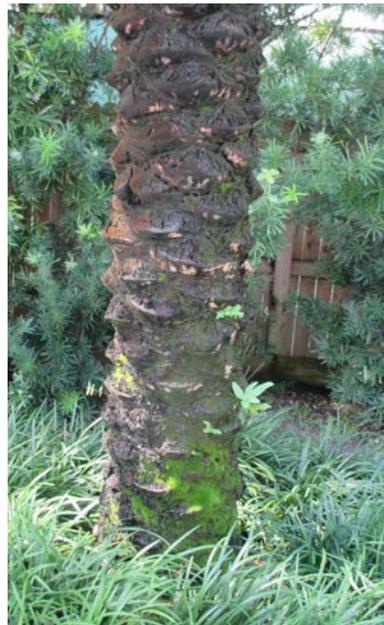
Tree #38 is a Date Palm located to the west of the driveway. It is in good condition with a healthy green canopy. This tree is to be relocated and root pruning shall occur a minimum of 4-6 weeks prior to digging the palm and shall be performed or supervised by Certified Arborist. Minimum rootball measurement shall be based upon the most recent *Florida Grades & Standards for Nursery Plants*. Prior to transplanting, the apical bud shall be protected by tying up palm fronds. Leaves shall be untied as soon as the palm is planted. When lifting the palm, a nylon sling with adequate padding shall be used and care shall be taken to not injure or compress the trunk. Plant at grade, with 2" of root initiation zone visible if applicable. Transplanting shall occur as soon as possible and no more than 24 hours after being dug for relocation. The backfill soil shall be irrigated during and following relocation. Wooden braces shall be installed to stabilize the tree. Following relocation, a 7.5ft radius TPZ shall be erected.

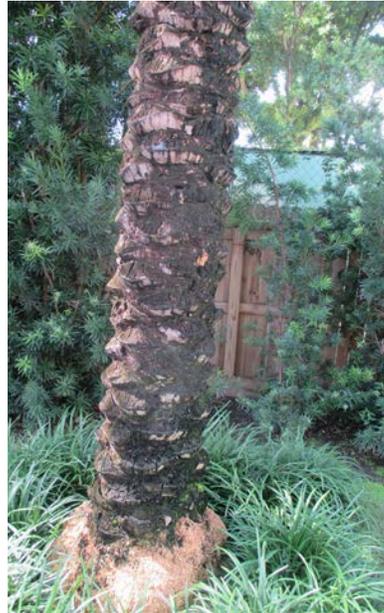
Tree #39 is a Date Palm located to the west of the driveway. It is in good condition with a healthy green canopy. This tree is to be relocated and root pruning shall occur a minimum of 4-6 weeks prior to digging the palm and shall be performed or supervised by Certified Arborist. Minimum rootball measurement shall be based upon the most recent *Florida Grades & Standards for Nursery Plants*. Prior to transplanting, the apical bud shall be protected by tying up palm fronds. Leaves shall be untied as soon as the palm is planted. When lifting the palm, a nylon sling with adequate padding shall be used and care shall be taken to not injure or compress the trunk. Plant at grade, with 2" of root initiation zone visible if applicable. Transplanting shall occur as soon as possible and no more than 24 hours after being dug for relocation. The backfill soil shall be irrigated during and following relocation. Wooden braces shall be installed to stabilize the tree. Following relocation, a 7.5ft radius TPZ shall be erected.

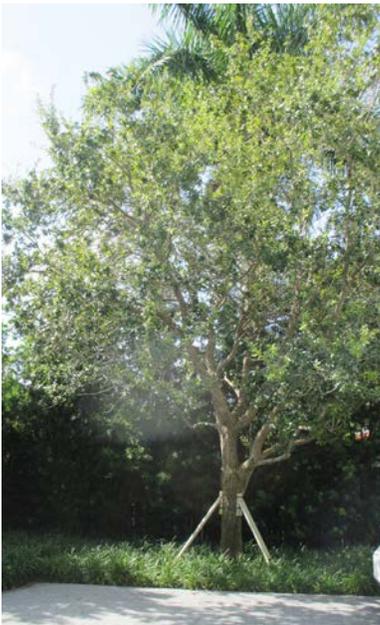
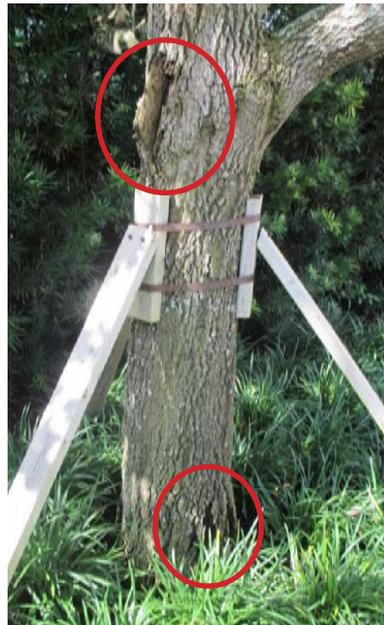
Tree #40 is a Live Oak located at the front of the property. The tree is in good condition with a healthy green canopy. There are two small wounds on the trunk (circled in red) that are closing over and buckling the outer bark. Remove the stakes before they girdle the trunk. This tree is to be relocated and root pruning shall occur a minimum of 8 weeks prior to digging the tree and shall be performed or supervised by Certified Arborist. Minimum rootball measurement shall be based upon the most recent *Florida Grades & Standards for Nursery Plants*. Transplanting shall be performed or supervised by Certified Arborist. Prior to transplanting, only branches that are dead or broken are to be removed; no live foliage is to be pruned off. When lifting the tree, ensure that the trunk is not damaged. The diameter of the planting hole shall be twice the root ball diameter. Plant at grade, with the trunk flare visible. Transplanting shall occur as soon as possible and no more than 24 hours after being dug for relocation. Proper irrigation shall be provided during and after transplanting. Following relocation, a 14ft radius TPZ shall be erected.

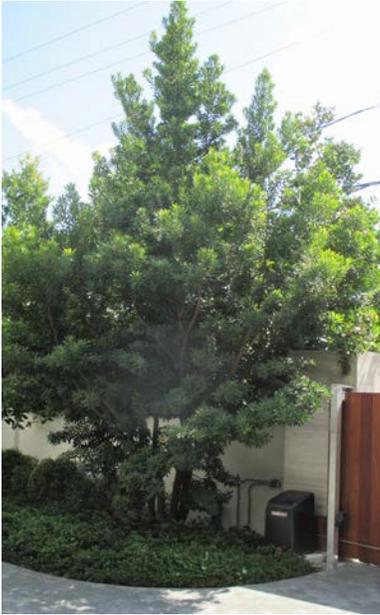
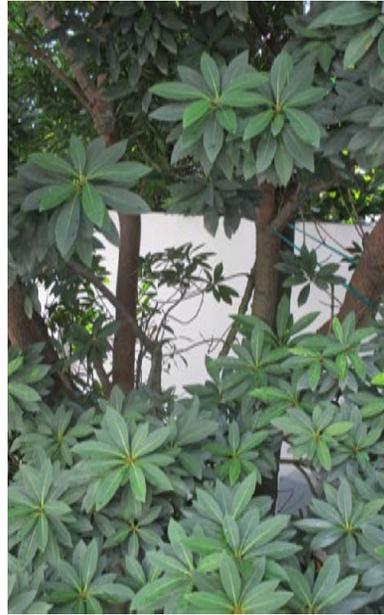
Tree #41 is a Japanese Blueberry located at the front of the property. It is in good condition and is growing vigorously. This tree is to be relocated and root pruning shall occur a minimum of 8 weeks prior to digging the tree and shall be performed or supervised by Certified Arborist. Minimum rootball measurement shall be based upon the most recent *Florida Grades & Standards for Nursery Plants*. Transplanting shall be performed or supervised by Certified Arborist. Prior to transplanting, only branches that are dead or broken are to be removed; no live foliage is to be pruned off. When lifting the tree, ensure that the trunk is not damaged. The diameter of the planting hole shall be twice the root ball diameter. Plant at grade, with the trunk flare visible. Transplanting shall occur as soon as possible and no more than 24 hours after being dug for relocation. Proper irrigation shall be provided during and after transplanting. Following relocation, a 7.5ft radius TPZ shall be erected.

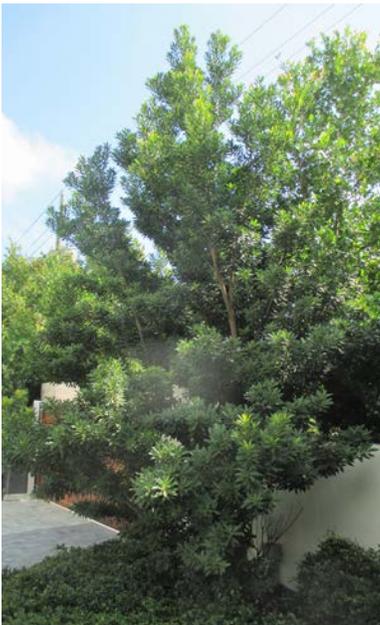
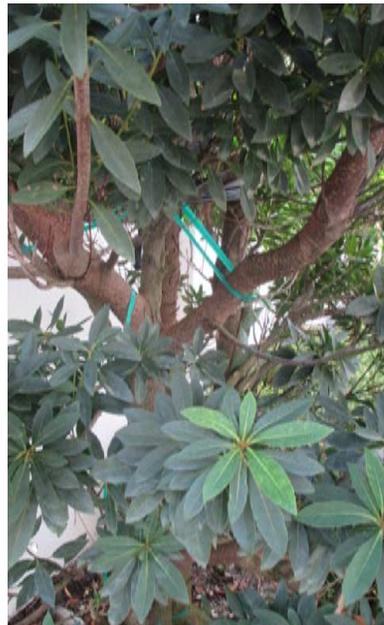
Tree #42 is a Japanese Blueberry located at the front of the property. It is in good condition and is growing vigorously. This tree is to be relocated and root pruning shall occur a minimum of 8 weeks prior to digging the tree and shall be performed or supervised by Certified Arborist. Minimum rootball measurement shall be based upon the most recent *Florida Grades & Standards for Nursery Plants*. Transplanting shall be performed or supervised by Certified Arborist. Prior to transplanting, only branches that are dead or broken are to be removed; no live foliage is to be pruned off. When lifting the tree, ensure that the trunk is not damaged. The diameter of the planting hole shall be twice the root ball diameter. Plant at grade, with the trunk flare visible. Transplanting shall occur as soon as possible and no more than 24 hours after being dug for relocation. Proper irrigation shall be provided during and after transplanting. Following relocation, a 5ft radius TPZ shall be erected.

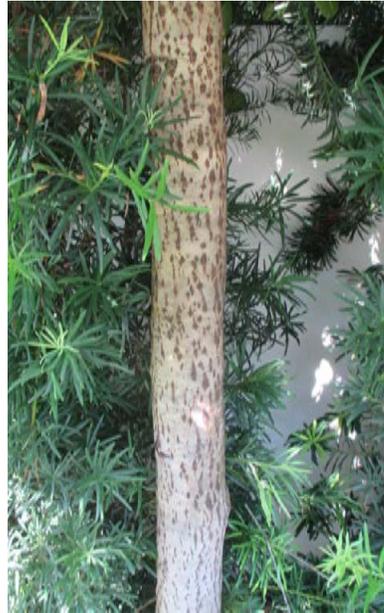
Tree #43 is a Brazilian Beautyleaf street tree located along North Bay Road. It is in good condition with a healthy green canopy and is growing vigorously. This tree is to be relocated and root pruning shall occur a minimum of 8 weeks prior to digging the tree and shall be performed or supervised by Certified Arborist. Minimum rootball measurement shall be based upon the most recent *Florida Grades & Standards for Nursery Plants*. Transplanting shall be performed or supervised by Certified Arborist. Prior to transplanting, only branches that are dead or broken are to be removed; no live foliage is to be pruned off. When lifting the tree, ensure that the trunk is not damaged. The diameter of the planting hole shall be twice the root ball diameter. Plant at grade, with the trunk flare visible. Transplanting shall occur as soon as possible and no more than 24 hours after being dug for relocation. Proper irrigation shall be provided during and after transplanting. Following relocation, a 5ft radius TPZ shall be erected.

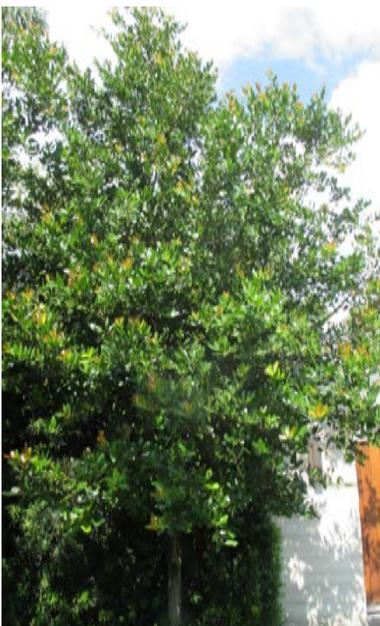
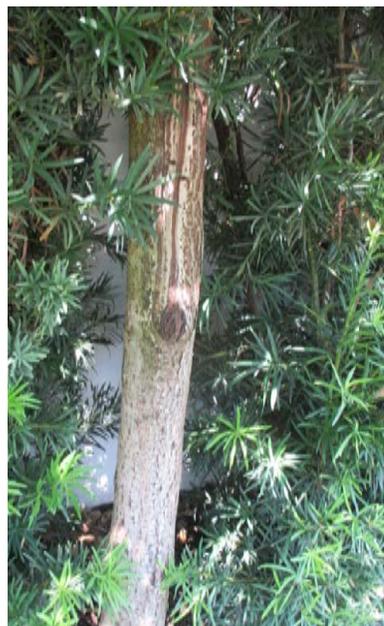
Tree #44 is a Brazilian Beautyleaf street tree located along North Bay Road. It is in good condition with a healthy green canopy and is growing vigorously. This tree is to be relocated and root pruning shall occur a minimum of 8 weeks prior to digging the tree and shall be performed or supervised by Certified Arborist. Minimum rootball measurement shall be based upon the most recent *Florida Grades & Standards for Nursery Plants*. Transplanting shall be performed or supervised by Certified Arborist. Prior to transplanting, only branches that are dead or broken are to be removed; no live foliage is to be pruned off. When lifting the tree, ensure that the trunk is not damaged. The diameter of the planting hole shall be twice the root ball diameter. Plant at grade, with the trunk flare visible. Transplanting shall occur as soon as possible and no more than 24 hours after being dug for relocation. Proper irrigation shall be provided during and after transplanting. Following relocation, a 5ft radius TPZ shall be erected.
