Arborist Report

6342-6360 North Bay Road
Miami Beach

11/9/2020

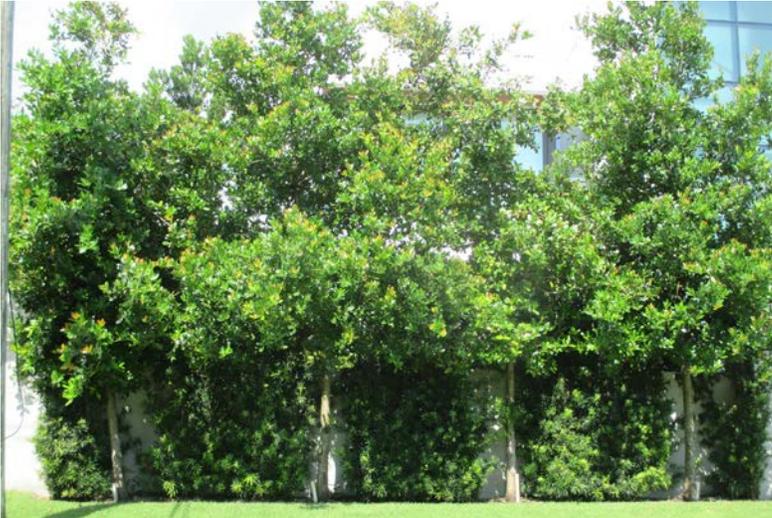
Trees #45 - 48 are four Brazilian Beautyleaf street trees located along North Bay Road. They are in good condition with healthy green canopies and are growing vigorously. These trees are to be relocated and root pruning shall occur a minimum of 8 weeks prior to digging the tree and shall be performed or supervised by Certified Arborist. Minimum rootball measurement shall be based upon the most recent *Florida Grades & Standards for Nursery Plants*. Transplanting shall be performed or supervised by Certified Arborist. Prior to transplanting, only branches that are dead or broken are to be removed; no live foliage is to be pruned off. When lifting the tree, ensure that the trunk is not damaged. The diameter of the planting hole shall be twice the root ball diameter. Plant at grade, with the trunk flare visible. Transplanting shall occur as soon as possible and no more than 24 hours after being dug for relocation. Proper irrigation shall be provided during and after transplanting. Following relocation, a 5ft radius TPZ shall be erected.

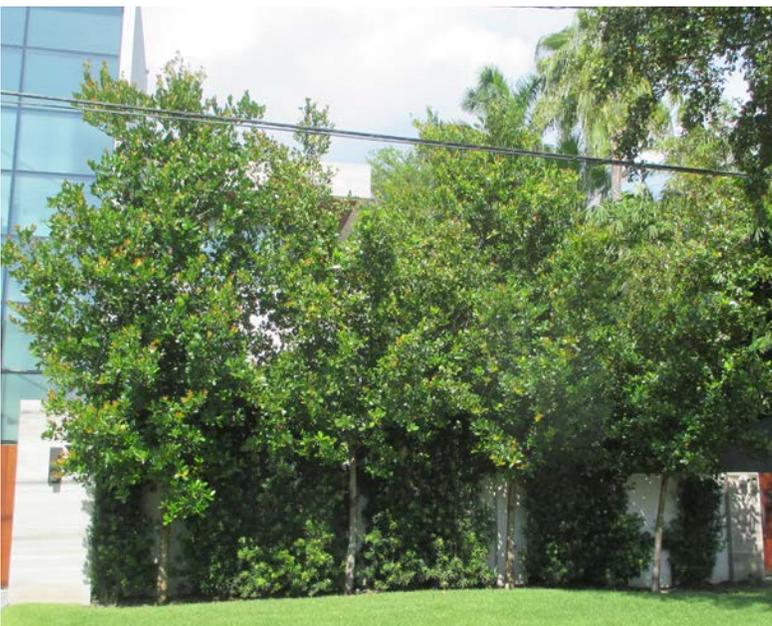
Trees #49 - 52 are four Brazilian Beautyleaf street trees located along North Bay Road. They are in good condition with healthy green canopies and are growing vigorously. These trees are to be relocated and root pruning shall occur a minimum of 8 weeks prior to digging the tree and shall be performed or supervised by Certified Arborist. Minimum rootball measurement shall be based upon the most recent *Florida Grades & Standards for Nursery Plants*. Transplanting shall be performed or supervised by Certified Arborist. Prior to transplanting, only branches that are dead or broken are to be removed; no live foliage is to be pruned off. When lifting the tree, ensure that the trunk is not damaged. The diameter of the planting hole shall be twice the root ball diameter. Plant at grade, with the trunk flare visible. Transplanting shall occur as soon as possible and no more than 24 hours after being dug for relocation. Proper irrigation shall be provided during and after transplanting. Following relocation, a 5ft radius TPZ shall be erected.

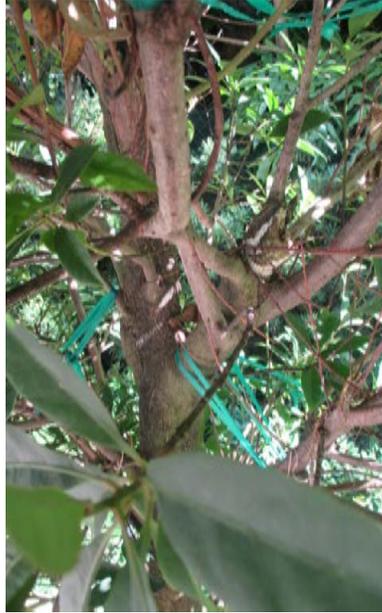
Tree #53 is a Japanese Blueberry located on the eastern side of the house. It is in good condition with a dense green canopy.

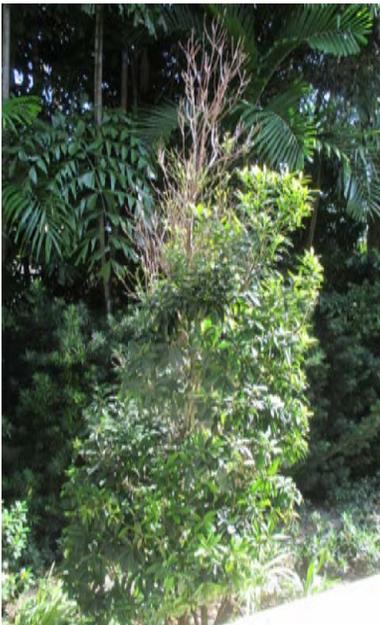
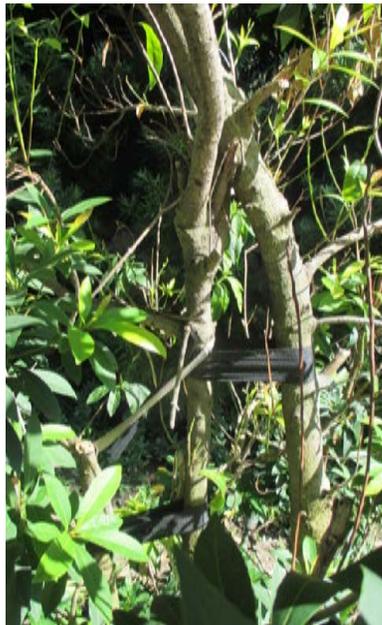
Tree #54 is a Japanese Blueberry located on the eastern side of the house. It is in poor condition with dieback at the top.

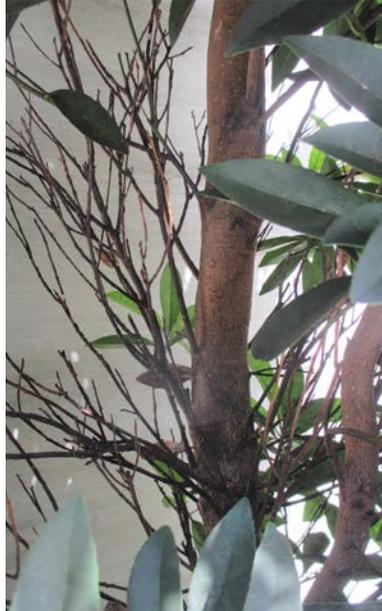
Trees #55 - 56 are two Japanese Blueberry trees located at the front of the house. They are in good condition with dense green canopies.
