PUBLIC WORKS DEPT Flooding from Stormwater Grates

Roy Coley, Public Works Director April 29, 2021 Land Use and Sustainability Committee

Flooding from Stormwater Grates

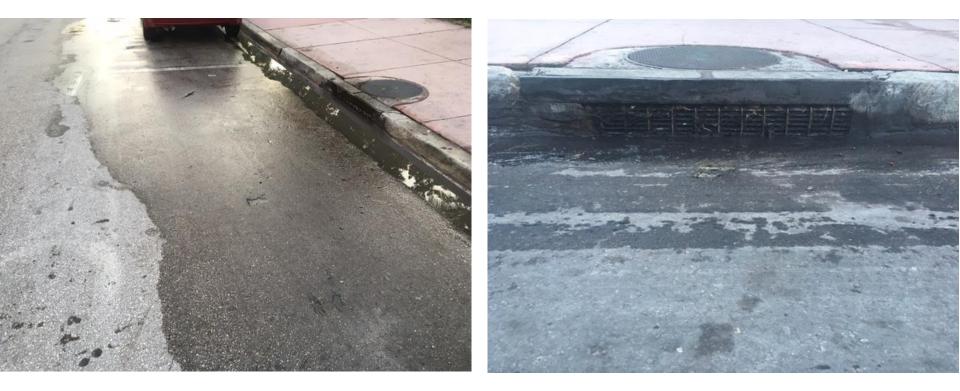
Flooding from Stormwater Grates, 8th Street

Figure 1: Pictures (above) taken after street sweepers passed by drains.

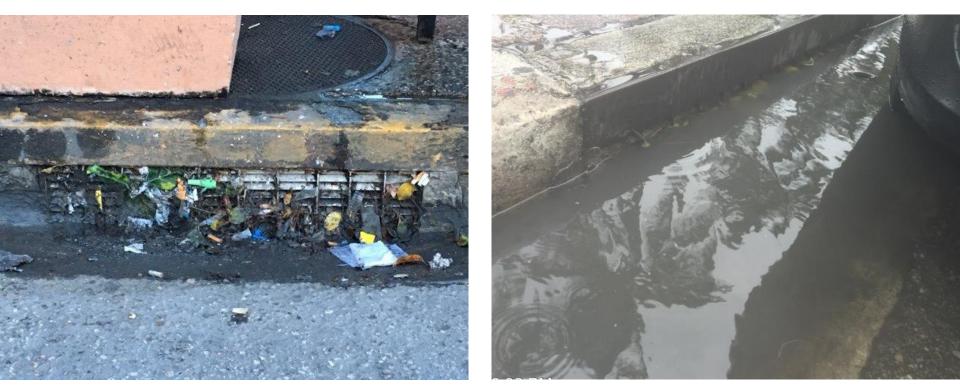
Figure 2: Stop Ocean Pollution Grates clogged with trash and debris do not look aesthetically pleasing in between cleanings.

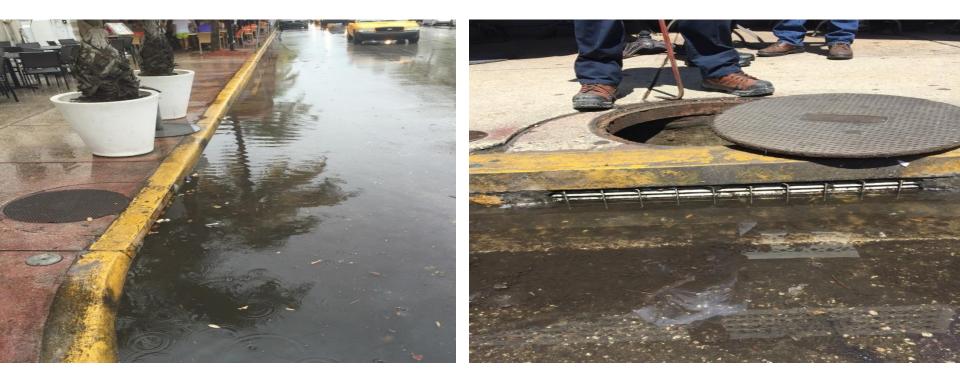
Figure 3: Grates clog and backup water into the street.

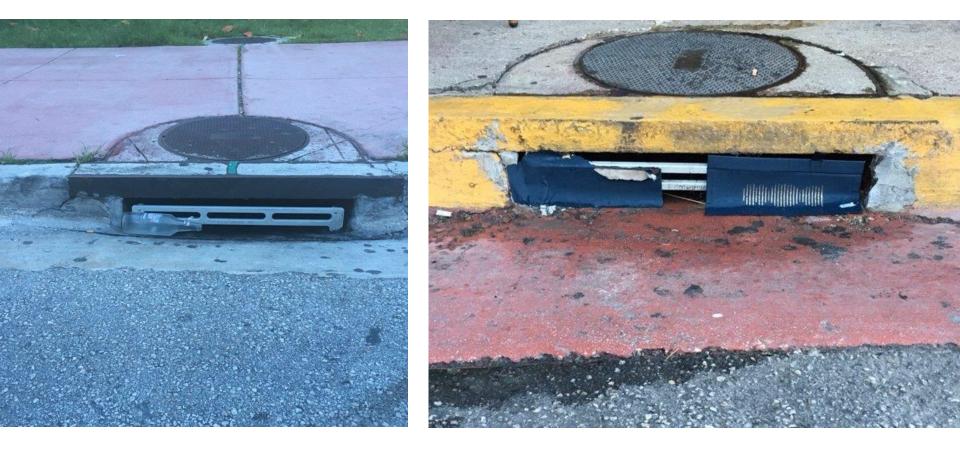
Figure 4: EcoSense grates are better for stopping larger items but need to be cleaned frequently by street sweepers.

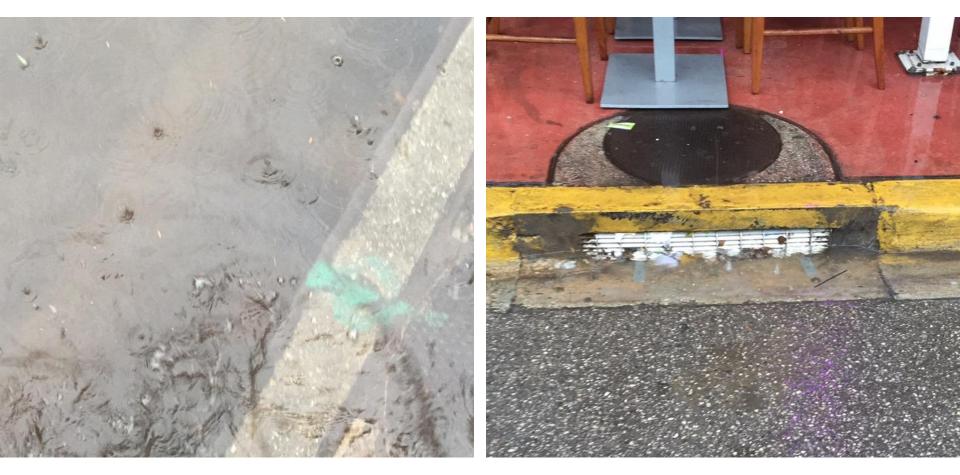
EcoSense grates are better for stopping larger items but need to be cleaned frequently by street sweepers.

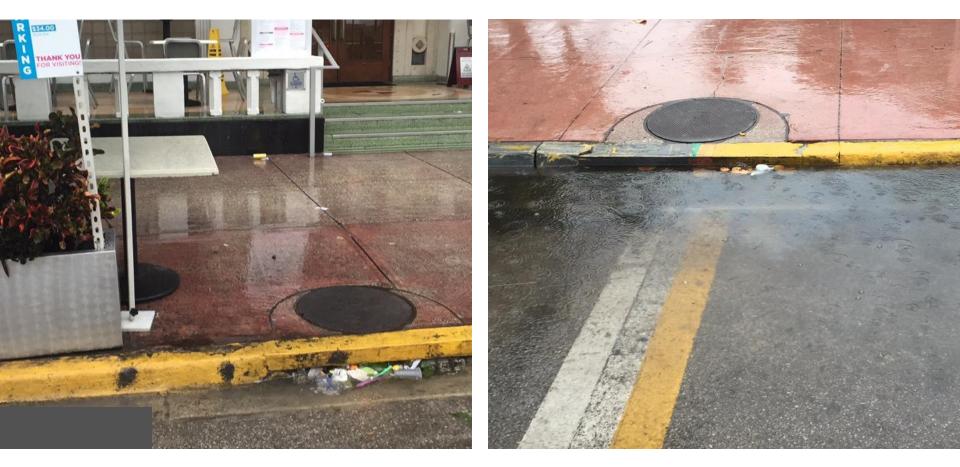
EcoSense grates are better for stopping larger items but need to be cleaned frequently by street sweepers.

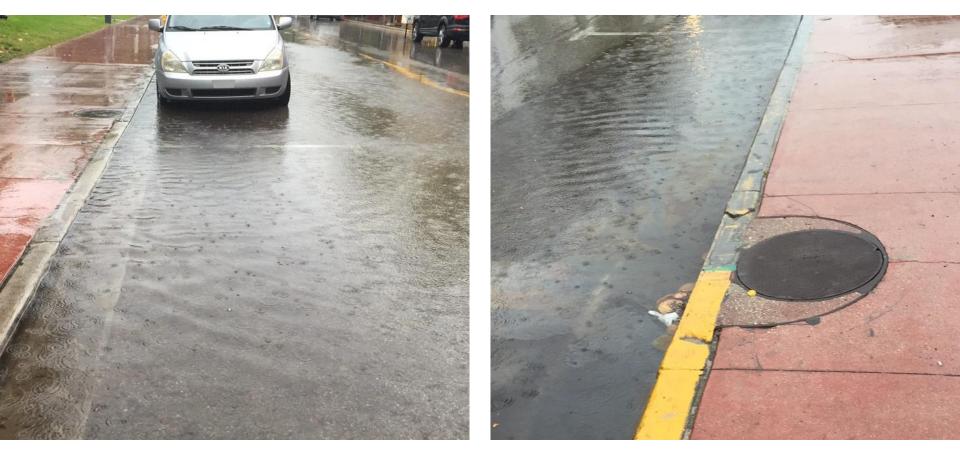
EcoSense grates, flooding from stormwater grates

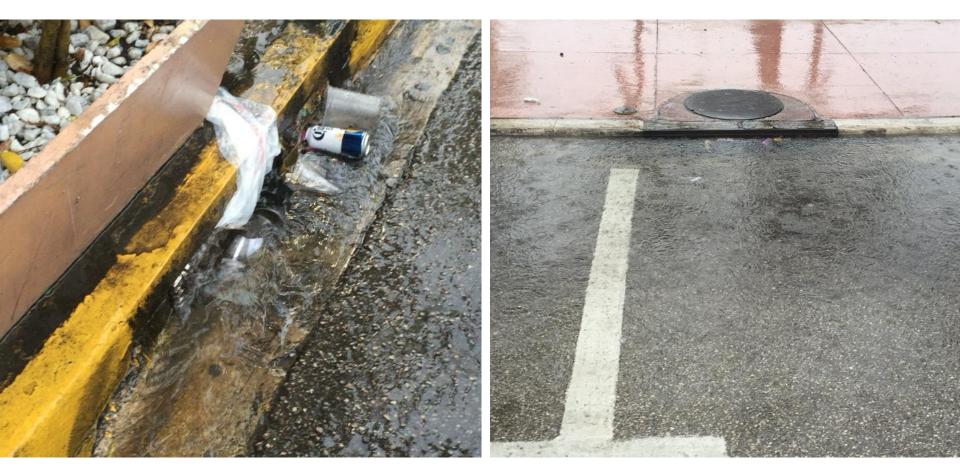
EcoSense grates are better for stopping larger items but need to be cleaned frequently by street sweepers.

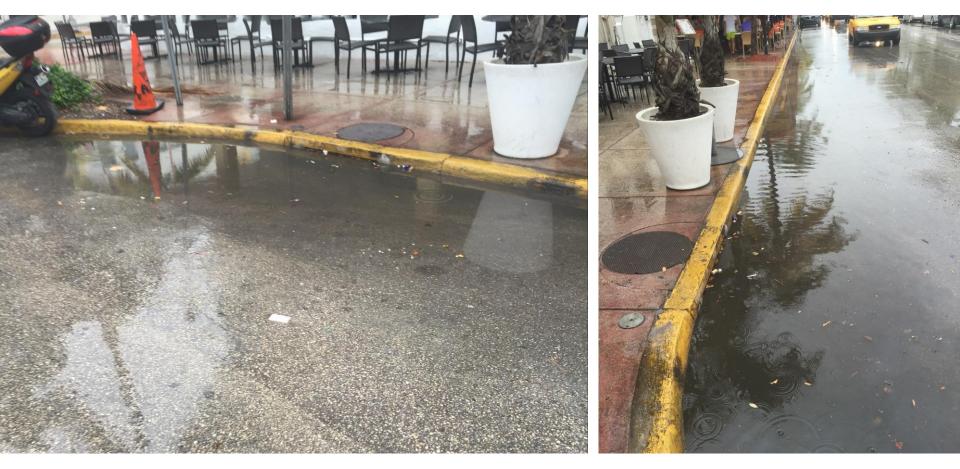
EcoSense grates, flooding from stormwater grates

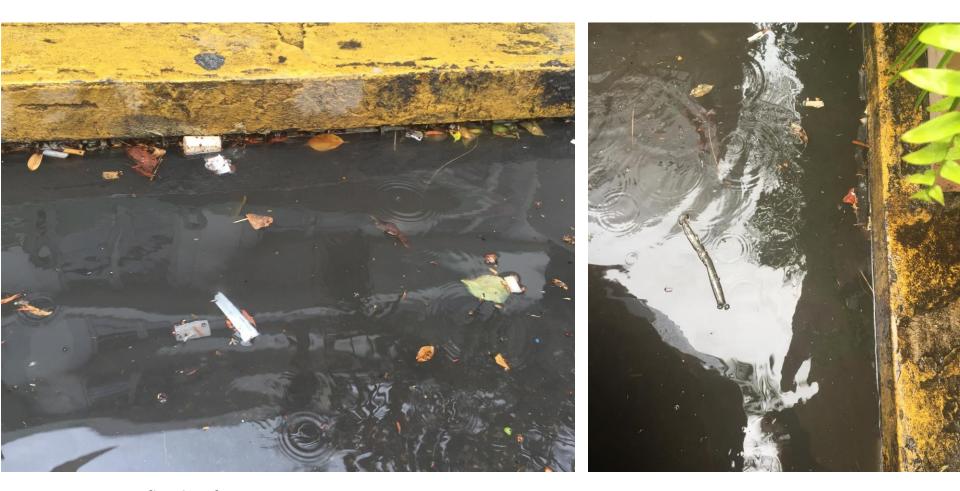
EcoSense grates, flooding from stormwater grates

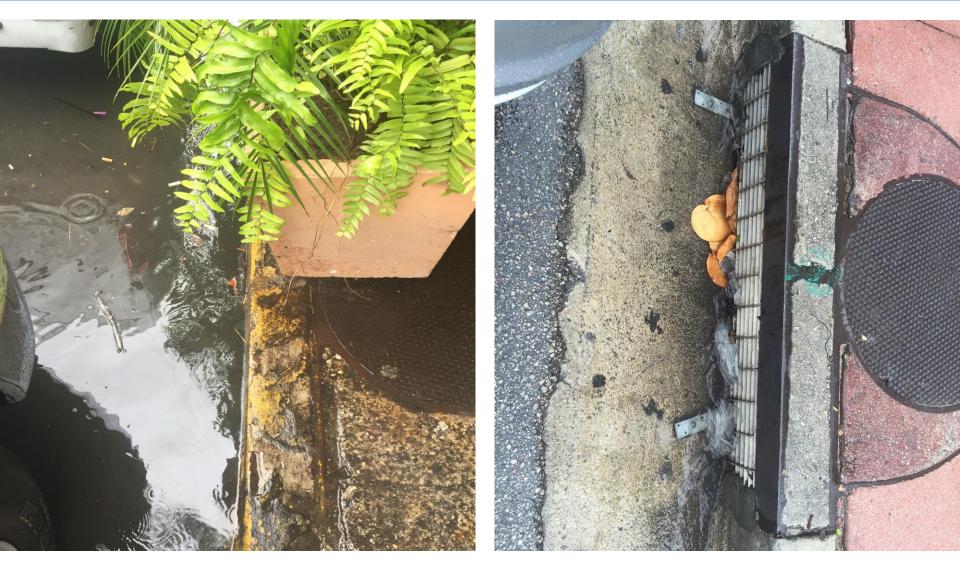
EcoSense grates are better for stopping larger items but need to be cleaned frequently by street sweepers.
