RE: 940 71 St, Miami Beach, FL 33141

Enclosed please find the Certified Arborist Report for the property located at 940 71 St. in Miami Beach conducted on March 29, 2021 by Treage LLC.

ARBORIST REPORT

940 71 St.
Miami Beach, FL 33141

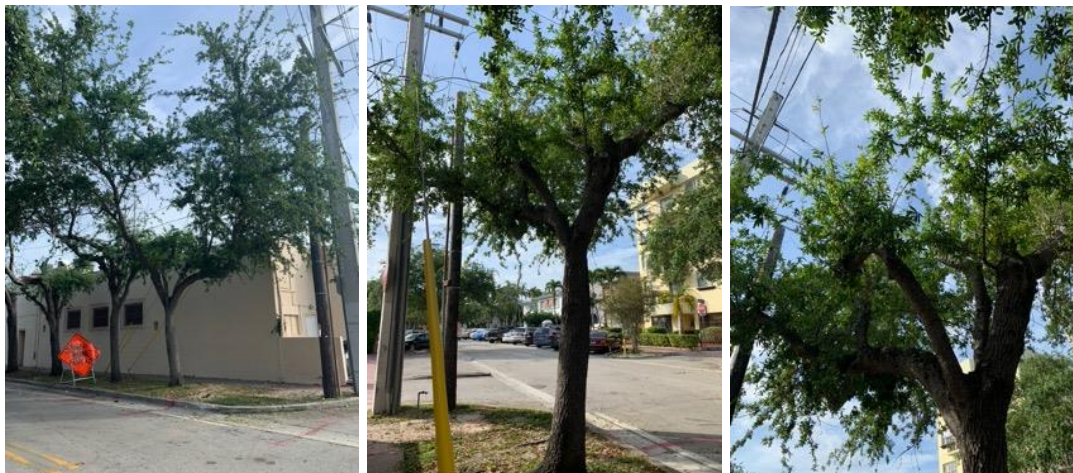
Tree #1 – *Quercus virginiana*, Live Oak – this tree is the southernmost of 5 Oaks located in the ROW on the west side of the building. It is in fair condition with multiple previous improper pruning cuts, resulting in stubs and sprouts and a rather poor branching structure. It is also growing in close proximity to the utility lines and has been cleared in the center of the canopy to avoid the lines, creating an unbalanced canopy. The canopy is also slightly constricted on the east/southeast side by the existing building. This tree is currently intended to remain and will require protection during construction.

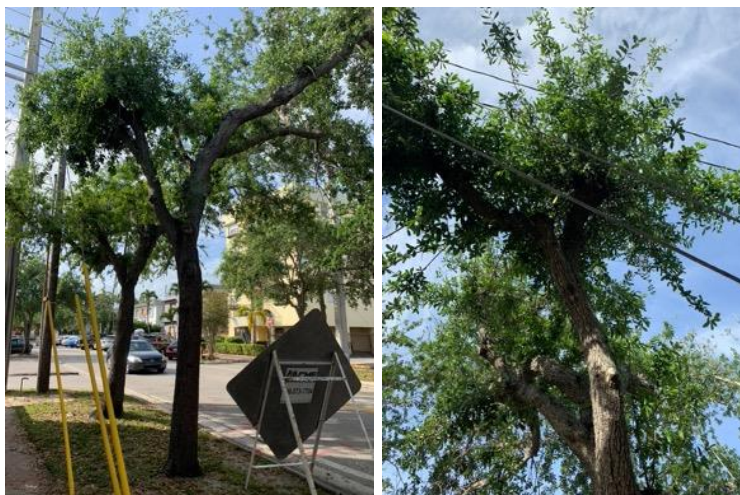
Tree #2 – *Quercus virginiana*, Live Oak – this tree is growing just north of Tree #1 in the ROW on the west side of the building. It is in fair condition with an uneven canopy due to crowding by the adjacent building, as well as pruning for utility line clearance. There is resprouting present from improper pruning cuts and there is some deadwood present. This tree is currently intended to remain and will require protection during construction.

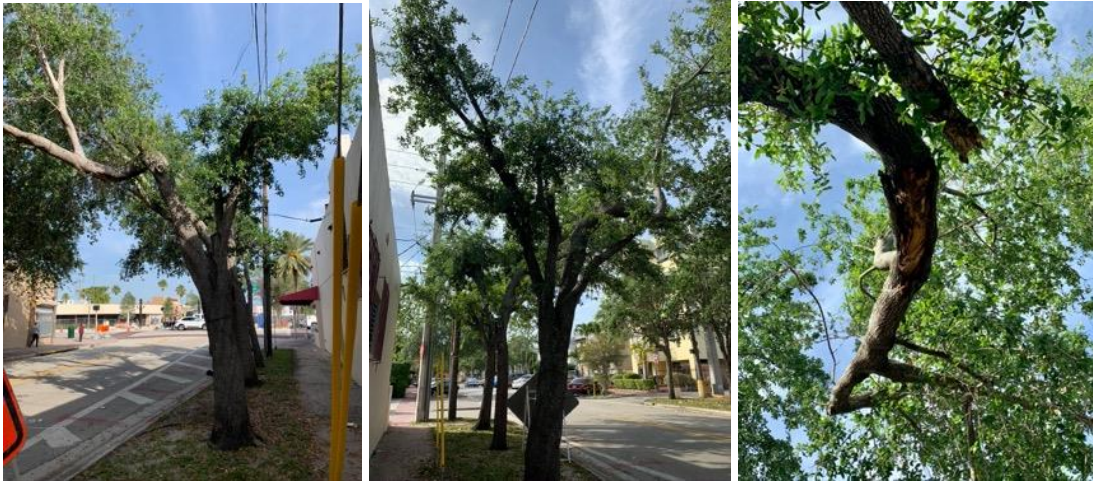
Tree #3 – *Quercus virginiana*, Live Oak – this tree is growing just north of Tree #2 in the ROW on the west side of the building. It is in fair condition with a rather poor branching structure and uneven canopy due to improper cuts, resprouting, utility line clearing, and crowding by the adjacent building. There is limb damage over the roadway with minor decay present. There are also circling surface roots visible. This tree is currently intended to remain and will require protection during construction.

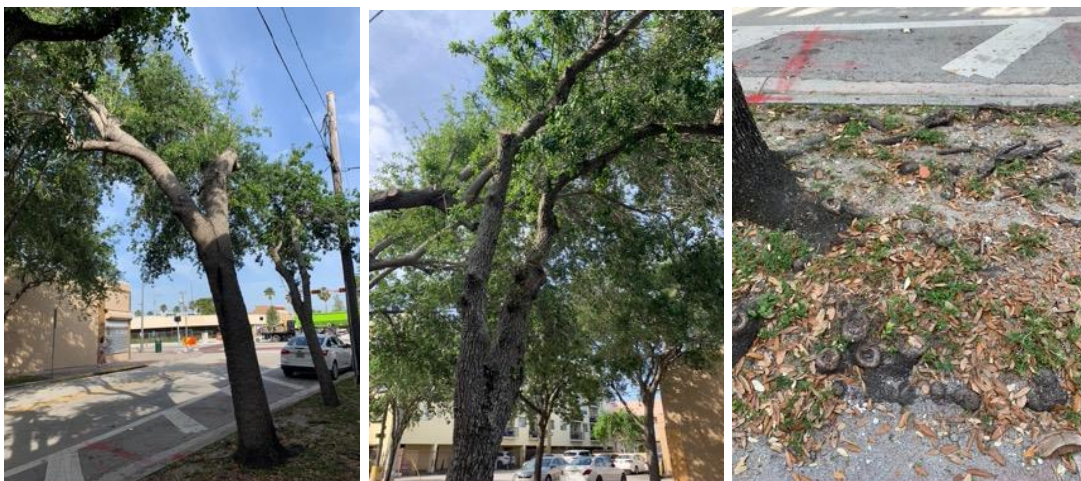
Tree #4 – *Quercus virginiana*, Live Oak – this tree is growing just north of Tree #3 in the ROW on the west side of the building. It is in fair condition but is leaning to the north due to crowding by the adjacent trees and building. There is codominance with included bark present, as well as improper pruning cuts present with resprouting. There is also surface root damage visible. This tree is currently intended to remain and will require protection during construction.

All of the Live Oaks are currently intended to remain, although they all have minor structural/cosmetic issues and are in fair condition at best. Tree #5, in particular, may be considered for removal due to its poor condition and overcrowding. Alternatively, Tree #4 can be pruned to reduce interference between the two canopies. Maintenance pruning of all remaining Oaks is recommended to remove any dead wood and selectively remove weak sprouts. Their specified TPZ's have been reduced due to the fact that their CRZ's are already largely covered by hardscape ie the roadway, sidewalk and existing building. However, protection measures detailed below should be adhered to in the specified TPZ's at a minimum, and pending work plans, may need to be increased if there is major construction or demolition of any surrounding hardscape.

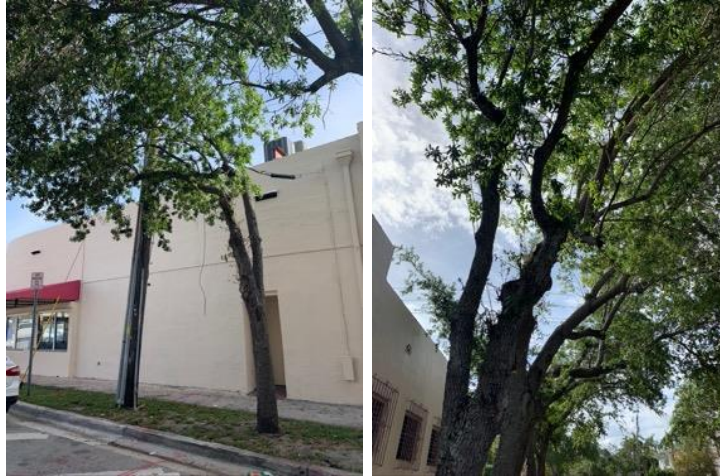
Tree #5 – *Quercus virginiana*, Live Oak – this tree is the northernmost of the 5 Live oaks located in the ROW on the west side of the building. It is in poor condition and is very crowded by the canopy of Tree #4. It has an overall weak structure with codominance, poor pruning cuts, resprouting, lean, and deadwood present. This tree is currently intended to remain, but may be considered for removal due to its condition and to reduce crowding.

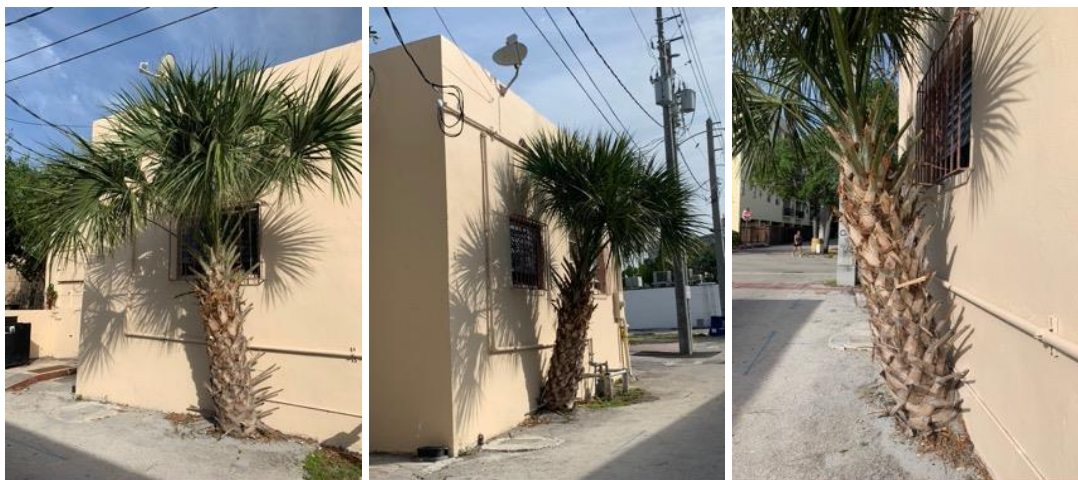
Tree #6 – *Sabal palmetto*, Sabal palm – this palm is growing directly against the south side of the building in the alleyway. It is in fair condition although crowded by the existing building and surrounded by asphalt. This tree is currently intended to remain, however should be considered for removal due to its location. It is currently under the size requiring regulation and may be removed without mitigation.

Tree #6, the Cabbage palm, is currently intended to remain and would also require protection per details below; however, it is recommended as a candidate for removal due to its location and the fact that it is currently under the size requiring regulation.
