Green Buttonwood at 28 Star Island Dr. Miami Beach, FL.

February 15, 2021

BRODSOON CONSTRUCTION INC.
120 NE 27th Street. Suite 100
Miami, FL 33137

Bartlett Tree Experts
560 NW 42nd Court
Oakland Park, FL 33334

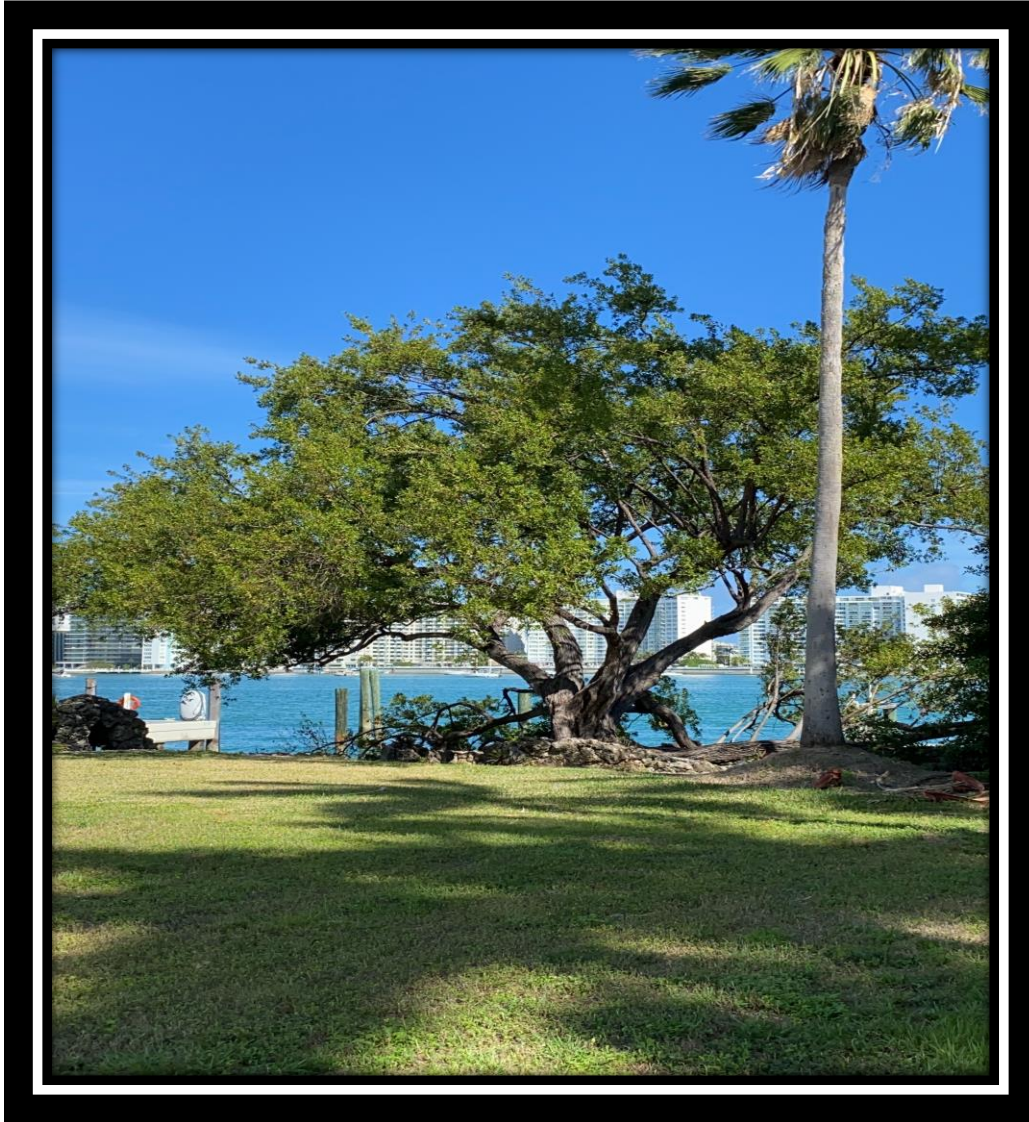
Photo # 1. Green Buttonwood

The tree has a multi-stem trunk with included bark (bark that is trapped between 2 stems creating a weak attachment), one of the stems growing towards the bay failed separating from the main trunk but is still attached to the tree.

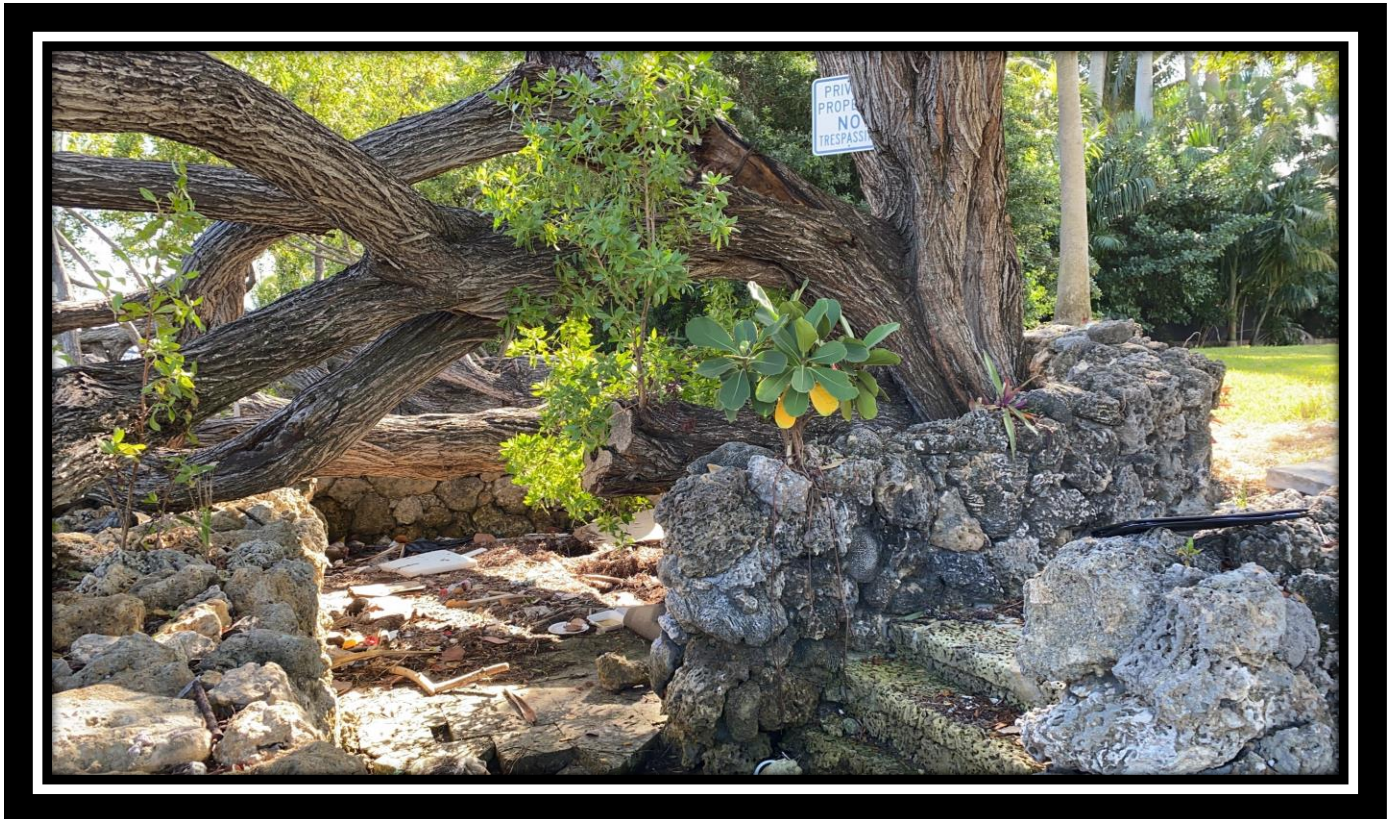
Photo # 2 showing the growing conditions of the tree, limestone retaining wall to form the tree well. Multi-stem trunk with included bark.

Two branches growing also towards the bay have ripped and are still attached to the tree. The higher and smaller branch is 18 inches in diameter near the ripped and the branch just below is 19 inches in diameter near the ripped. The stem that failed is approximately 30 inches in diameter and its closest to the ground. These branches and the large stem are resting on the seawall and growing above the water.

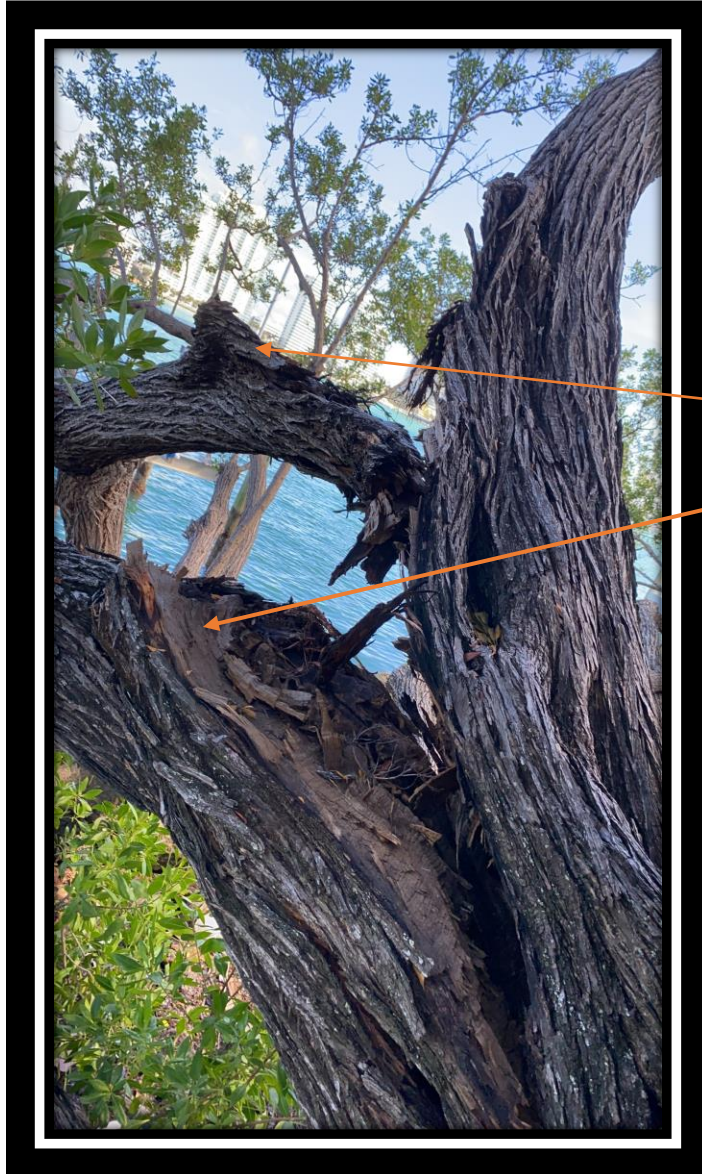
Photo # 3

Ripped branches still attached growing towards the water.

- Cut back the branches that are ripped, making a heading cut to leave a 3-5 Ft stub and try to reattach to the main parental branch using bracing bolts and cables if necessary. This will reduce the exposed surface area that possibly could decay. Work should be performed under the supervision of Board Certified Master Arborist and the work should be performed by a Certified Arborist.

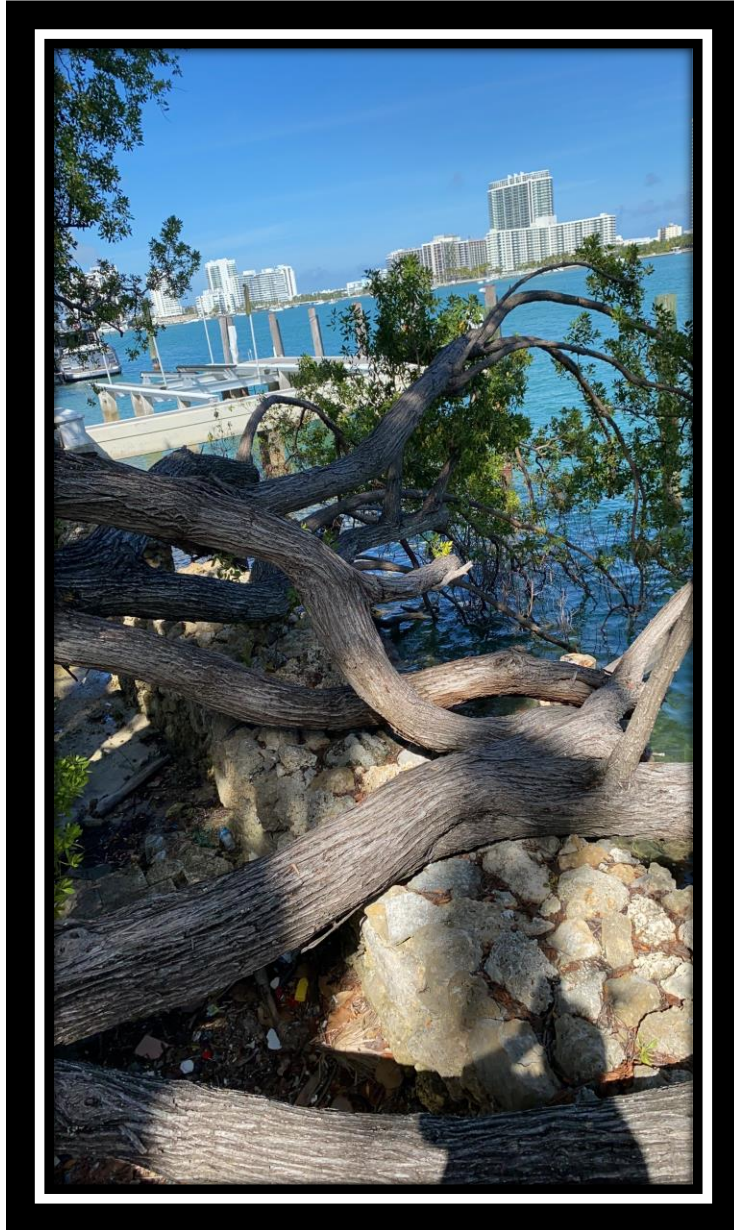
Photo # 4

Branches that failed are
resting on the seawall

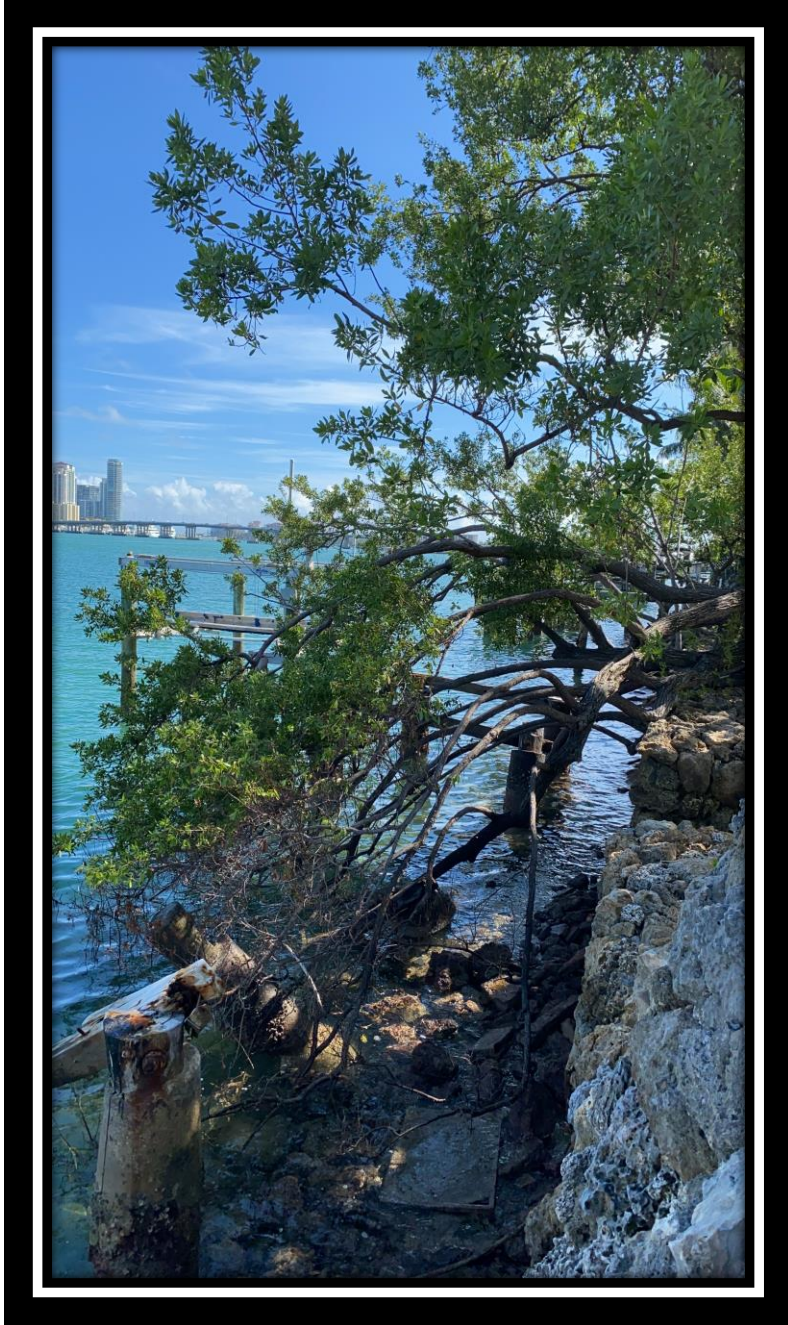
Photo # 5

Branches extend
over the water.

- Supply with irrigation to keep the soil moist and don't allow large variations in soil moisture and conditions.
- Prune to remove approximately 30% the canopy by removing the branches above the water to allow the construction of a new seawall. Pruning should be performed under the supervision of a Board Certified Master Arborist and the work should be performed by a Certified Arborist.

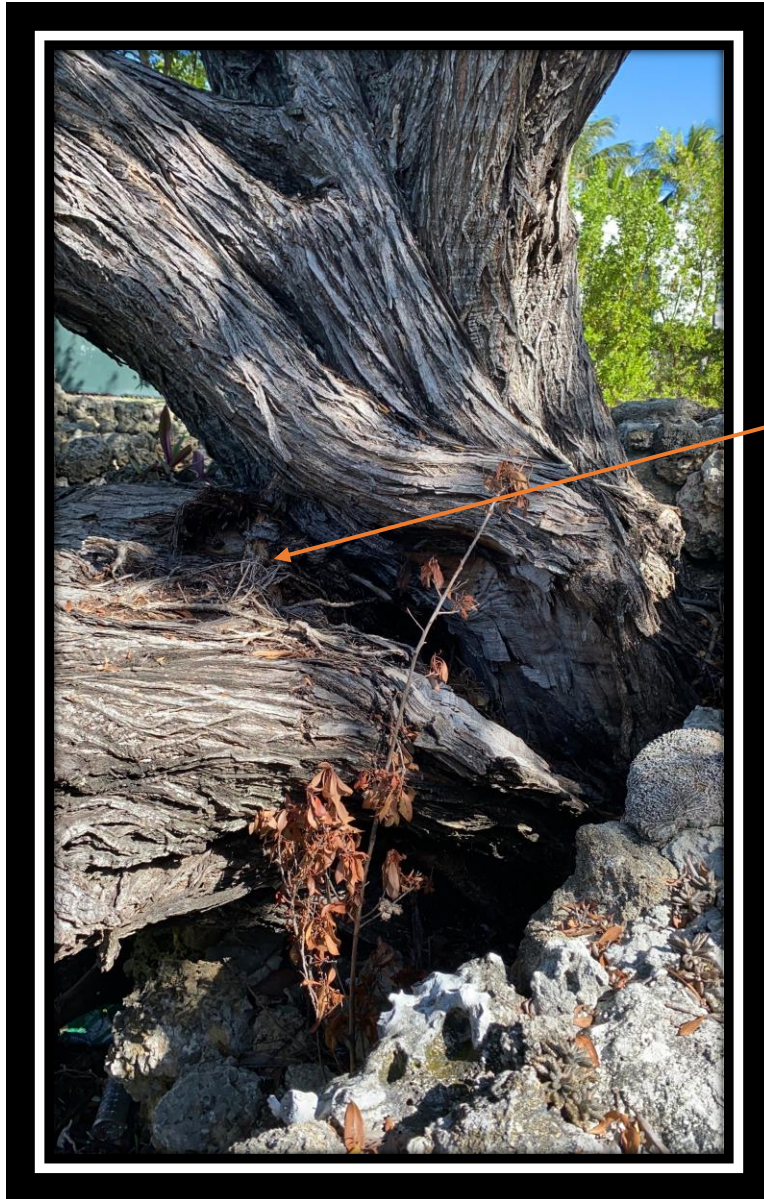
Photo # 6

Large stem failed and it's detached from the main trunk
