## Flooding and Drainage Issues

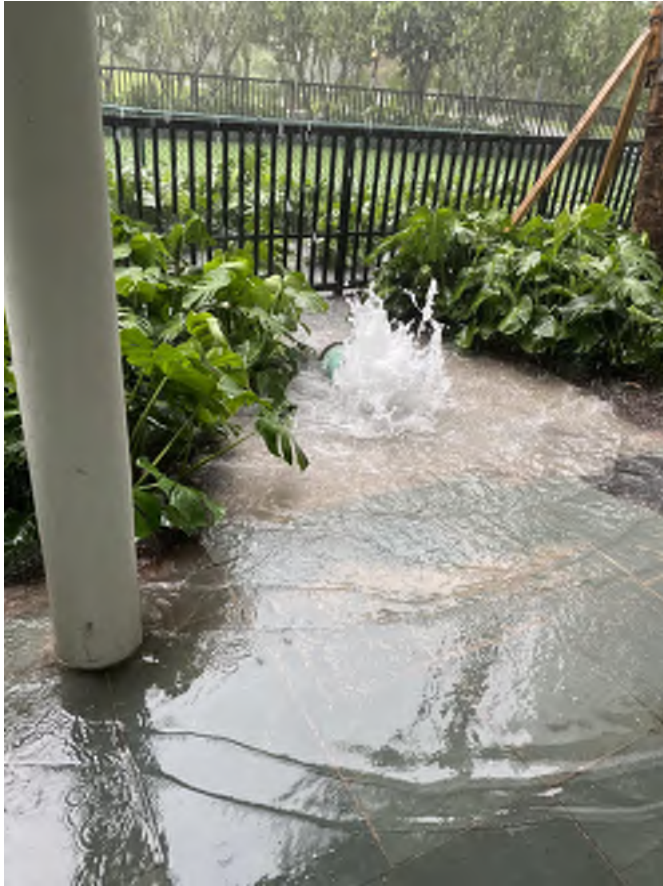
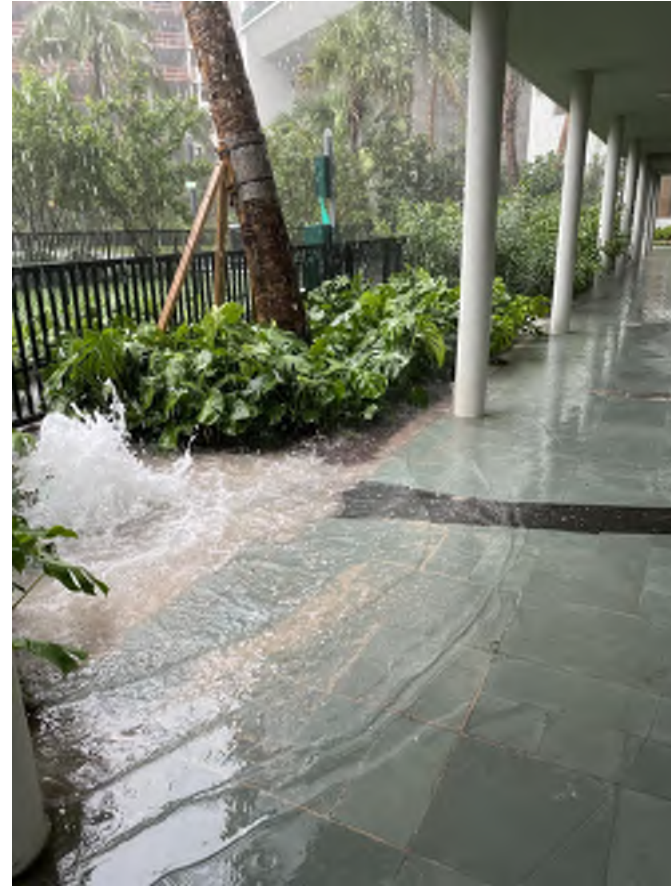
**Flooding and Drainage - flooding inside Elevate commercial unit,  
flooding inside main electrical room (far left image with foam)**

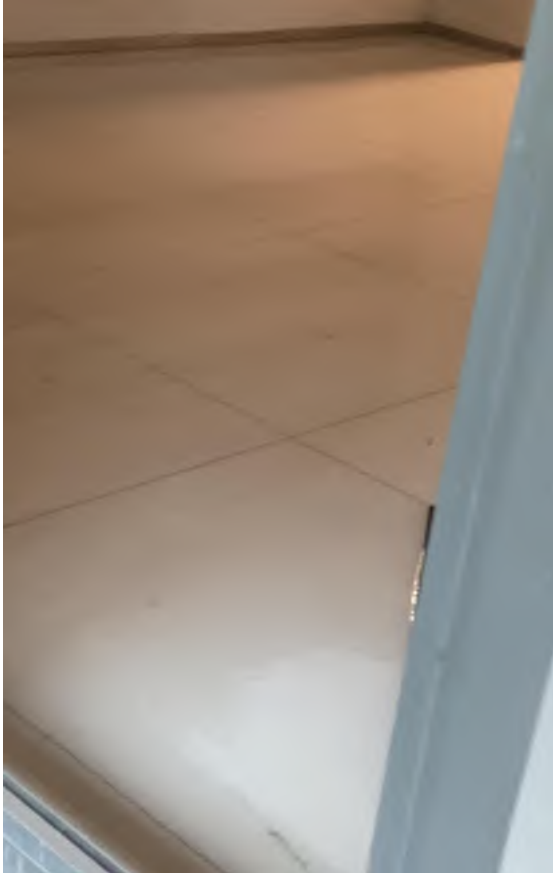
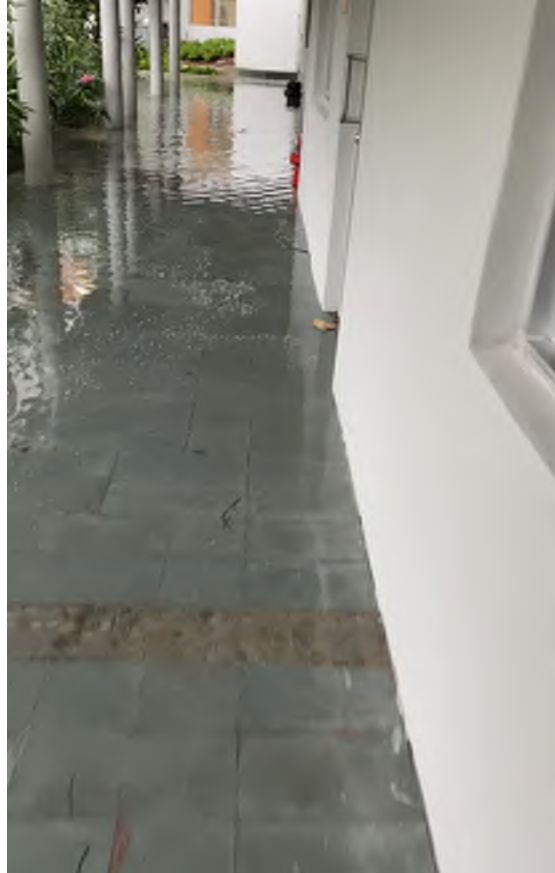
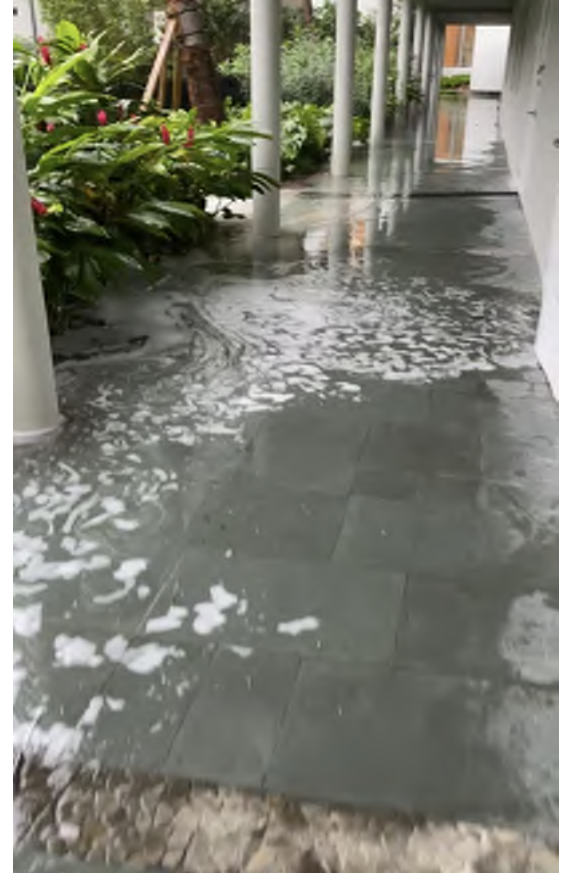
**Main Electrical Rooms for South Tower exposed to flooding because of poor drainage**

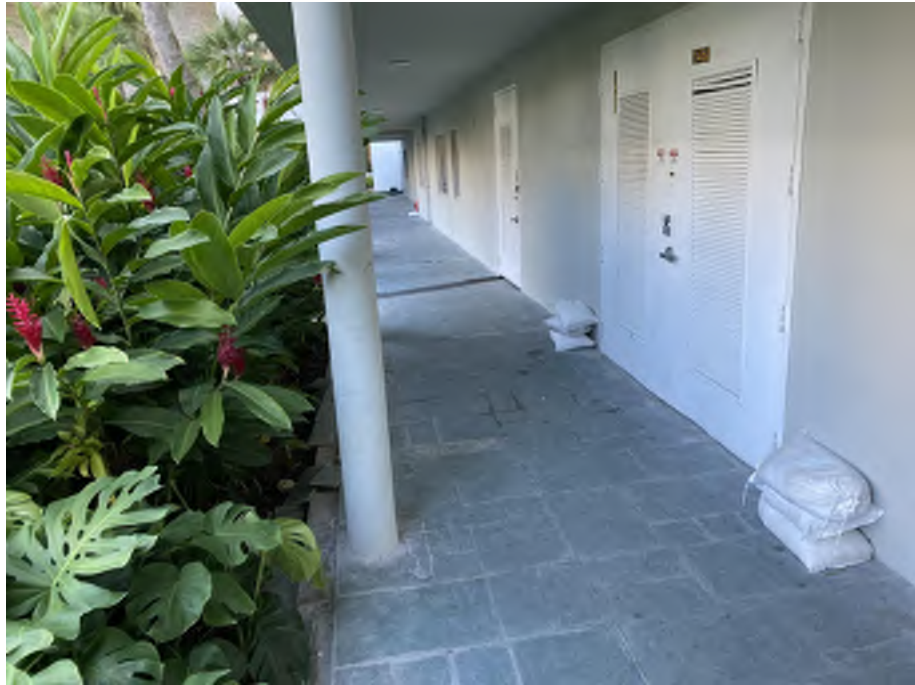
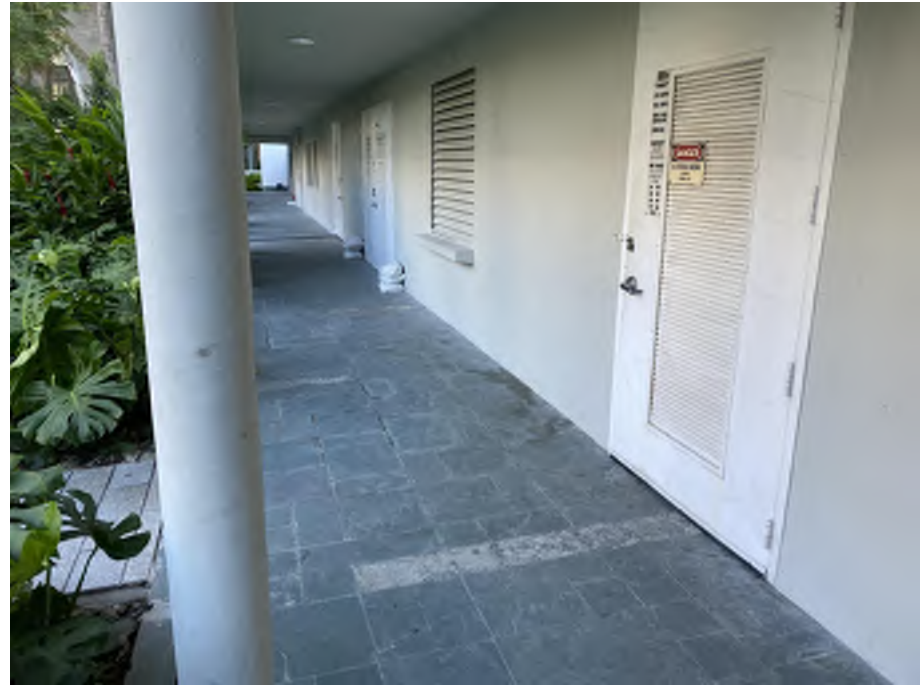
**Vegetation and Dog Park close proximity to commercial units - dog urine and excrement smell, overwhelming amount of pests and mosquitos (and rat traps), deteriorating pathway**

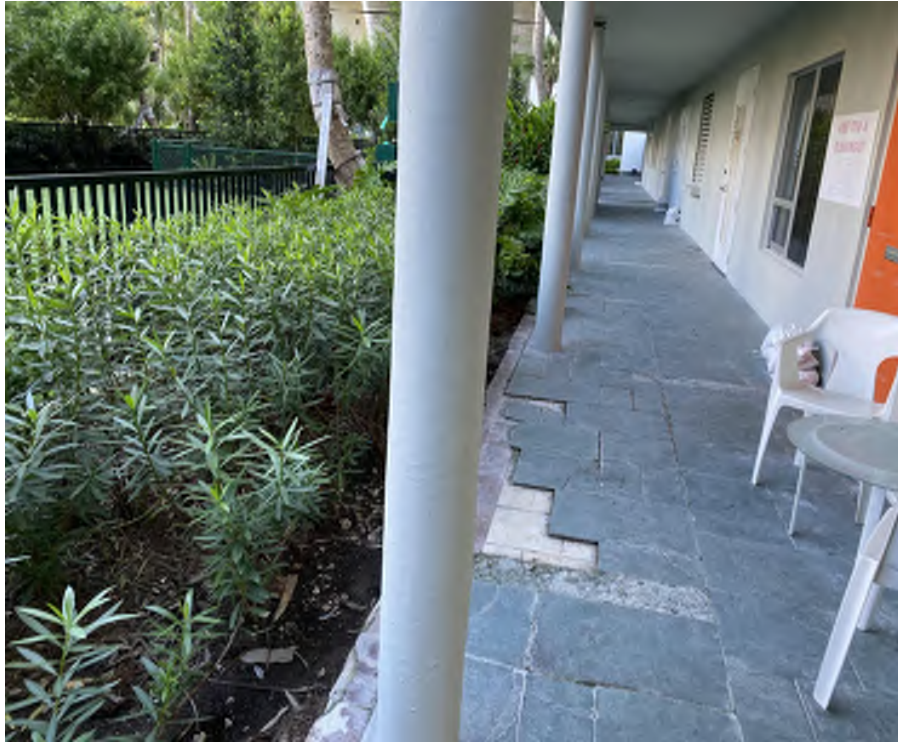
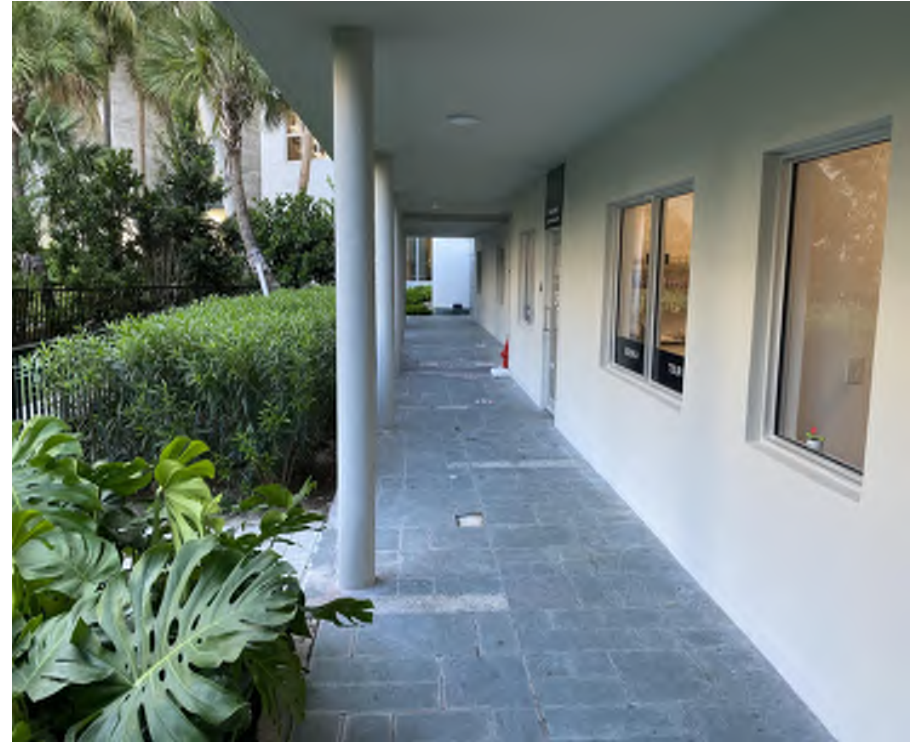
**East vs West “Walkway” to commercial units. Clearly the pathway to the east commercial units by dog park is obstructed by vegetation, whereas the pathway to the west commercial units was constructed with no vegetation obstruction.**

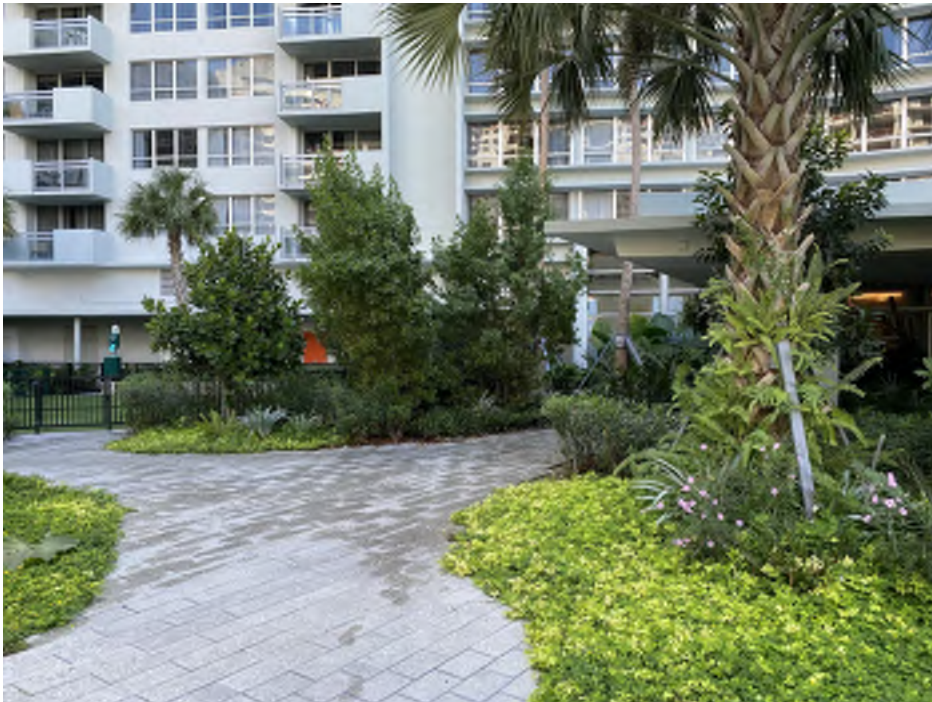
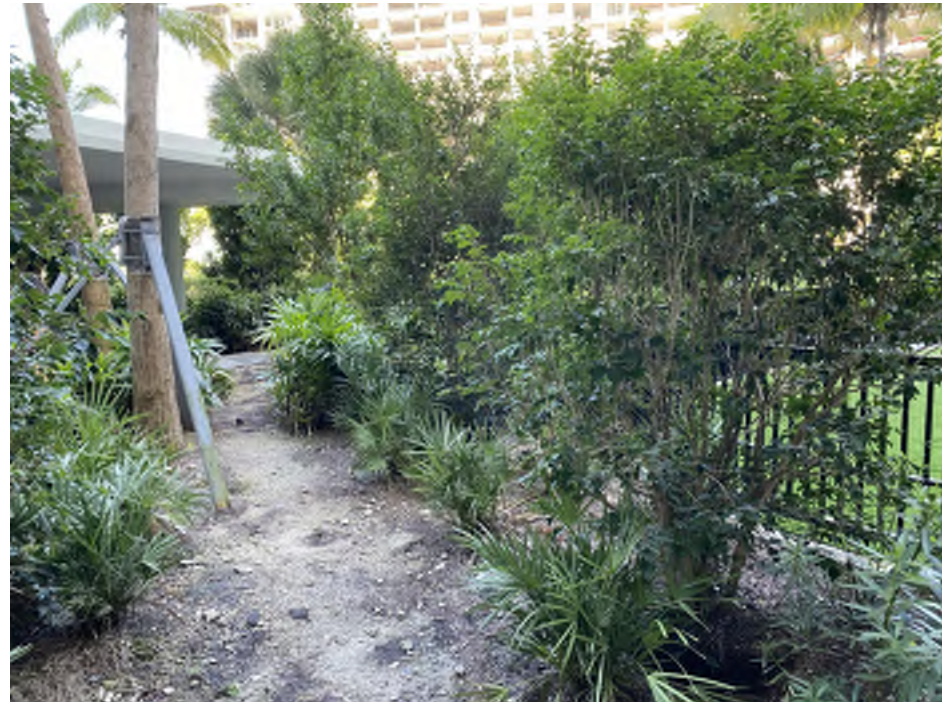
**Vegetation visually obstructing commercial units in south tower by dog park. Dog park proposed in project drawings for north tower is much smaller and is supposed to cater to three times the amount of residents, please reference project drawings in pdf attachment.**

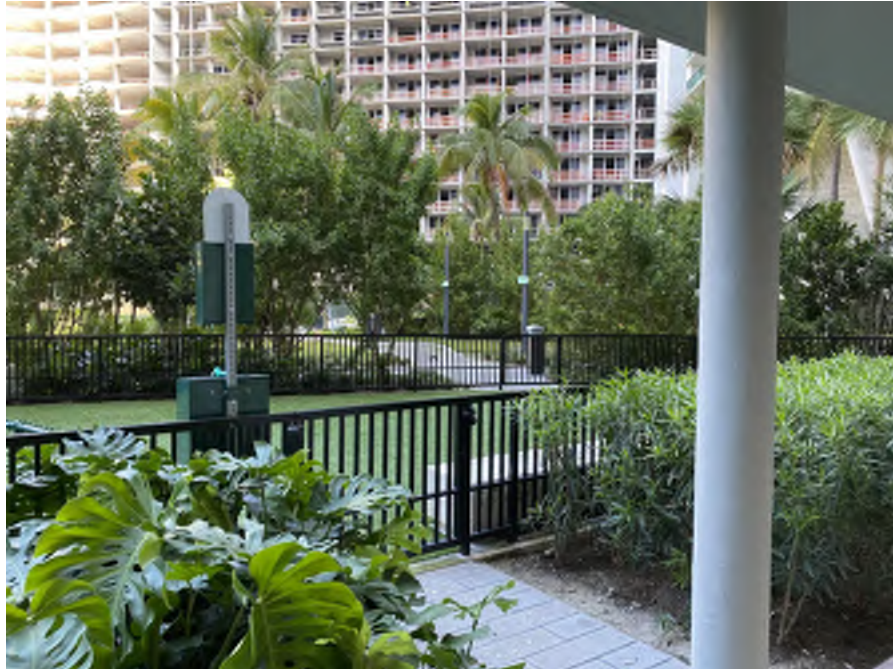
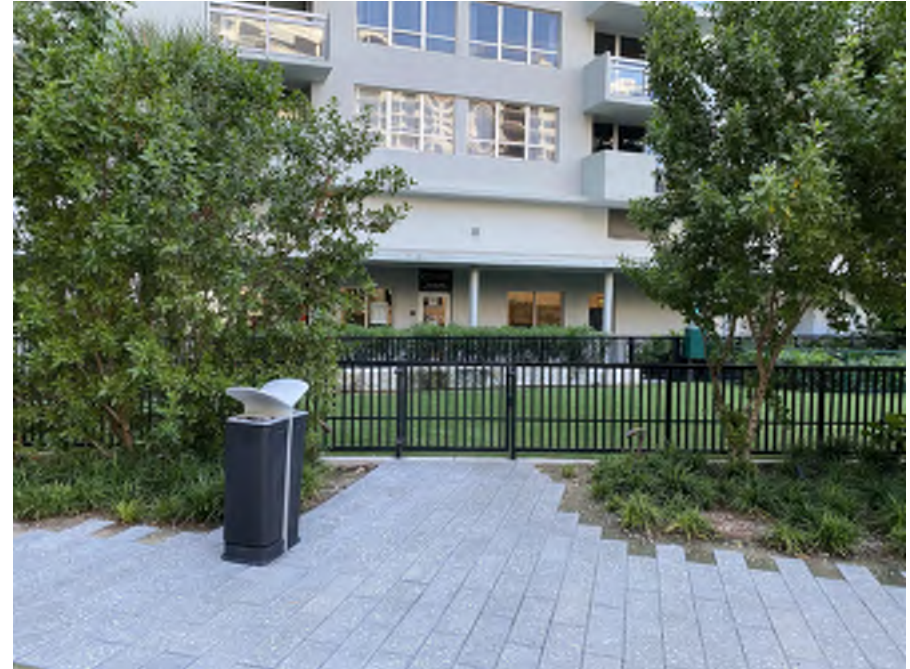
**New construction blocked ingress to south tower and commercial units. Because of this, there are now only a few extremely long distance options for wheelchair access and commercial access for wheeled loading/offloading, options shown in following slides.**

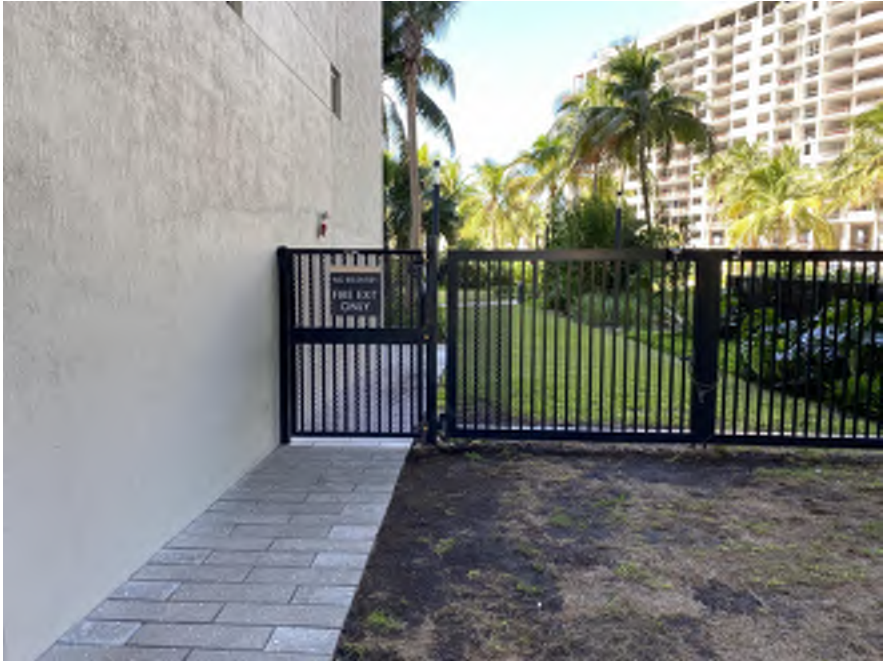
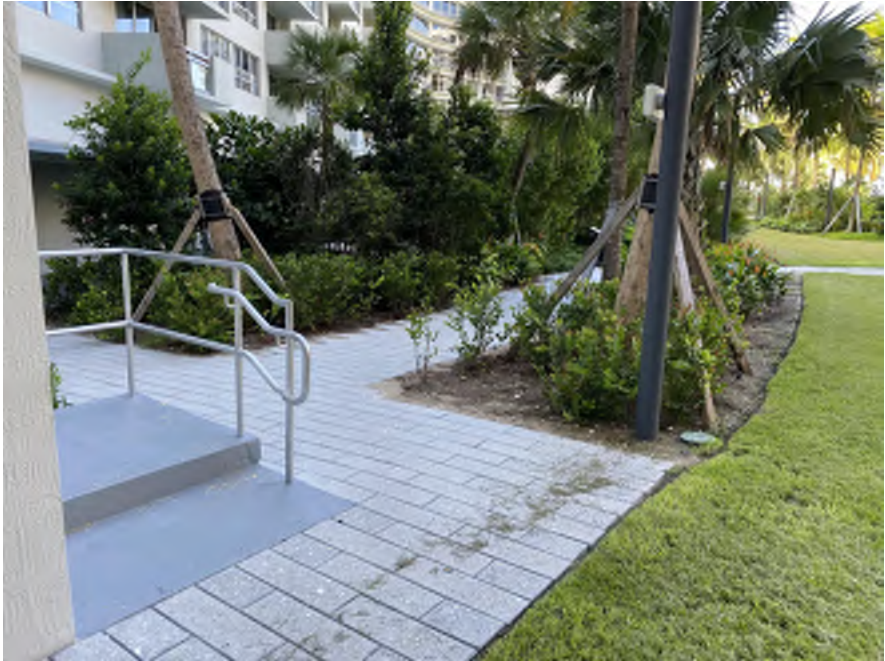
**Option 1, forced to go through south tower parking lot to access pool ramp, which is used to access south tower lobby for wheelchair ramp, continued next slide**

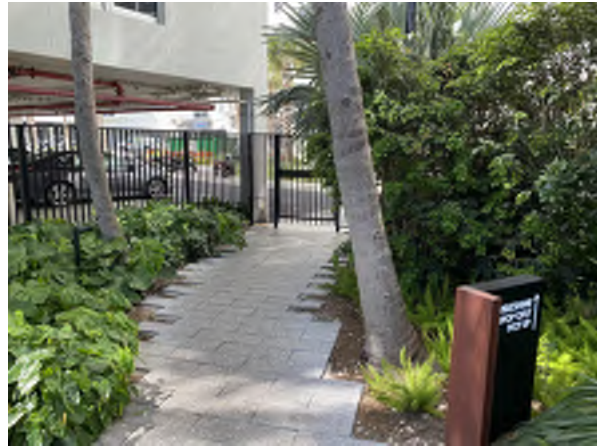
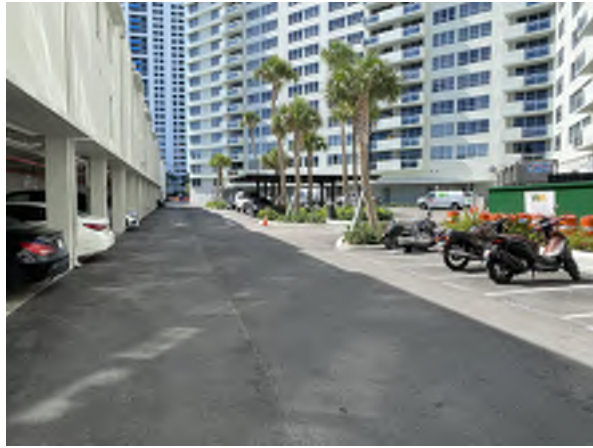
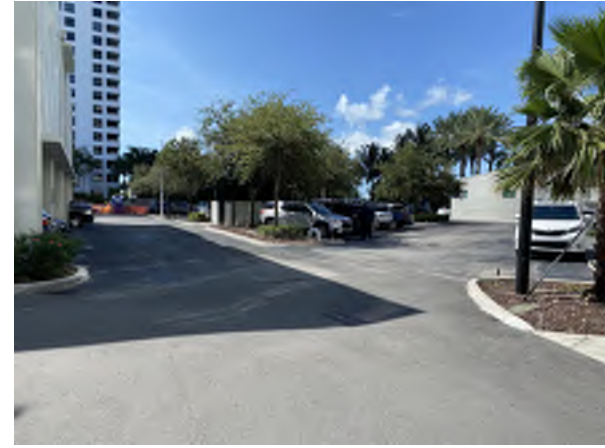
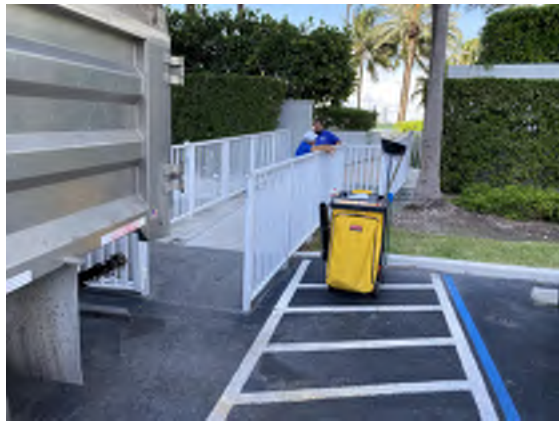
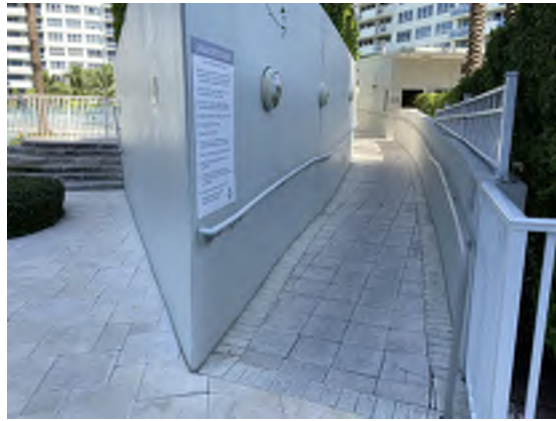
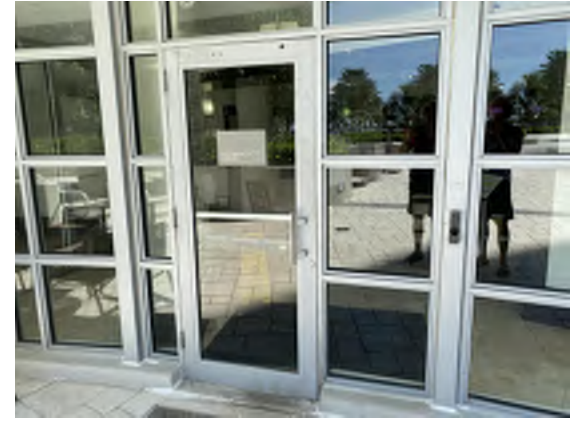
**Option 1, forced to go through south tower parking lot to access pool ramp, which is used to access south tower lobby for wheelchair ramp**

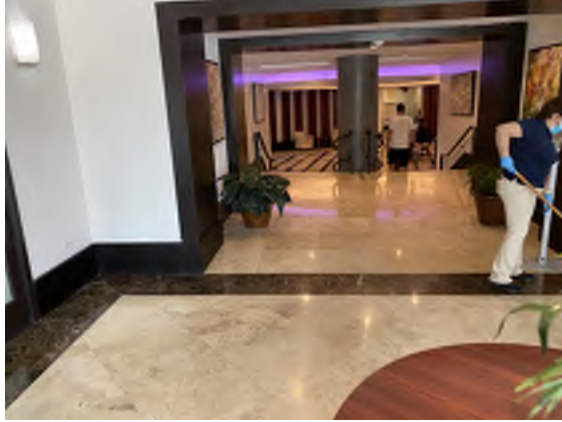
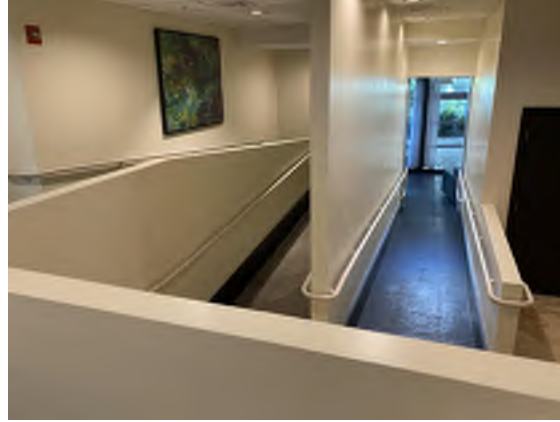
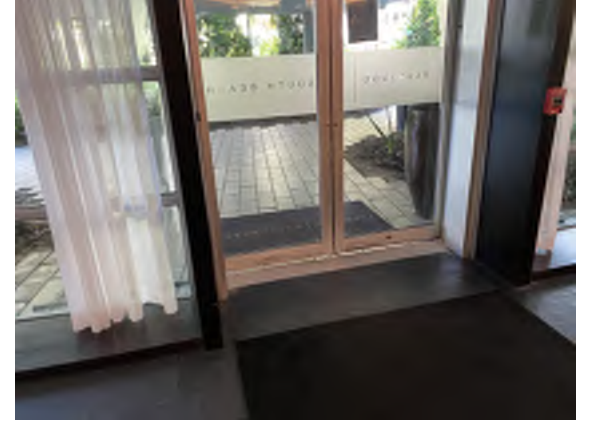
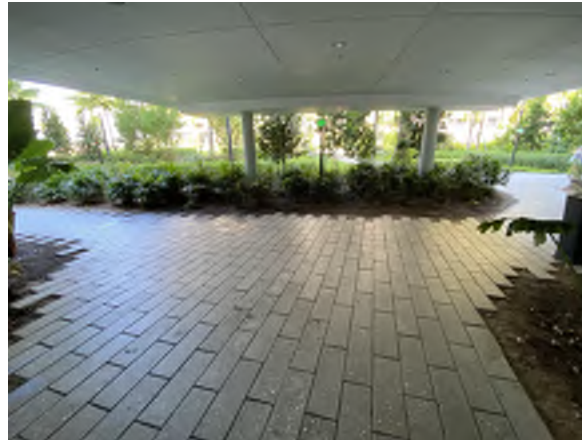
**Option 2, use south tower service elevator to take to 2nd floor and use main residential elevator to take to lobby for wheelchair ramp, continued next slide**

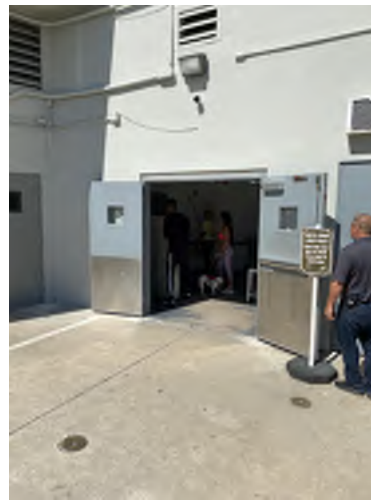
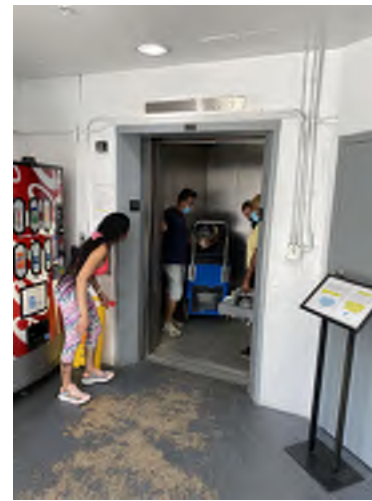
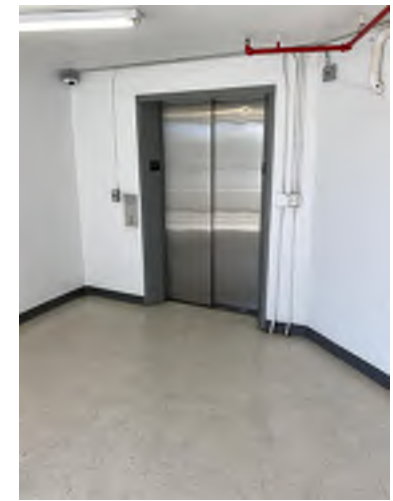
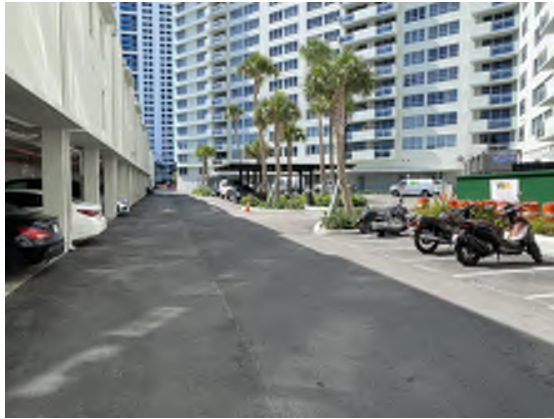
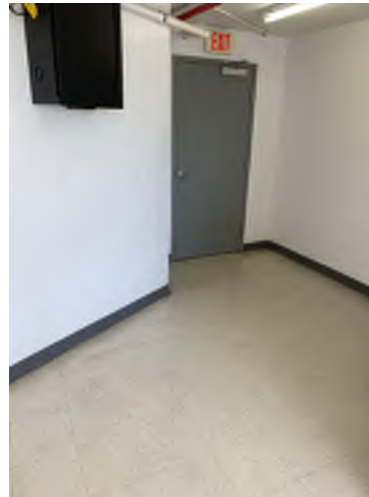
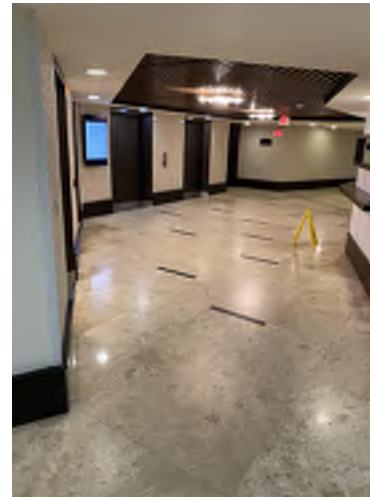
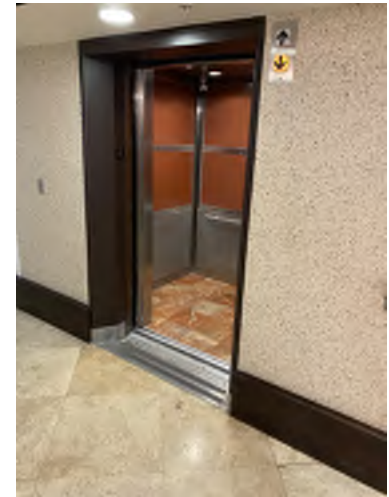
**Option 2, use south tower service elevator to take to 2nd floor and use main residential elevator to take to lobby for wheelchair ramp**

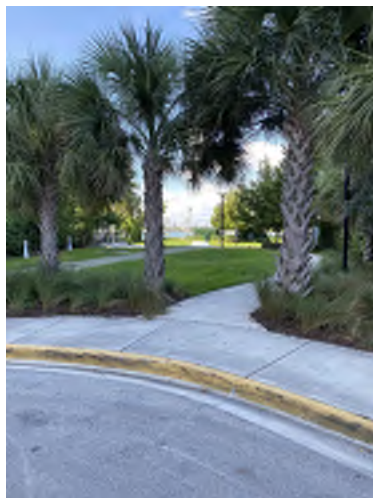
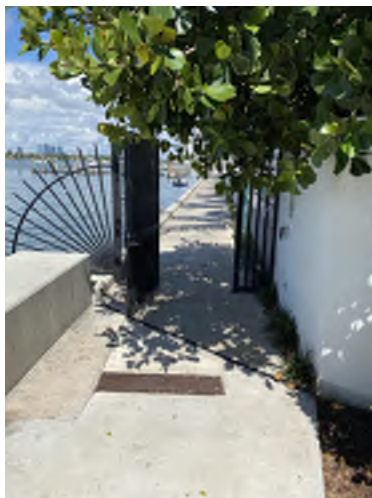
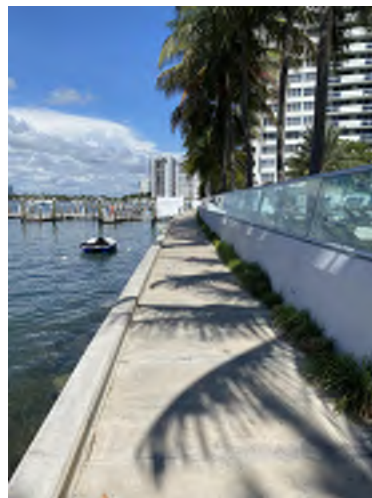
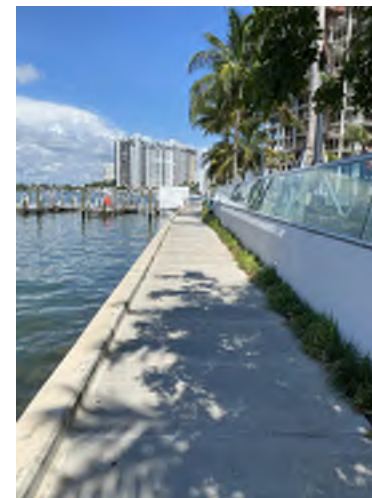
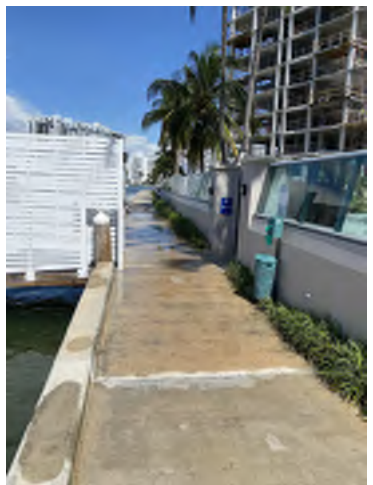
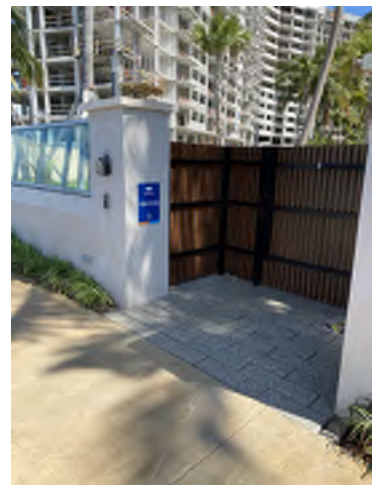
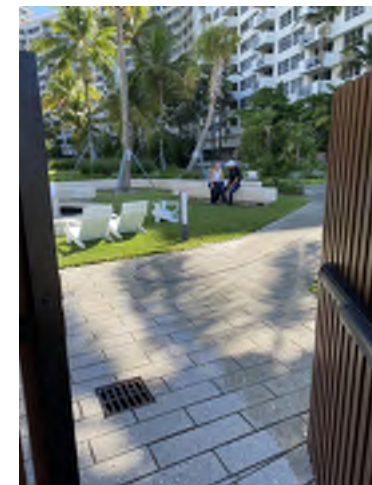
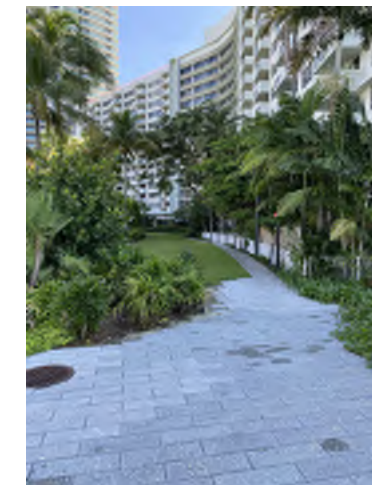
**Option 4:  
Must enter into  
valet drop off  
zone for  
wheeled  
access and  
double back to  
main pathway  
to main  
entrance. Note  
steps blocking  
path.**
