Byron Carlyle Theater

**500 71st Street
Miami Beach, Florida 33141**

CONDITIONS ASSESSMENT AND RECOMMENDATIONS

05-11-2021

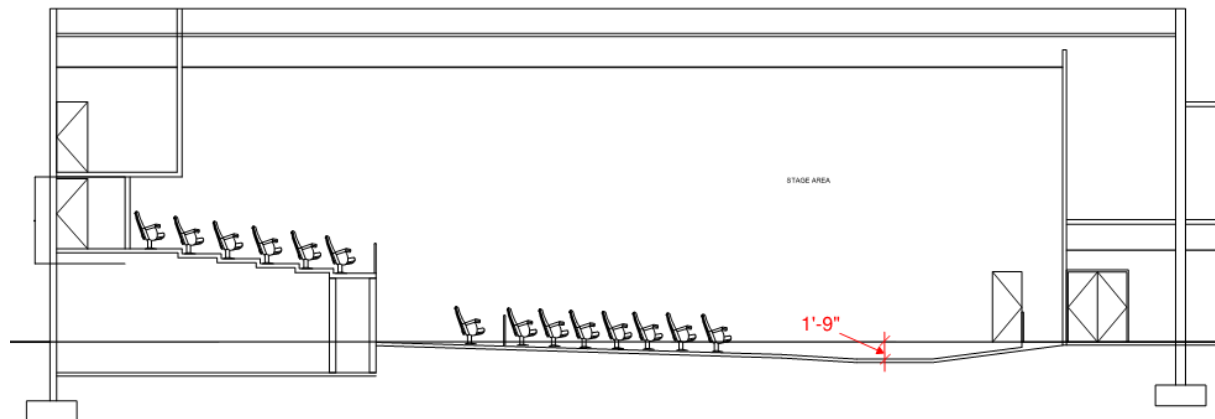
Figure 3 – Existing architectural cross-section through east theater (foundation members are not shown)

The east theater ground floor slab slopes down from the east to the west side. The difference in elevation between the high and low points of this ground floor slab is approximately 1'-9" (refer to Figure 3).

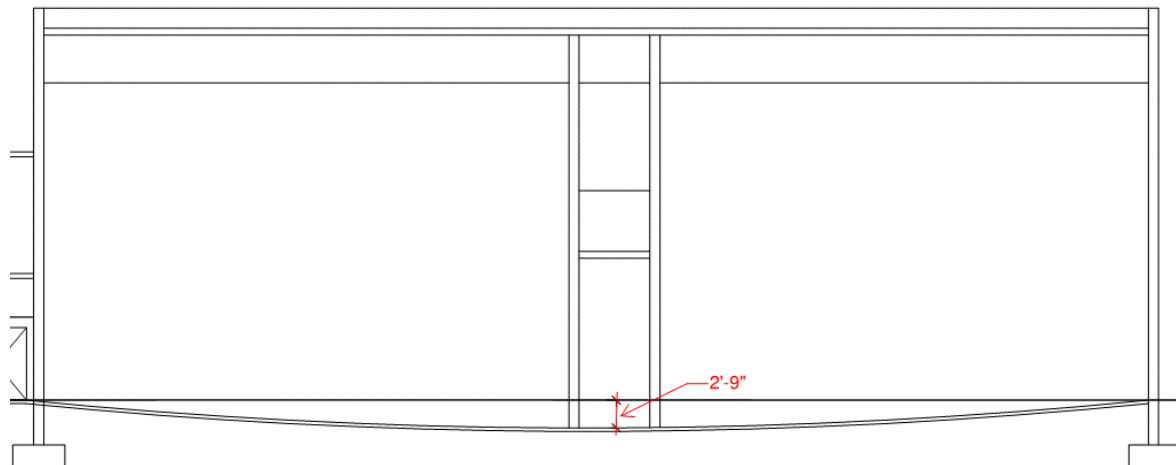
Figure 4 - Architectural cross-section through east theater (foundation members are not shown)

The west theater ground floor slab slopes down towards the center from both the east and west sides. The difference in elevation between the high and low points of this ground floor slab is approximately 2'-9" (refer to Figure 4).

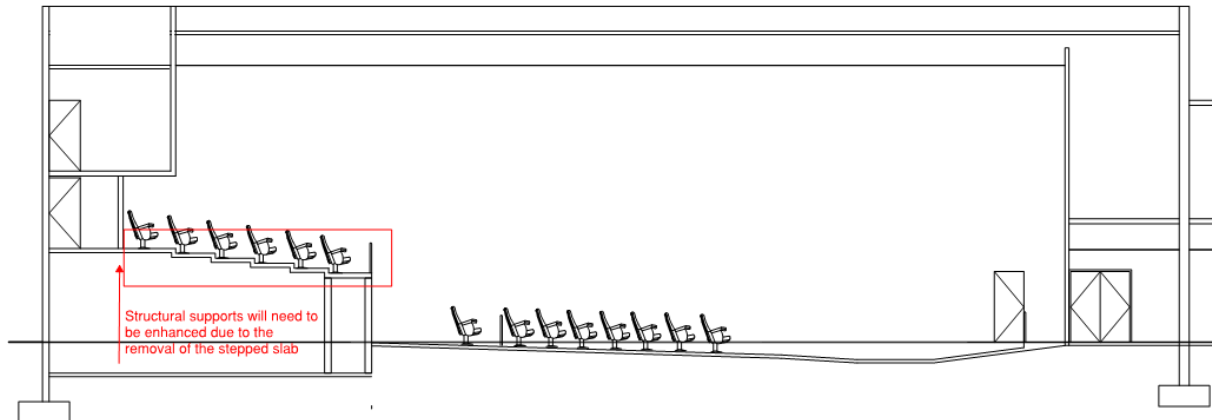
Figure 8. Architectural section through east theater (existing conditions)

The removal of the stepped concrete slab that currently supports the elevated seating area for the east theater will affect the existing support system for the east wall of the theater and elevated flat slabs on the east side. Refer to Figure 8 for an architectural section for the existing conditions.
