7 **DEMOLITION
BELOW GRADE & GROUND FLOOR PLANS**
BYRON CARLYLE THEATER

Gallagher Bassett Technical Services (GBTS) was retained by MC Harry Associates (Client) to conduct an asbestos survey of the Byron Carlyle Theater buildings (subject area) located at 500 71st street, Miami Beach, Florida. The survey was performed on April 1, 2021 by James Ebanks and Richard Grupenhoff of GBTS (both certified under the Asbestos Hazard Emergency Response Act, (AHERA). The purpose of this asbestos survey was to identify the presence, extent, and condition of asbestos-containing materials (ACM) for compliance with the Environmental Protection Agency (EPA) National Emissions Standards for Hazardous Air Pollutants (NESHAP), Miami- Dade County and applicable State and Federal Guidelines.

**Subject: Water and Mold Damage Assessment
Byron Carlyle Theater Complex
500 71st Street
Miami Beach, Florida 33141**

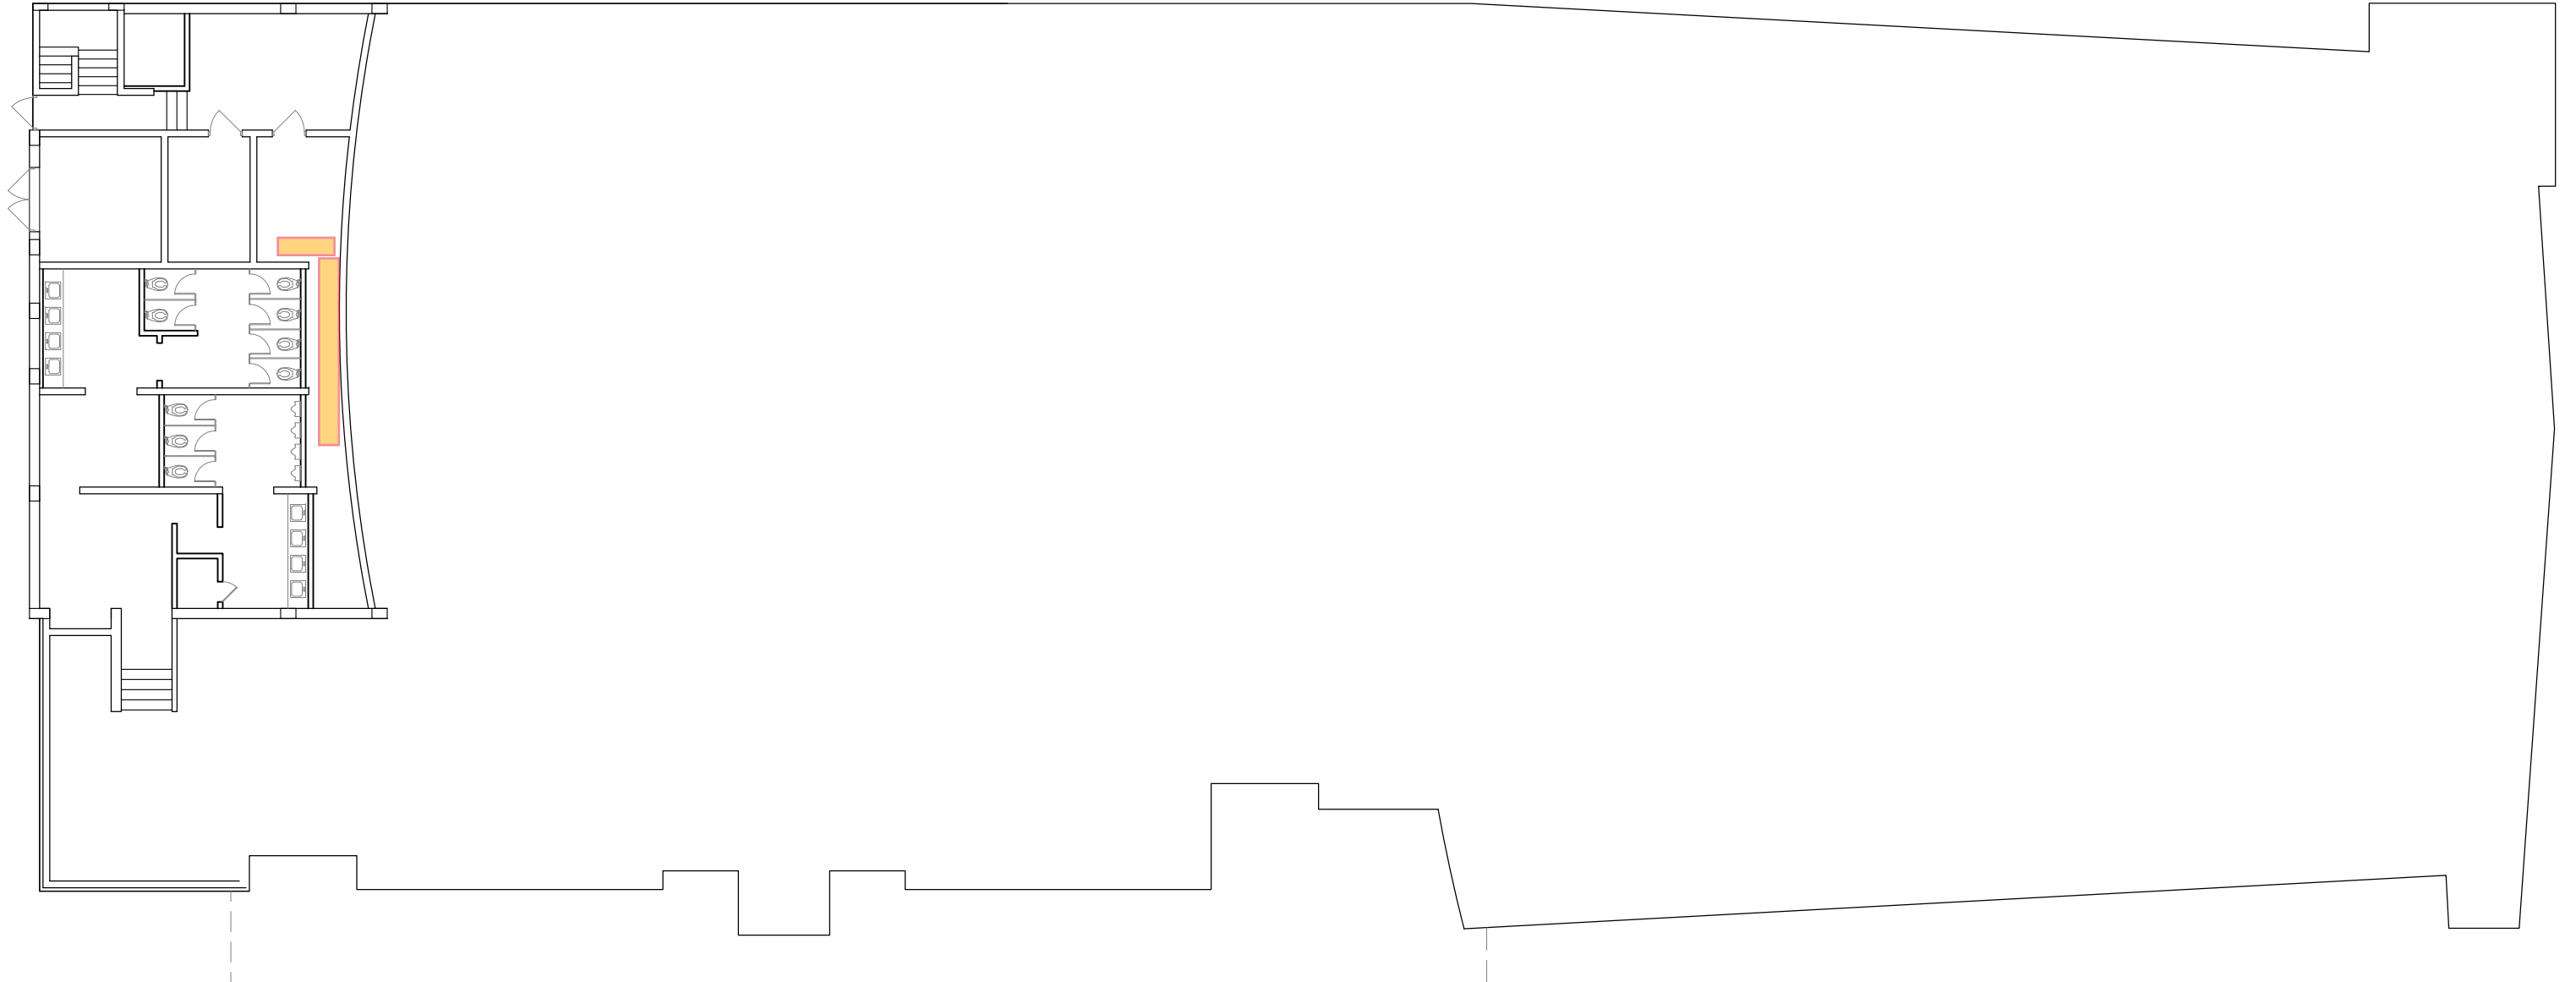
ACM BLACK MASTIC ON FOIL/FIBERGLASS DUCT

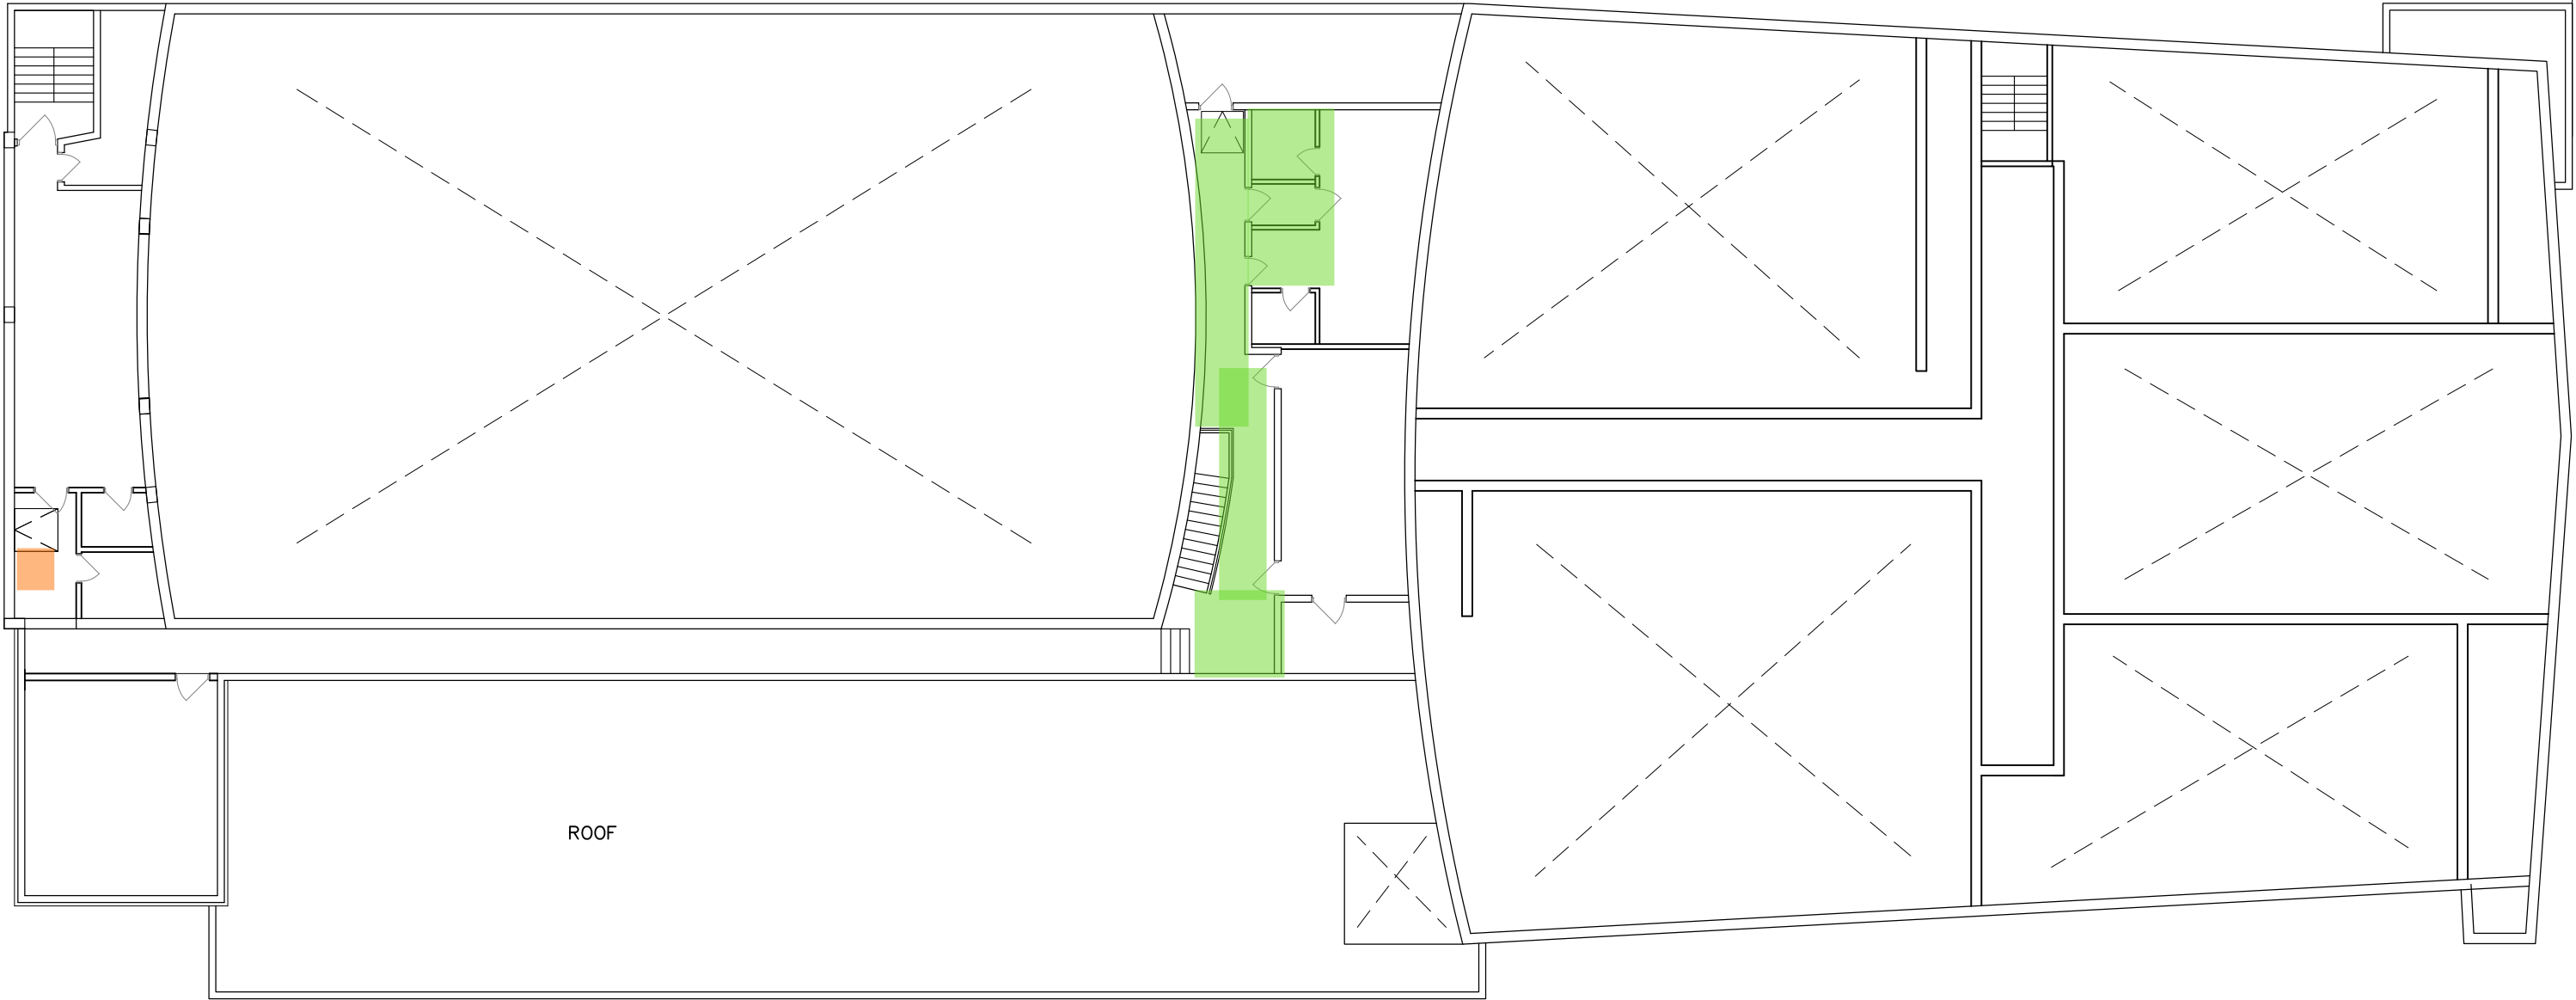
ACM 9X9" VFT AND BLACK MASTIC

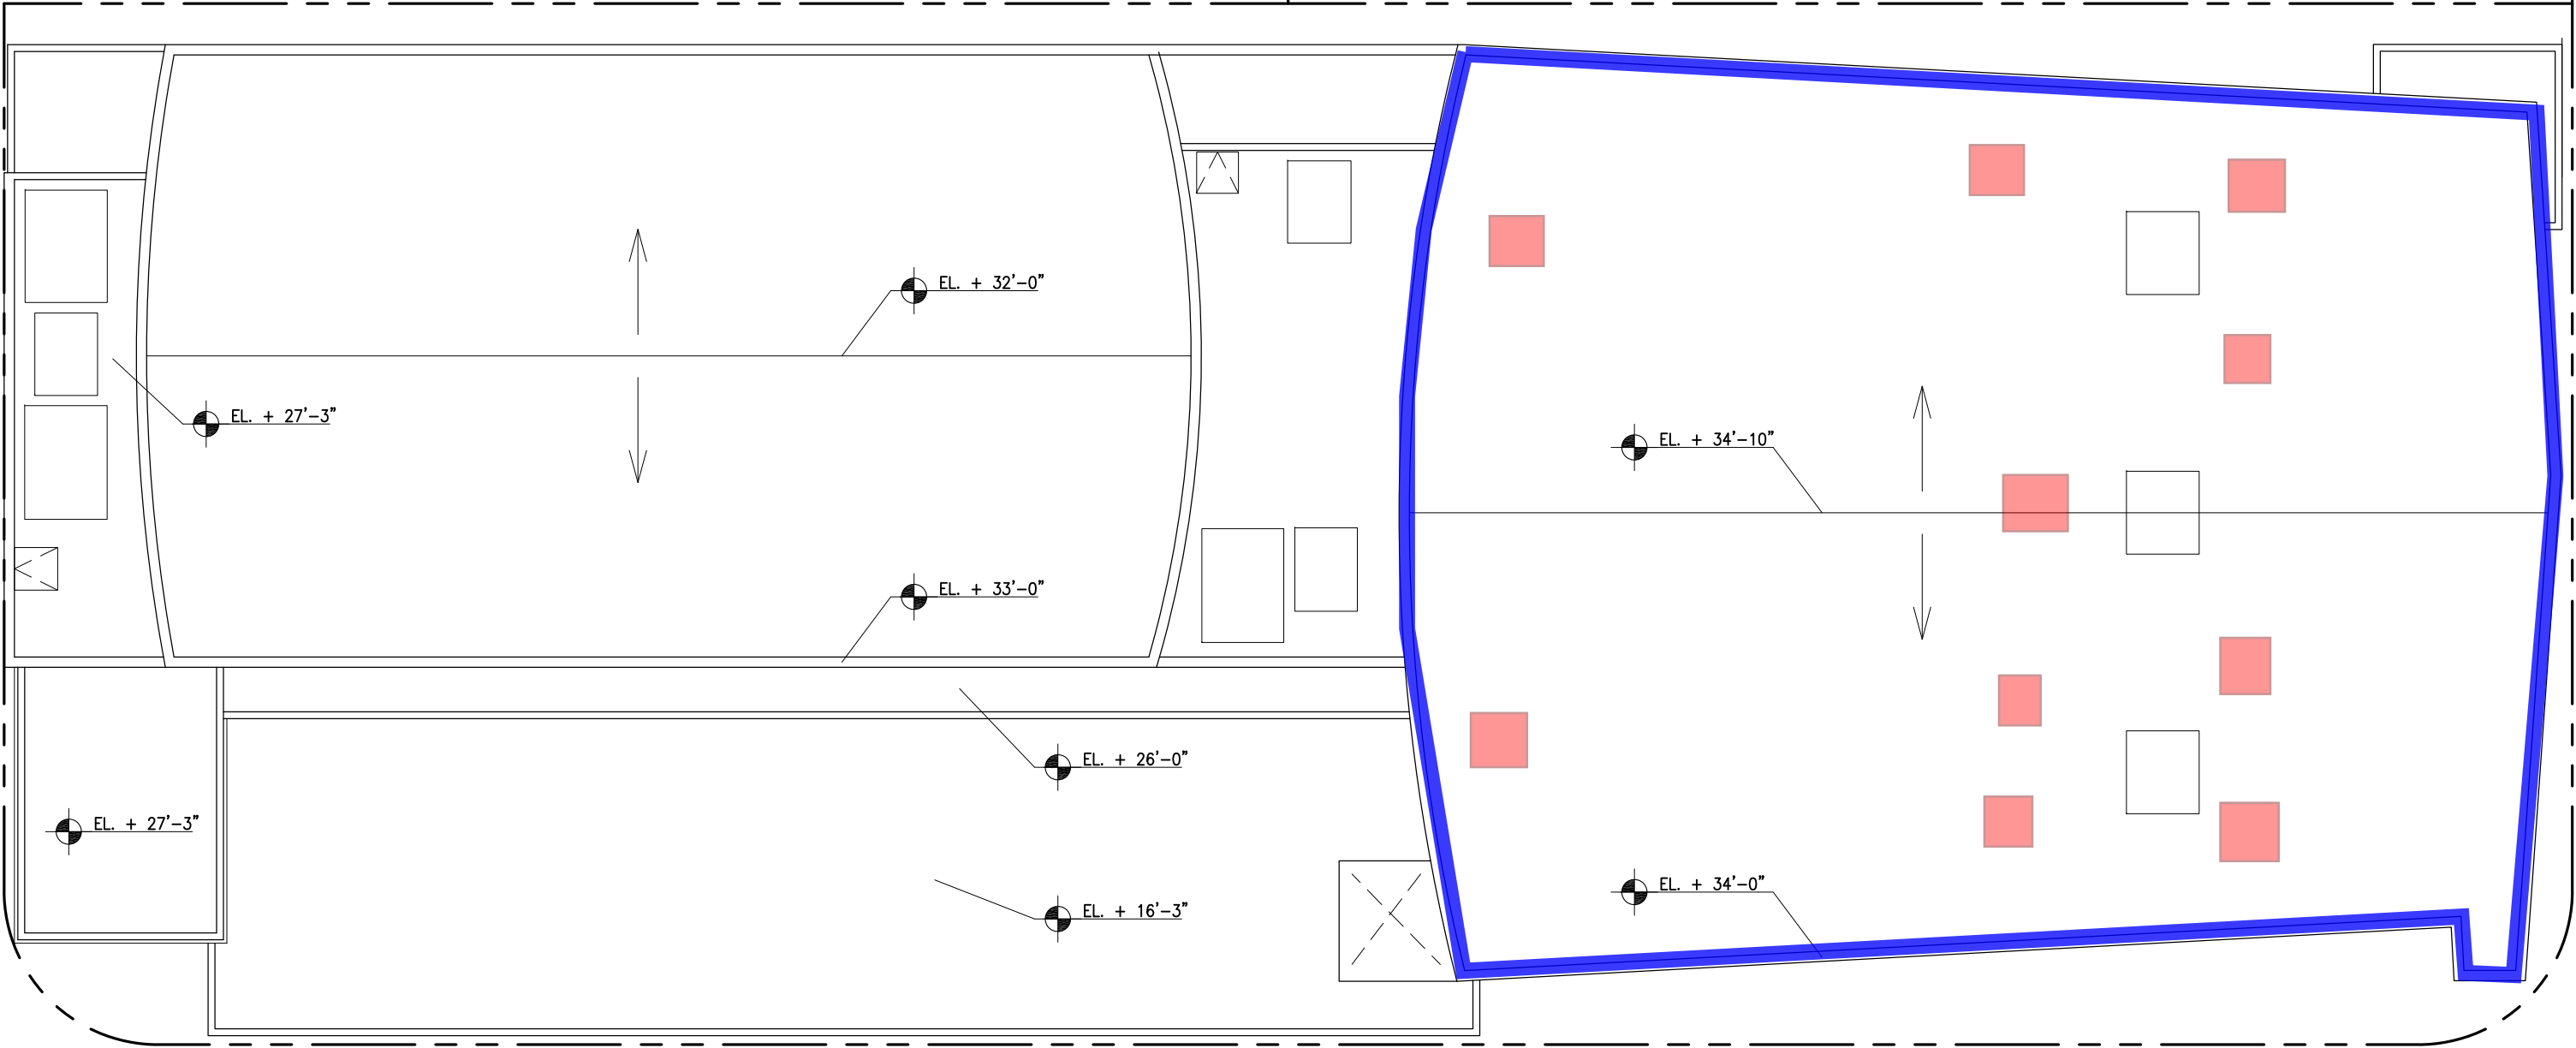
ROOF FAN EXHAUST WITH ACM FLASHING ~ 10 @ 20 SF = 200 SF TOTAL

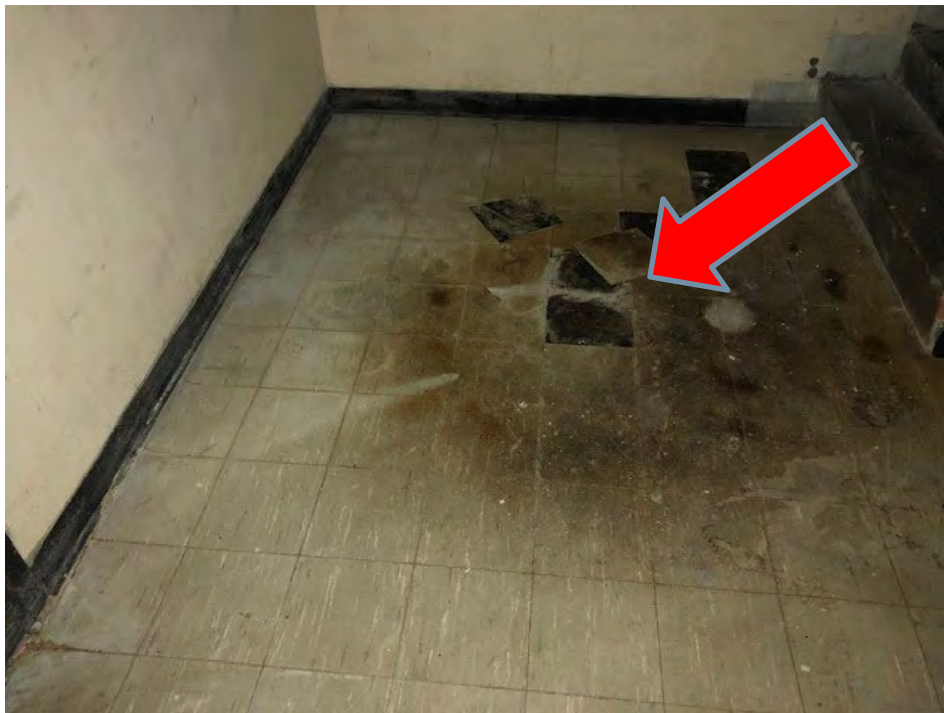
Photo 2: View of 9x9" ACM vinyl floor tile/mastic west corridor 2nd floor.

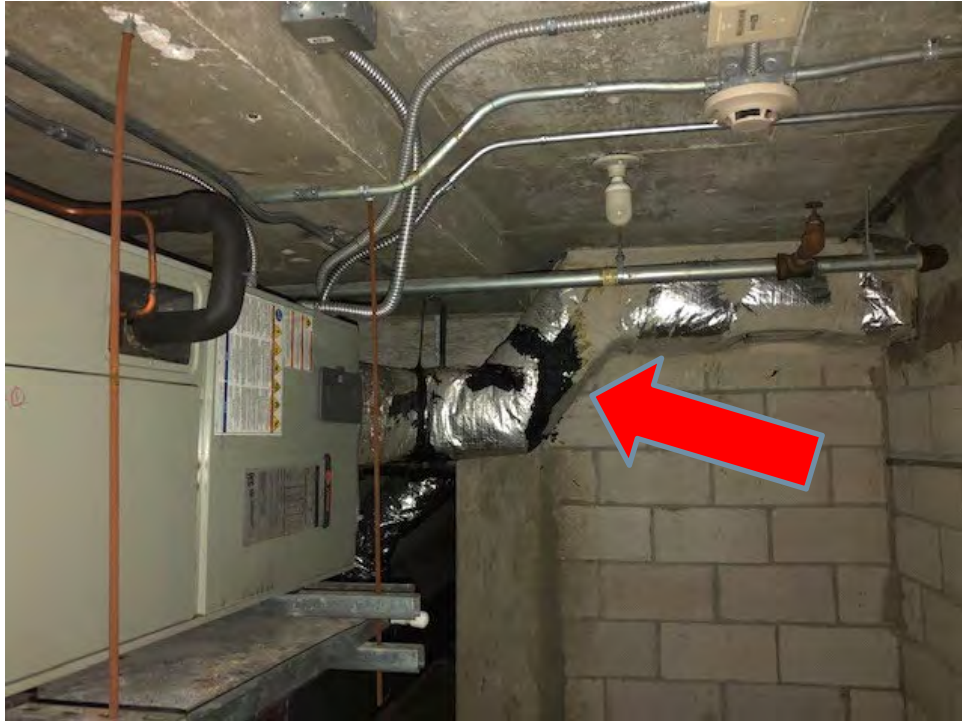
Photo 3: View of ACM HVAC mastic East mechanical room.

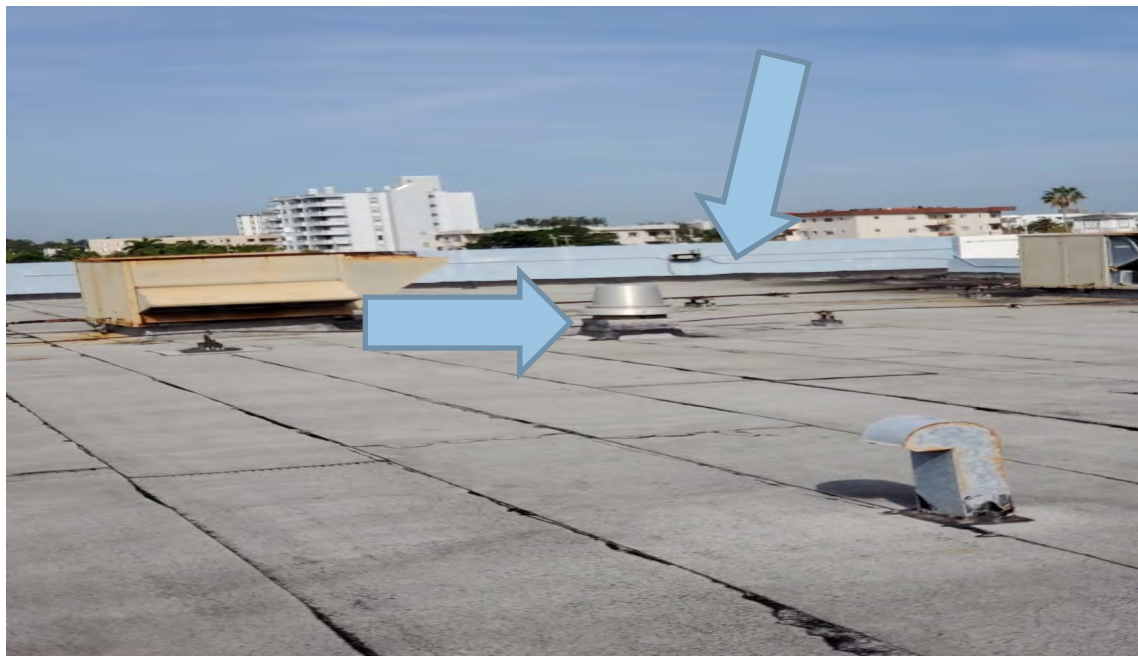
Photo 10: ACM counterflashing and exhaust flashing on West upper deck

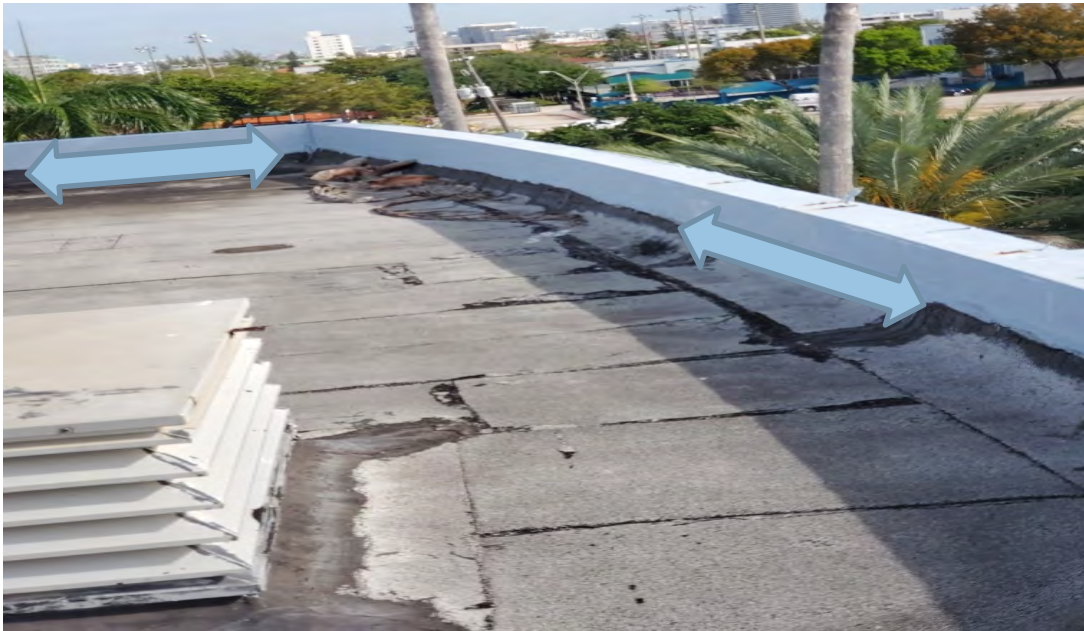
Photo 11: ACM counterflashing on perimeters of parapet walls of West deck only

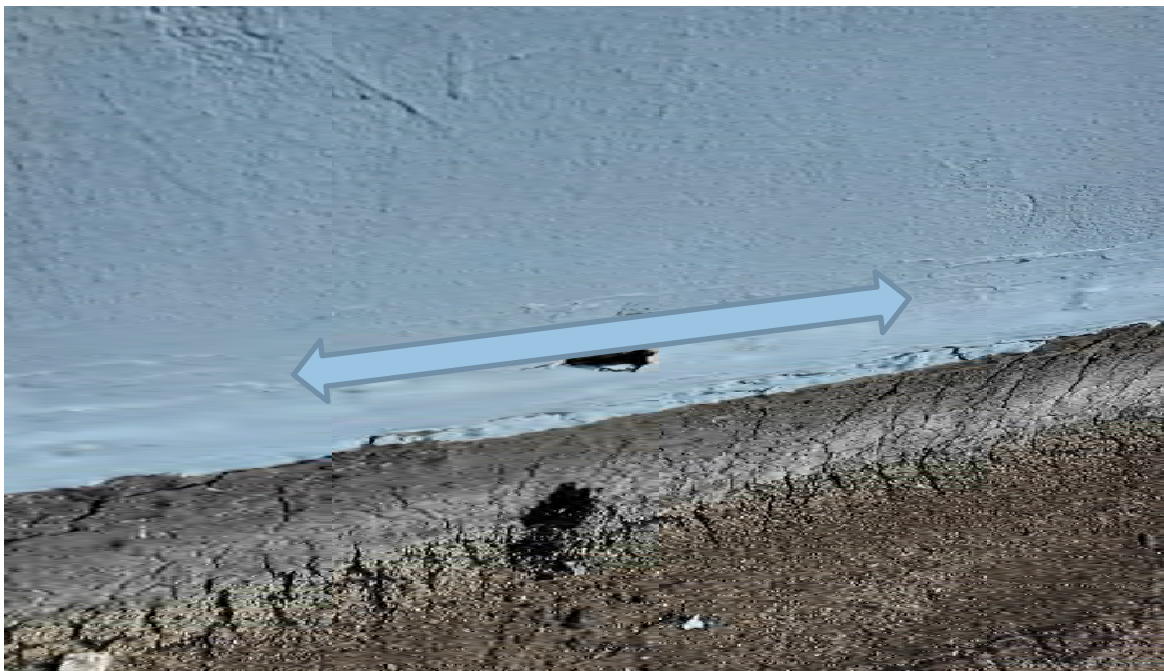
Photo 12: ACM counterflashing on perimeters of parapet walls of West deck only

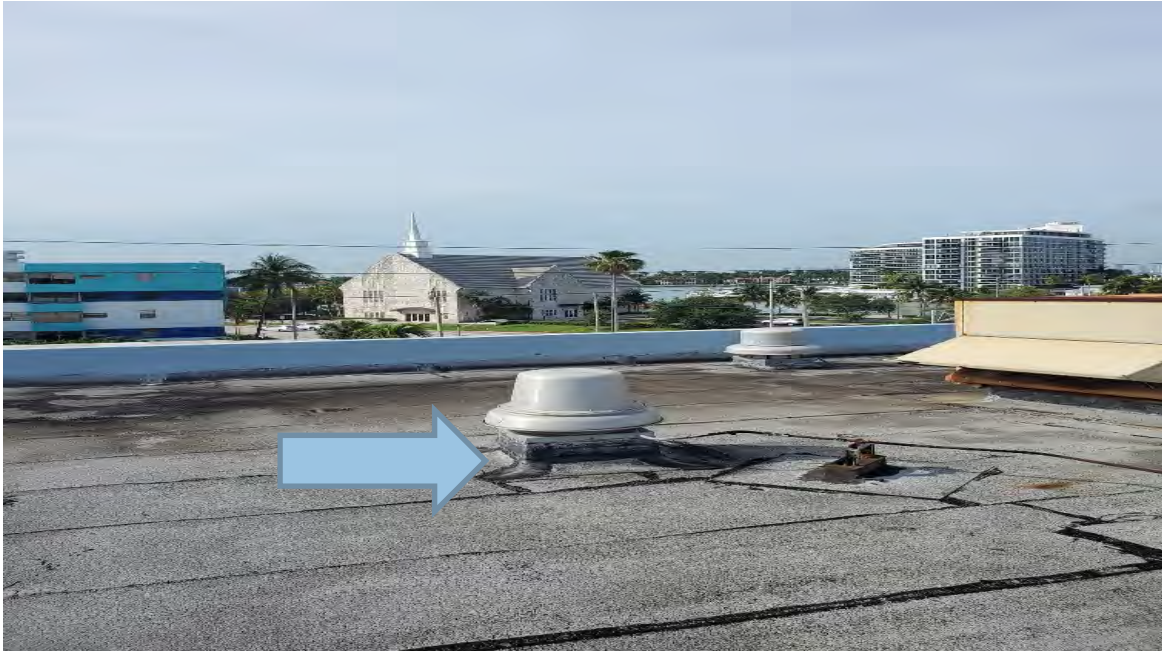
Photo 13: ACM exhaust flashing on fan bases of West deck only

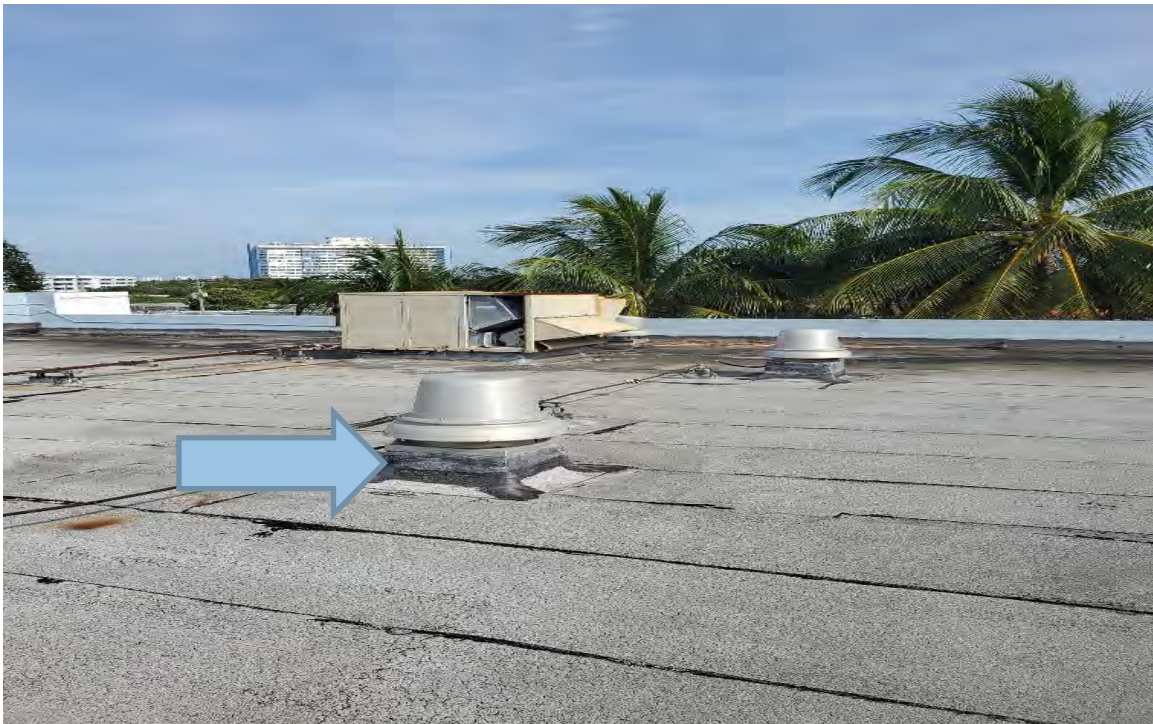
Photo 14: ACM exhaust flashing on fan bases of West deck only

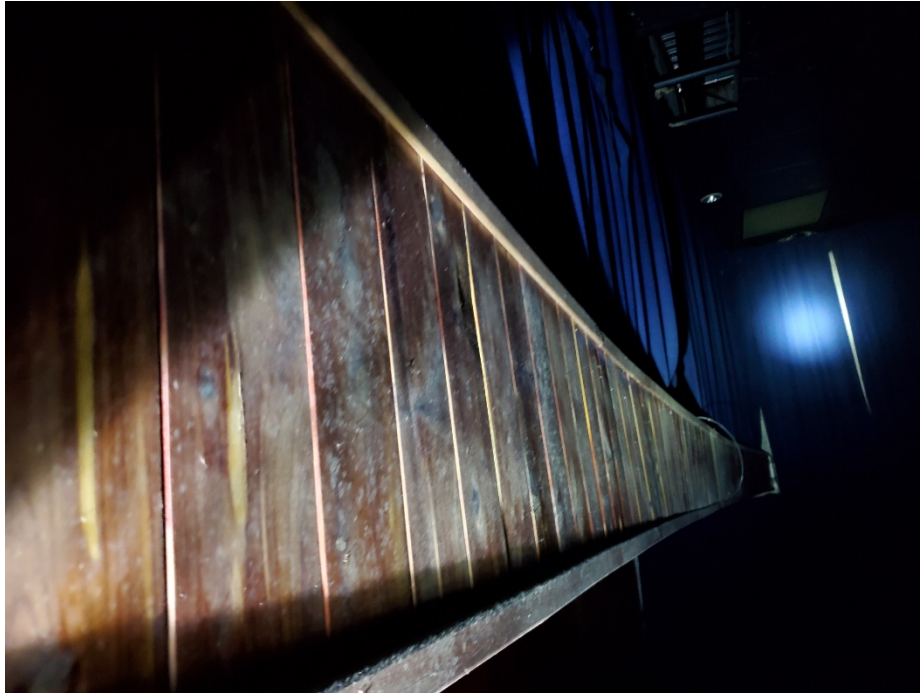
Photo 1: Representative view of SAMG damage on wooden façade on second floor auditorium.

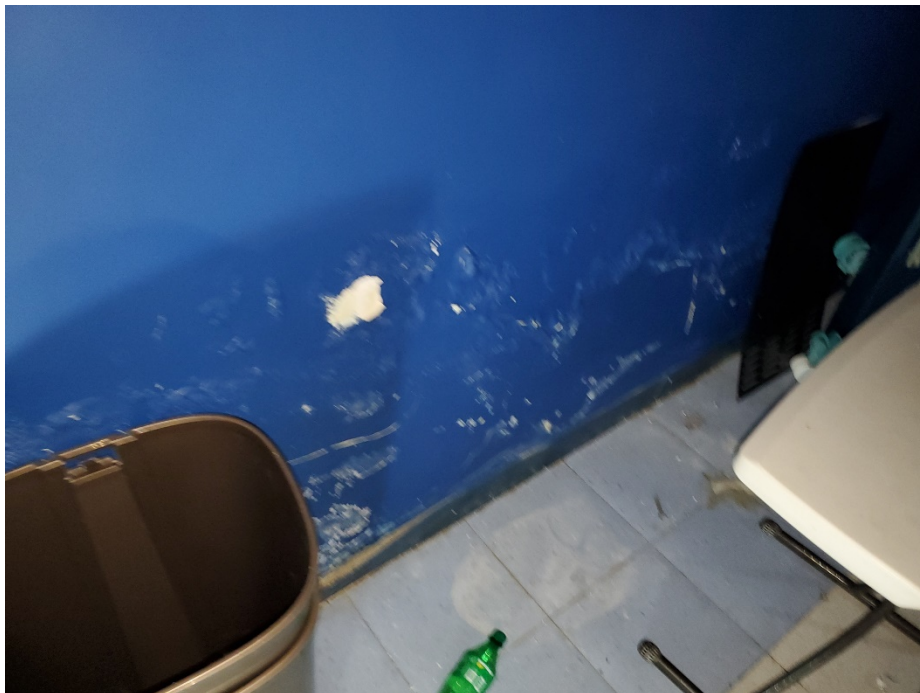
Photo 2: Representative view of water damage on eastern wall of second floor auditorium projection room.

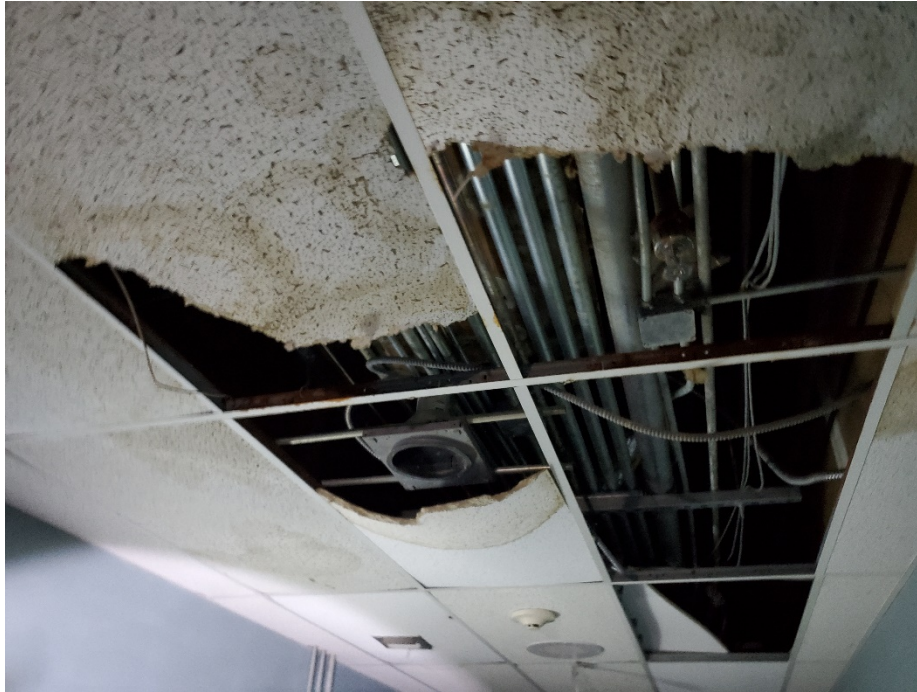
Photo 3: Representative view of damaged ceiling tiles in subject area.

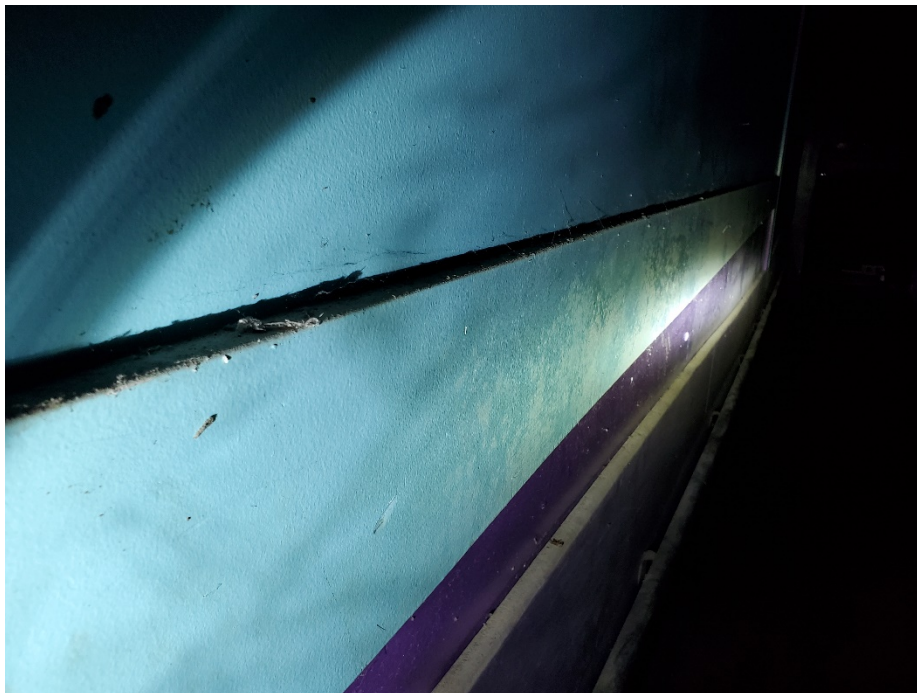
Photo 4: Representative view of surface AMG on back area corridor on ground floor.

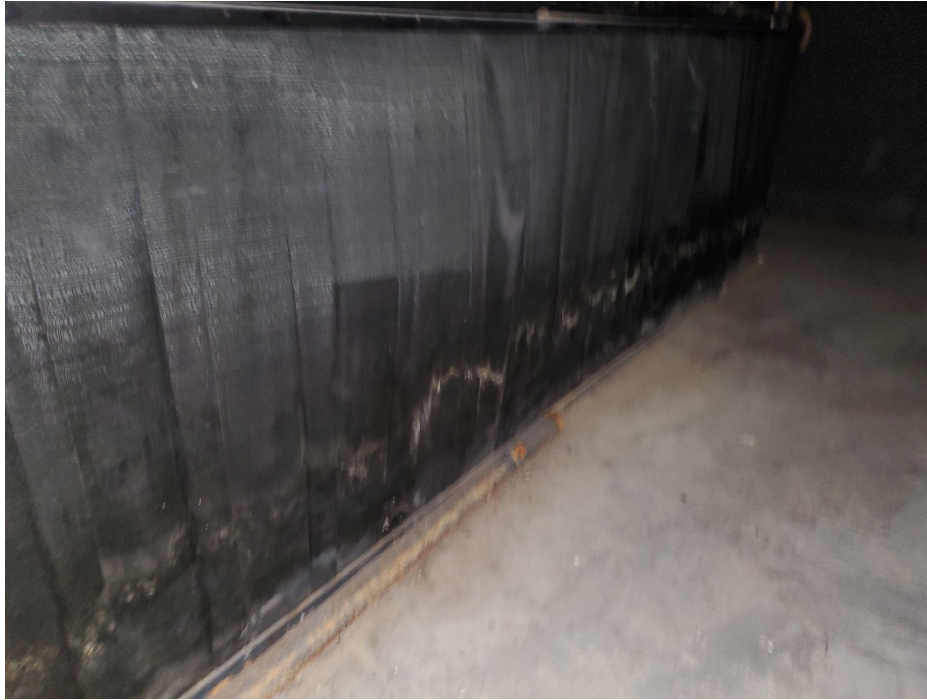
Photo 5: Representative view of water damage and AMG observed on drapes in theaters.

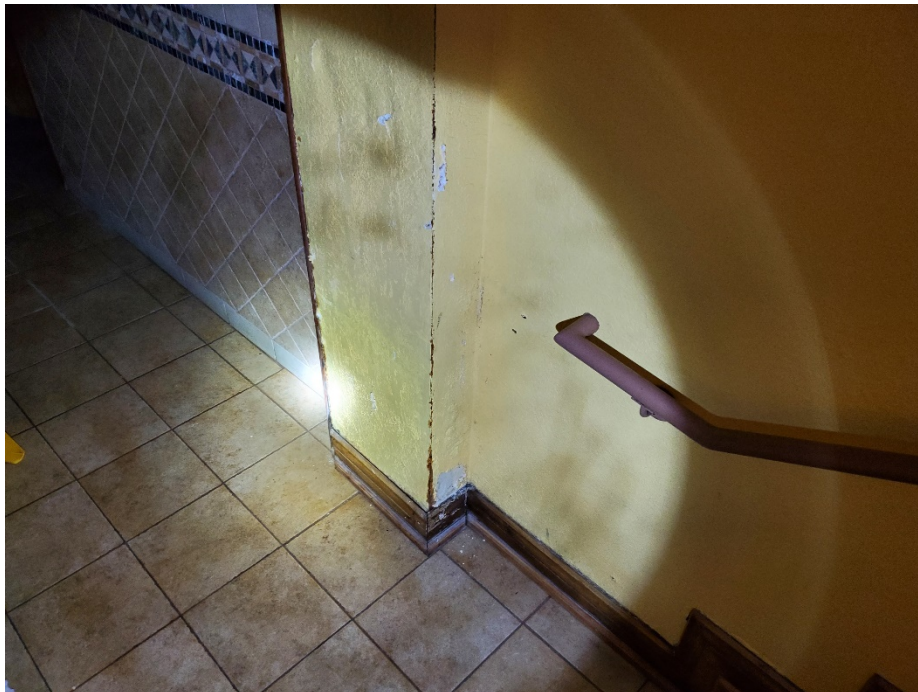
Photo 6: Representative view of water damage and AMG on corridor in main lobby restrooms.

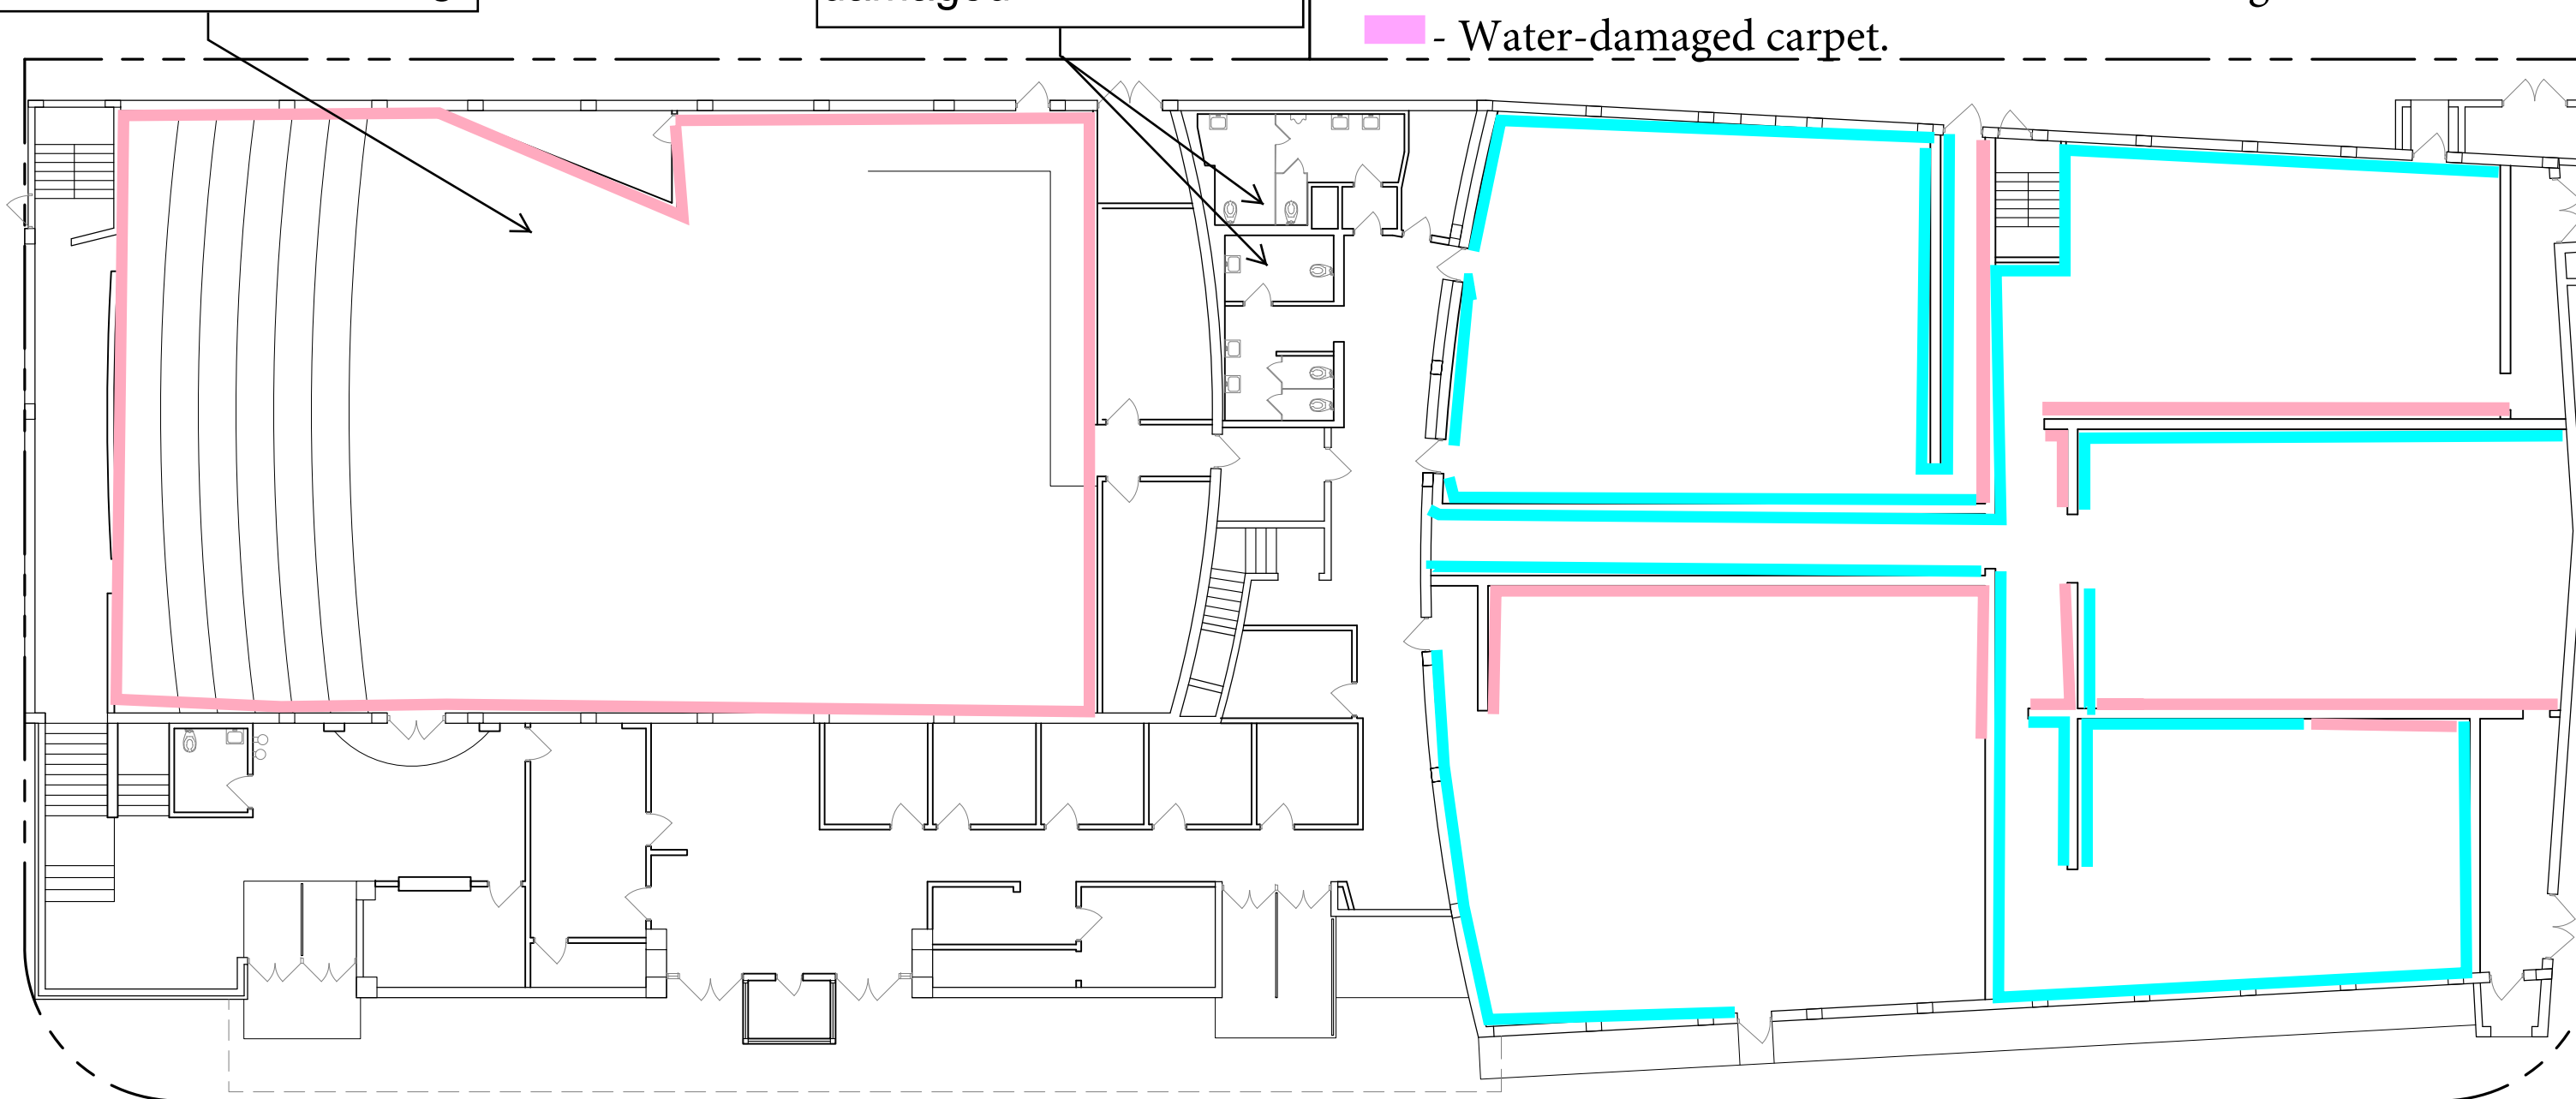
Ceiling tiles removed or damaged.

SAMG on theater seating.

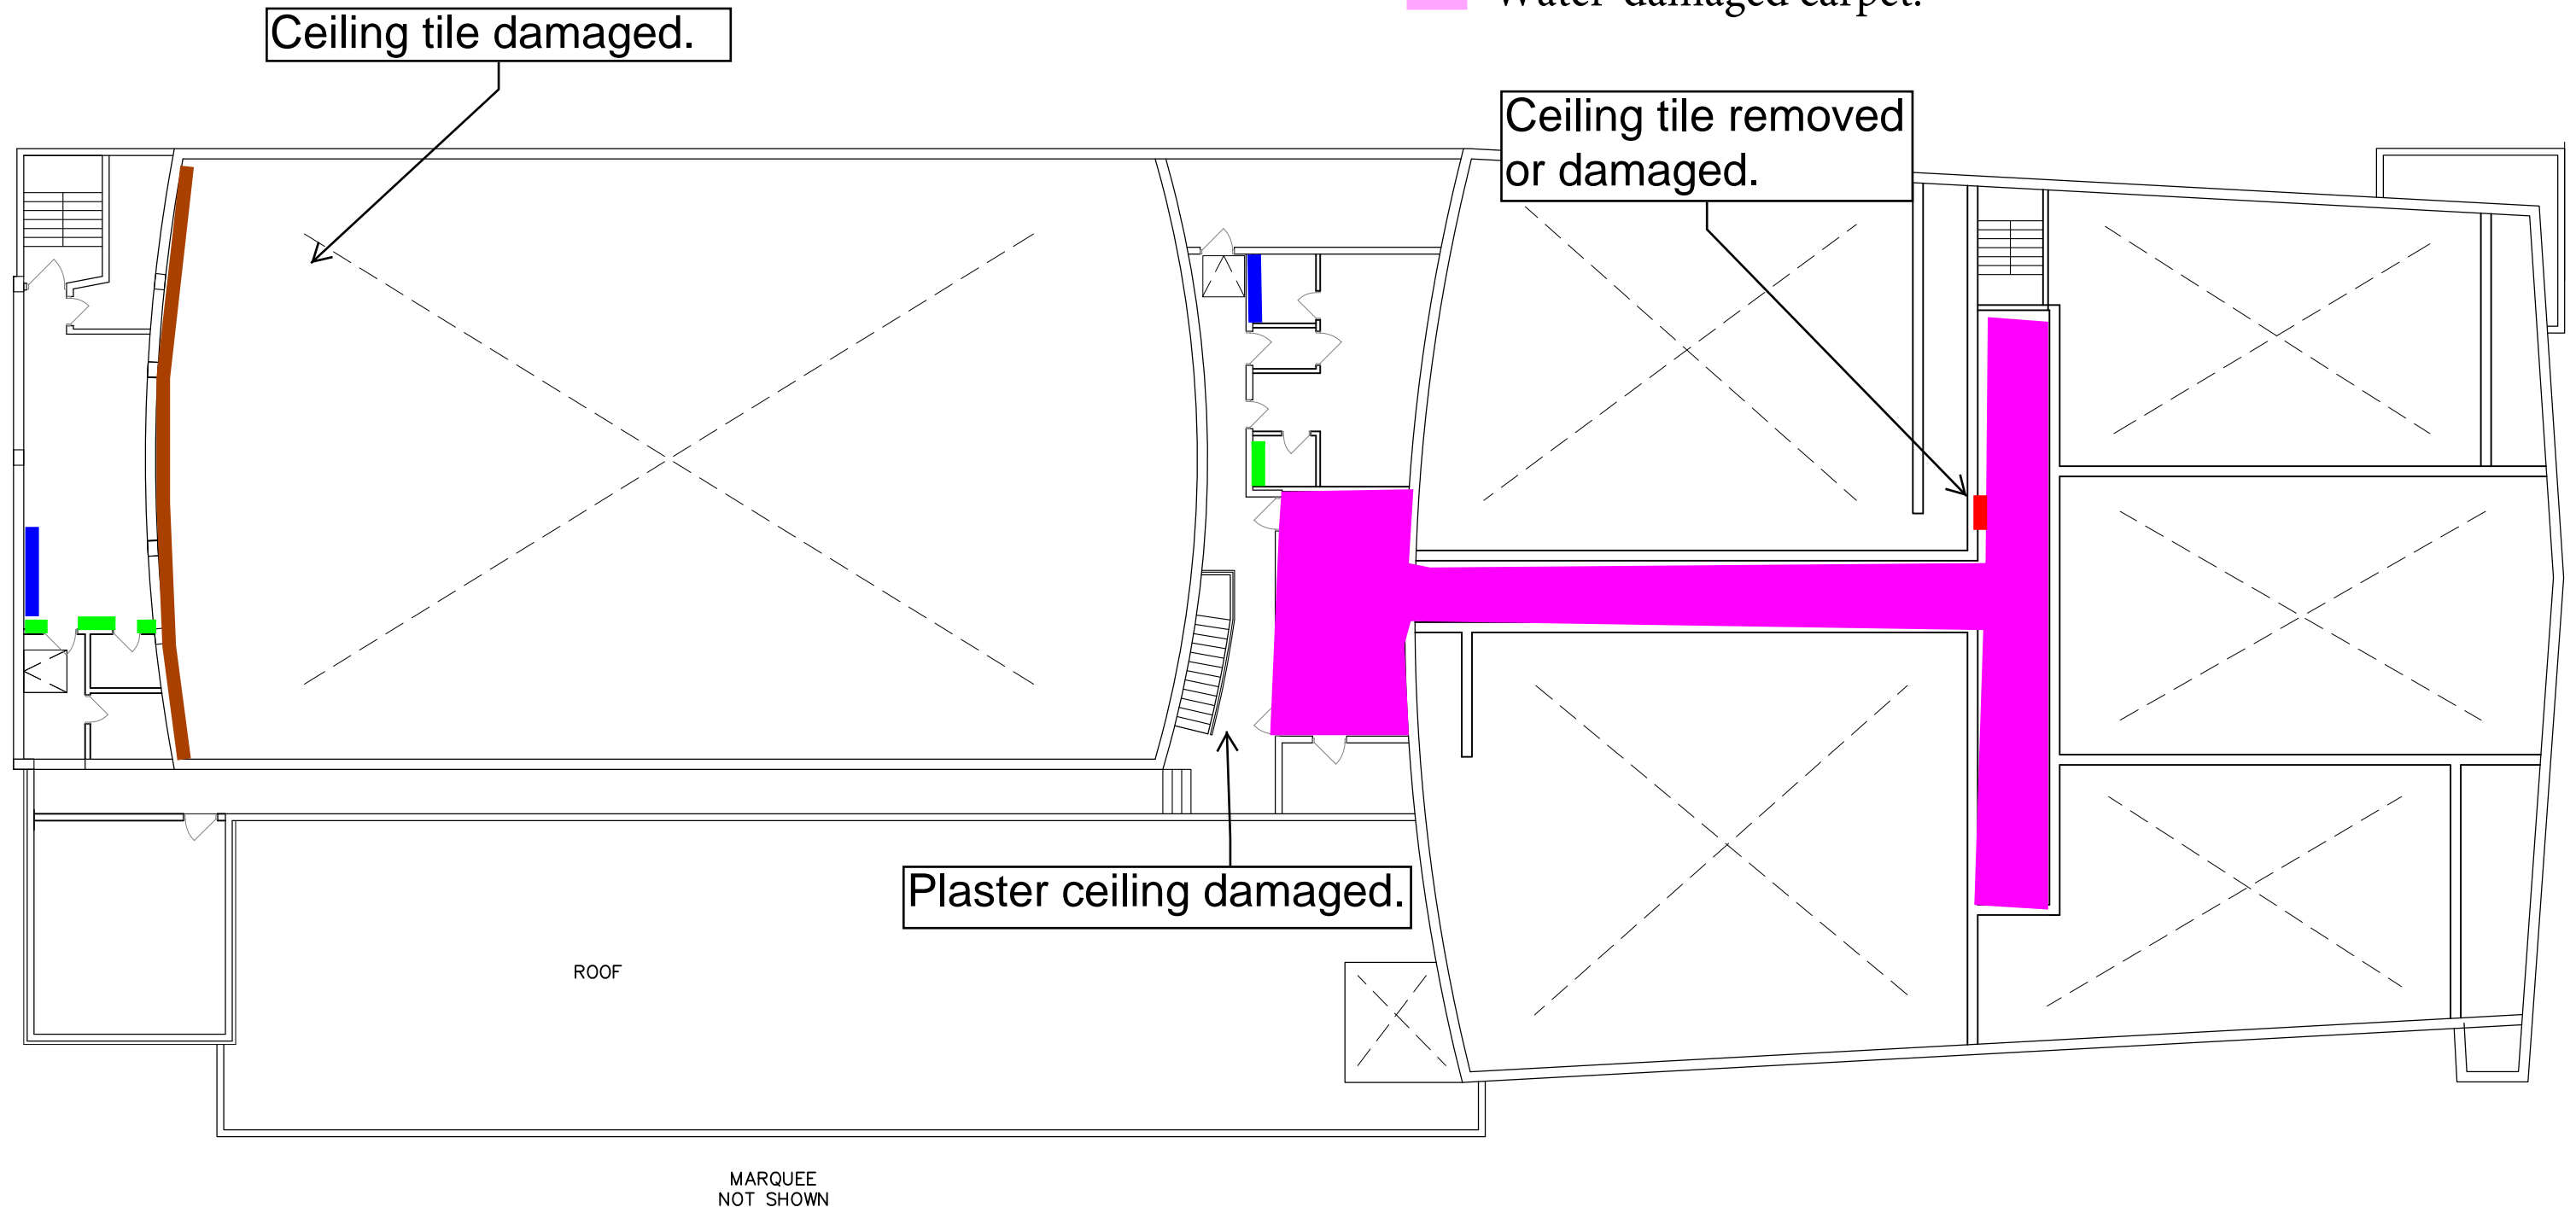
-Water-damaged carpet.
