ARBORIST REPORT

June 28, 2021

RE 5970 North Bay Road
Arborist's Evaluation of Specimen Trees

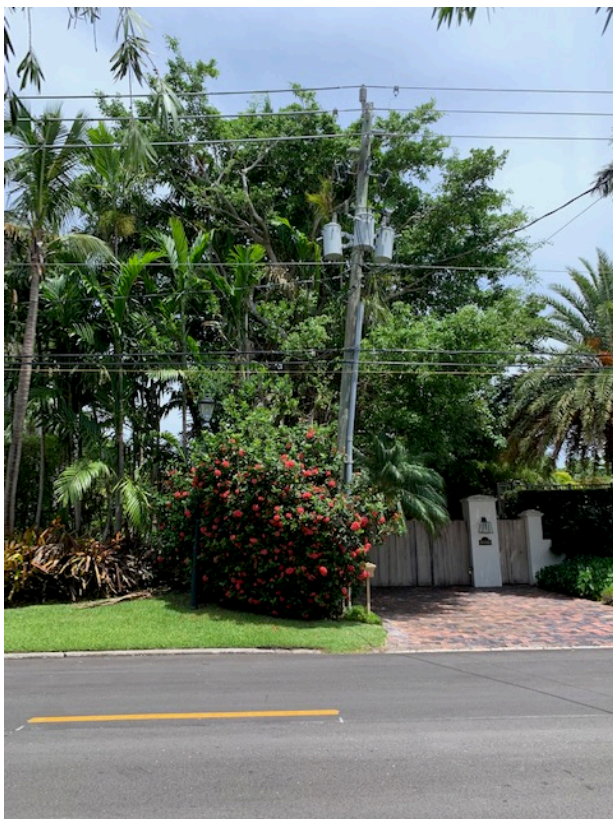
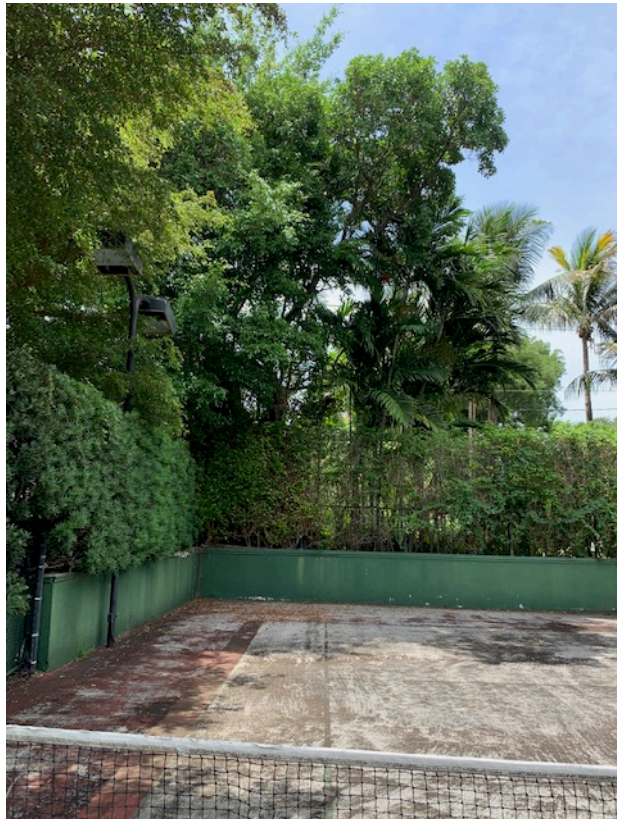
TREE # 51

COMMON NAME: Weeping fig	HEIGHT (FT): +/- 50'
SCIENTIFIC NAME: <i>Ficus benjamina</i>	SPREAD (FT): +/- 50'
CONDITION: Fair	DBH (INCHES): >72"
NATIVE: NO	CRZ (FT): +/- 10'
DISPOSITION: REMAIN

Tree #51 is located on the northeast corner of the property just east of the low wall that surrounds the tennis court, and adjacent to the Right-of-Way. The tree has two remaining codominant trunks approximately 48" in diameter with the canopy foliage beginning approximately 10' above ground. A third large trunk was previously removed as shown on the next page. The canopy of the tree has been shear cut on the east side of the tree to prevent the branches from interfering with the adjacent utility lines and electrical transformer. The tree has been maintained in this manner for many years and has produced new growth after each cutting. The canopy also extends to the north over the neighbor's driveway. Minor decay is present on the distal ends of some of the previously cut branches. No evidence of insect infestation was observed. The root system is intact and showed no signs of uplifting or tilting. Although the tree has been subject to long term vertical sheer pruning, the tree warrants preservation because the canopy it is providing. Therefore, the tree will be preserved and protected until the project has been completed and until Urban Forestry has approved removal of the protective barriers.

DESCRIPTION / NOTES: Tree Protection to be provided.
