Tree Assessment Report

PROJECT NAME / LOCATION:

3017 Flamingo Dr.

DATE: March 4th, 2021

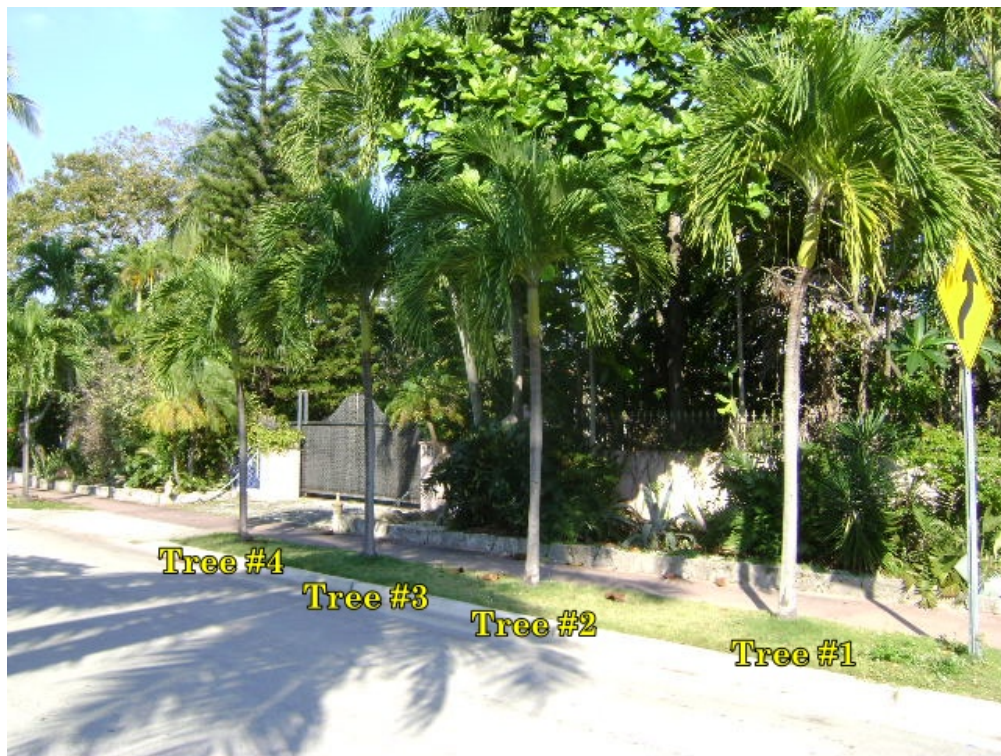
Picture 1 Taken from the Southwest. All Christmas palms are in good condition.

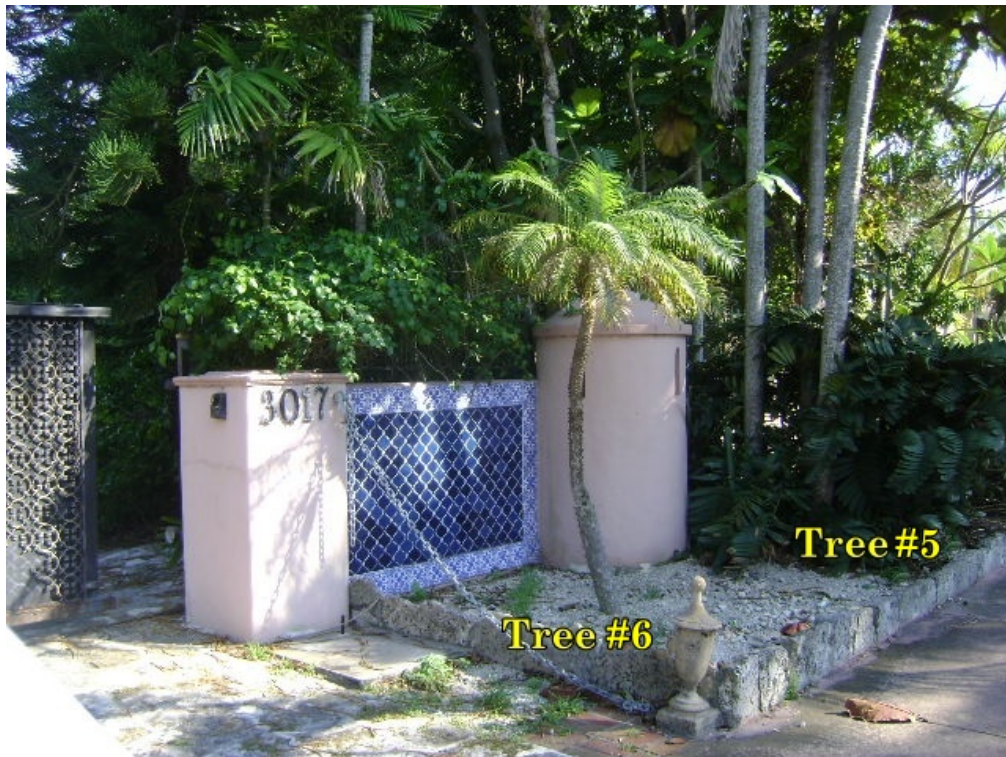
Picture Taken from the Northwest showing Christmas palm in good condition behind Pygmy date in moderate condition.

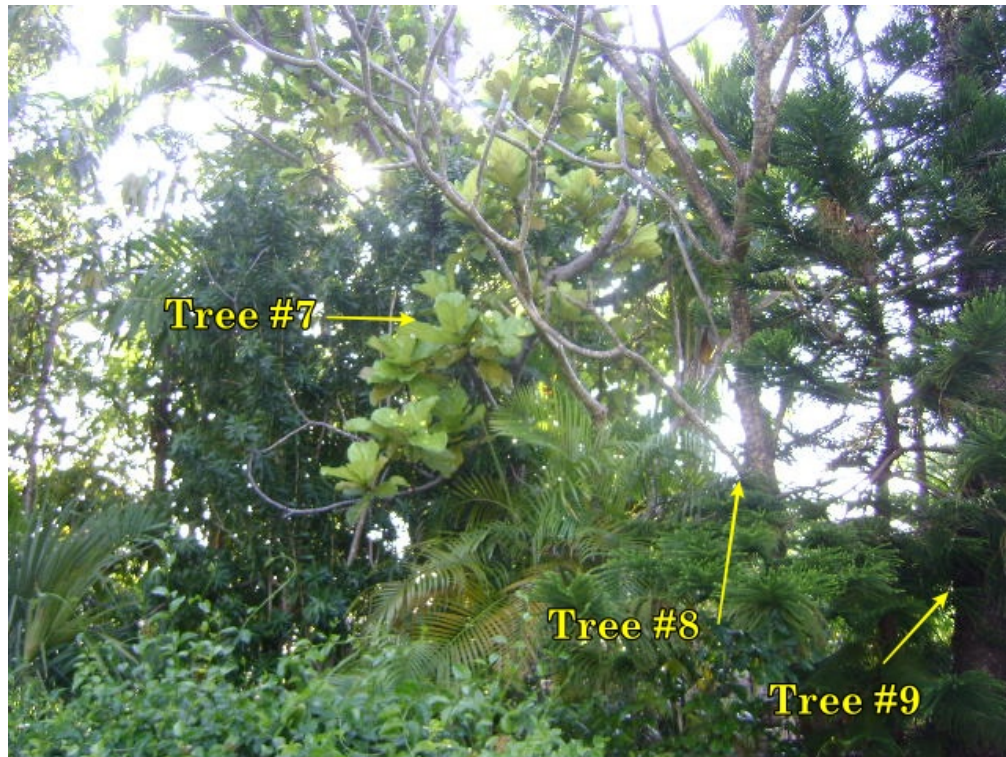
Picture Taken from the Northeast, showing Tropical almond, Frangipani and a bit of Norfolk pine to the right. Tree #7 is competing for light.

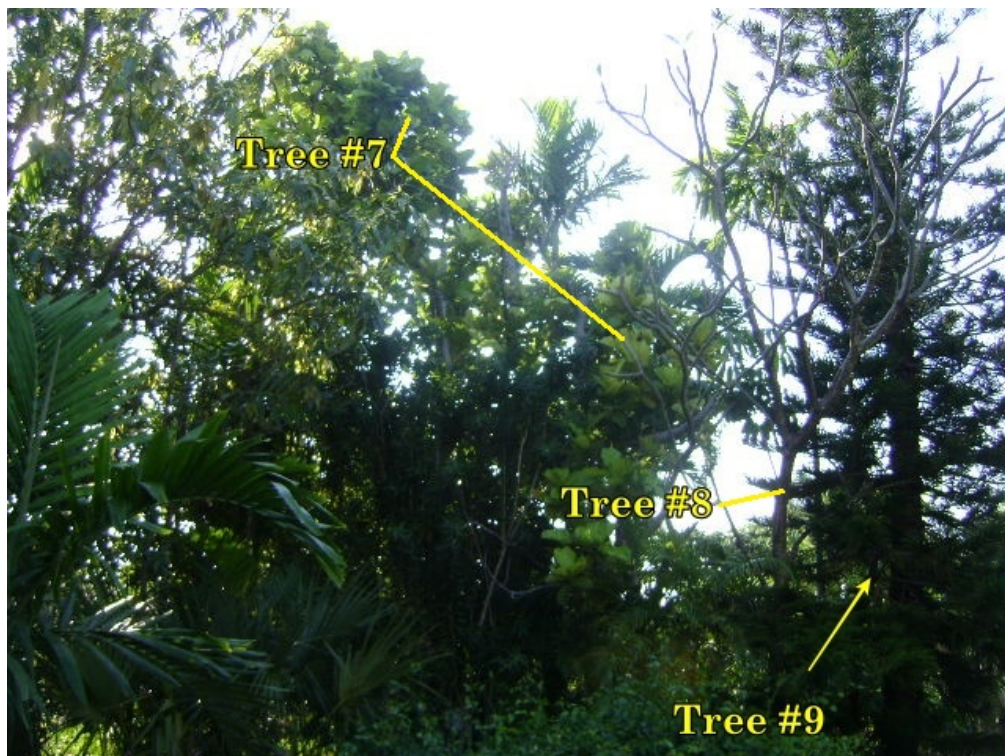
Picture Taken from the East, showing Tropical almond, Frangipani and Norfolk pine. Trees #7 and #8 are in Moderate condition. Tree #9 is in Good condition.

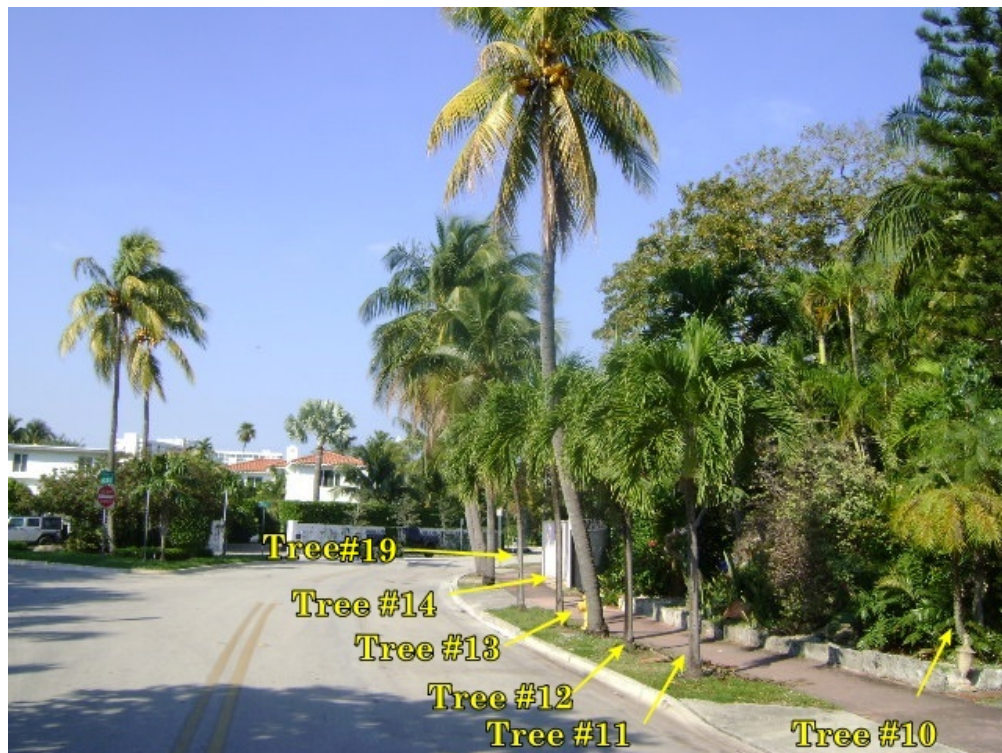
Picture Taken from the South, showing Christmas palm in good condition. Coconut is in Moderate condition due to the lack of K.

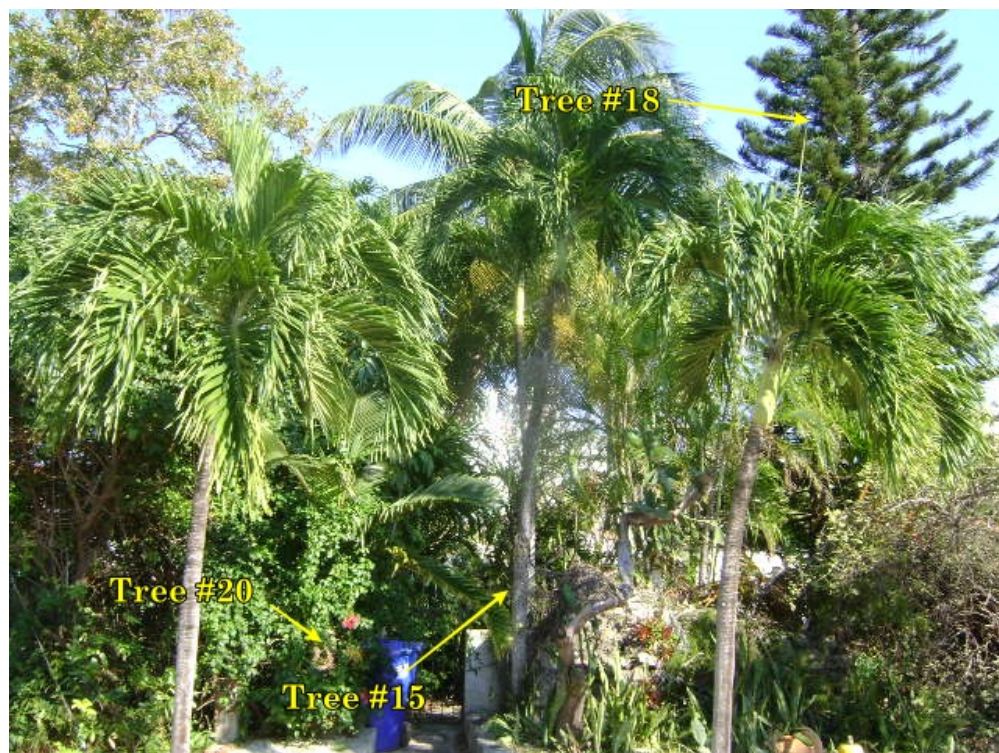
Picture Taken from the West, showing Christmas palms in Good condition.

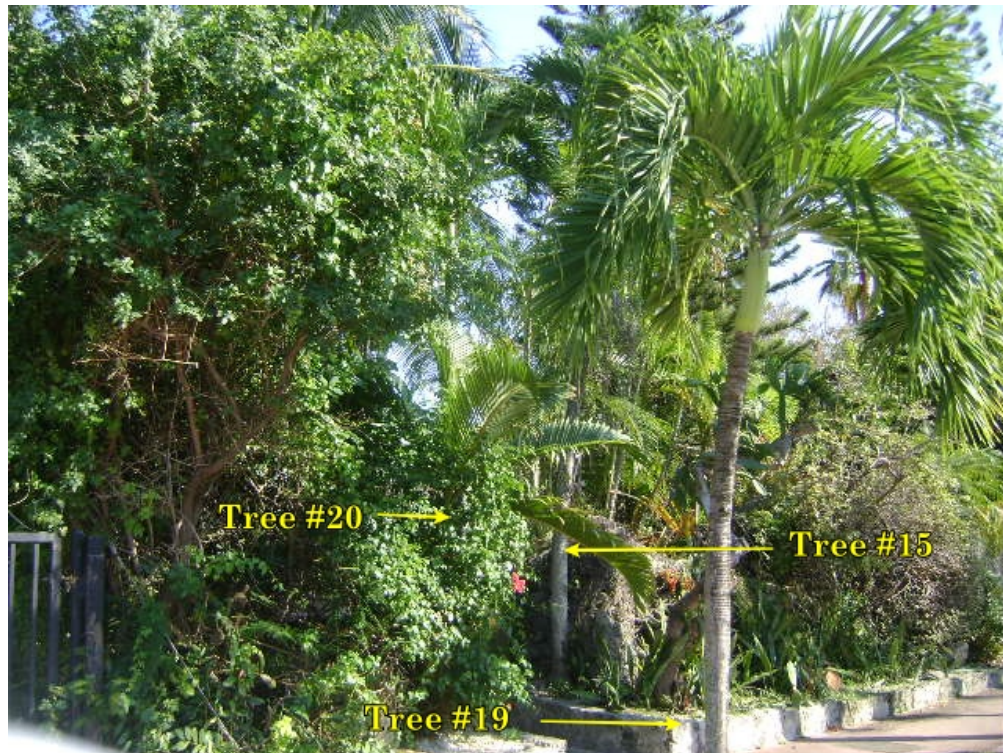
Picture 7 Taken from the North, showing Bottle palm in Moderate condition.

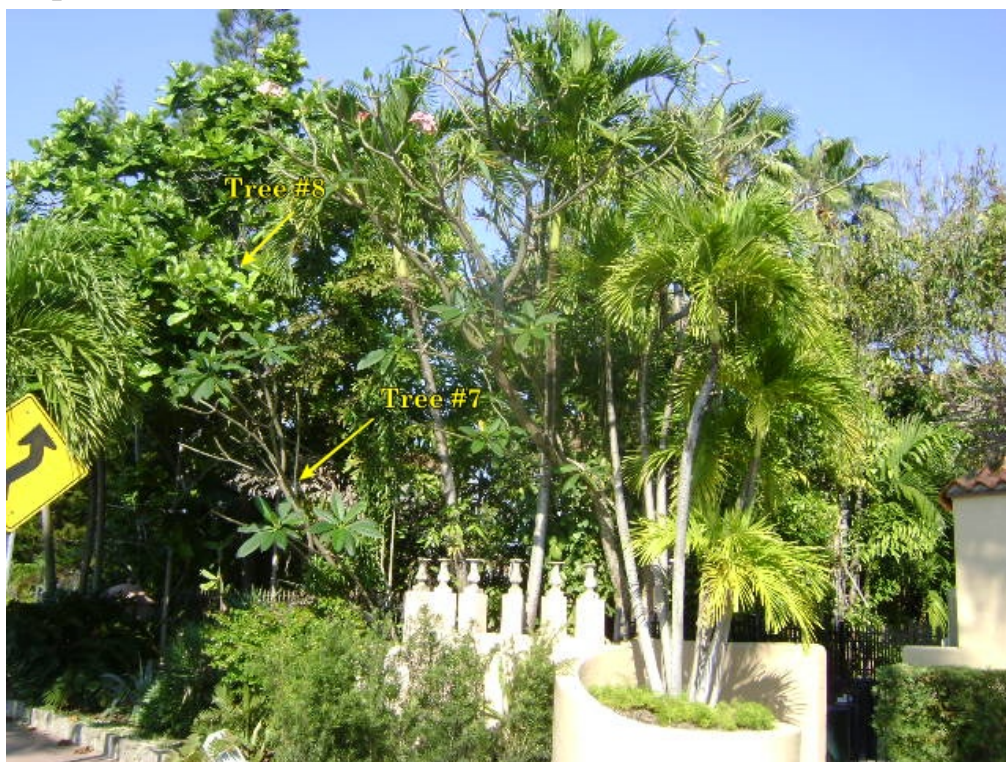
Picture Taken from the South Frangipani and Tropical almond in moderate condition. Christmas palm in the front is in property next door.

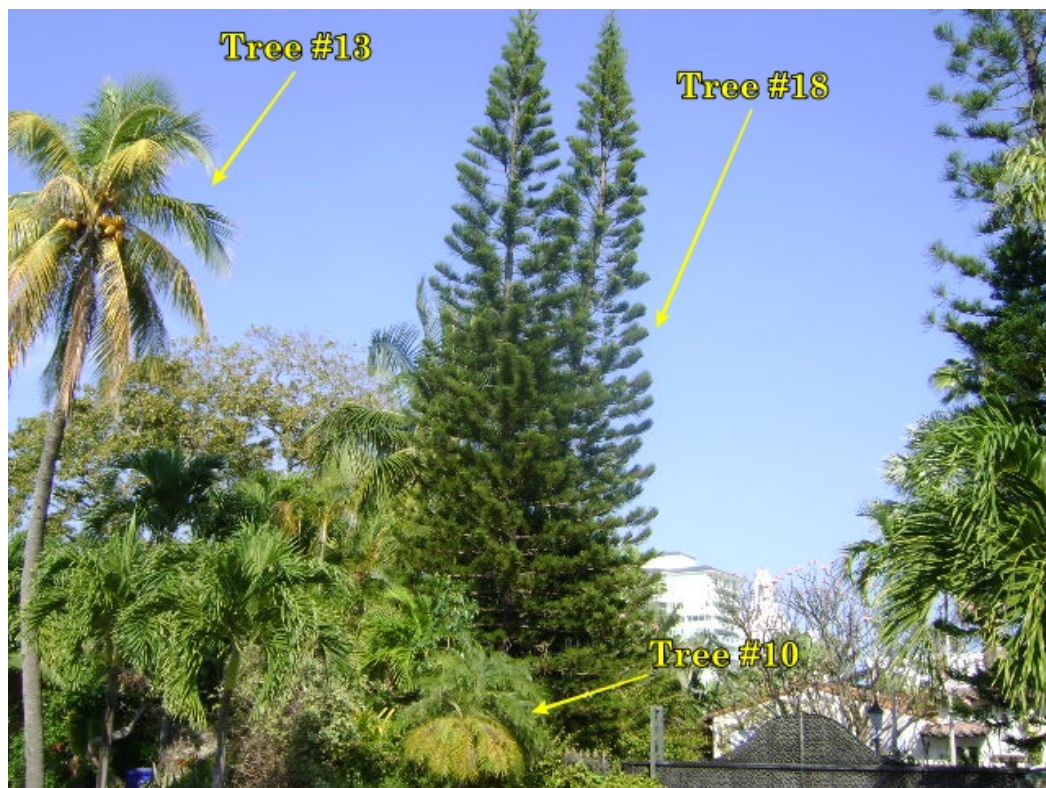
Picture Taken from the Northeast showing Coconut in Moderate condition (lack of K) and Norfolk pine in Good condition.

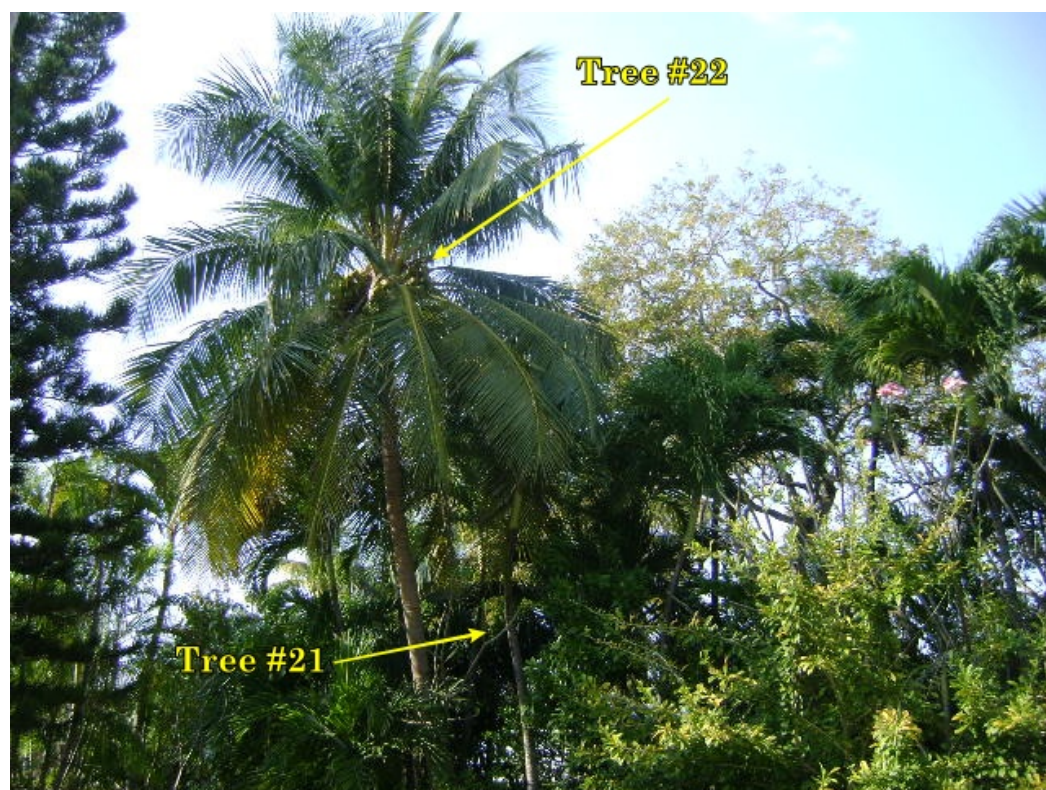
Picture 1 Taken from the South, showing Christmas palm and Coconut, both rated in Good condition.

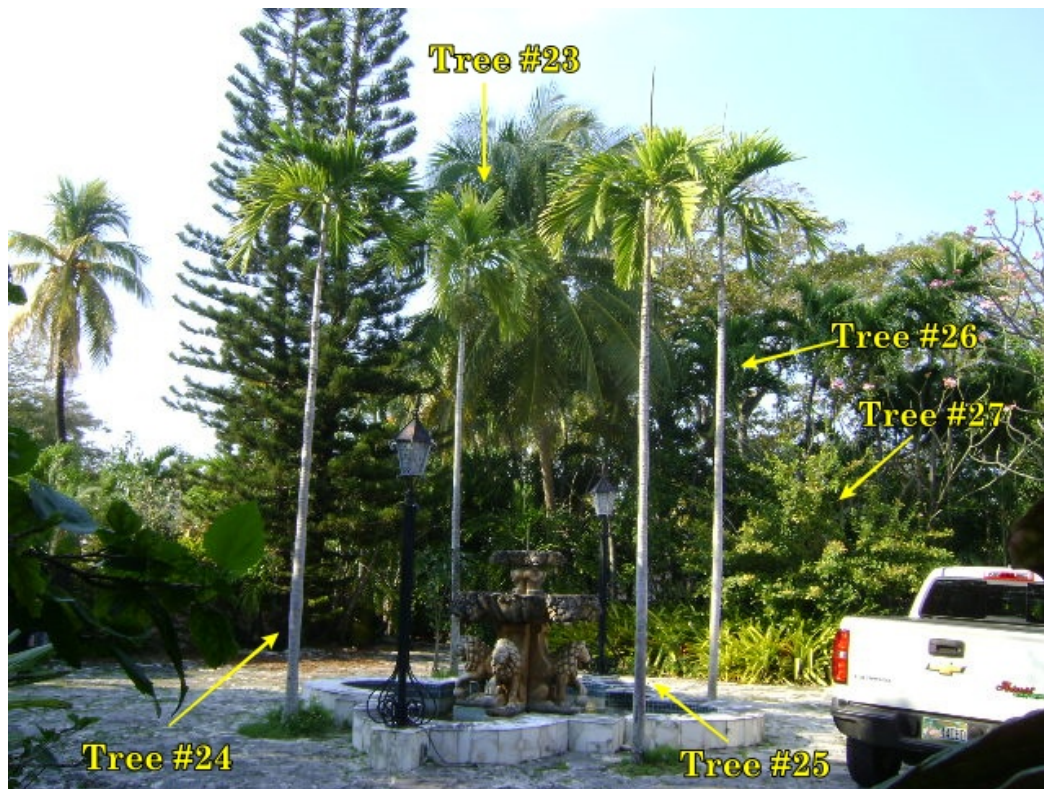
Picture 11 Taken from the South, showing Solitaire palms rated in Good condition.

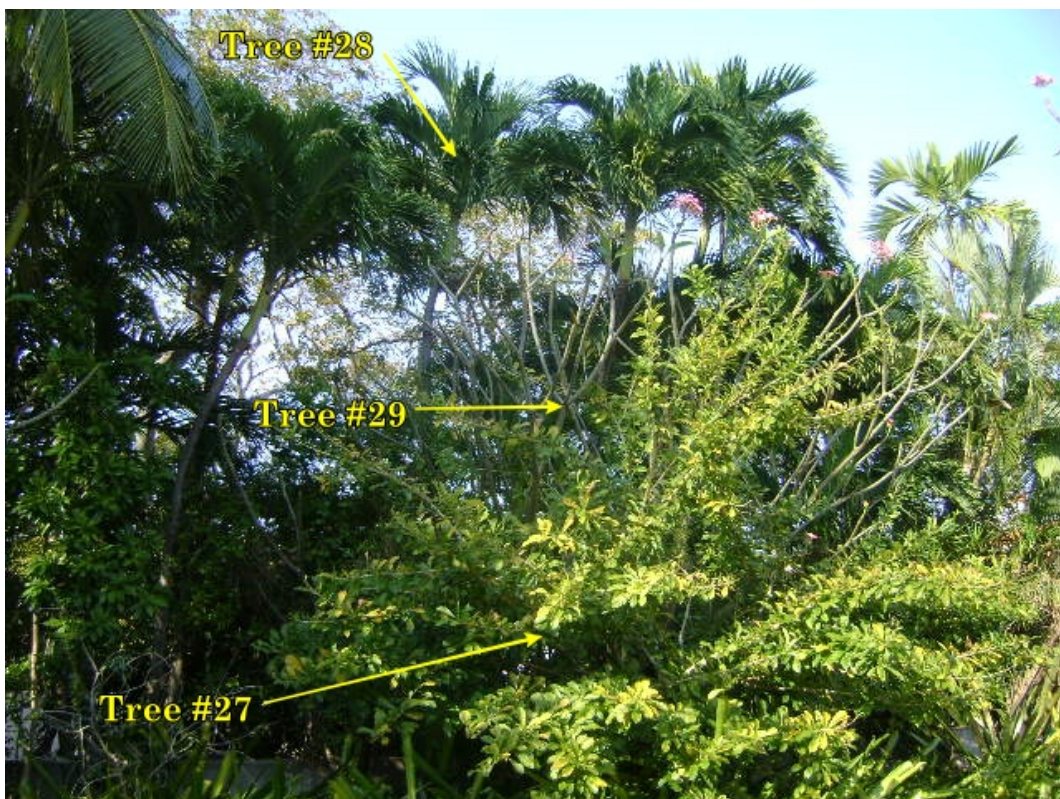
Picture 1 Taken from the Southwest, showing Christmas palms in Good condition and Calabash tree rated in Moderate condition.

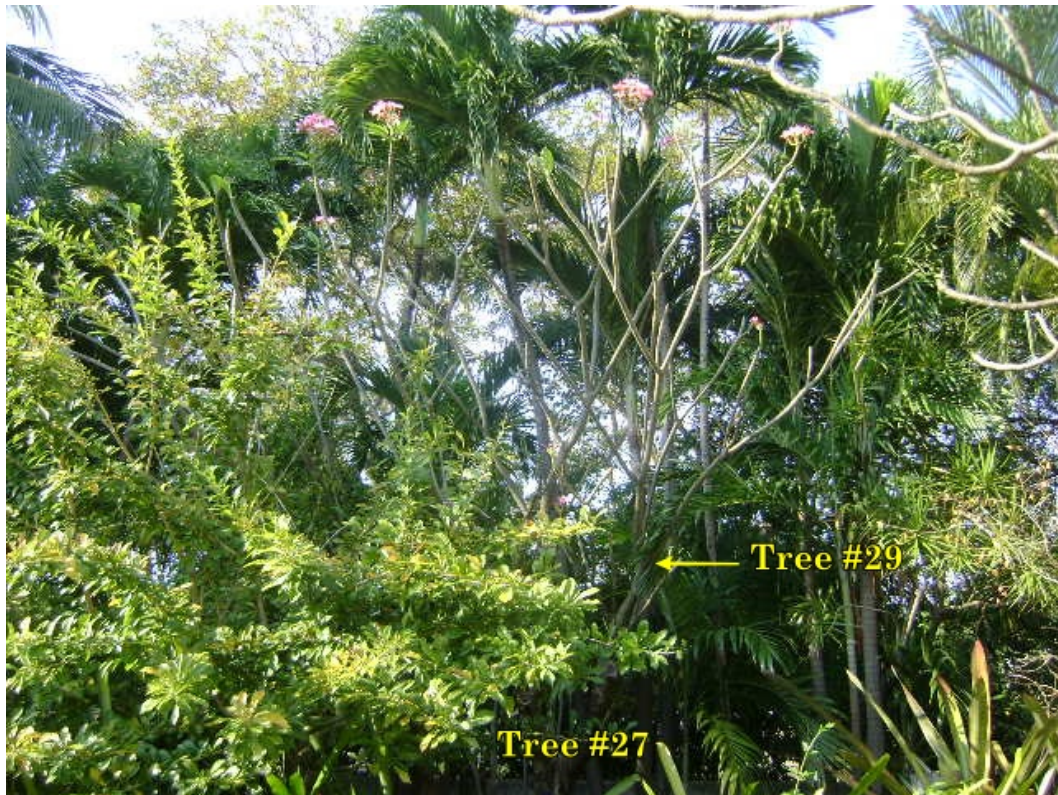
Picture 1 Taken from the East, showing Frangipani (tree to remain) and Calabash tree.

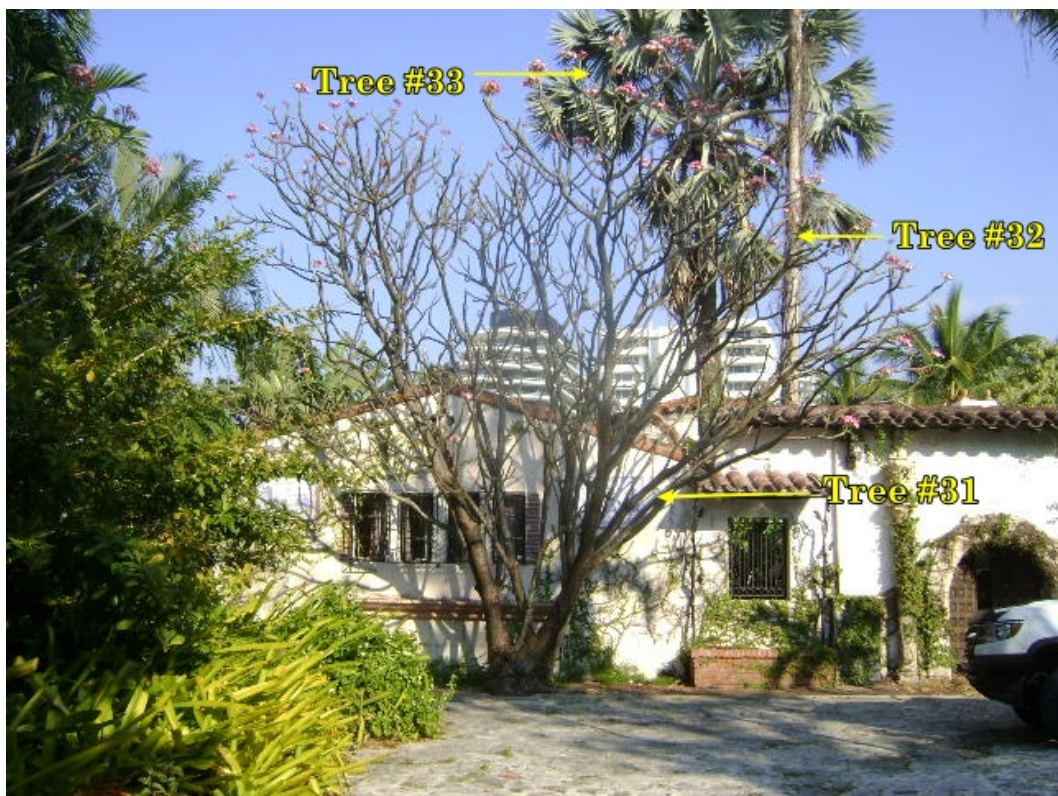
Picture 1 Taken from the West, showing Frangipani in Good condition (to be relocated) and Bismarckia to be relocated) in Moderate condition. partially shown Washingtonia palm to the right.

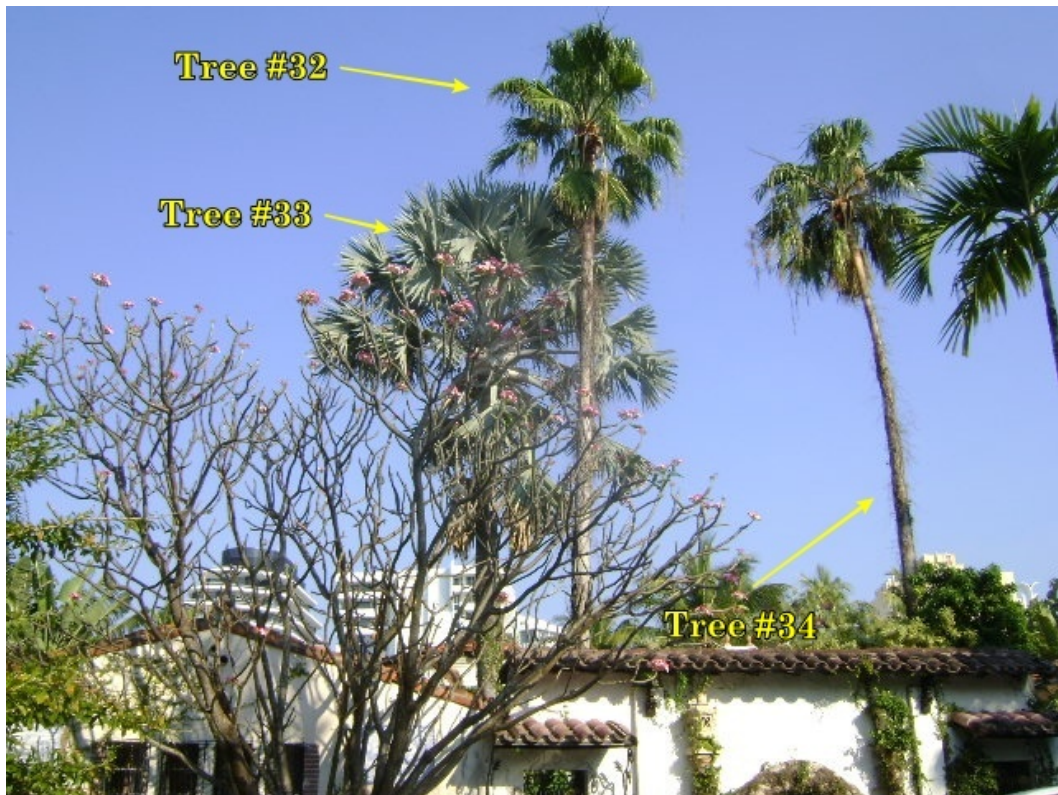
Picture 1 Taken from the West, showing Bismarckia (to be relocated) and Washingtonias in Moderate condition

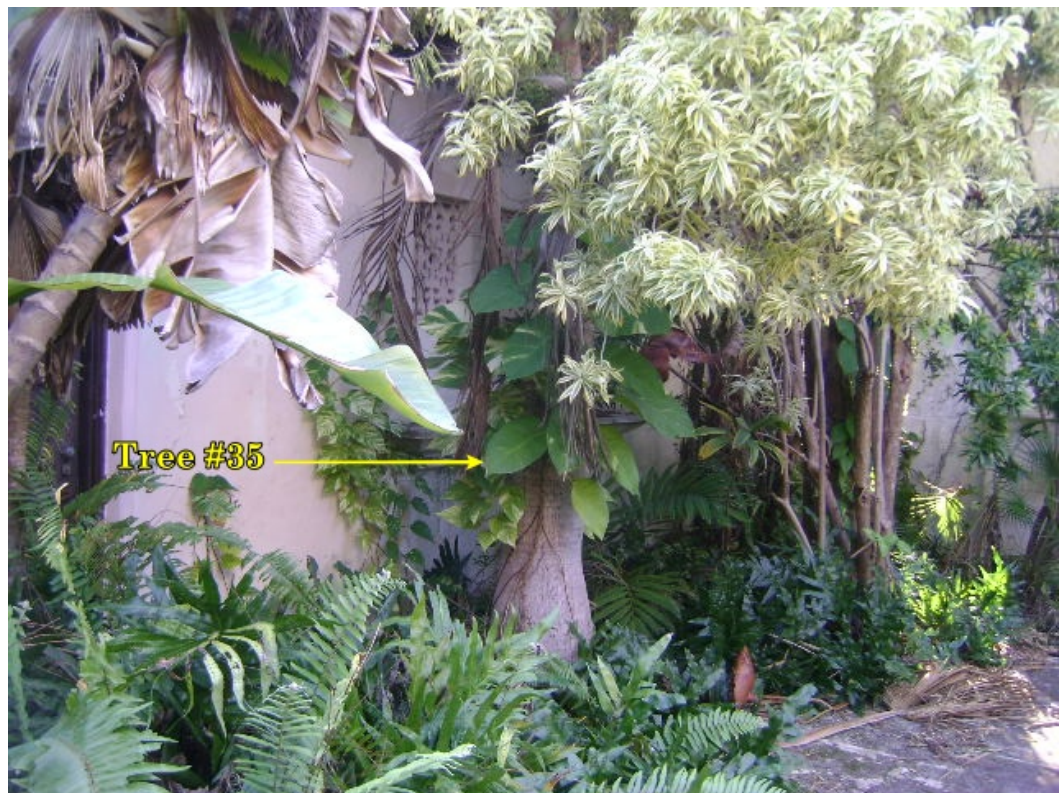
Picture 1 Taken from the East inside courtyard showing Bottle palm in Moderate condition. Song of India to the right.

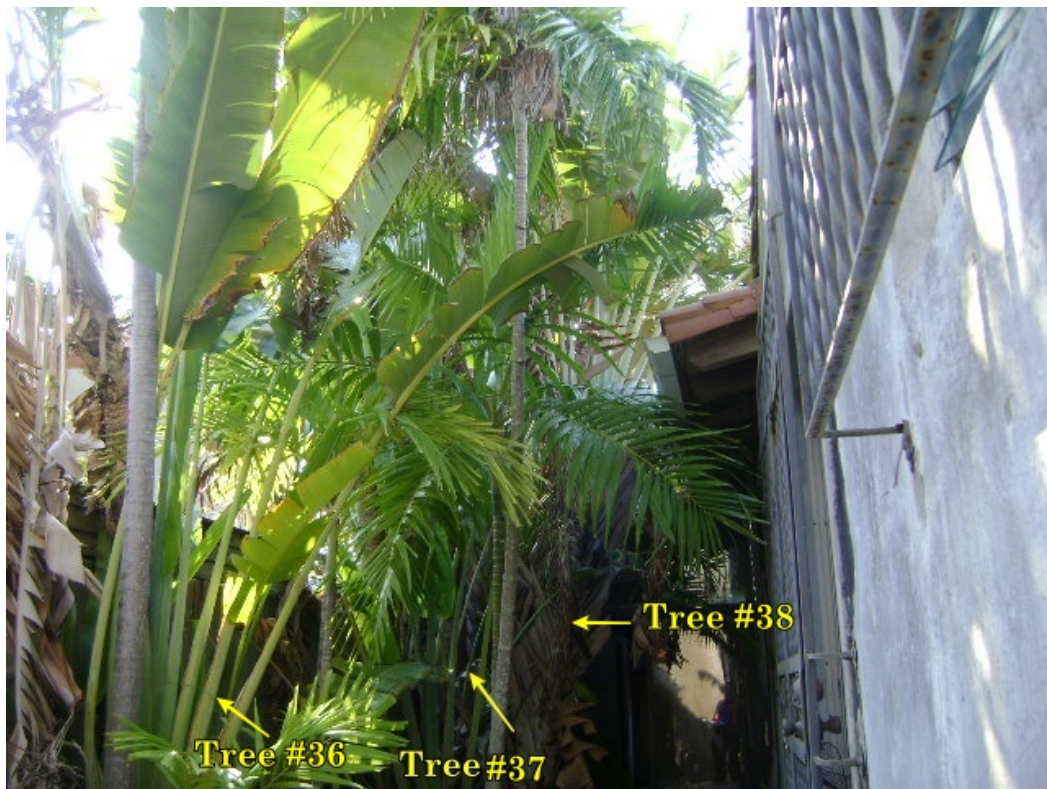
Picture 17 Taken from the West, showing White birds of paradise in Moderate condition. Frangipani hidden behind is in Moderate condition.

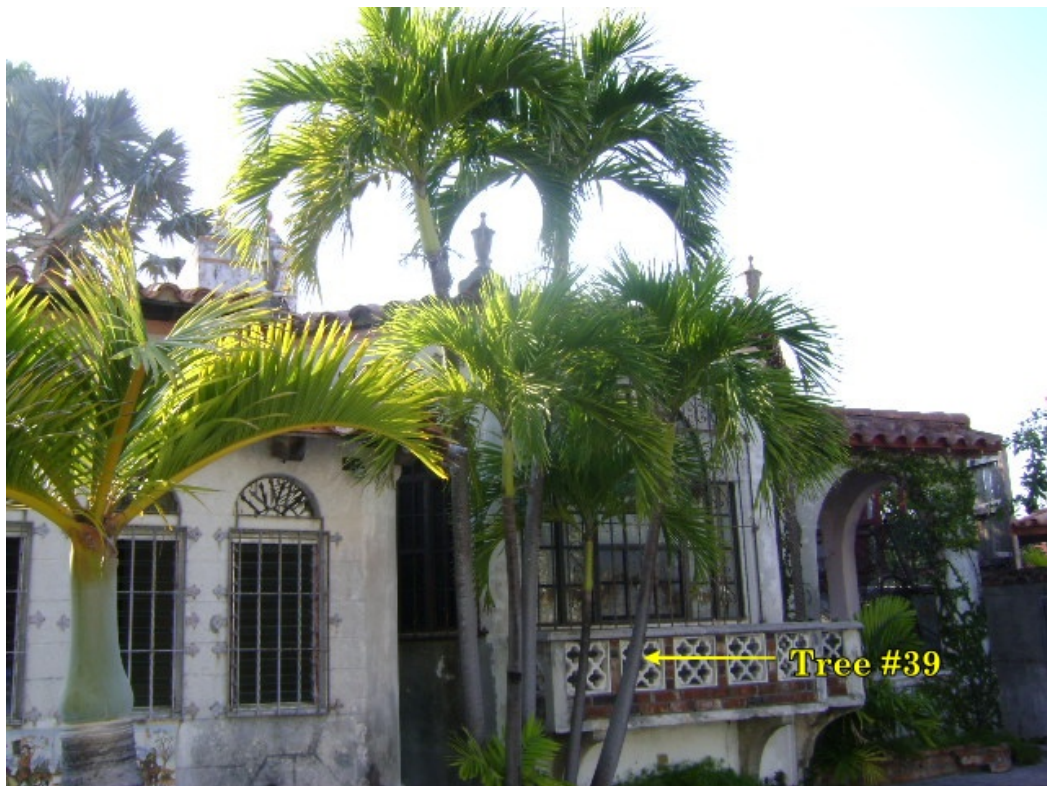
Picture 1 Taken from the Southwest showing Multi-trunked Christmas palm in Good condition.

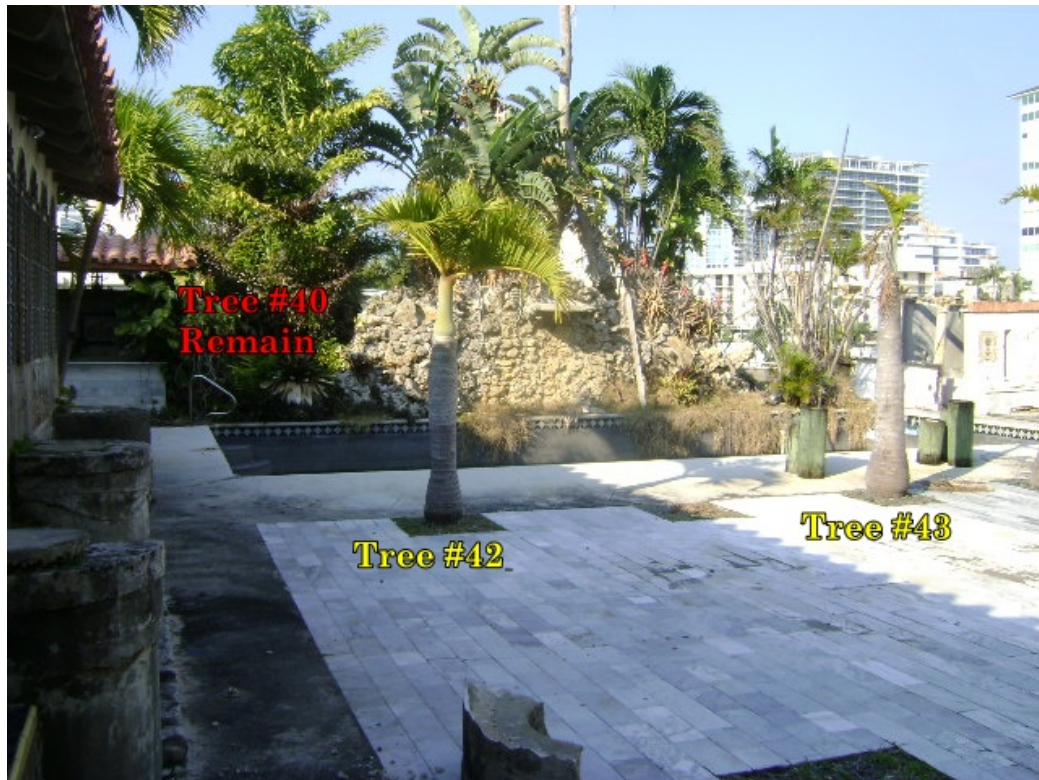
Picture 1 taken from the South, showing fish tail palm (to remain) and Bottle palms in poor condition

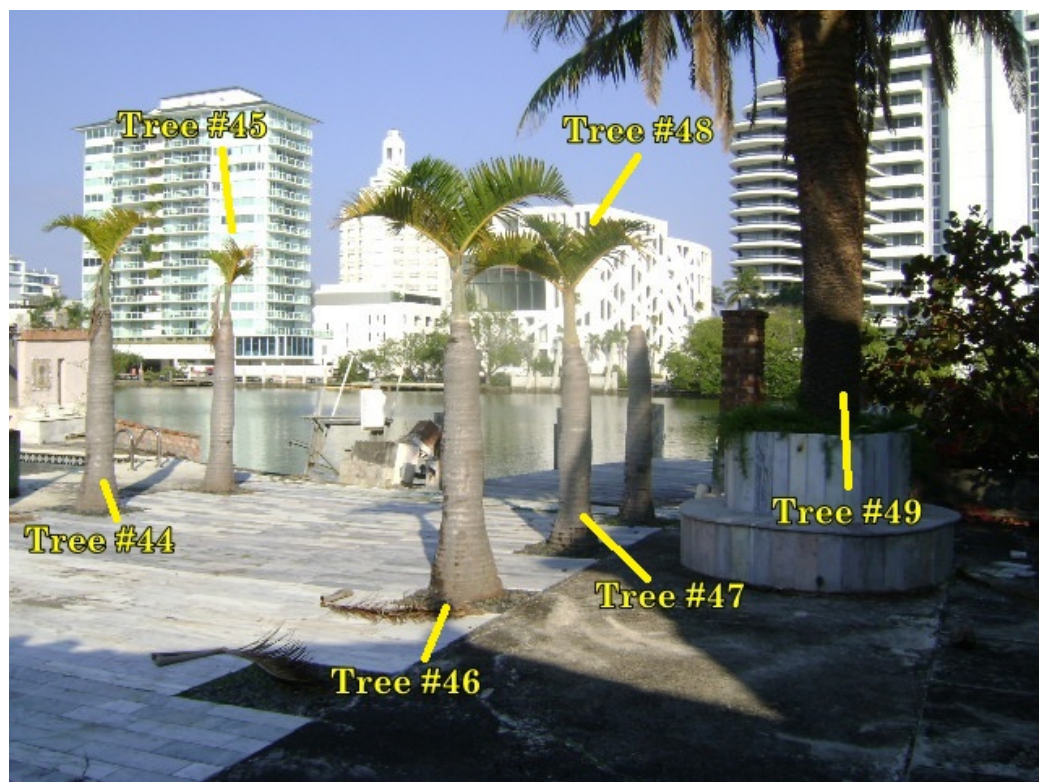
Picture Taken from the North, showing Bottle palms in Poor condition. Partially seen Date palm (to be relocated)

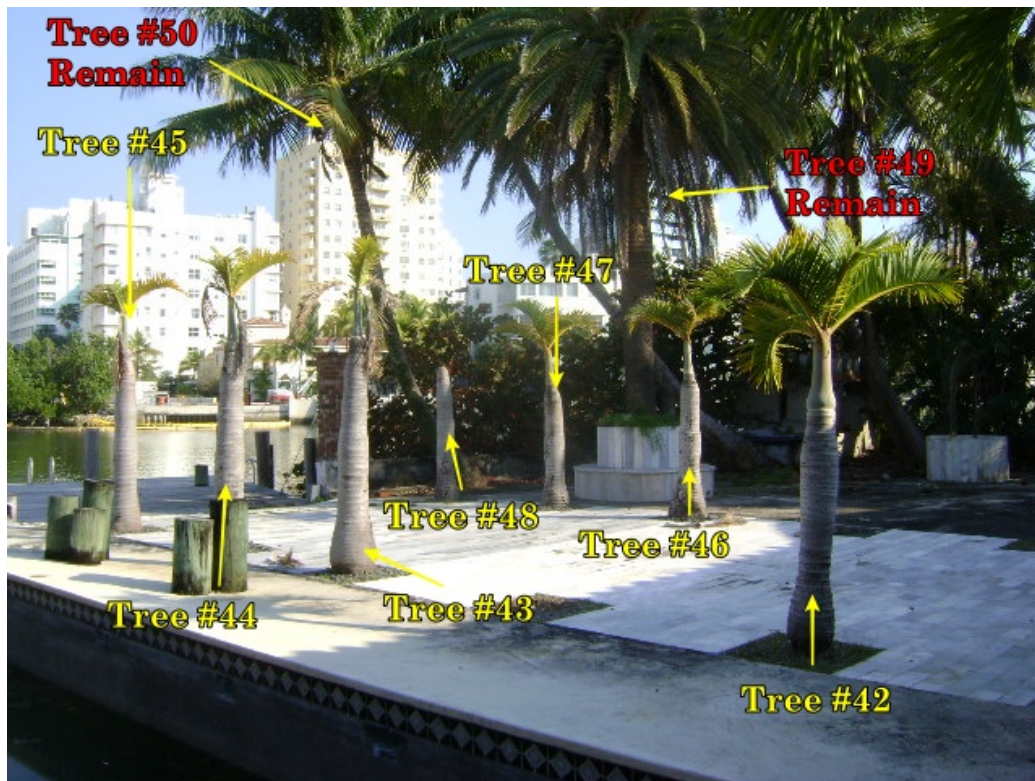
Picture 1 Taken from the Northwest, showing Bottle palms in poor condition. Trees #49 in Moderate condition and #50 in Good condition (to be relocated)

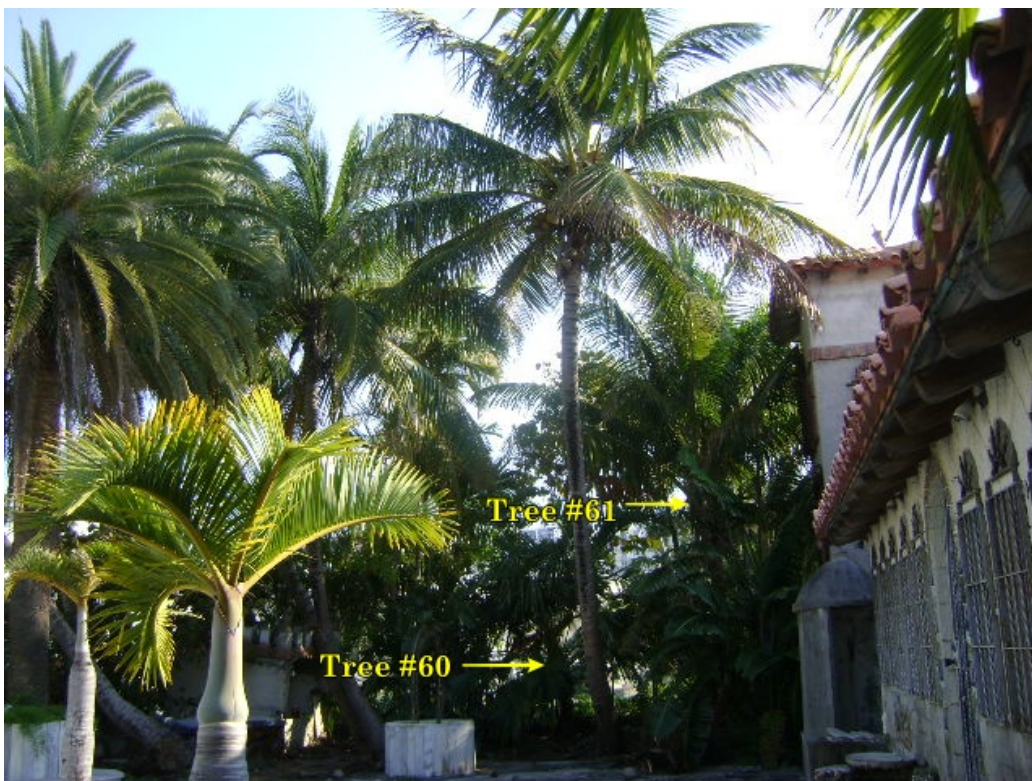
Picture Taken from the North, showing Washingtonia palm (hidden due to deep shade) . Tree #61 Coconut (to be relocated) rated in Good condition

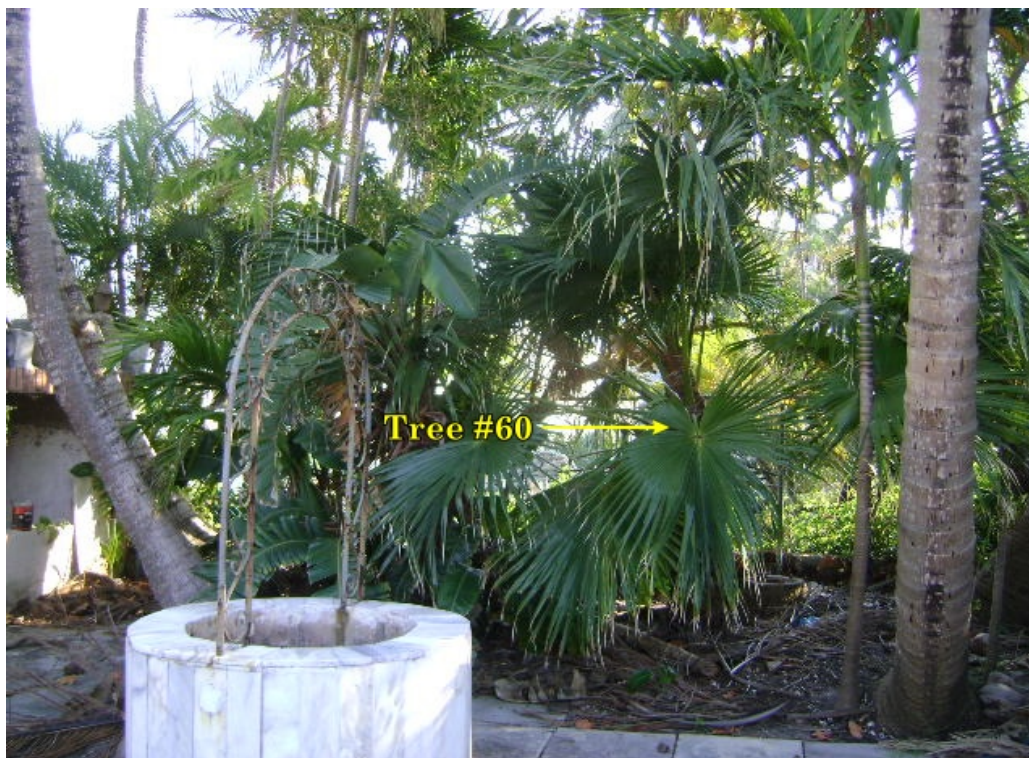
Picture 3 Taken from the North, showing Washingtonia palm rated in Moderate condition.

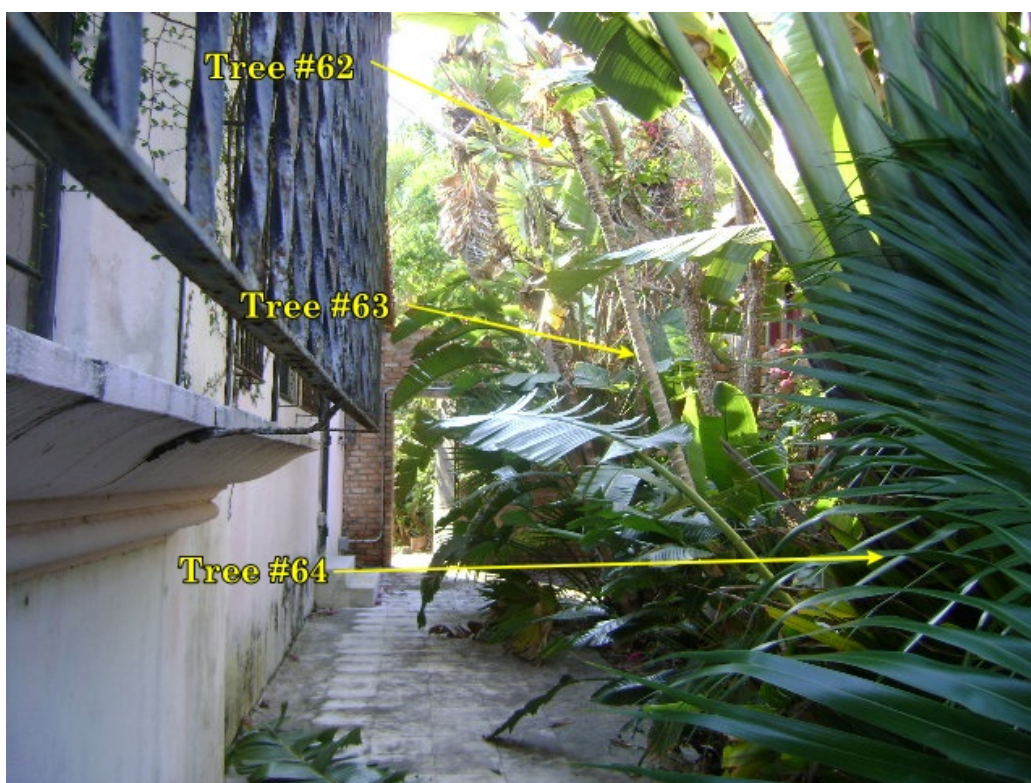
Picture 4 Taken from the West, showing Frngipani in Poor condition (hidden behind White bird of paradise. Both White birds of paradise rate in Moderate condition.

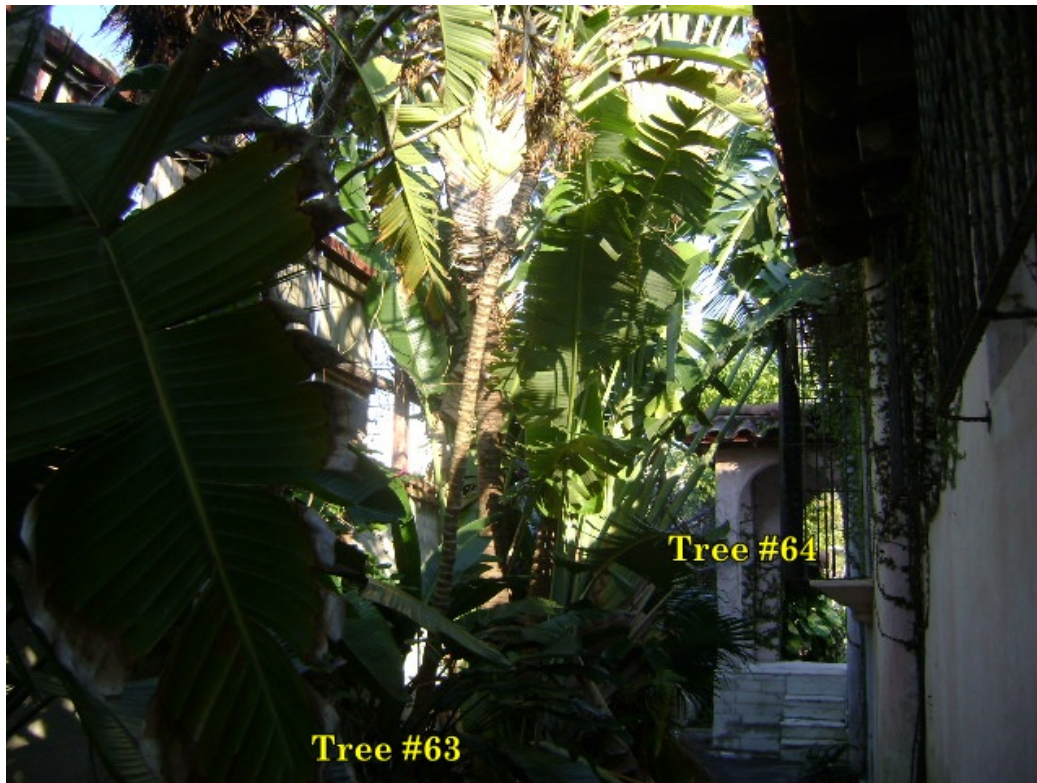
Picture 5 Taken from the East, showing another angle of White birds of paradise rated in Moderate condition.

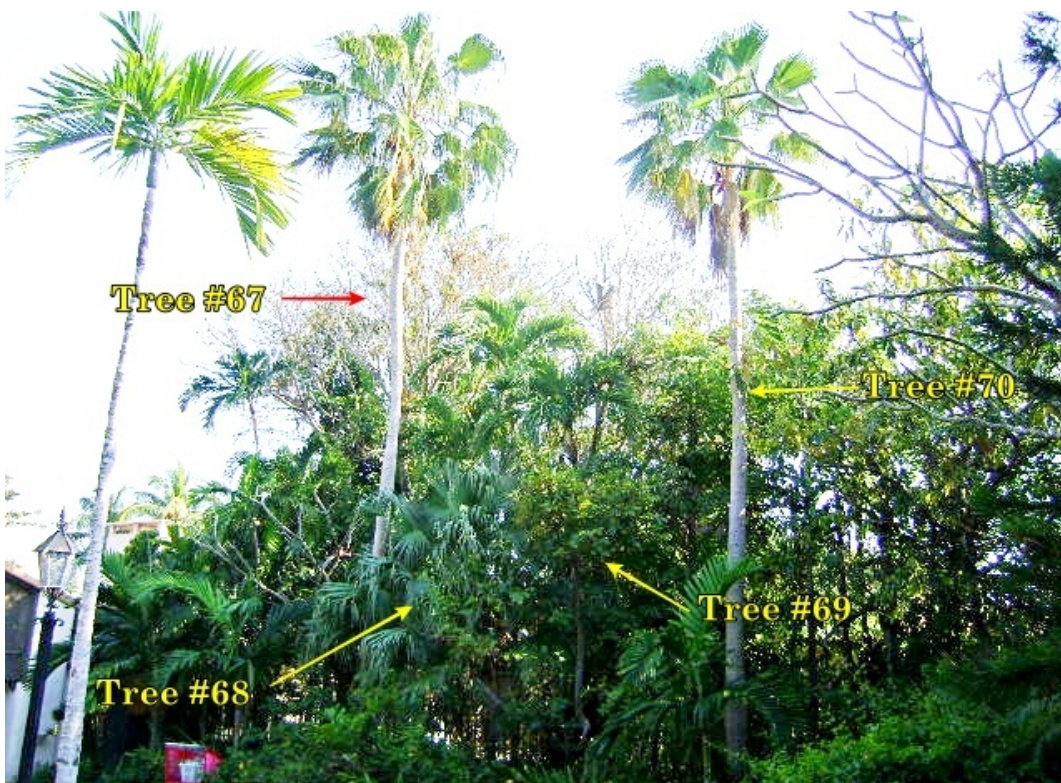
Picture 6 Taken from the North, showing Washingtonia palms #67 and #70 in Moderate condition. Chinese palm #68 is in Moderate condition. Avocado tree #69 is rated in Poor condition.

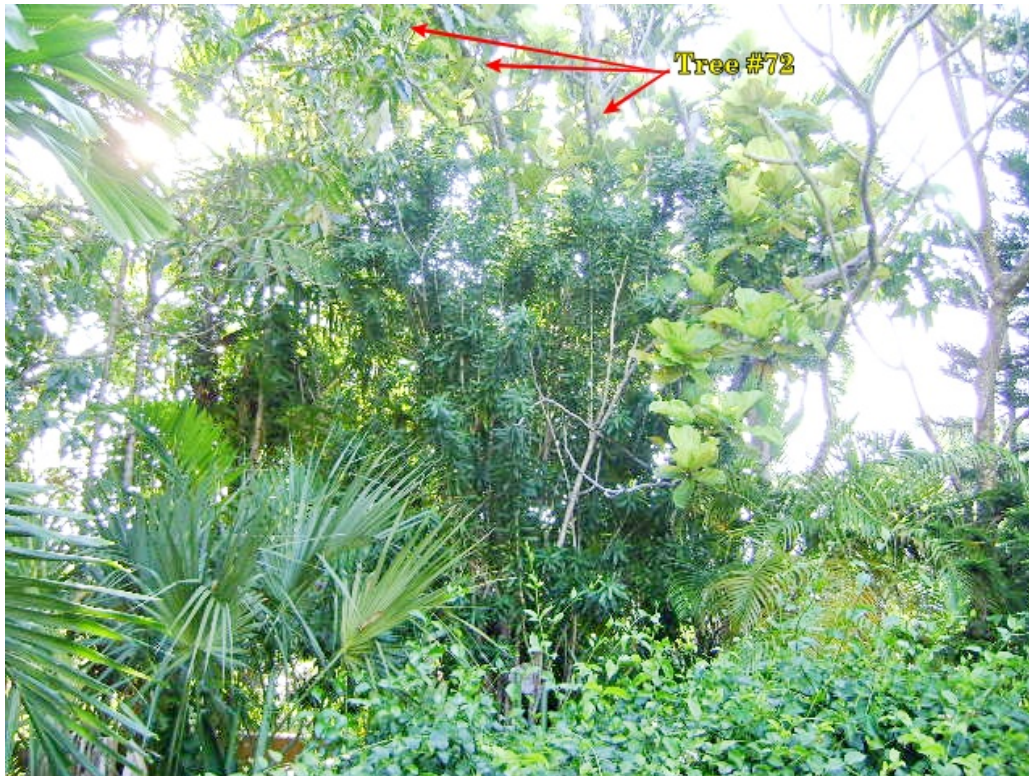
Picture 7 Taken from the West showing Mango tree rated in moderate condition. Tropical almond, Frangipani, and other remaining vegetation are competing for light and space.
