Flooding from Stormwater Grates

On October 2015, the City initiated a pilot program for inlet grates. Two types of grates were chosen from two different vendors, Stop Ocean Pollution and EcoSense.

Seven Stop Ocean Pollution and nine EcoSense grates were installed along Ocean Drive from 5th Street to 12th Street.

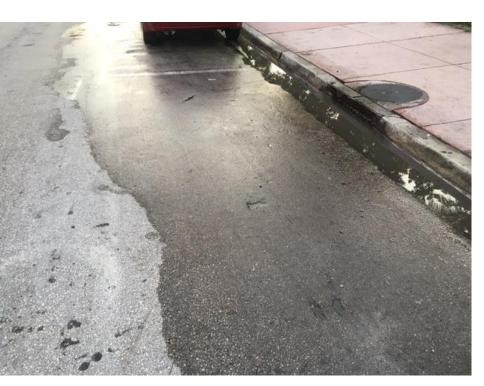
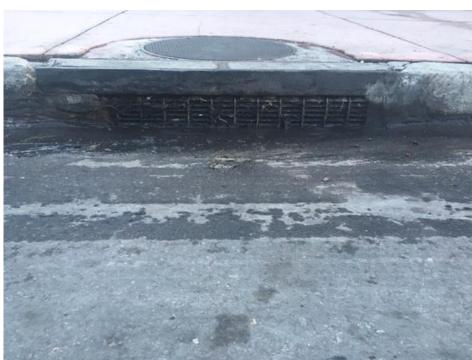
Figure 1: Pictures (above) taken after street sweepers passed by drains.

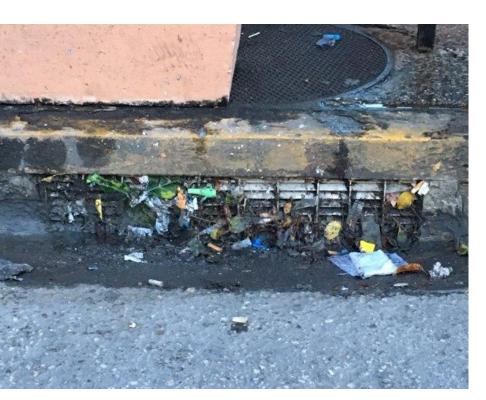
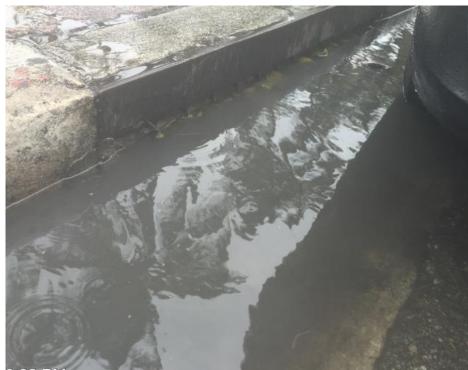
Figure 2: Stop Ocean Pollution Grates clogged with trash and debris do not look aesthetically pleasing in between cleanings.

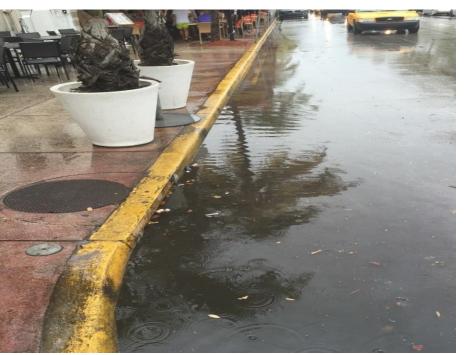
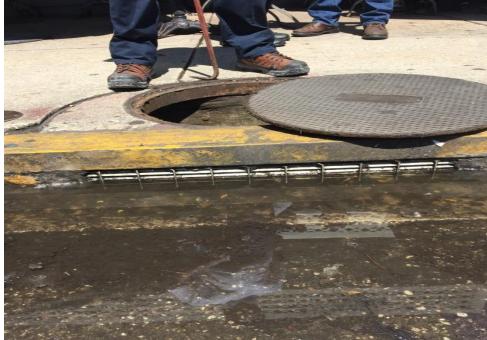
Figure 3: Grates clog and backup water into the street.

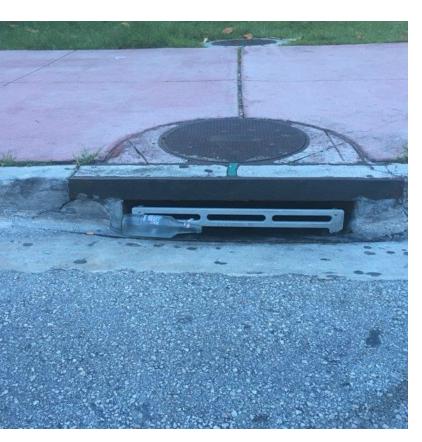
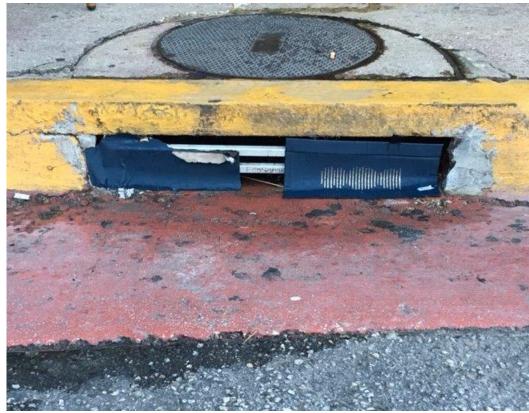
Figure 4: EcoSense grates are better for stopping larger items but need to be cleaned frequently by street sweepers.

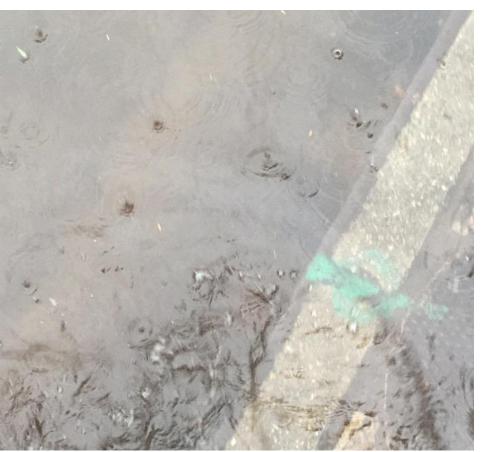
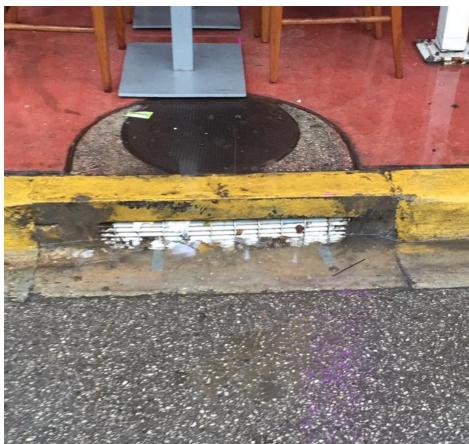
EcoSense grates are better for stopping larger items but need to be cleaned frequently by street sweepers.

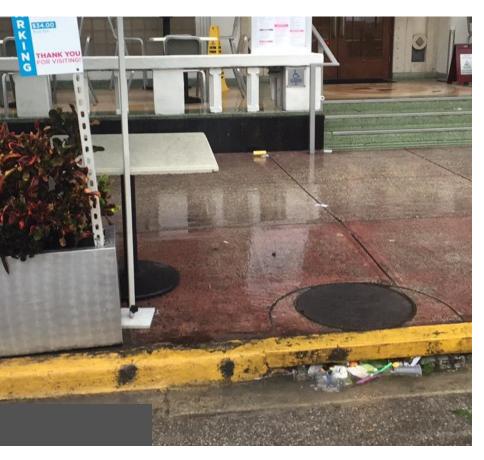
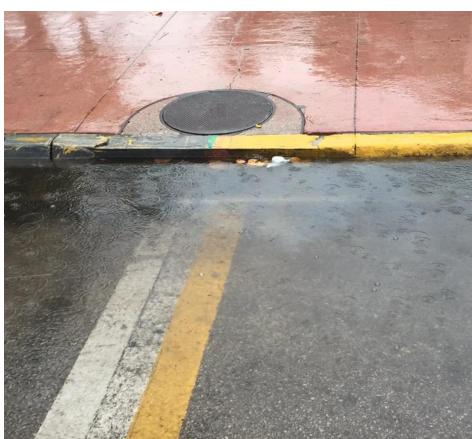
EcoSense grates are better for stopping larger items but need to be cleaned frequently by street sweepers.

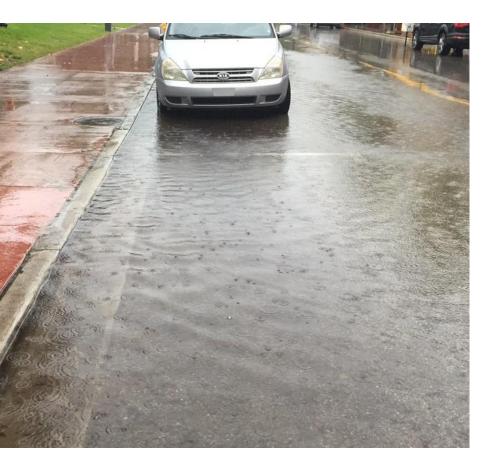
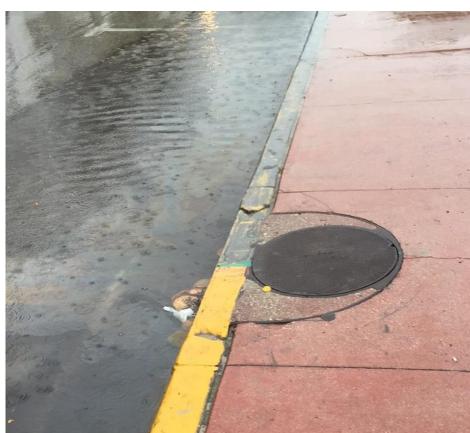
EcoSense grates, flooding from stormwater grates

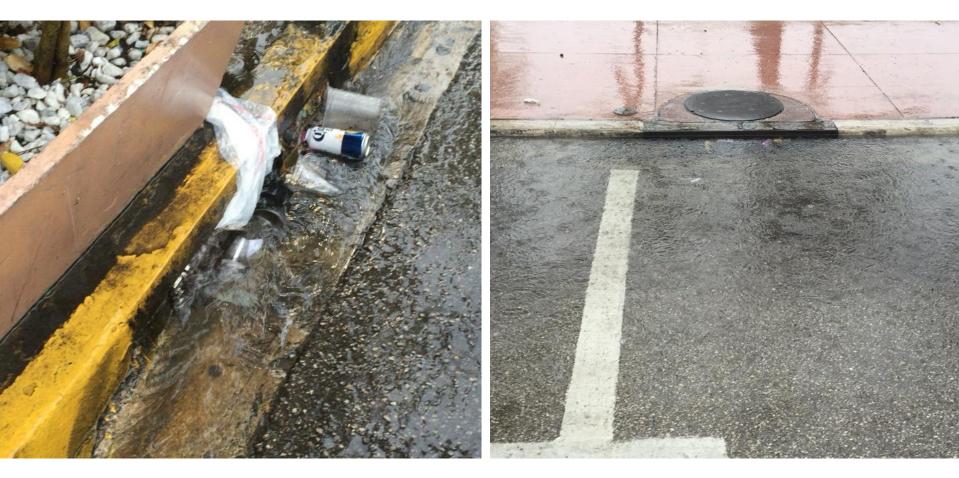
EcoSense grates are better for stopping larger items but need to be cleaned frequently by street sweepers.

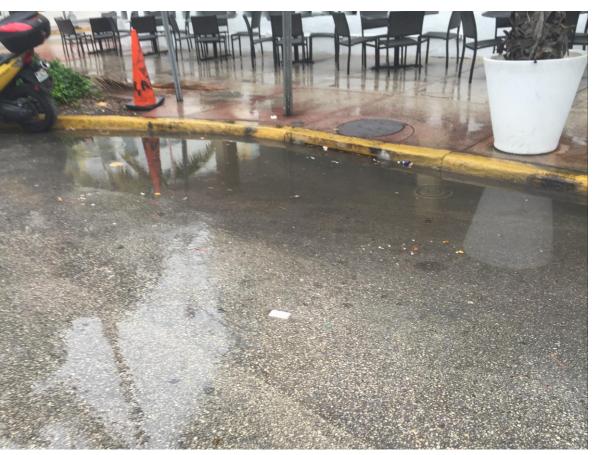
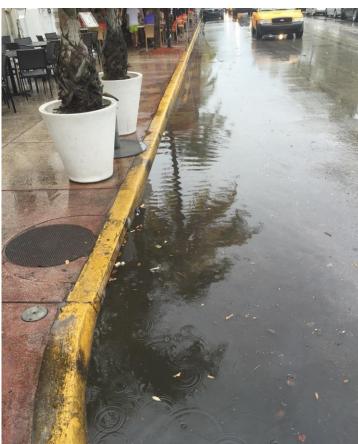
EcoSense grates, flooding from stormwater grates

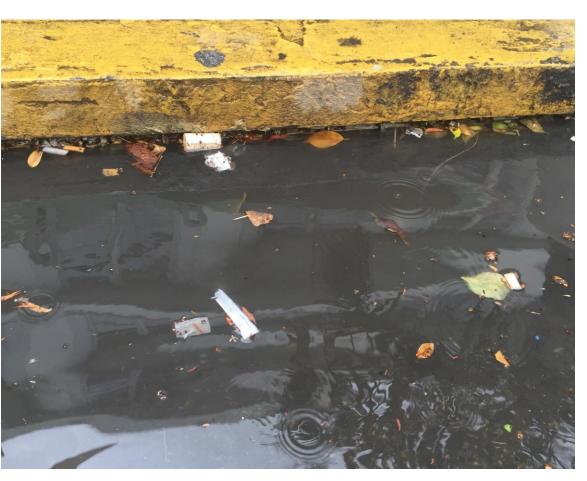
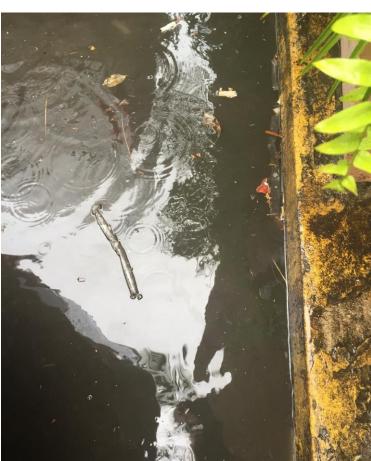
EcoSense grates, flooding from stormwater grates

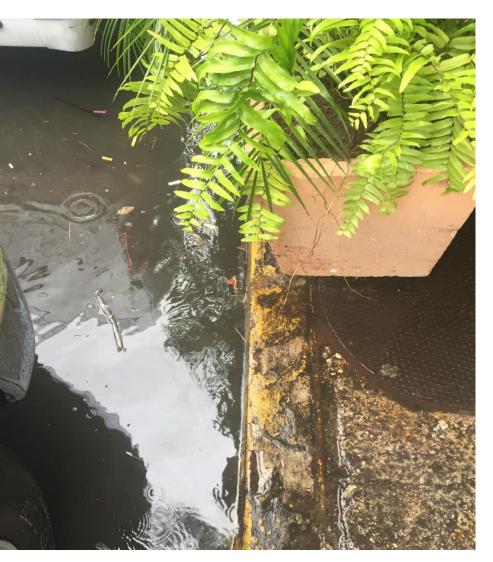
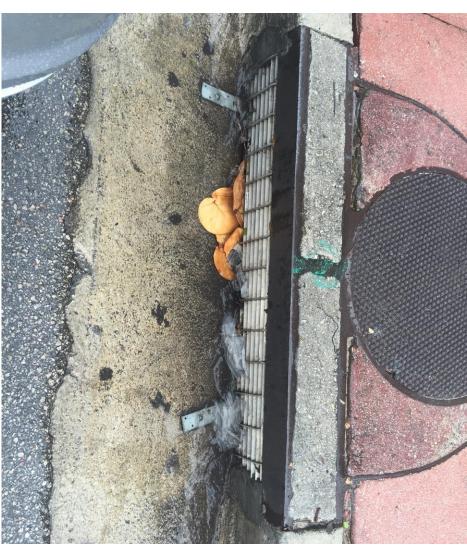
EcoSense grates are better for stopping larger items but need to be cleaned frequently by street sweepers.
