STRUCTURAL CONDITION ASSESSMENT  
1415 Marseille Dr.  
Miami Beach, Florida 33141

May 28, 2021  
H210920

STRUCTURAL CONDITION ASSESSMENT for  
1415 Marseille Dr.  
Miami Beach, Florida

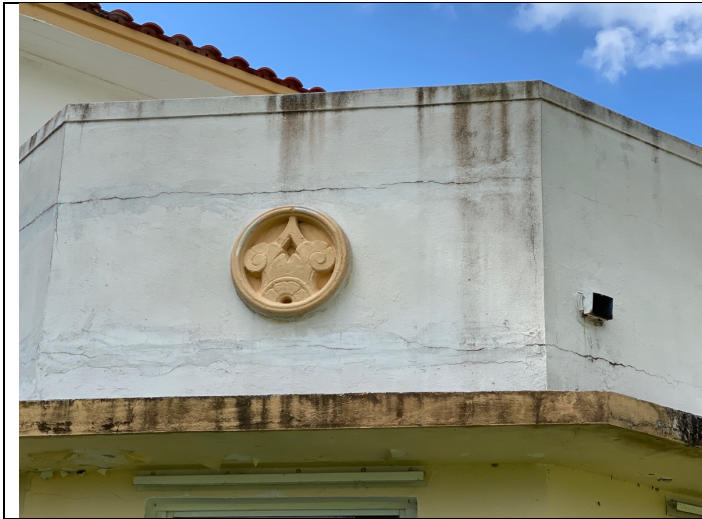
Photo 7 - North East Elevation wall and beam cracking

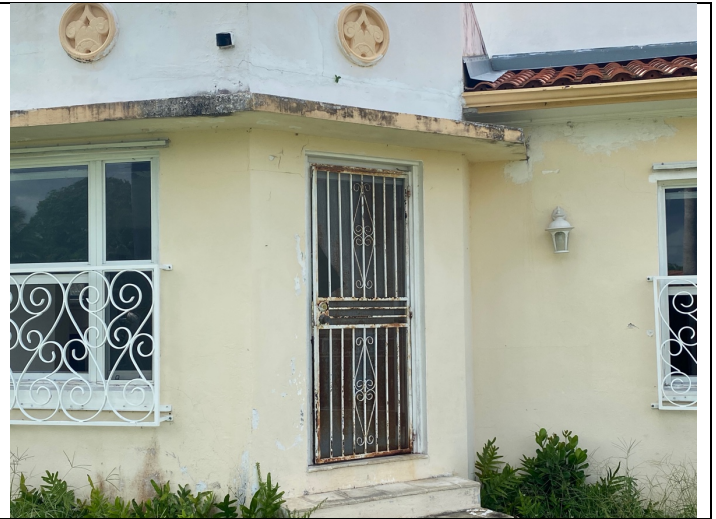
Photo 8 – NW corner beam cracking over eyebrow

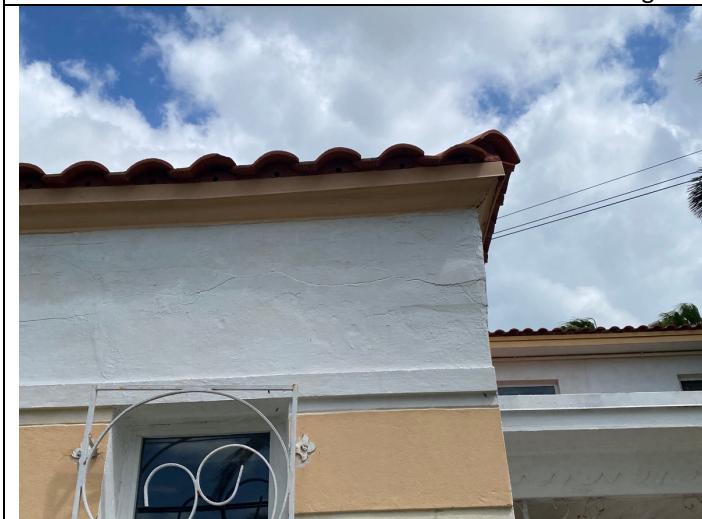
Photo 9 - Concrete Cracking SW elevation

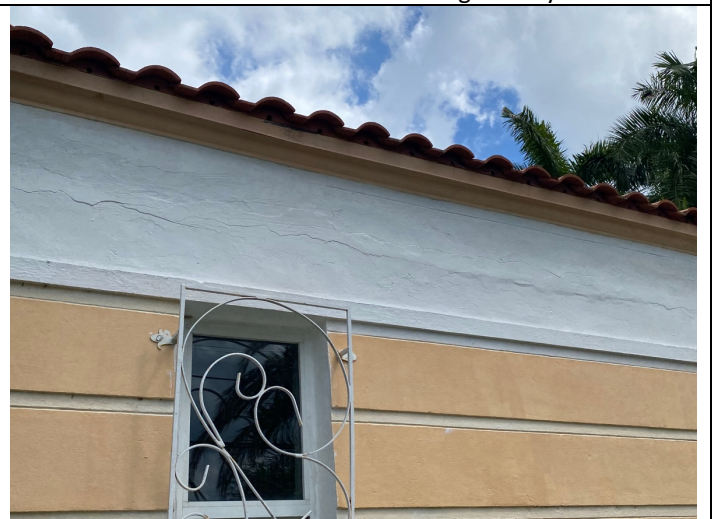
Concrete members observed; including the tie beams over openings and corner columns, have variable levels of deterioration. It is evident that there is rebar corrosion and concrete spalling in these members at varying levels from severe to moderate. Moreover, previous repairs have been performed on the concrete members.

Photo 10 – Concrete spalling on SW elevation

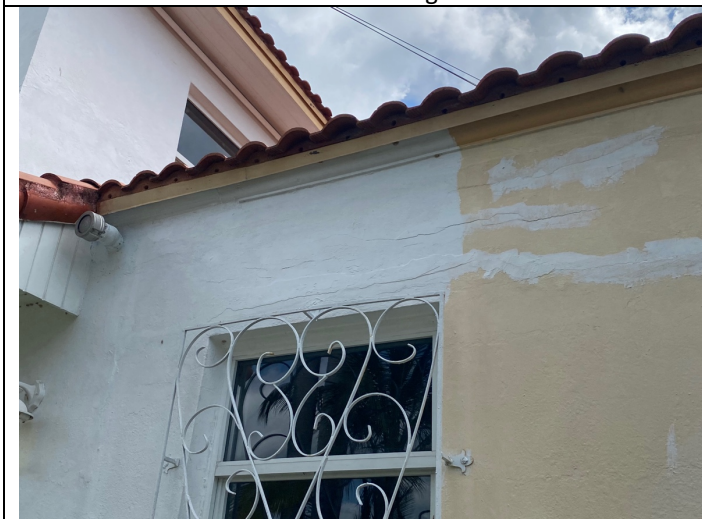
Photo 11 - West Elevation, concrete spalling

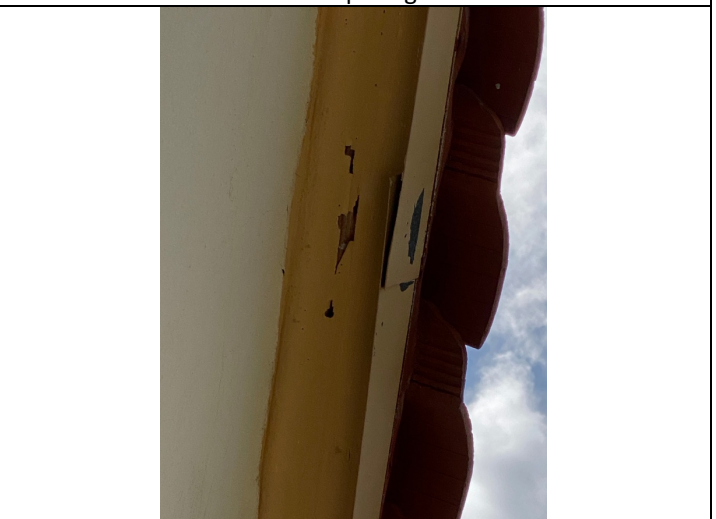
Wood members, including the roof wood members and the 2<sup>nd</sup> floor wood members, have evidence of heavy termite and wet rot damage.

Photo 12 – Roof eave termite damage

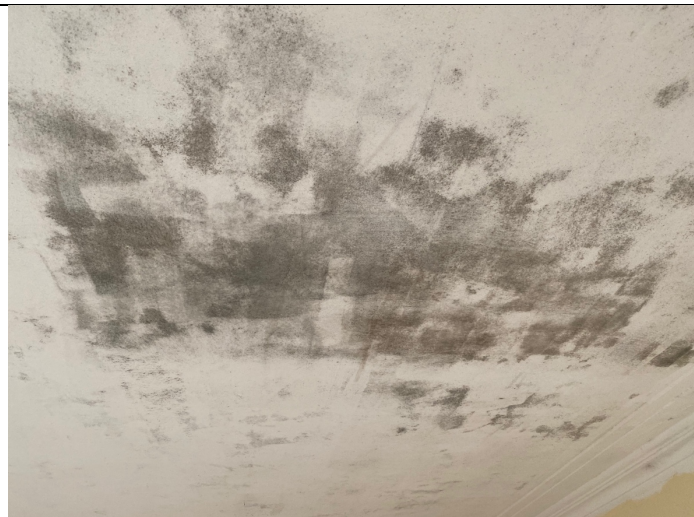
Moisture intrusion into the structure is evident in several locations. Moreover, heavy mold presence is evident on the ceiling of the first floor.

Photo 14 – Mold on ceiling of first floor

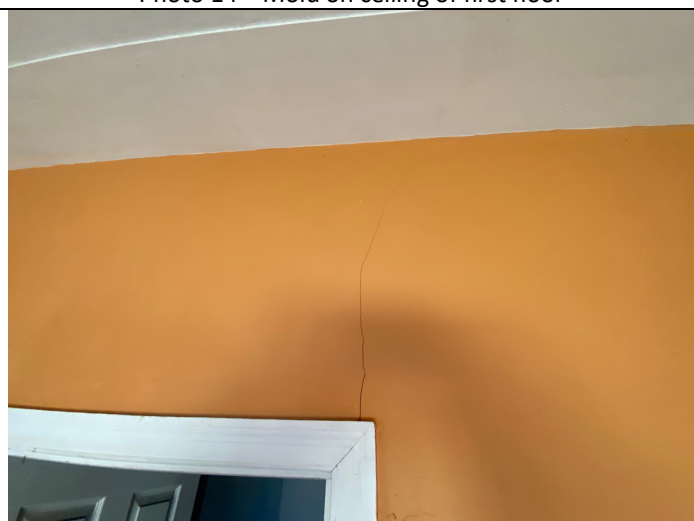
Photo 16 – Plaster cracking over door indicative of settlement

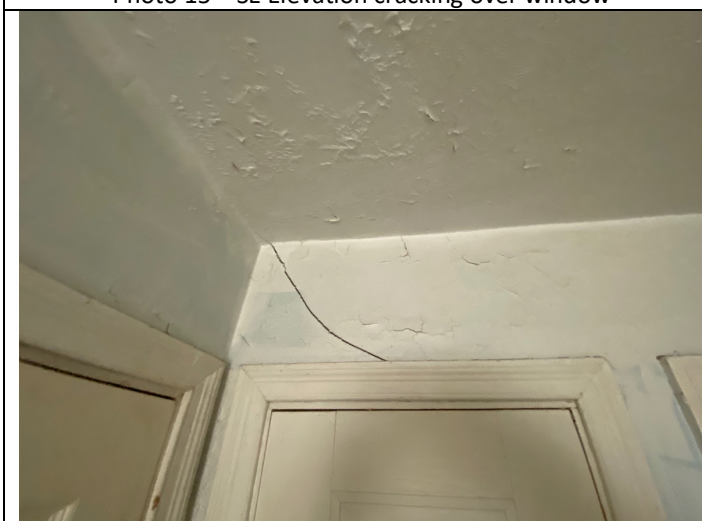
Photo 17 – Plaster cracking over door indicative of settlement

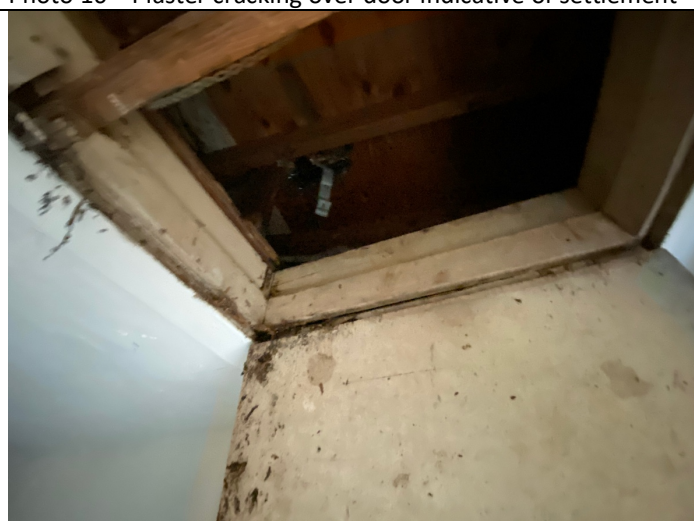
Photo 18 – Wood Damage of 2<sup>nd</sup> floor

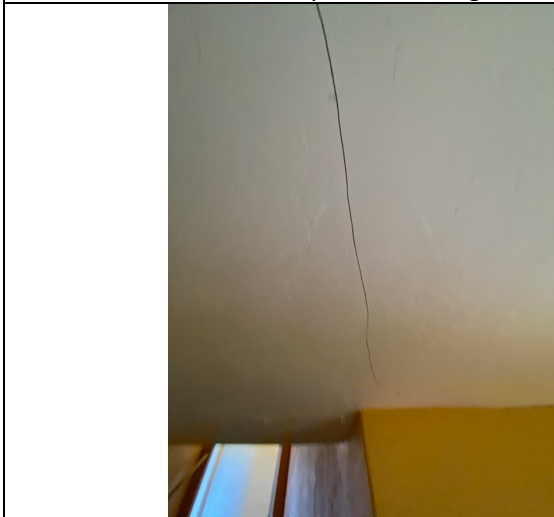
Photo 21 - 2<sup>nd</sup> floor ceiling plaster cracking due to settlement

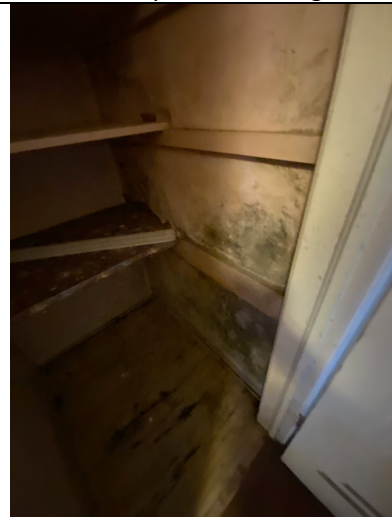
Photo 22 – mold presence in the second floor

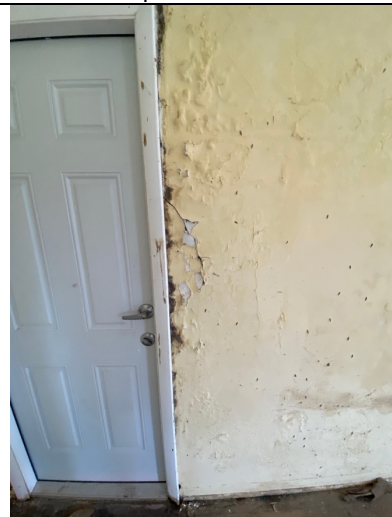
Photo 24 – Moisture damage on walls
