Re: **PB21-0420** - Request for a Lot Split of the Property Located at 1415
Marseille Drive in Miami Beach, Florida

STRUCTURAL CONDITION ASSESSMENT
1415 Marseille Dr.
Miami Beach, Florida 33141

May 28, 2021
H210920

Youssef Hachem Consulting Engineering

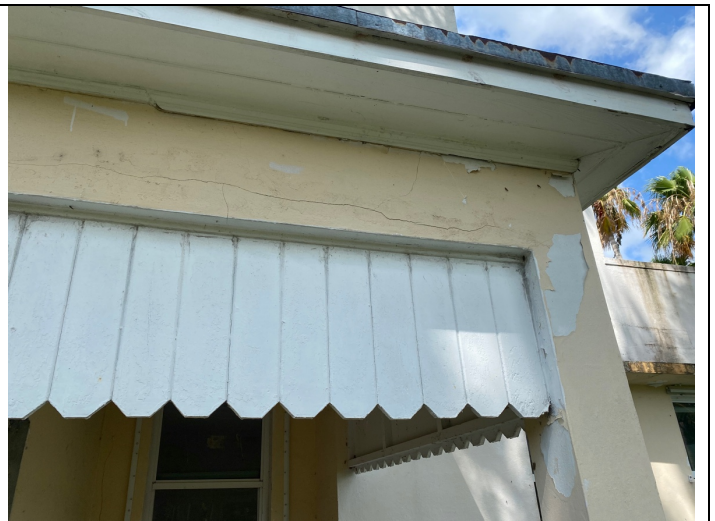
Concrete members observed; including the tie beams over openings and corner columns, have variable levels of deterioration. It is evident that there is rebar corrosion and concrete spalling in these members at varying levels from severe to moderate. Moreover, previous repairs have been performed on the concrete members.

Photo 2- Concrete beam cracking in back of garage

Based on the site observations of the conditions of structural members of the building, and level III alteration required by the Florida Building Code, the structural members of this building need to undergo extensive rehabilitation, including CMU reinforcement, lateral systems construction, and strengthening of the foundations. Moreover, repairs to the roof and spalled concrete has to be done, and foundations augmentation has to be done to remedy the settlement.

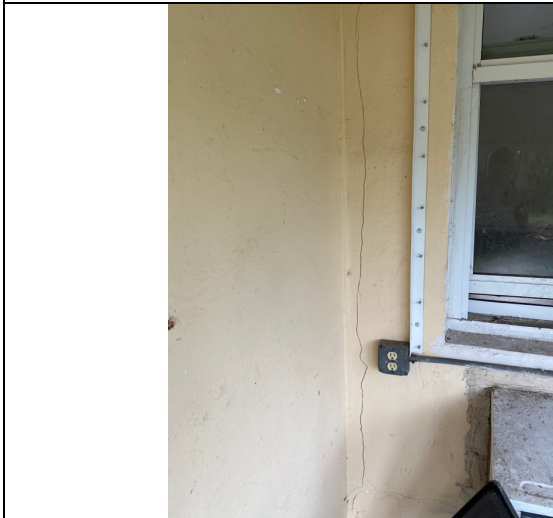
There are substantial cracks in walls, beams, and columns indicating settlement of the structure at different locations throughout the building.

Photo 3 - Wall cracking on East elevation

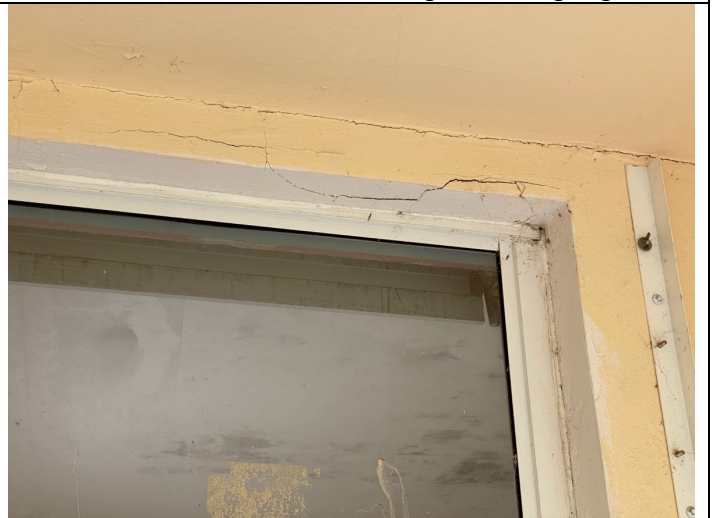
Photo 4 - Beam cracking over window on East elevation

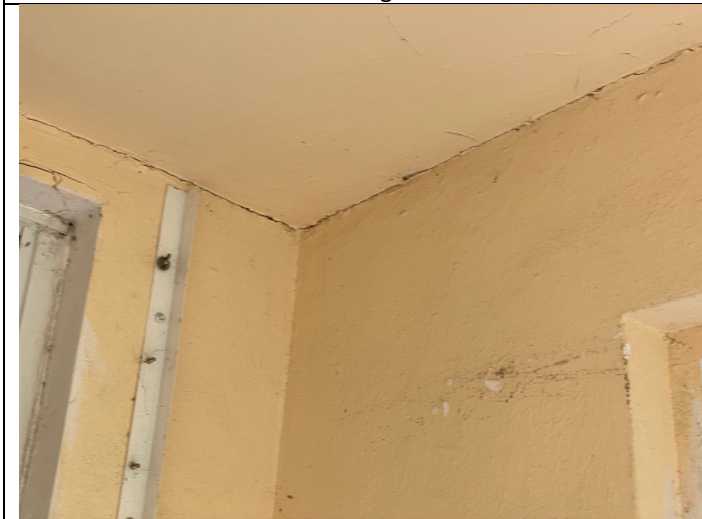
Photo 5- wall / roof separation on East elevation foundation settlement

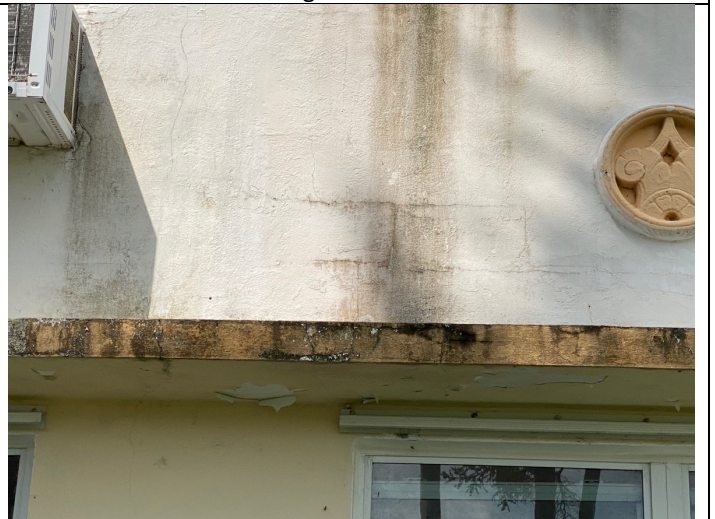
Photo 6 - Drop in office (South west corner) due to foundation settlement

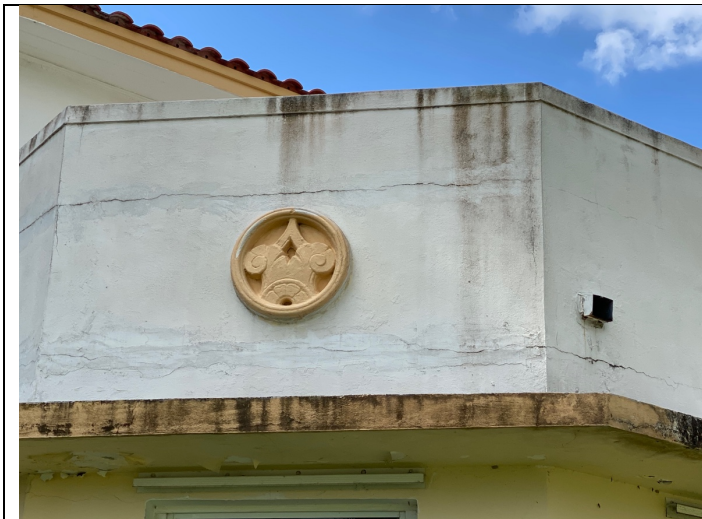
Photo 7 - North East Elevation wall and beam cracking

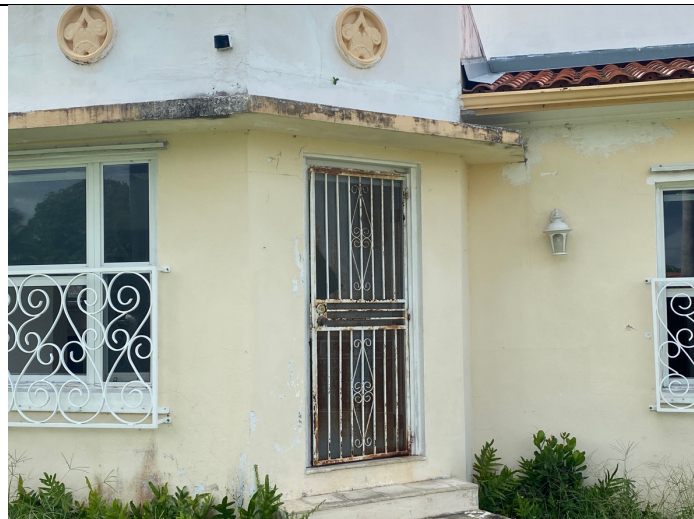
Photo 8 - NW corner beam cracking over eyebrow

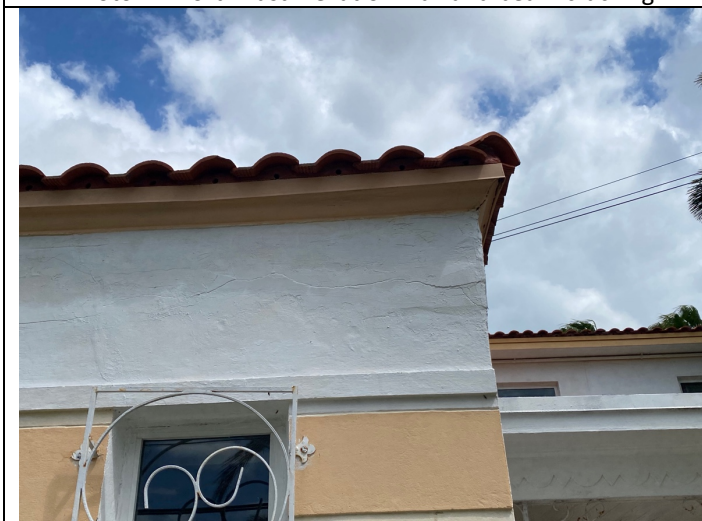
Photo 9 - Concrete Cracking SW elevation

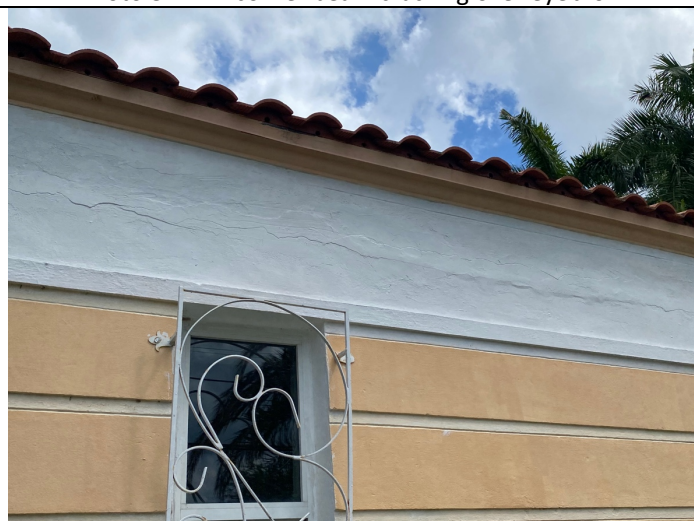
Photo 10 - Concrete spalling on SW elevation

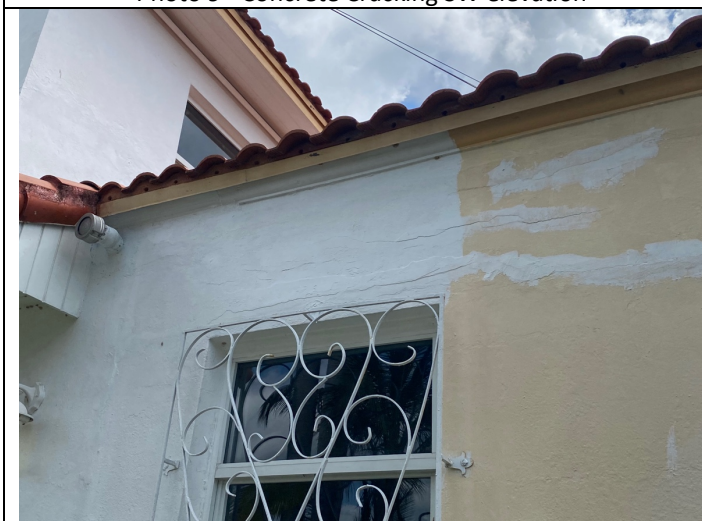
Photo 11 - West Elevation, concrete spalling

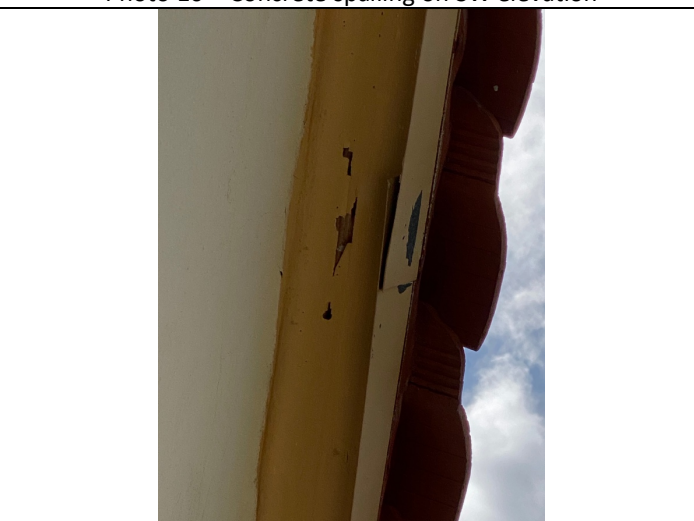
Wood members, including the roof wood members and the 2nd floor wood members, have evidence of heavy termite and wet rot damage.

Photo 12 - Roof eave termite damage

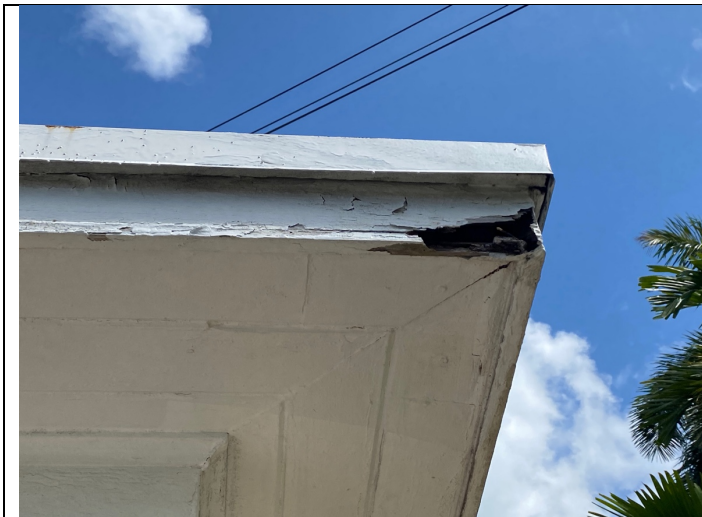
Photo 13 – SE Elevation, roof Eave damage

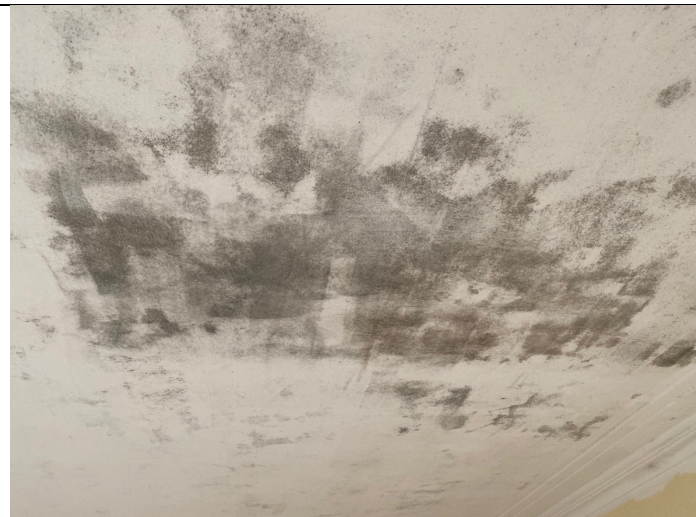
Moisture intrusion into the structure is evident in several locations. Moreover, heavy mold presence is evident on the ceiling of the first floor.

Photo 14 – Mold on ceiling of first floor

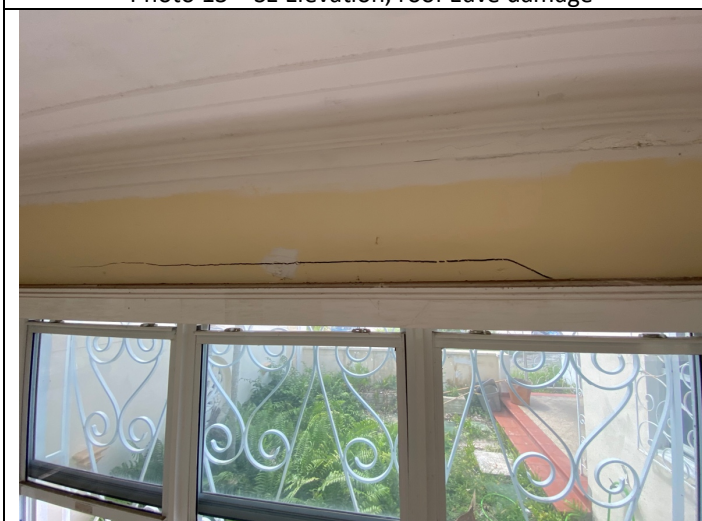
Photo 15 – SE Elevation cracking over window

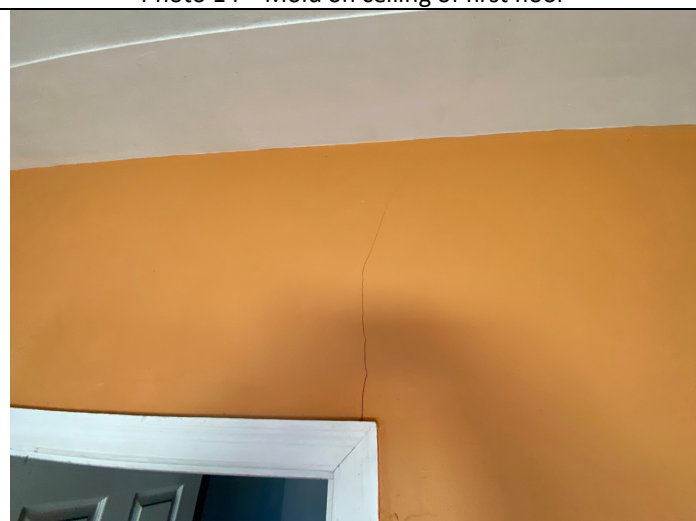
Photo 16 – Plaster cracking over door indicative of settlement

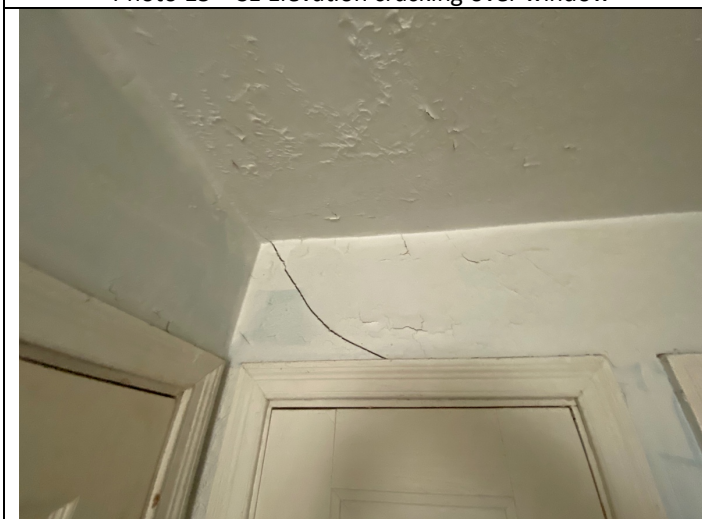
Photo 17 – Plaster cracking over door indicative of settlement

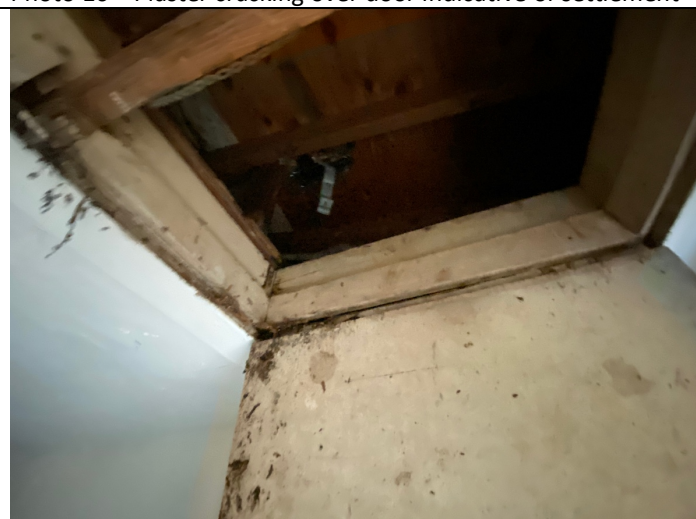
Photo 18 – Wood Damage of 2nd floor

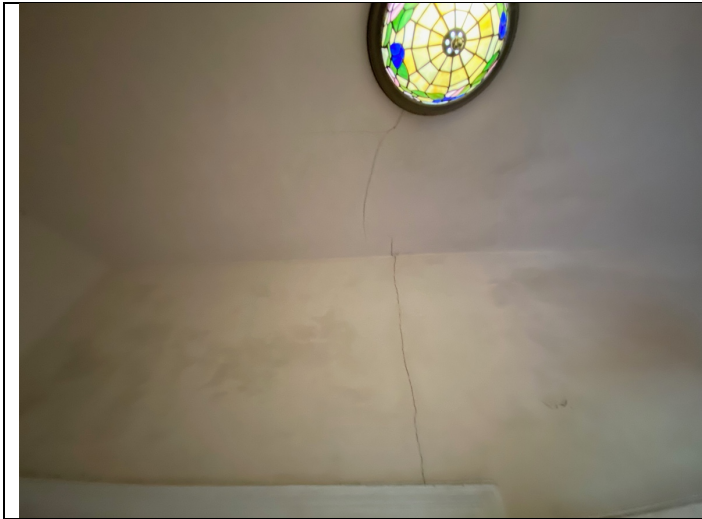
Photo 19 – 2nd floor wall plaster cracking due to settlement

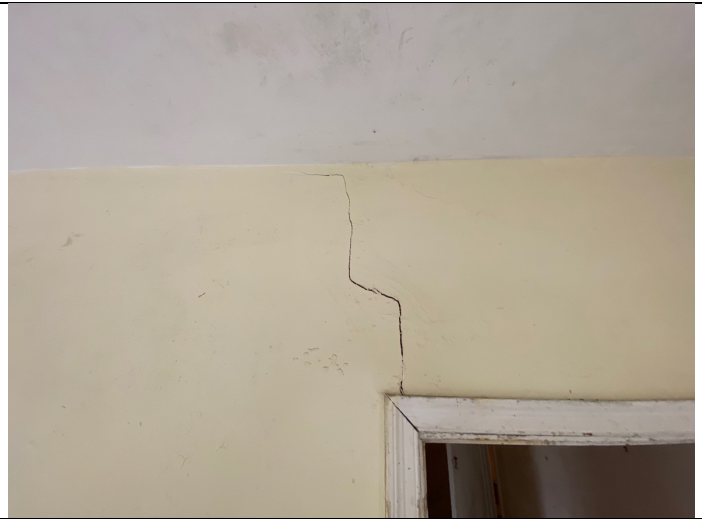
Photo 20 – 2nd floor wall plaster cracking due to settlement

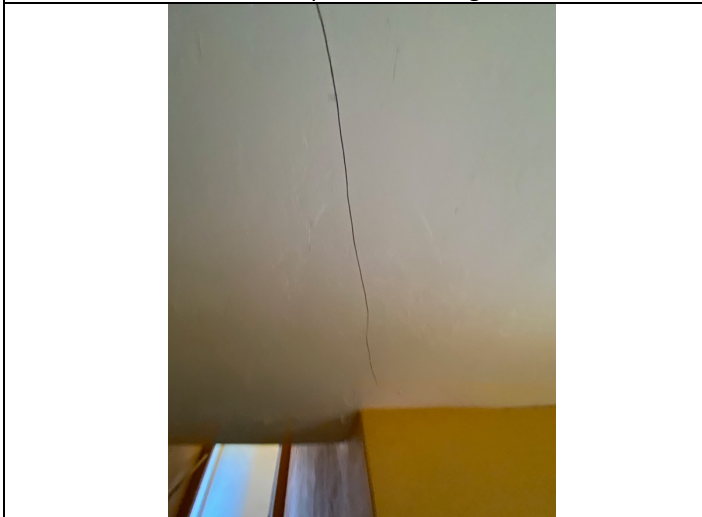
Photo 21 - 2nd floor ceiling plaster cracking due to settlement

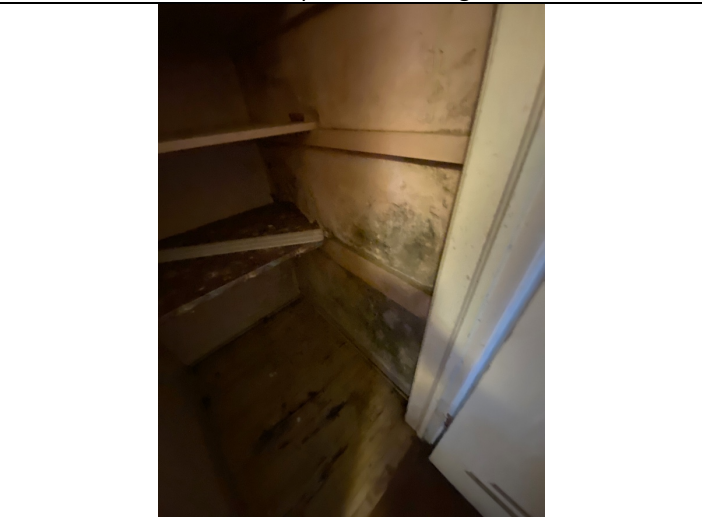
Photo 22 – mold presence in the second floor

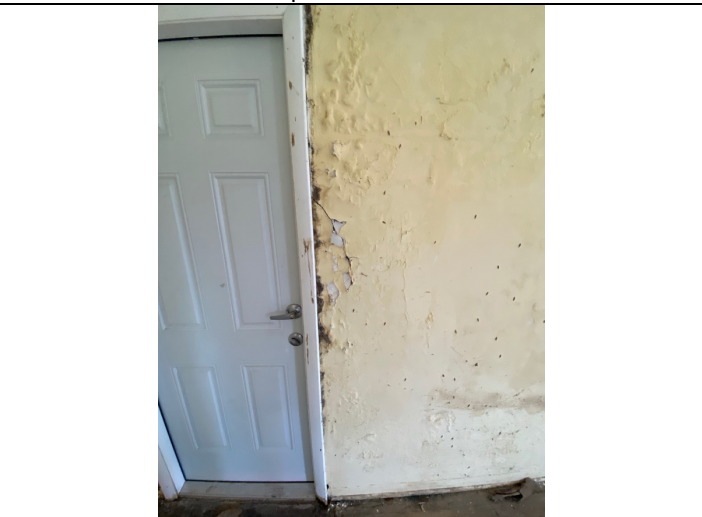
Photo 24 – Moisture damage on walls

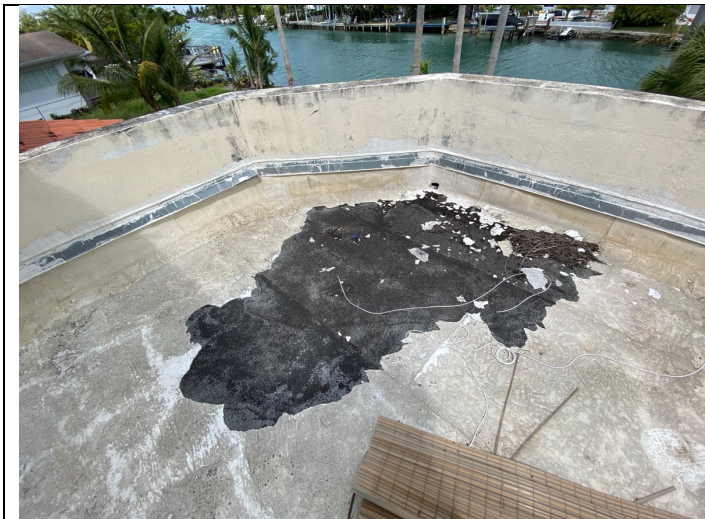
Photo 25 – Roof Membrane damage

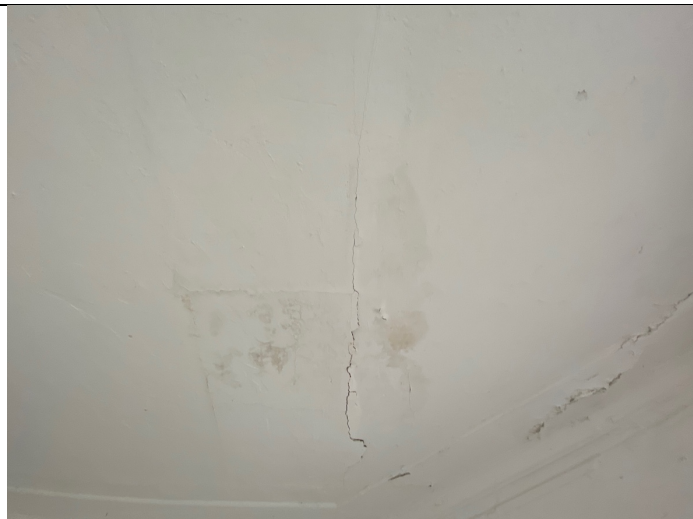
Photo 26 – North corner living room ceiling damage
