GENERAL CONDITIONS ASSESSMENT REPORT

EXISTING STRUCTURAL SYSTEMS

EXISTING RESIDENTIAL APARTMENT BUILDING

1158 MARSEILLE DRIVE
MIAMI BEACH, FLORIDA

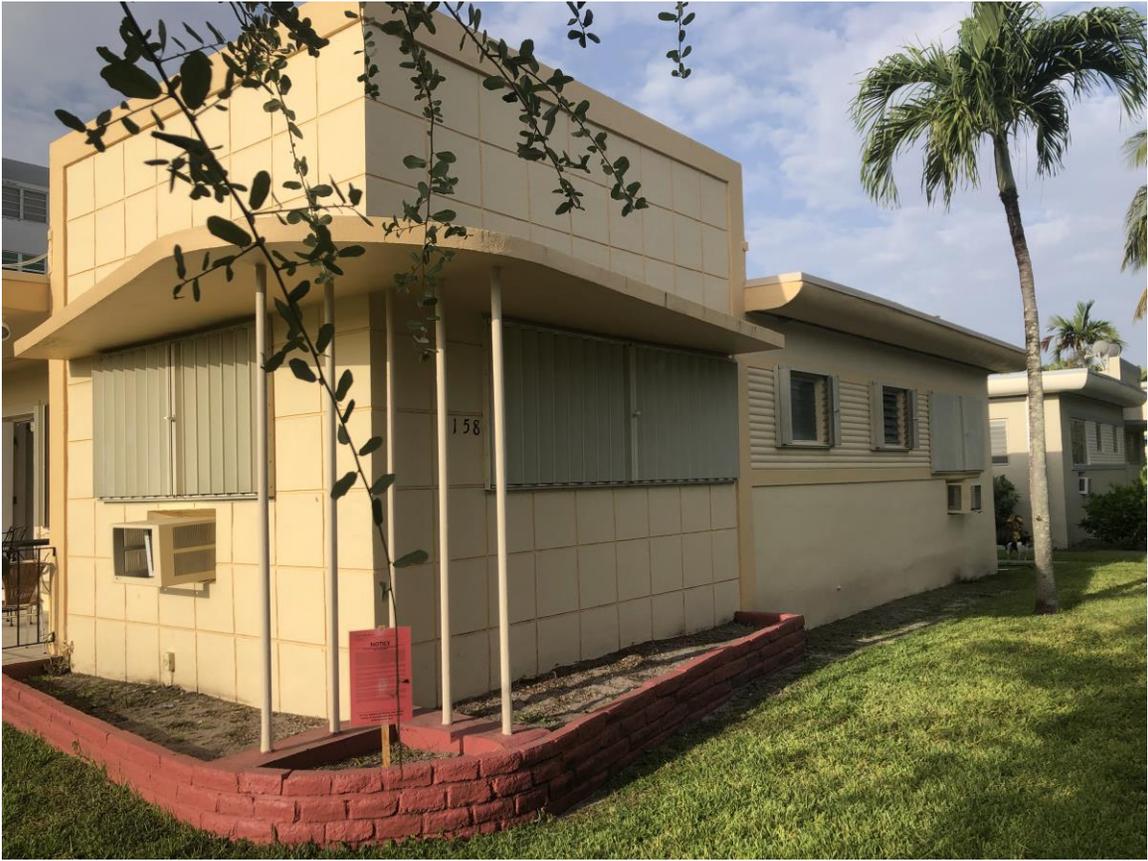
PHOTOGRAPH NO. 1

5. There are through-wall air conditioning units (refer to Photographs Nos. 1, 3, 6, 14, 28, and 30). Most of these units have been replaced, leaving former housings and reduced openings. These units are likely sources of air and water leaks, and they do not provide appropriate wind and impact resistance.

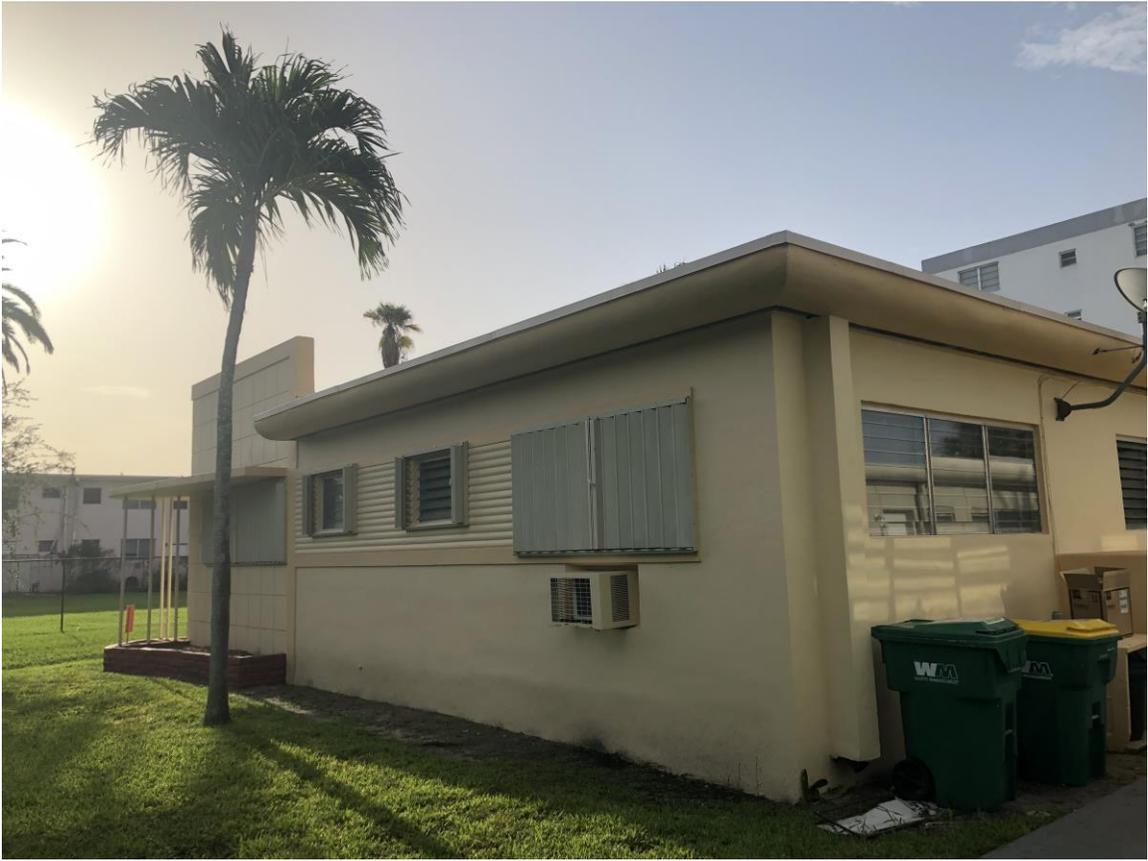
PHOTOGRAPH NO. 3

1. All of the exterior windows are the jalousie type (refer to Photographs Nos. 3 through 8, 28, 29, and 30). The windows on the north and east sides have been equipped with accordion shutters. The windows on the west and south sides have not been equipped with shutters. Jalousie windows perform

2. There are abandoned pipes and pipe enclosures on the west side of the building (refer to Photographs Nos. 3, 4, 5, 8, 13, 32, and 35). These pipes appear to have been former roof drainpipes. At this time, the roof drains directly from the edge of the roof.

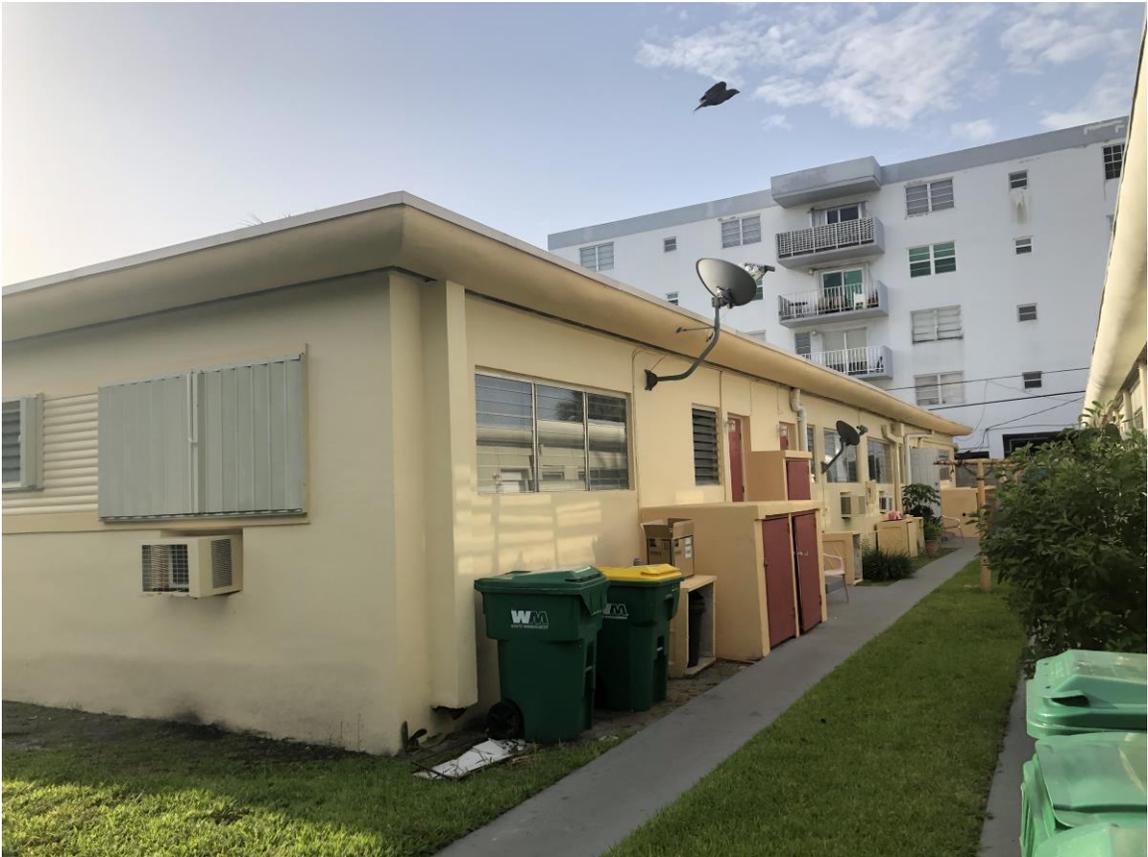
PHOTOGRAPH NO. 4

3. The doors of the storage closets (and meter closet, washer closet and dryer closet) consist of single sheets of plywood with two surface-mounted hinges and a hasp lock (refer to Photographs Nos. 4, 5, 34, and 36). One hinge is broken, and one hasp is broken. One door is rotted at the bottom. These doors and their attachments are flimsy. They are not appropriately wind resistant.

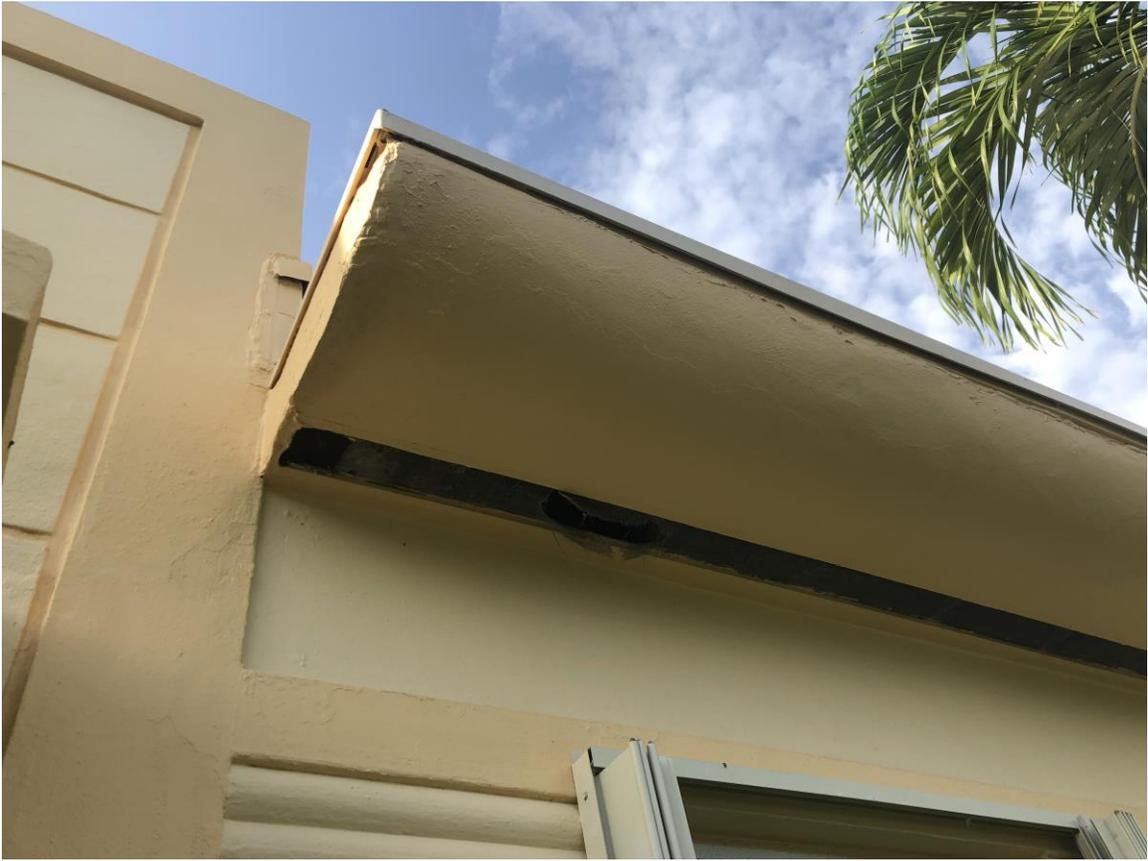
PHOTOGRAPH NO. 9

5. The screening at the eave soffit vents is deteriorated and torn (refer to Photograph No. 9). This condition can allow the entry of insects, birds, and rodents.

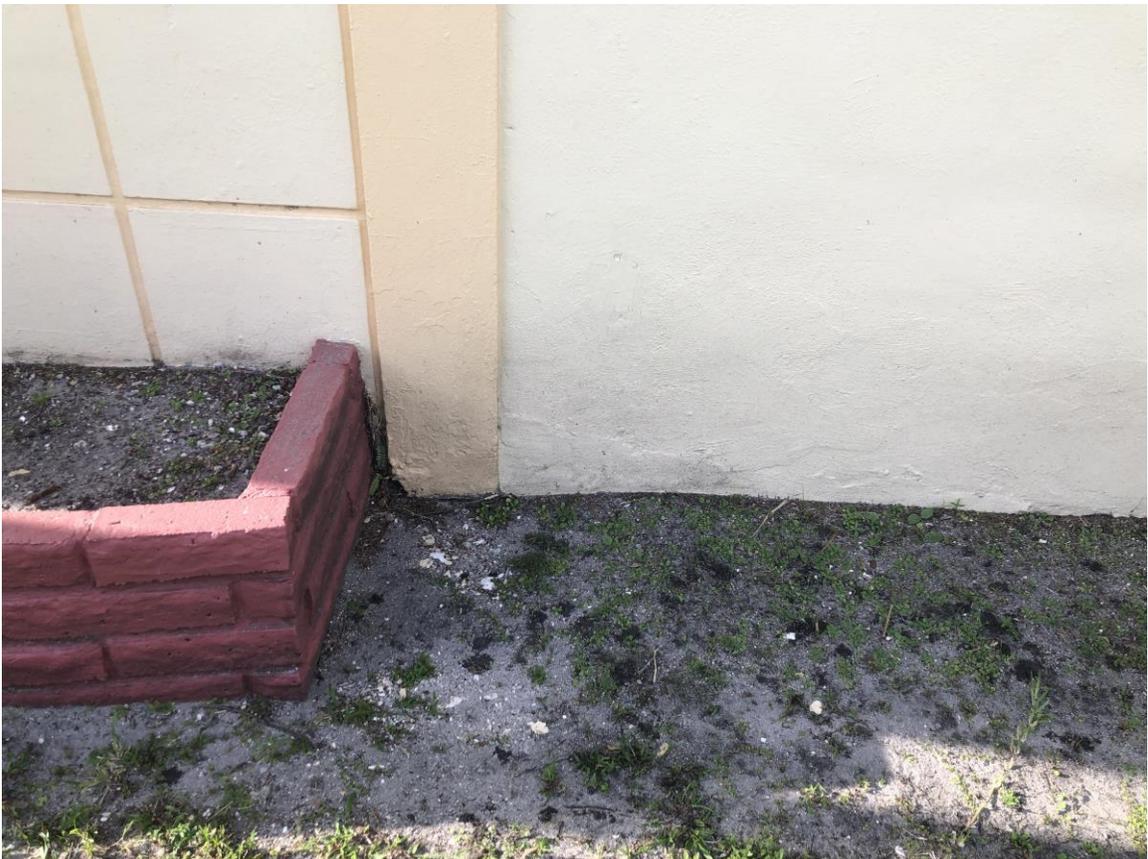
PHOTOGRAPH NO. 10

4. There are many locations of previous patching of concrete members around the exterior of the building (refer to Photographs Nos. 10, 11, 15, and 26).

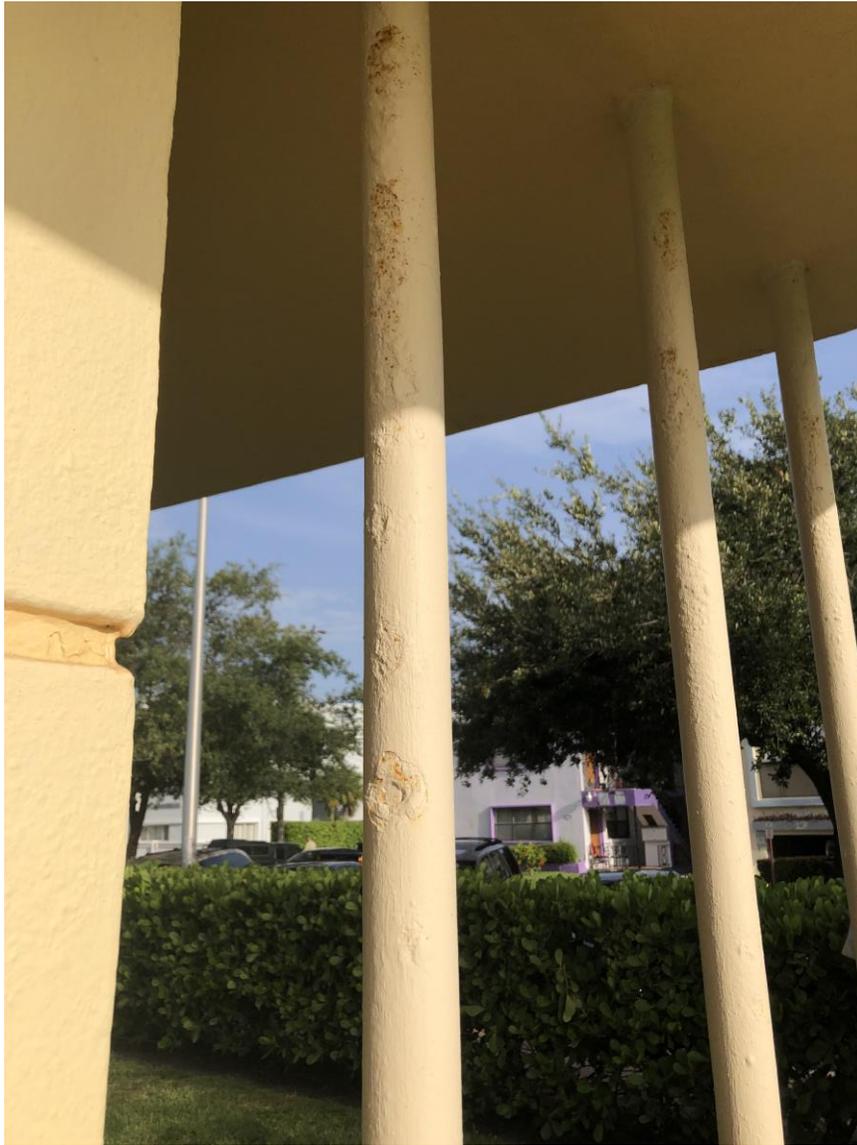
PHOTOGRAPH NO. 16

6. The five steel pipe columns under the concrete eyebrow are corroded, with deep corrosion pits in some locations (refer to Photographs Nos. 16 and 17).

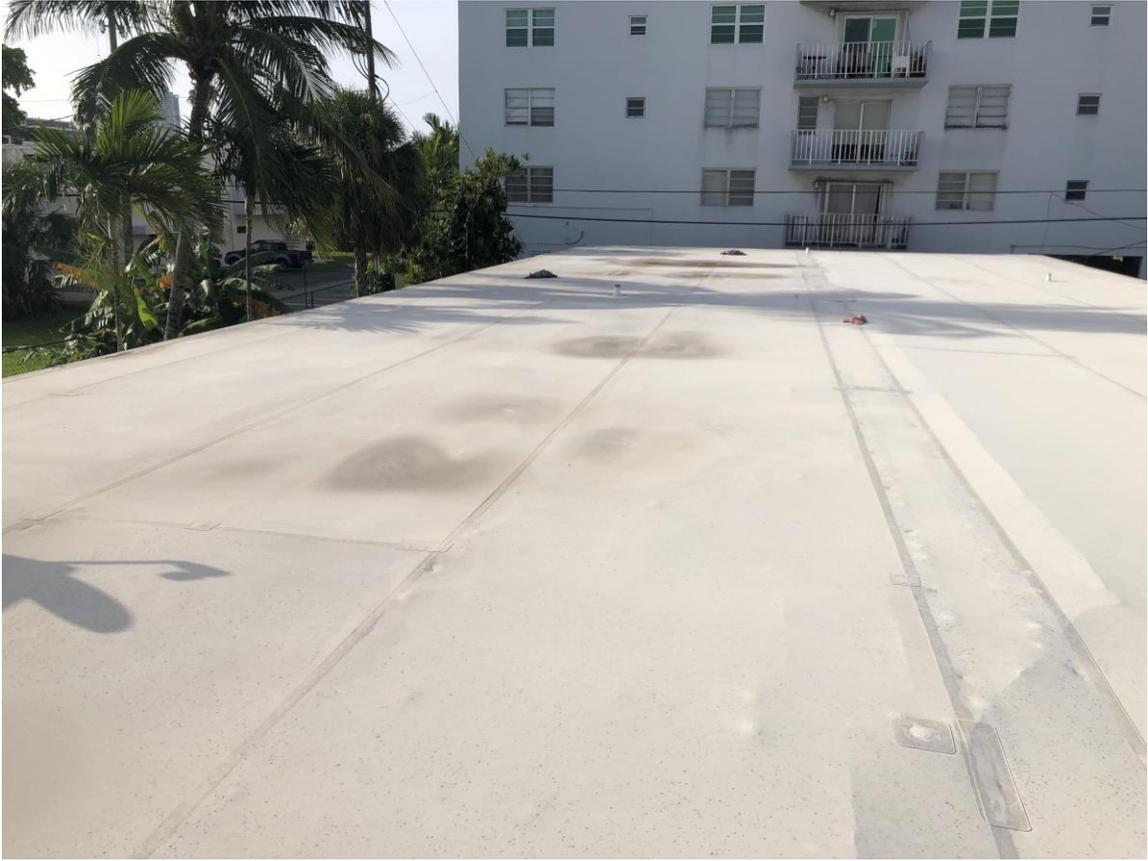
PHOTOGRAPH NO. 18

1. There is some puddling on the roof (refer to Photographs Nos. 18 through 23).
2. There are several patches in the roofing (refer to Photographs Nos. 18 through 25). There was a recently reported roof leak which is reported to have been stopped. Patched areas on the ceilings in a few locations inside the building indicate previous roof leaks (refer to Photographs Nos. 43 and 44).

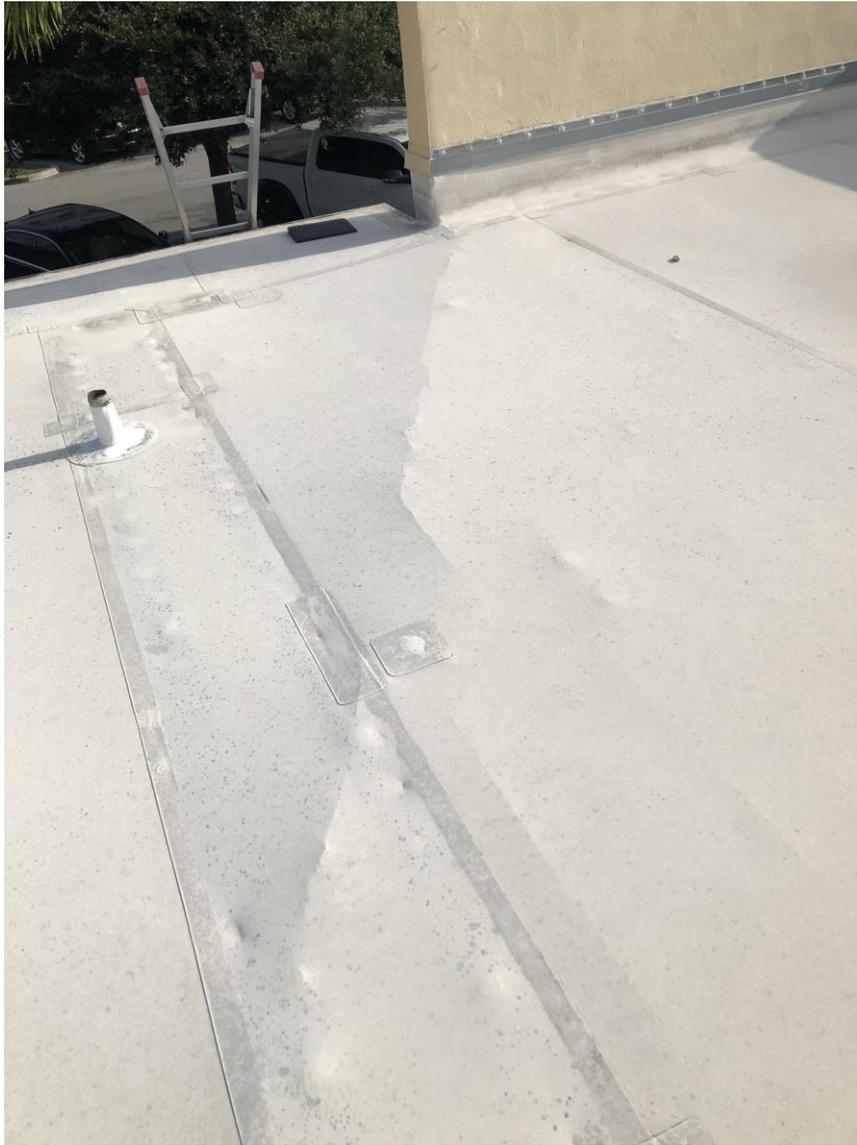
PHOTOGRAPH NO. 25

3. There is an odd, hard ridge under the roofing, running diagonally from the east end of the northeast parapet (refer to Photograph No. 25). It appears that this ridge may be the end of shallow cricket installed to improve drainage from the corner of the roof edge closed by the parapet. This sharp edge could wear on or tear the roofing membrane if subjected to foot traffic, debris or impact.

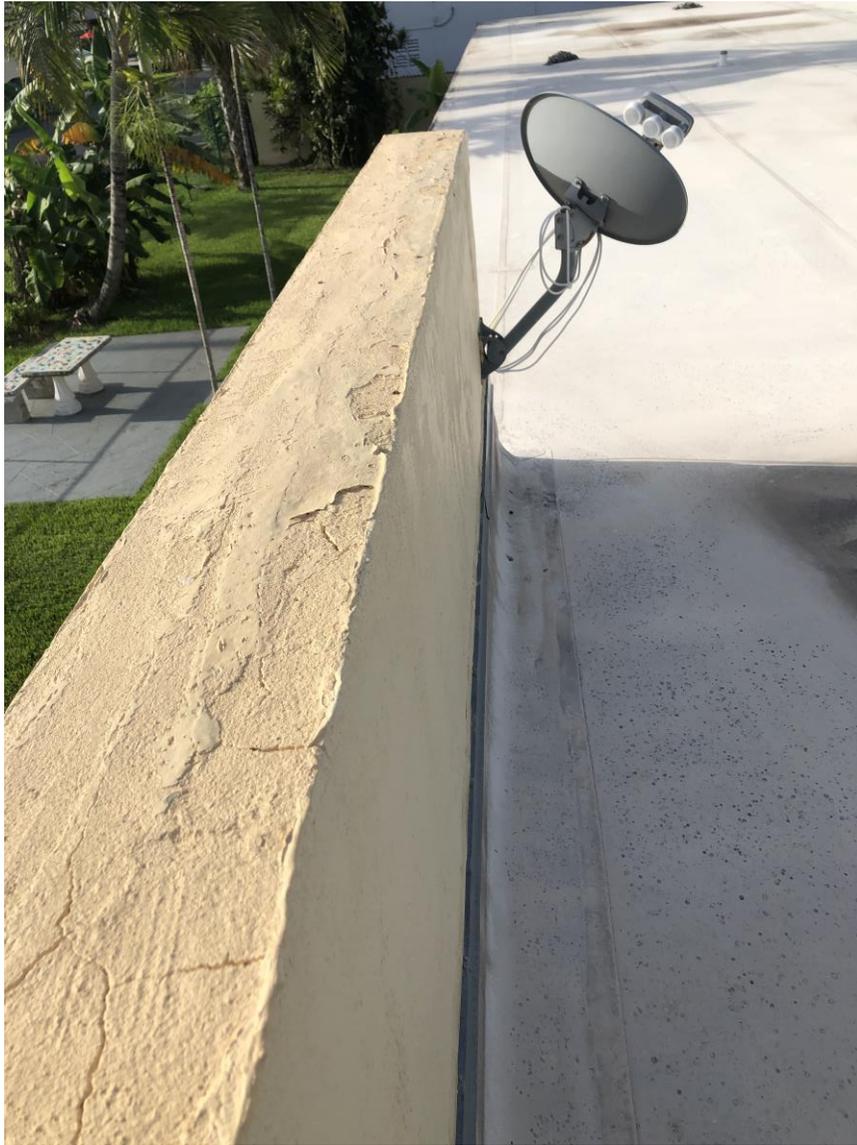
PHOTOGRAPH NO. 26

1. There are many locations throughout the exterior of the building that respond with a hollow sound when “sounded.” These locations include:
 - a. many locations along the tie beams/lintels below the roof around all four sides of the building (refer to Photographs Nos. 29 and 31),
 - b. many locations along the stem walls and slab edges around all four sides of the building (refer to Photographs Nos. 10 and 33),
 - c. column at the south end of the east side eyebrow,
 - d. numerous locations at the windowsills (refer to Photograph No. 30),
 - e. a few locations in the concrete eyebrow (refer to Photographs Nos. 12, 15, and 27), and
 - f. the top of the south end of the parapet (refer to Photograph No. 26).

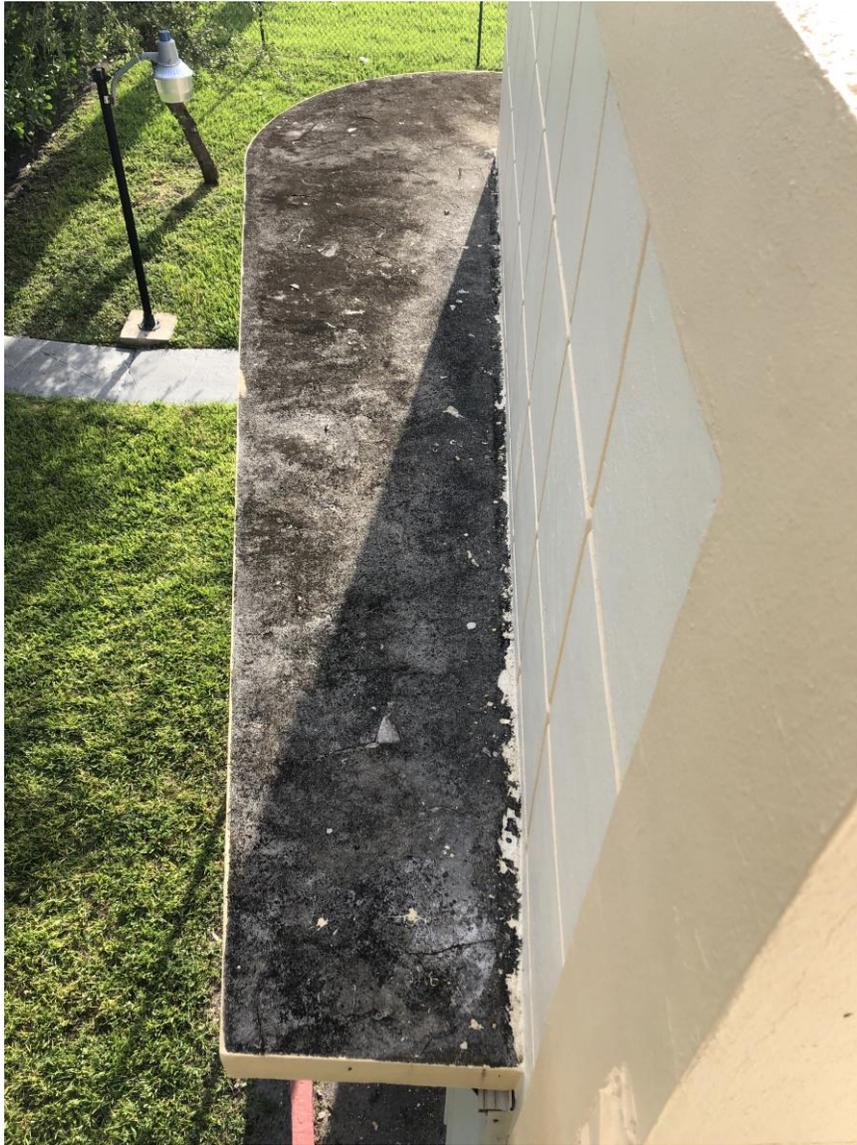
PHOTOGRAPH NO. 27

7. The top of the concrete eyebrow is not waterproofed (refer to Photograph No. 27). This condition allows air and water to hasten deterioration of the concrete member.

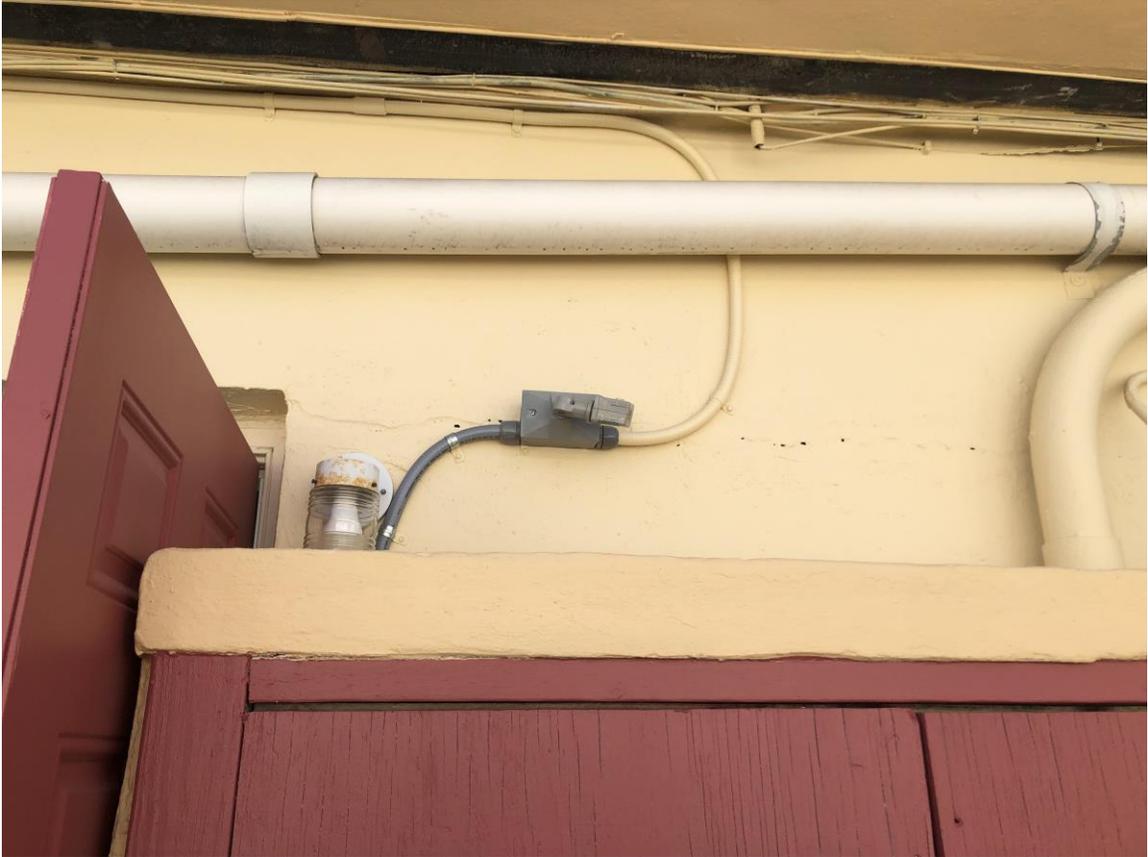
PHOTOGRAPH NO. 32

3. There is a horizontal crack in the concrete block masonry above the electric meter closet on the west side of the building (refer to Photograph No. 32). This crack also appears to be the result of some foundation settlement.

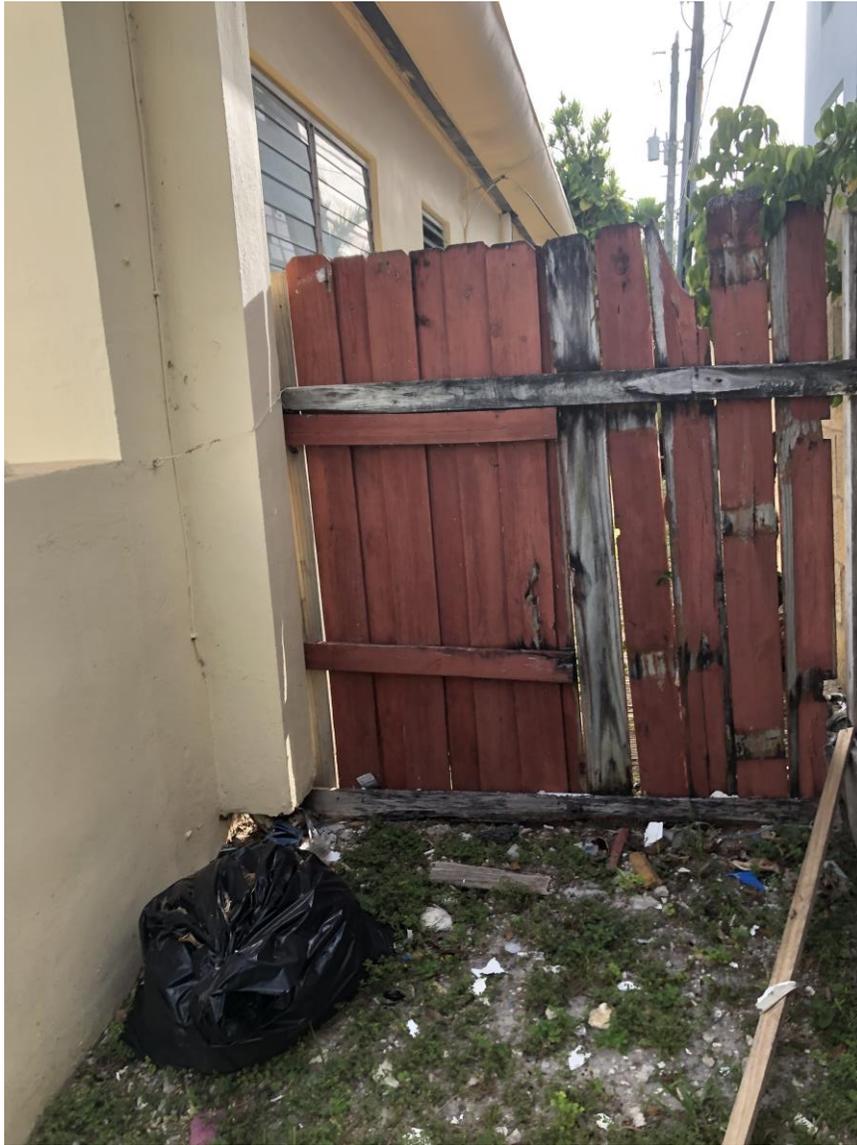
PHOTOGRAPH NO. 35

4. There is a wood fence near the west end of the south wall (refer to Photograph No. 35). This fence is in poor condition, and it or its parts could become wind-borne debris in a windstorm.

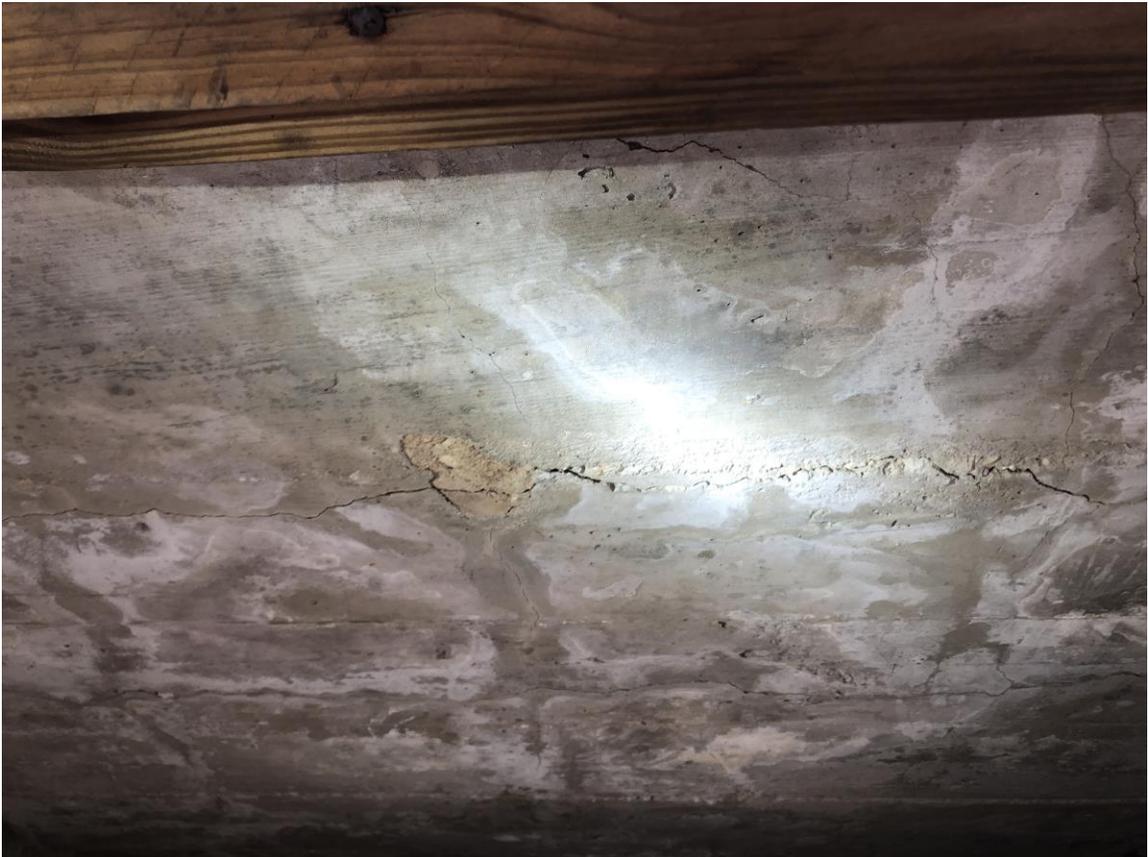
PHOTOGRAPH NO. 37

6. The roofs of the storage closets are thin concrete slabs. There are several locations of spalled concrete (detected by “sounding”) and cracked concrete (refer to Photograph No. 37) in these slabs. There is a location of “honeycombed” concrete on the bottom of these slabs (refer to Photograph No. 41). This condition is from the original construction. This condition hastens deterioration of the concrete member.

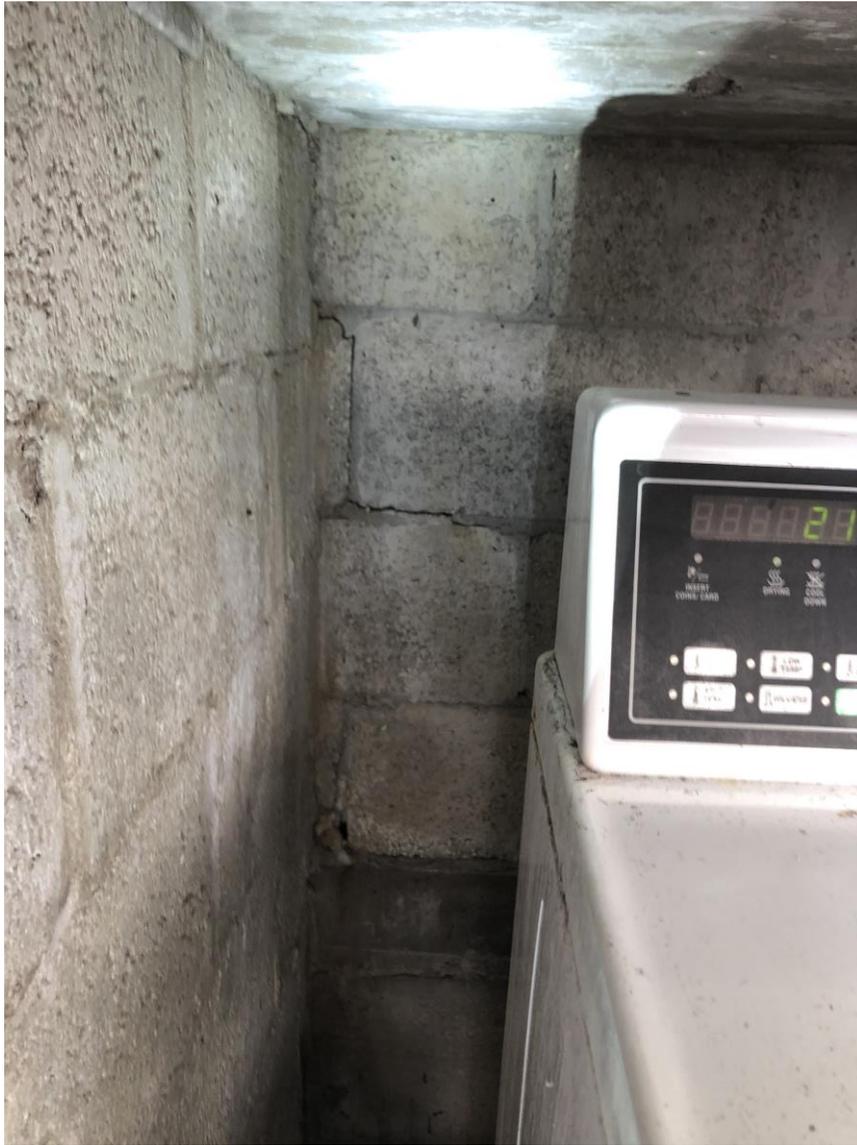
PHOTOGRAPH NO. 38

2. There is a crack in the concrete block bearing wall of the main building at the back of the washing machine closet (refer to Photograph No. 38). This crack is likely the result of some foundation settlement.

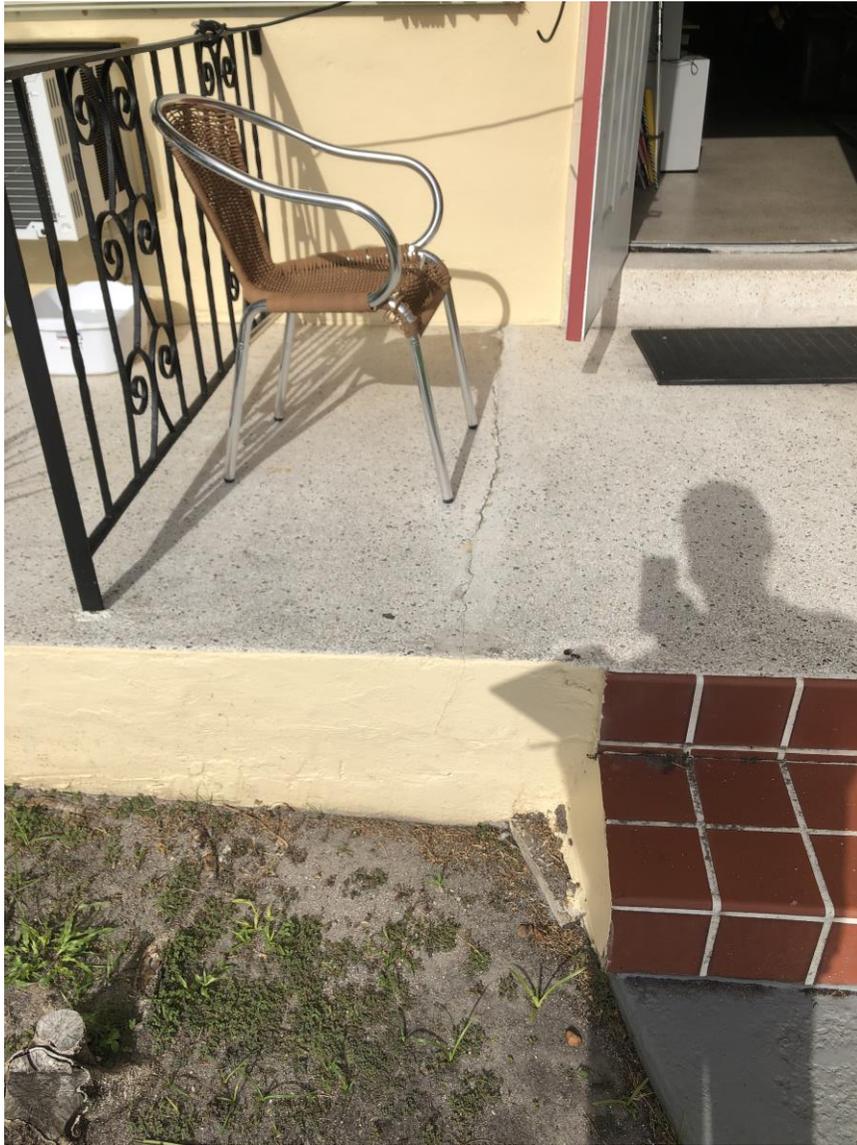
PHOTOGRAPH NO. 42

1. The exterior steps to unit #2 respond to “sounding” with a hollow sound, indicating spalled concrete.
2. There are numerous cracks in the terrazzo floors (refer to Photographs Nos. 42 and 46 through 50). These cracks may indicate cracking and spalling in the concrete floor slab below the terrazzo finish.
3. There are cracks in the exterior site walkways (refer to Photographs Nos. 39 and 40). These cracks are likely due to a combination of concrete shrinkage and soil settlement.
4. As noted above, many locations at the edges of the concrete floor and porch slabs respond with a hollow sound when “sounded.” This indicates many locations of spalled concrete.
