Arborist Report

114 W San Marino Drive
Miami Beach

7/8/2021

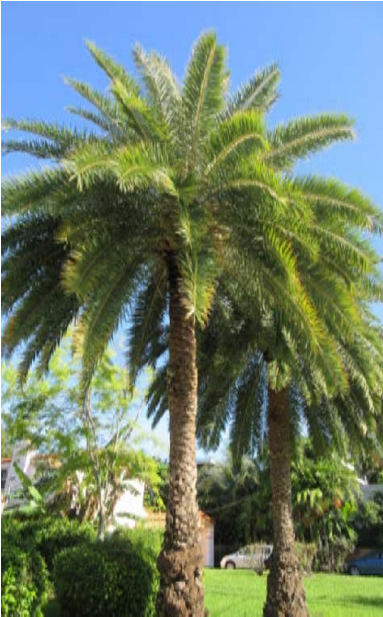
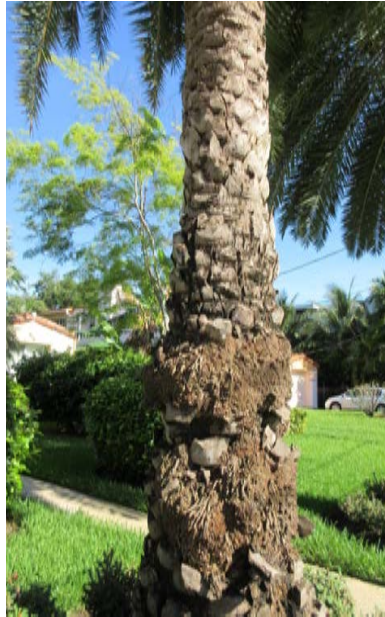
Condition -
Good

Tree #217 is a Date Palm located at the front of the property. It is in good condition with a dense canopy. There is some yellowing on the margins of the leaflets. This tree has not been incorporated into the landscape plan and will therefore be removed.

Disposition -
Remove

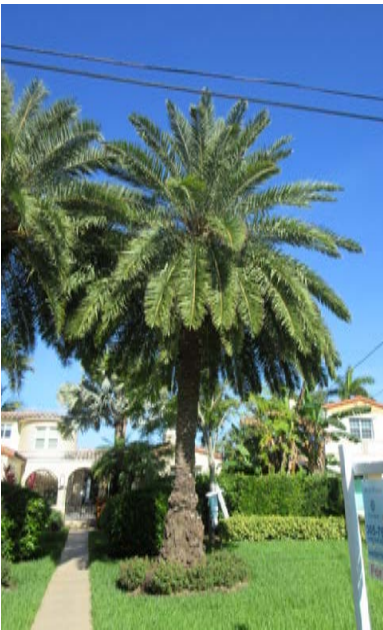
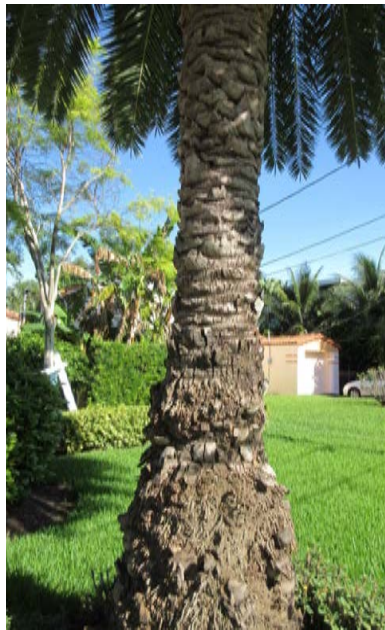
Condition -
Good

Tree #218 is a Date Palm located at the front of the property. It is in good condition with a dense canopy. There is some yellowing on the margins of the leaflets. This tree has not been incorporated into the landscape plan and will therefore be removed.

Disposition -
Remove

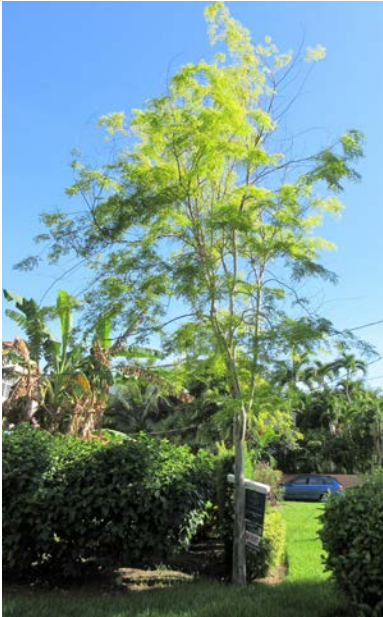
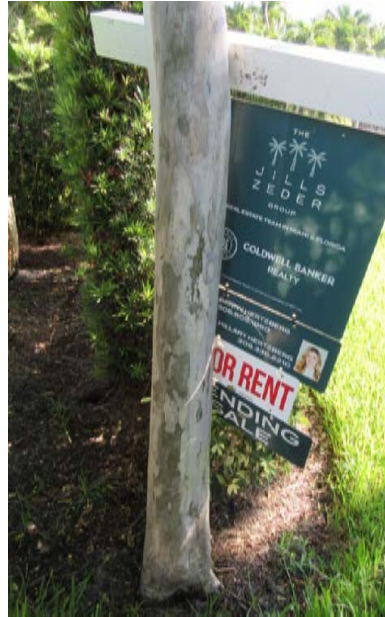
Condition -
Poor

Tree #219 is a Bridalveil located at the front of the property. It is in poor condition - the foliage is very chlorotic and there is small deadwood and dieback throughout the canopy. There are crossing limbs with included bark.

Disposition -
Remove

This tree has not been incorporated into the landscape plan and will therefore be removed.

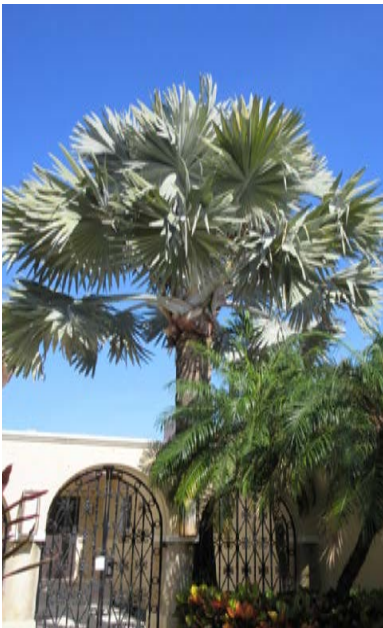
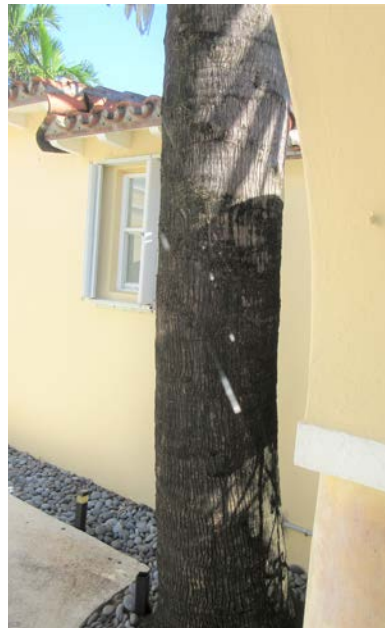
Condition -
Good

Tree #238 is a Bismarck Palm located in the front courtyard. It is in good condition with a dense canopy and symmetrical form. It is growing with limited rooting space.

Disposition -
Remove

This tree has not been incorporated into the landscape plan and will therefore be removed.

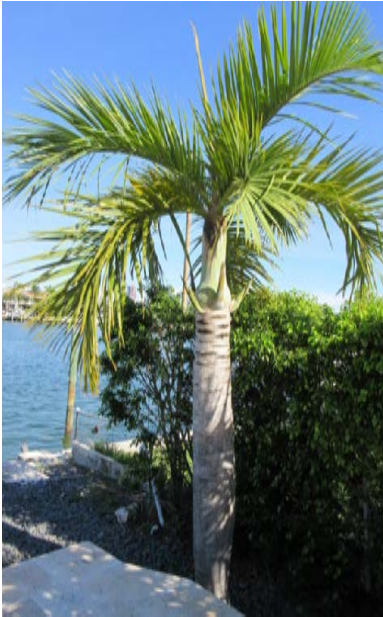
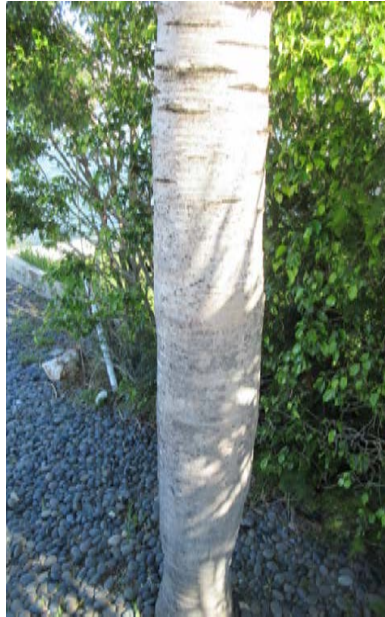
Condition -
Fair

Tree #256 is a Spindle Palm located on the north side of the backyard. It is in fair condition with chlorotic fronds. This tree has not been incorporated into the landscape plan and will therefore be removed.

Disposition -
Remove

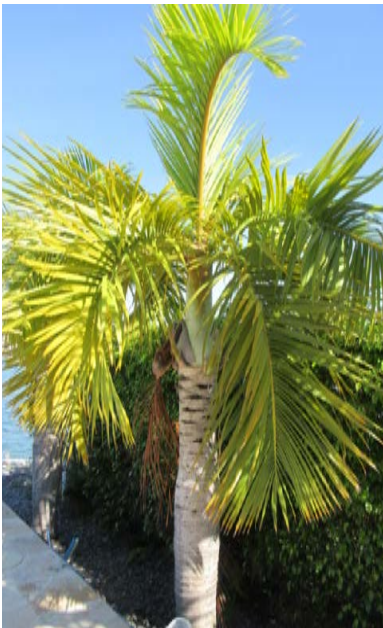
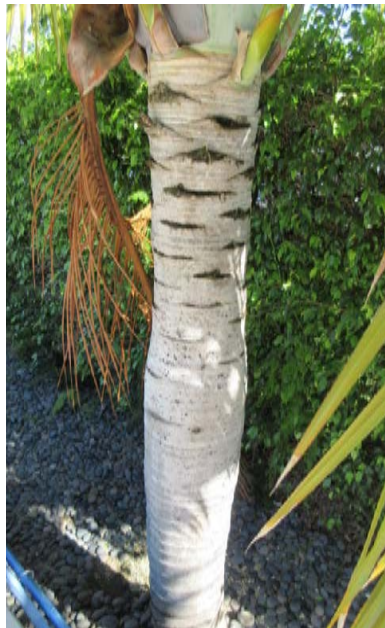
Condition -
Fair

Tree #257 is a Spindle Palm located on the north side of the backyard. It is in fair condition with chlorotic fronds. This tree has not been incorporated into the landscape plan and will therefore be removed.

Disposition -
Remove

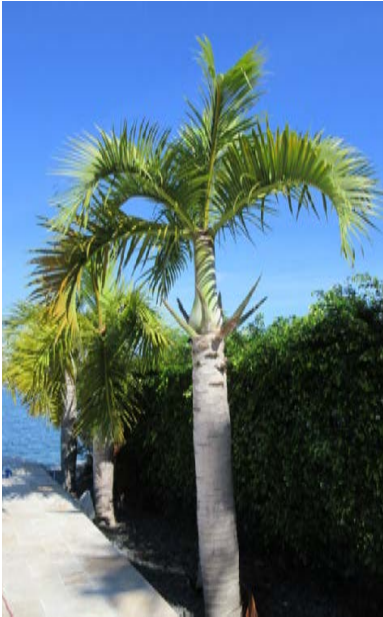
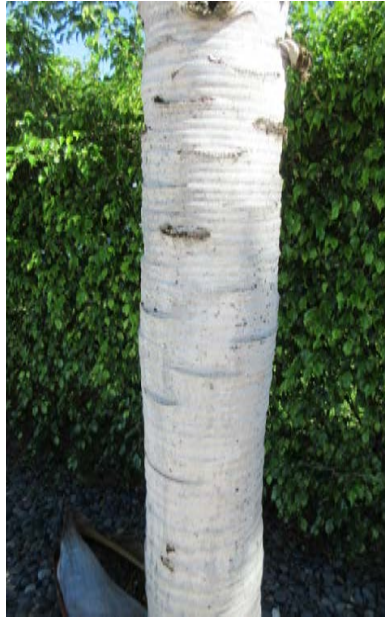
Condition -
Fair

Tree #258 is a Spindle Palm located on the north side of the backyard. It is in fair condition with chlorotic fronds. This tree has not been incorporated into the landscape plan and will therefore be removed.

Disposition -
Remove

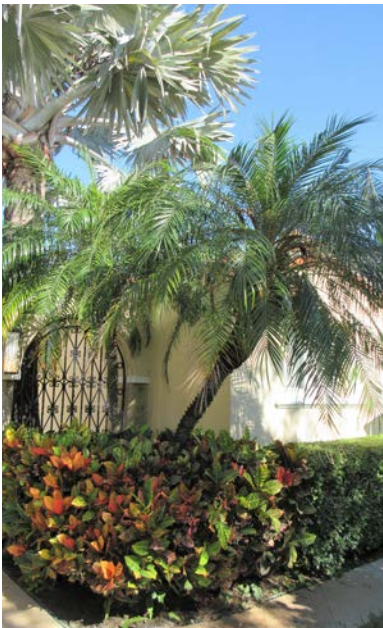
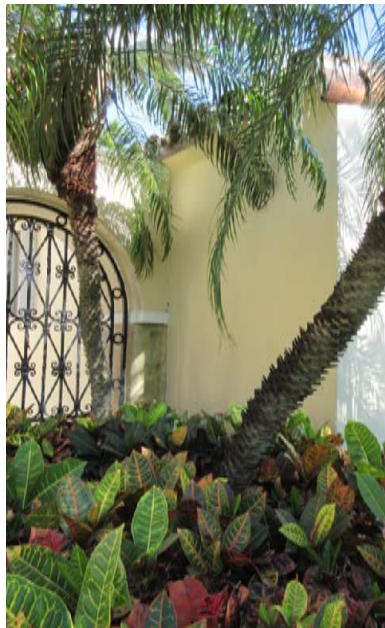
Condition -
Good

Trees #272 & 275 are two Pygmy Date Palms located at the front of the existing house. They are in good condition.

Disposition -
Remove

These trees have not been incorporated into the landscape plan and will therefore be removed.

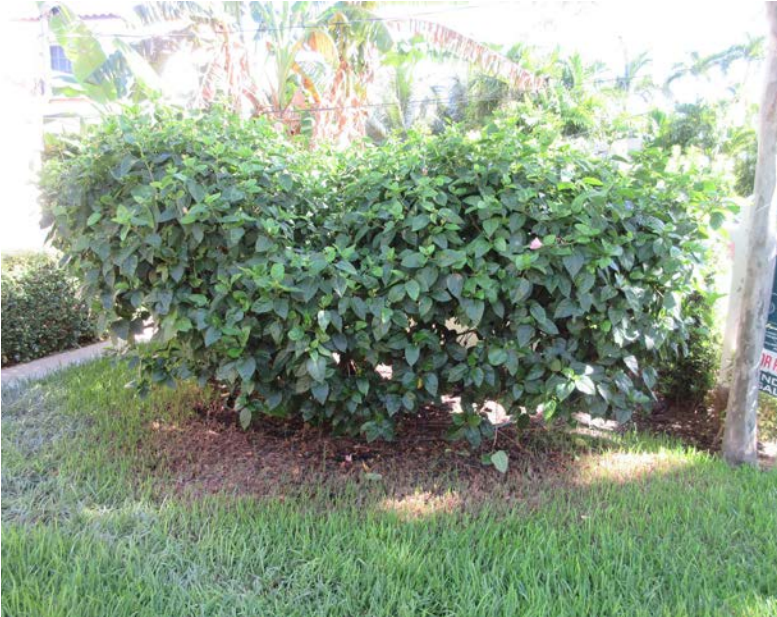
Condition -
Fair

Tree #276 is a Hibiscus shrub located in the front yard. It is in fair condition with new foliage that is distorted. This shrub has not been incorporated into the landscape plan and will therefore be removed.

Disposition -
Remove

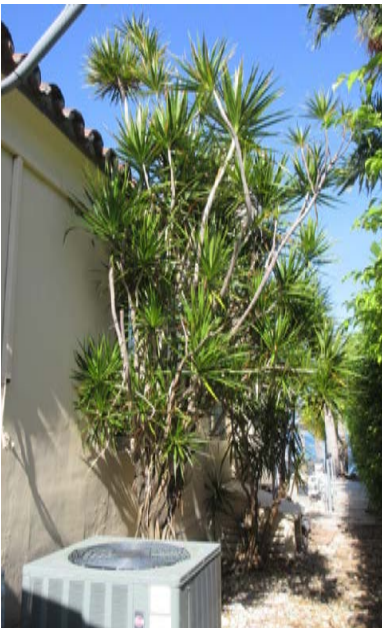
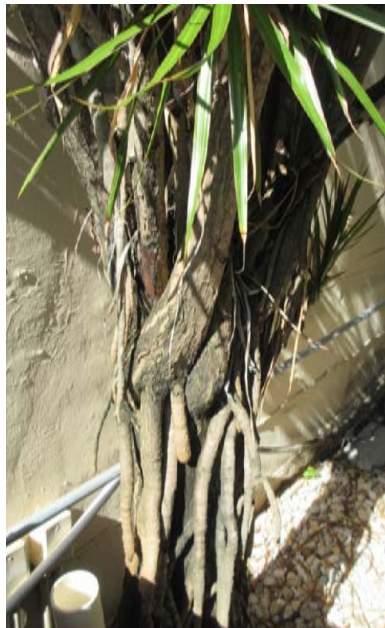
Condition -
Good

Tree #277 is a Dracaena located on the north side of the existing house. It is in good condition. This shrub has not been incorporated into the landscape plan and will therefore be removed.

Disposition -
Remove

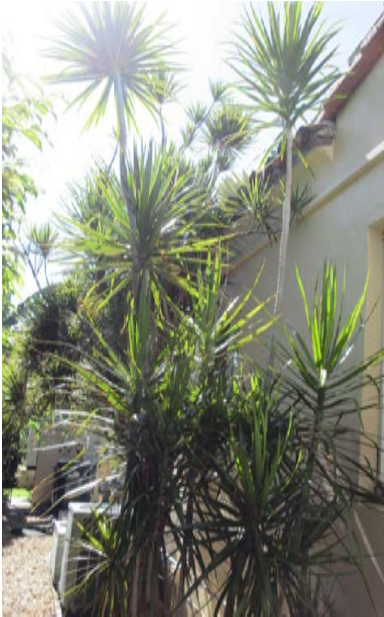
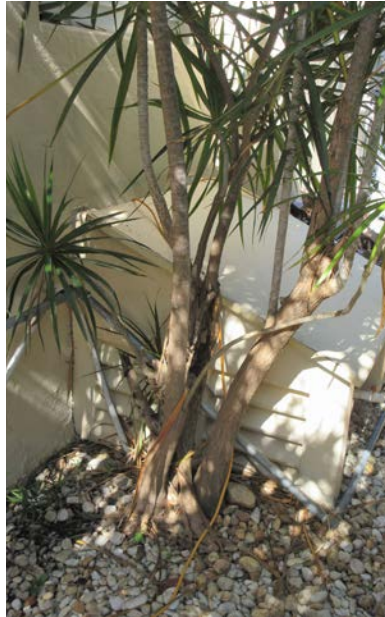
Condition -
Fair

Tree #278 is a Dracaena located on the north side of the existing house. It is in fair condition with some stems decayed.

Disposition -
Remove

This shrub has not been incorporated into the landscape plan and will therefore be removed.
