## ARBORIST REPORT

**RE** 2702 Alton Road  
Arborist's Evaluation of Specimen Trees

**Site Inspection and Report by Christopher Cawley + David Ettman of Biscayne Environmental**

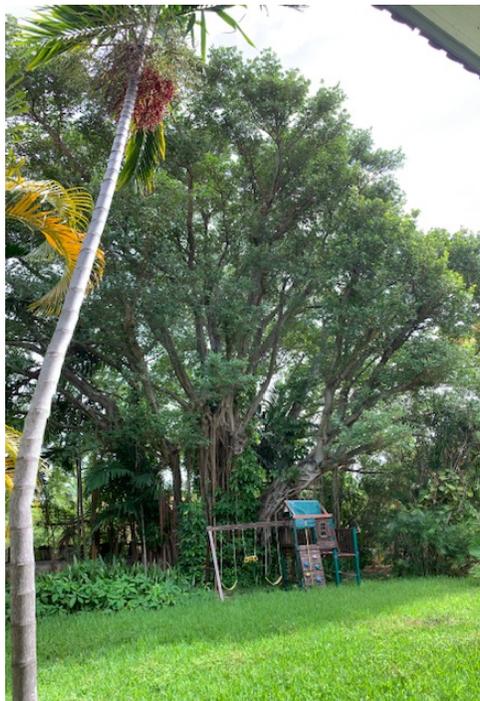
**TREE #s 18 & 19**

<b>COMMON NAME:</b> Strangler fig	<b>HEIGHT (FT):</b> +/- 70'
<b>SCIENTIFIC NAME:</b> <i>Ficus aurea</i>	<b>SPREAD (FT):</b> +/- 80'
<b>CONDITION:</b> Good	<b>DBH (INCHES):</b> > 180"
<b>NATIVE:</b> YES	<b>CRZ (FT):</b> +/- 180'

The initial Tree Survey showed this as two separate trees (Tree Nos 18 & 19) growing to the south of the existing CBS wall. In actuality, this is one tree with four large trunks (three at +/- 48" DBH and one at 72" DBH) and one large contiguous root system, as shown below. The tree has a fairly symmetrical canopy with the foliage beginning +/- 12' above the ground and has a broad canopy spread. The tree is generally in good condition although there are several previously cut branches that are resprouting, and a fairly large hanger branch mid canopy. There was no evidence of white fly or other insect infestation, minimal decay on branch stubs, and the root system is totally intact without any evidence of tilting or uplifting. Syngonium vine is present from the ground to mid canopy, and dracaena, Alexander palms, and snake plant are growing beneath the canopy on the south side of the tree. This tree is clearly worthy of preservation and will be protected until the project has been completed and Urban Forestry has approved the removal of the protective barriers. It is recommended that the canopy be thinned, dead wood and hangers be removed, the vines be removed from the canopy, and the non-desirable species be removed beneath the canopy within the critical root zone.

**DESCRIPTION / NOTES:** Tree protection to be provided.

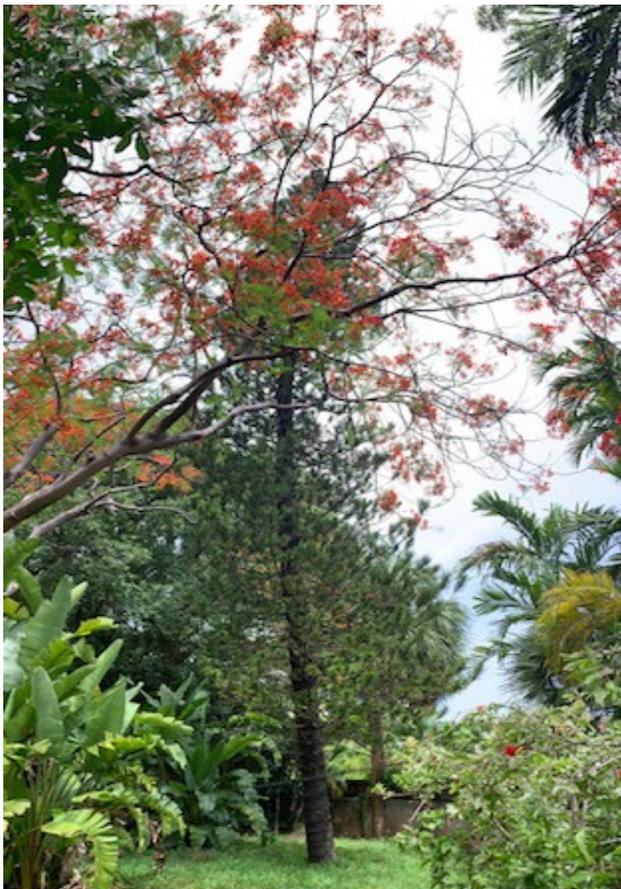
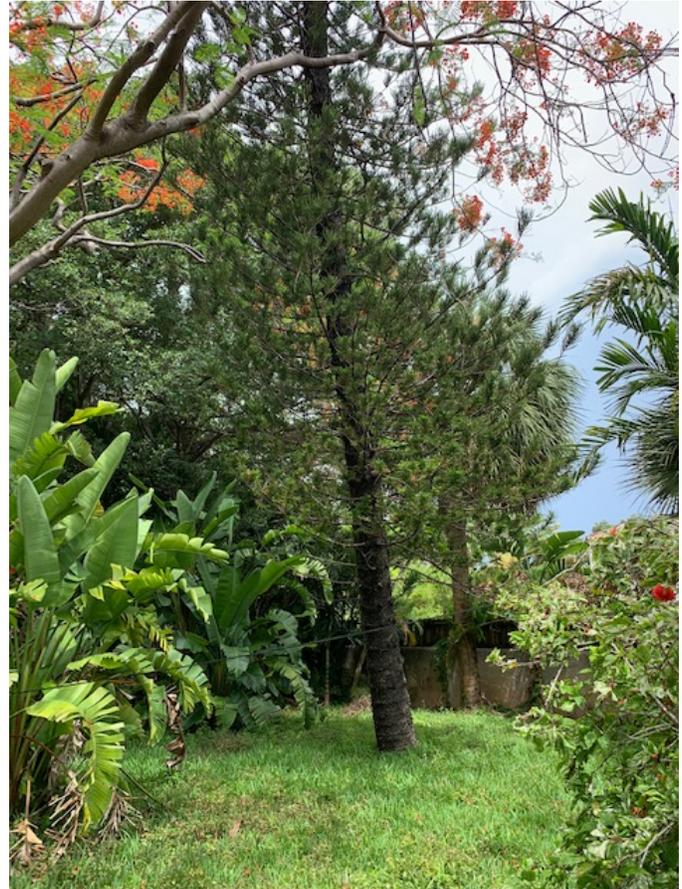
**TREE # 24**

This tree, which is located in the northeast portion of the property, is growing through the canopy of the adjacent royal poinciana tree, and the trunk is arching to the north as it is competing for light. This tree is in fair to good condition, the whorls of branches begin +/- 7' above ground and the canopy has not suffered any previous storm damage. The root system is intact and has not suffered from uplifting. Because the tree conflicts with new construction, its current height and potential for future risk to property due to its normal propensity to break up in storm events, the tree is proposed for removal.

**DISPOSITION:** REMOVE

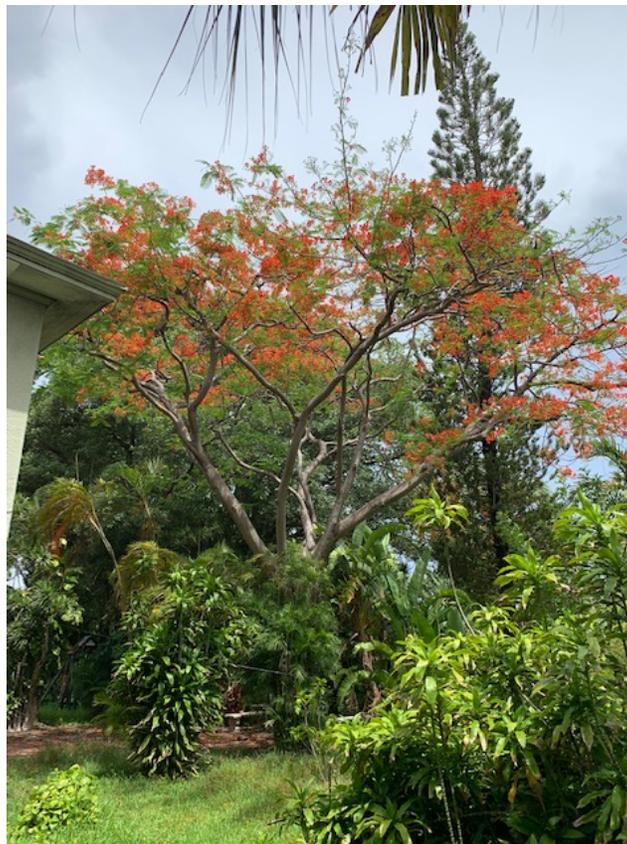
**TREE # 28**

This tree, which is also growing in the northeast portion of the property, is also competing for light with the adjacent Norfolk Island Pine and strangler fig. This tree is in fair to good condition with the main trunk splitting into two trunks +/- 10' above ground. The canopy begins +/- 20' above ground and is fairly sparse and the branch structure and growth habitat is poor. The tree was in flower at the time of the inspection. This tree is in conflict with new construction and poincianas are very brittle and are known to break up during storm events. For these reasons, this tree will be removed.

**DISPOSITION:** REMOVE

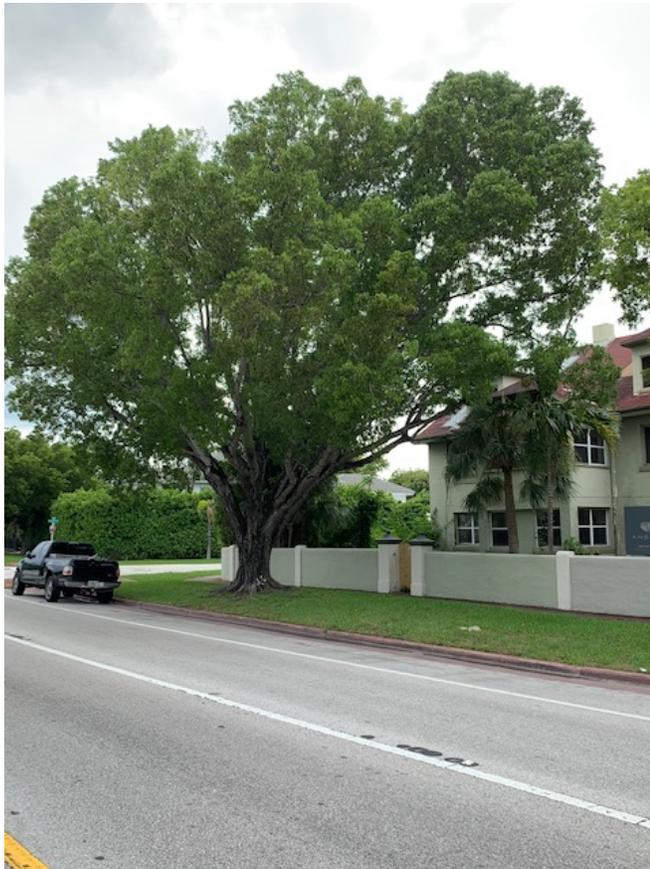
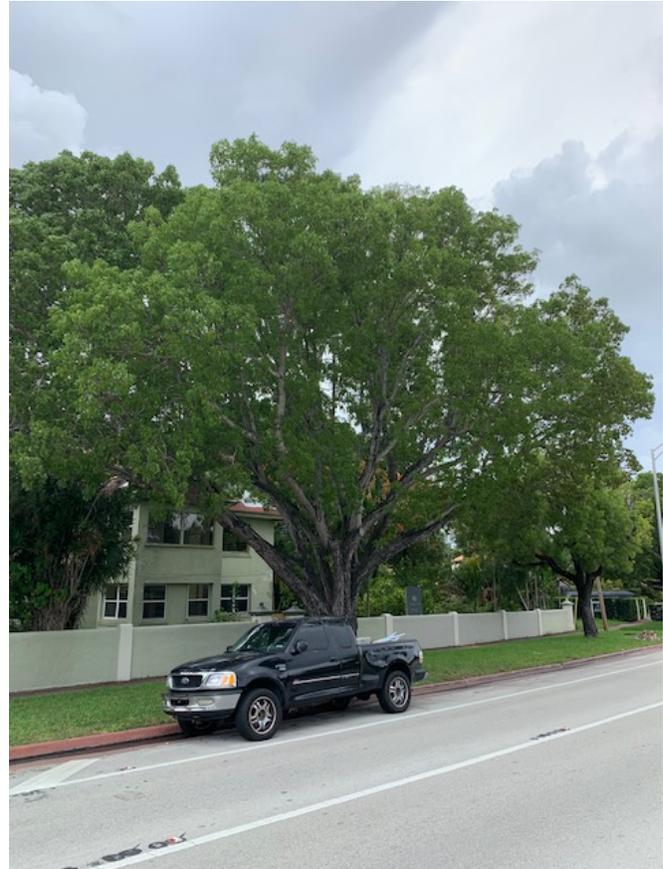
**TREE # 38**

This mahogany is in good condition and is in the Right-of-Way close to the intersection of 27<sup>th</sup> Street and Alton Road. The main trunk splits into five main branches or trunks 6' above ground and the canopy foliage begins +/- 12' above ground. The canopy is symmetrical, has no evidence of recent storm damage, although there has been some die back on the proximal branch tips. There was no evidence of insect infestation or decay, and no evidence of uplift or tilt in the root system which has some large above ground roots close to the main trunk. This tree will be preserved and protected throughout the duration of the project and the protective barriers will remain until Urban Forestry approved their removal.

**DESCRIPTION / NOTES:** Tree Protection to be provided.

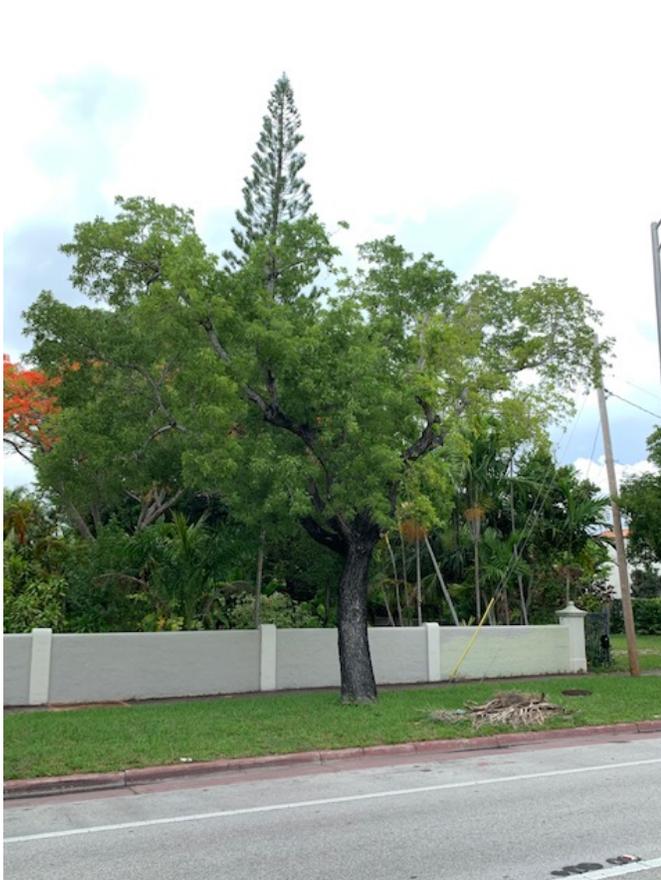
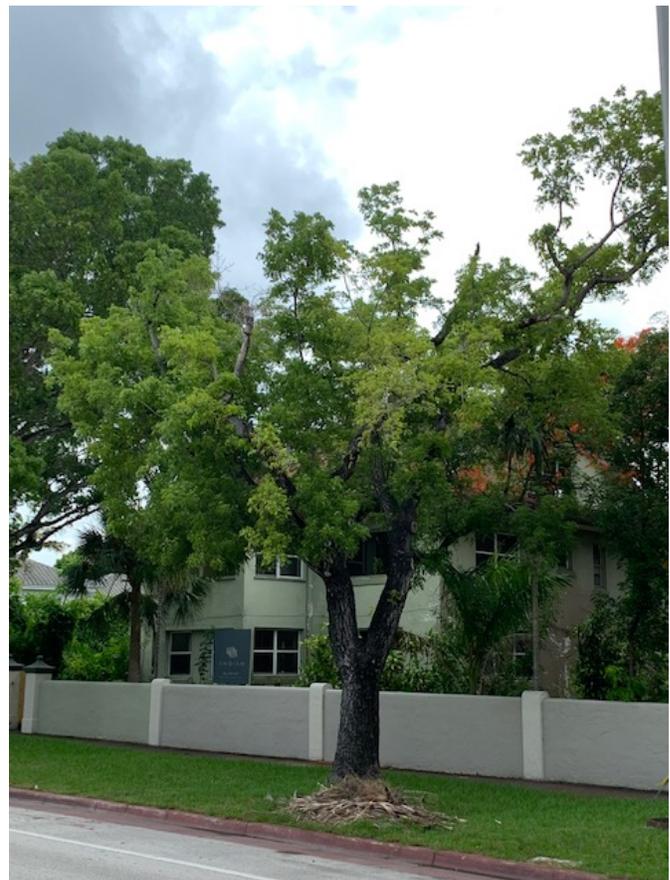
**TREE # 39**

This mahogany is in fair condition and is also located in the Right-of-Way of Alton Road approximately 50' north of the other Mahogany (Tree No. 38). The main trunk splits into two codominant trunks approximately 7' above ground and the canopy foliage begins +/- 10' above ground. This tree has been subject to recent storm damage as evidenced by the cut stub branches and broken branches at the top of the tree which has resulted in a disfigured canopy, as shown below. With proper pruning of the canopy, this tree can be restored and should therefore be preserved and protected. As with other trees that are being protected, the protective barriers will remain in place until Urban Forestry approves their removal.

**DESCRIPTION / NOTES:** Tree Protection to be provided.
