Arborist Report

6881 Indian Creek Drive
Miami Beach

6/14/2021

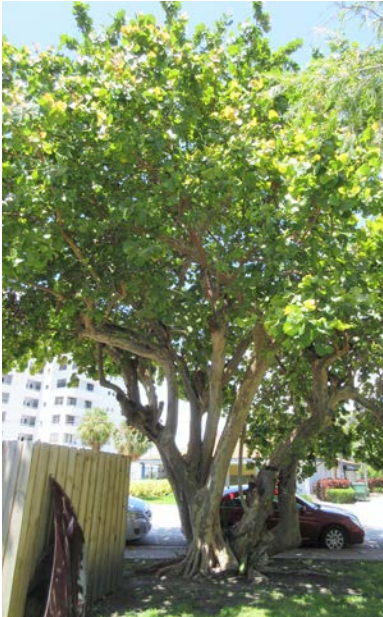
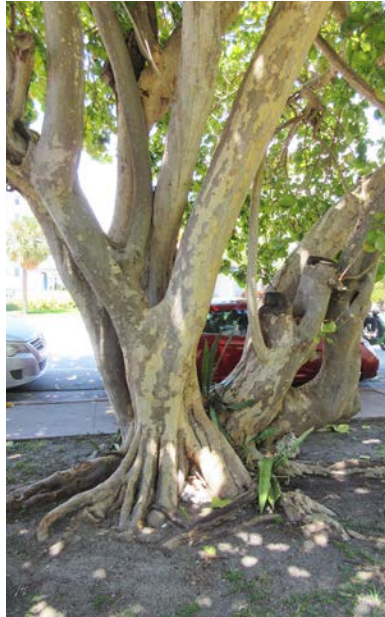
Condition -
Fair

Tree #1 is a Seagrape located on the south side of the property. It is multi-trunked and in fair condition. A number of limbs have been hatracked. The canopy is dense and symmetrical. Prune to remove deadwood and to increase clearance over the street.

This tree is to remain and protective barriers shall be placed 15ft from the tree trunk. Barriers shall be installed prior to the start of construction, and shall remain in place until development is completed and until the department authorizes their removal. Barriers shall be a minimum of 4ft high, and shall be constructed of continuous chain link fence with metal posts at 8ft spacing, or of 2x4 posts with three equally spaced 2x4 rails. Posts may be shifted to avoid roots. No materials shall be placed or disposed of within the TPZ. Natural grade shall be maintained within the TPZ.

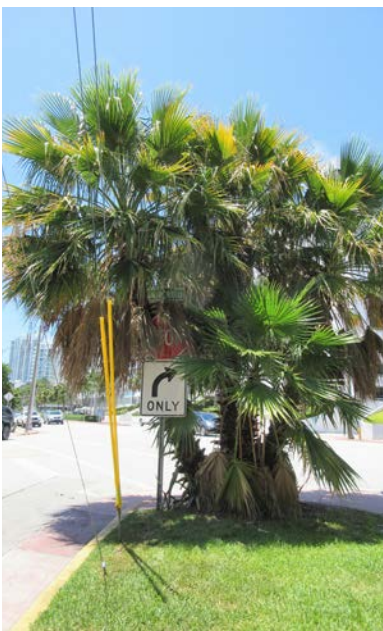
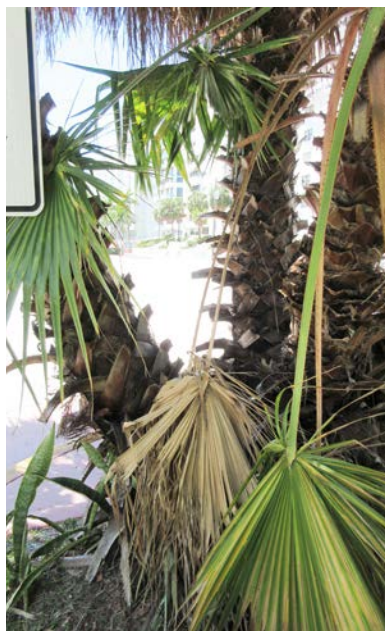
Trees #2 - 4 are three Washingtonia Palms located at the corner of Indian Creek Drive and Byron Ave. They are in fair condition with yellowing of the ends of the fronds. They are blocking the stop sign.

These trees have not been incorporated into the landscape plan and will therefore be removed.

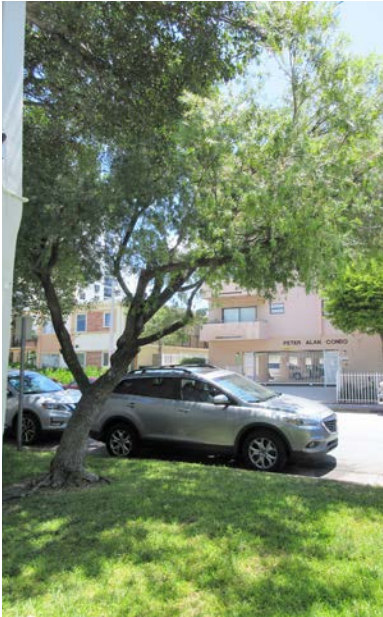
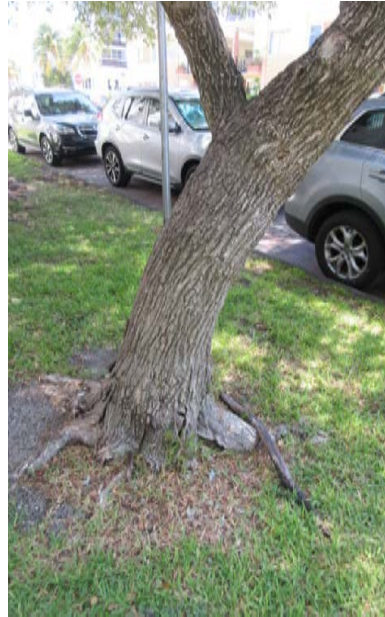
Tree #5 is a Bottlebrush located on the east side of the property. It is in fair condition - it has a curved trunk and an asymmetrical canopy. There are broken limbs and bark is coming off at the base of the trunk. This tree has not been incorporated into the landscape plan and will therefore be removed.

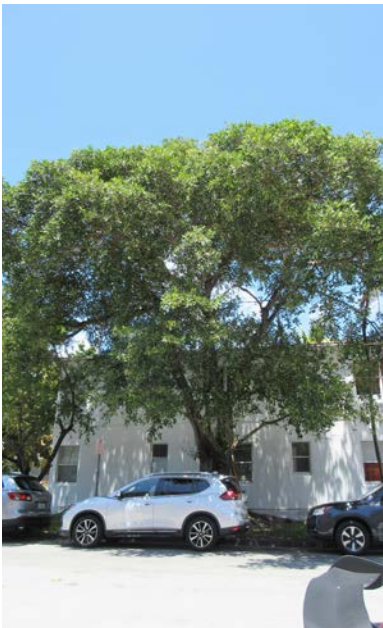
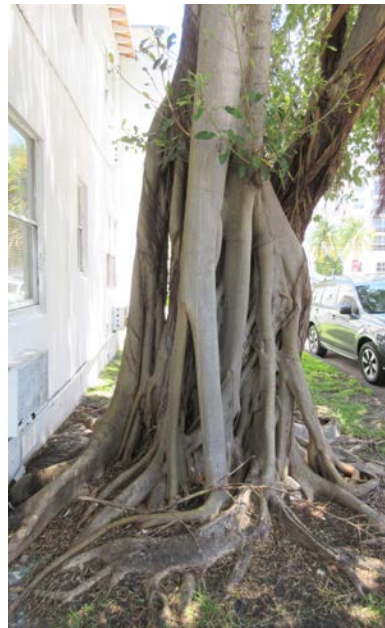
Tree #6 is a Strangler Fig located on the east side of the property. The canopy is dense and spreading. The tree has been pruned away from the building. Overhead wires are nearby. The leaves have been damaged by a chewing insect.

This tree has not been incorporated into the landscape plan and will therefore be removed.

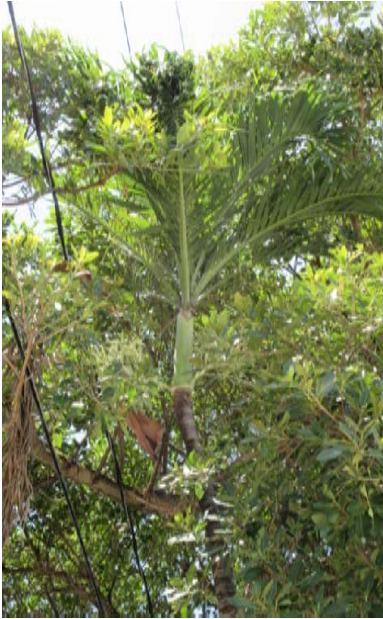
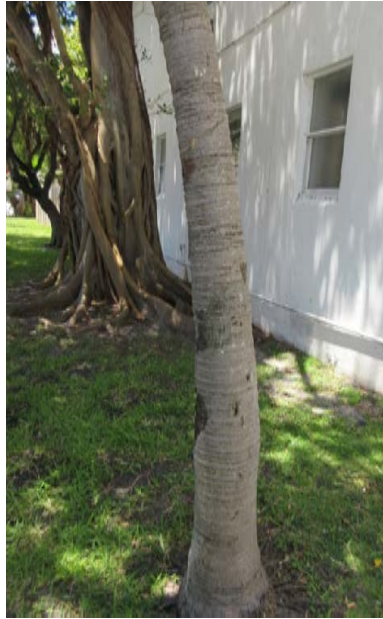
Tree #7 is a Christmas Palm located on the east side of the property. It is in poor condition and is growing through the canopy of Ficus #6. It has a small canopy and a pencil-like trunk. This tree has not been incorporated into the landscape plan and will therefore be removed.

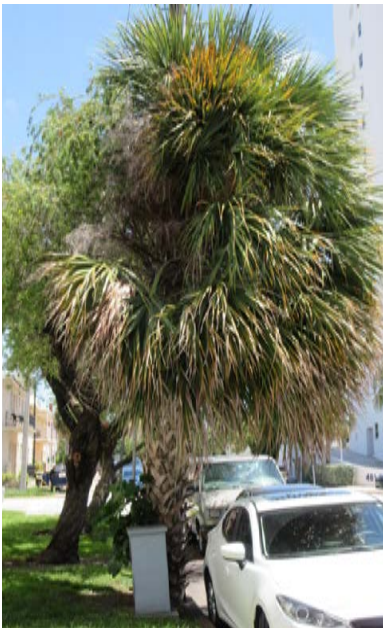
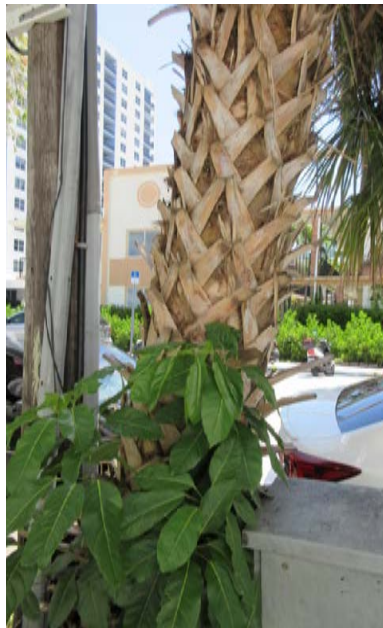
Tree #8 is a Sabal Palm located on the east side of the property. It is in fair condition with a number of lower brown fronds. This tree has not been incorporated into the landscape plan and will therefore be removed.

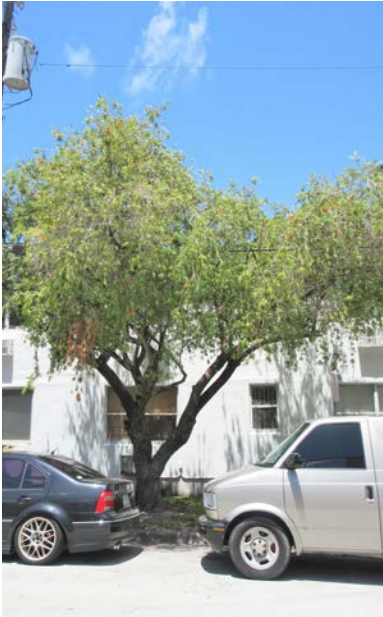
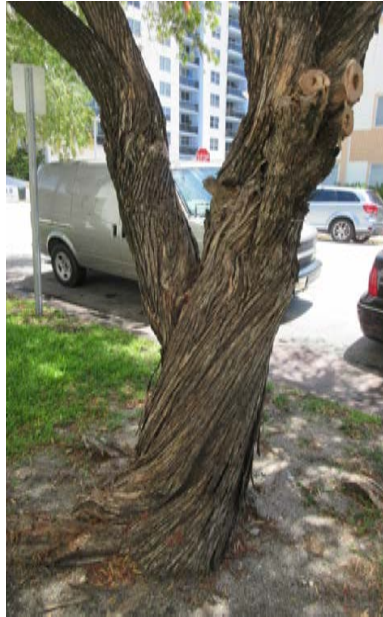
Tree #9 is a Bottlebrush located on the east side of the property. It is in fair condition - there are a number of limbs with heading cuts, old flush cuts, and included bark is present. Overhead wires are nearby. This tree has not been incorporated into the landscape plan and will therefore be removed.

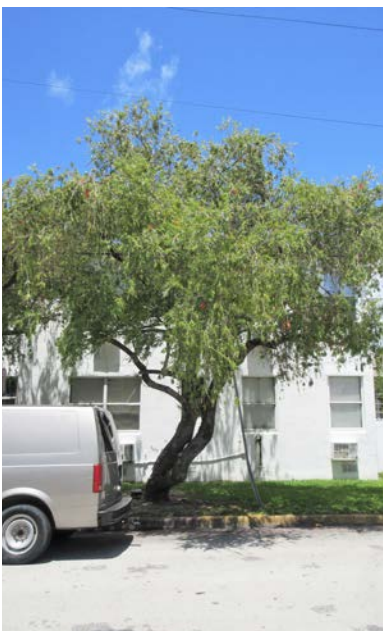
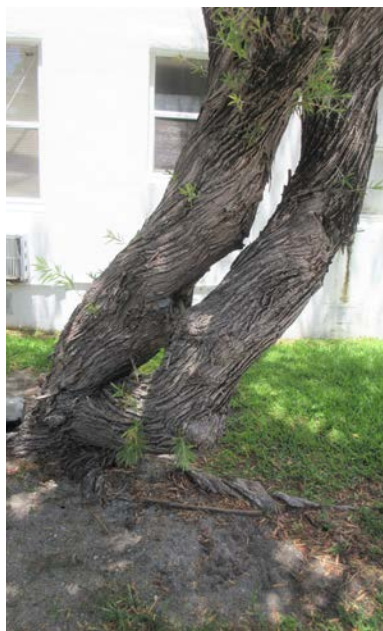
Tree #10 is a Bottlebrush located on the east side of the property. It is in fair condition - there are a number of limbs with heading cuts and there are flush cuts. The tree is double-trunked with crossing leaders and included bark. This tree has not been incorporated into the landscape plan and will therefore be removed.

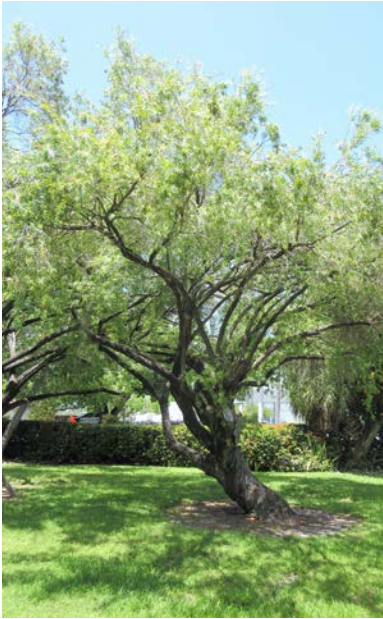
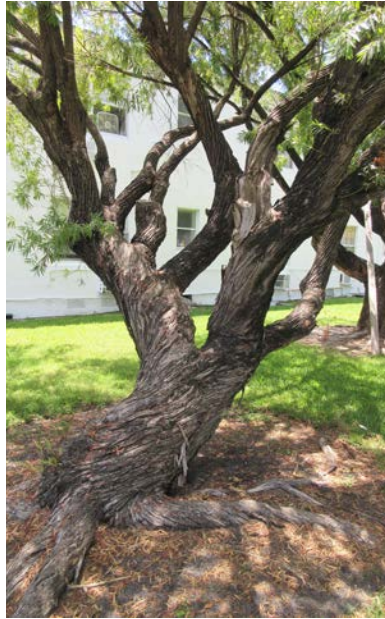
Tree #11 is a Bottlebrush located on the north side of the property. It is in good condition overall. There are crossing limbs and included bark is present. This tree has not been incorporated into the landscape plan and will therefore be removed.

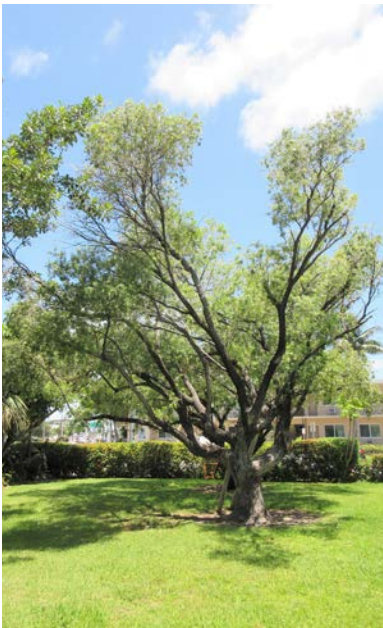
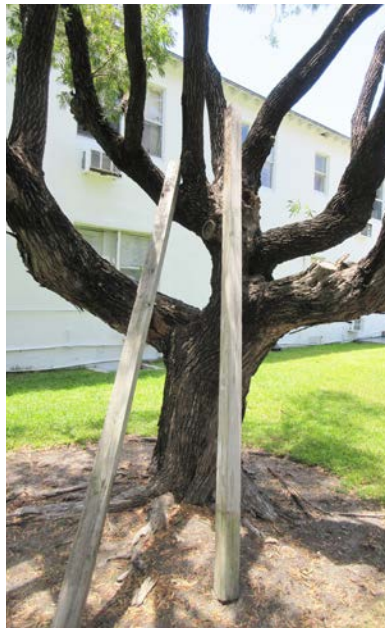
Tree #12 is a Bottlebrush located towards the center of the property. It is in fair condition - there is some branch dieback and the interior of the canopy has been pruned out. This tree has not been incorporated into the landscape plan and will therefore be removed.

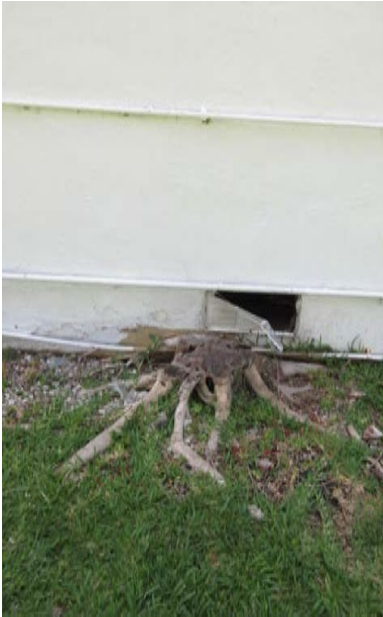
Tree #13 was listed as a Bottlebrush located next to the existing building. This tree has been removed and a stump remains.

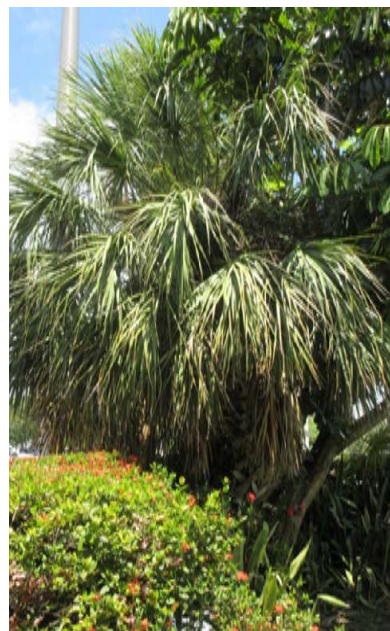
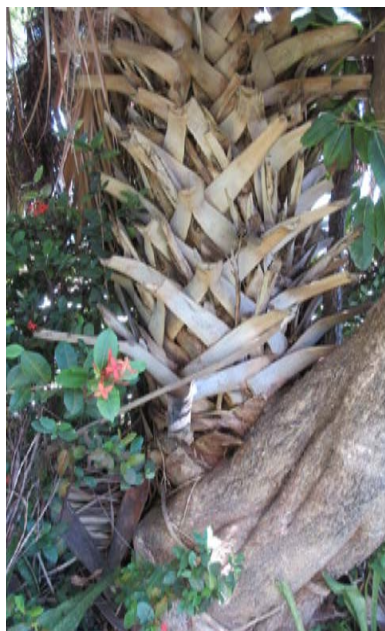
Tree #14 is a Sabal Palm located towards the northwest corner of the property. It is in fair condition. Umbrella Tree #20 is growing around the palm's trunk. This tree has not been incorporated into the landscape plan and will therefore be removed.

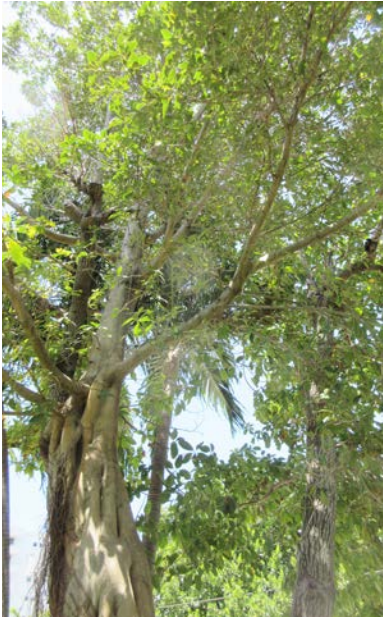
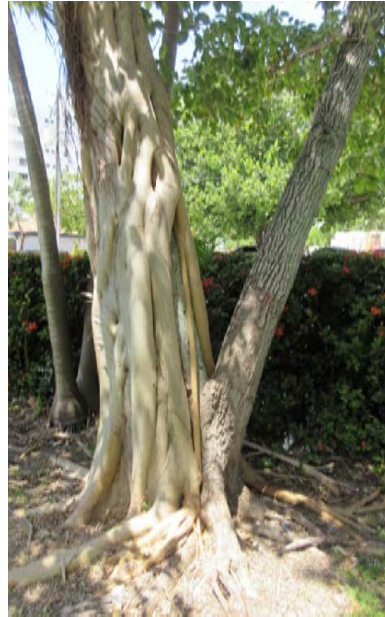
Tree #15 is an Avocado located on the western side of the property. It is in poor condition and half dead. A Strangler Fig has grown over the tree and now forms most of the canopy. The DBH includes both trees. This tree has not been incorporated into the landscape plan and will therefore be removed.

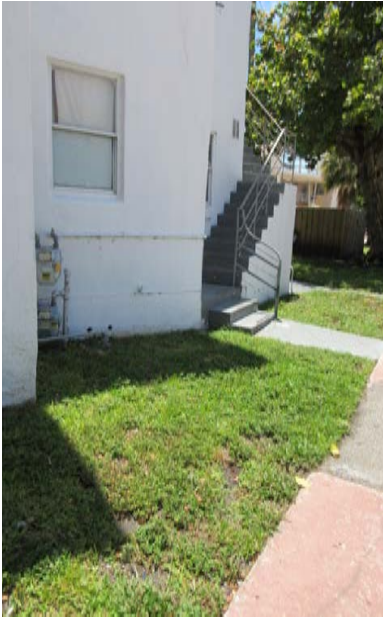
Tree #19 was listed as a Coconut Palm located on the western side of the property. This tree has been removed.

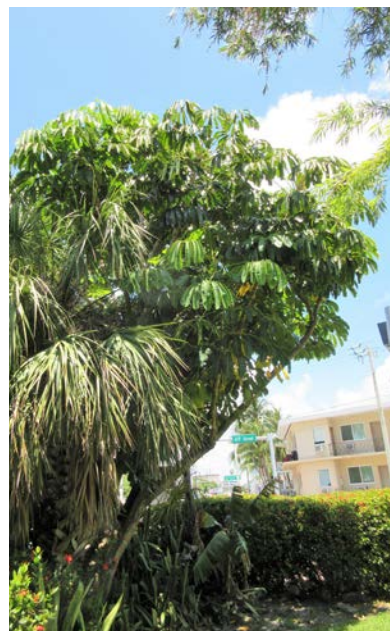
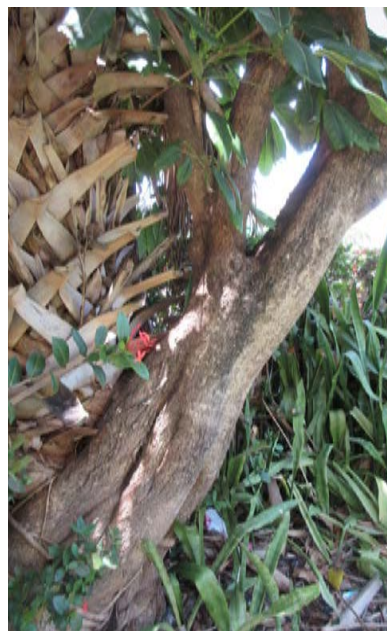
Tree #20 is an Umbrella Tree located next to Sabal Palm #14. It is in fair condition and is growing over the Sabal Palm.

This species is highly invasive in South Florida and this tree will therefore need to be removed.

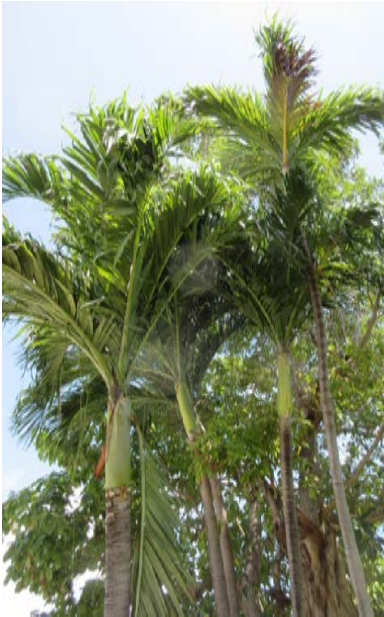
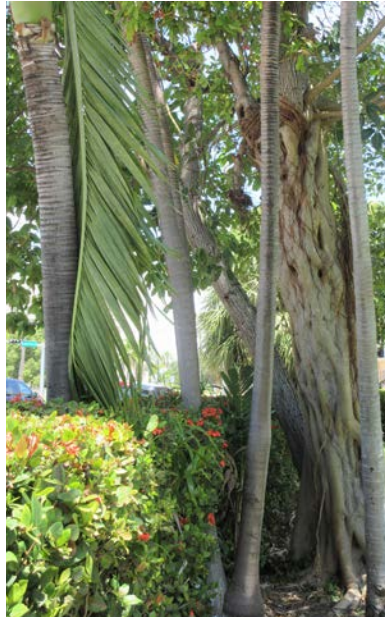
Tree #21 is a cluster of five Christmas Palms located on the western side of the property. They are in fair condition with some yellowing of the fronds. These trees have not been incorporated into the landscape plan and will therefore be removed.
