Tree Resource Evaluation for 4540 North Bay Road, Miami Beach

June 28, 2021

Summary

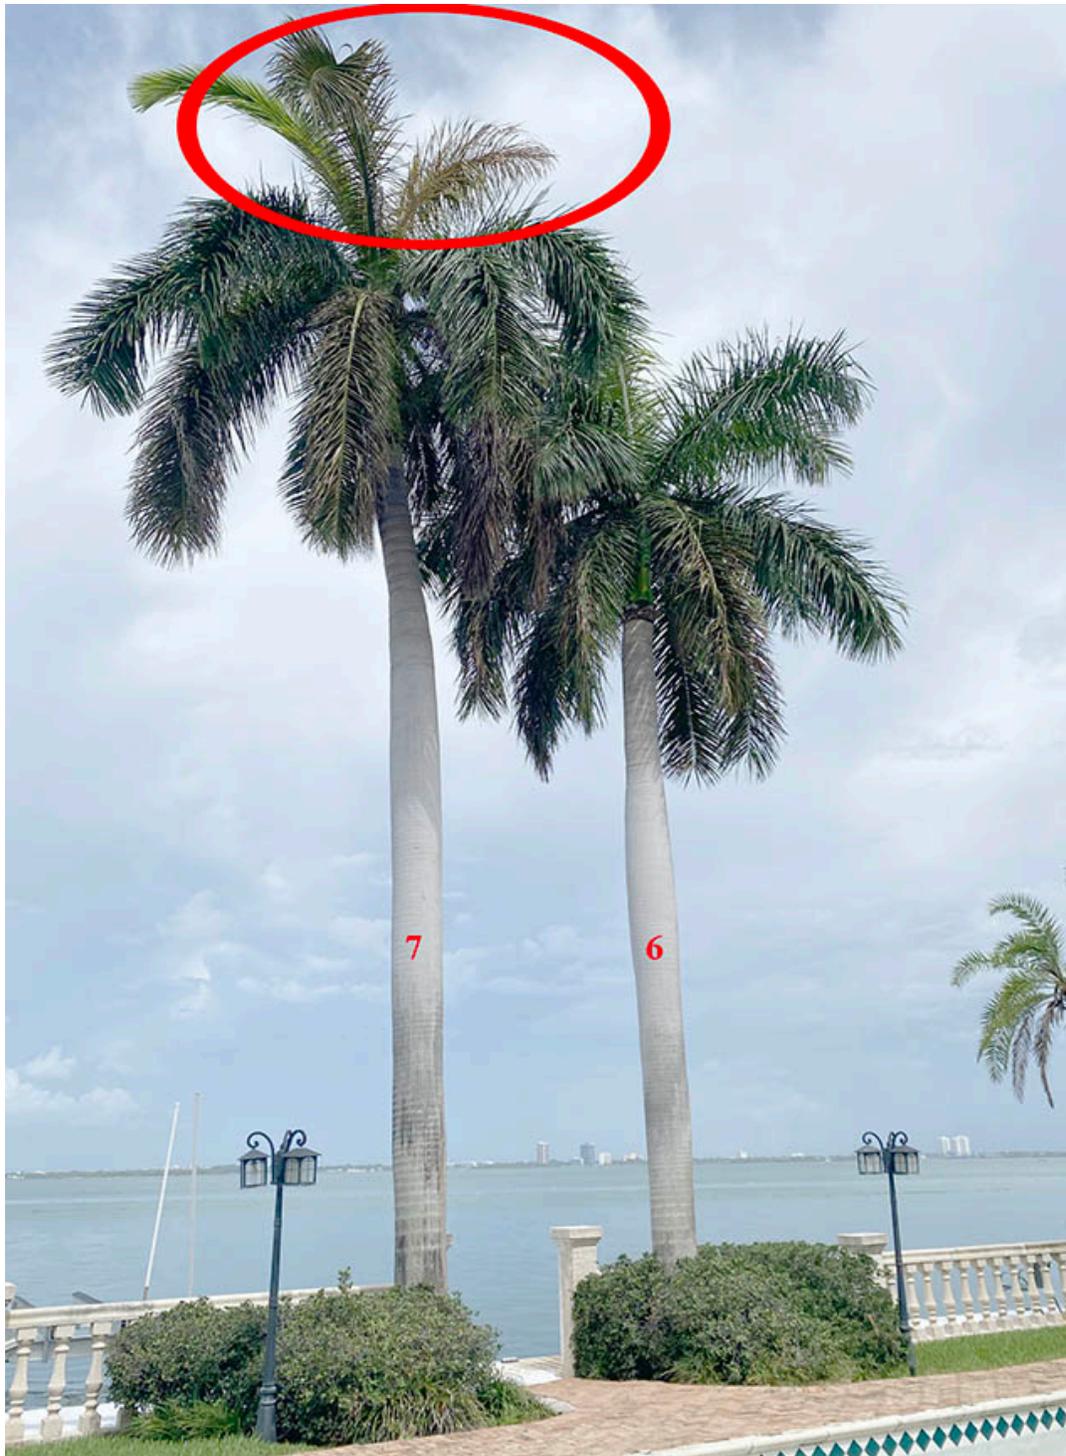
Photo 6 above is palms 7 & 8. The circle indicates an infestation of royal palm bug on the newest fronds of palm 7. This infestation should naturally decline, and no pesticide use is recommended.

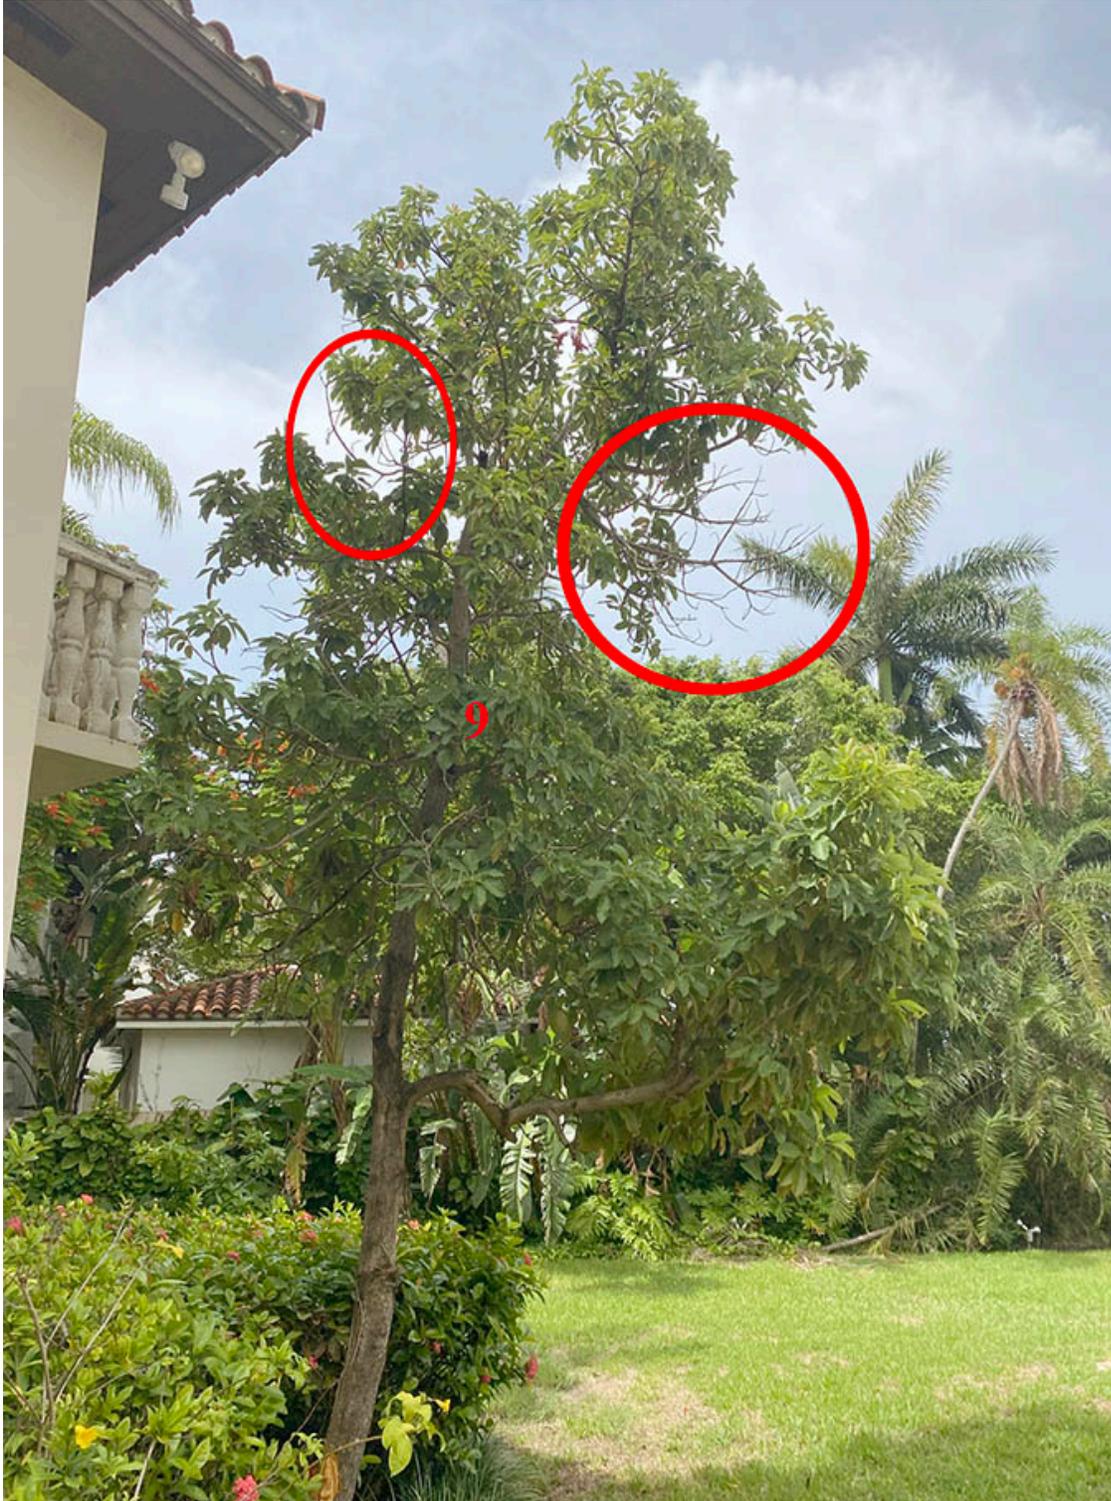
Photo 7 above is tree 9 showing signs of decline.

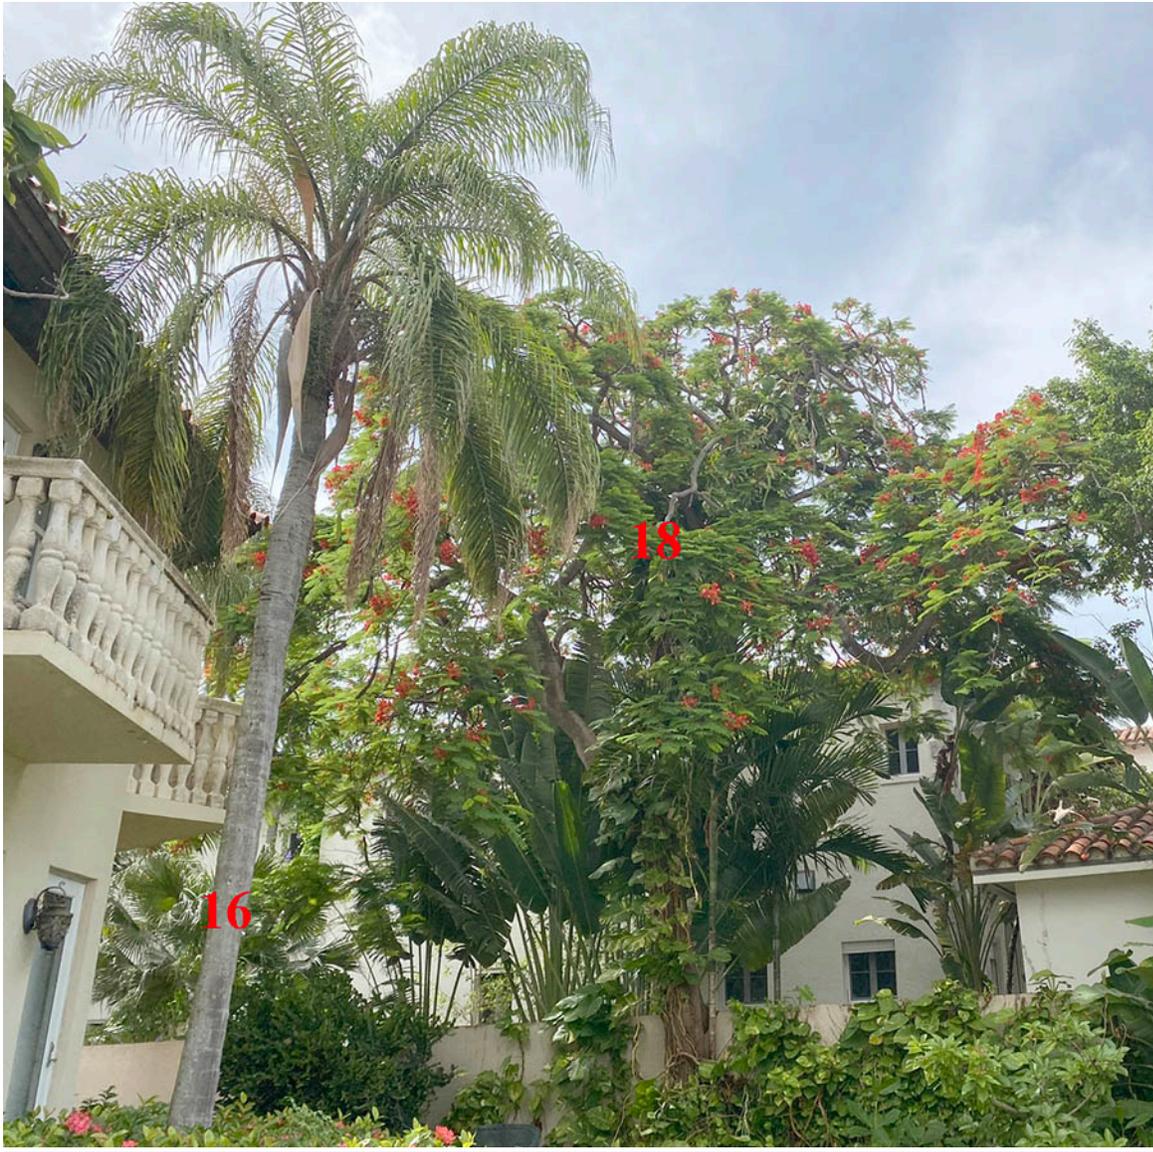
Photo 14 above is palm 16 & tree 18. I noted spike holes in the trunk palm 16.

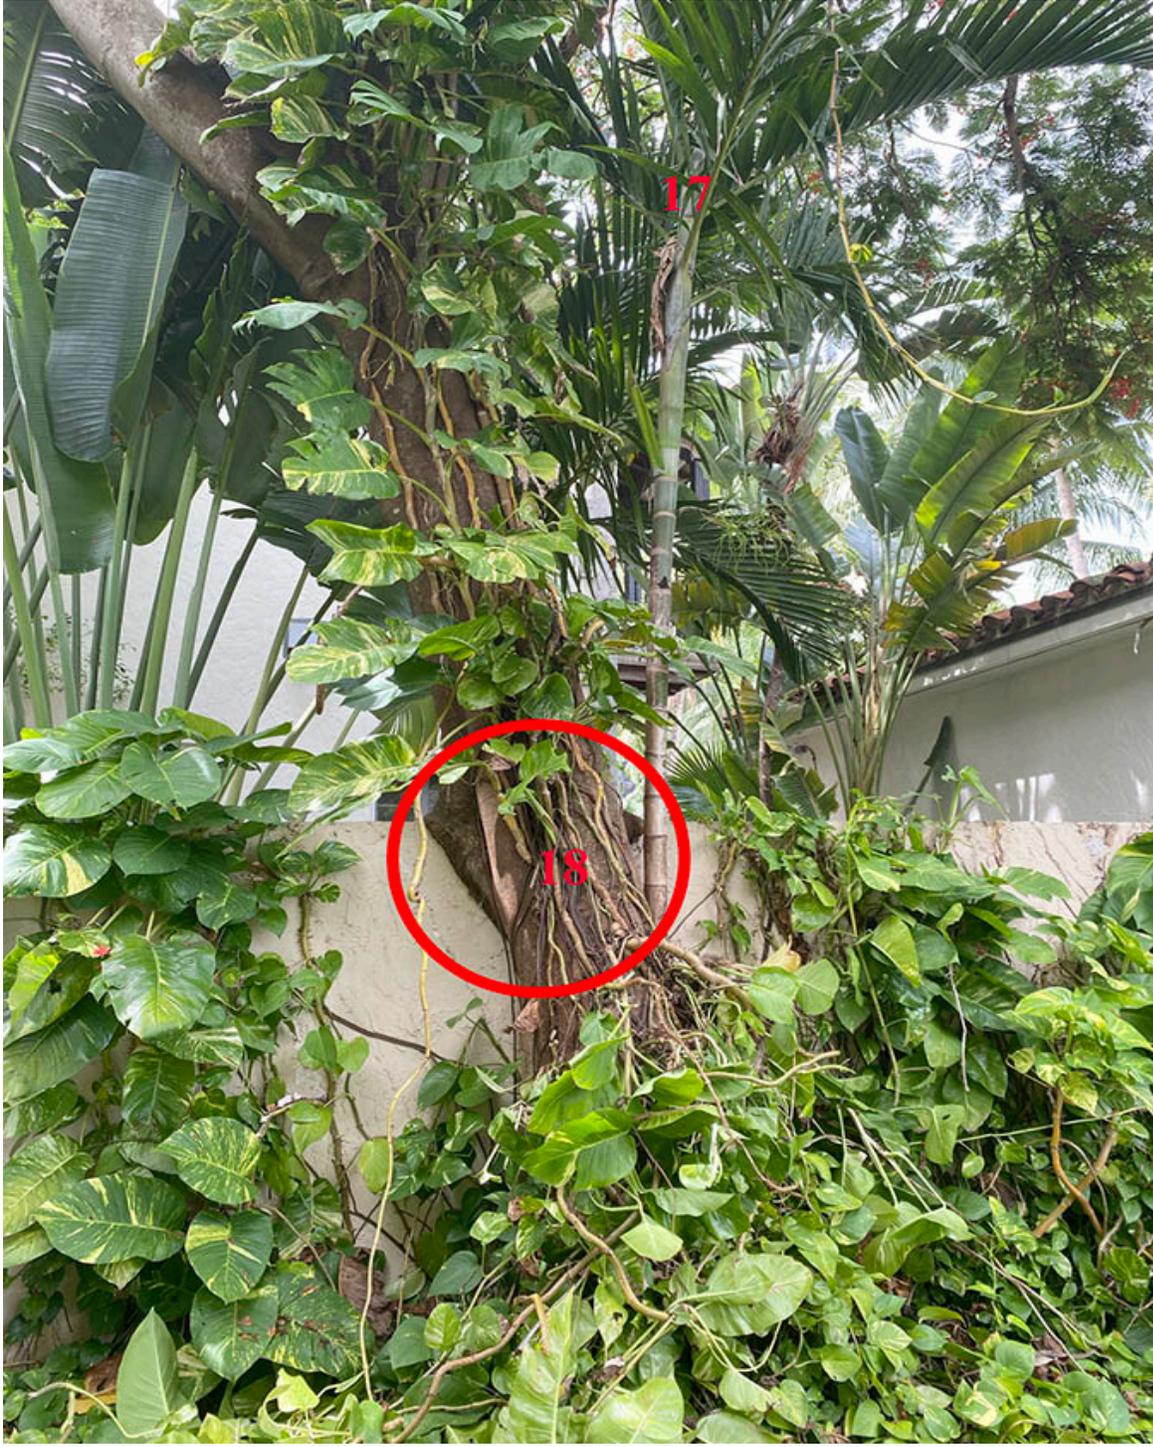
Photo 15 above is a view of the trunk of tree 18 growing against the wall. See following photo. It is highly likely that the root plate/CRZ of this tree does not go beyond the wall.

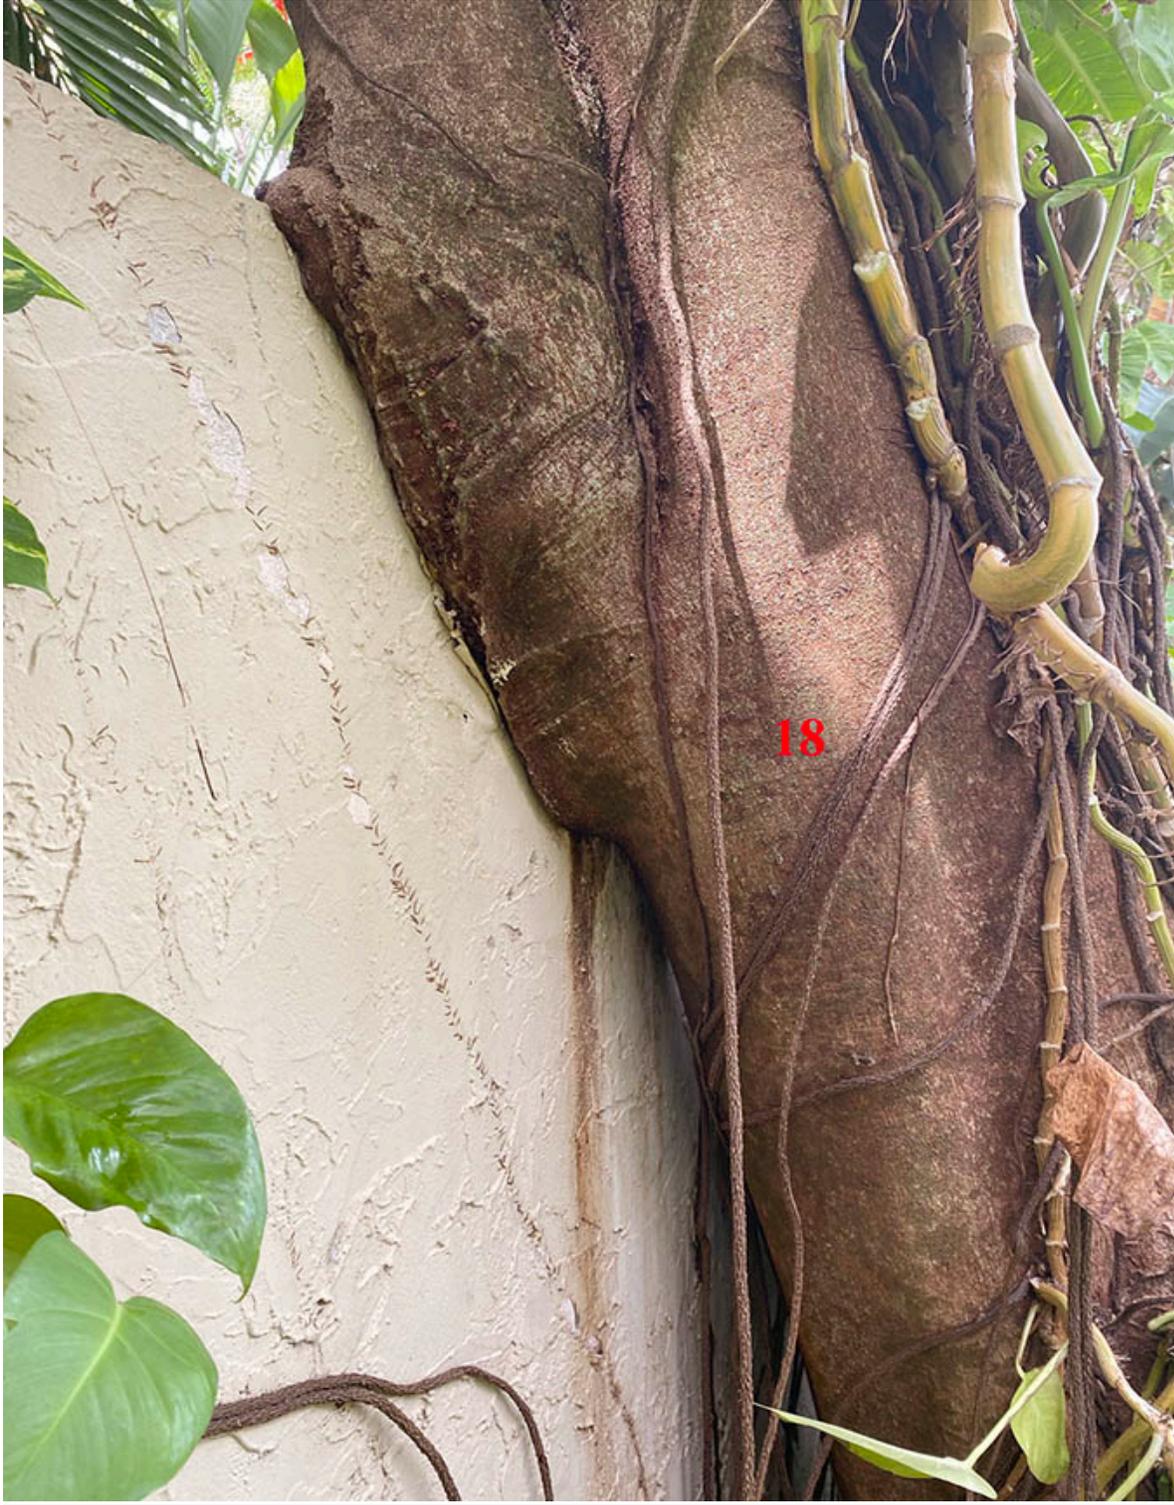
Photo 16 above is a closer view of the trunk of tree 18 growing against and being supported structurally by the wall. I recommend the removal of this tree.

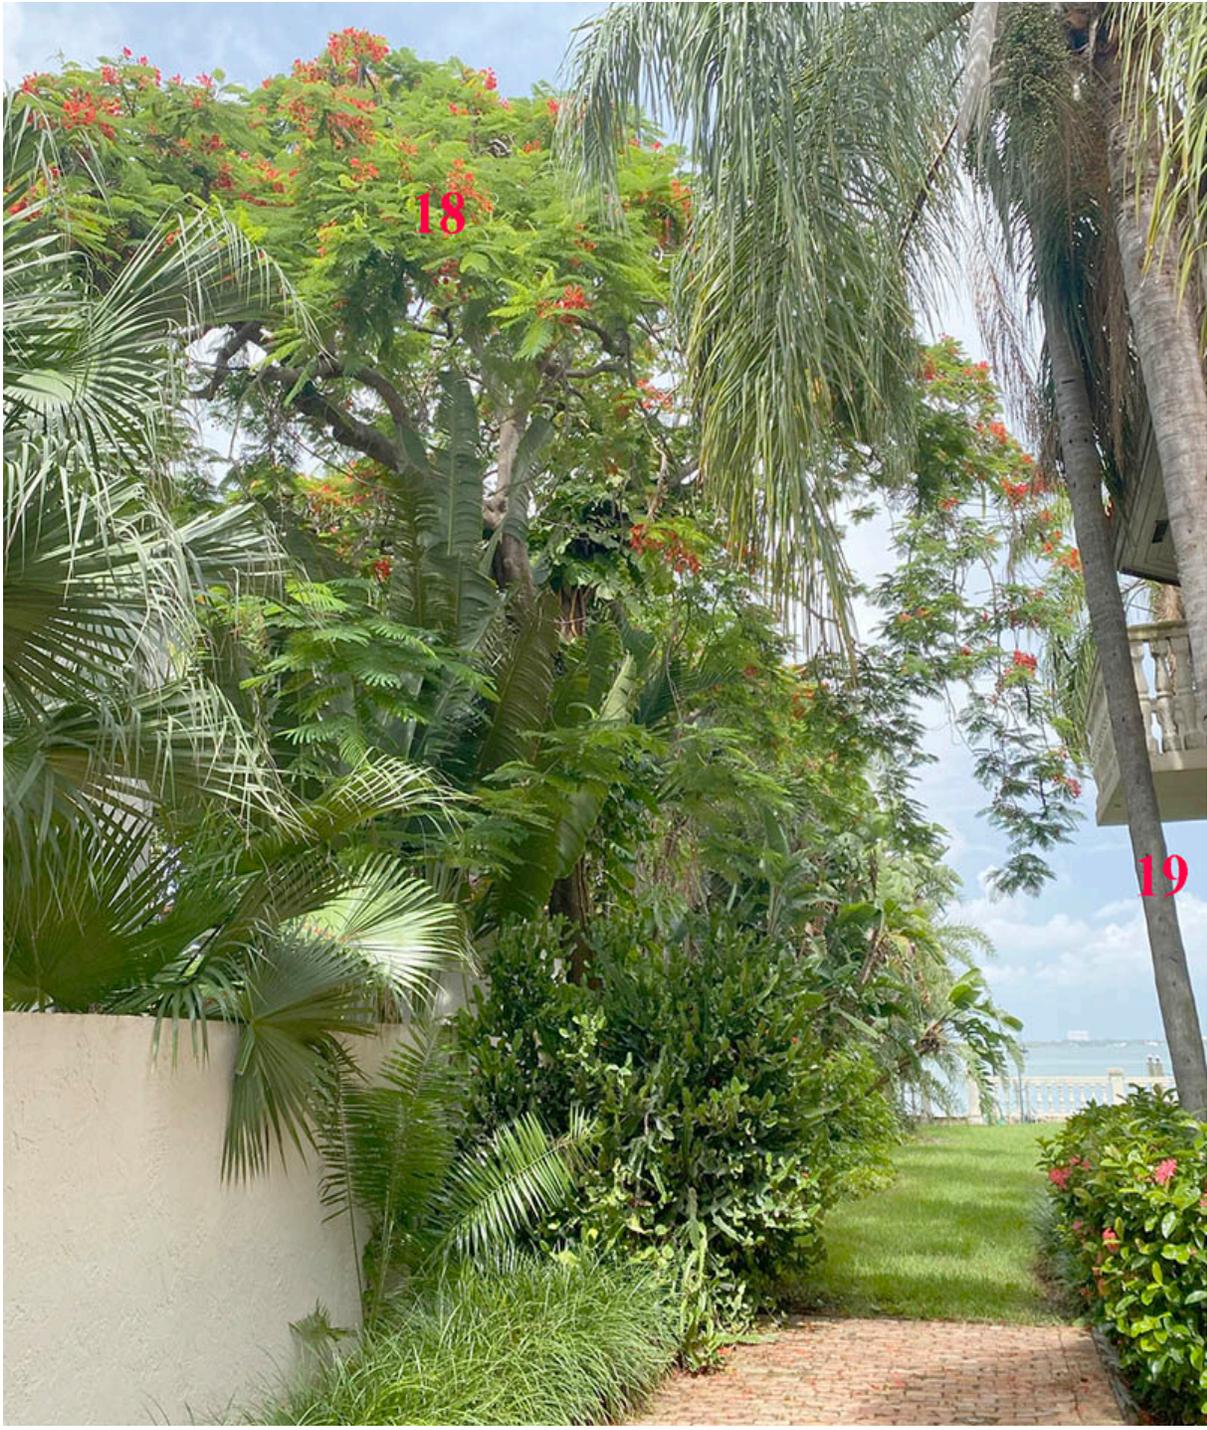
Photo 17 above is tree 18. It appears that the majority of the canopy is over the neighboring property. With the weight of the tree being supported by the wall seen in the previous photo, I recommend the removal of this tree.

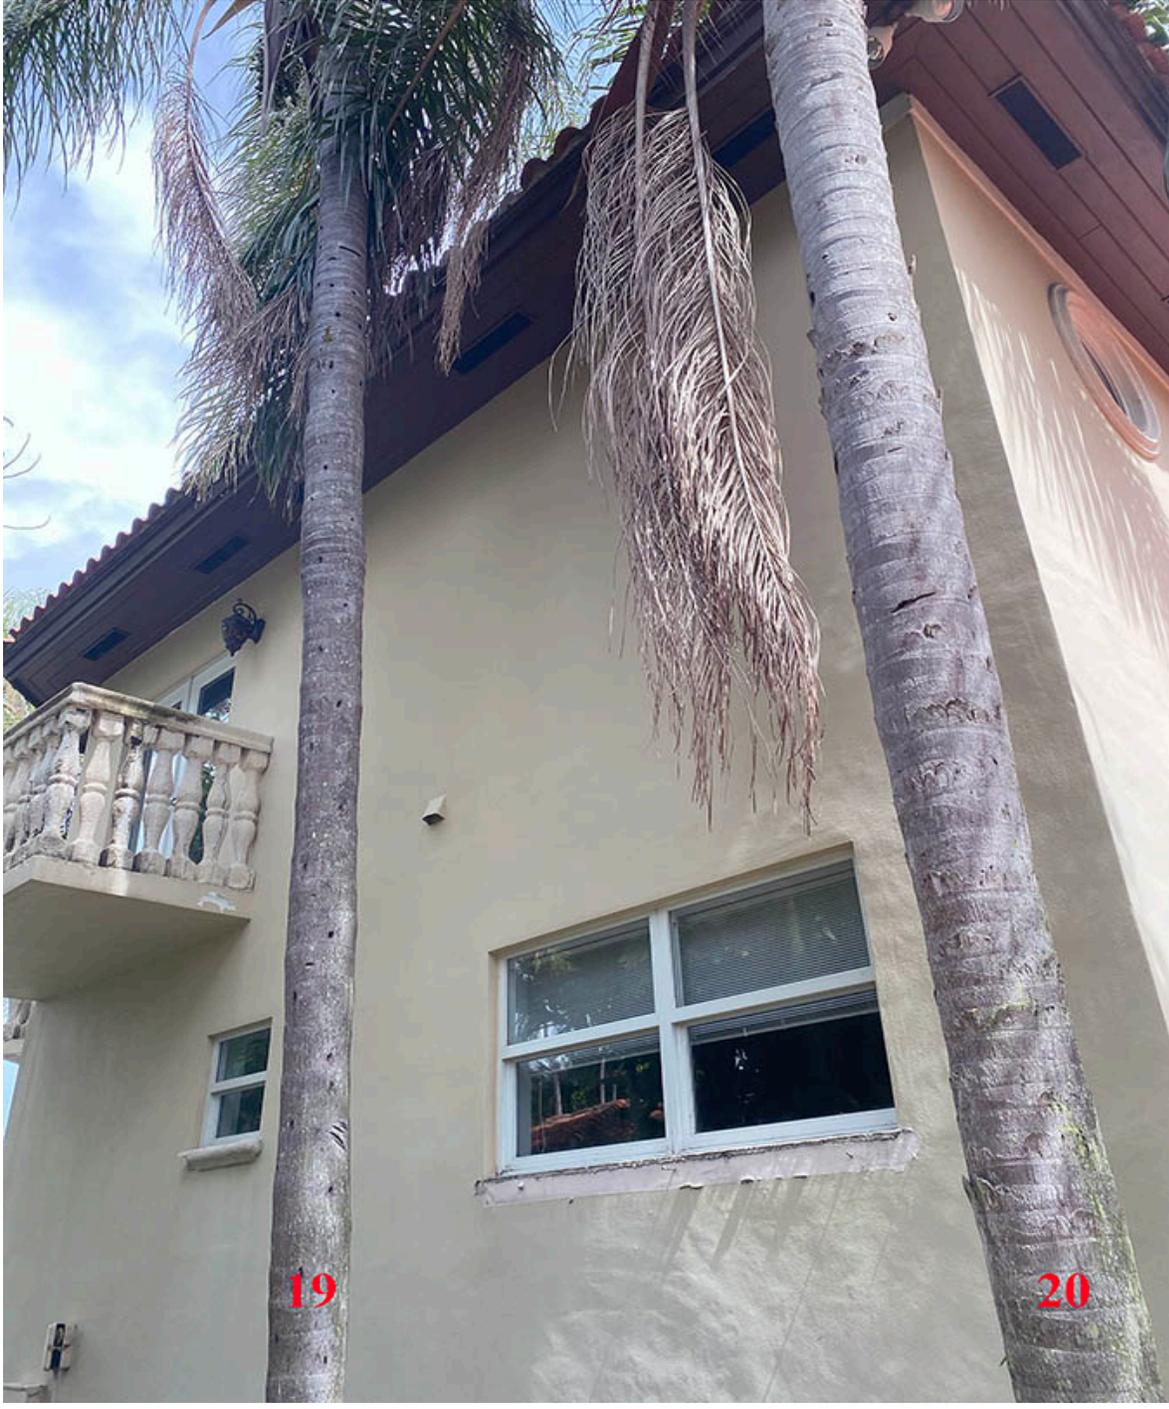
Photo 19 above is palms 19 & 20 with spike holes in their trunks. See Appendix G below. If palms have damage to their trunks or climbing spike holes in their trunks, I do not recommend the relocation of these palms. These palms should be removed.

Any trunk wounds caused by careless pruning, climbing spikes, or pulling off old leaves before they completely abscise or rot off can result in unsightly scars and provide entry sites for *thielaviopsis* trunk rot.

When climbing palms for canopy maintenance, the use of climbing spikes is not recommended. “Spiking” is a prescription for future problems. The holes left by these devices will never heal and *Thielaviopsis paradoxa* has been known to colonize such wounds. Only lift vehicles, ladders, or pulley/sling systems should be used with palms.

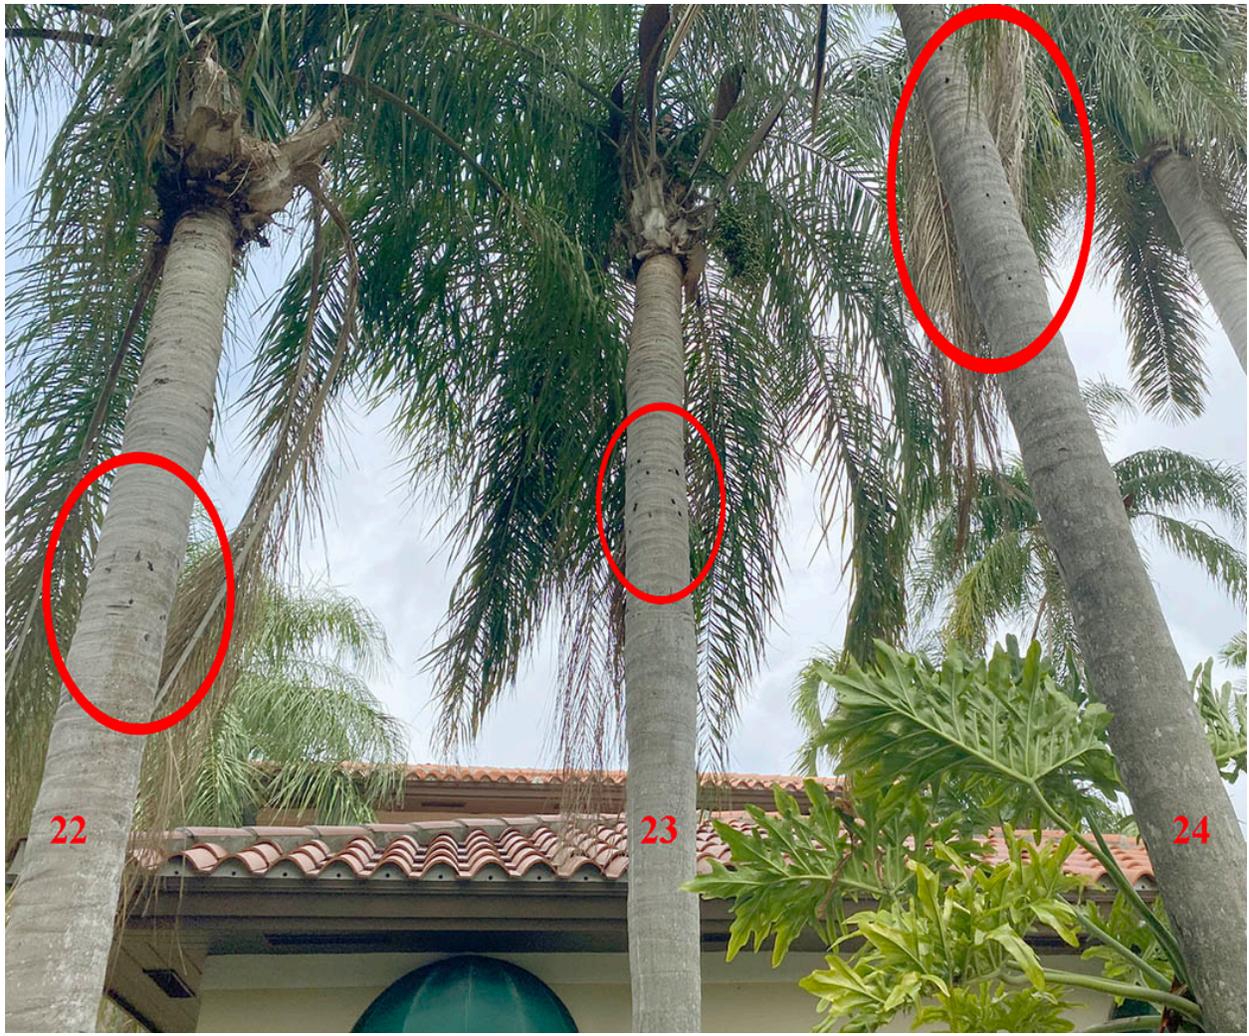
Photo 22 above is palms 22, 23 & 24 with climbing spike holes in their trunks. See Appendix G below. If palms have damage or climbing spike holes in their trunks, I do not recommend the relocation of these palms. These palms should be removed.

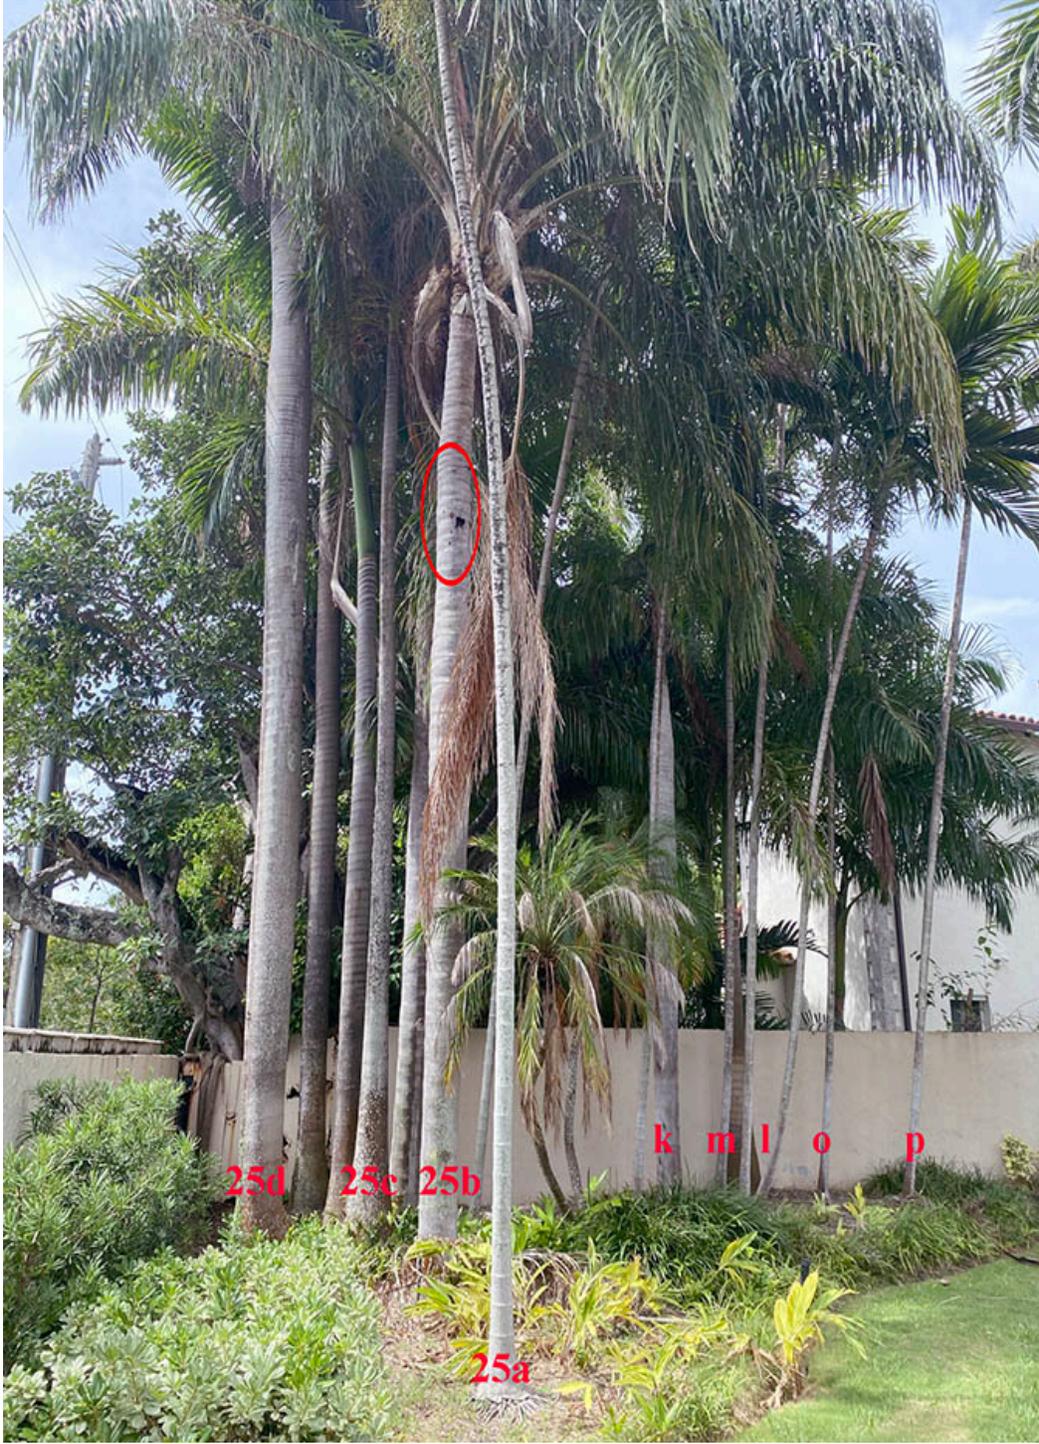
Photo 23 above is palms 25a through 25p. Note the hole in the trunk of palm 25b. This palm should be removed.

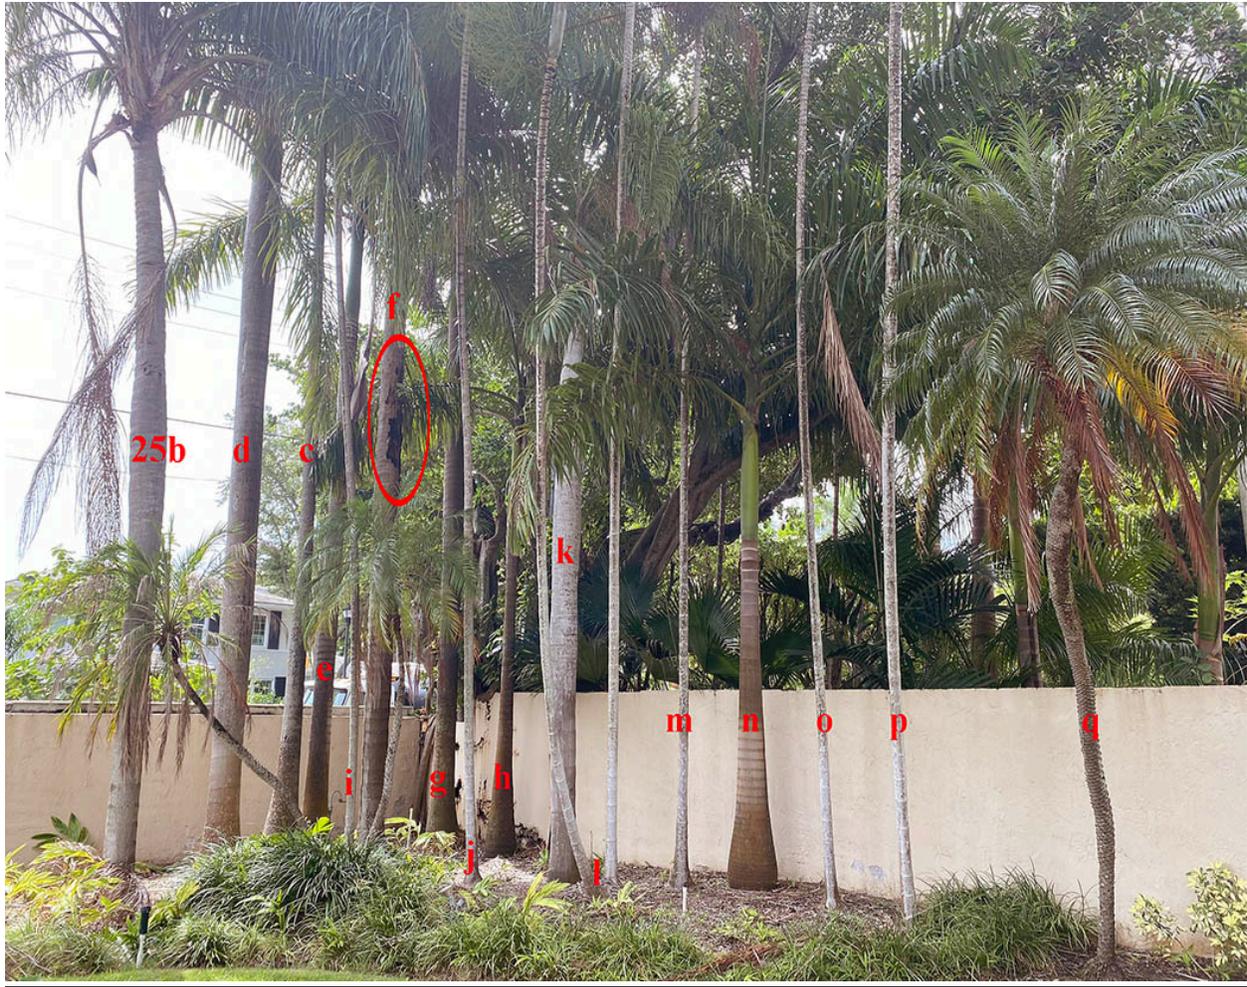
Photo 24 above is palms 25b through 25q. Note the damage to the trunk of palm 25f. This palm should be removed.

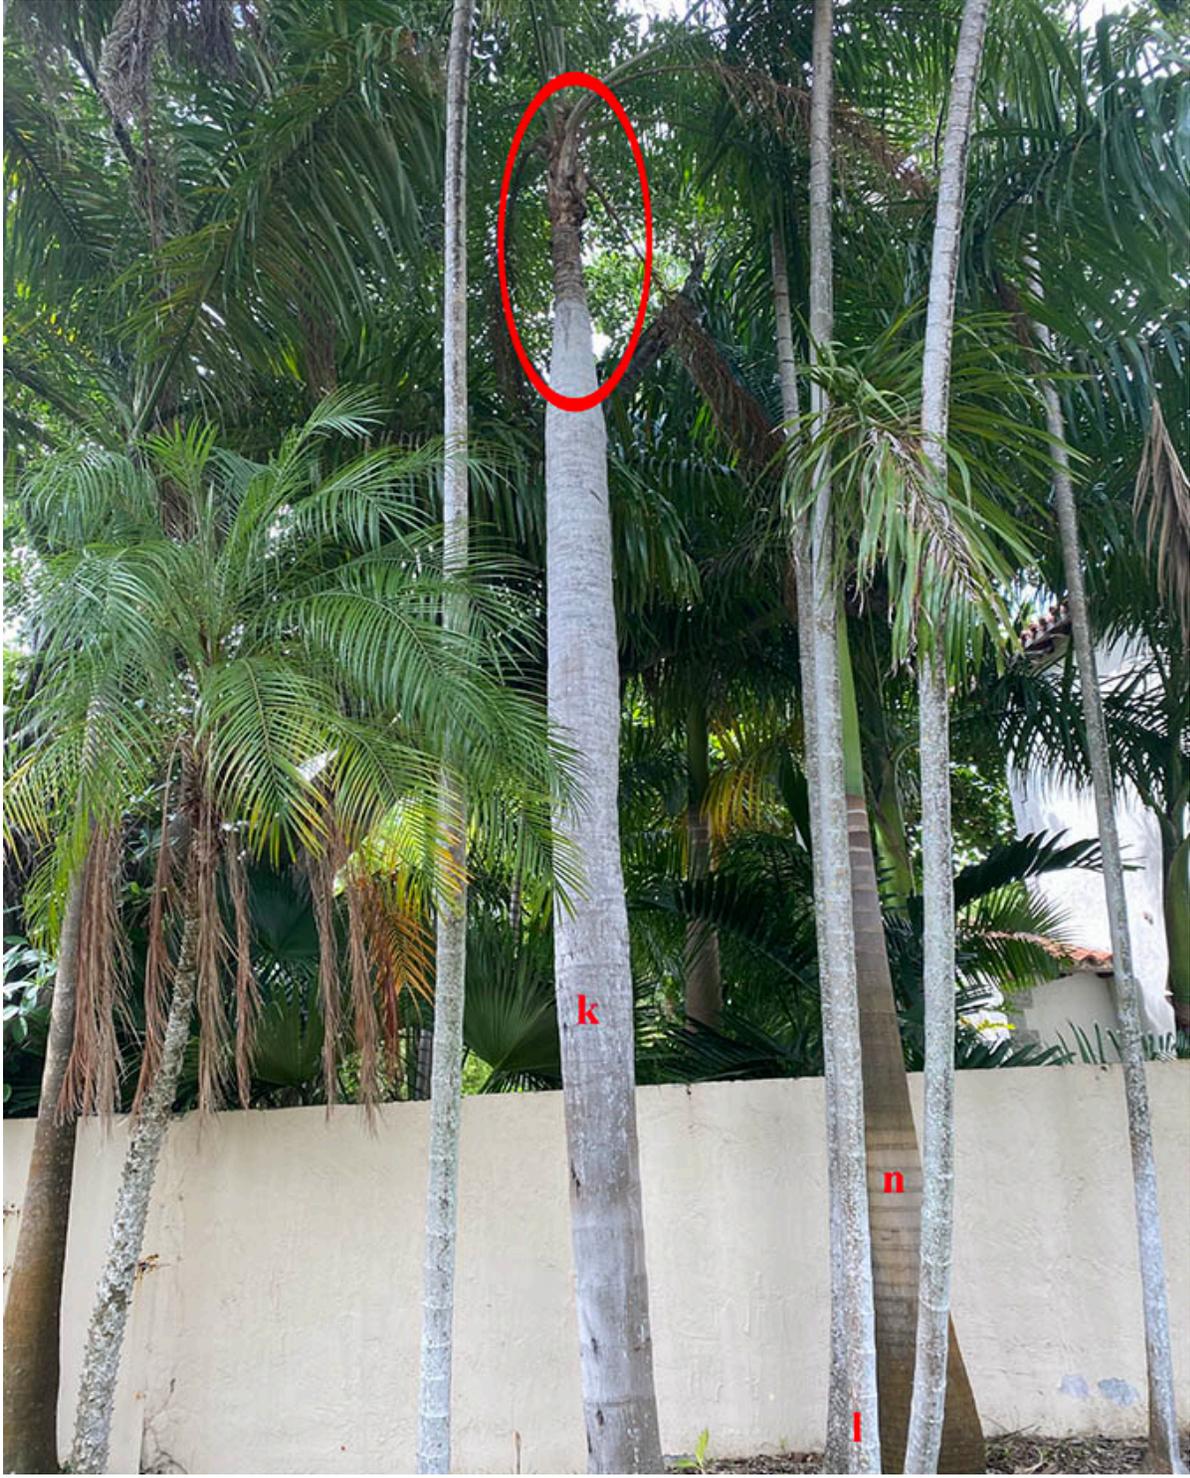
Photo 26 above is the trunk of palm 25k that is severely pinning. This palm should be removed.

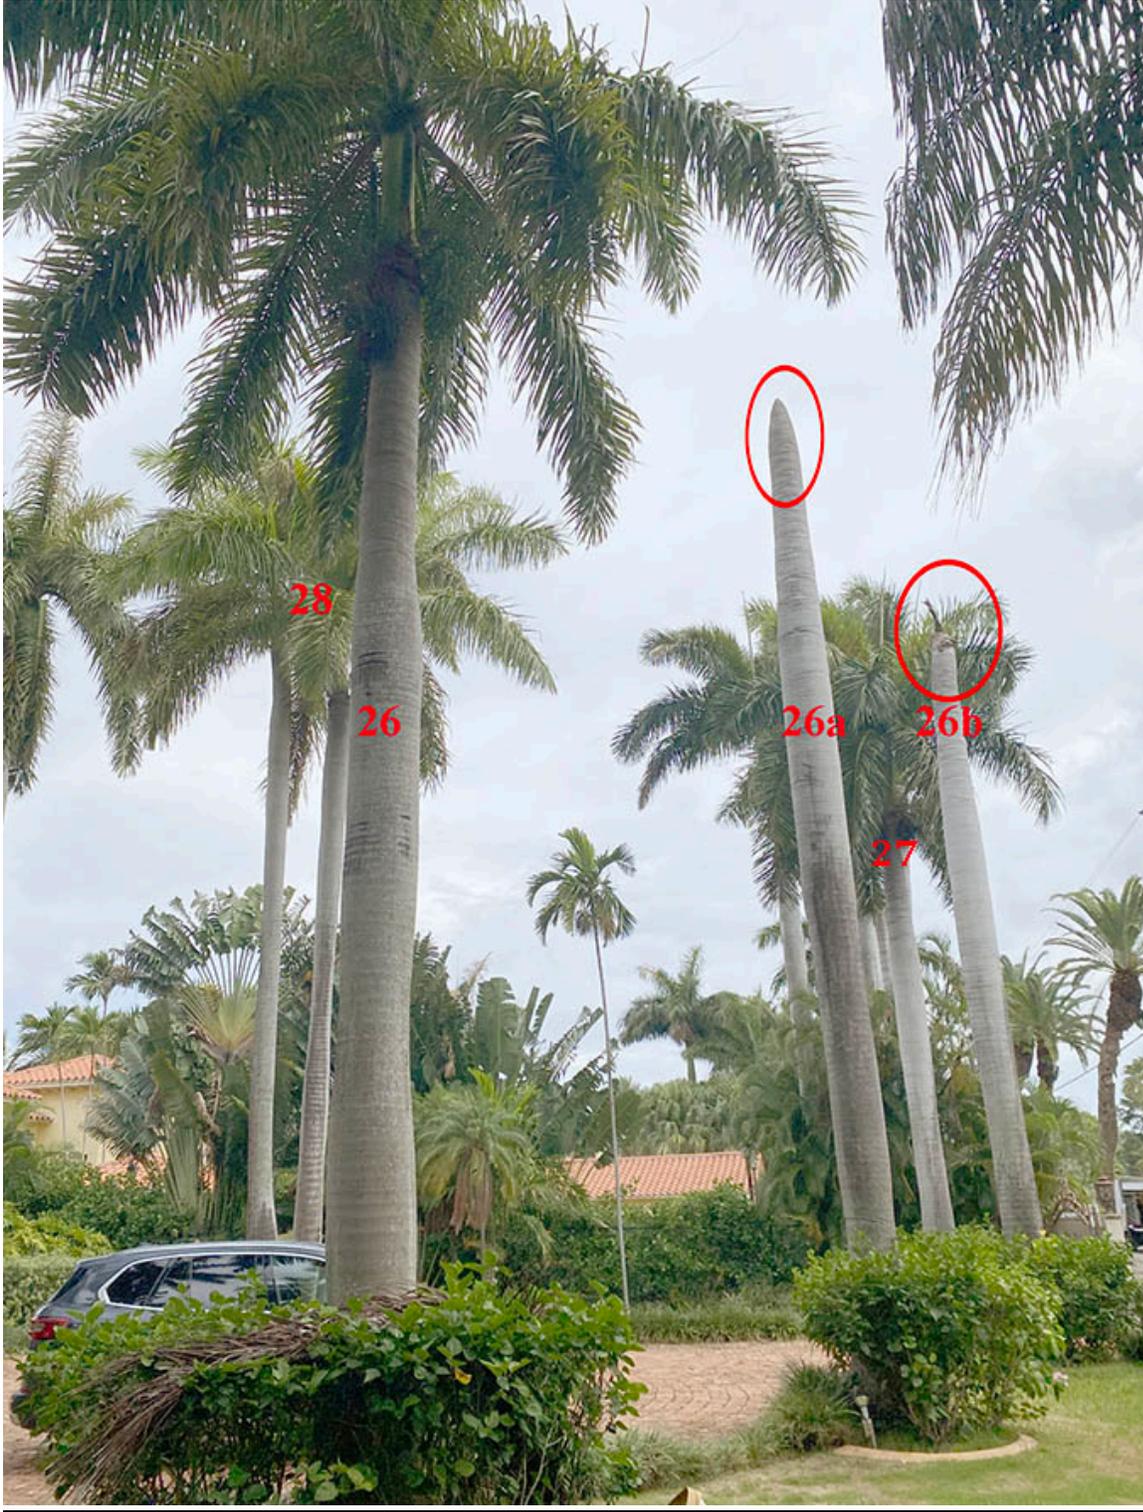
Photo 27 above is palms 26, 26a, 26b & 27. Note that 26a & 26b are dead.

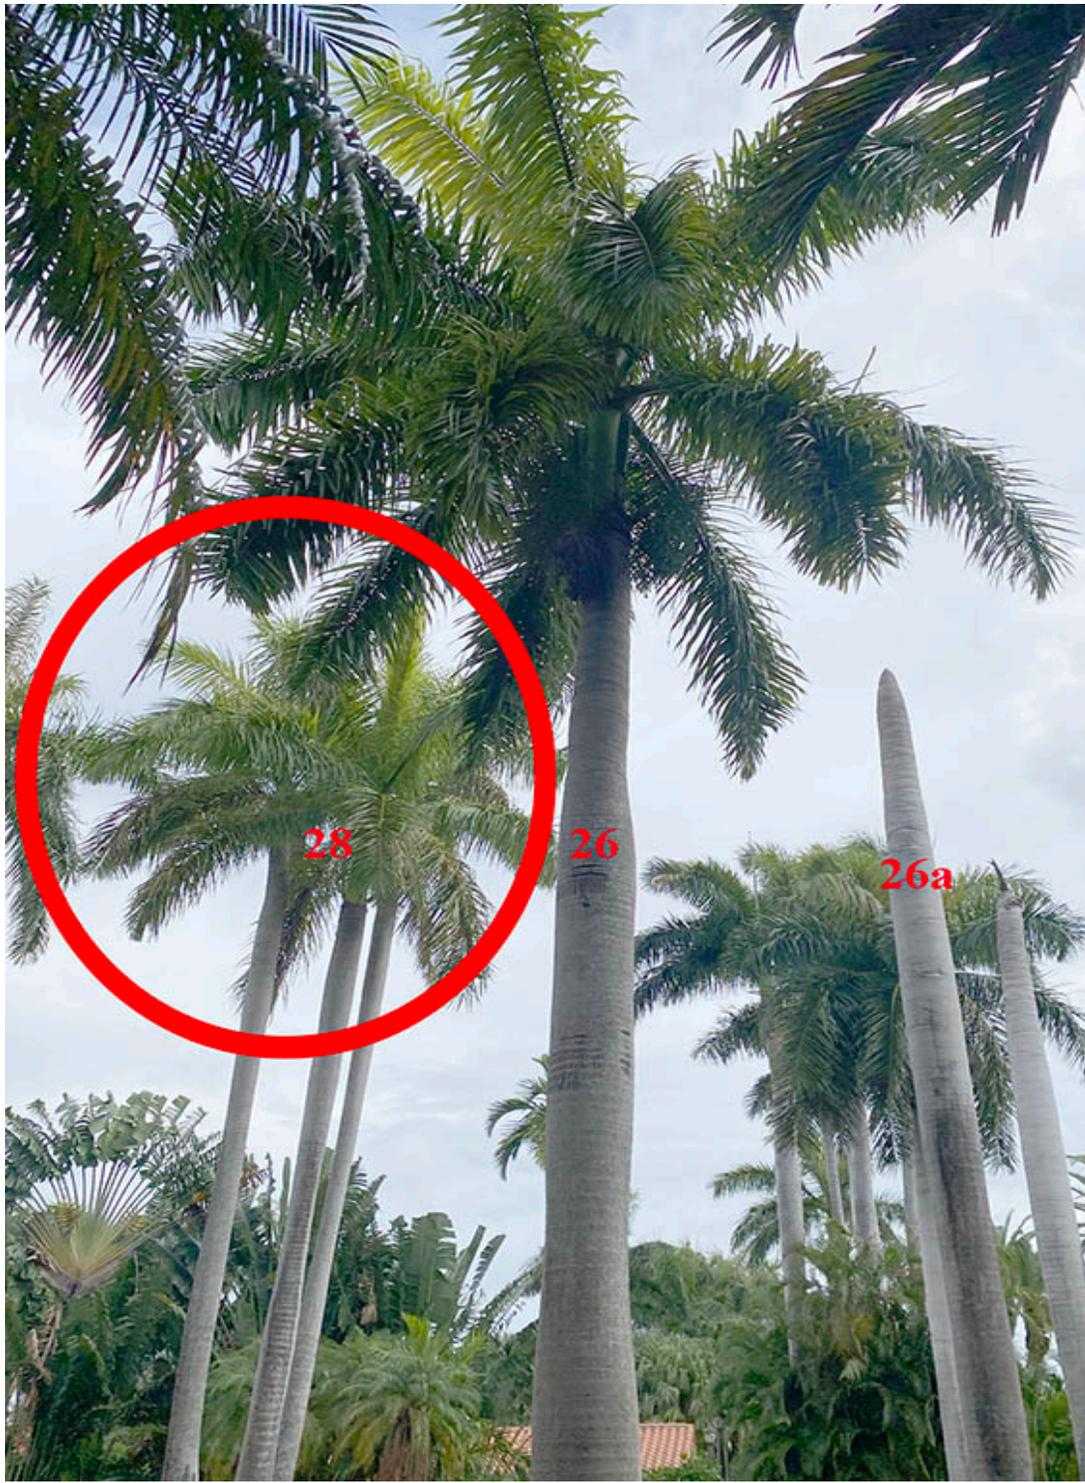
Photo 28 above is triple-trunked palm 28. The fronds are showing signs of a developing severe nutrient deficiency.

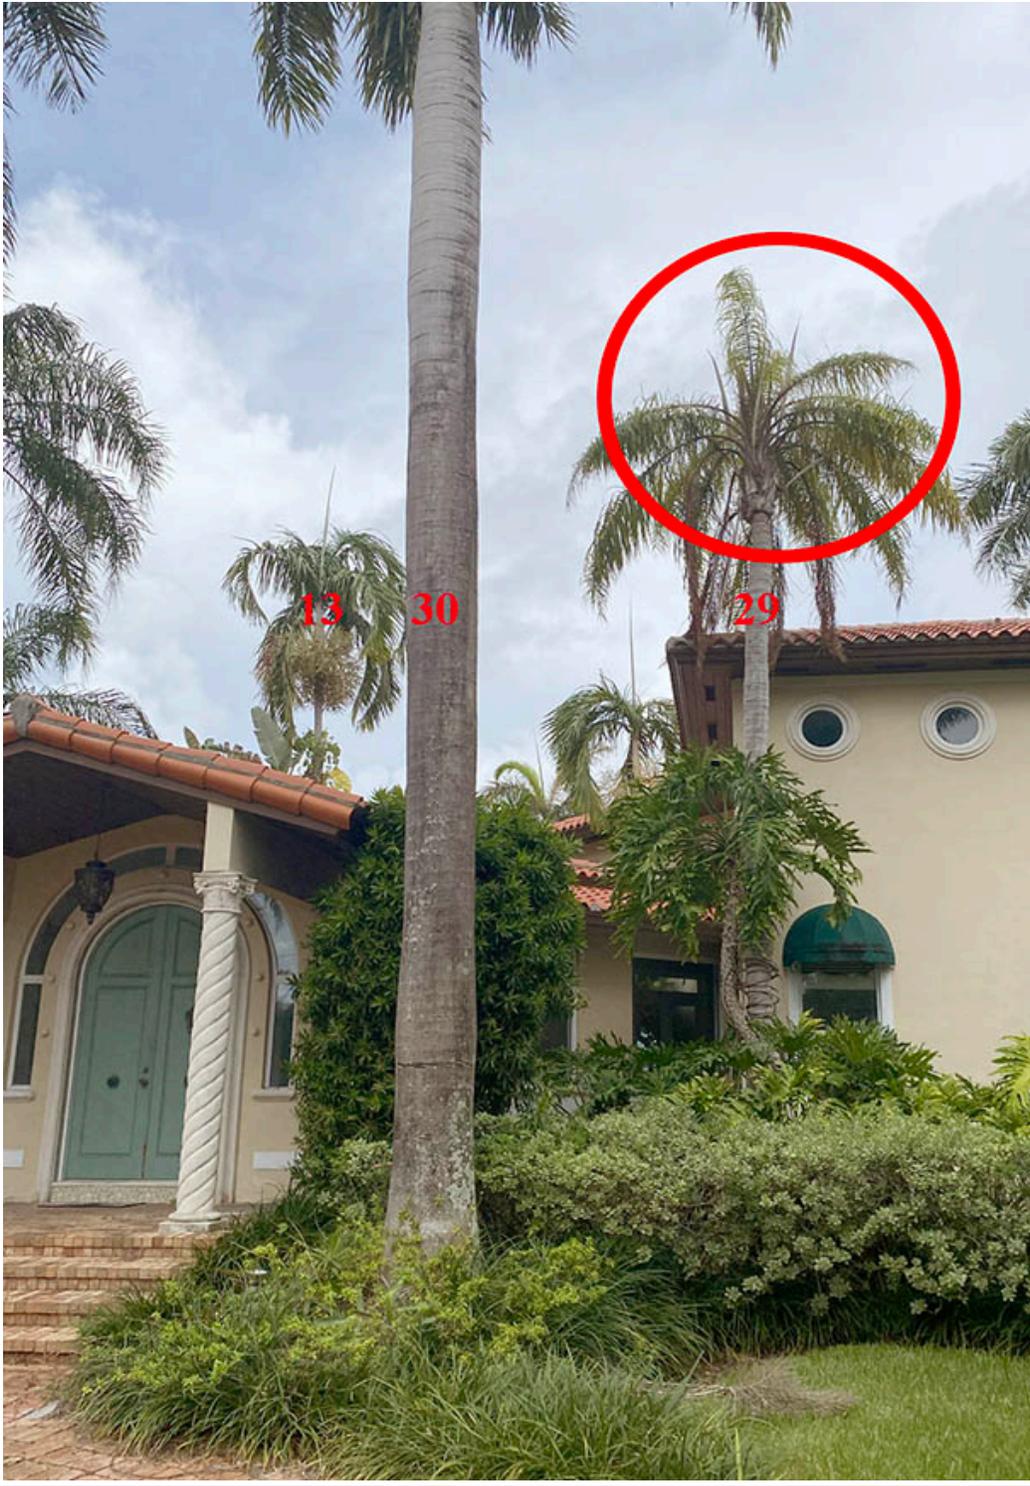
Photo 29 above is palms 29 & 30. The trunk of palm 29 is full of climbing spike holes and should be removed.
