Tree Resource Evaluation for 4540 North Bay Road, Miami Beach

June 28, 2021

Summary

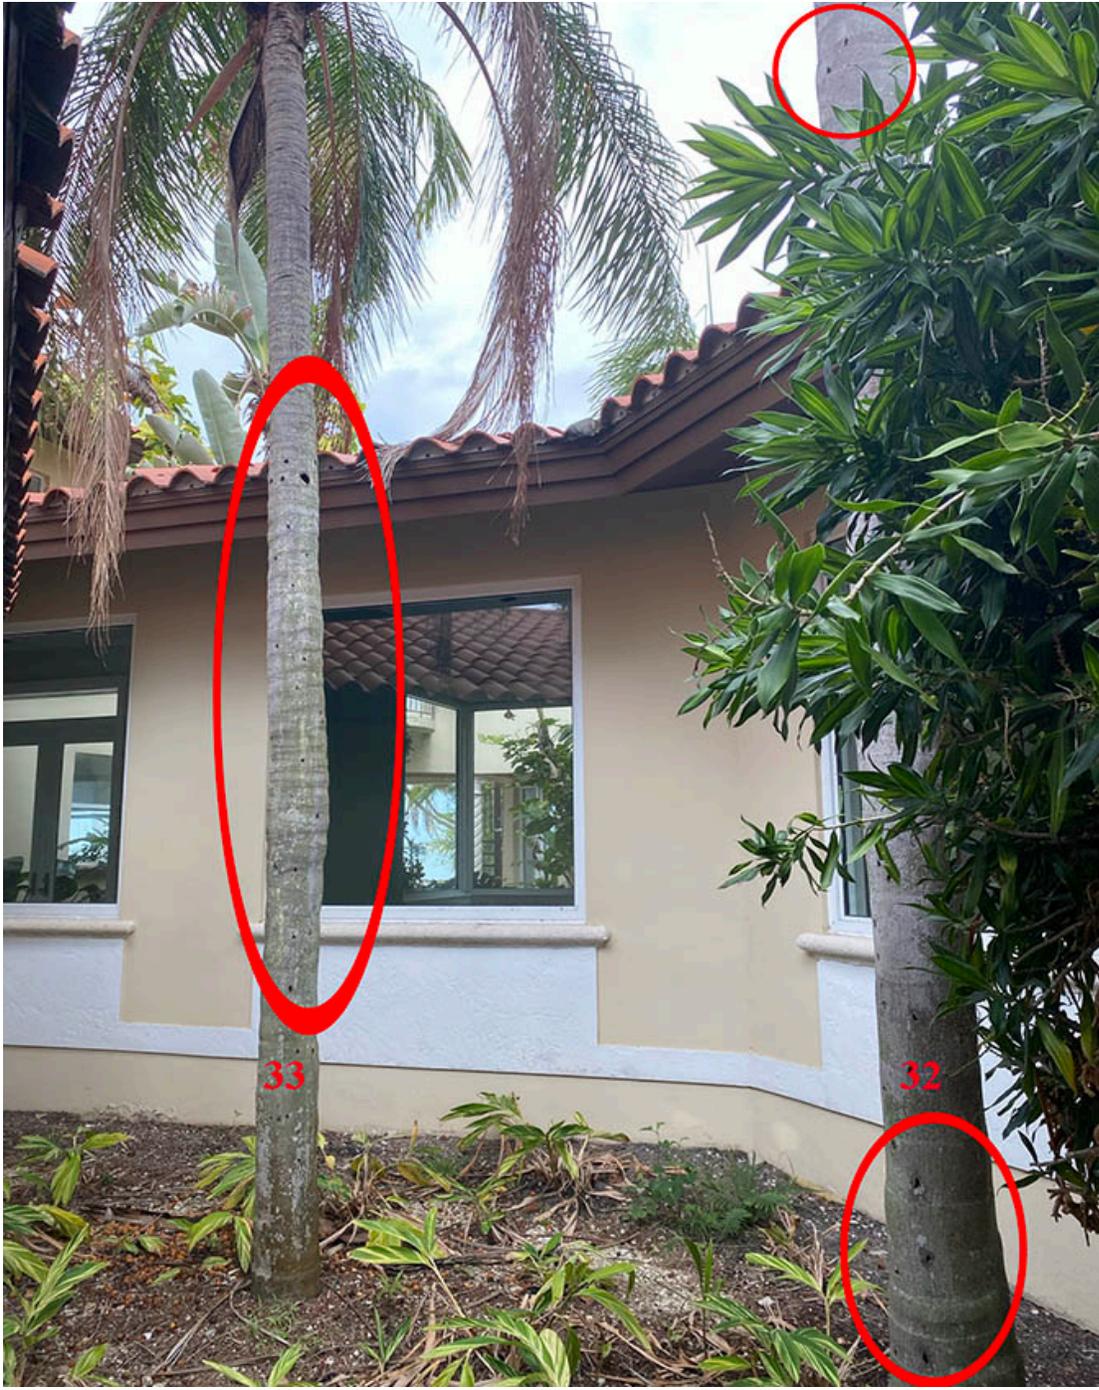
Photo 31 above is palms 32 & 33 with damage and climbing spike holes in their trunks. See Appendix G below. If palms have damage or climbing spike holes in their trunks, I do not recommend the relocation of these palms. These palms should be removed.

Any trunk wounds caused by careless pruning, climbing spikes, or pulling off old leaves before they completely abscise or rot off can result in unsightly scars and provide entry sites for *thielaviopsis* trunk rot.

When climbing palms for canopy maintenance, the use of climbing spikes is not recommended. “Spiking” is a prescription for future problems. The holes left by these devices will never heal and *Thielaviopsis paradoxa* has been known to colonize such wounds. Only lift vehicles, ladders, or pulley/sling systems should be used with palms.

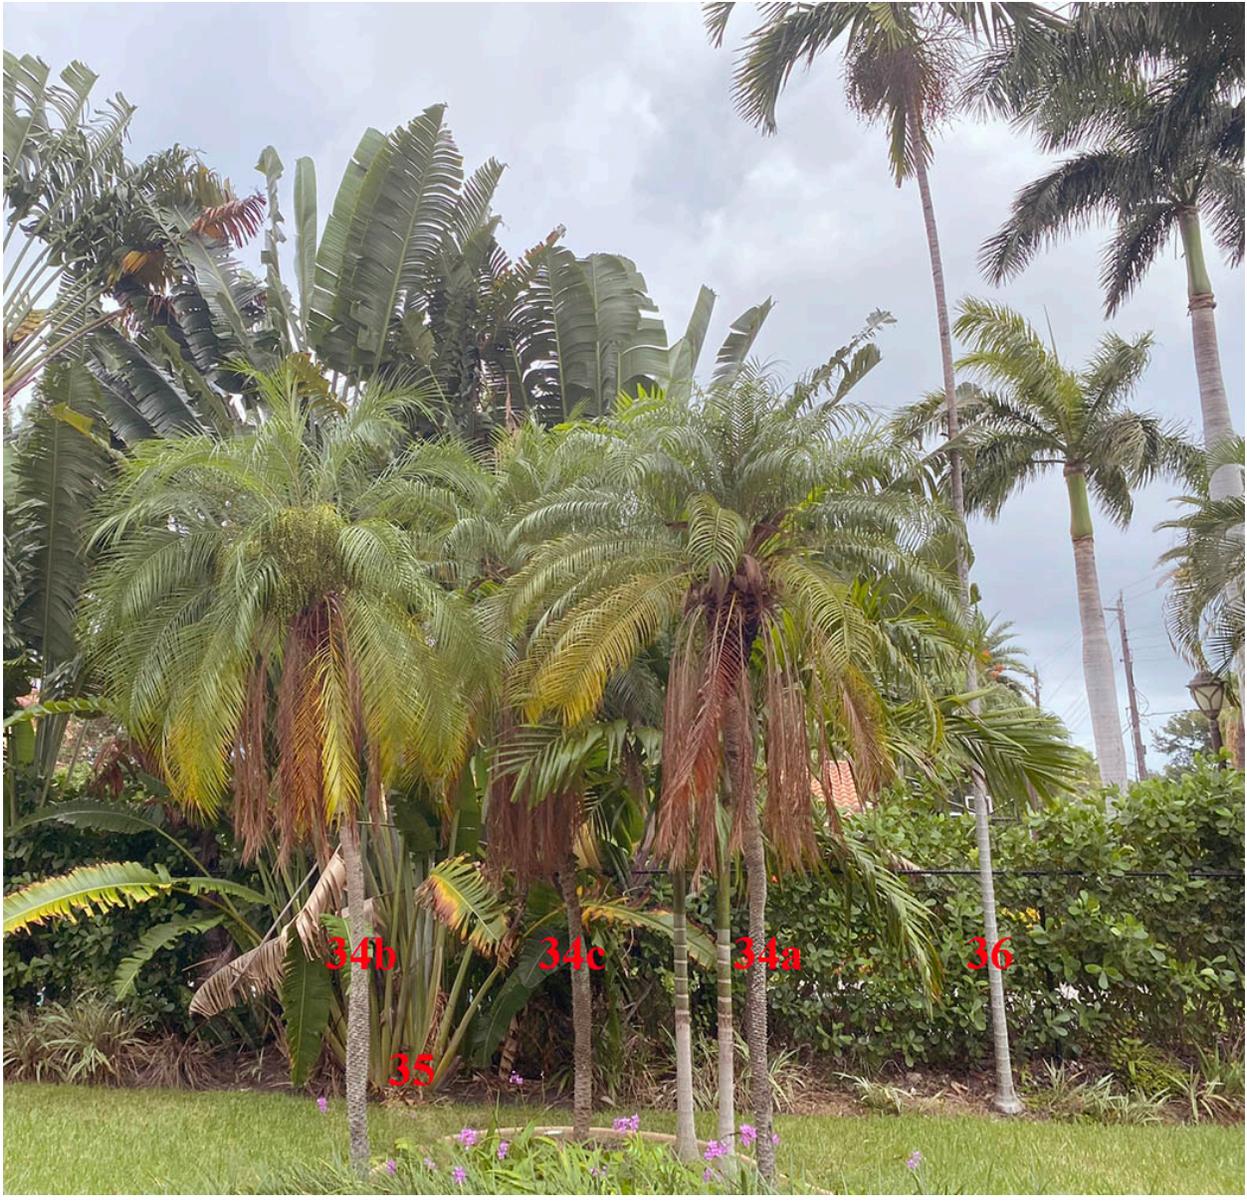
Photo 32 above is palms 34a, 34b, 34c & 36. All other palms in this photo have no trunk at 4.5 feet above grade.

Traveller's tree 35 has no trunks to measure on this side of the fence.

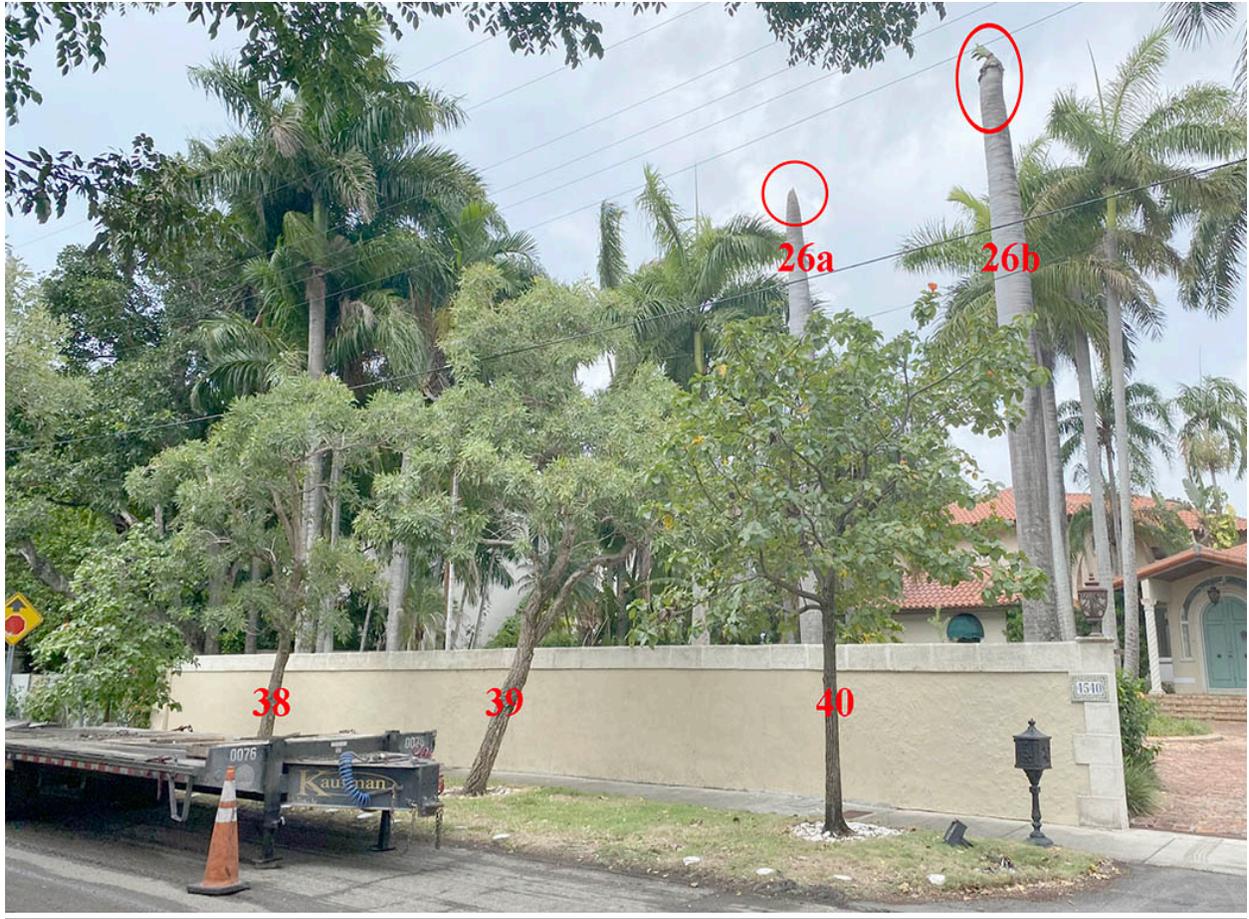
Photo 35 above is trees 38, 39 & 40 and dead palms 26a & 26b.
