Arborist Report

1649 W 22nd Street
Miami Beach

8/16/2021

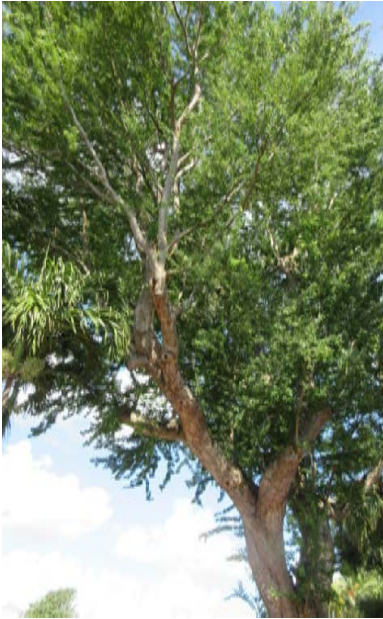
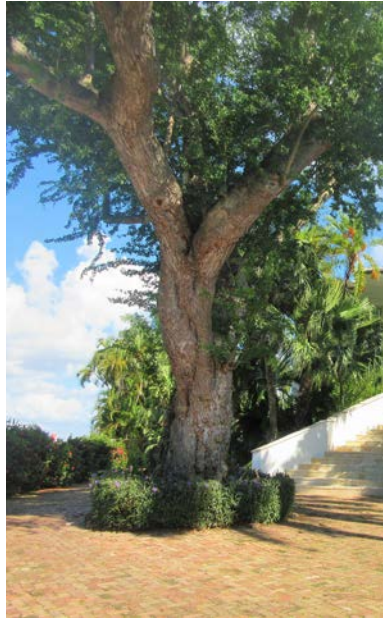
Tree #1 is a Manila Tamarind located at the center of the driveway. It is in fair condition. The tree has been hatracked and the canopy consists of poorly attached shoot growth over the years. There is visible decay in a number of limbs. The trunk divides into two. This tree has not been incorporated into the landscape plan and will therefore be removed.

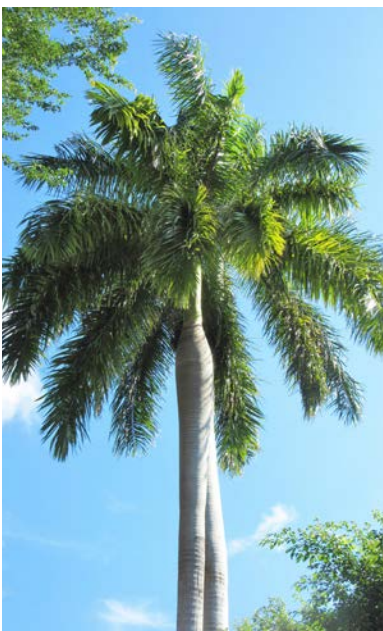
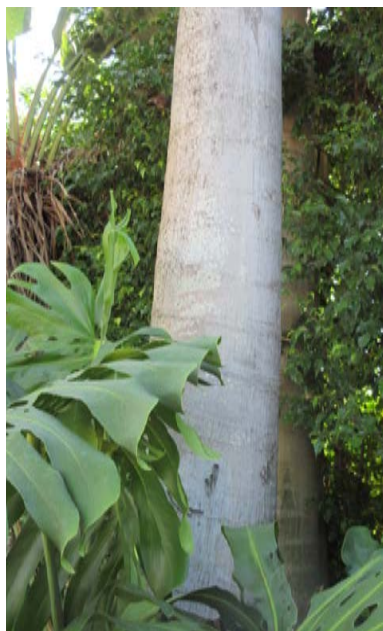
Tree #2 is a Royal Palm located on the east side of the front yard. It is in fair condition with a pencilling trunk. This tree has not been incorporated into the landscape plan and will therefore be removed.

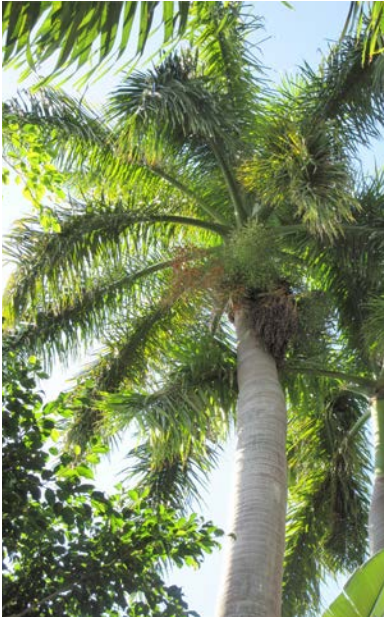
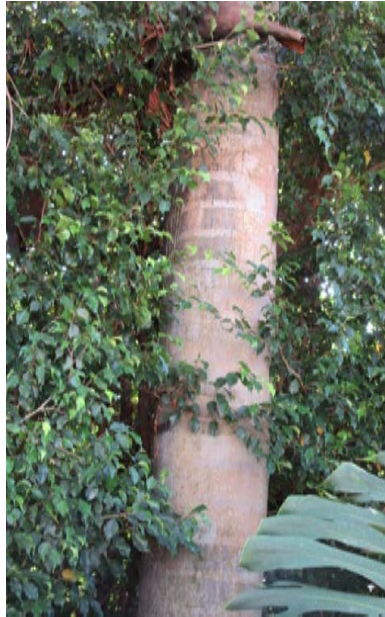
Tree #3 is a Royal Palm located on the east side of the front yard. It is in good condition with some trunk irregularities. This tree has not been incorporated into the landscape plan and will therefore be removed.

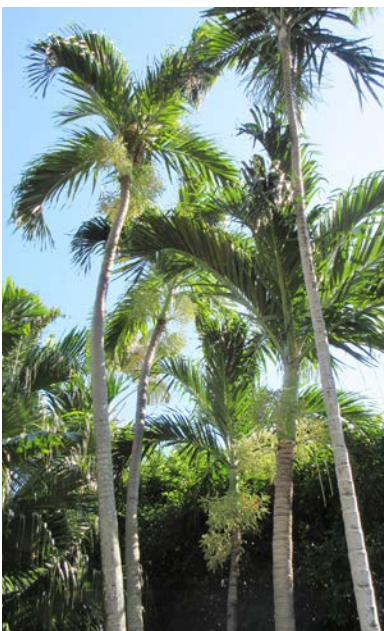
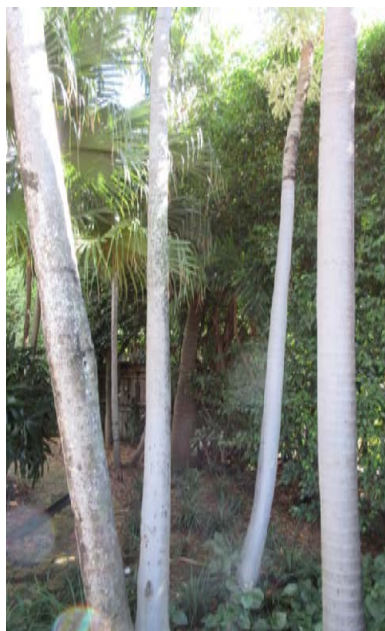
Tree #4 is a cluster of four Christmas Palms located on the east side of the front yard. It is in good condition with some yellow spotting on the fronds. This tree has not been incorporated into the landscape plan and will therefore be removed.

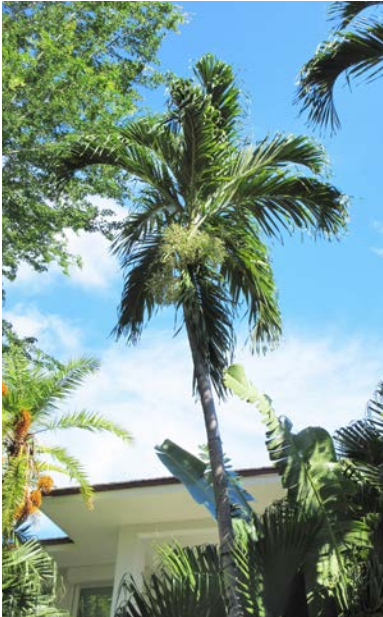
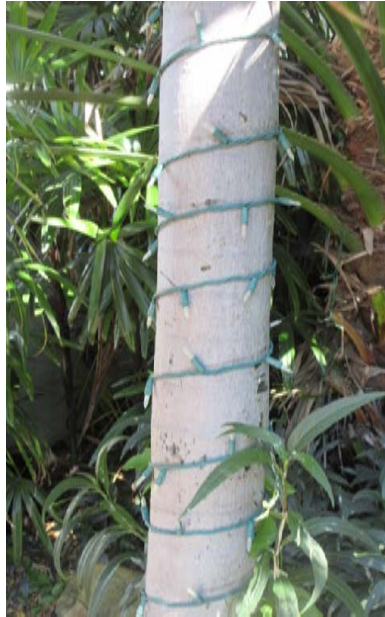
Tree #5 is a Christmas Palm located at the front of the existing house. It is in good condition. This tree has not been incorporated into the landscape plan and will therefore be removed.

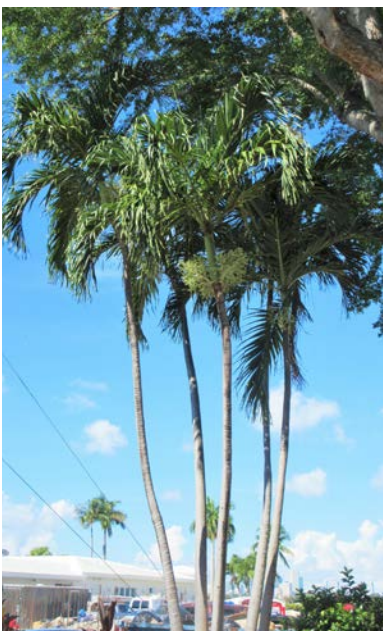
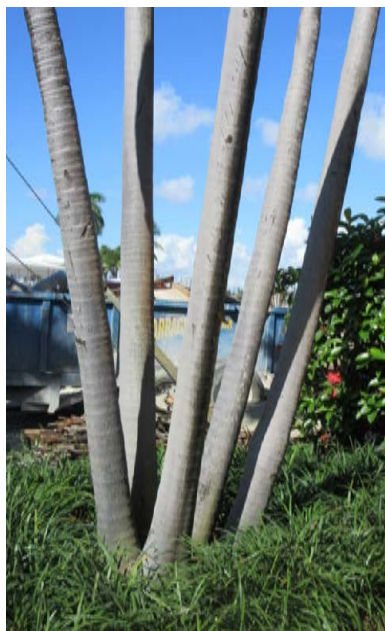
Tree #6 is a cluster of five Christmas Palms located in the front southwest corner of the property. It is in good condition. This tree has not been incorporated into the landscape plan and will therefore be removed.

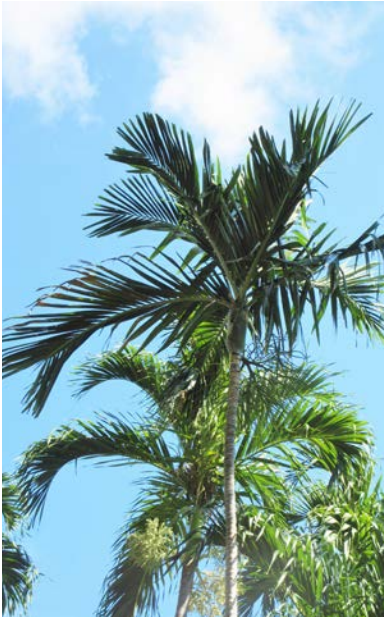
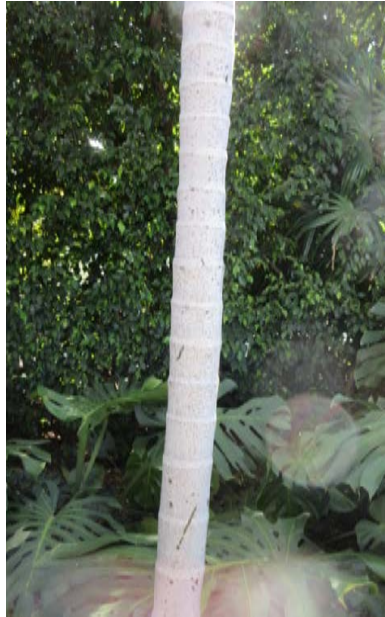
Tree #7 is an Alexander Palm located on the east side of the front yard. It is in fair condition with some tattered fronds.

This tree has not been incorporated into the landscape plan and will therefore be removed.

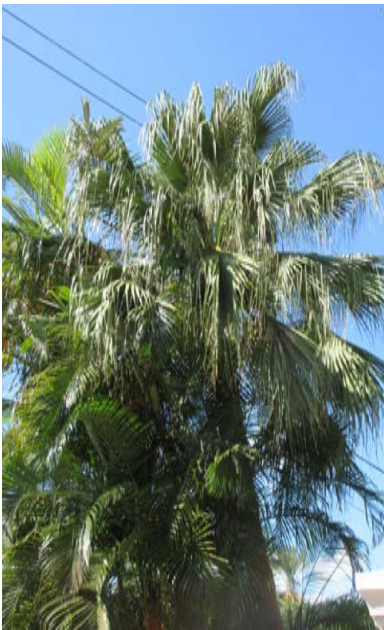
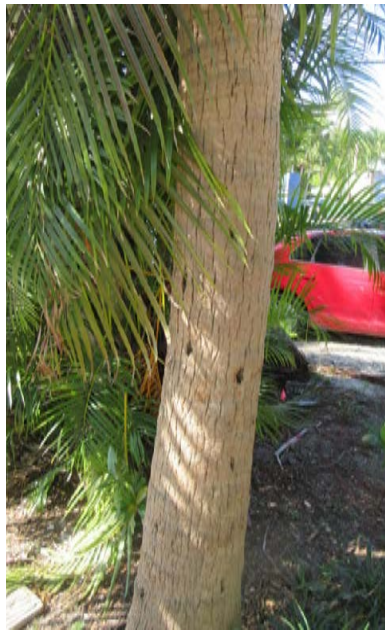
Tree #8 is a Chinese Fan Palm located in the front southwest corner of the property. It is in good condition. This tree has not been incorporated into the landscape plan and will therefore be removed.

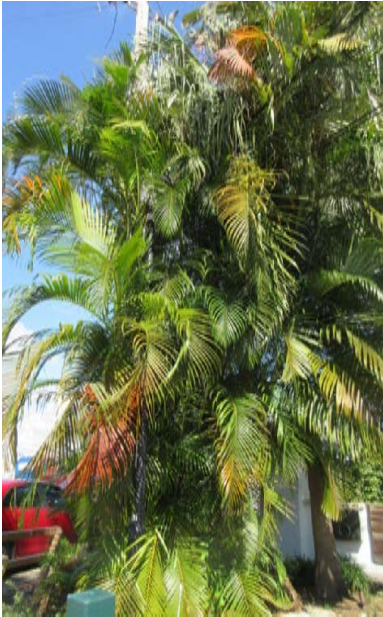
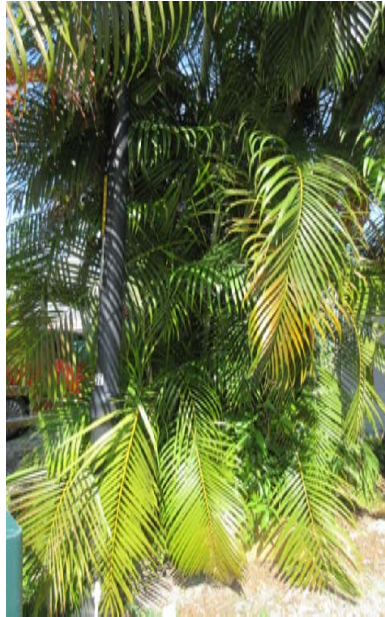
Tree #9 is an Areca Palm street tree located along W 22nd Street. It is in good condition with some off-color fronds. This tree has not been incorporated into the landscape plan and will therefore be removed.

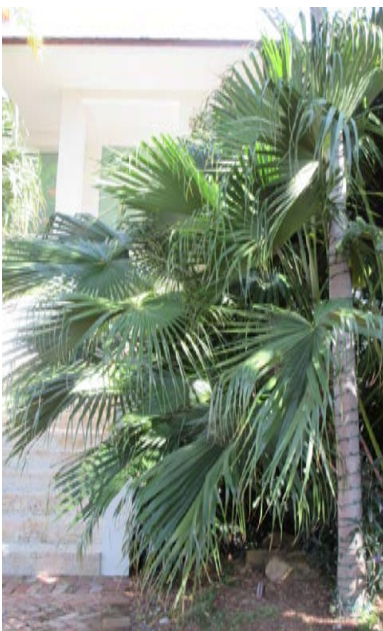
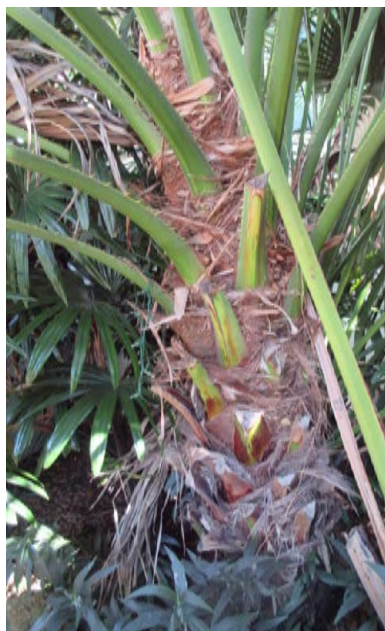
Tree #10 is a Chinese Fan Palm located at the front of the existing house. It is in good condition. This tree has not been incorporated into the landscape plan and will therefore be removed.

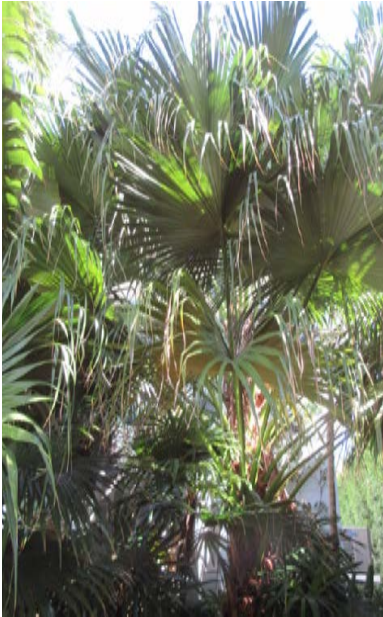
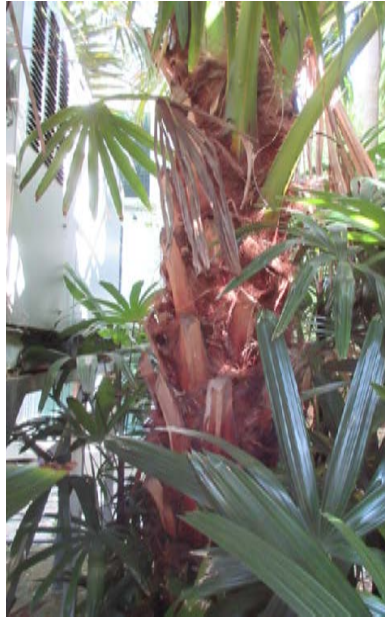
Tree #11 is a Chinese Fan Palm located at the front of the existing house. It is in good condition. This tree has not been incorporated into the landscape plan and will therefore be removed.

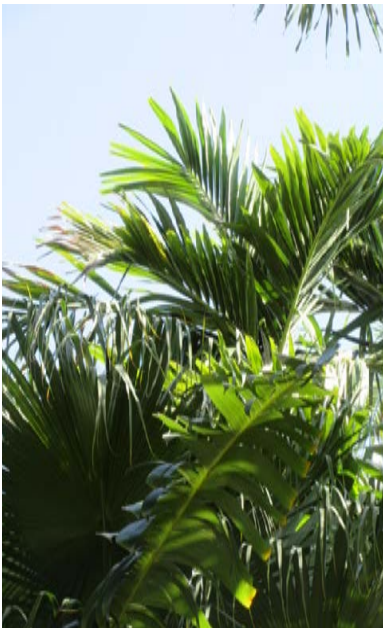
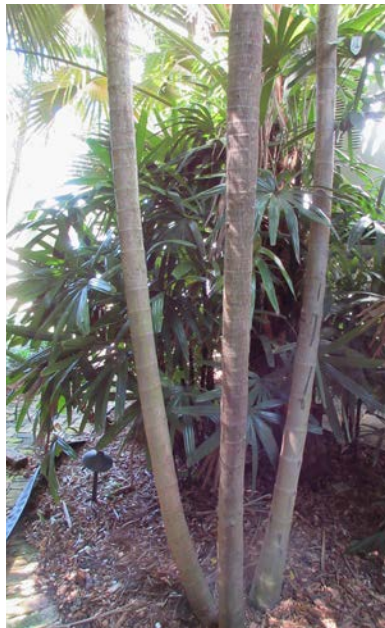
Tree #12 is a triple Alexander Palm located at the front of the existing house. It is in good condition. This tree has not been incorporated into the landscape plan and will therefore be removed.

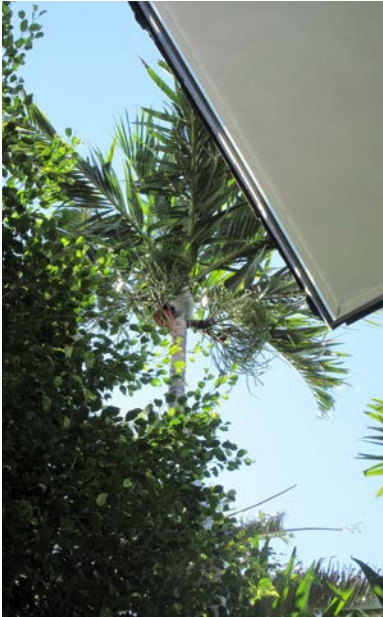
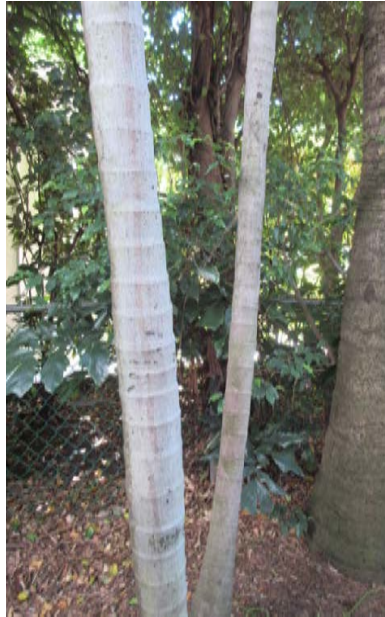
Tree #13 is a double Alexander Palm located on the east side of the property. It is in good condition. This tree has not been incorporated into the landscape plan and will therefore be removed.

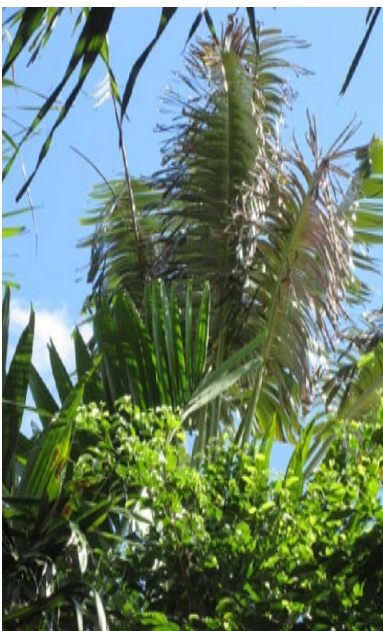
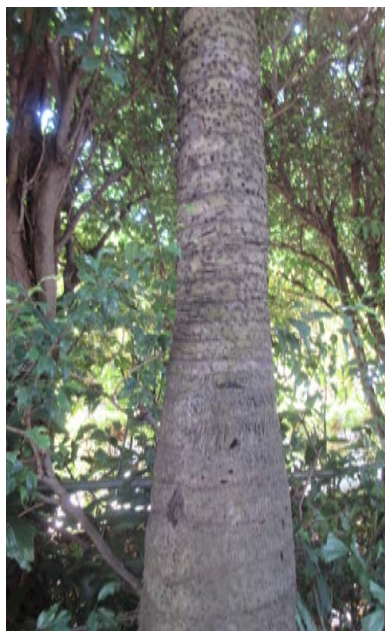
Tree #14 is a Traveler's Palm located on the east side of the property. It is in poor condition with brown, tattered fronds.

This tree has not been incorporated into the landscape plan and will therefore be removed.

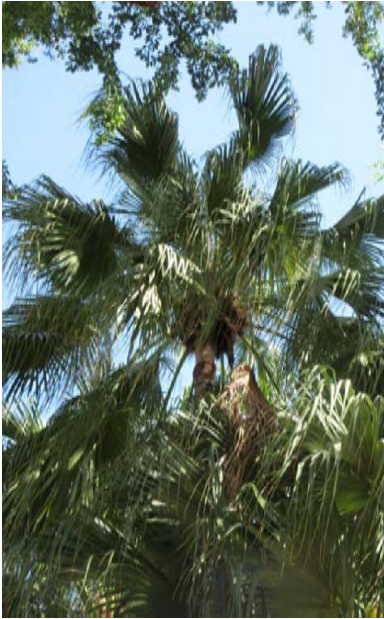
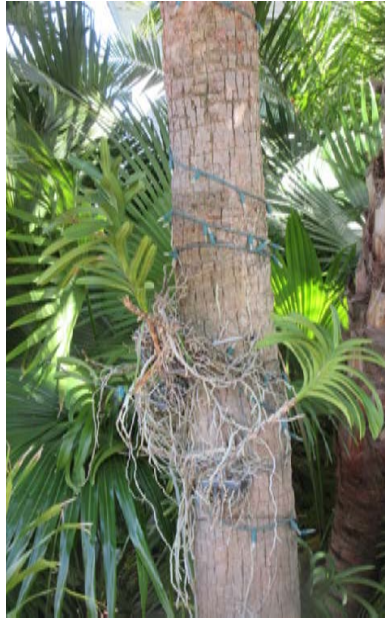
Tree #15 is a Chinese Fan Palm located at the front of the existing house. It is in good condition. This tree has not been incorporated into the landscape plan and will therefore be removed.

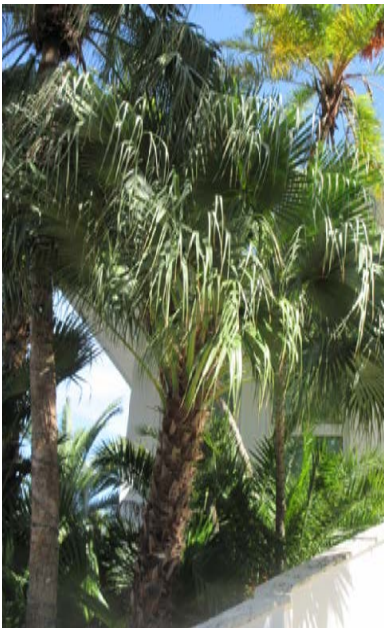
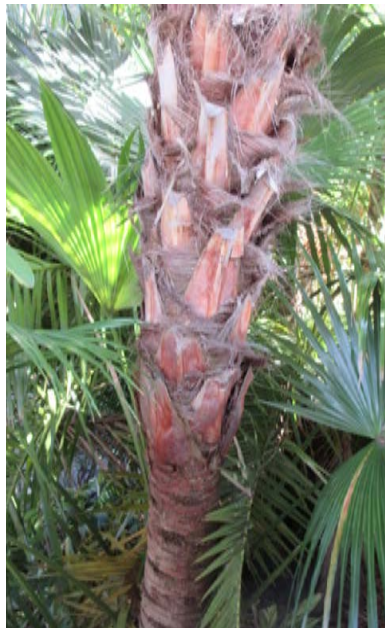
Tree #16 is a Chinese Fan Palm located at the front of the existing house. It is in good condition. This tree has not been incorporated into the landscape plan and will therefore be removed.

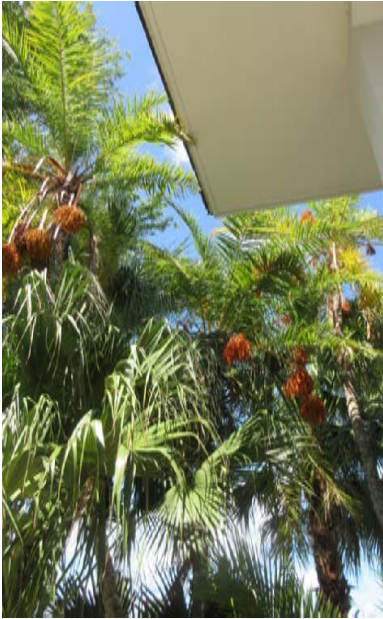
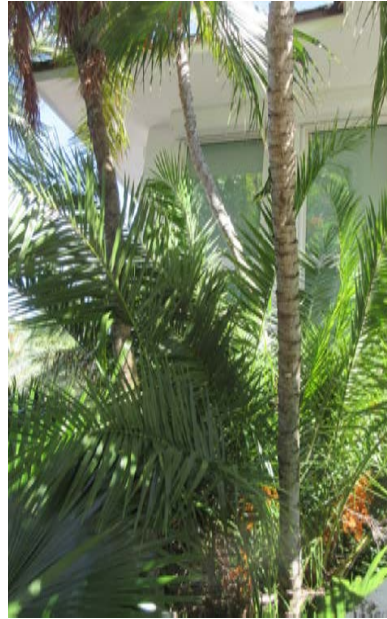
Tree #17 is a Senegal Date Palm cluster located at the front of the existing house. It is in poor condition with only a few trunks and chlorotic foliage. This tree has not been incorporated into the landscape plan and will therefore be removed.

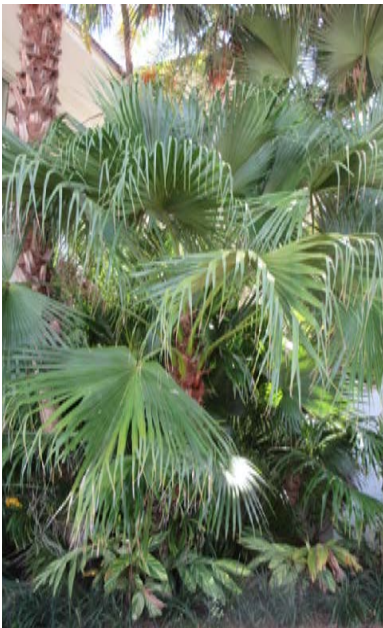
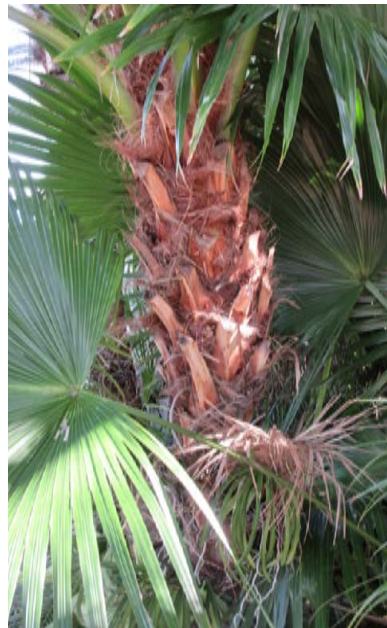
Tree #18 is a Chinese Fan Palm located at the front of the existing house. It is in good condition. This tree has not been incorporated into the landscape plan and will therefore be removed.

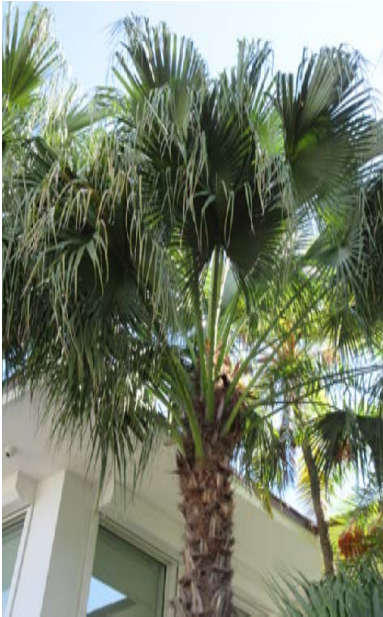
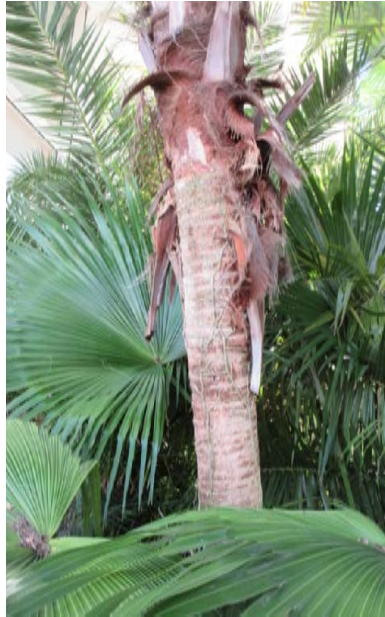
Tree #19 is a Chinese Fan Palm located at the front of the existing house. It is in good condition with a few off-color fronds.

This tree has not been incorporated into the landscape plan and will therefore be removed.

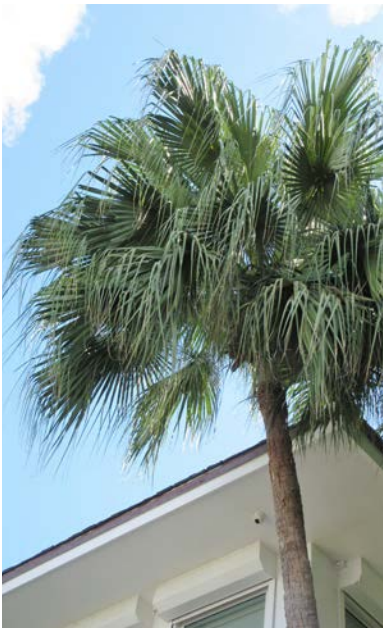
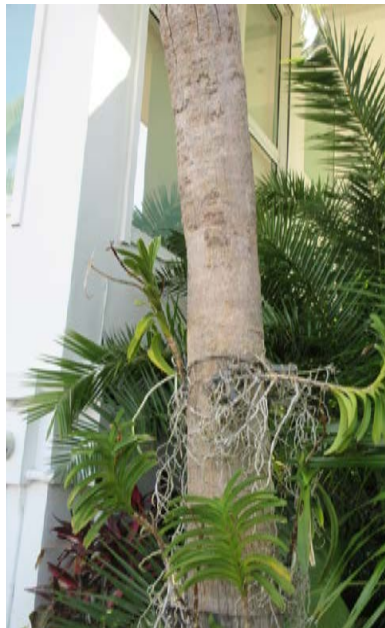
Tree #20 is a Chinese Fan Palm located at the front of the existing house. It is in fair condition with some off-color fronds and bark sloughing off the trunk.

This tree has not been incorporated into the landscape plan and will therefore be removed.

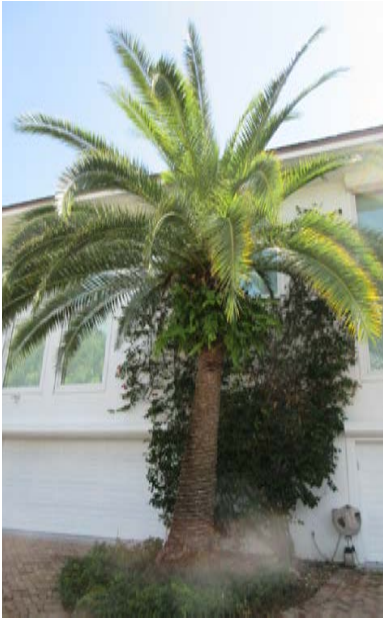
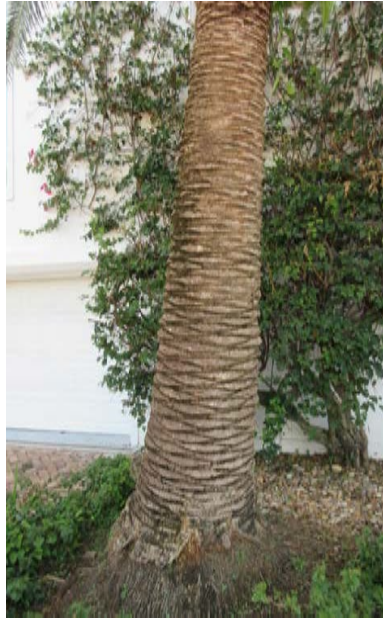
Tree #21 is a Canary Island Date Palm located on the west side of the existing house. It is in fair condition with chlorotic fronds and a pencilling trunk. This tree has not been incorporated into the landscape plan and will therefore be removed.

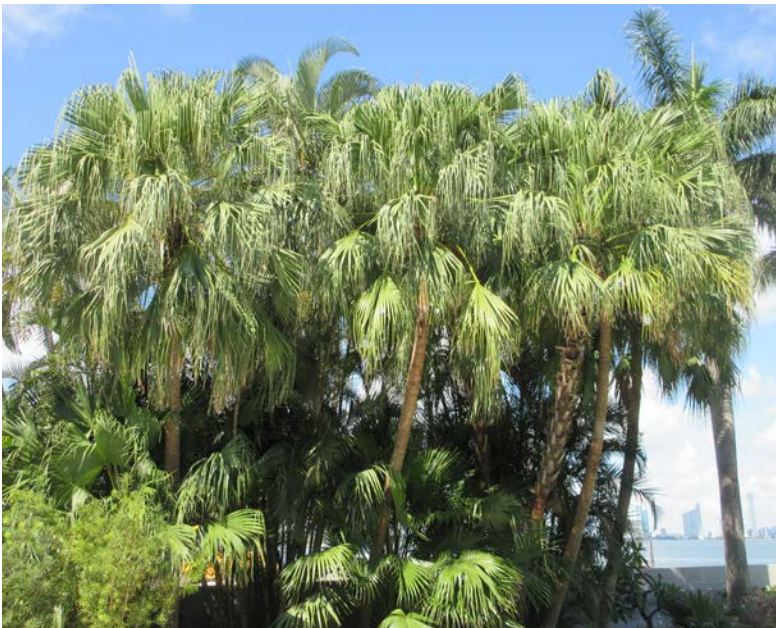
Trees #22 - 27 are six Chinese Fan Palms located on the west side of the backyard. They are in good condition. These trees have not been incorporated into the landscape plan and will therefore be removed.

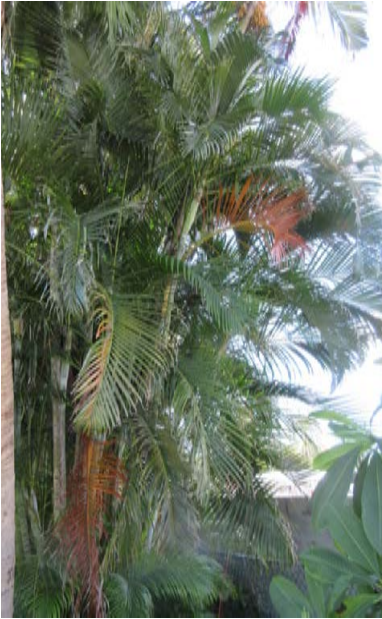
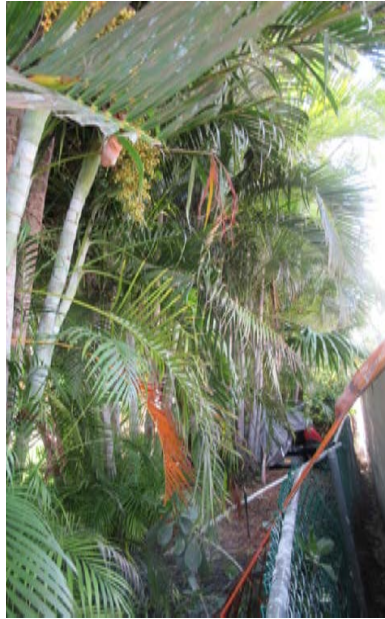
Trees #28 - 31 are four clusters of Areca Palms located on the west side of the backyard. They are in good condition with some yellow fronds. These trees have not been incorporated into the landscape plan and will therefore be removed.

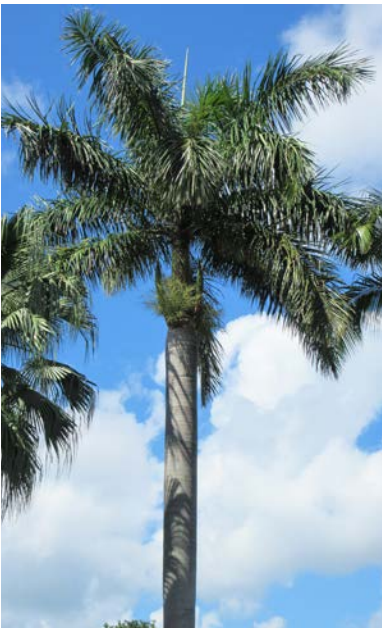
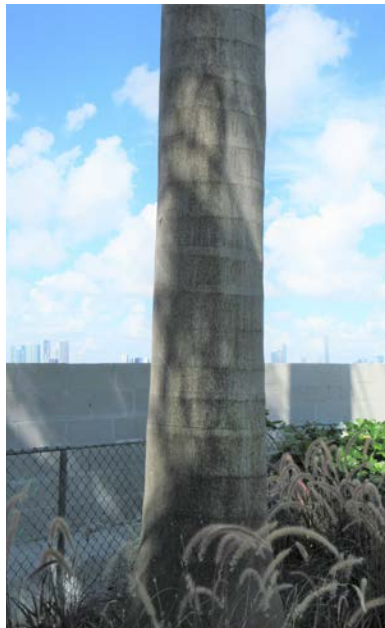
Tree #32 is a Royal Palm located on the west side of the backyard. It is in fair condition with a trunk injury with decay.

This tree has not been incorporated into the landscape plan and will therefore be removed.

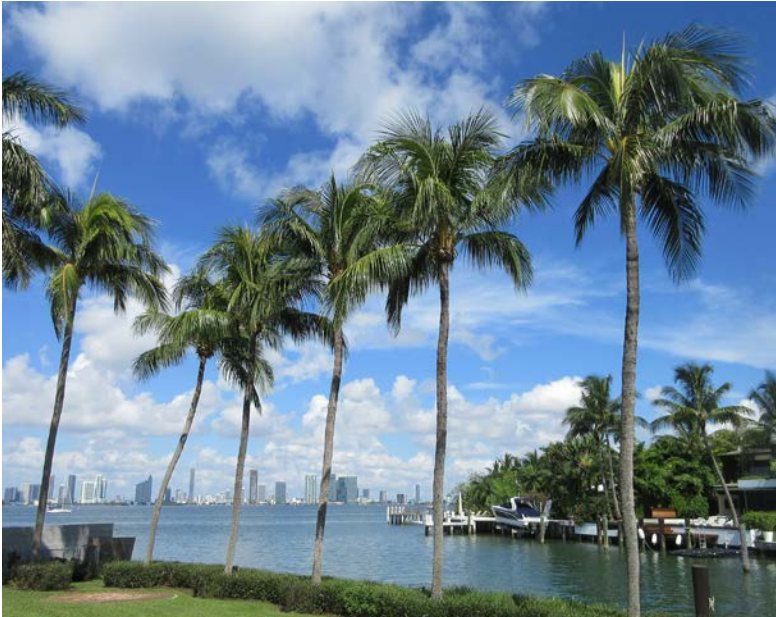
Trees #33 - 38 are six Coconut Palms located at the rear of the property. They are in fair condition with climbing spike injuries to the trunks. These trees have not been incorporated into the landscape plan and will therefore be removed.

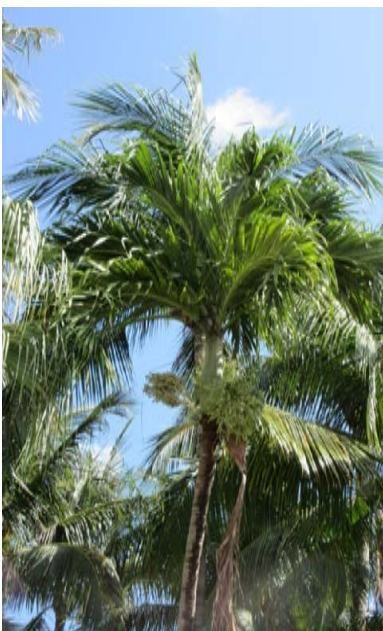
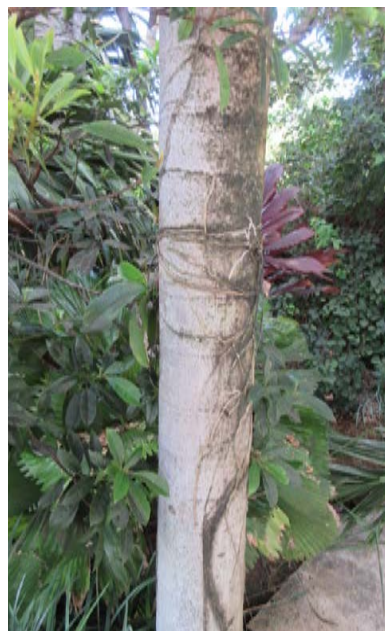
Tree #39 is a Christmas Palm located in the northeast corner of the backyard. It is in fair condition with yellow spotting on the fronds. This tree has not been incorporated into the landscape plan and will therefore be removed.

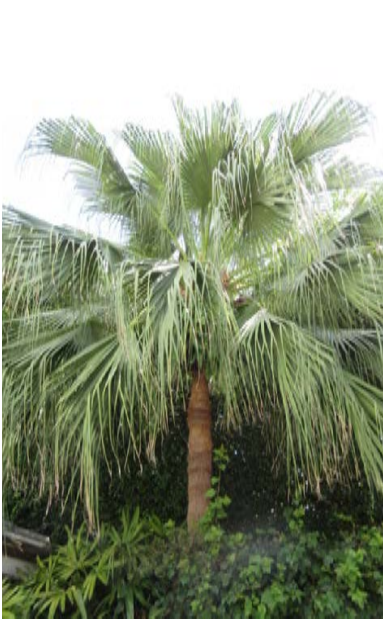
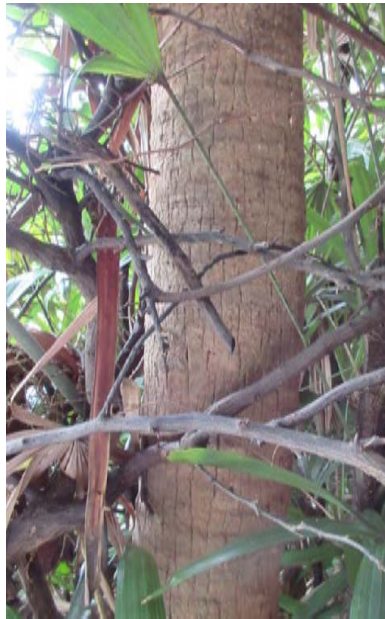
Tree #40 is a Chinese Fan Palm located on the east side of the backyard. It is in good condition. This tree has not been incorporated into the landscape plan and will therefore be removed.

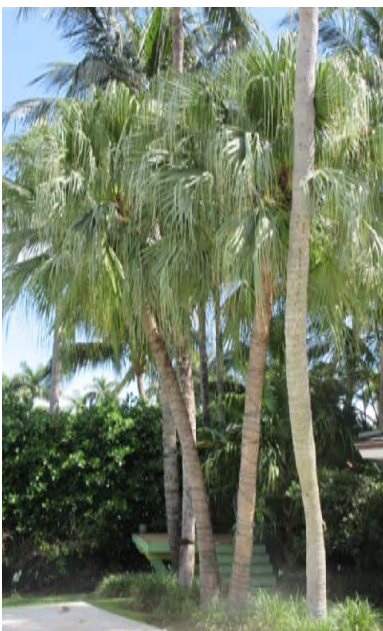
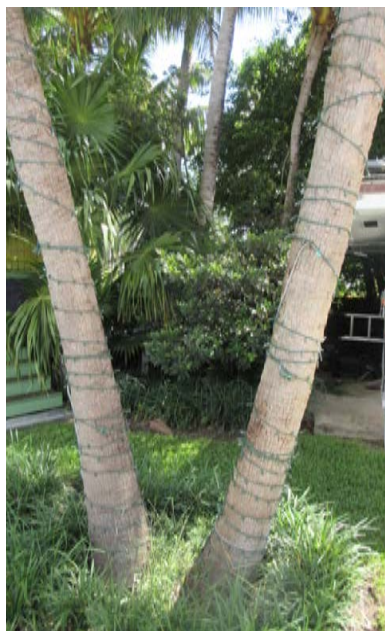
Trees #41 - 42 are two Chinese Fan Palms located east of the pool deck. They are in good condition. These trees have not been incorporated into the landscape plan and will therefore be removed.

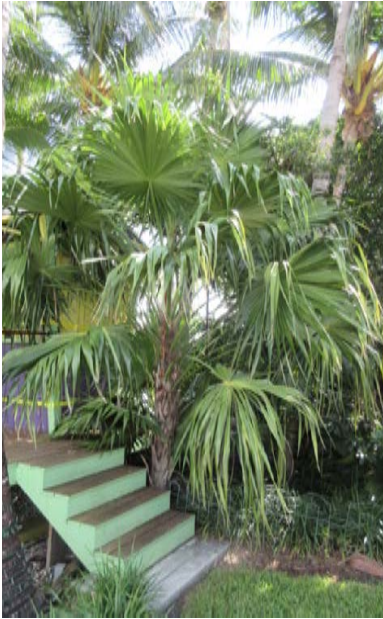
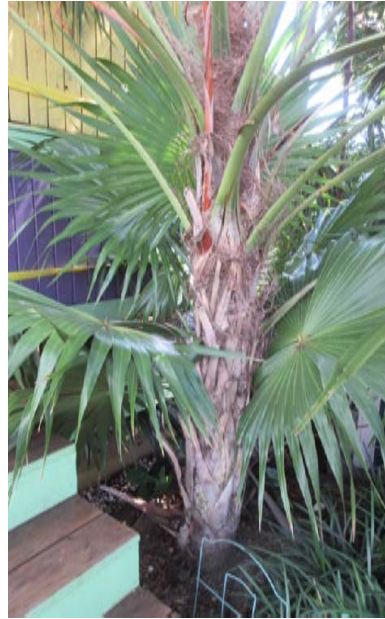
Tree #43 is a Florida Thatch Palm located in the northeast corner of the backyard. It is in good condition. This tree is to be relocated and root pruning shall occur a minimum of 4-6 weeks prior to digging the palm and shall be performed or supervised by Certified Arborist. Minimum rootball measurement shall be based upon the most recent *Florida Grades & Standards for Nursery Plants*. Prior to transplanting, the apical bud shall be protected by tying up palm fronds. Leaves shall be untied as soon as the palm is planted. When lifting the palm, a nylon sling with adequate padding shall be used and care shall be taken to not injure or compress the trunk. Plant at grade, with 2" of root initiation zone visible if applicable. Transplanting shall occur as soon as possible and no more than 24 hours after being dug for relocation. The backfill soil shall be irrigated during and following relocation. Wooden braces shall be installed to stabilize the tree. Following relocation, a 6.5ft radius TPZ shall be erected.

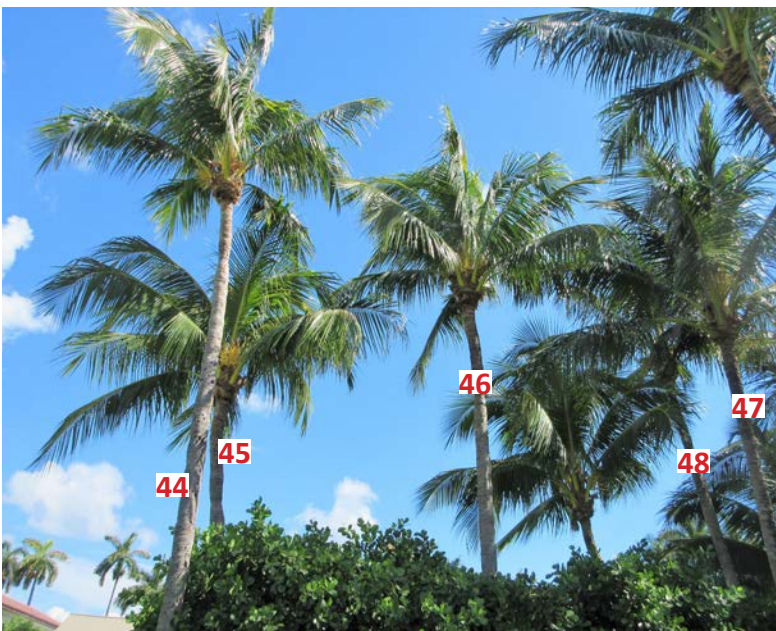
Trees #44 - 48 are five Coconut Palms located in the northeast corner of the backyard. They are in fair condition with climbing spike injuries on the trunks. These trees have not been incorporated into the landscape plan and will therefore be removed.

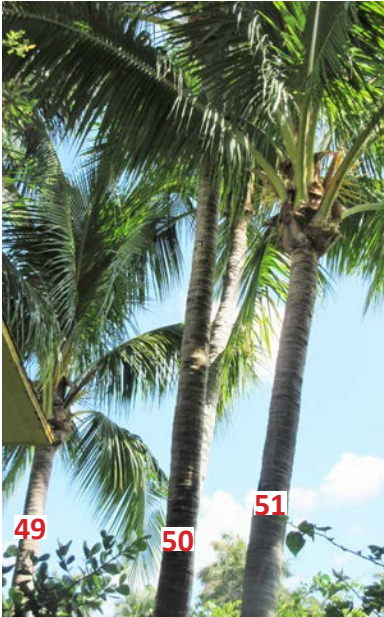
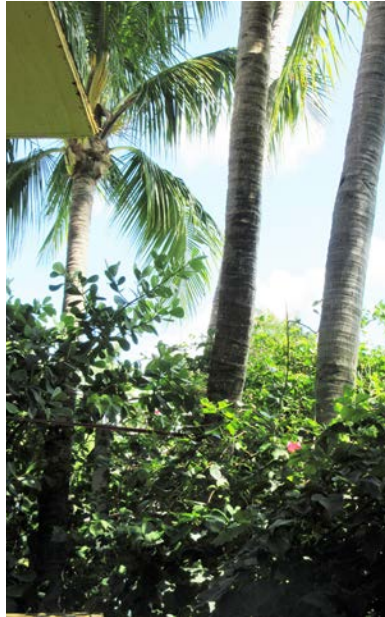
Trees #49 - 51 are three Coconut Palms located in the rear northeast corner of the backyard. They are in good condition. Tree #51 has not been incorporated into the landscape plan and will therefore be removed. Trees #49 - 50 are to be relocated and root pruning shall occur a minimum of 4-6 weeks prior to digging the palm and shall be performed or supervised by Certified Arborist. Minimum rootball measurement shall be based upon the most recent *Florida Grades & Standards for Nursery Plants*. Prior to transplanting, the apical bud shall be protected by tying up palm fronds. Leaves shall be untied as soon as the palm is planted. When lifting the palm, a nylon sling with adequate padding shall be used and care shall be taken to not injure or compress the trunk. Plant at grade, with 2" of root initiation zone visible if applicable. Transplanting shall occur as soon as possible and no more than 24 hours after being dug for relocation. The backfill soil shall be irrigated during and following relocation. Wooden braces shall be installed to stabilize the tree. Following relocation, a 7ft radius TPZ shall be erected around each tree.

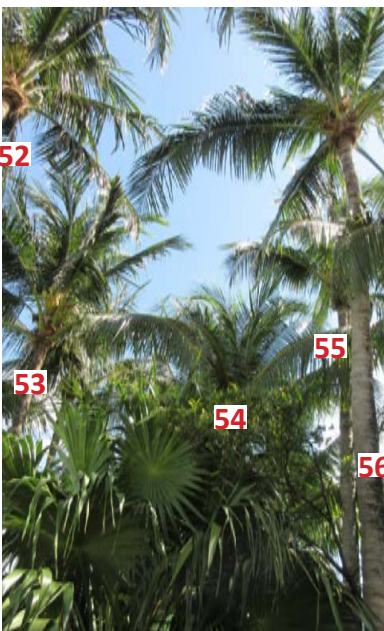
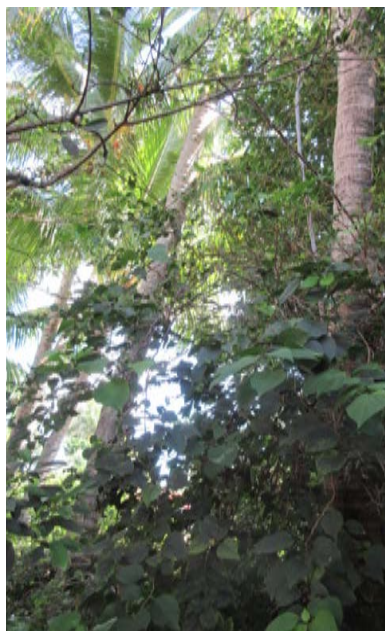
Trees #52 - 56 are five Coconut Palms located in the rear northeast corner of the backyard. They are in good condition. Tree #56 has not been incorporated into the landscape plan and will therefore be removed. Trees #52 - 55 are to be relocated and root pruning shall occur a minimum of 4-6 weeks prior to digging the palm and shall be performed or supervised by Certified Arborist. Minimum rootball measurement shall be based upon the most recent *Florida Grades & Standards for Nursery Plants*. Prior to transplanting, the apical bud shall be protected by tying up palm fronds. Leaves shall be untied as soon as the palm is planted. When lifting the palm, a nylon sling with adequate padding shall be used and care shall be taken to not injure or compress the trunk. Plant at grade, with 2" of root initiation zone visible if applicable. Transplanting shall occur as soon as possible and no more than 24 hours after being dug for relocation. The backfill soil shall be irrigated during and following relocation. Wooden braces shall be installed to stabilize the tree. Following relocation, a 7ft radius TPZ shall be erected around each tree.

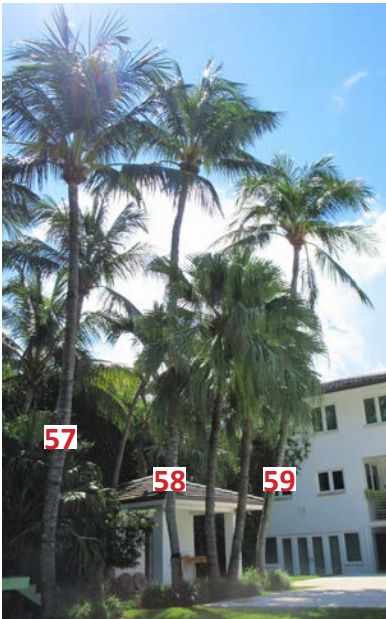
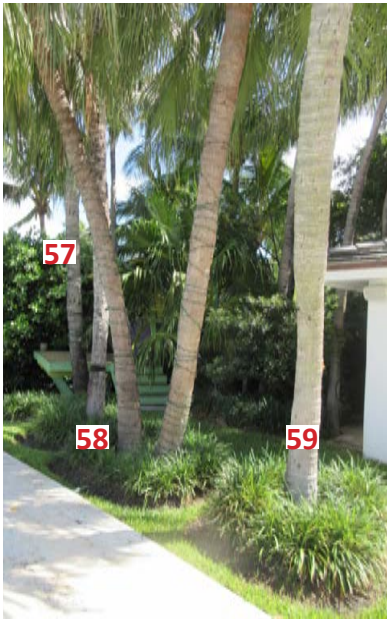
Trees #57 - 59 are three Coconut Palms located to the east of the pool deck. They are in fair condition with climbing spike injuries on the trunks. These trees have not been incorporated into the landscape plan and will therefore be removed.
