# ARBORIST REPORT

## 5860 La Gorce Drive

## Miami Beach, FL 33140

Treage LLC ~ Tree and Garden Experts  
www.treage.com ~ info@treage.com ~ 786.525.7883

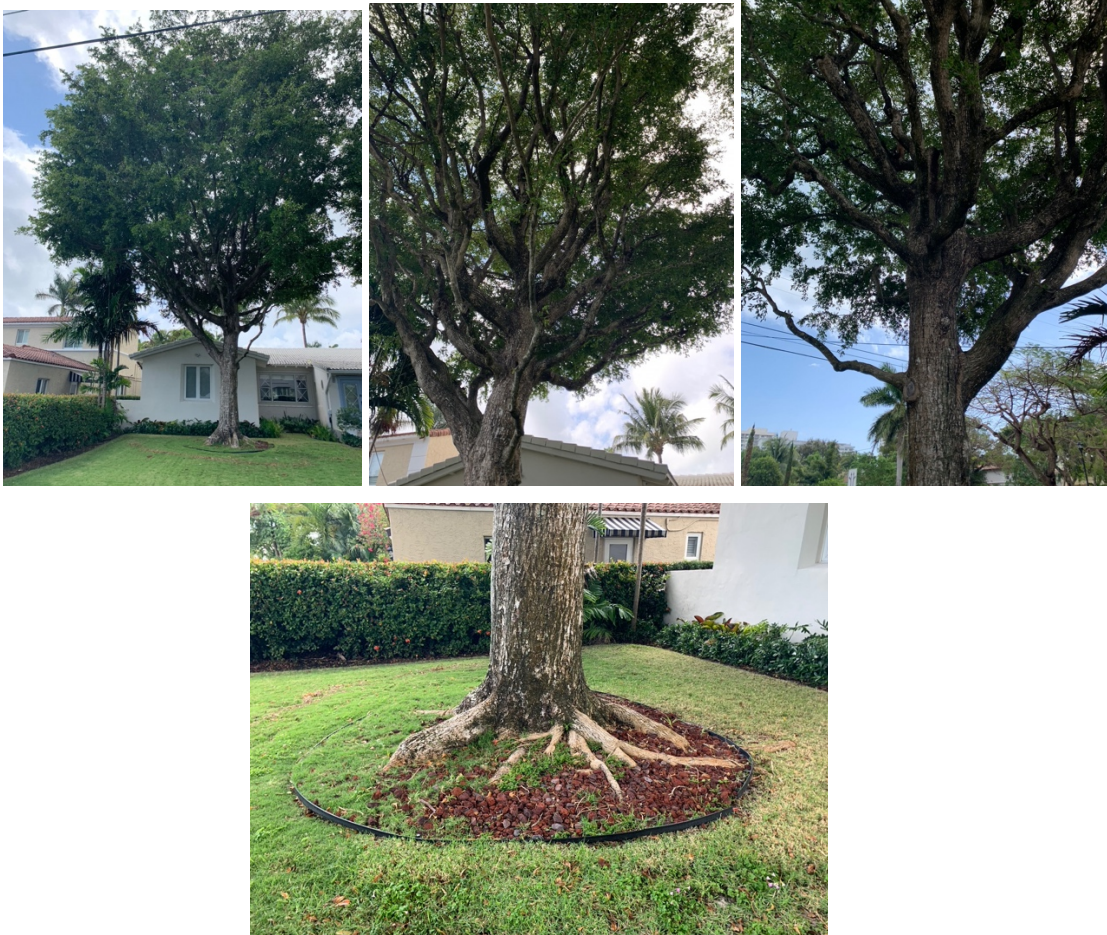
**Tree #1– *Bucida buceras*, Black Olive** – this tree is located in the front yard on the south side of the property. It is in fair to good condition with no significant defects other than a minimal deadwood, crossing branches, and a constricted canopy on the north side of the tree. It is proposed for removal due to a 561 sq ft. addition in the front of the residence on the south side. The trunk of the tree is currently less than 15' from the existing foundation, which will be extended by approximately 15'. This tree has presented some maintenance issues in the past, and the potential of future damage to the pipes/septic system and foundation of the house is of concern to the property owners. This tree is proposed for removal, and its mitigation will be covered by the installation of more appropriate native trees.

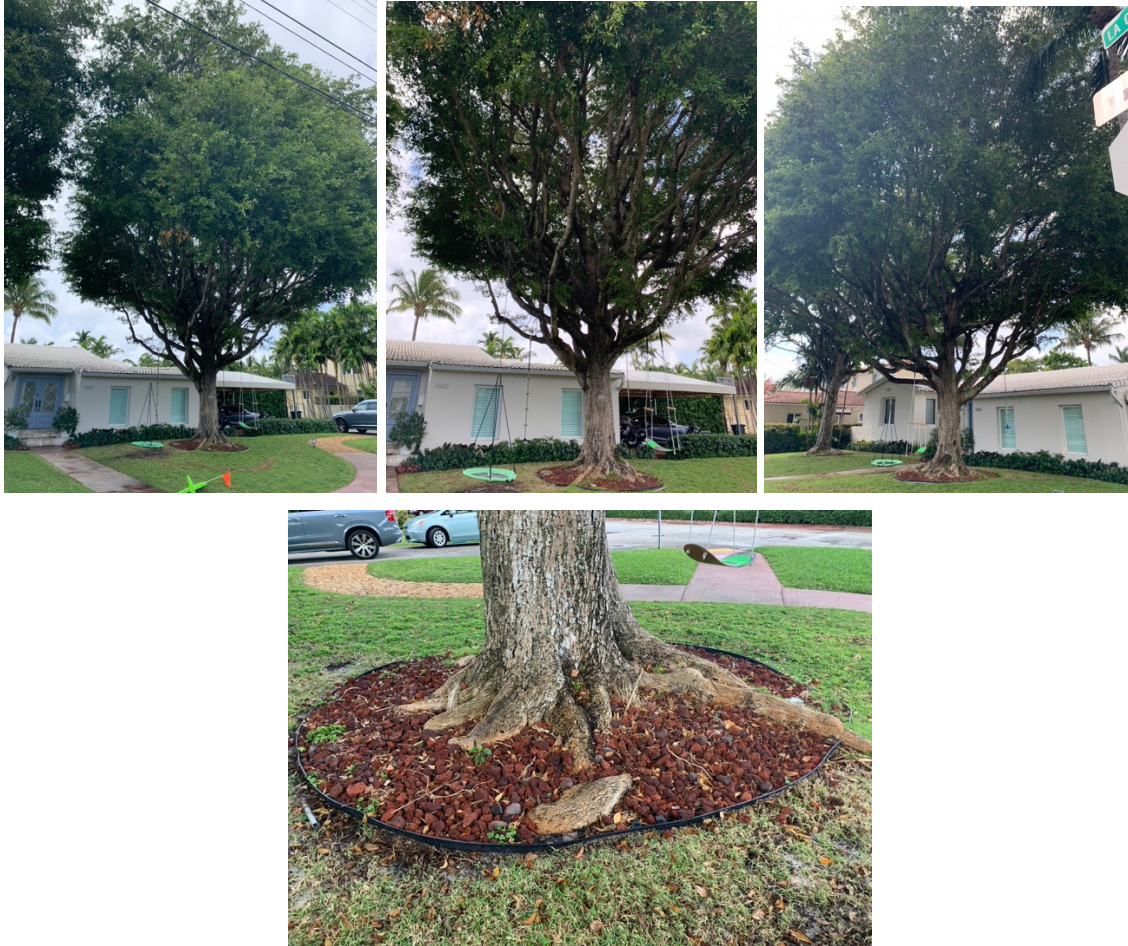
**Tree #2 – *Bucida buceras*, Black Olive** – this tree is located on the north side of the front yard. It is in fair to good condition with no significant defects other than a somewhat sparse canopy on the south side of the tree due to its proximity due to Tree #1. This tree is proposed for removal due to a 157 sq ft. addition in the front of the residence which will further reduce the current distance of 14' between the tree and foundation of the house. This tree is also of concern to the owners due to its aggressive root system and messy canopy, so they would like to remove it and replace it with a more appropriate native tree.

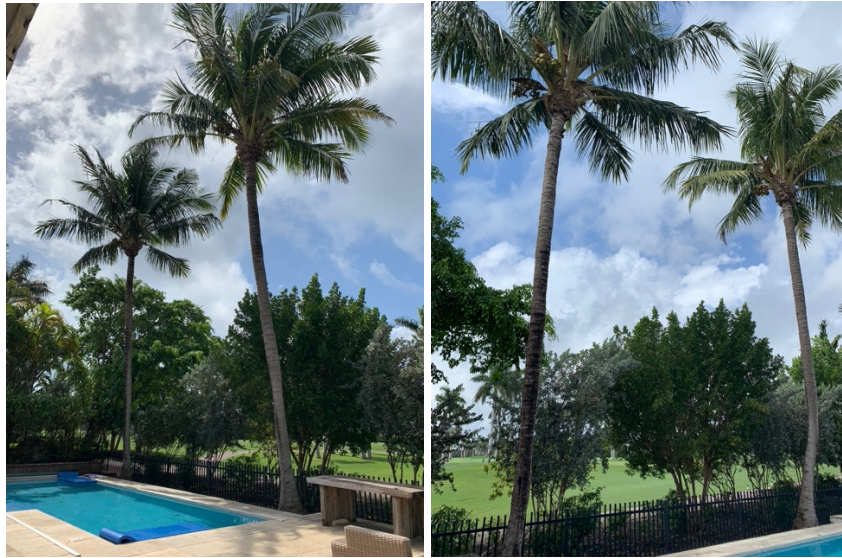
**Tree #3 – *Cocos nucifera*, Coconut** – this palm is located on the south side of the backyard/pool area. It is not near the work area nor any access route to the work area, so it will not be impacted by construction activities. This tree will remain.

**Tree #4 – *Cocos nucifera*, Coconut** – this palm is located on the north side of the backyard/pool area. It is not near the work area nor any access route to the work area, so it will not be impacted by construction activities. This tree will remain.

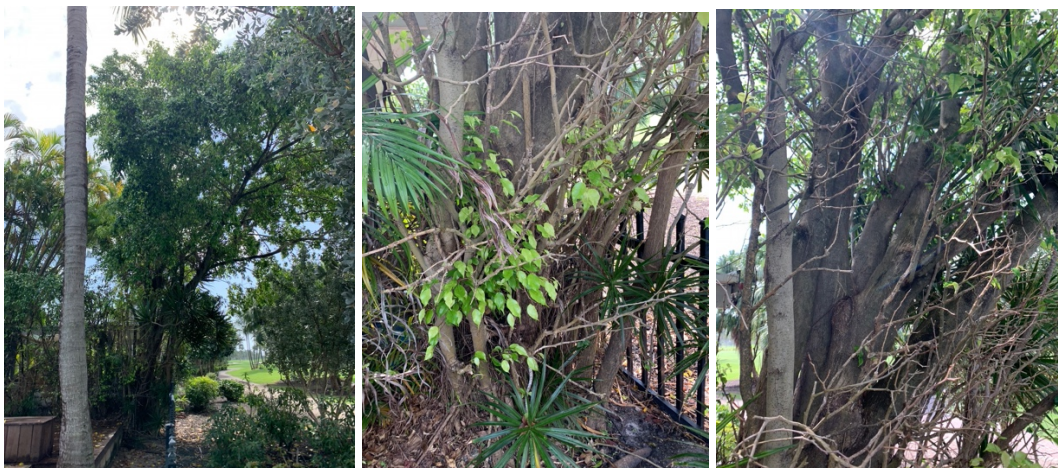
**Tree #5 – *Ficus benjamina*, Weeping Fig** – this tree is located on the west end of an existing Ficus hedge in the back yard. It is overgrown and leaning with the majority of the canopy extending over the property line onto the neighboring golf course. There is some deadwood and decay present. This tree will not be impacted by any construction activities or access, and is currently intended to remain.

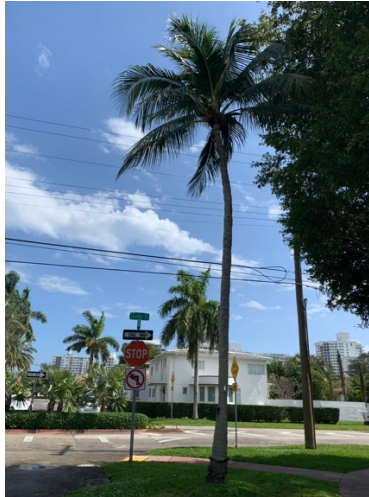
**Tree #6 – *Cocos nucifera*, Coconut** – this palm is located in the ROW just outside of the northeast corner of the property. It is in close proximity to Trees #1 and #2 and may require protection during their removal. See protection measures below.

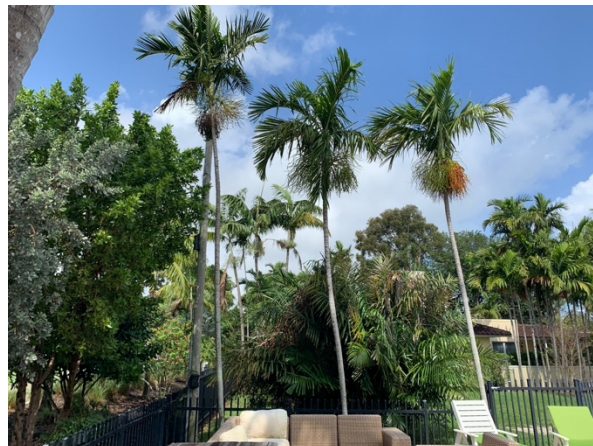
**Tree #7 – *Ptychosperma elegans*, Solitaire Palm** – this is the easternmost of 3 palms located just outside of the fence at the property line on the north side of the backyard. It is not near the work area nor any access route to the work area, so it will not be impacted by construction activities. This tree will remain.

**Tree #8 – *Ptychosperma elegans*, Solitaire Palm** – this is the middle of 3 palms located just outside of the fence at the property line on the north side of the backyard. It is not near the work area nor any access route to the work area, so it will not be impacted by construction activities. This tree will remain.

**Tree #9 – *Ptychosperma elegans*, Solitaire Palm** – this is the westernmost of 3 palms located just outside of the fence at the property line on the north side of the backyard. It is not near the work area nor any access route to the work area, so it will not be impacted by construction activities. This tree will remain.

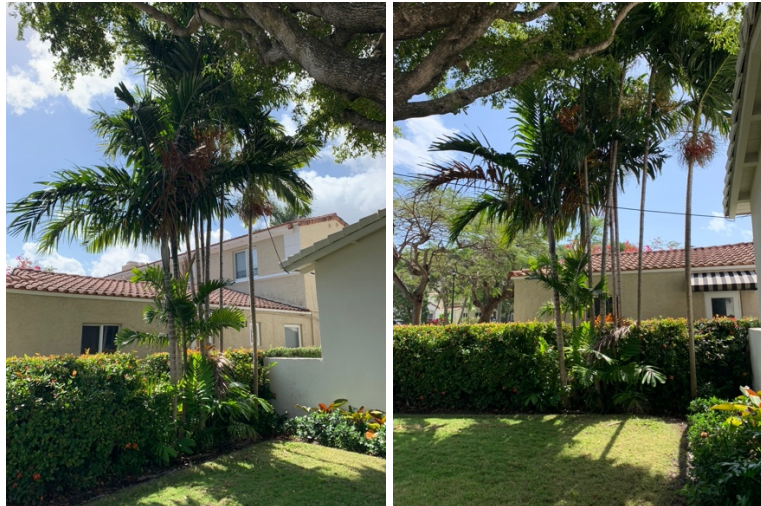
**Tree #10 – *Ptychosperma elegans*, Solitaire Palm** – there is a cluster of 8 Solitaire palms growing on the south side of the front yard, 6 of which are over the size requiring regulation. These palms are in proximity of the work area but will remain and will require protection during construction.
