Tree Resource Evaluation for 4000 Alton Road, Miami Beach

May 11, 2020

I performed a tree resource evaluation on the property located at 4000 Alton Road, Miami Beach on May 2nd and 3rd 2020. The approximate locations of these trees and palms can be found on the schematic in Appendix B.

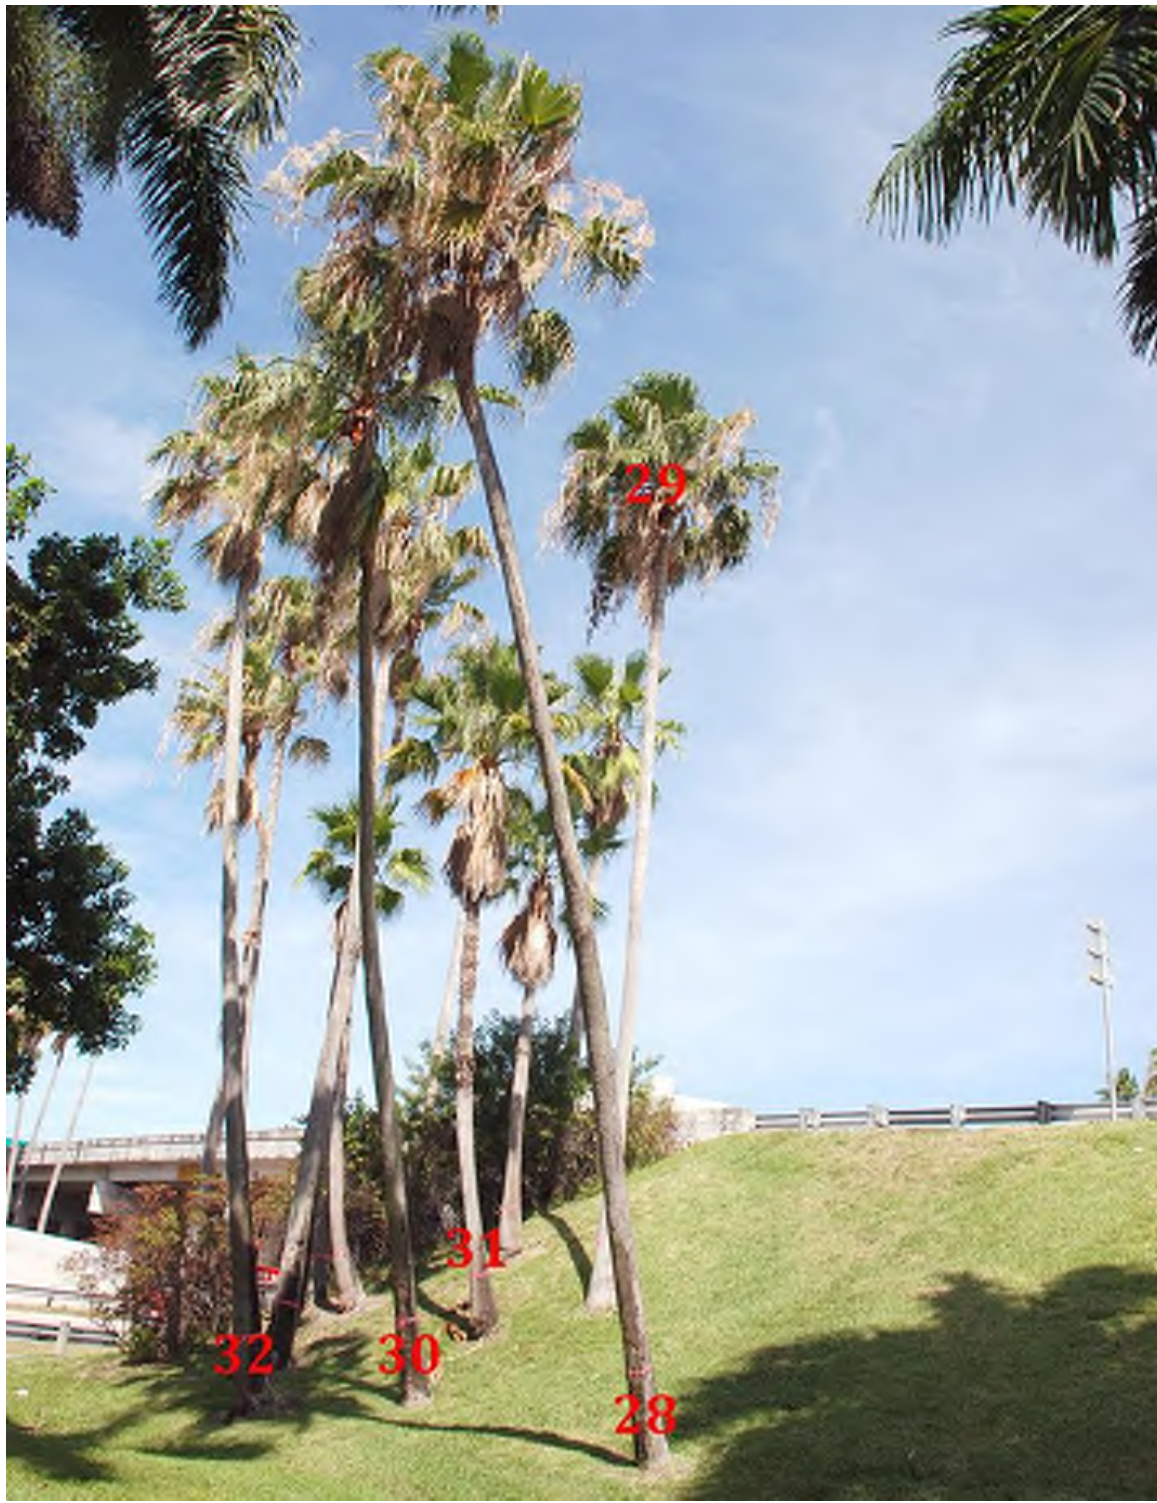
Photo 16 above is palms 28, 30, 31 & 32. Palms 28 & 30 are rated as moderate due the lean of the trunk.

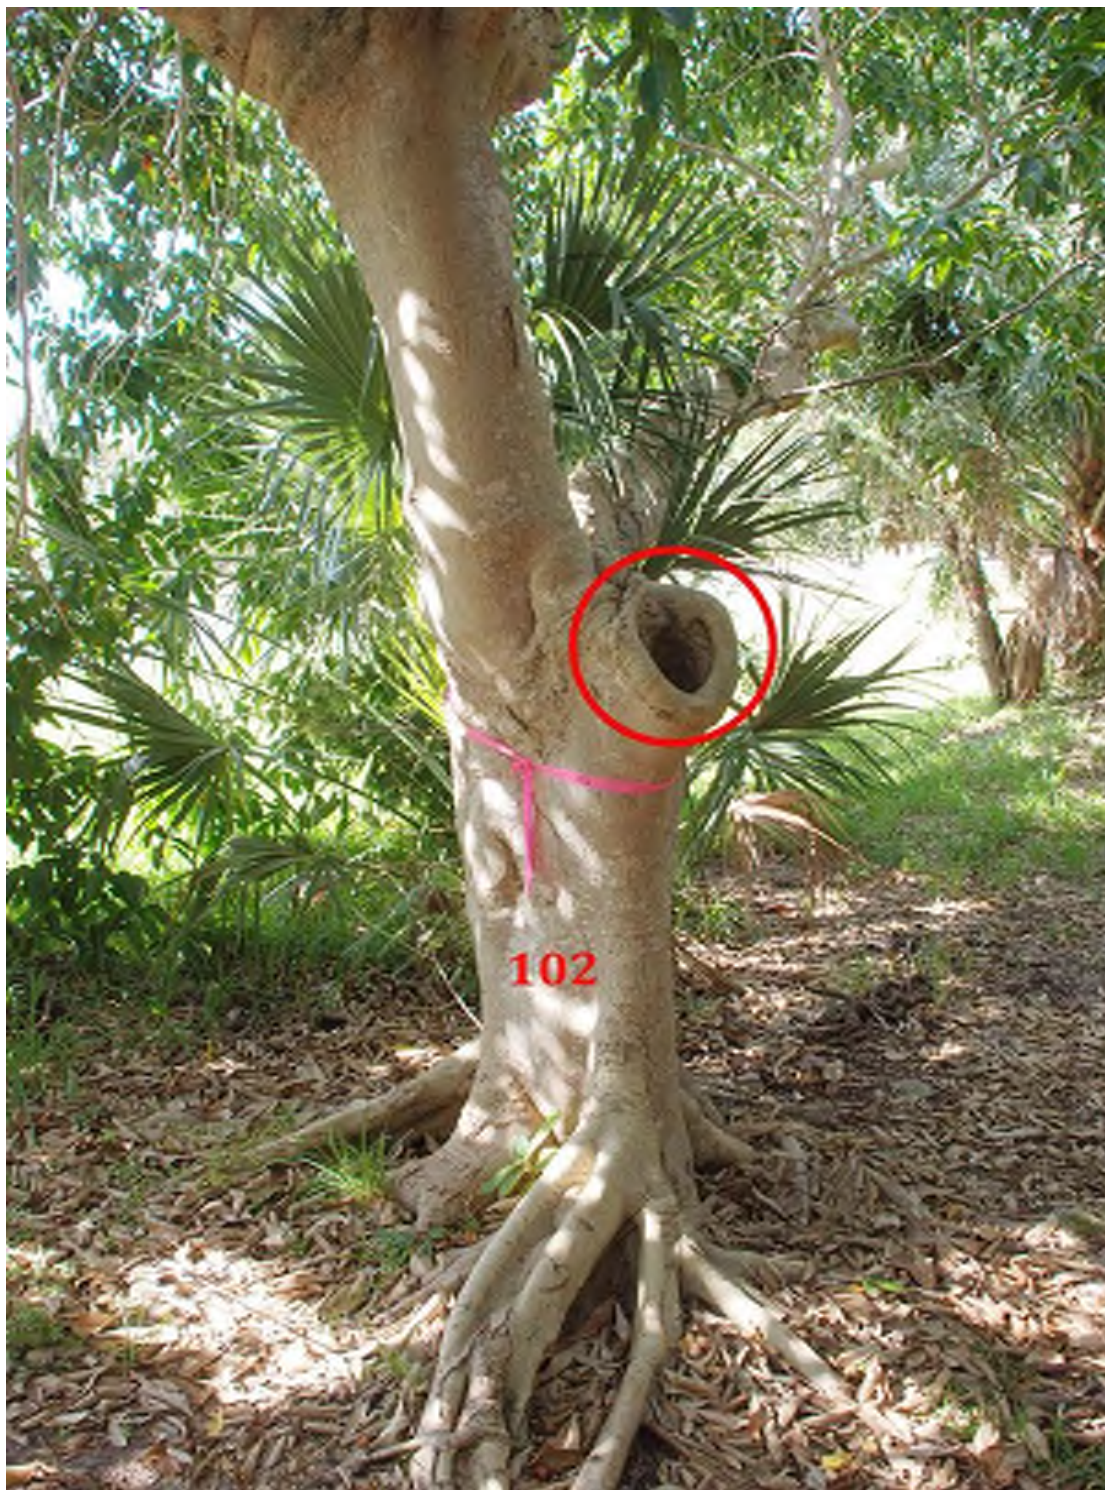
Photo 62 above is the trunk of tree 102 viewed from the north. There is a cavity indicated however there appears to be no active decay.

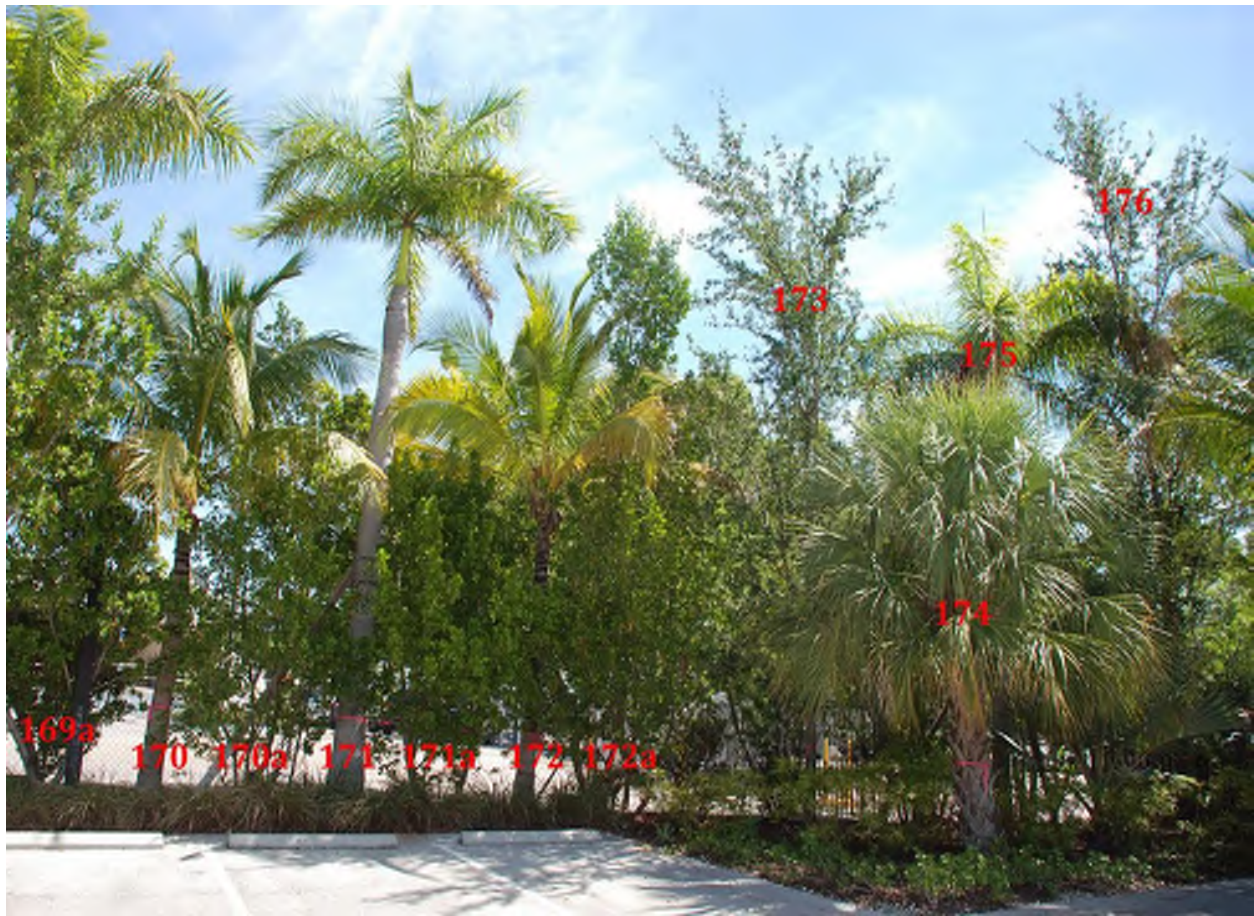
Photo 85 above is palms 171, 172 & 175 showing signs of severe nutrient deficiencies.

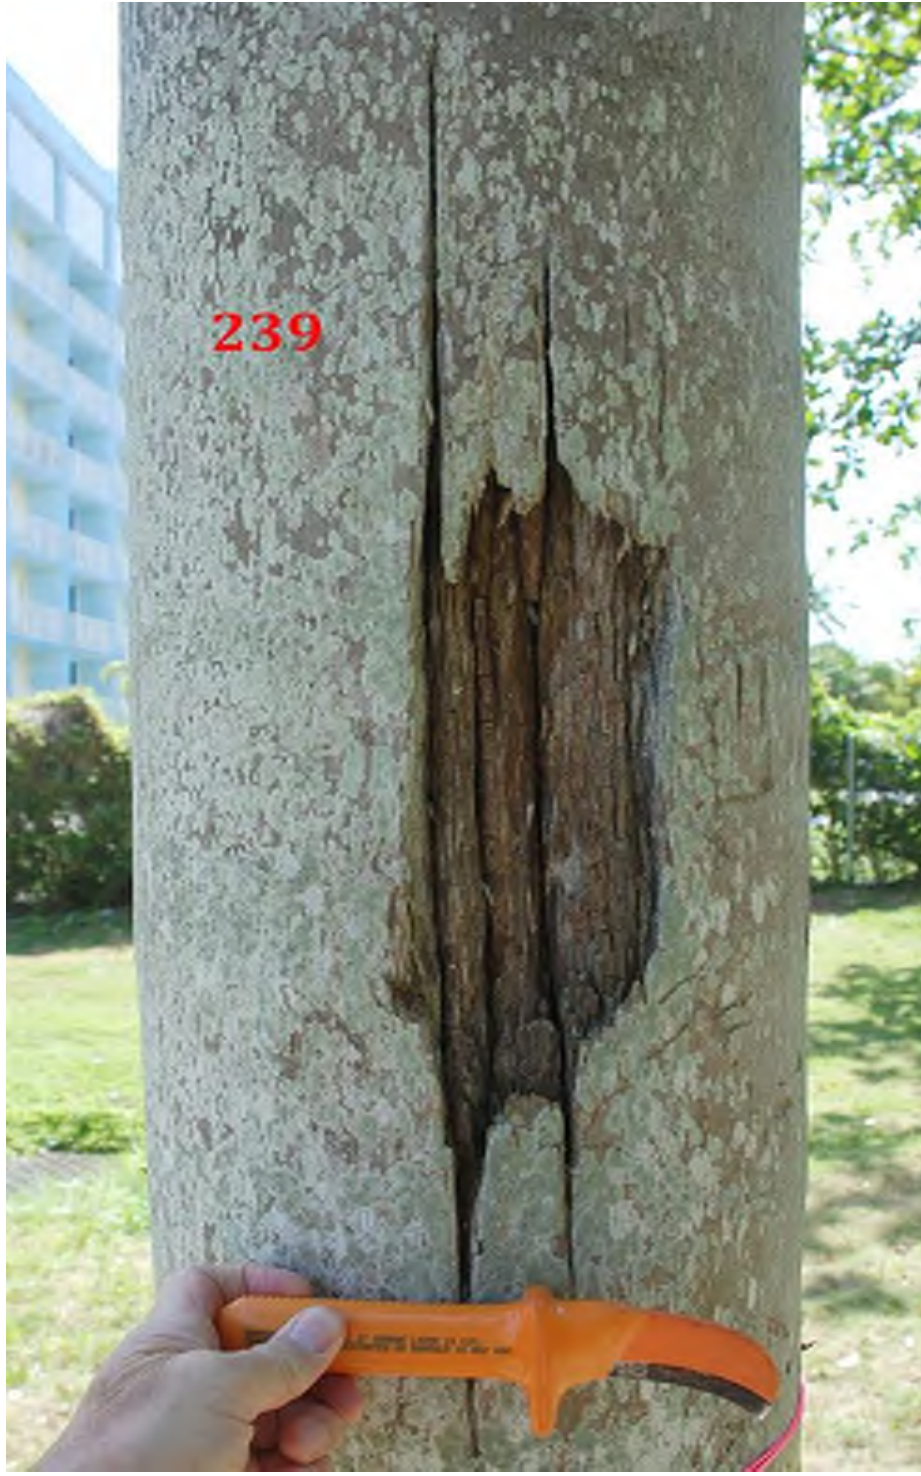
Photo 134 above is the cracked and damaged trunk of palm 239. This palm should be removed. The orange knife is 7 inches in length.
